ABANDONED MINE FEATURES ASSESSMENT

WHEAL ELLEN, WA REHABILITATION REPORT

11953-G-R-002 Public Document

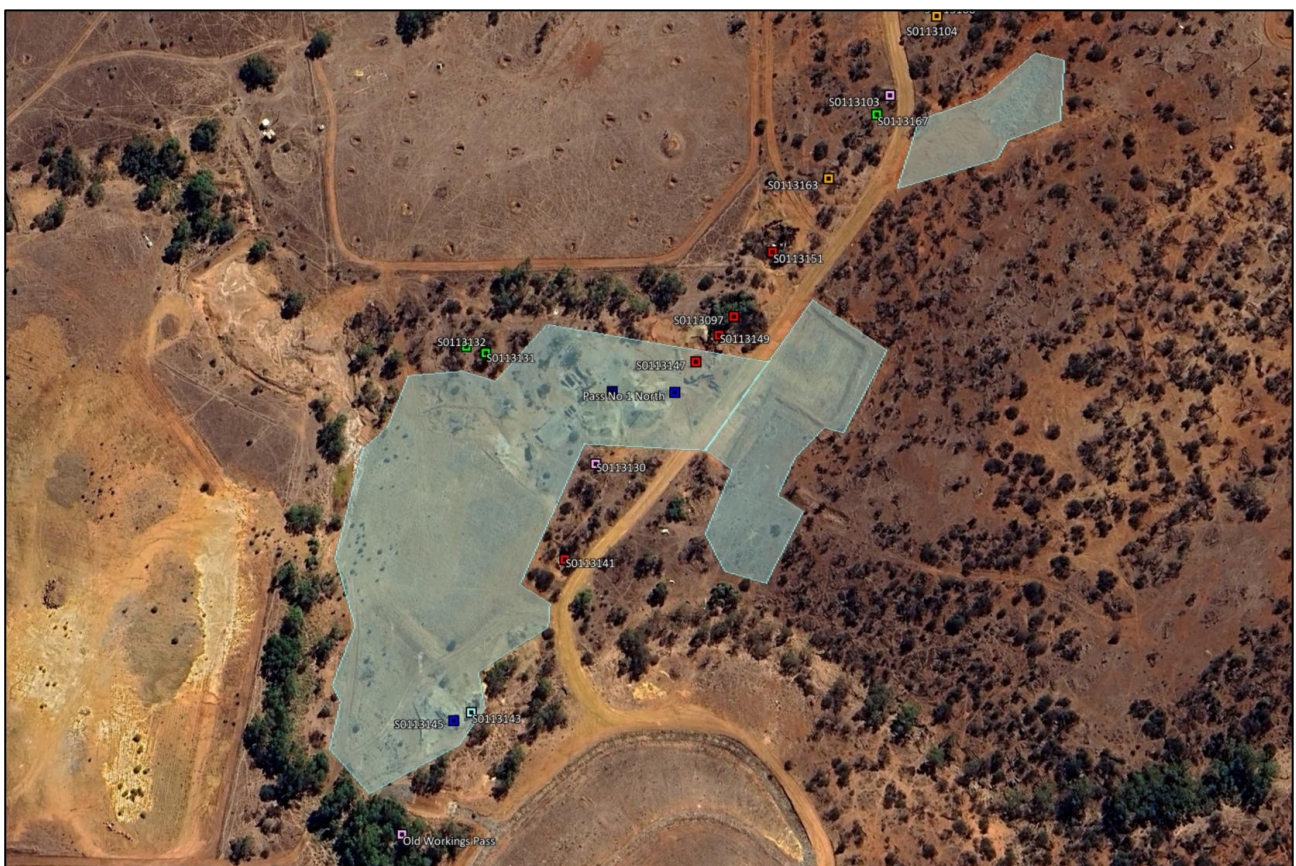
Figure 1: Potential areas of fill source

Fill may potentially be won from the areas indicated on Figure 1. It is anticipated that up to 0.6 m to 1 m of material may be available. However, this option would require further investigation by way of excavation of test pits to determine the depth of fill material and 3D ground modelling to determine the volume available for use.

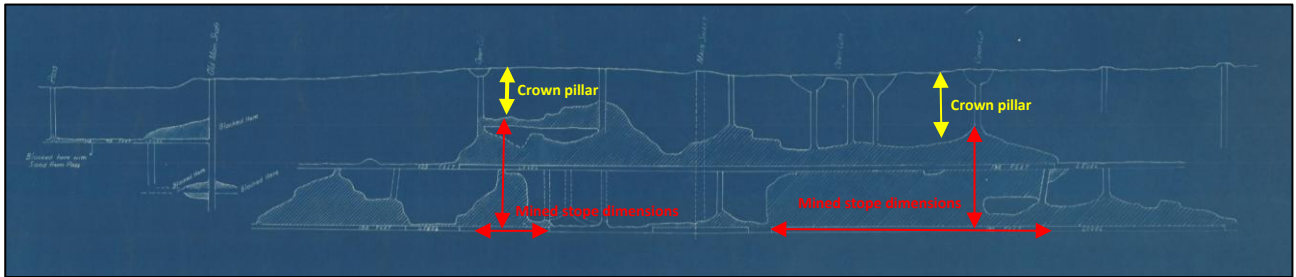
Figure 2: Longitudinal plan of workings (1926)

hundred millimetres. Vehicle loadings from 4x4 vehicles and light plant are not expected to cause failure of the underground stopes.

Based on the above, large machinery, when not actively working on the rehabilitation of the mine features, should maintain an offset distance of 5 m from the edge of known mine voids or the open cut slopes. The risk of voids or subsidence occurring outside of this exclusion zone is very low.

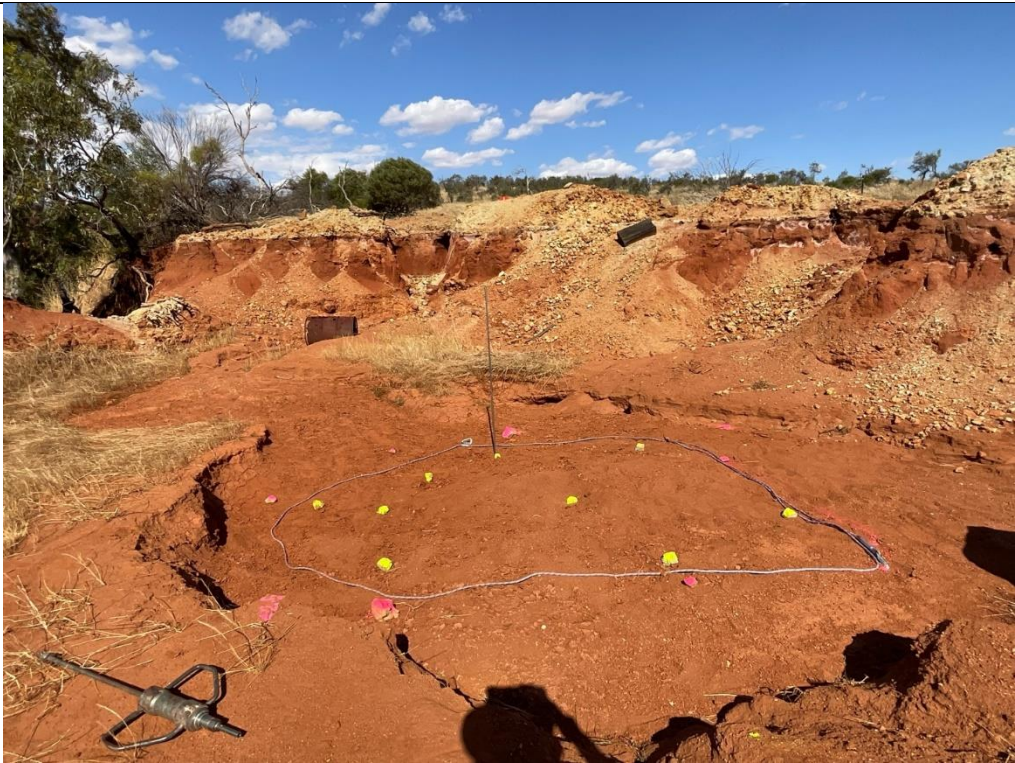
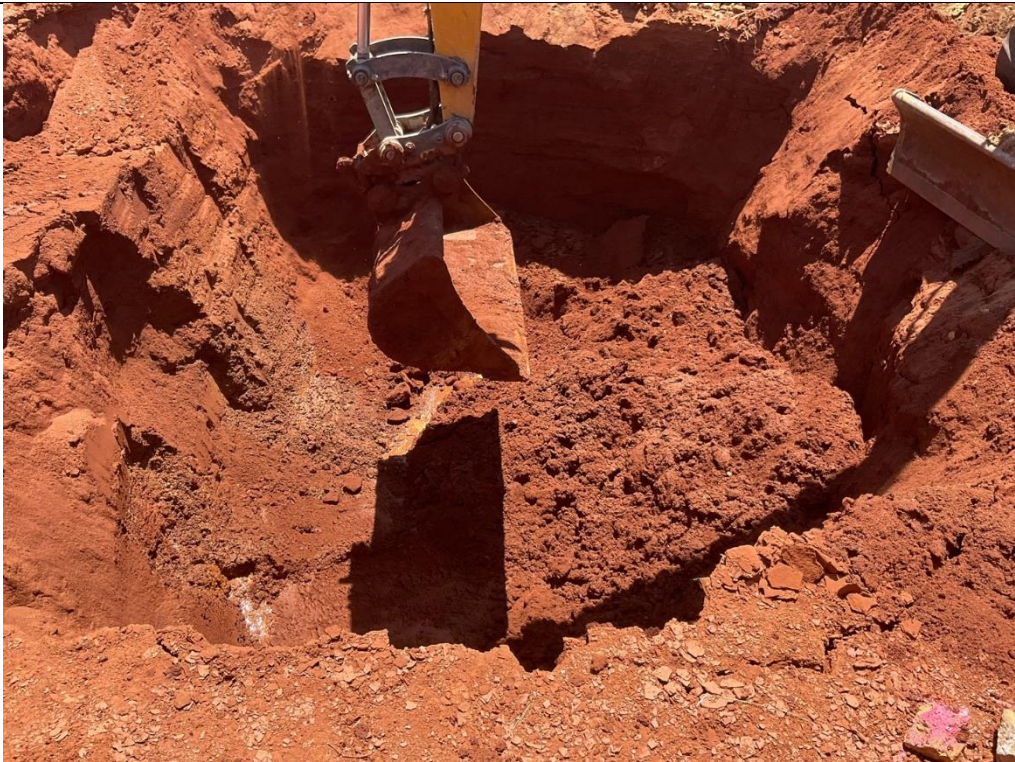
Feature S0113147	Project No:	11953
	Client: Department of Energy, Mines, Industry Regulation and Safety (DEMIRS)	Date:	18/11/24

During the investigation undertaken by GHD in 2020, a sinkhole was observed at Feature S0113147. It should be noted that this feature has been historically mapped to comprise lateral workings and is situated within an erosion gully that transports with loose silty materials into the shaft. After periods of prolonged rainfall or after the wet season, these silty materials become saturated and can become suspended in water and have very little to no shear strength. In this condition, the soils are susceptible to sudden and catastrophic deformation (i.e. sinkholes) which occur because the soil cannot hold itself under its own weight and “liquefies”. The soil in the base of the feature behaves like a liquid and flows downwards into the network of underground lateral mine workings (i.e. flow liquefaction).

These features are situated within lower lying areas and are susceptible to surface run-on / run-off erosion. Evidence of erosion within the walls of the open cuts was observed on site and Feature S0113147 is situated within an erosion gully and is backfilled with silty materials that have washed into the void. Improving the drainage in the areas around these features is recommended to prevent erosion and minimise ponding on top of the rehabilitated features.
