ABANDONED MINE FEATURES ASSESSMENT

NORTHAMPTON – COMMONAGE & WANERENOOKA REHABILITATION OPTIONS STUDY

11126-G-R-002 Public Document

11126-G-R-001 Public Document

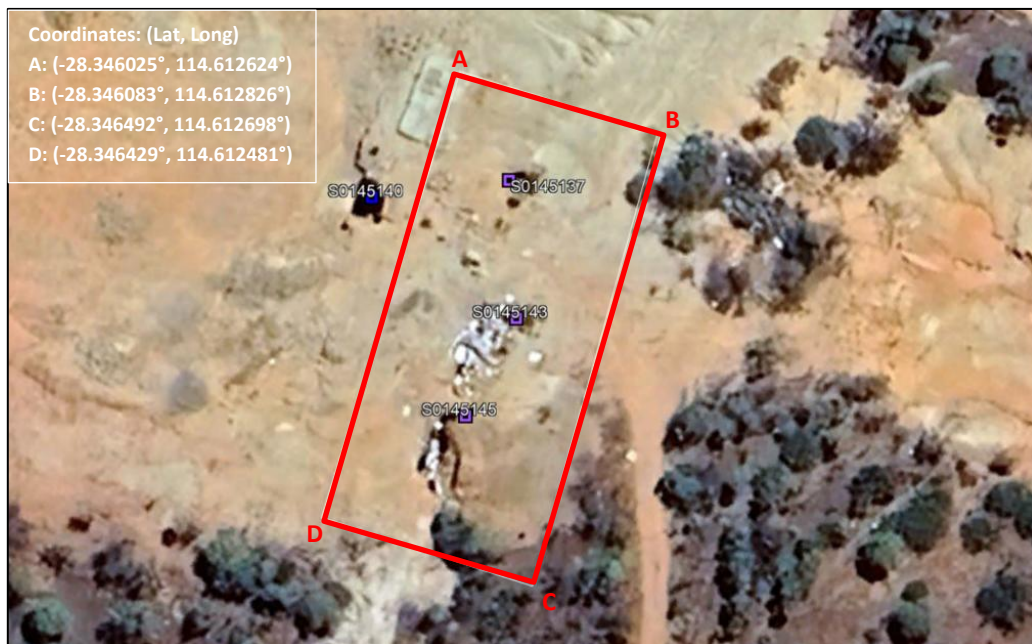
Figure 1: Reinforced earth area Commonage (Area 1)

These areas may be prone to subsidence and pose high risk to humans, livestock, pets, and vehicles. In addition to the recommended treatment individual features within these areas may be subject to, it is also recommended that the surrounding ground in these areas be rehabilitated.
