ABANDONED MINE FEATURES ASSESSMENT

MORAWA-YALGOO ROAD GEOTECHNICAL REPORT

12009-G-R-001 Public Document

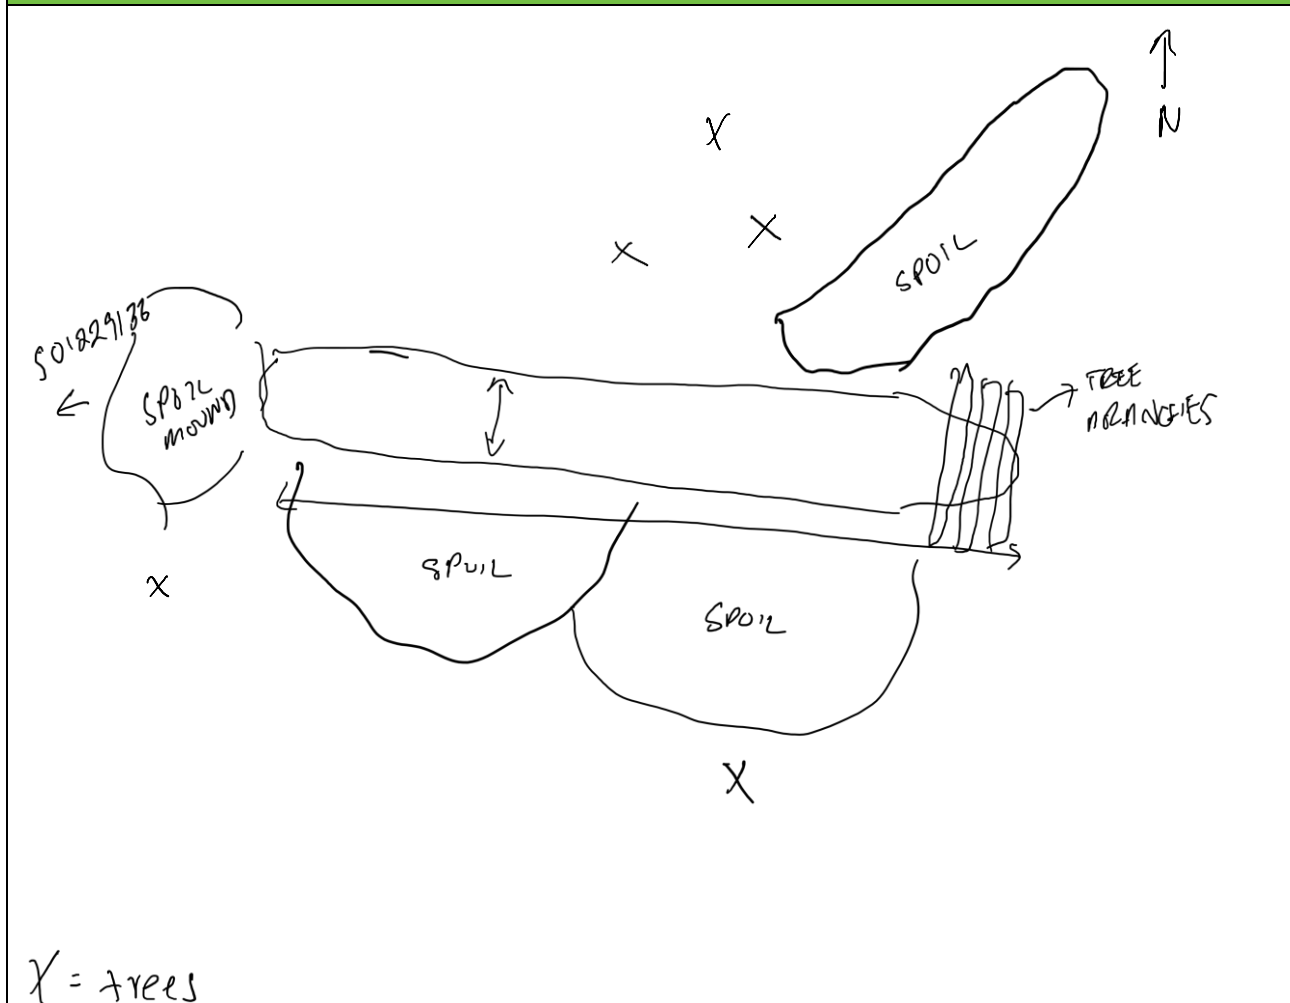
Sketch of Feature:

Rock mass / soil profile comments:	Preliminary remediation recommendations:
Poor quality rock mass from the ground surface, however the rock is more competent further north of the site.	Backfill with surrounding spoil material and imported fill.

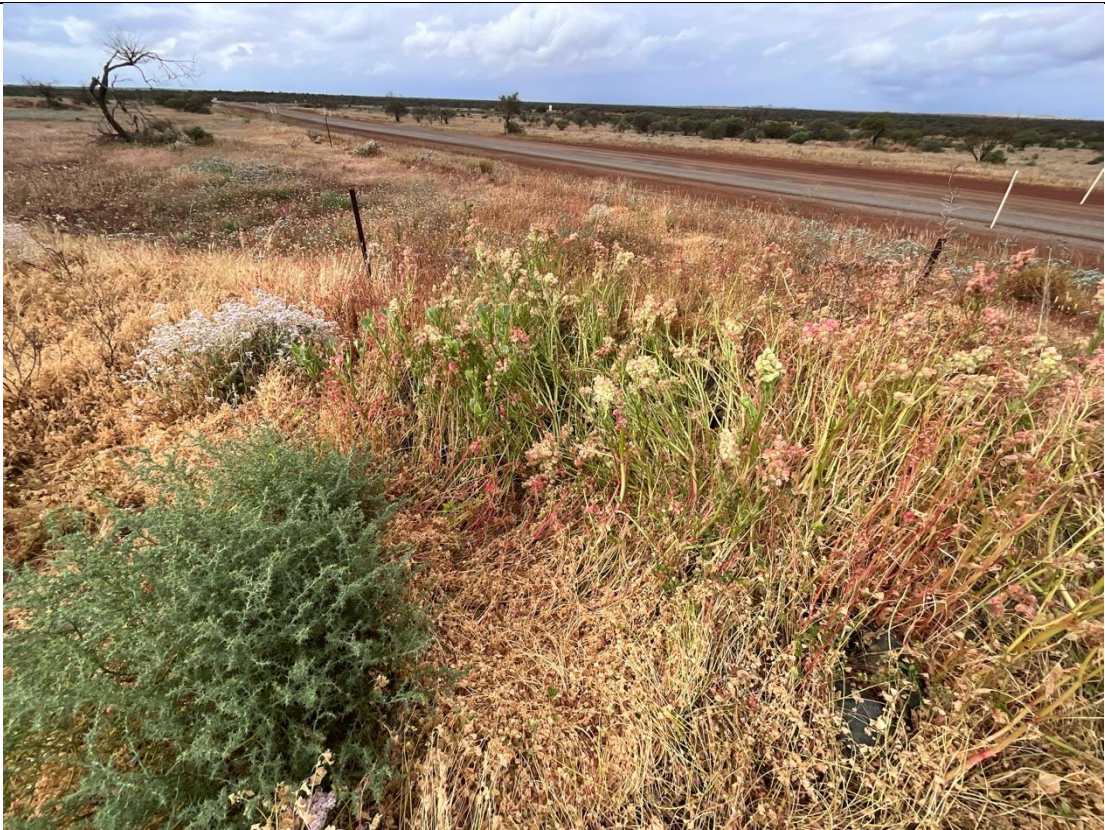
Figure 1

Rock mass / soil profile comments:	Preliminary remediation recommendations:
Poor quality rock mass as evidenced in the walls of the feature.	Pending results of phase 2 works.

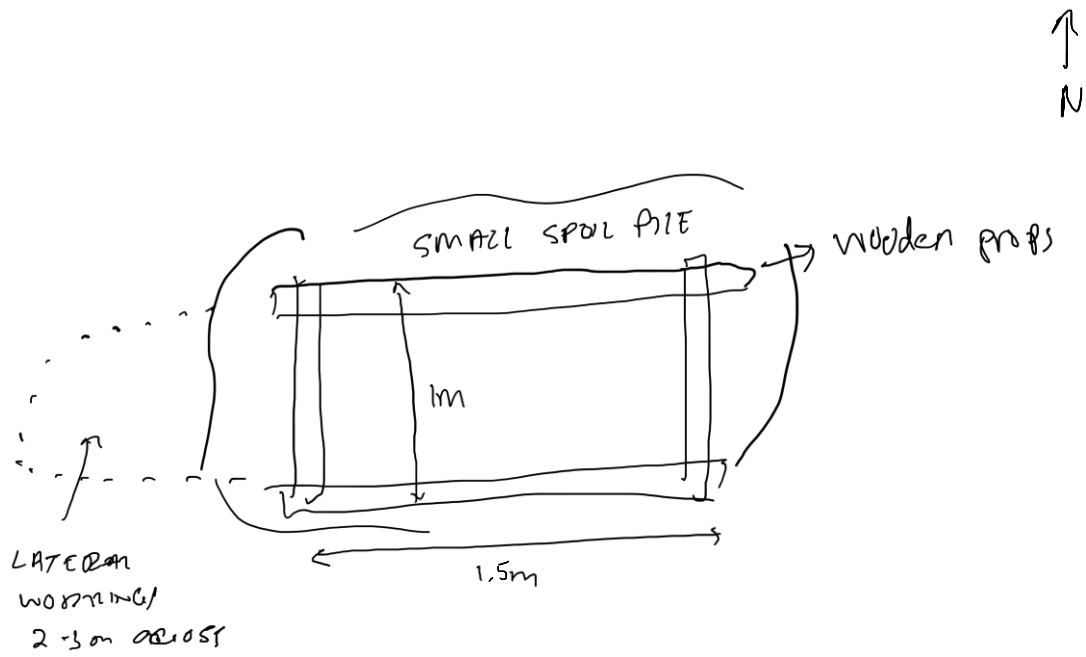
Rock mass / soil profile comments:	Preliminary remediation recommendations:
Poor quality rock mass. Near vertical rock walls. Highly weathered – rock may be dug with an excavator?	Break out drive and collapse in on itself. Mirafi soil plug the base of the shaft.

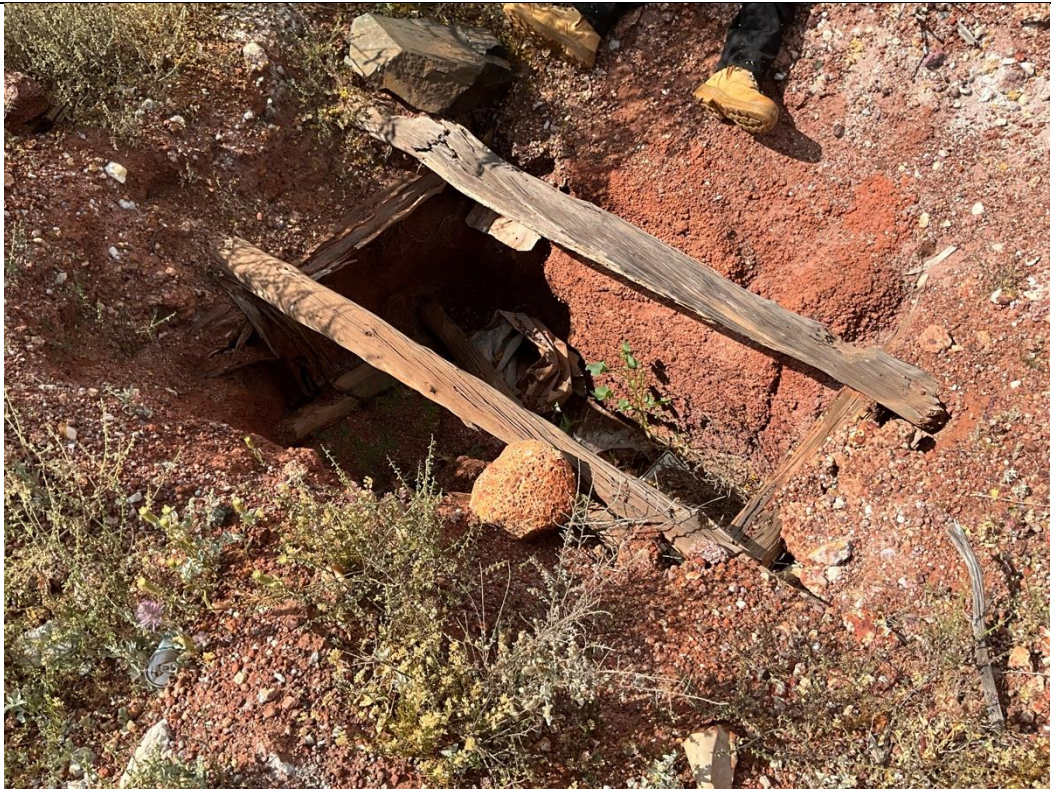
Figure 1

Rock mass / soil profile comments:	Preliminary remediation recommendations:
Cemented pizolithic gravels.	Mirafi cone plug – pending phase 2 results.

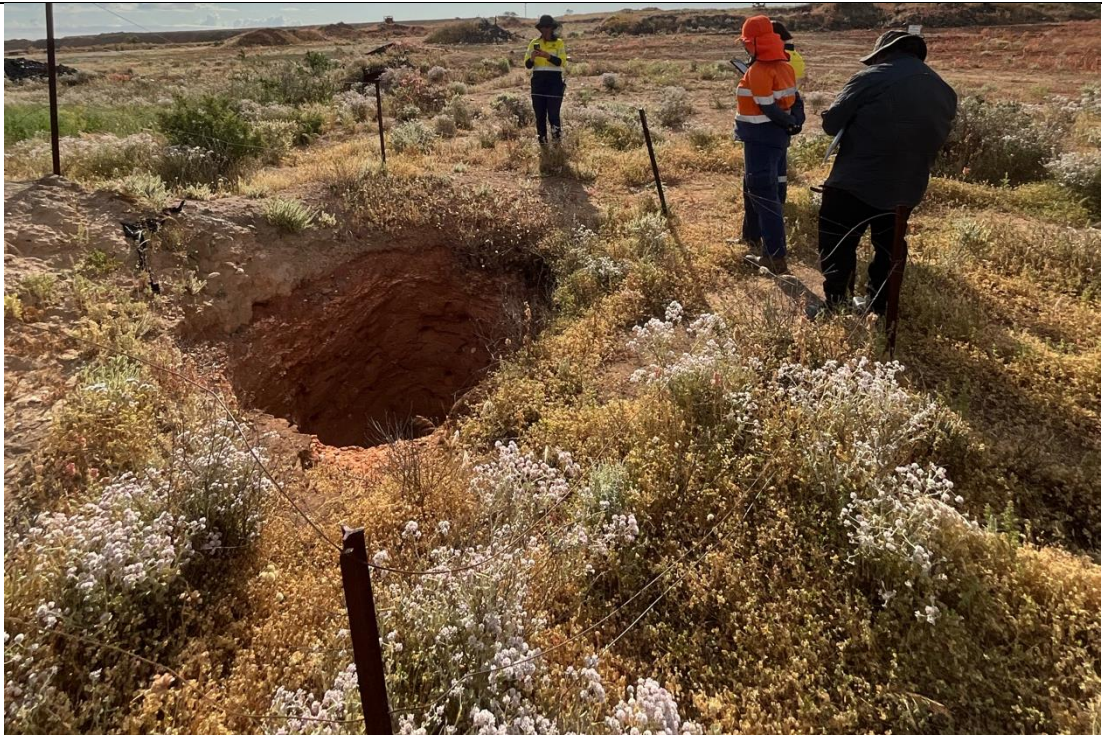
Figure 1

Rock mass / soil profile comments:	Preliminary remediation recommendations:
Very poor quality rock mass. Lateritic highly weathered rock from the ground surface.	Concrete cone plug, or a mirafi cone plug backfill solution.

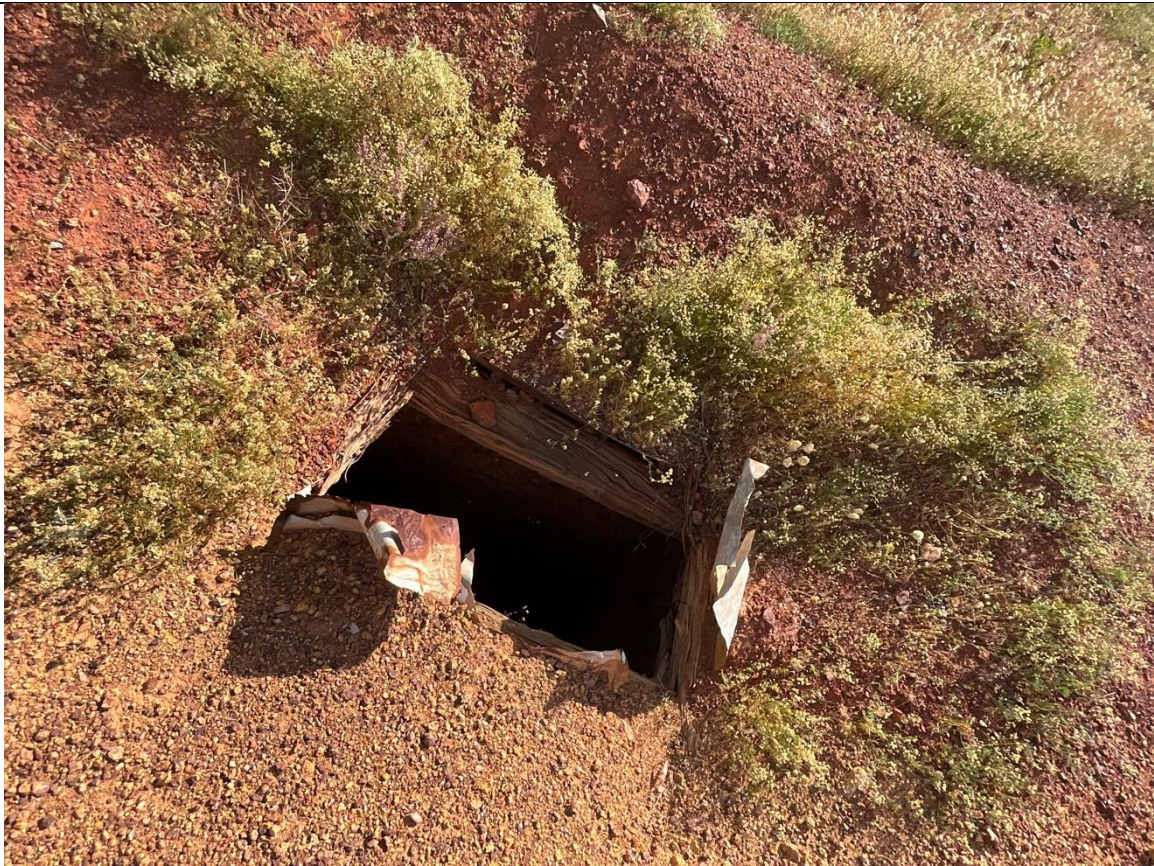
Figure 1

Rock mass / soil profile comments:	Preliminary remediation recommendations:
Pizolithic gravels and sands from the ground surface.	Concrete cone plug ? If a planking solution is to be adopted, removal of the spoil pile and top 1 m if crumbly rock material will be required. Alternatively, use a mirafi cone plug backfill.

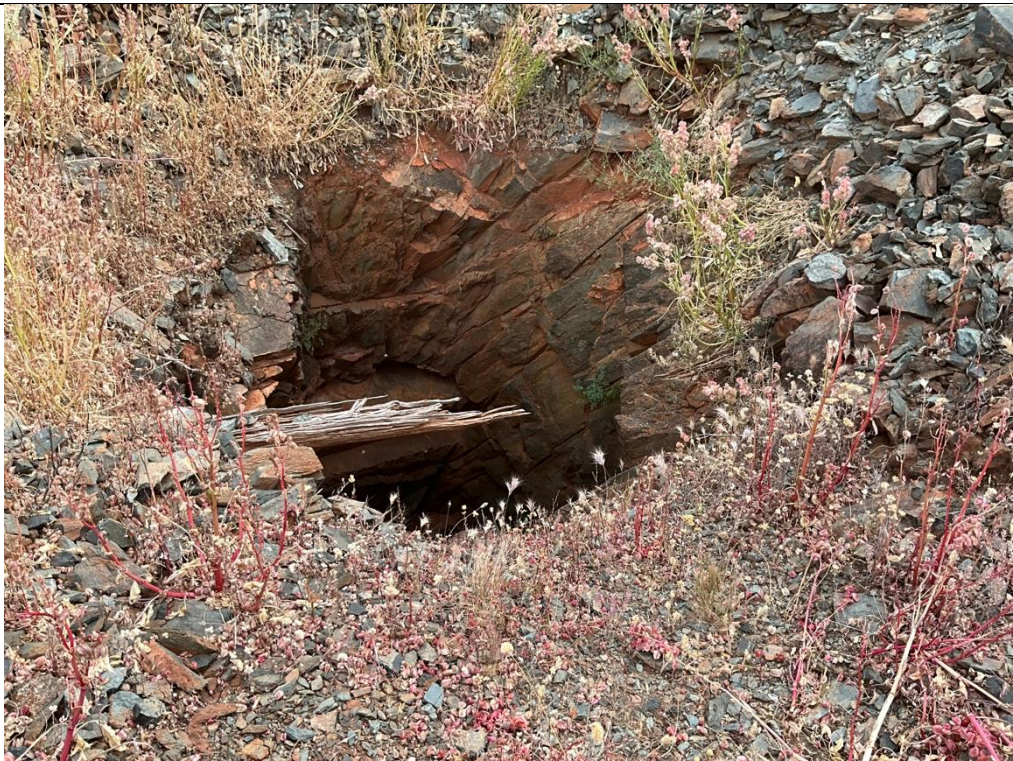
Figure 2

Rock mass / soil profile comments:	Preliminary remediation recommendations:
Reasonably good quality and competent rock mass. Moderately weathered. Near vertical rock walls that are jagged.	Concrete cone plug ?

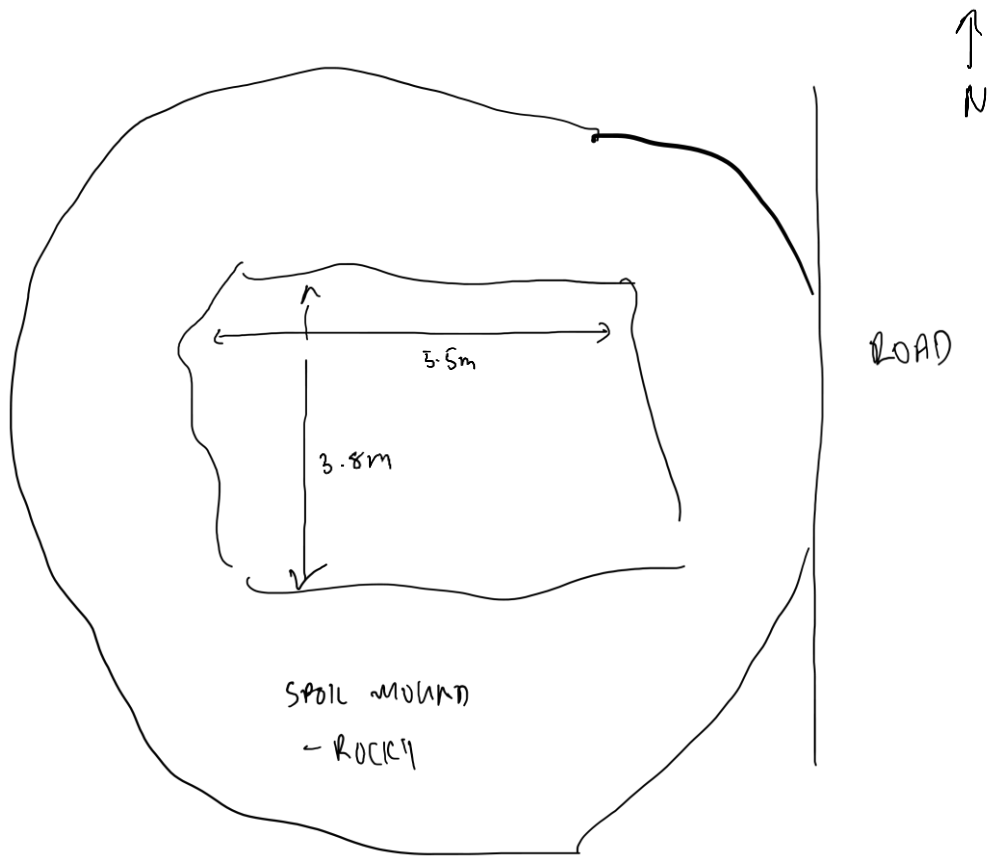
Rock mass / soil profile comments:	Preliminary remediation recommendations:
Poor quality rock mass and reasonably competent. Highly weathered rock, that is jagged and near vertical rock walls.	Concrete cone plug.

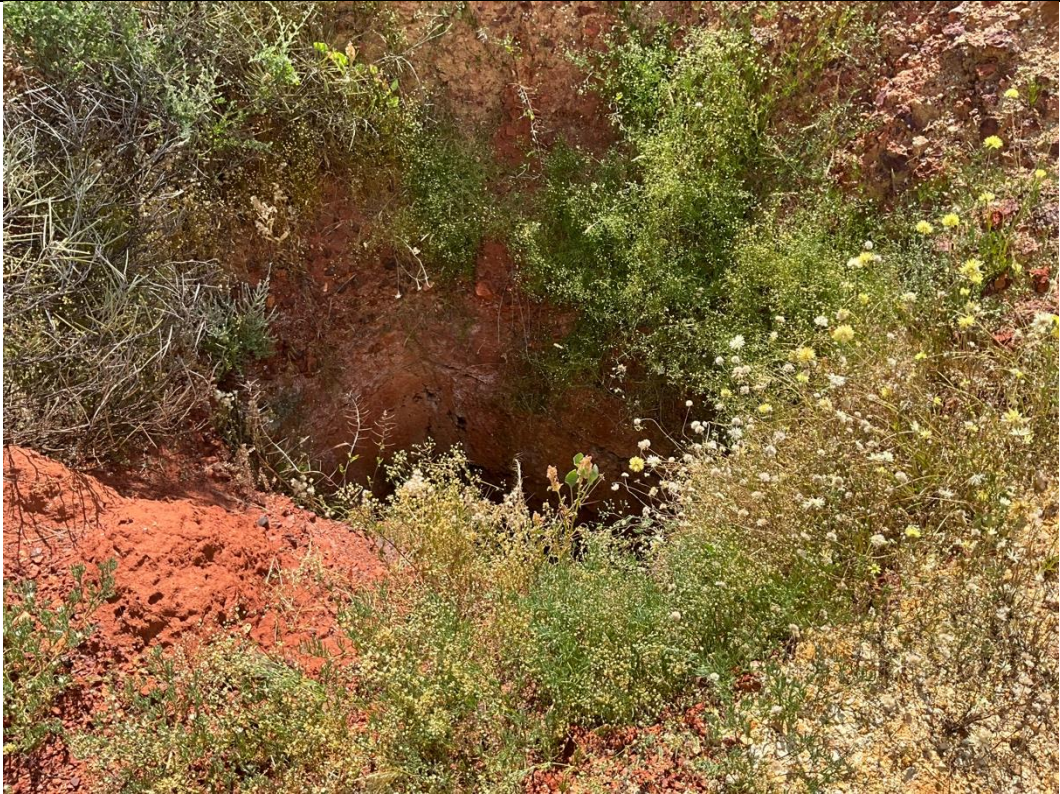
Figure 1

Rock mass / soil profile comments:	Preliminary remediation recommendations:
Very poor crumbly soil like rock mass. Extremely weathered rock. Near vertical walls.	Mirafi cone plug? Ground is unsuitable for founding planks or capping solutions.

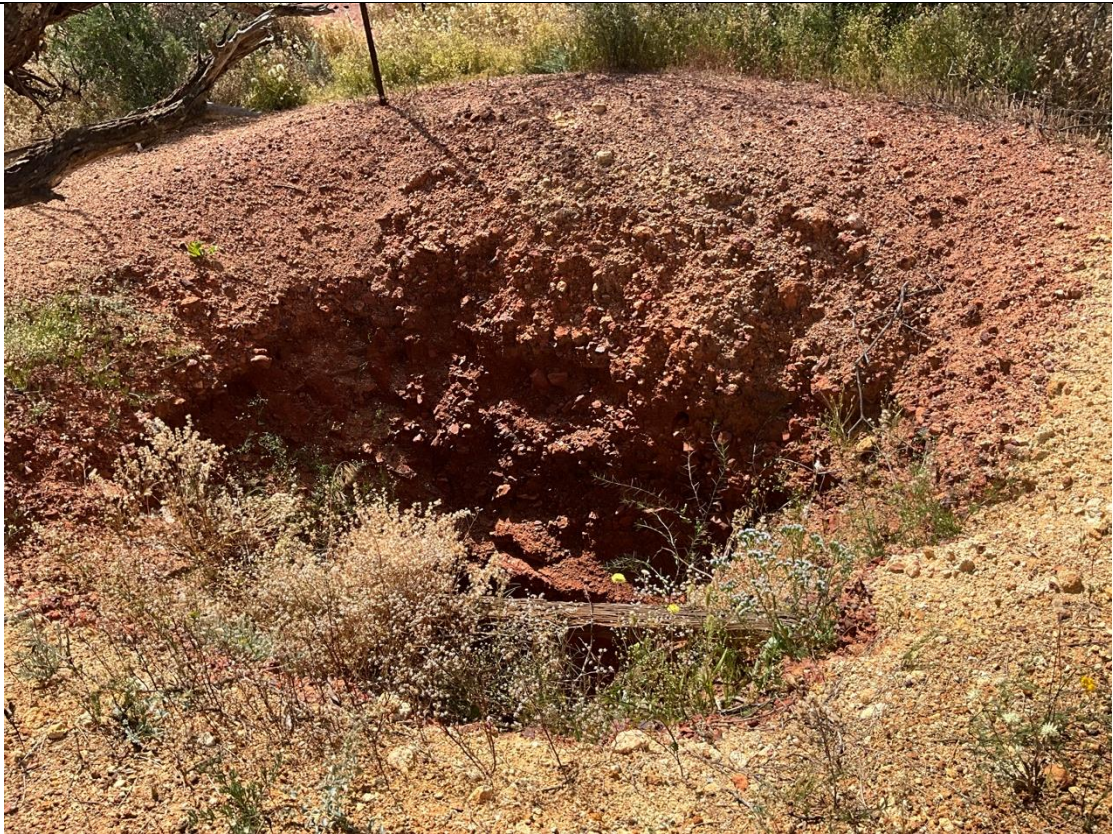
Figure 1

Rock mass / soil profile comments:	Preliminary remediation recommendations:
Very poor soil like rock mass. Extremely weathered. Near vertical walls. Approximately 2 m of gravelly lateritic soils overlying the rock.	Mirafi cone plug ?

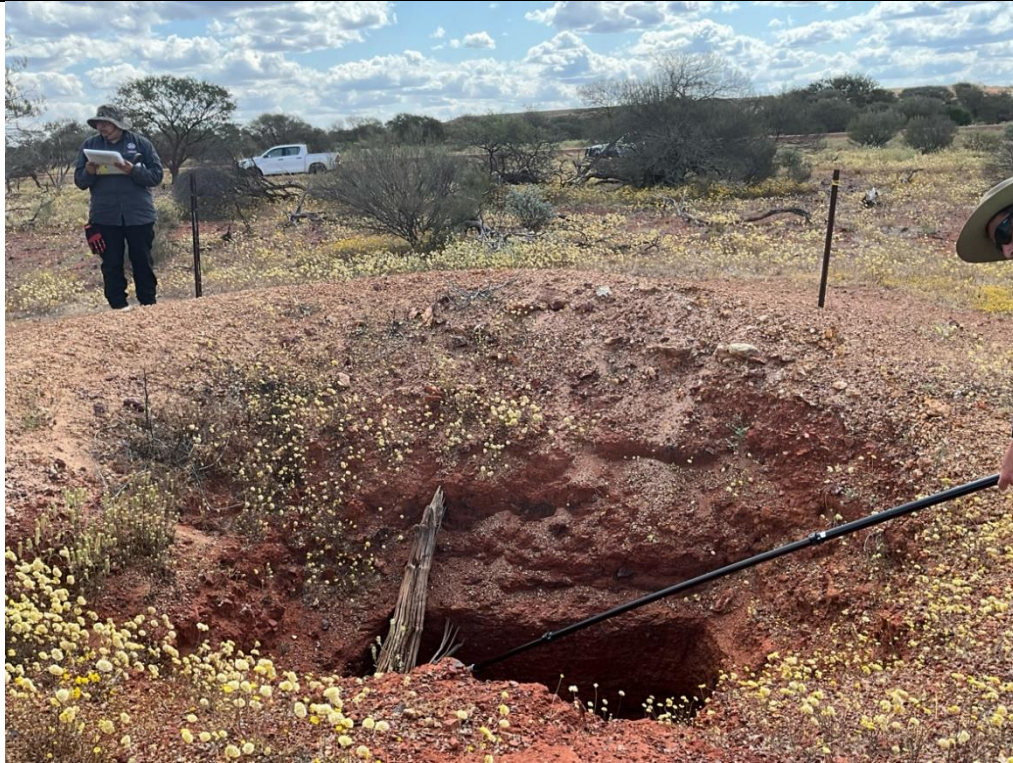
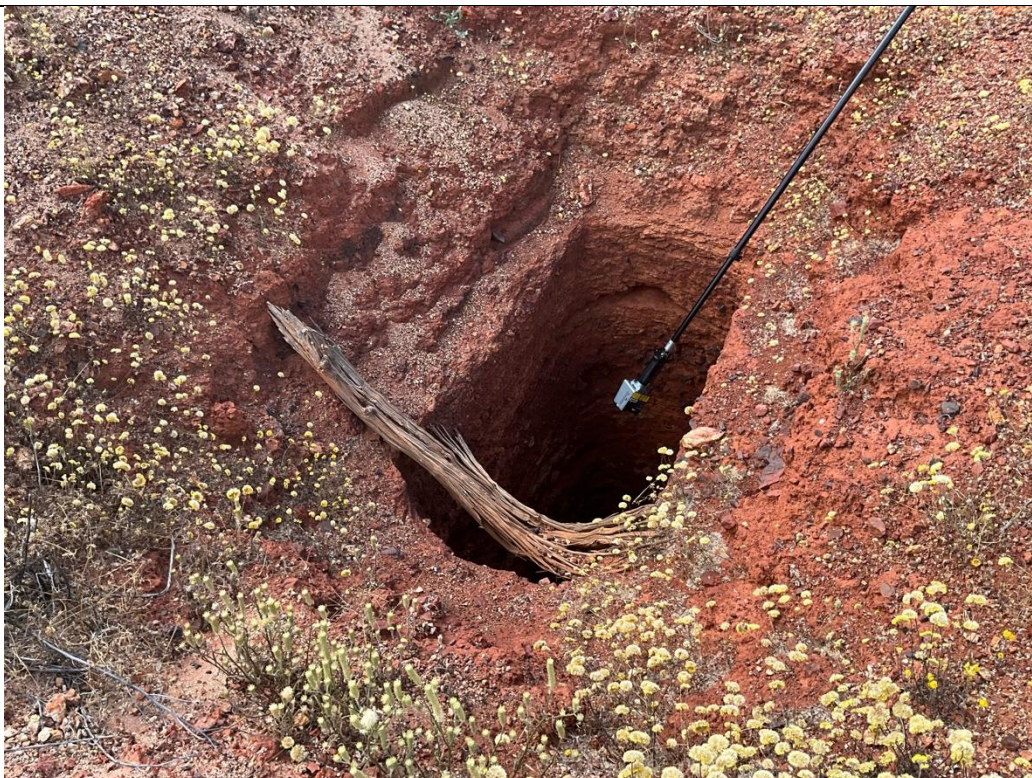
Rock mass / soil profile comments:	Preliminary remediation recommendations:
Very poor soil like rock mass. Extremely weathered. Near vertical rock walls. There is approximately 1 m of crumbly lateritic soils overlying very poor quality rock mass.	Mirafi cone plug?

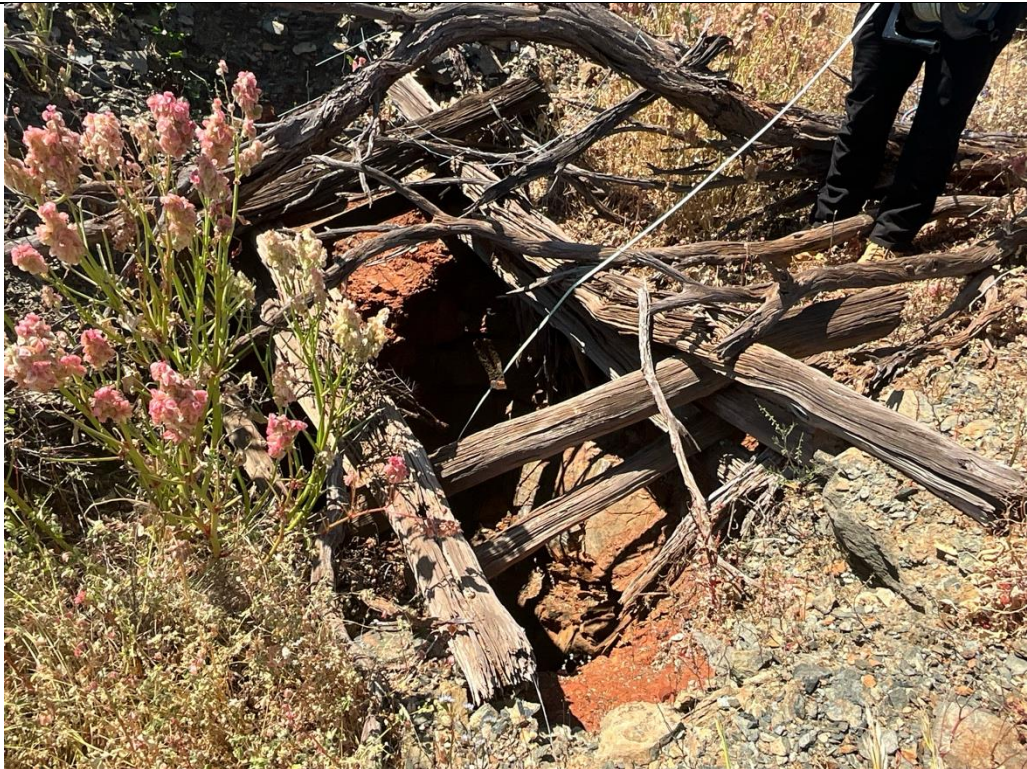
Figure 2

Rock mass / soil profile comments:	Preliminary remediation recommendations:
Poor quality rock mass, however, more competent than the features further south.	Mirafi plug backfill. No need to collapse the drive.

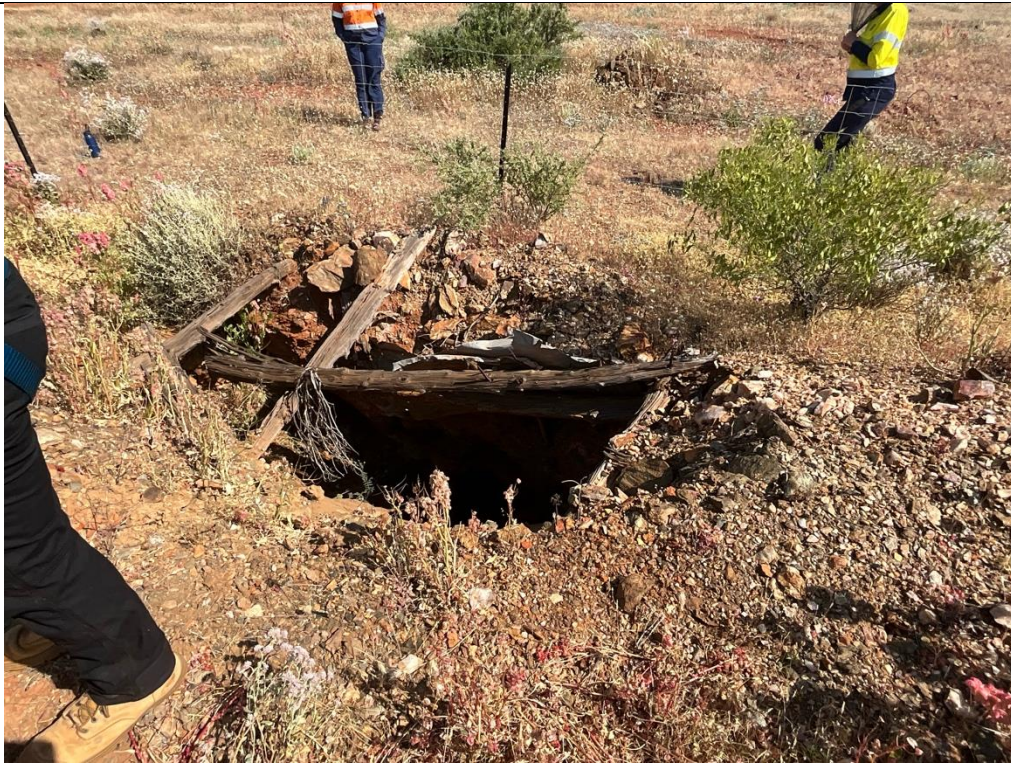
Figure 1

Rock mass / soil profile comments:	Preliminary remediation recommendations:
Poor quality rock mass. Near vertical rock walls.	Break out and collapse drive to the east – explosives? And backfill the main stope using mirafi?

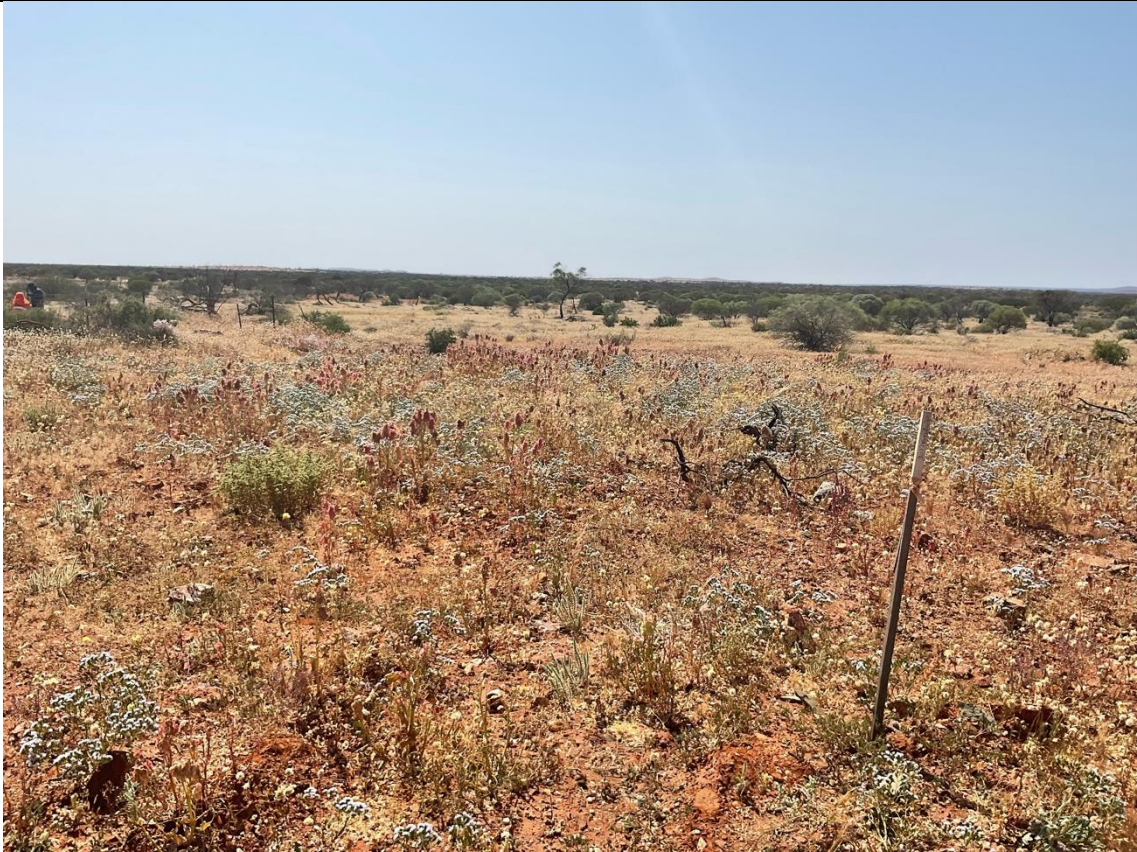
Figure 1

Coordinates	Recommendations for future investigation:
Latitude: -28.658930 Longitude: 116.316260	N/A
Geometric characteristics:	Flora and fauna:
Approximate Dimensions (L x W x D): N/A Volume (m³): N/A Depth to groundwater (m): N/A Hydrological Features: N/A	N/A
Description / comments / observations:	Noxious / flammable gas readings:
Not a mining feature. Likely are RC pad sumps. Graded flat area. BH ID: 23KSRC006.	N/A
Rock mass / soil profile comments:	Preliminary remediation recommendations:
N/A	Do not rehabilitate.
