ABANDONED MINE FEATURES ASSESSMENT

YALGOO, WA REHABILITATION OPTIONS STUDY

11715-G-R-002 Public Document

Issued to:	Department of Energy, Mines, Industry Regulation & Safety (DEMIRS)
WML Project Number:	11715
Document Name:	11715-G-R-002 Public Document

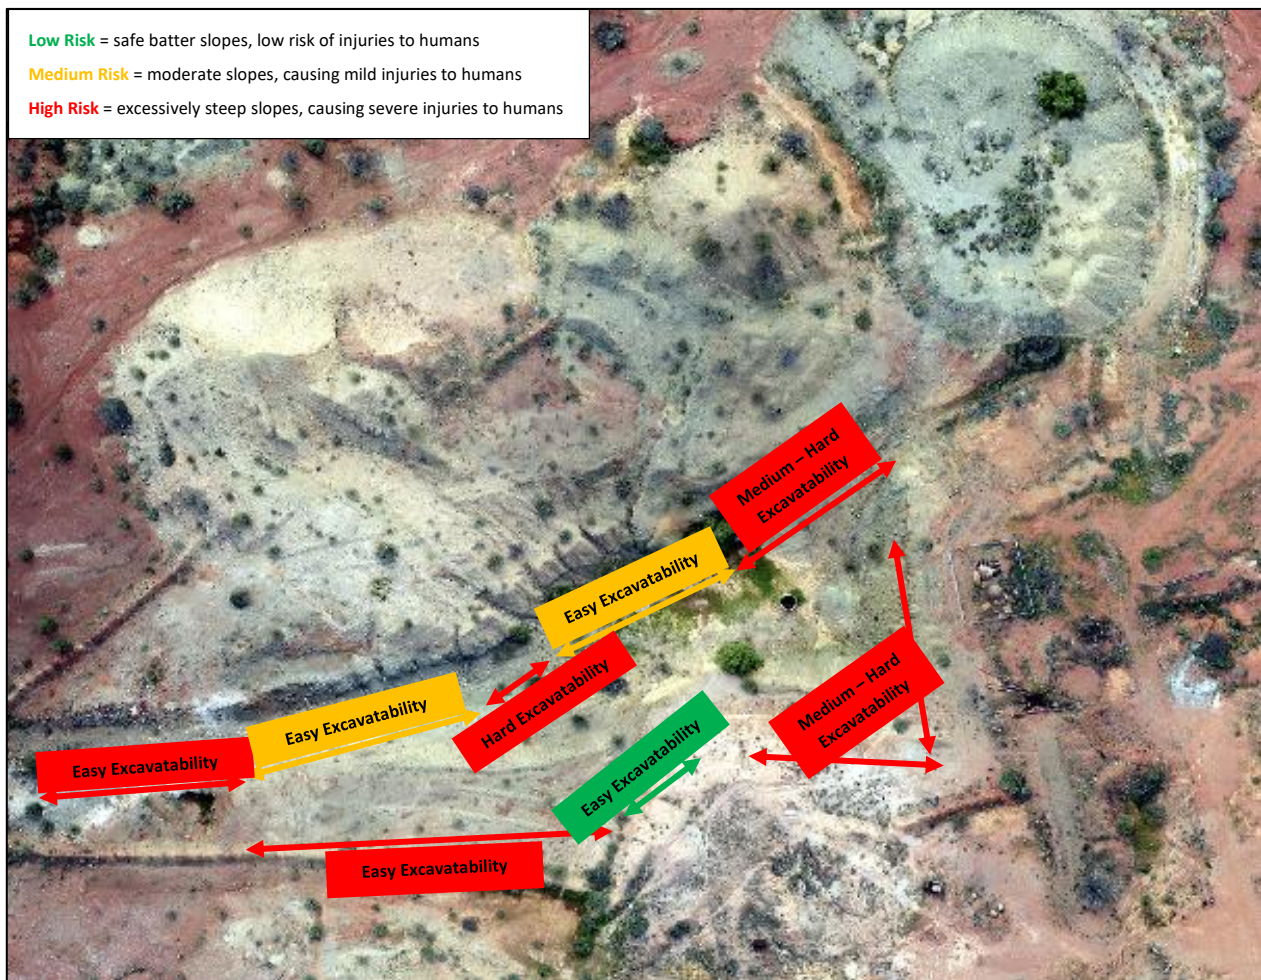
Figure 1: Risk assessment of the open pit walls

Excavatability	Requirements
Easy	Material on the slopes may be freely dug with a 40t excavator.
Medium	Material on the slopes may require occasional use of a rock pick attached to a 40t excavator.
Hard	A rock pick attached to a 40t excavator shall be required to excavate the material on the slopes.

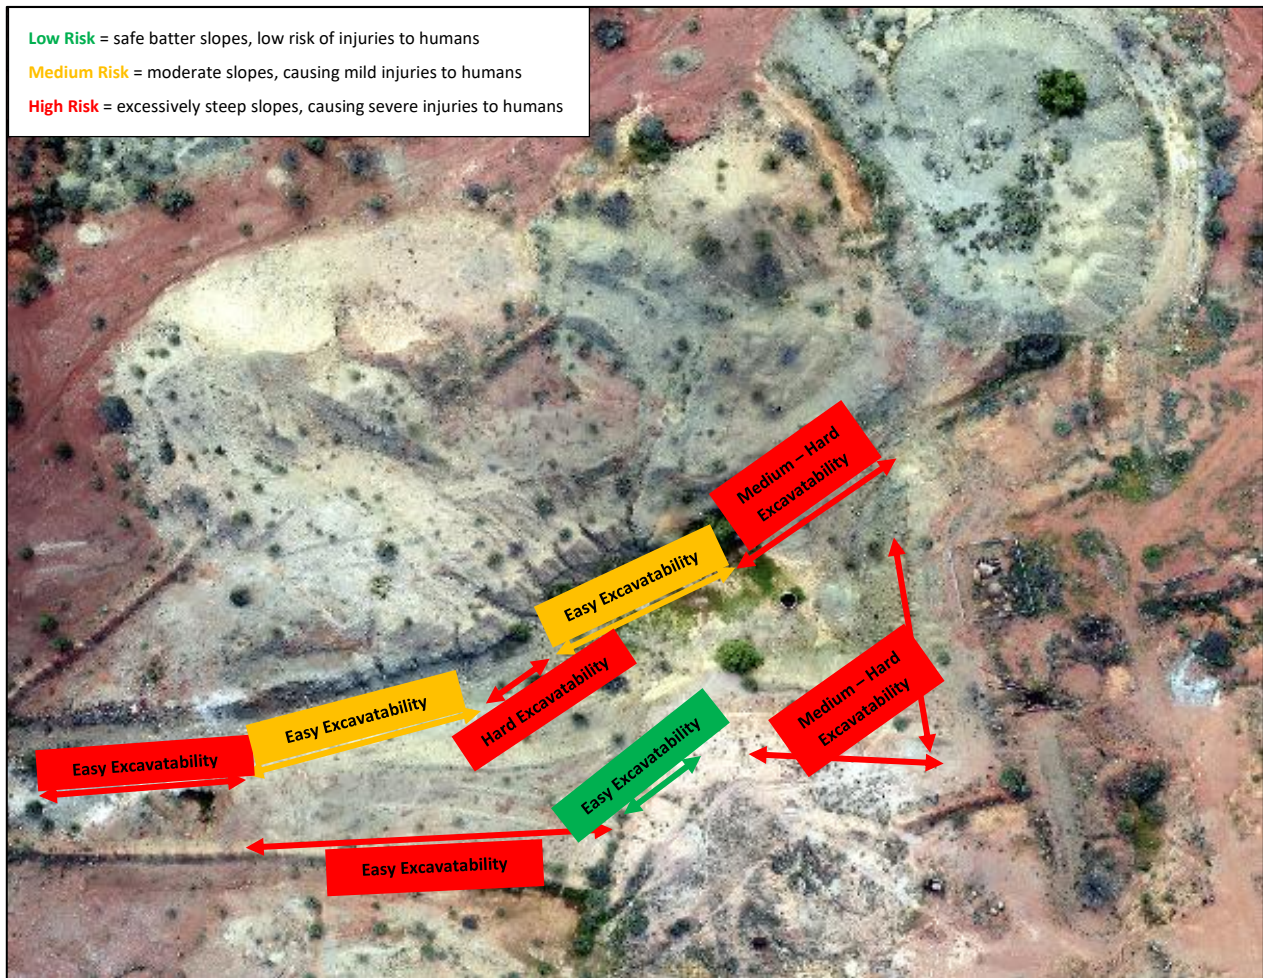
Figure 16: Risk assessment of the open pit walls

Children's toys were noted in the base of the open pit and the feature takes form of a playground for the local children, particularly as the open pit is situated directly opposite the Primary School.

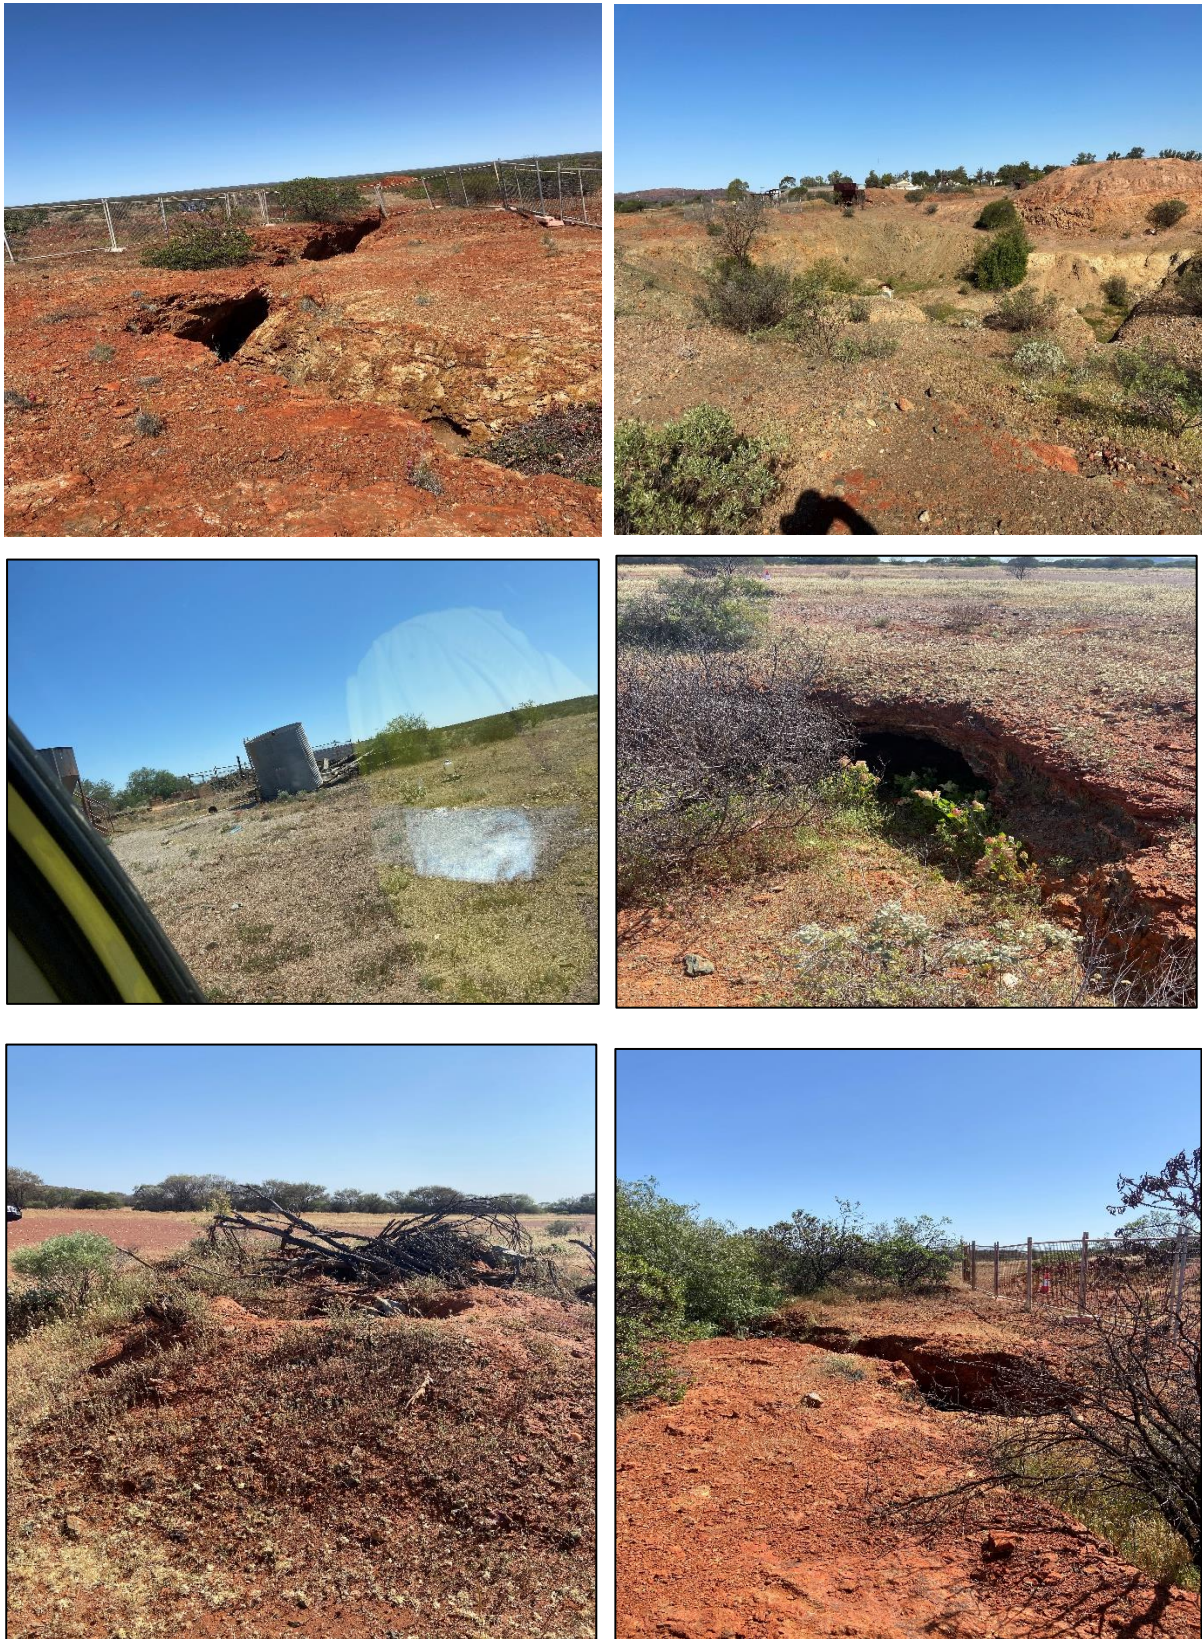
Figure 2: Typical ground surface conditions at Yalgoo.
