# ABANDONED MINE FEATURES ASSESSMENT

## YALGOO PHASE 1 GEOTECHNICAL REPORT

11715-G-R-001 Public Document

<b>Issued to:</b>	Department of Energy, Mines, Industry Regulation & Safety (DEMIRS)
<b>WML Project Number:</b>	11715
<b>Document Name:</b>	11715-G-R-001 Public Document

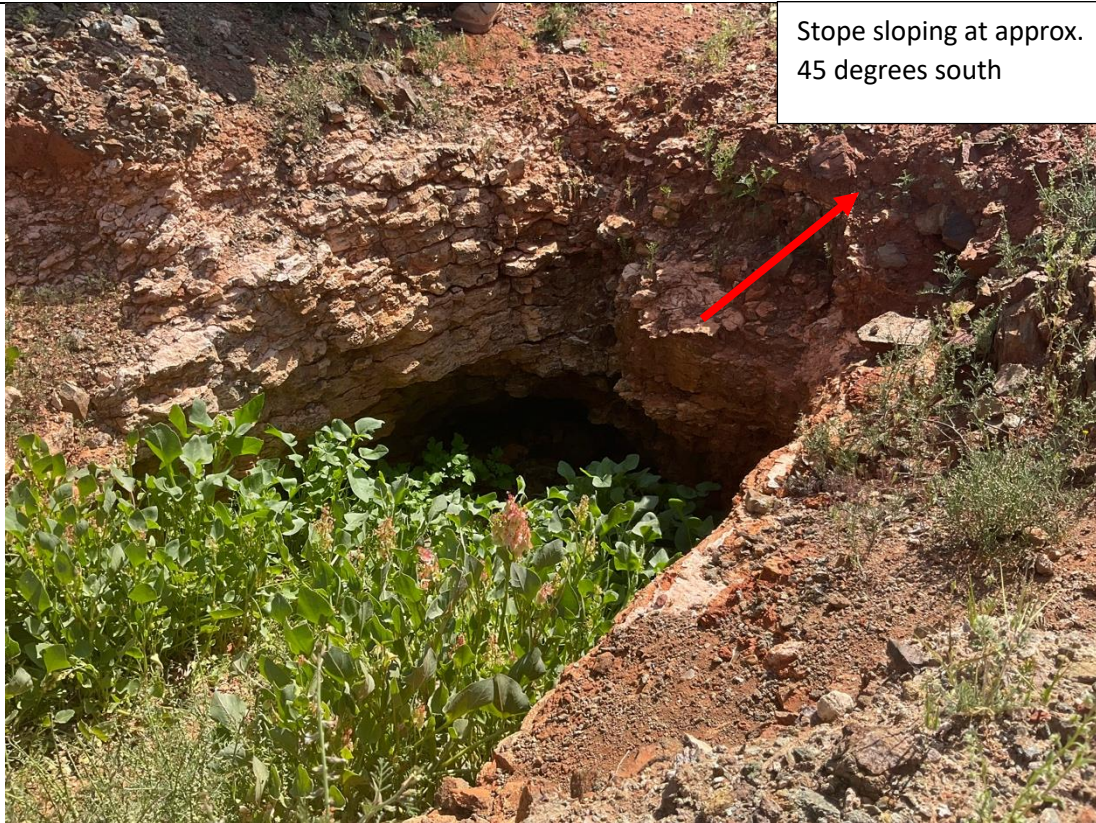
**Figure 1**

Stope sloping at approx.  
45 degrees south
