Department of **Local Government,
Industry Regulation and Safety**

General inspection report ten

Residential Class 1 and Class 2 shower areas

2023-24

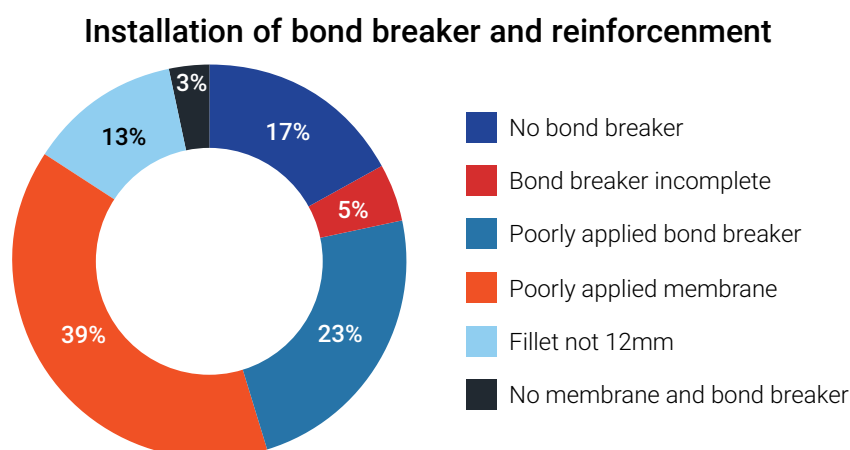
Figure 5: Bond breaker non-compliances

The inspections identified a high level of unsatisfactory outcomes in the application of membrane bond breaker fillets and tape to junctions. From the total 539 items of unsatisfactory waterproofing work, 64 were attributed to bond breaker fillets, bond breaker tape and membrane not being correctly applied to corner junctions. Analysis of these unsatisfactory items identified six common areas of concern:

- Poorly applied membrane to junctions resulting in pinholes, cracking, and thin or no membrane.
- Poorly applied bond breaker to junctions resulting in air pockets, lumps and/or hollows.
- No bond breaker having been applied to junctions.
- Bond breaker sealant fillet not reaching the minimum size of 12mm (Class 3 membrane).
- The installation of bond breaker being incomplete resulting in gaps.
- Junctions having no waterproof membrane or bond breaker installed where it was required.

AS 3740:2010, Waterproofing of domestic wet areas, Part 3.13.7 requires the use of bond breakers at all wall/floor and hob/wall junctions, and at any joint where the membrane is bonded to the substrate where there may be movement. Table 3.2 of AS 3740:2010 is then used to identify appropriate bond breakers for the class of membrane used. Figure 3.7 can then be used for examples of typical bond breaker details.

Typically, waterproof membrane was observed to be installed with both a sealant fillet and tape at junctions.

To properly identify the bond breaker required, installers should refer to the manufacturer's product data and installation requirements. Most manufacturers of membrane, develop systems for different situations and applications of their membrane. Manufacturer data will identify the membrane class and manufacturer installation requirements will specify the bond breaker fillets and tapes required for the intended application. This information can generally be found on the membrane container. More detailed information may also be found on the manufacturer's website and/or the manufacturer's published literature.

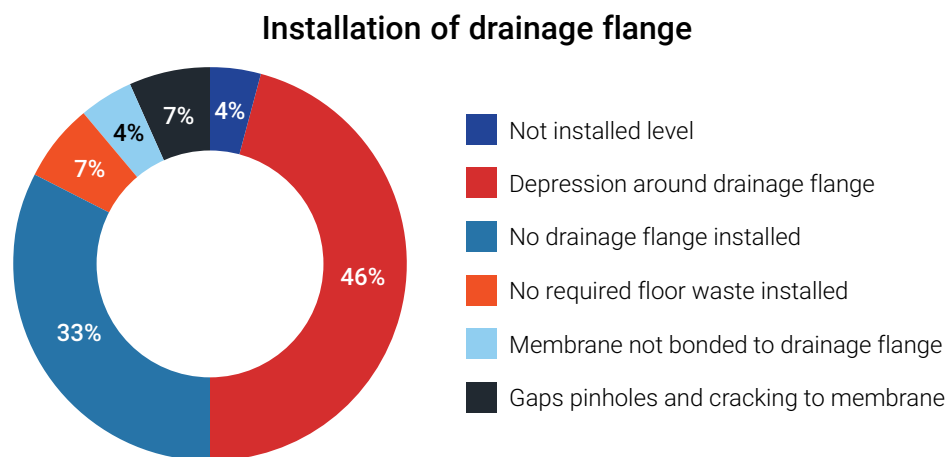
Figure 6: Drainage flange non-compliances

The inspections identified instances of unsatisfactory installation of drainage flanges to floor drains. From the 539 items of unsatisfactory waterproofing work, 46 of those were attributed to unsatisfactory installation of drainage flanges. Analysis of the 46 unsatisfactory items identified six common areas of concern:

- depression observed around the drainage flange resulting in an area where water can collect;
- no drainage flange installed;
- no required floor waste installed and therefore no drainage flange;
- gaps pinholes and cracking observed in the membrane around the drainage flange;
- the drainage flange not installed level resulting in a depression where water can collect; and
- the membrane not bonded to the drainage flange resulting in a pathway for water to bypass the membrane.

AS 3740:2010, Waterproofing of domestic wet areas, Part 3.14.1 requires a drainage flange to be installed with the waterproof membrane terminated at/in the drainage flange to provide a waterproof connection. As such, any drain that is installed in a floor that is waterproofed is required to be fitted with a drainage flange. Figure 3.8 details the typical drainage flange installation and termination of the membrane.

While most buildings were observed to have drainage flanges fitted, observed issues were generally a matter of substandard workmanship regarding the floor substrate and membrane application. Drainage flanges were observed to sit higher than the substrate, have depressions in the substrate around them or be installed in a way that created an area lower than the drainage flange. This results in water pooling around the drain that is unable to drain away.

On lesser occasions, drainage flanges were observed buried under screed with the membrane not bonded to the drainage flange or the drainage flange not being correctly primed, resulting in delamination of the membrane. To correctly identify the priming requirements of the membrane in use, installers should refer to the manufacturer's product data and installation requirements. It is also important to note that the manufacturer may require the use of a different primer on a porous substrate than the one required on a non-porous drainage flange. This information can generally be found on the membrane container. More detailed information may also be found on the manufacturer's website and/or published literature.

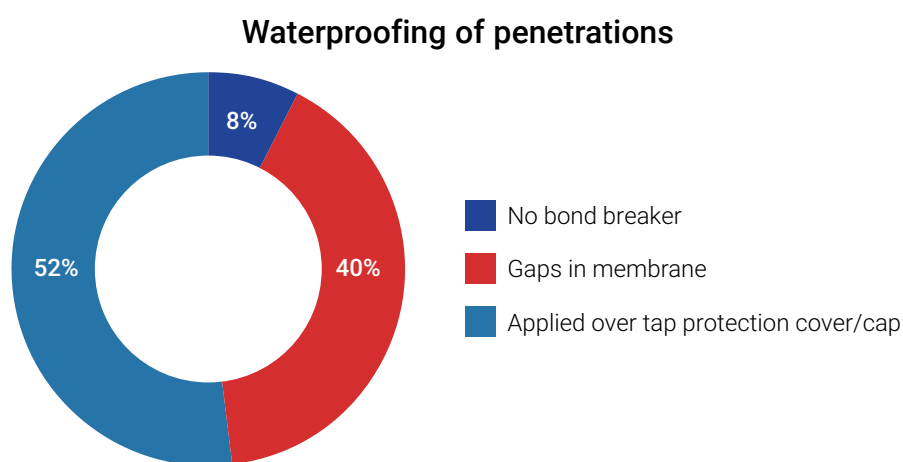
Figure 7: Waterproofing of penetrations non-compliances

The inspection identified instances of unsatisfactory waterproofing of plumbing fixture penetrations. From the 539 items of unsatisfactory waterproofing work, 52 of those were attributed to unsatisfactory waterproofing of penetrations. Analysis of the 52 unsatisfactory items identified three common areas for concern:

- no bond breaker used at the junction of plumbing fixtures and wall substrate;
- gaps observed between the membrane and the plumbing fixture; and
- membrane applied over plumbing fixtures protective covering, resulting in damage to the membrane and gaps between the membrane and plumbing fixture when the protection is removed.

AS 3740:2010, Waterproofing of domestic wet areas, Part 3.10.1 requires penetrations for taps, shower roses, recesses and similar fixtures to be waterproof.

In all cases, some attempt had been made to waterproof the penetration, with the observed non-compliance deemed to be the result of substandard workmanship. The workmanship defects observed generally indicated a lack of clear understanding by the applicator of how the waterproofing system works to prevent water ingress, as well as a lack of quality control.

On all occasions, the wall containing the penetration was observed to be waterproofed, with the membrane in use for the penetration. The applicator should refer to the manufacturer's instructions for the appropriate system of waterproofing penetrations with the membrane in use.

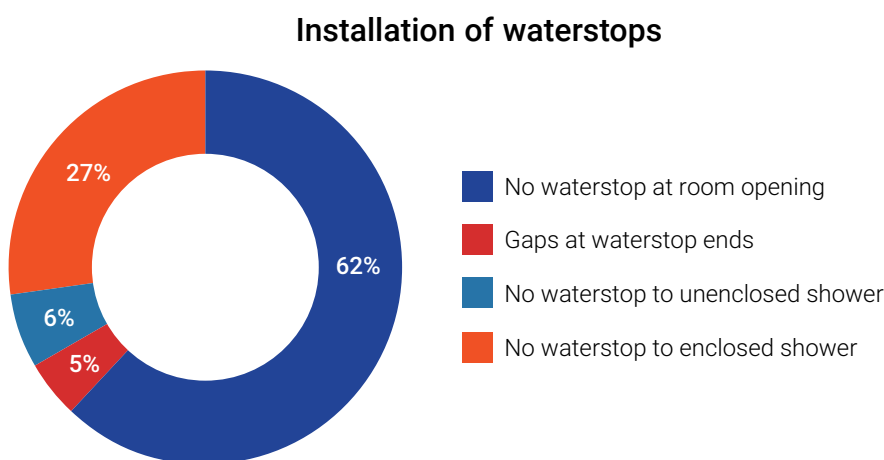
Figure 8: Installation of Waterstops

The inspection identified waterstops as an area of concern in the waterproofing of shower areas. From the 539 items of unsatisfactory waterproofing work, 111 of those were attributed to the unsatisfactory or non-installation of waterstops. Analysis of the 111 unsatisfactory items identified four problems:

- no waterstops installed at room openings forming part of the perimeter flashing;
- waterstops installed with gaps at the ends;
- no waterstop installed to unenclosed shower areas; and
- no waterstop installed to enclosed shower areas.

AS 3740:2010, Waterproofing of domestic wet areas, Part 3.9.1.2 specifies the requirement for waterstops in perimeter flashing at floor level openings (door openings), while parts 3.13.4 and 3.13.5 specify the requirement for waterstops to enclosed and unenclosed showers.

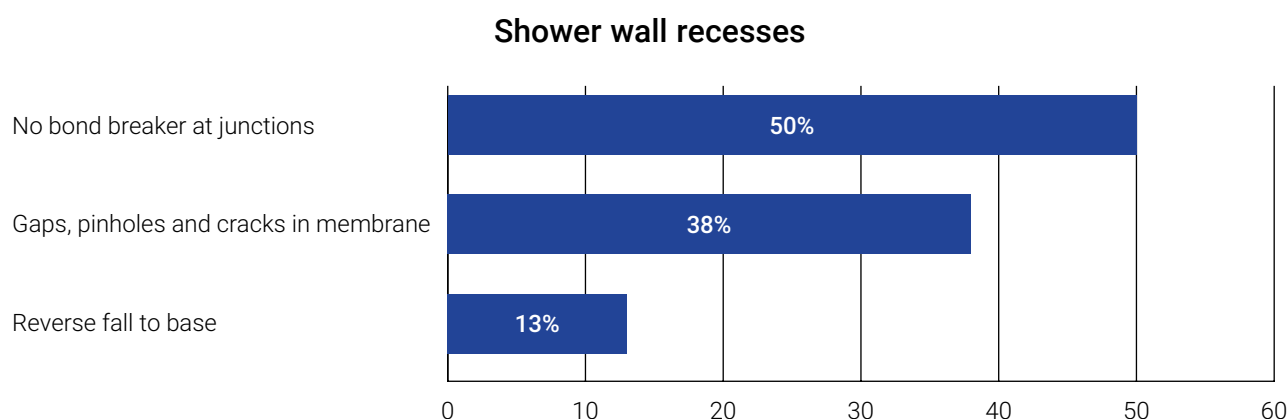
Figure 9: Shower wall recesses

The inspection identified the installation of wall recesses within shower areas as an area of concern. From the 539 items of unsatisfactory waterproofing work, 16 of those were attributed to the unsatisfactory installation and waterproofing of shower wall recesses. These represent 50 per cent of all wall recesses inspected as being unsatisfactory. Analysis of the 16 unsatisfactory items identified three problem areas:

- the base of the wall recesses having no fall;
- poorly applied membrane to wall recess junctions resulting in lumps, pinholes, cracking, and thin or no membrane; and
- no bond breaker of any type having been applied to junctions.

Shower wall recesses were typically observed with poorly applied bond breaker and poorly applied membrane resulting in defects such as holes and cracking. Incorrect fall to the recess shelf was usually a result of poorly applied bond breaker creating a high point at the front edge, trapping water.

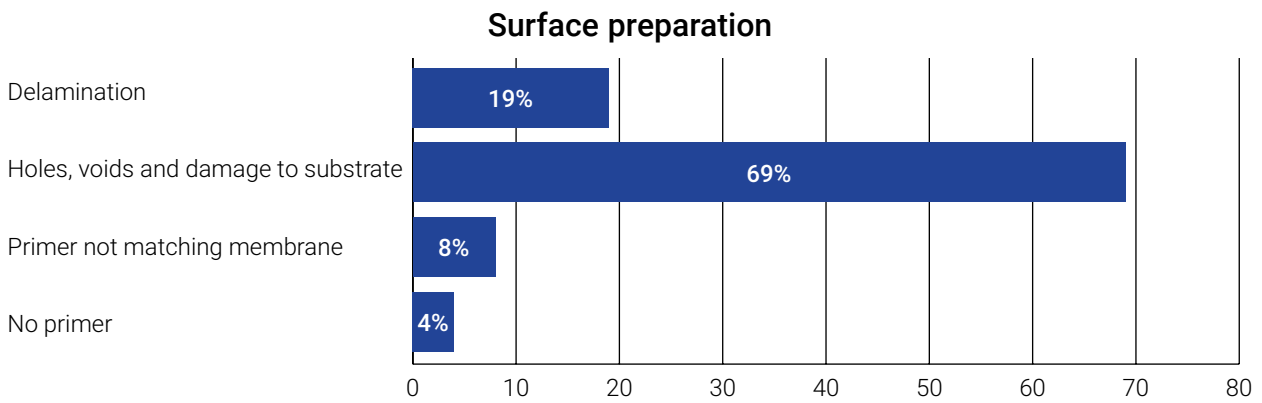
Figure 10: Surface preparation

The inspection identified the preparation of substrates as a point of concern. From the 539 items of unsatisfactory waterproofing work, 26 of those were attributed to the unsatisfactory preparation of surfaces prior to the application of waterproof membrane. Analysis of the 26 unsatisfactory items identified four problem areas:

- absence of primer used as per the membrane manufacturer’s application instructions;
- the primer used being incorrect and not suitable for the membrane used;
- holes, voids and damage to the substrate not repaired prior to the application of the membrane; and
- delamination of the membrane from the substrate indicating the substrate was not clean and/or the substrate was not correctly primed.

A significant number of shower areas were observed to not have been prepared to a satisfactory standard. The wall and floor substrate were often observed to be poorly finished, generally with large depressions at the base of wall render. This leaves a gap between the wall render and floor screed that would prevent any bond breaker from being correctly applied. It would also often result in areas where water could pool and not be able to make its way to the drain. Additionally, bubbles were often observed in floor membrane, indicating that the membrane had lost its bond with the substrate. This generally indicates that the substrate was not correctly cleaned of all sand and/or dust before application of the membrane, or the membrane primer had not been correctly applied.

AS 3740:2010, Waterproofing of domestic wet areas, Part 3.13.1 specifies that “the area shall be cleaned and dust free. Indentations and imperfections shall be kept to a minimum and repaired where necessary”. Additionally, the membrane manufacturer’s application instructions should be referred to for specific preparation and priming requirements necessary for the membrane being applied. Membranes are generally not suitable gap-fillers, so it is important that substrates are adequately prepared.

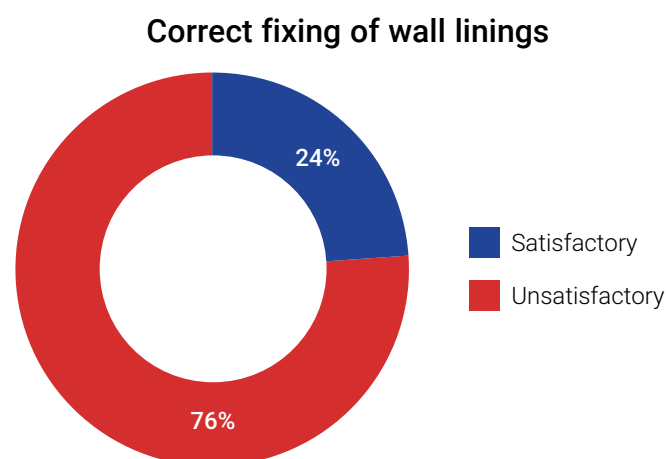
Figure 11: Correct fixing of wall linings

While not directly related to the application of waterproofing, the inspection identified the unsatisfactory and incorrect fixing of internal wall lining to walls that are to be tiled. From the 539 items of unsatisfactory waterproofing work, 45 of those were attributed to the unsatisfactory and incorrect fixing of wall linings.

Generally, gypsum wall linings to walls that were to be tiled were observed to have an insufficient number of mechanical fixings. Failure of the wall lining due to incorrect fixing may result in breaches of the waterproof membrane and therefore directly affect the waterproofing of the wet area.

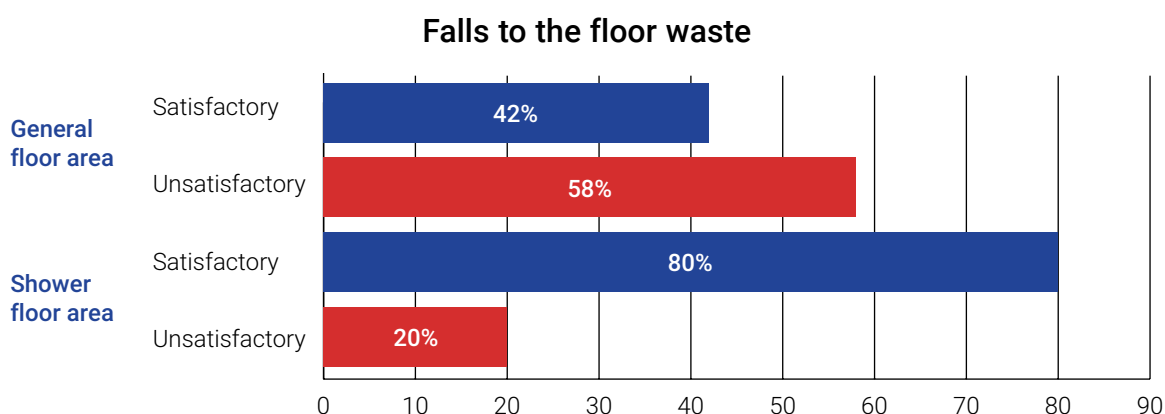
Figure 12: Falls to the floor waste

Analysis of the 54 unsatisfactory items identified that, while 20 per cent of shower floors were observed to be unsatisfactory, 58 per cent of floors outside of the shower were observed to have insufficient fall.

AS 3740:2010, Waterproofing of domestic wet areas, Part 3.3 specifies a minimum fall to the waste of 1:100. Part 3.3 also refers to Appendix B for further information. Appendix B, while informative, notes the primary consideration for fall in floors is “to ensure water does not remain on the finished floor in a manner that can adversely affect the health or amenity of the occupants or deteriorate building elements”. And “to ensure water exits the area at the floor waste or doorway that is the designed exit point”. And “water should not pond on the floor, with the exception of residual water remaining due to surface tension”.

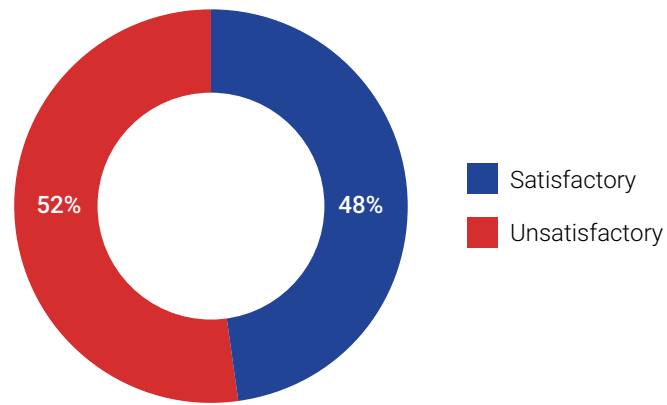
Figure 13: Membrane dry film thickness.

Analysis of the 539 items found 75 items to be attributed to unsatisfactory membrane dry film thickness. Of 145 membrane tests, over half (52 per cent) were measured to be less than the manufacturer’s specified thickness.

It is important for membrane applicators to understand the characteristics of waterproof membrane and how a failure to achieve the correct thickness may affect the performance of the membrane. AS 3740:2010, Waterproofing of domestic wet areas, Table 3.2 specifies Class 3 membrane to have an elongation at break of more than 300 per cent. Manufacturers test and warrant their products to perform as per their installation instructions. If the membrane is applied at less than the specified thickness, this may result in the membrane breaking at less than 300 per cent elongation.

Building and Energy inspector discussions with membrane applicators during inspections found that very few applicators were checking membrane thickness as part of the application process. Many were not aware of the minimum membrane thickness required. Most applicators advised that they applied one primer coat and two coats of membrane as thick as they could manage. It is also important for applicators to be aware of the requirements of the membrane in use, as manufacturer requirements for dry film thickness of common shower area membranes can range from 0.5mm to 1.5mm.

For information on the correct membrane dry film and wet film thickness, applicators should refer to the manufacturer’s requirements for the membrane in use.
