# Capel River Action Plan

1999

Prepared for Geographe Catchment Council - GeoCatch  
and the Capel Land Conservation District Committee

by  
Kirrily White and Sarah Comer  
in association with  
Evangelisti & Associates

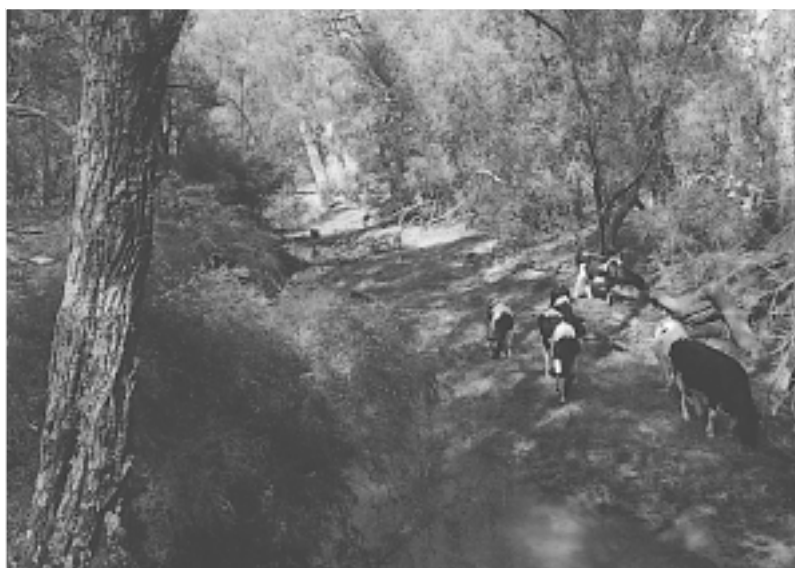
The degradation of a river valley continues when stock access becomes more regular. Understorey species are trampled or eaten, exotic weeds are spread more prolifically. Localised soil exposure may also lead to the risk of erosion. An example of uncontrolled stock access on the Capel River foreshore is illustrated in Plate 3 (page 12).

*Plate 3: Uncontrolled access leads to a degraded river foreshore.*

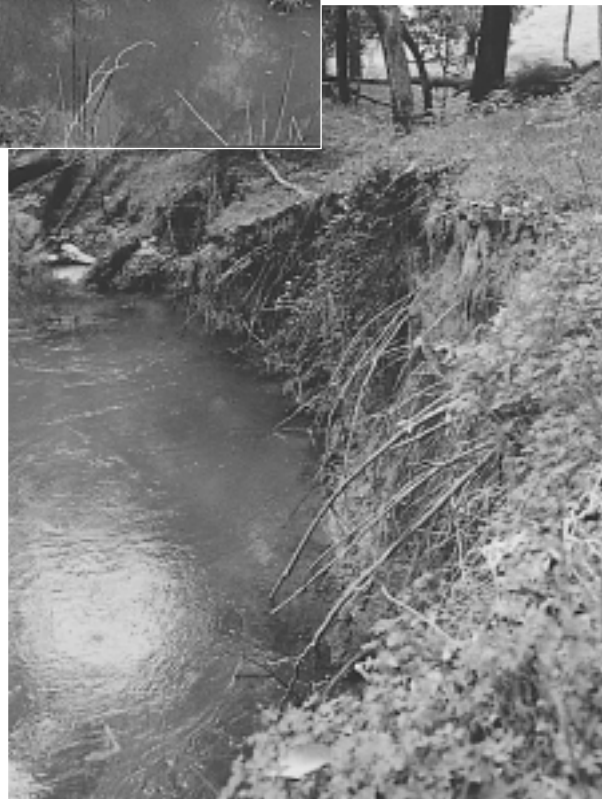
*Plate 4: Subsidence or slumping of the river bank.*

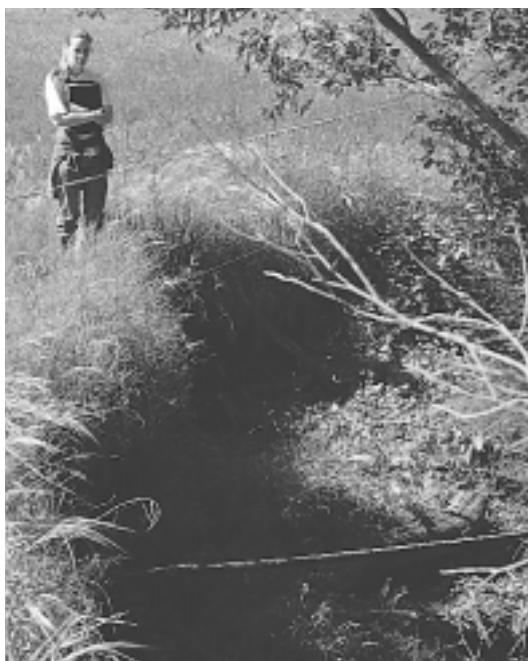
In addition to these, social issues of concern include the loss of fences as the river course deviates (Plates 9 and 10, page 21); the loss of valuable soil; reduced visual amenity associated with the river; and a potential for the limitation of beneficial uses, such as fishing, marroning and water supply, as water quality deteriorates.

Plate 9: Loss of fence-lines due to subsidence.

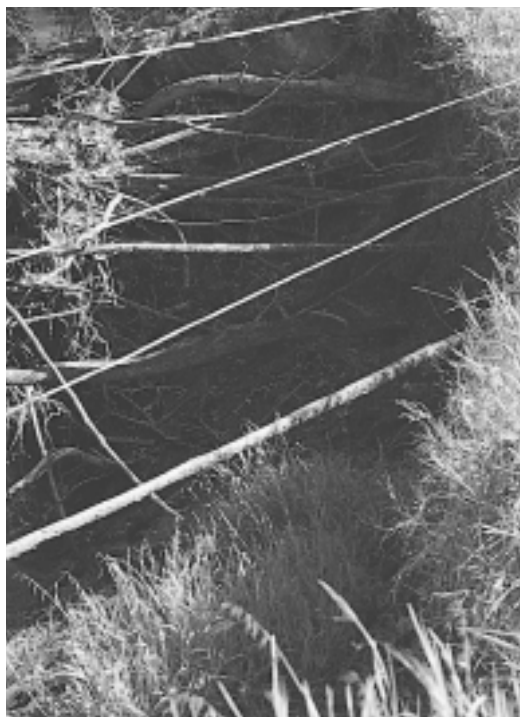
Plate 10: Close up of fence-line and subsidence.

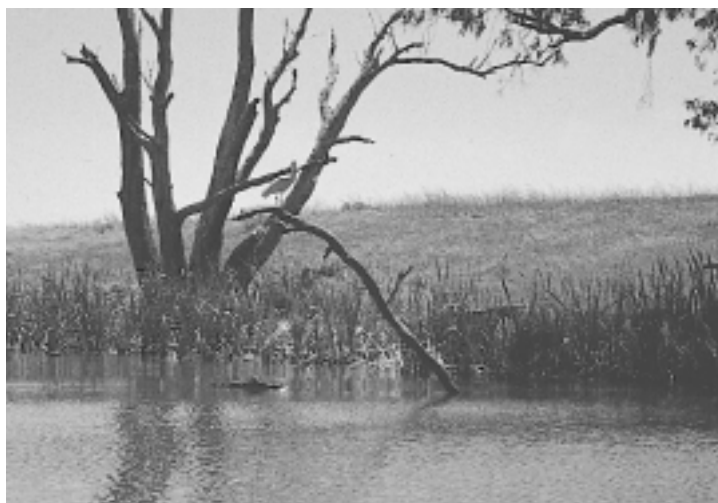
Plate 11: The lower Capel foreshore with *Typha* and Kikuyu.

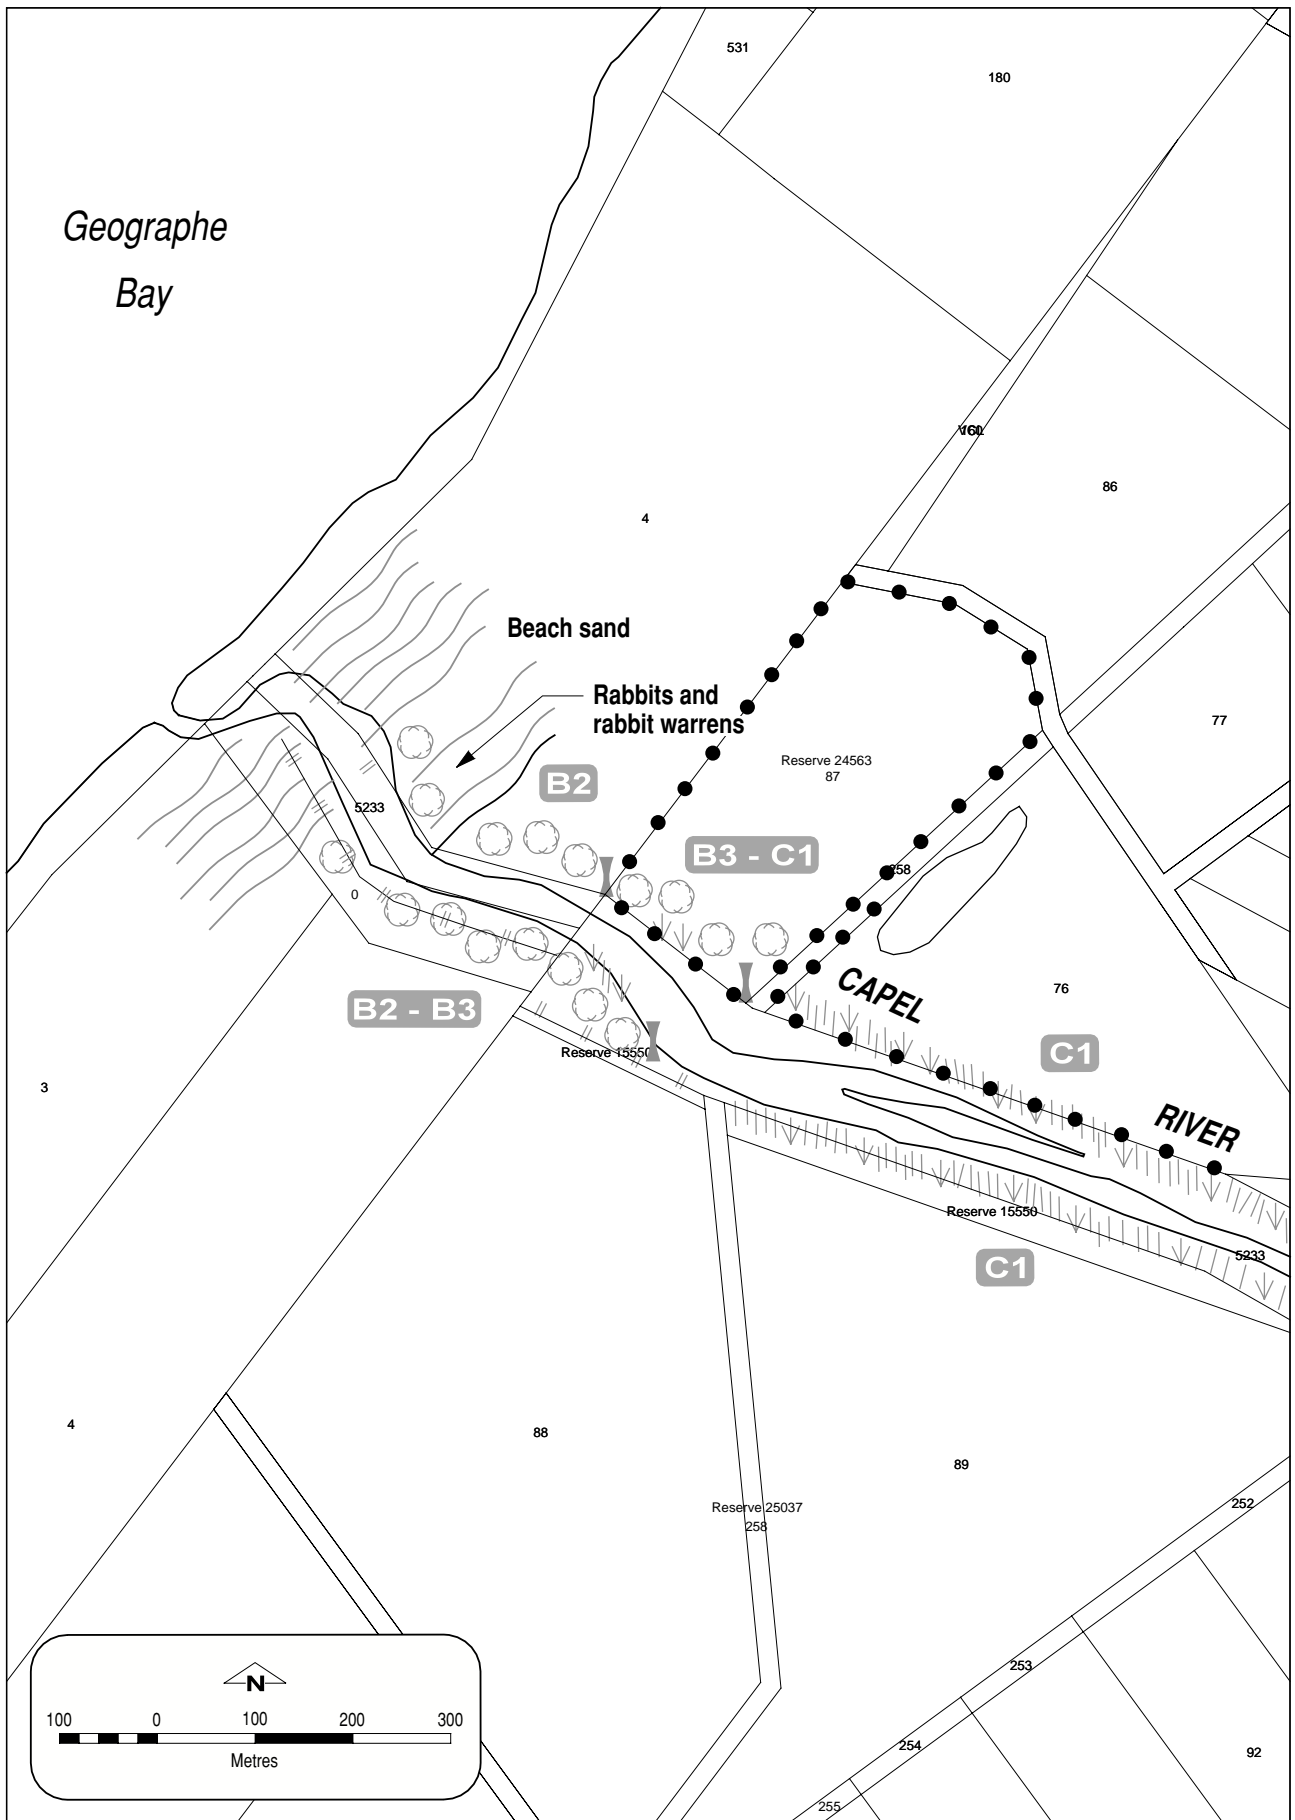
Capel River Map 1

Issues	Comments	Management Advice
General foreshore condition	River mouth and coastal dunes are well vegetated though degraded (channel to river mouth is artificial with a raised embankment). The reserve is grazed on both sides.	N/A
Fencing	The lower section has been fenced although the fencing is now in poor condition, and is set well back from the river bank. It is possible that stock may still have access to these areas. The upper section is not fenced.	Fencing is required to exclude horses and cattle on the north bank. Length of fencing recommended: ~ 900 m.
Erosion	N/A	
Revegetation requirement	The Capel River acts as a flood channel in this section, thus precluding the area from revegetation.	N/A
Weed invasion	Reserve 24563: thistles and Pelargonium observed (not on foreshore).	Refer to Specific weed management advice Chapter 8.1.2 point 16 (page 25).
Other comments	The foreshore area is dominated by Kikuyu, yet this is stabilising the banks.	N/A

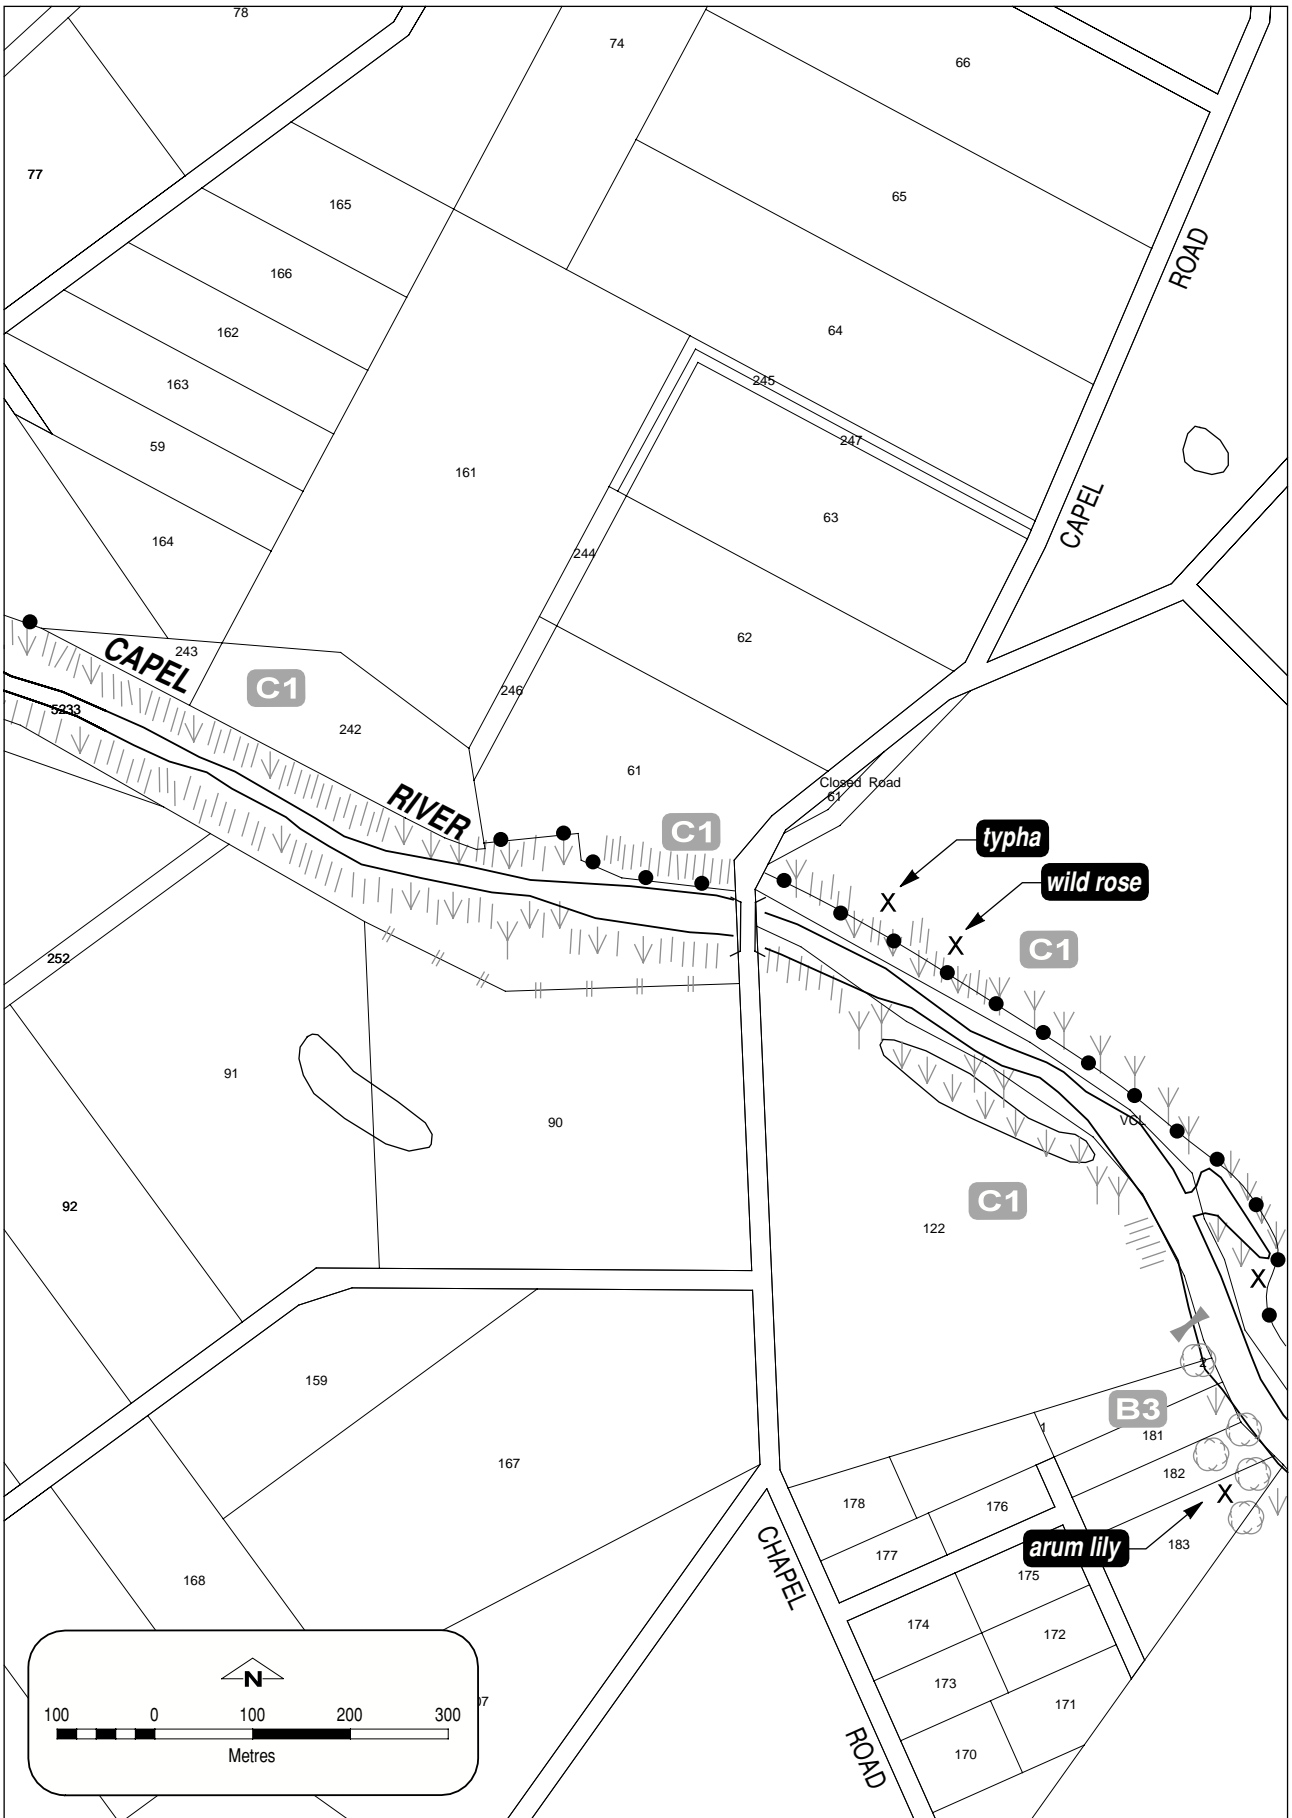
Capel River Map 2

Weed invasion	<i>Typha orientalis</i> was common in this area, particularly in the upper section. Arum lily and wild rose were also recorded in this area.	Refer to Specific weed management advice Chapter 8.1.2 points 2, 17 and 19 (page 23 - 26).
Other comments	The club-rush <i>Bolboschoenus caldwellii</i> was recorded in this section. <i>B. caldwellii</i> can congest waterways, and is invasive in disturbed areas.	Monitor spread of this rush.

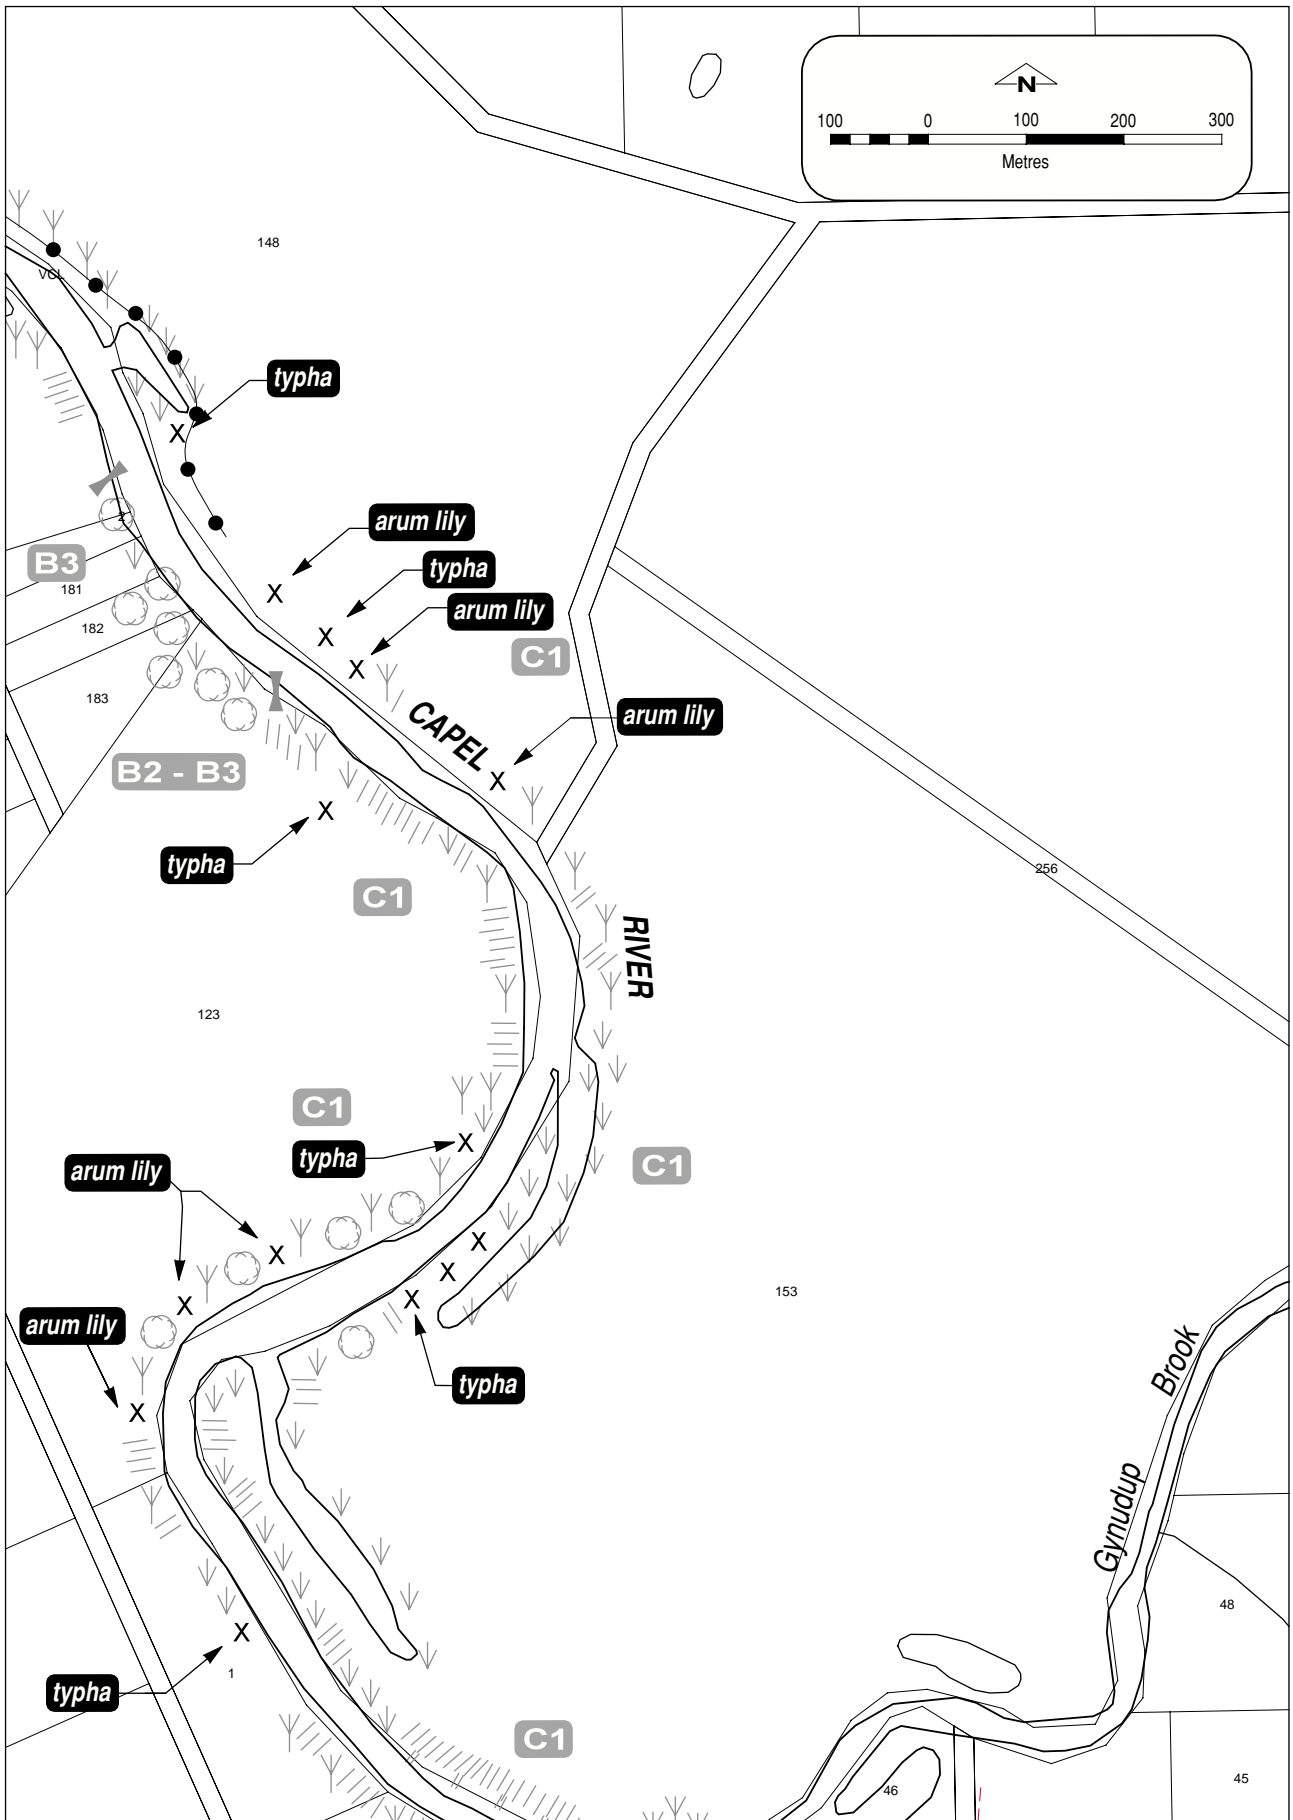
Capel River Map 3

Other management comments	The club-rush <i>Bolboschoenus caldwellii</i> was recorded in this section. <i>B. caldwellii</i> can congest waterways, and is invasive in disturbed areas.	Monitor spread of this rush.

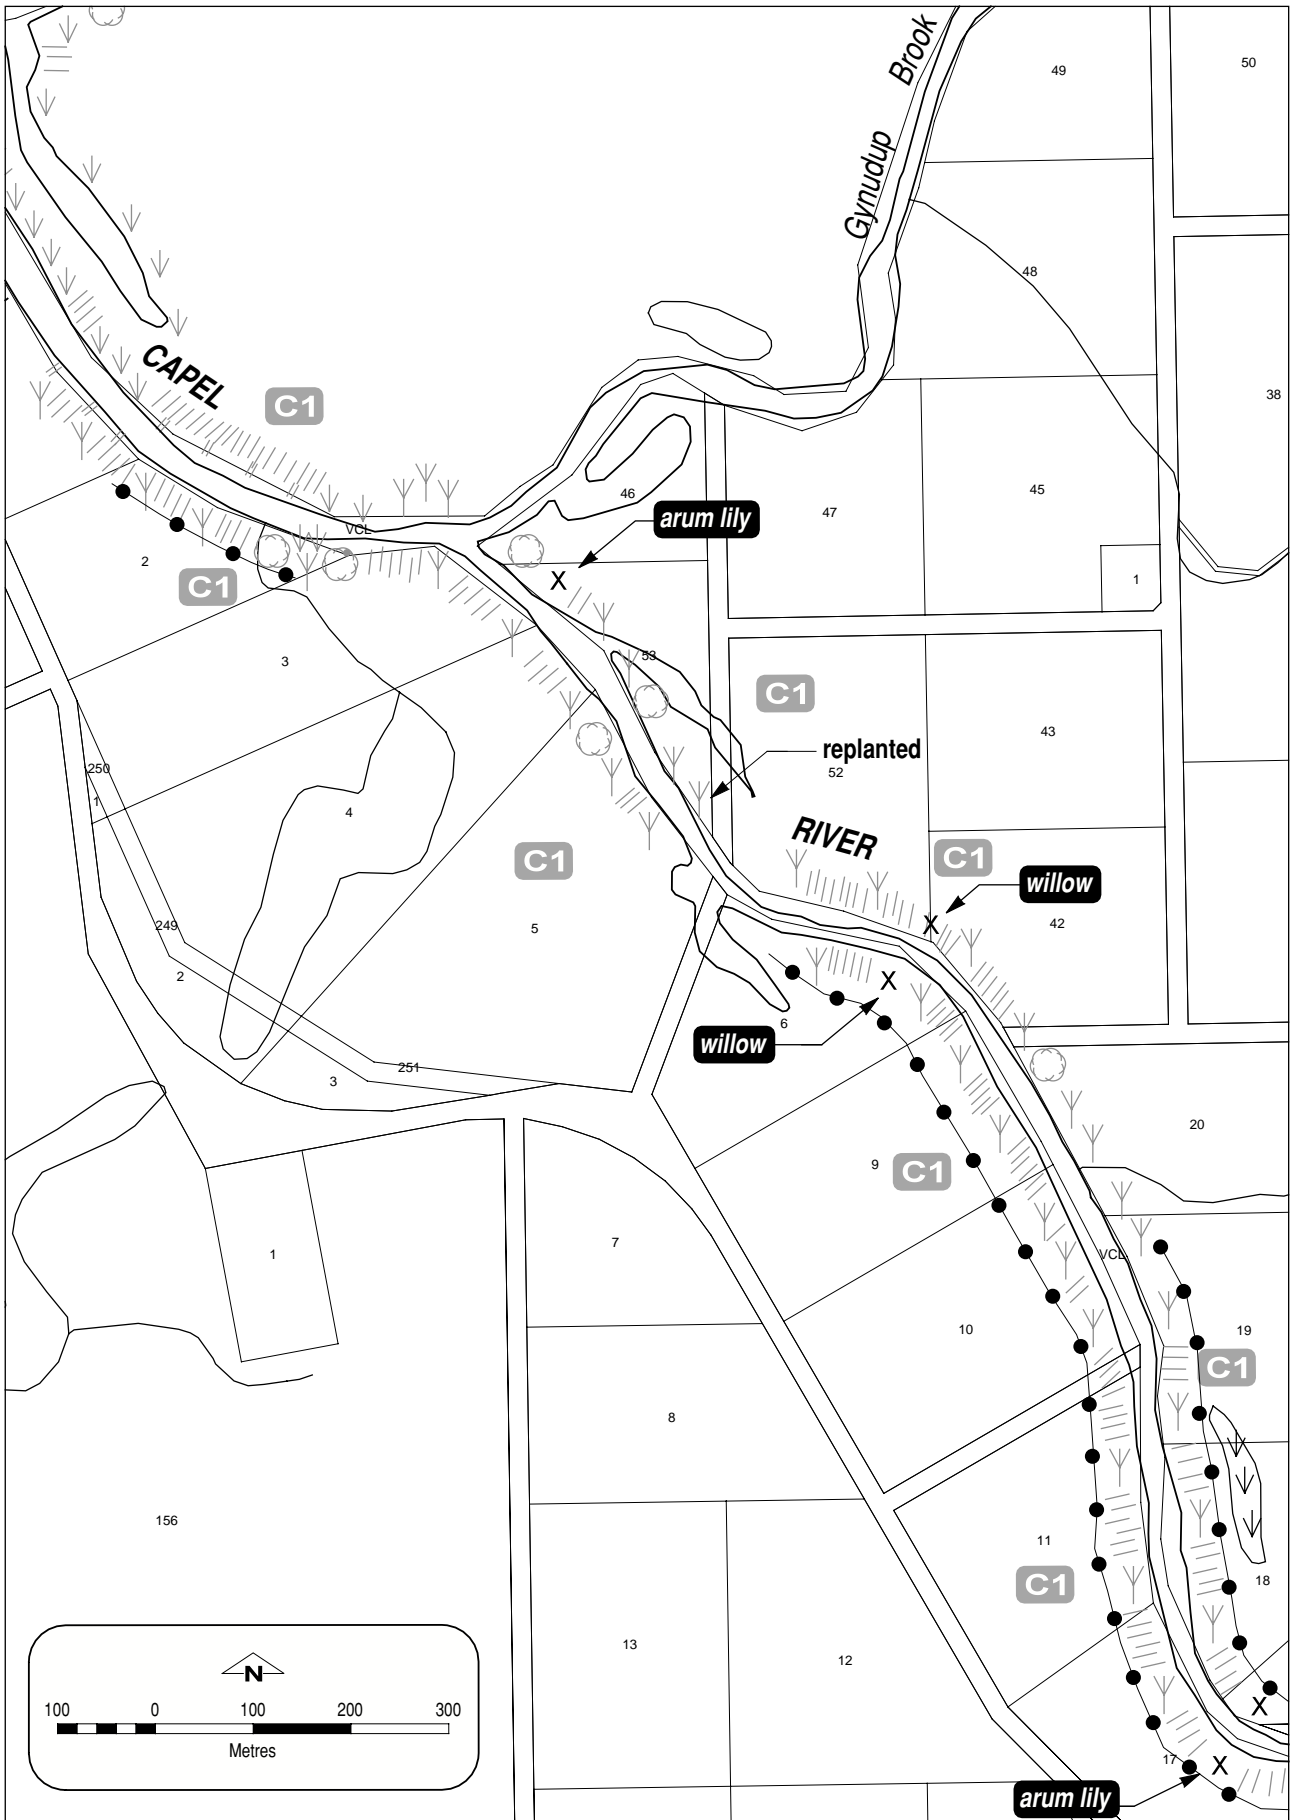
Capel River Map 4

Issues	Comments	Management Advice
General foreshore condition	Narrow foreshore, isolated trees, little or no understorey.	
Fencing	Some sections were fenced close to the foreshore, in other areas fencing was absent or set well back from the foreshore. The smaller lots in the upper section were not stocked at the time of survey.	Fencing is recommended along sections of the north and south bank. Length of fencing recommended: south bank ~1000 m, north bank ~ 600 m.
Erosion	N/A	
Revegetation requirement	Understorey is particularly sparse in this area, a narrow band of flooded gum lined the foreshore, with isolated clumps of rushes and sedges.	Revegetation with understorey and sedge species is recommended. This should include widening the riparian buffer zone to allow natural regeneration to occur. Select species for replanting from community types 1 & 4, Table 8.1 (pages 28 & 32).
Weed invasion	Typha was common in the lower section. Large willows were recorded in the middle reaches of this section. Occasional arum lilies were also recorded	Treat arum lily and Typha; consider removing willows and replacing with native trees such as flooded gum, or peppermint. Refer to Specific weed management advice Chapter 8.1.2 points 2 and 17 (page 23 & 25).

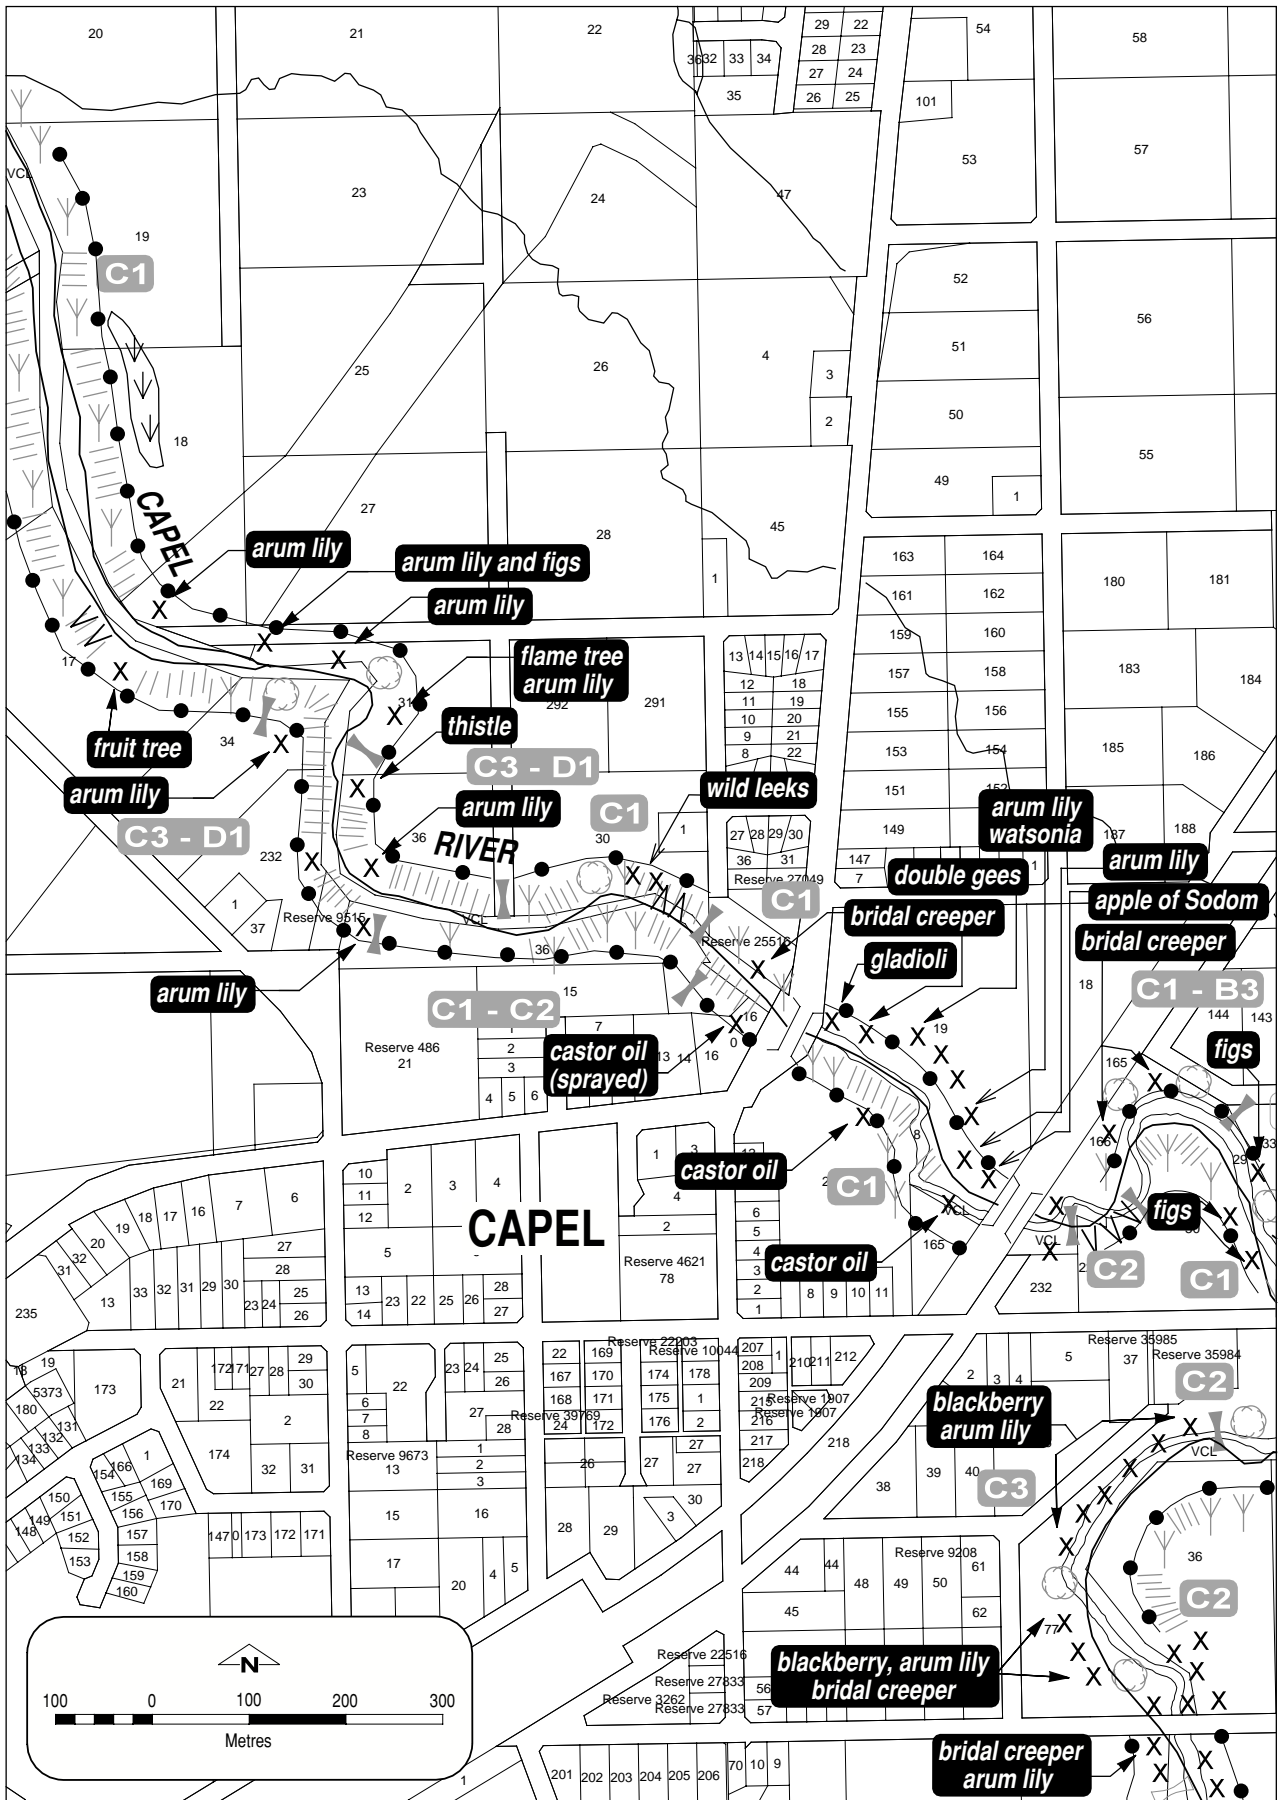
Capel River Map 5

Weed invasion	Arum lily, wild rose, bridal creeper, blue periwinkle, figs, apple of Sodom, double gees all recorded in this section. In addition, wild grapes, wild garlic and easter lilies are problematic in this area.	Refer to Specific weed management advice Chapter 8.1.2 points 2, 19, 5, 4, 10, 1, and 9 (pages 23 -26). Also treat wild grapes, wild garlic and easter lilies.
Other management comments	Due to its proximity and high visibility to the town of Capel this section could be used as a priority site for restoration action. <i>Bolboschoenus caldwellii</i> recorded in this section. <i>B. caldwellii</i> readily invades disturbed areas and can clog waterways.	<b>PRIORITY ACTION SITE</b> Monitor spread of this rush.

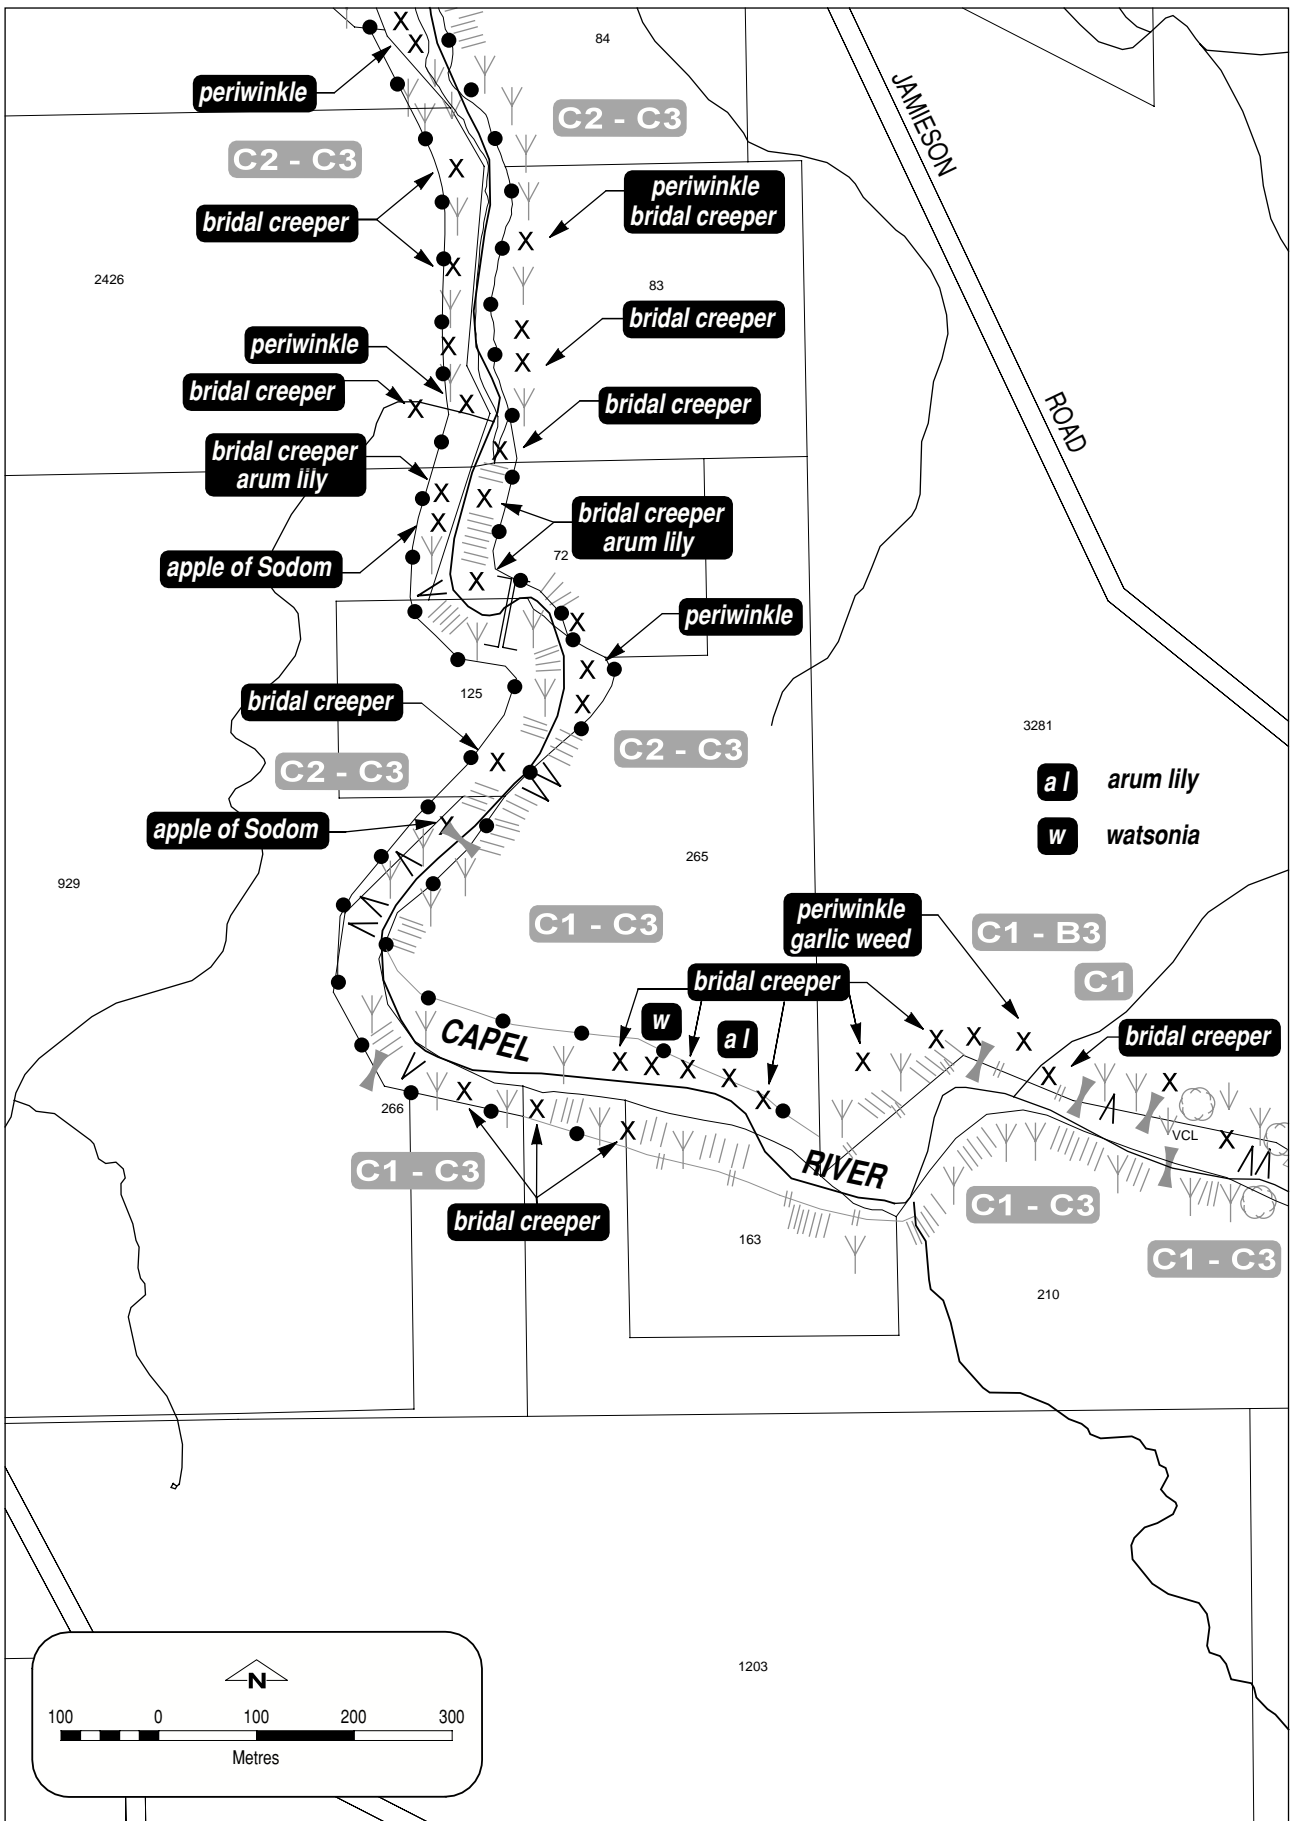
Capel River Map 7

Weed invasion	A variety of invasive weeds were recorded in this section, including blue periwinkle, bridal creeper, arum lily, apple of Sodom, and garlic weed.	Refer to Specific weed management advice Chapter 8.1.2 points 1, 2, 4, and 5 (page 23).
Other management comments

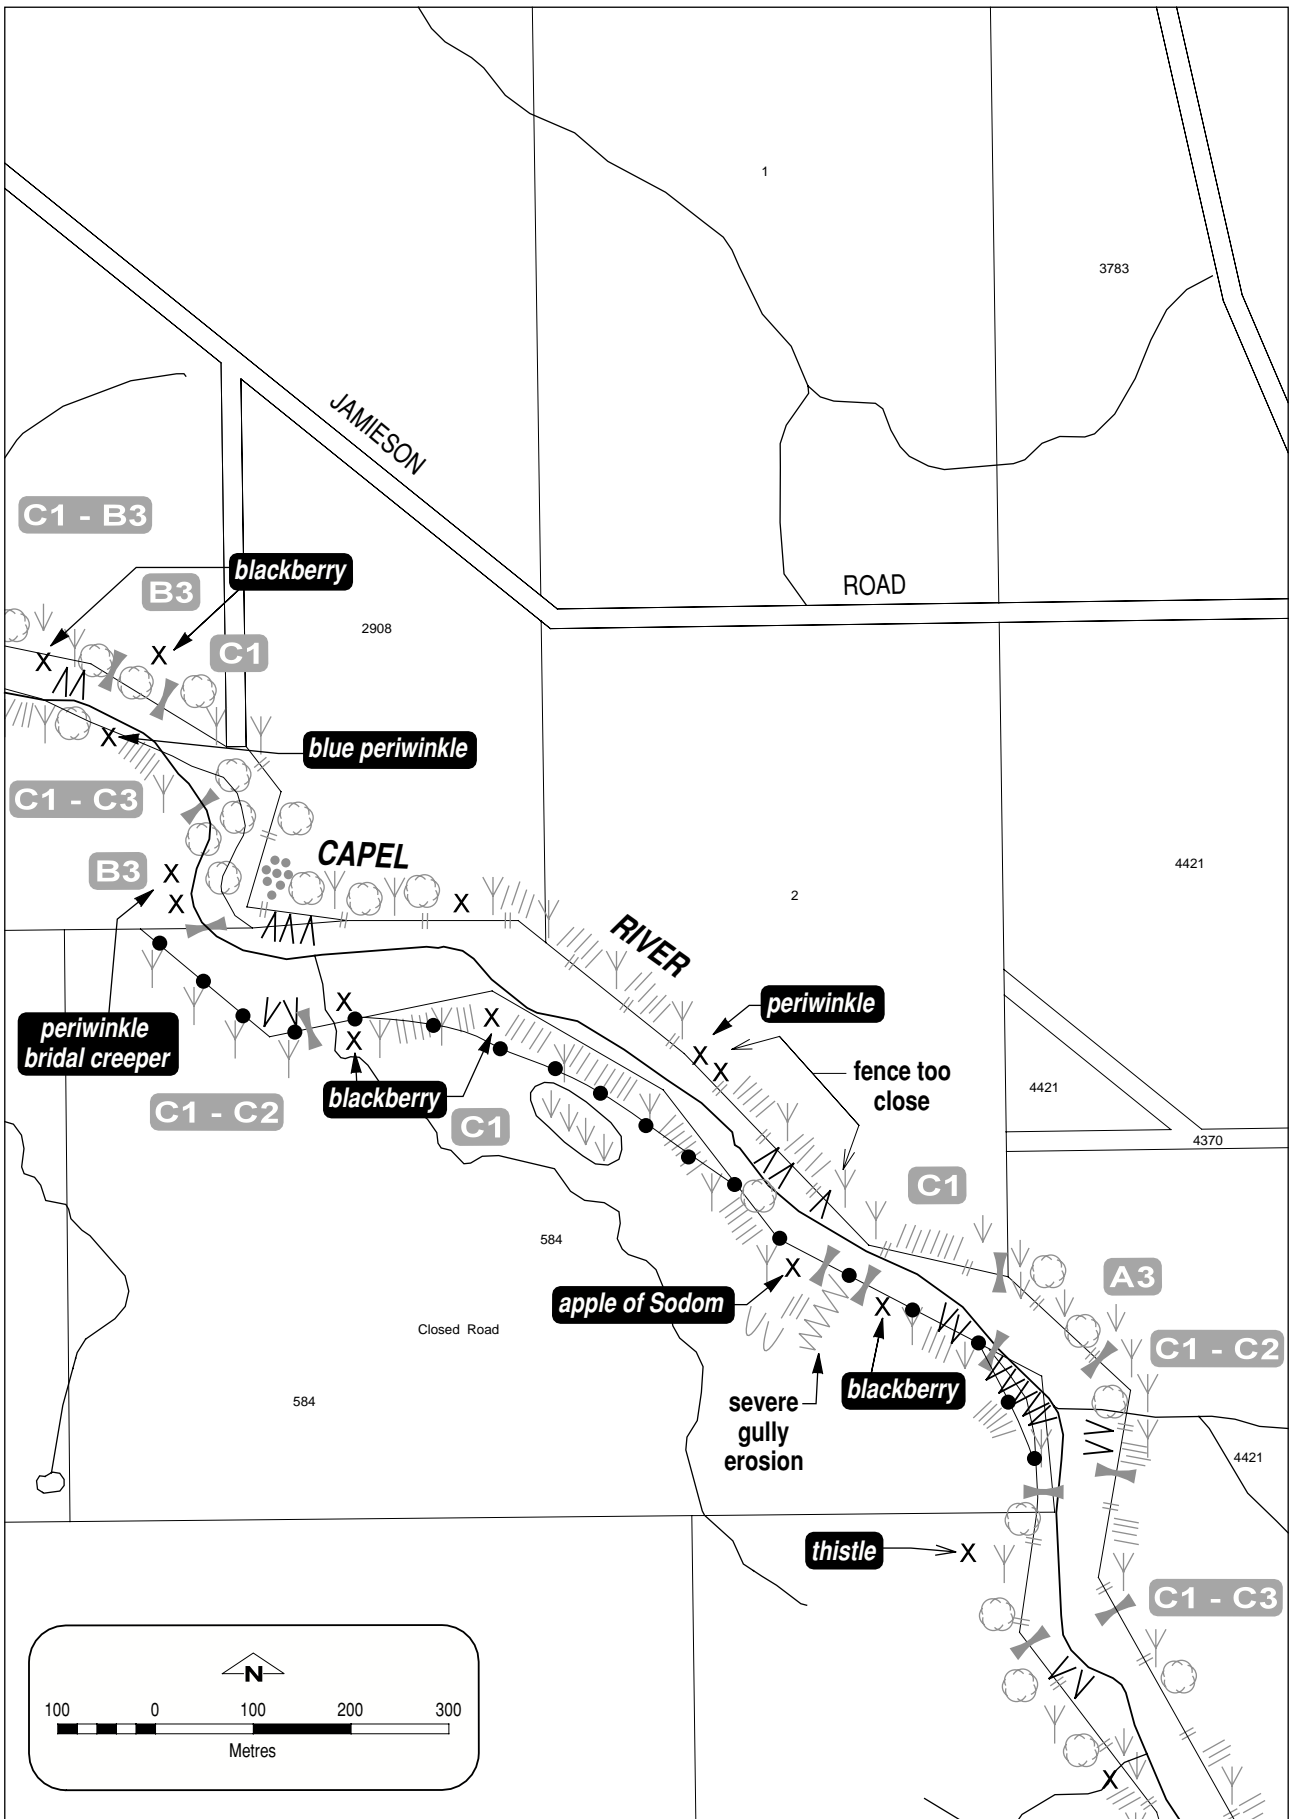
Capel River Map 8

Issues	Comments	Management Advice
General foreshore condition		
Fencing	Fencing recommended along much of the southern foreshore of this section. Fence too close to the riverbank on some sections of the northern foreshore.	Length of fencing recommended: south bank ~ 1300 m
Erosion	Frequent sites of scouring along this section. Also, two small areas of sheet erosion noted on the southern bank. Some severe gully erosion and sheet erosion on the southern foreshore of this section.	Refer to Erosion control Chapter 8.3, points 1 and 2 (page 33).
Revegetation requirement	Revegetation of understorey species recommended along much of this section.	Select species from community type 2 & 3, Table 8.1 (pages 29 - 31).
Weed invasion	Bridal creeper, blackberry, apple of Sodom, periwinkle, figs and thistles.	Refer Specific weed management advice Chapter 8.1.2 points 1, 5, 3, 4, 10, and 16 (pages 23 - 25).
Other management comments	Small area of excellent vegetation on northern foreshore could be used as potential seed source for revegetation.	Complete detailed vegetation survey of this area.

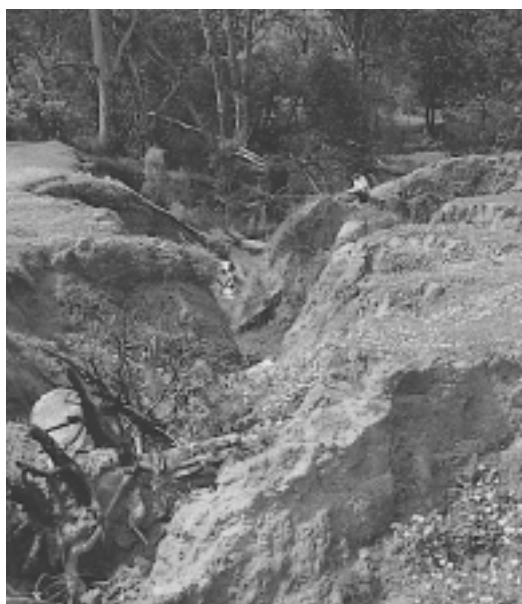
Plate 12: Severe gully erosion on the Capel River.

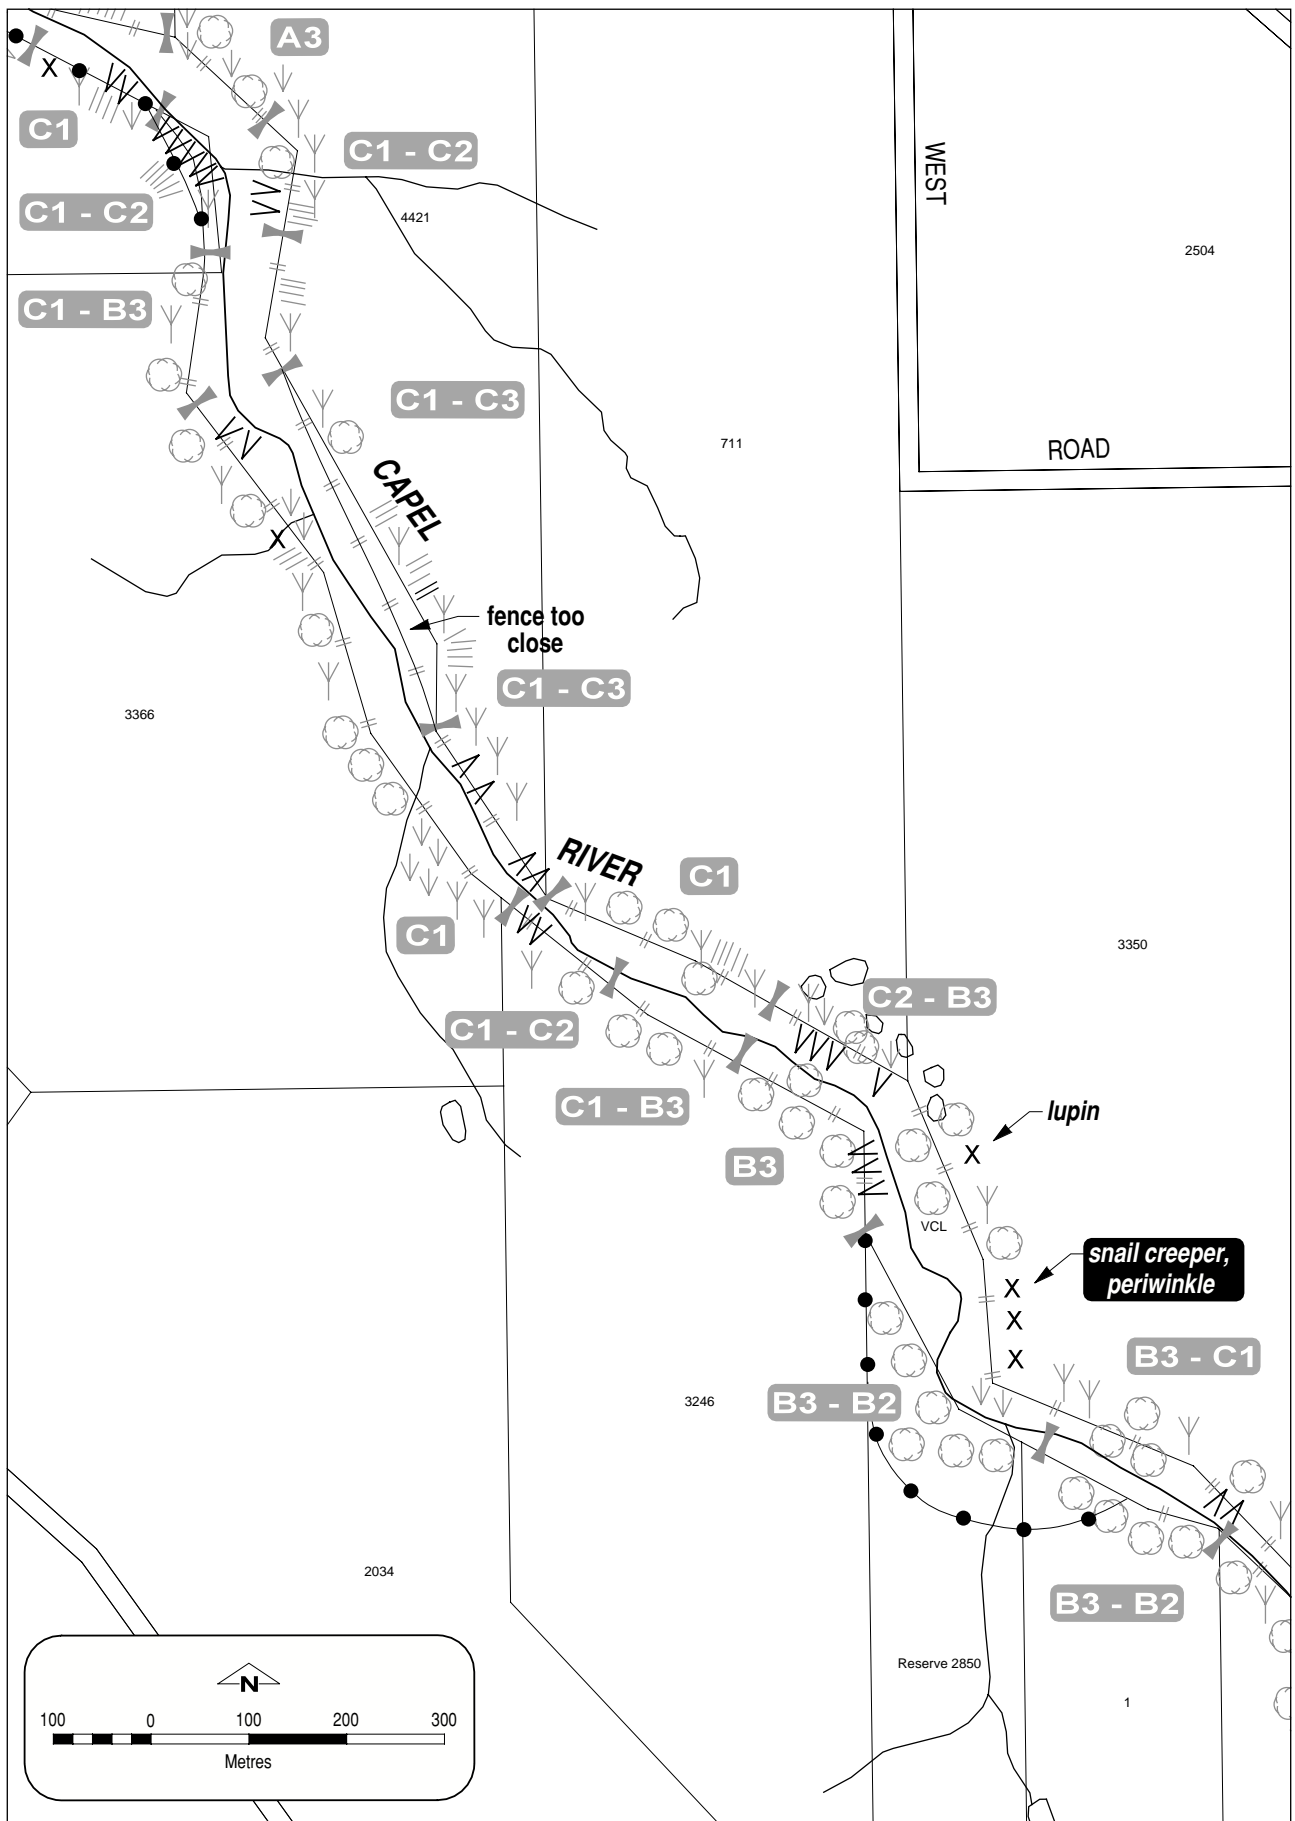
Capel River Map 9

Weed invasion	Periwinkle, snowdrops and snail creeper.	Refer to Specific weed management advice Chapter 8.1.2 points 4, 14 and 13 (pages 23 & 25).
Other management comments	Good source of seed for revegetation around soaks on reserve 2850.	Complete detailed vegetation survey of vegetation surrounding the soak on reserve 2850.
