# Capel River Action Plan

1999

Prepared for Geographe Catchment Council - GeoCatch  
and the Capel Land Conservation District Committee

by  
Kirrily White and Sarah Comer  
in association with  
Evangelisti & Associates

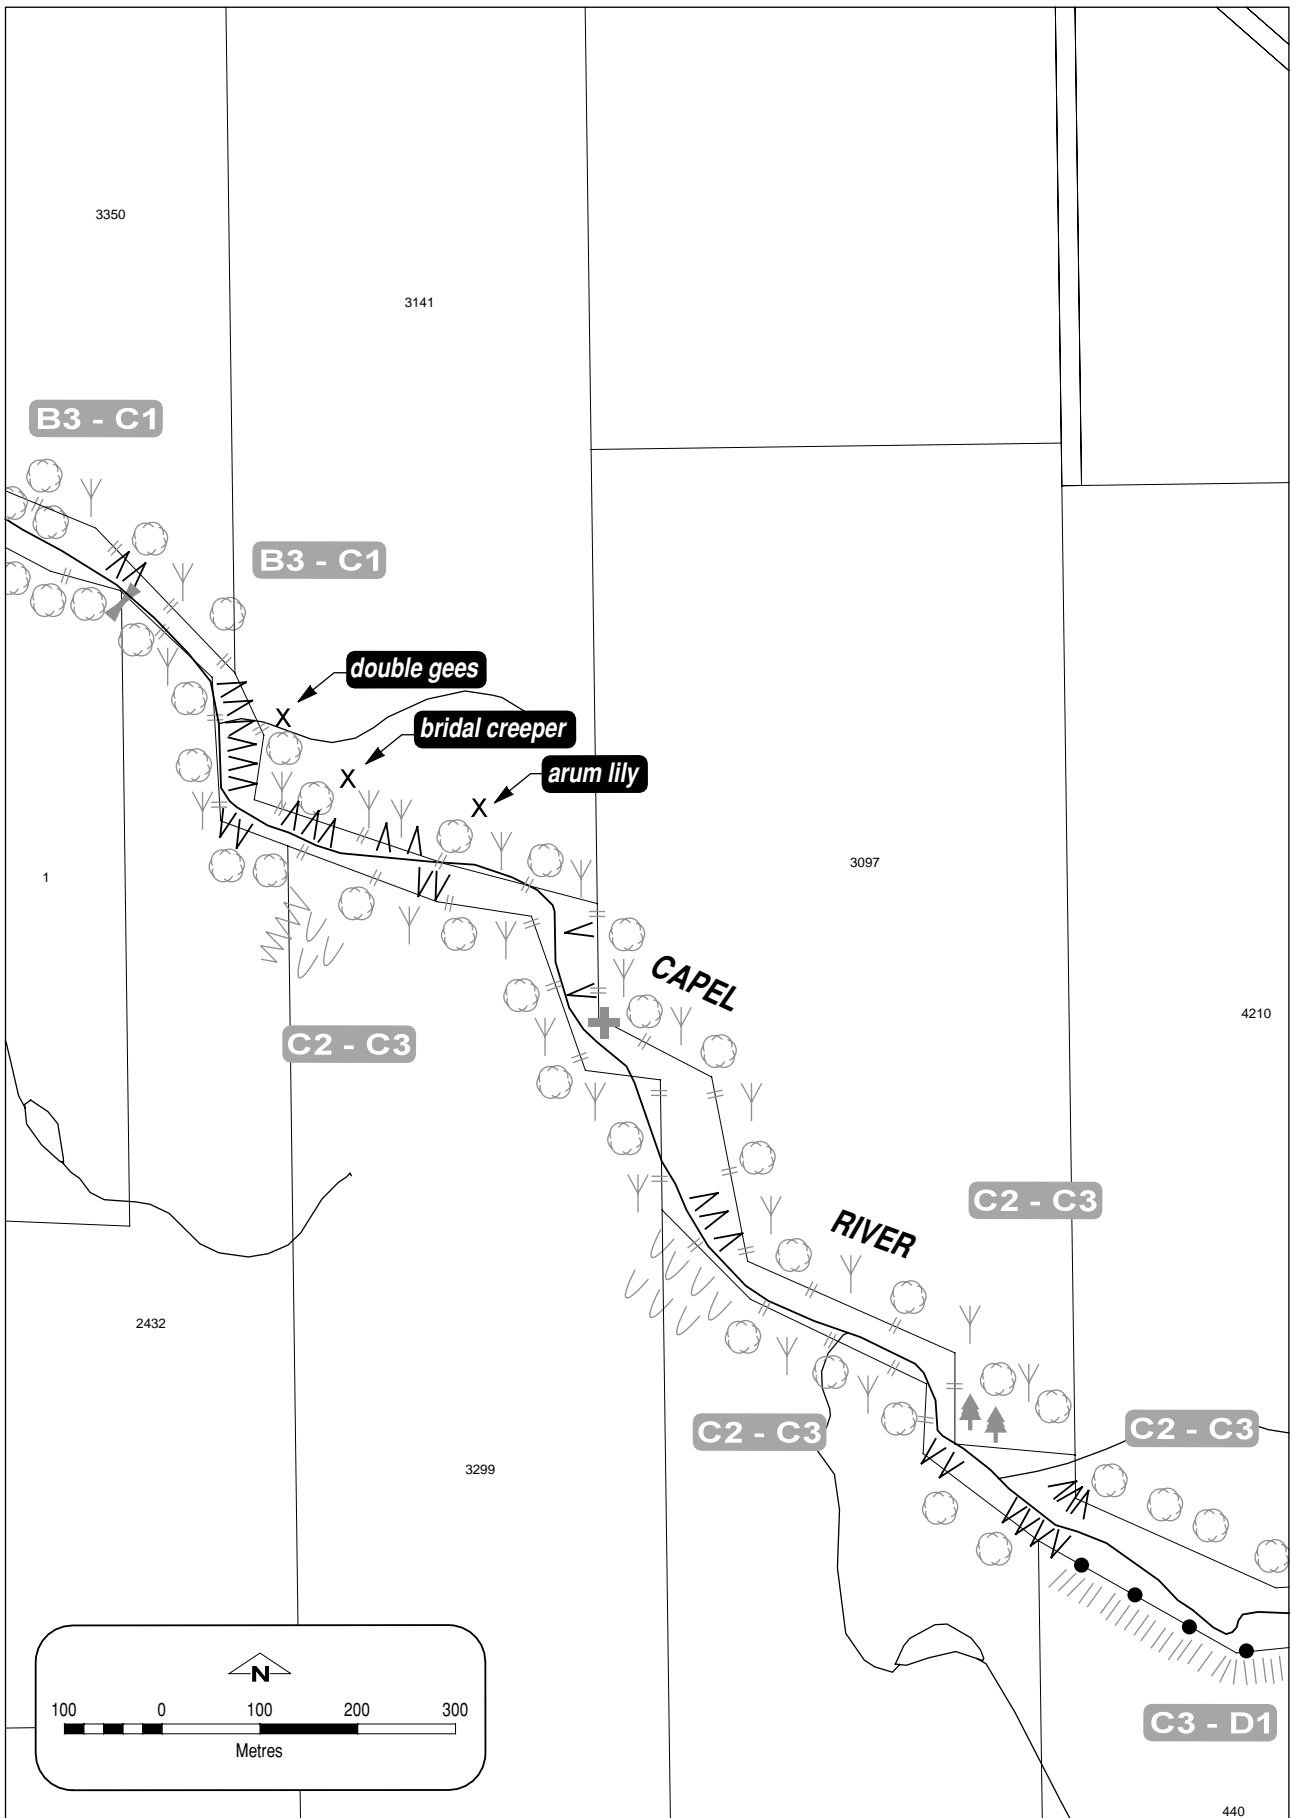
Capel River Map 10

Other management comments	Some restoration/bunding attempted.

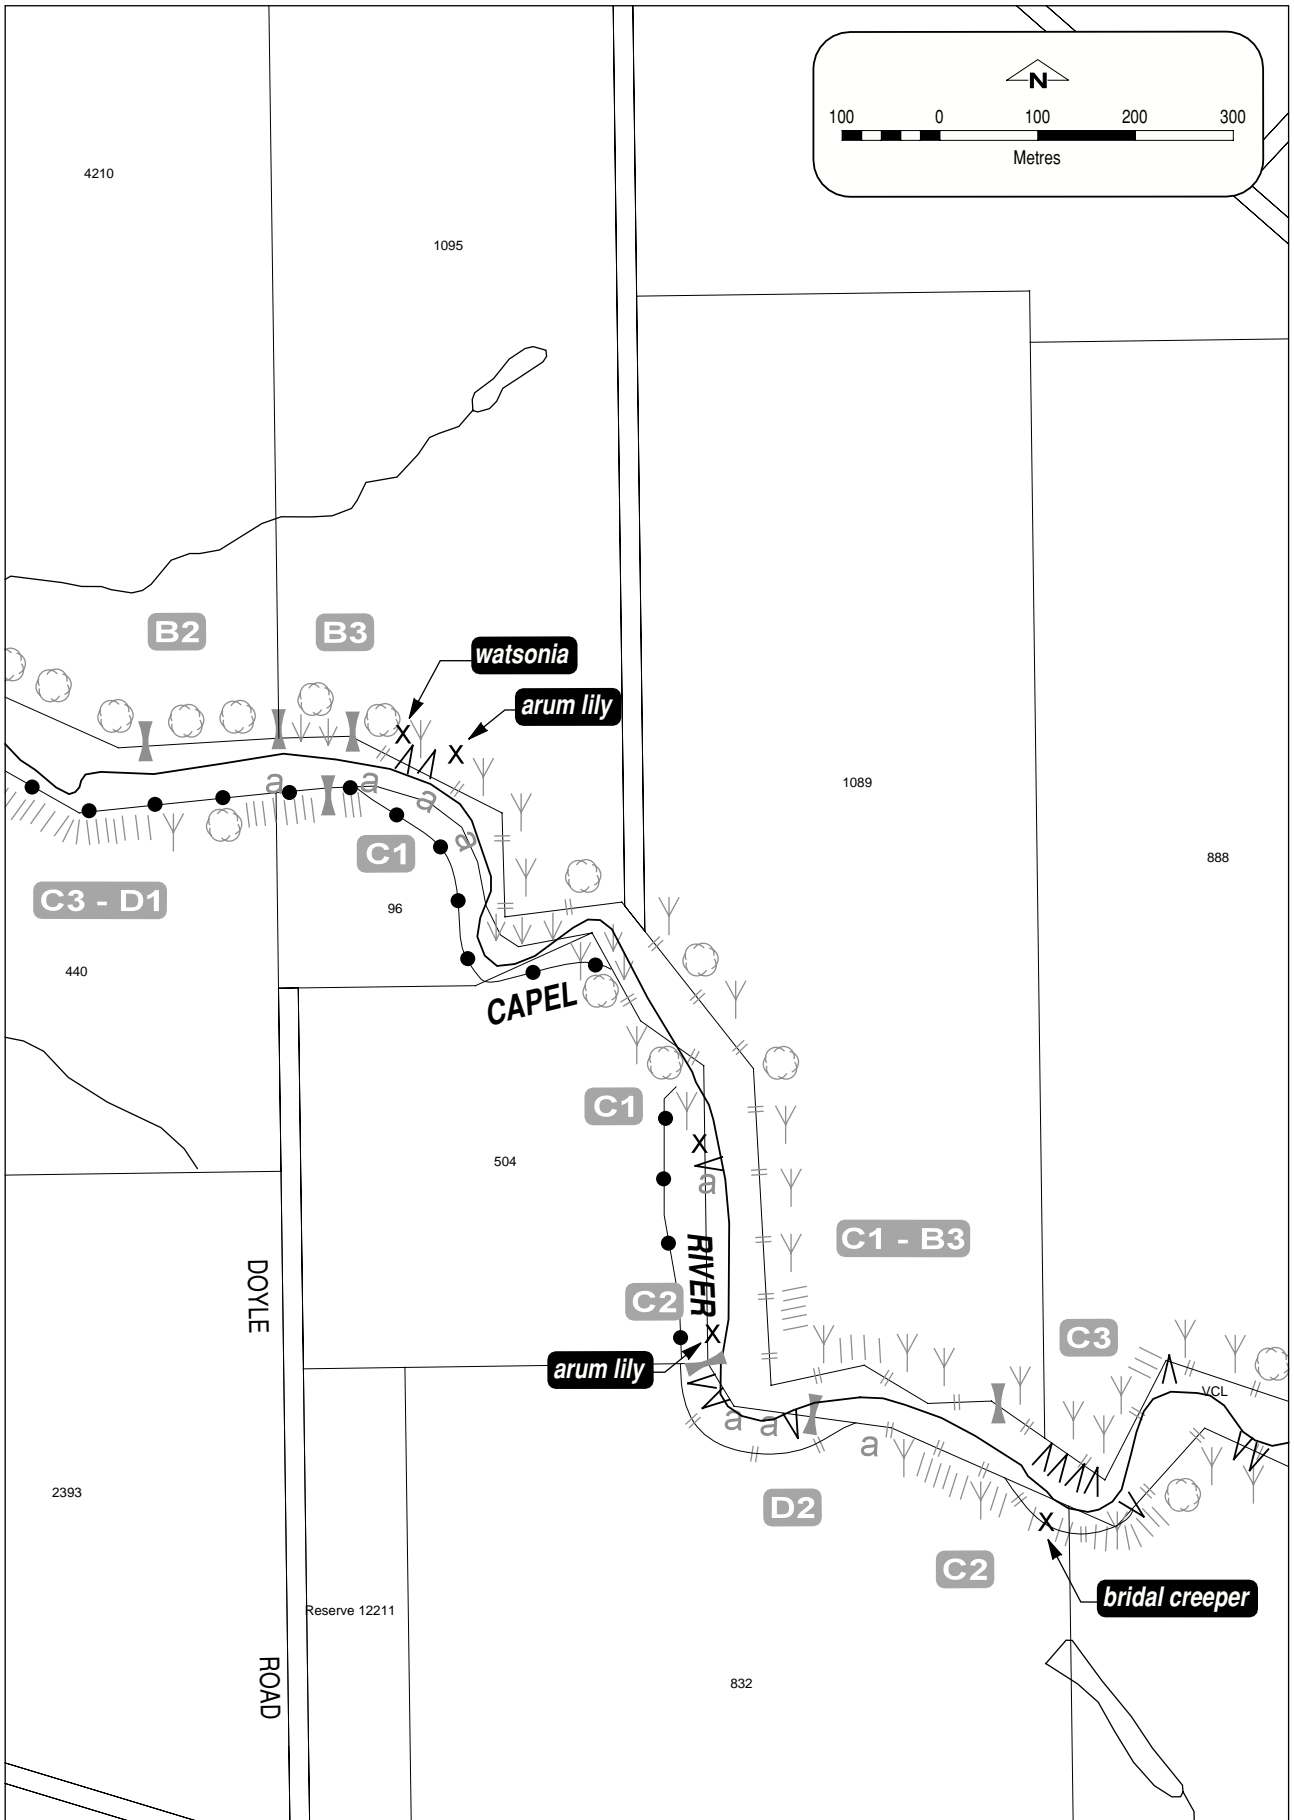
Capel River Map 11

Other management comments	Areas rated D1 require priority action.	All management advice with respect to fencing, restoration and revegetation is appropriate for this section.

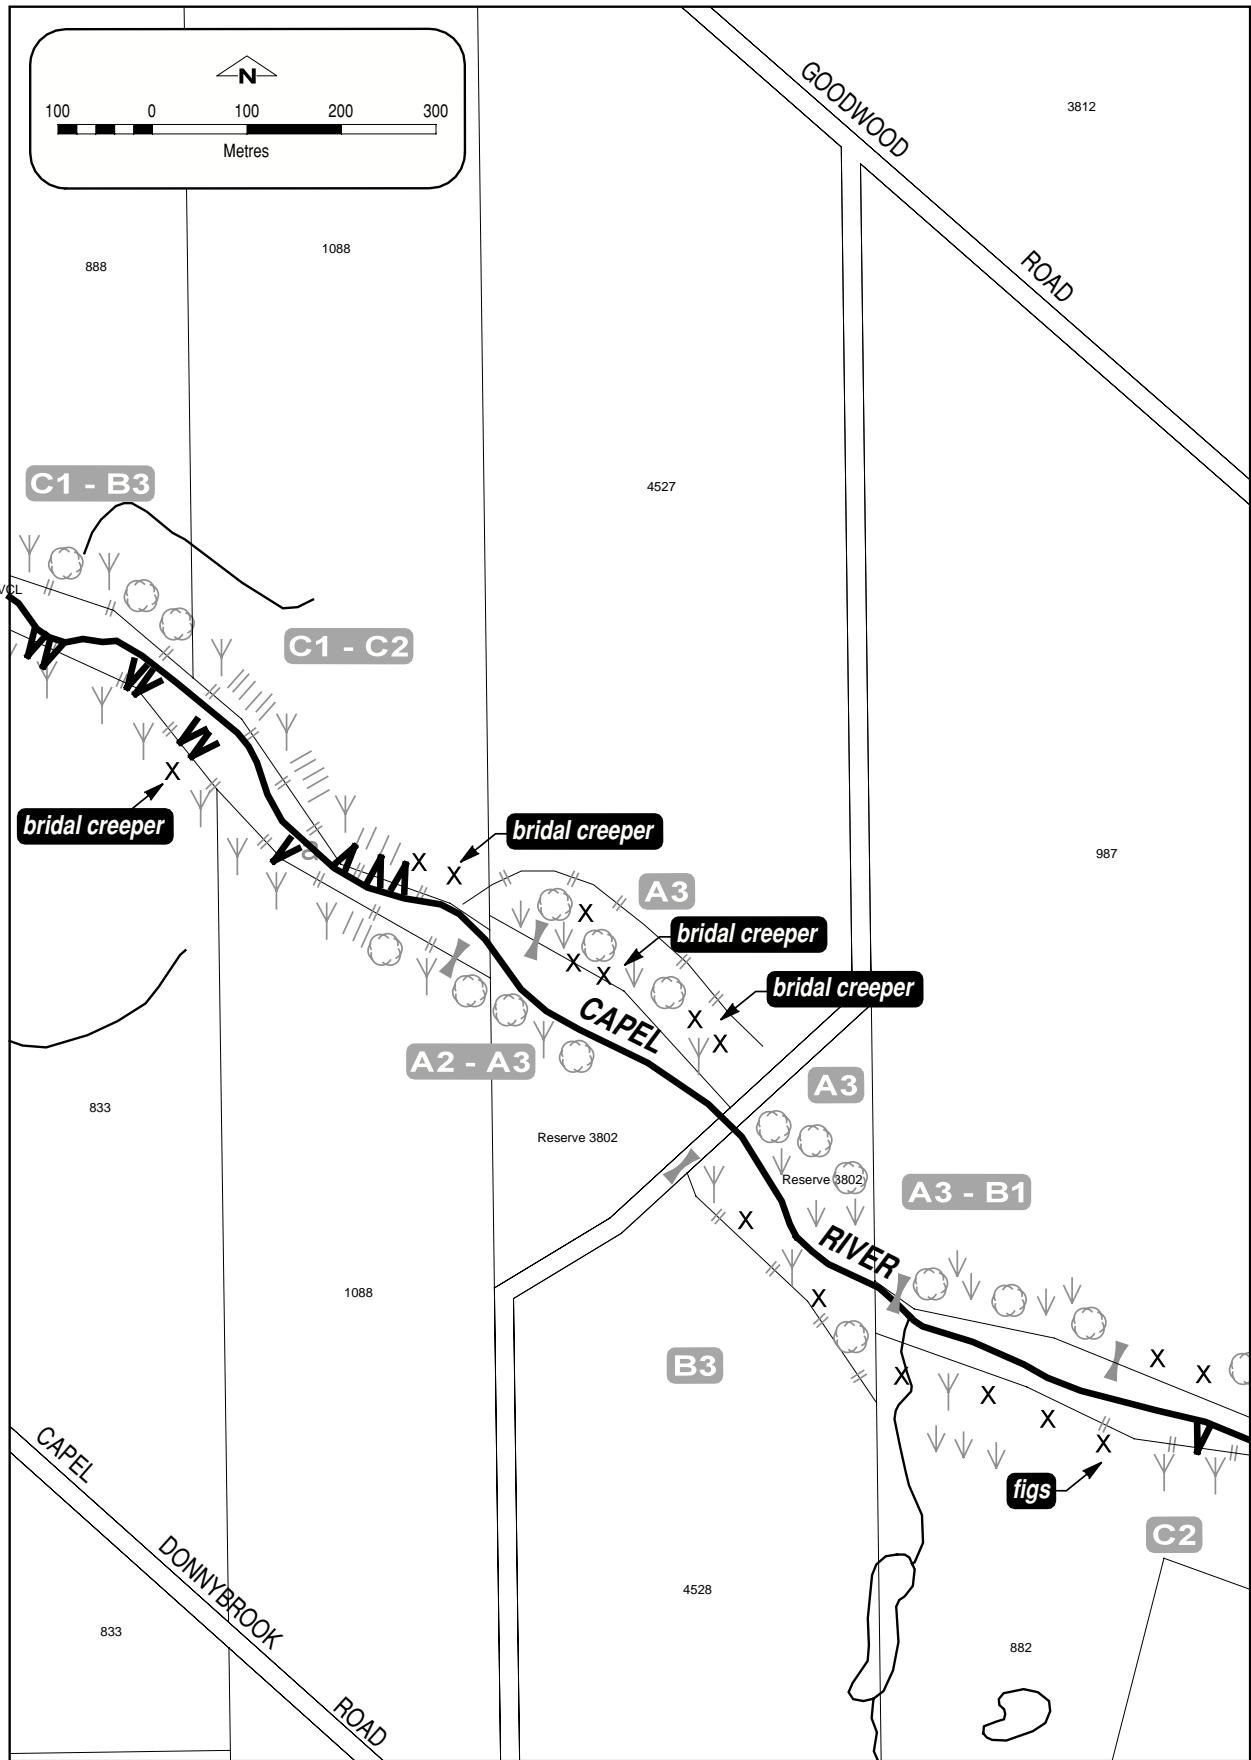
Capel River Map 12

Weed invasion	Some arum lily and bridal creeper, occasional Pittosporum and patches of figs found in this section.	Refer to Specific weed management advice Chapter 8.1.2 points 2, 5, 10 and 15 (pages 23 - 25).
Other management comments	Stock access point needs maintenance to limit area of access on foreshore. Reserve 3802 contains good quality remnant vegetation.	Complete a detailed vegetation survey of reserve 3802.

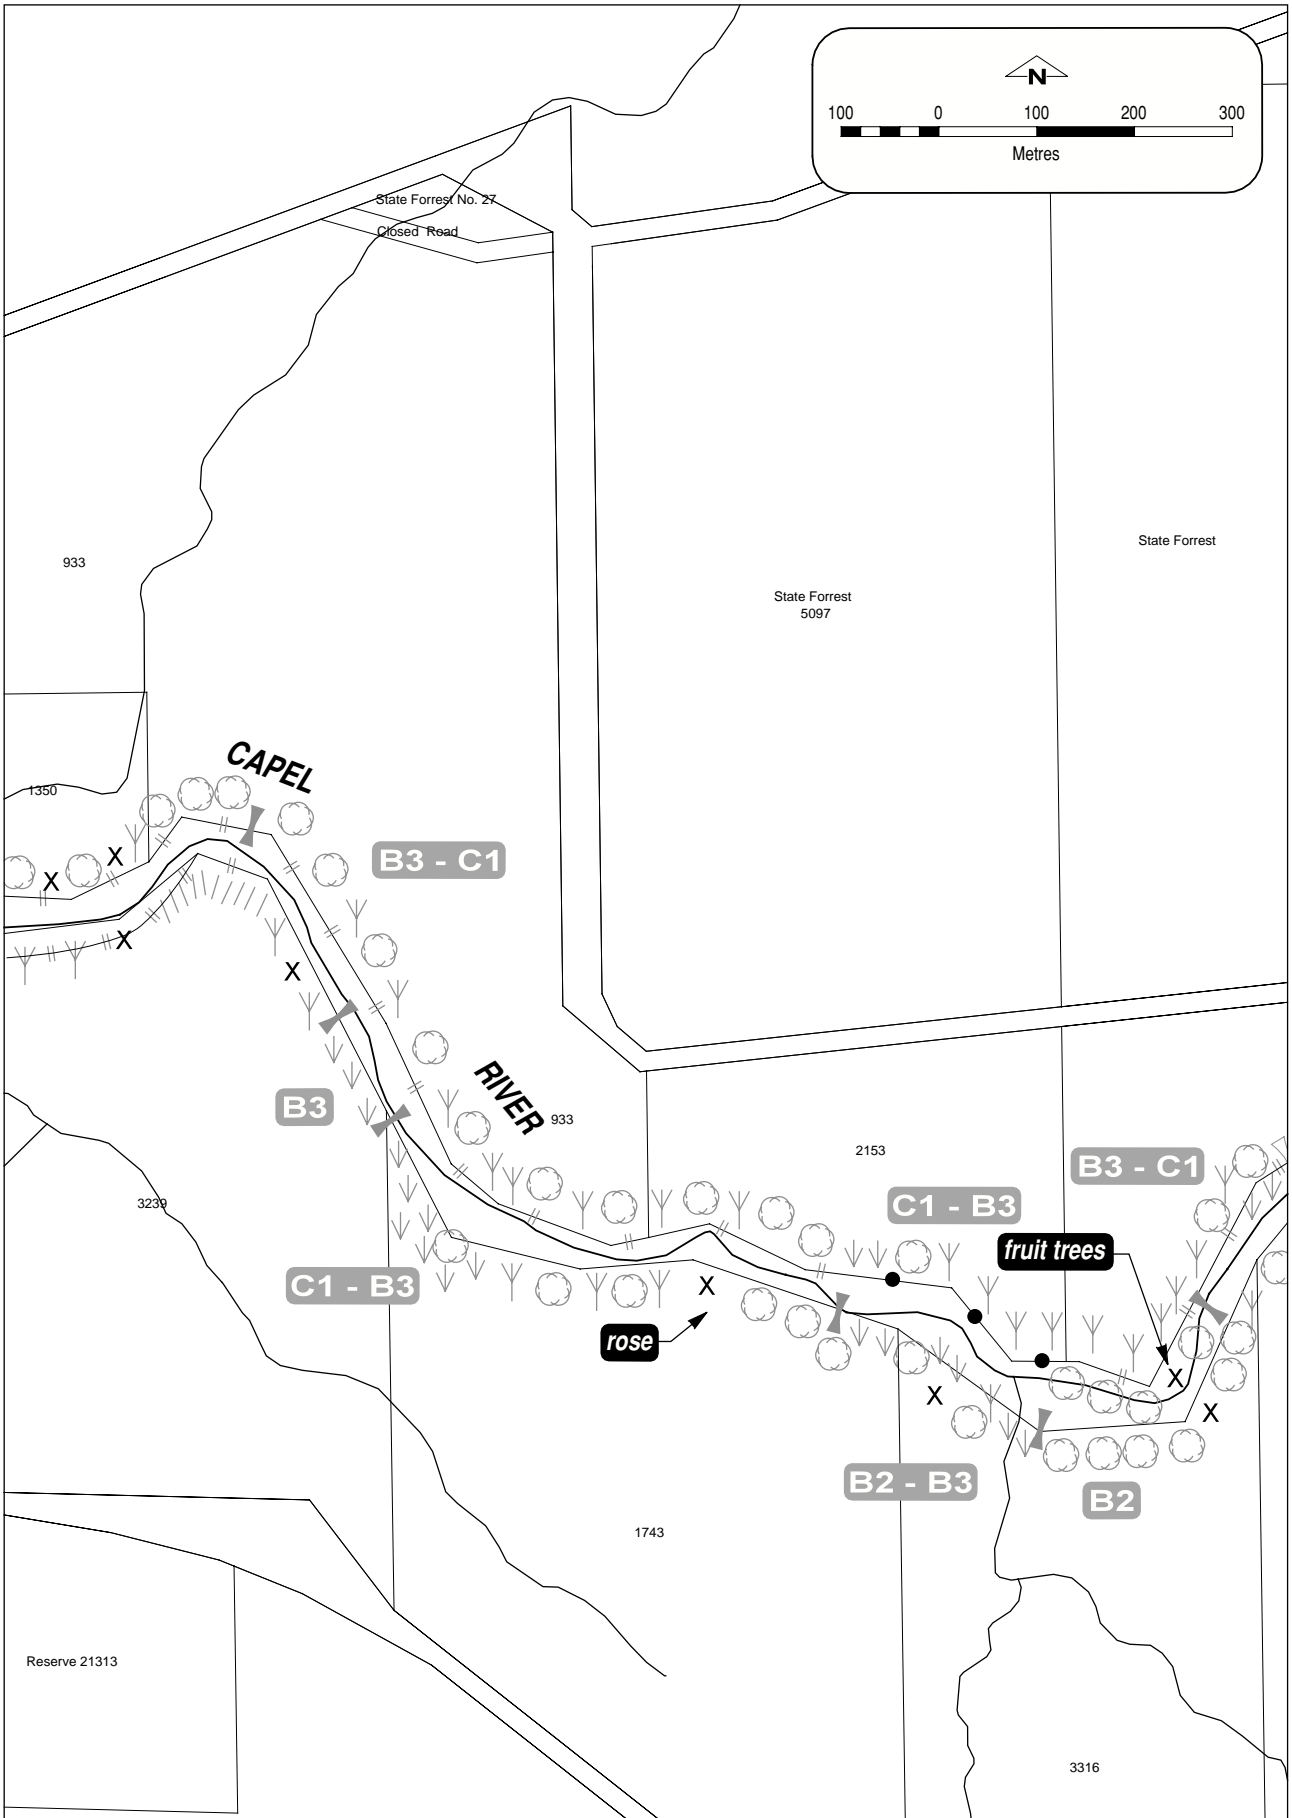
Capel River Map 14

Issues	Comments	Management Advice
General foreshore condition	Some good areas of remnant vegetation remain on the southeastern foreshore in this section.	N/A
Fencing	Much of this section either fenced or does not require fences due to nature of land use.	Length of fencing recommended 200 m on north bank.
Erosion	N/A	
Revegetation requirement	Revegetation with understorey species would increase diversity and improve vegetation structure in areas on this map. On the south-west section of this map some canopy species could be planted.	Select species from community type 1 on the riparian fringe & 2 on the floodplain, Table 8.1 (pages 28 - 30).
Weed invasion	Fruit trees, wild rose, arum lily, bridal creeper, and cotton bush found on this section.	Control weeds where possible. Refer to Specific weed management advice Chapter 8.1.2 points 12, 19, 2, 5 and 8 (pages 23 - 26).
Other management comments

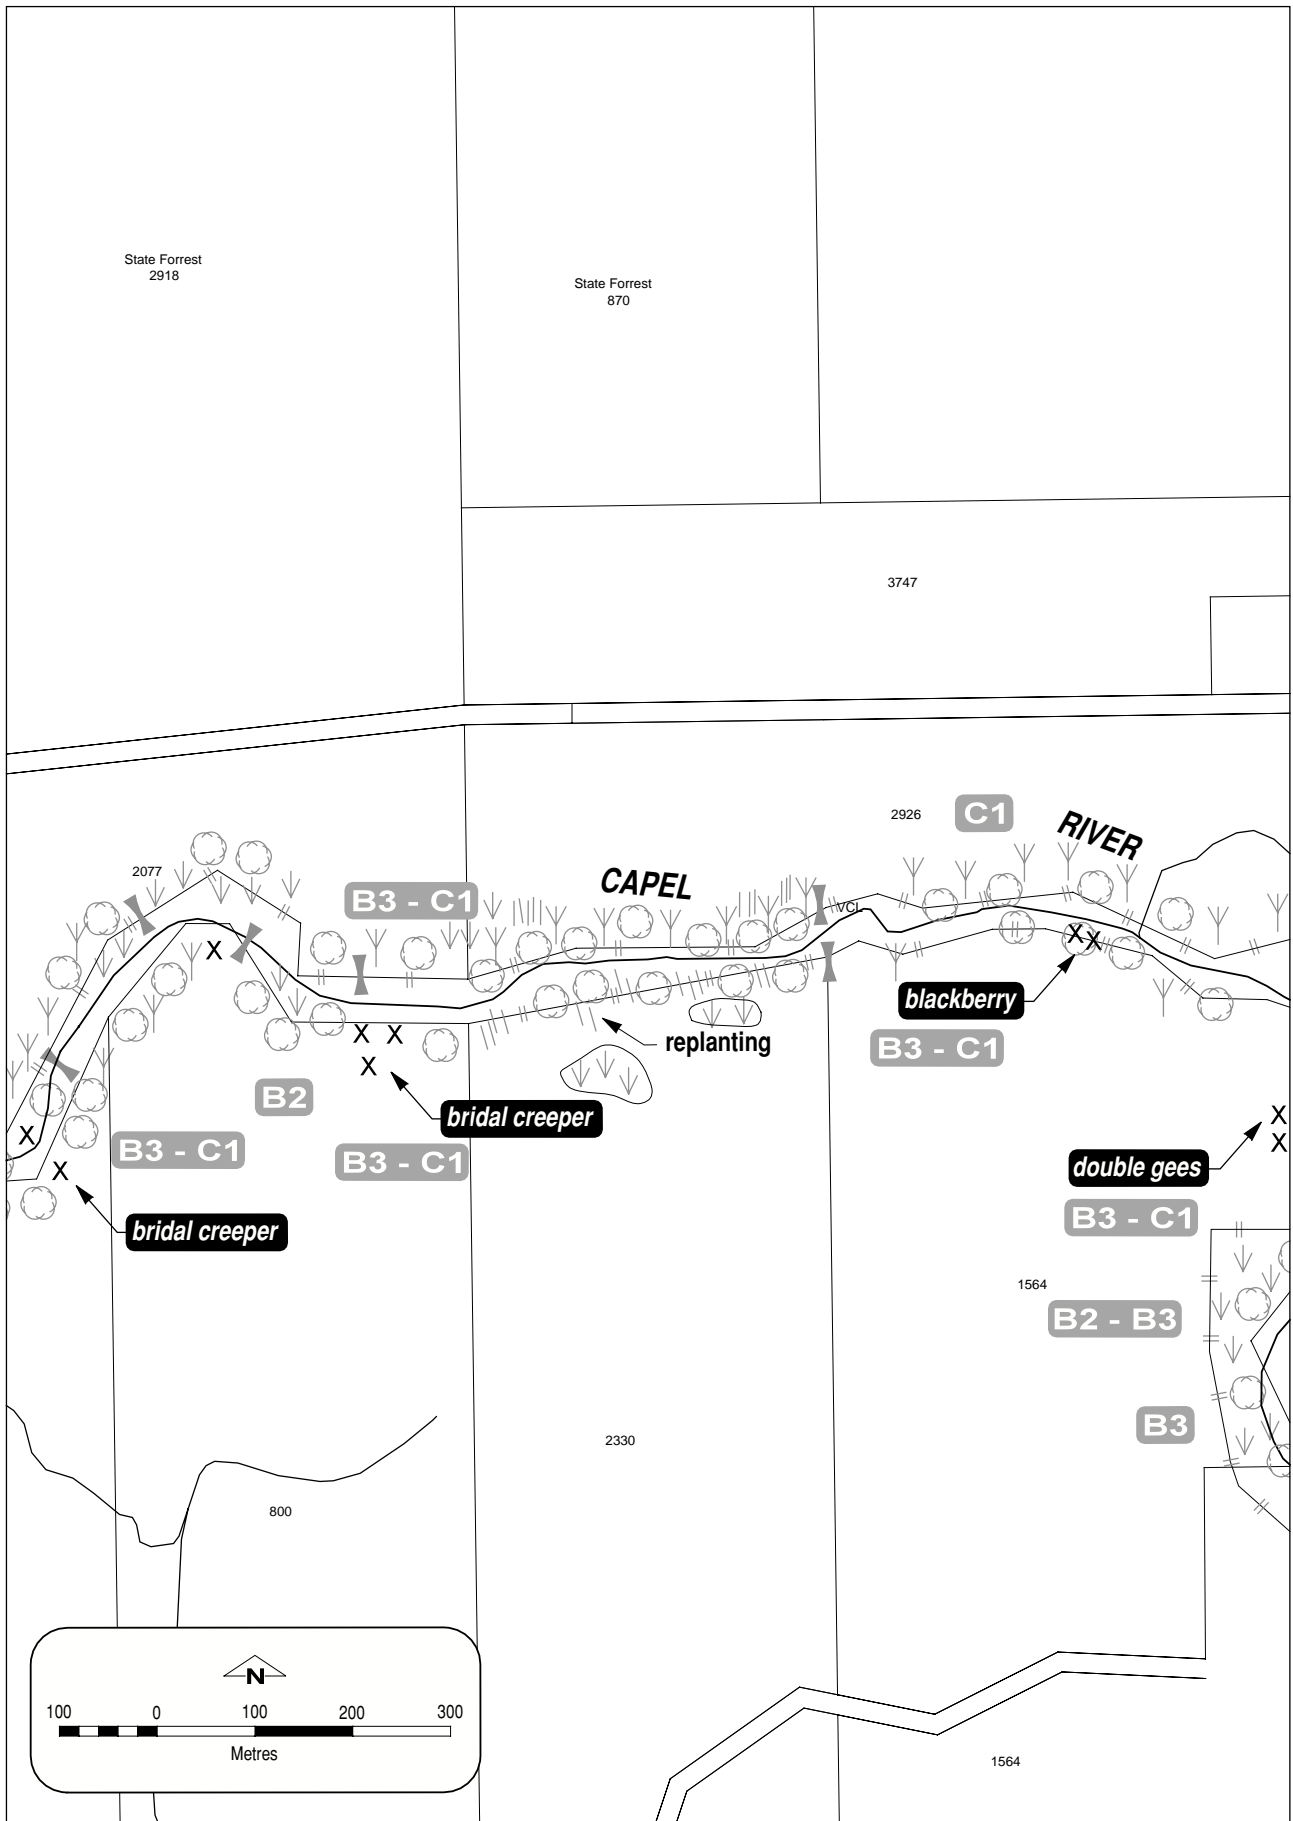
Capel River Map 15

Issues	Comments	Management Advice
General foreshore condition	Some good areas of remnant vegetation remain on the northwestern foreshore in this section.	N/A
Fencing	Only a short section of fencing recommended on the southeastern bank of this section.	Length of fencing recommended ~ 200 m on southern bank.
Erosion	N/A	
Revegetation requirement	Understorey species lack diversity along much of this map.	Revegetate with understorey species, and sedges and rushes. Select species from community type 1 on the riparian fringe & 2 on the floodplain, Table 8.1. (pages 28 & 29)
Weed invasion	Bridal creeper, blackberry and double gees found on this section.	Control weeds where possible. Refer to Specific weed management advice Chapter 8.1.2 points 5, 3, and 9 (pages 23 & 24).
Other management	Previous control of blackberry requires follow-up as regeneration was observed. comments

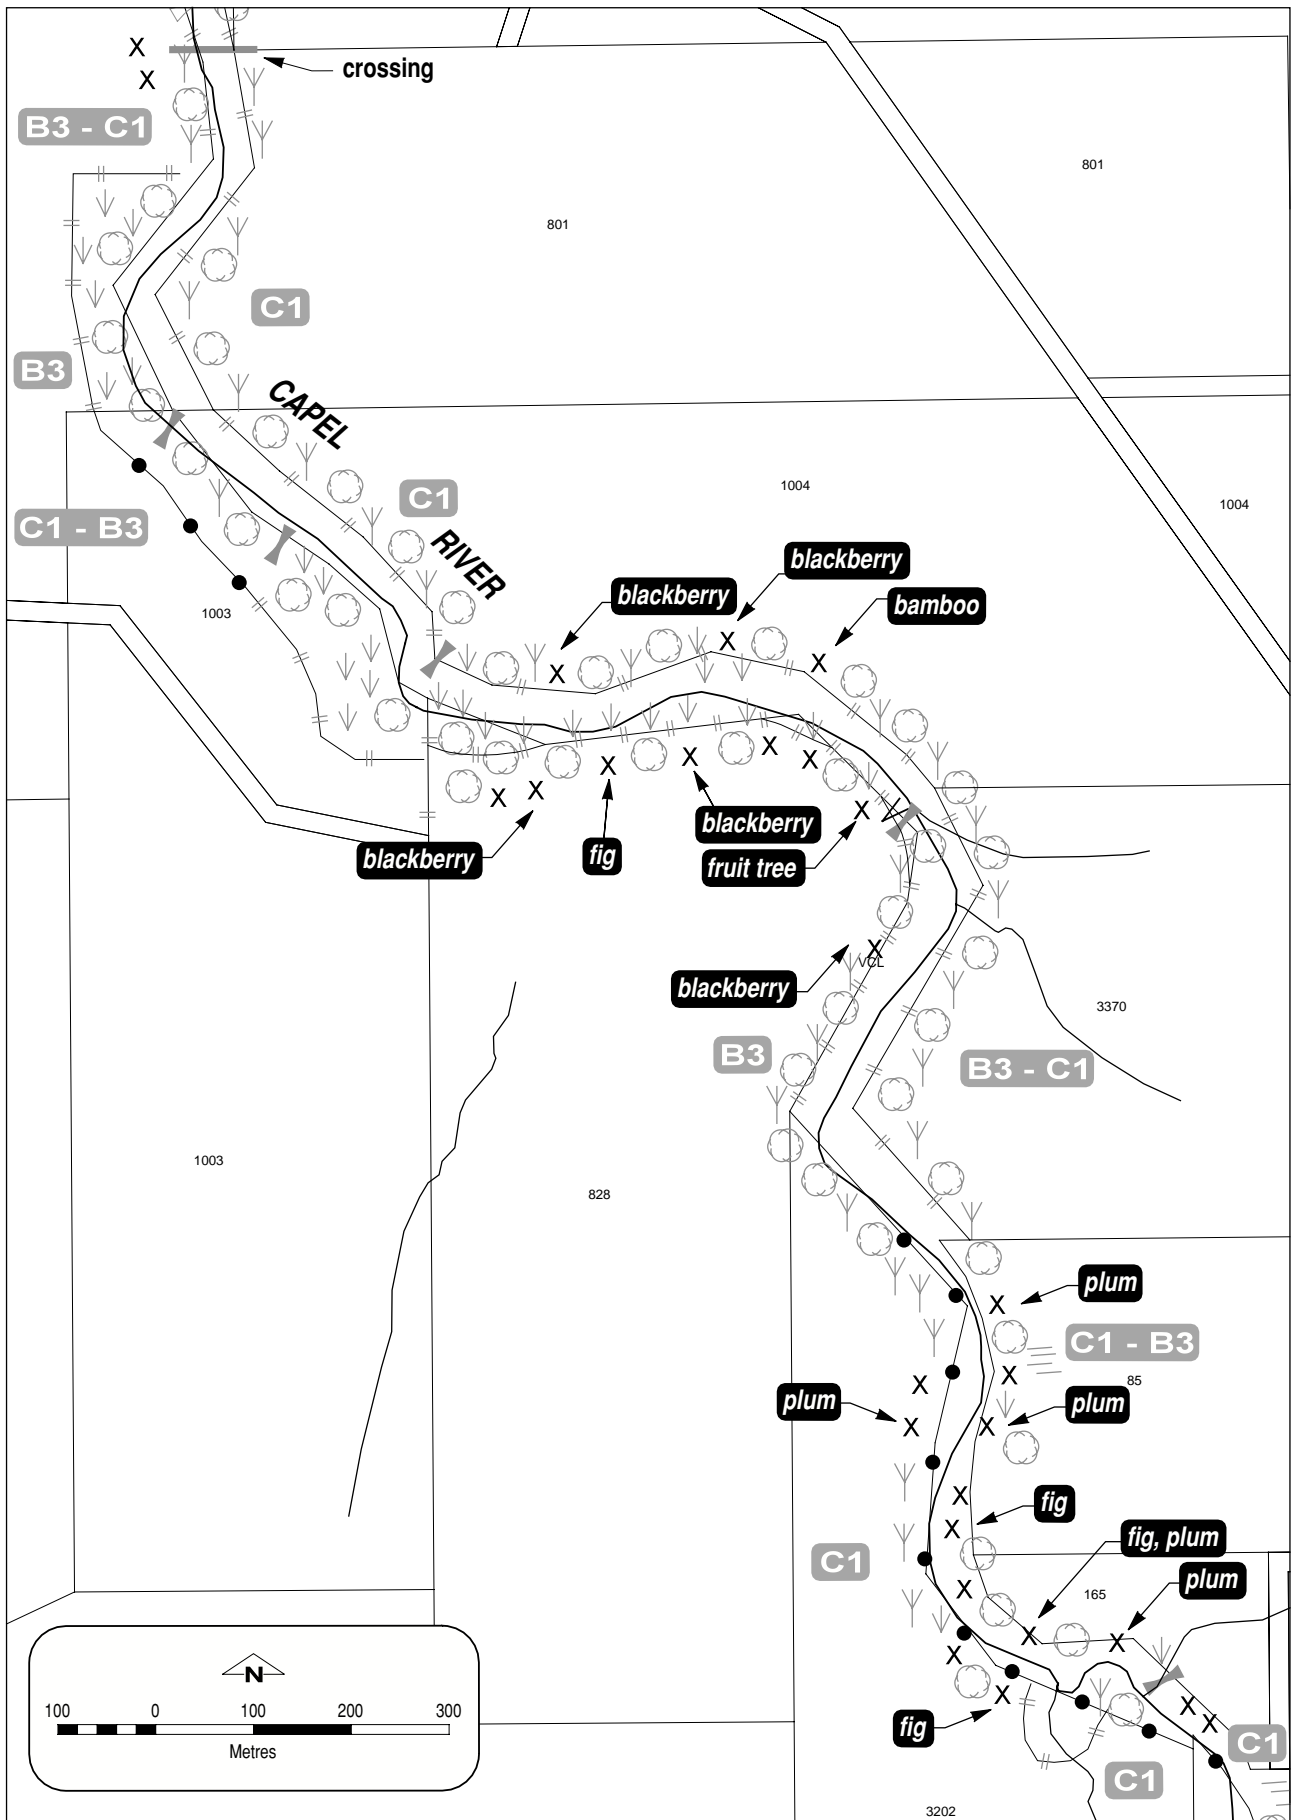
Capel River Map 16

Other management comments	Previous control of blackberry requires follow-up.

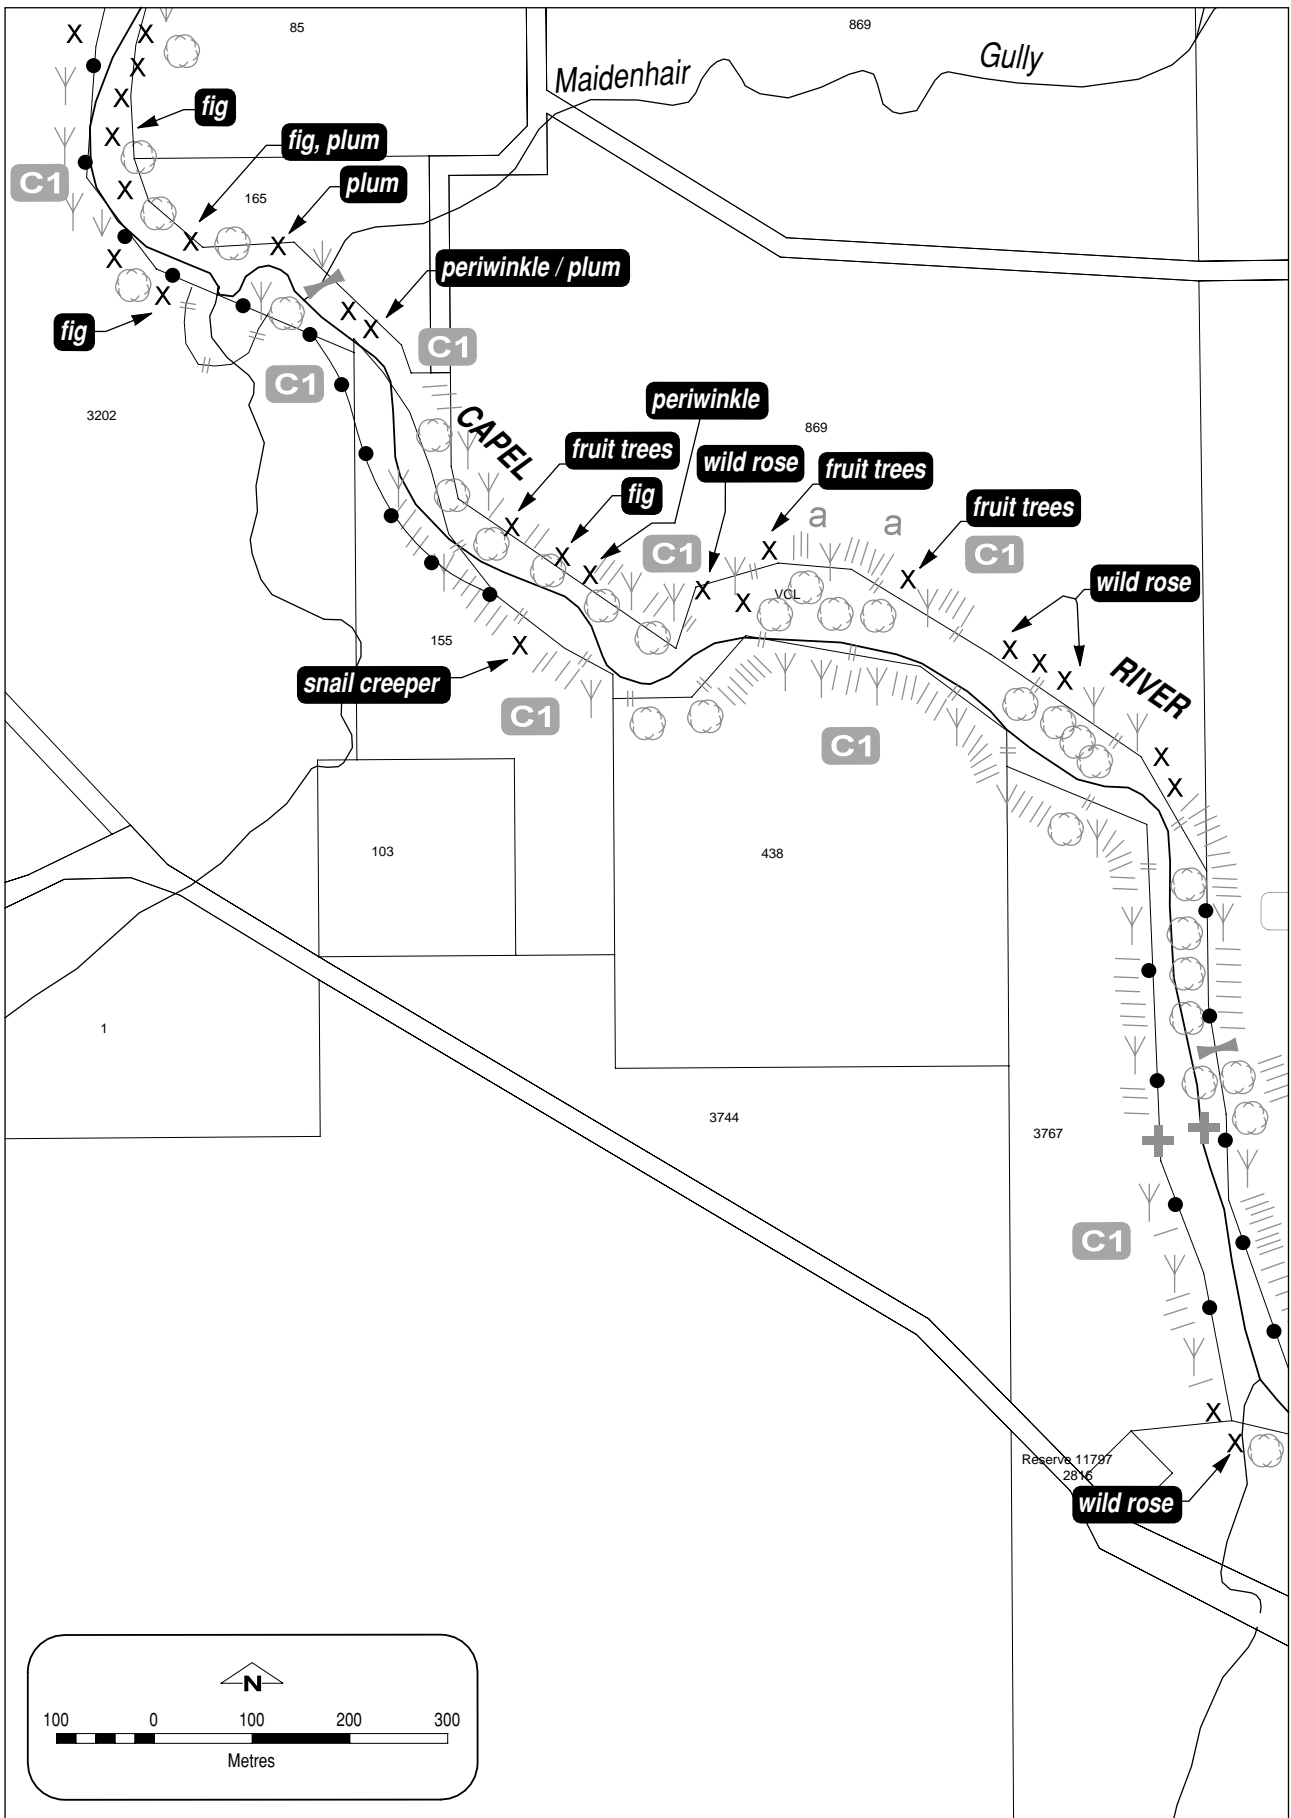
Capel River Map 17

Issues	Comments	Management Advice
General foreshore condition	Much of the southern bank limited to trees with grassy weeds in the understorey.	
Fencing	The majority of this section was fenced, although stock have access to the river shore at a few properties.	Length of fencing recommended, north bank ~ 1350 m, south bank ~ 450 m.
Erosion	N/A	
Revegetation requirement	Understorey species absent or lacking diversity along much of this section.	Revegetate with understorey species, and sedges and rushes. Select species from community type 1, Table 8.1 (page 28).
Weed invasion	Plum, fig, periwinkle and wild rose.	Refer to Specific weed management advice Chapter 8.1.2 points 12, 10, 4 and 19 (pages 23 - 26).
Other management comments	Fencing only recommended where stock access obviously a problem - much of this section was orchard. Issues which might be relevant to the river include use of chemical sprays. Old stock crossing on lot 3767 has been stabilised

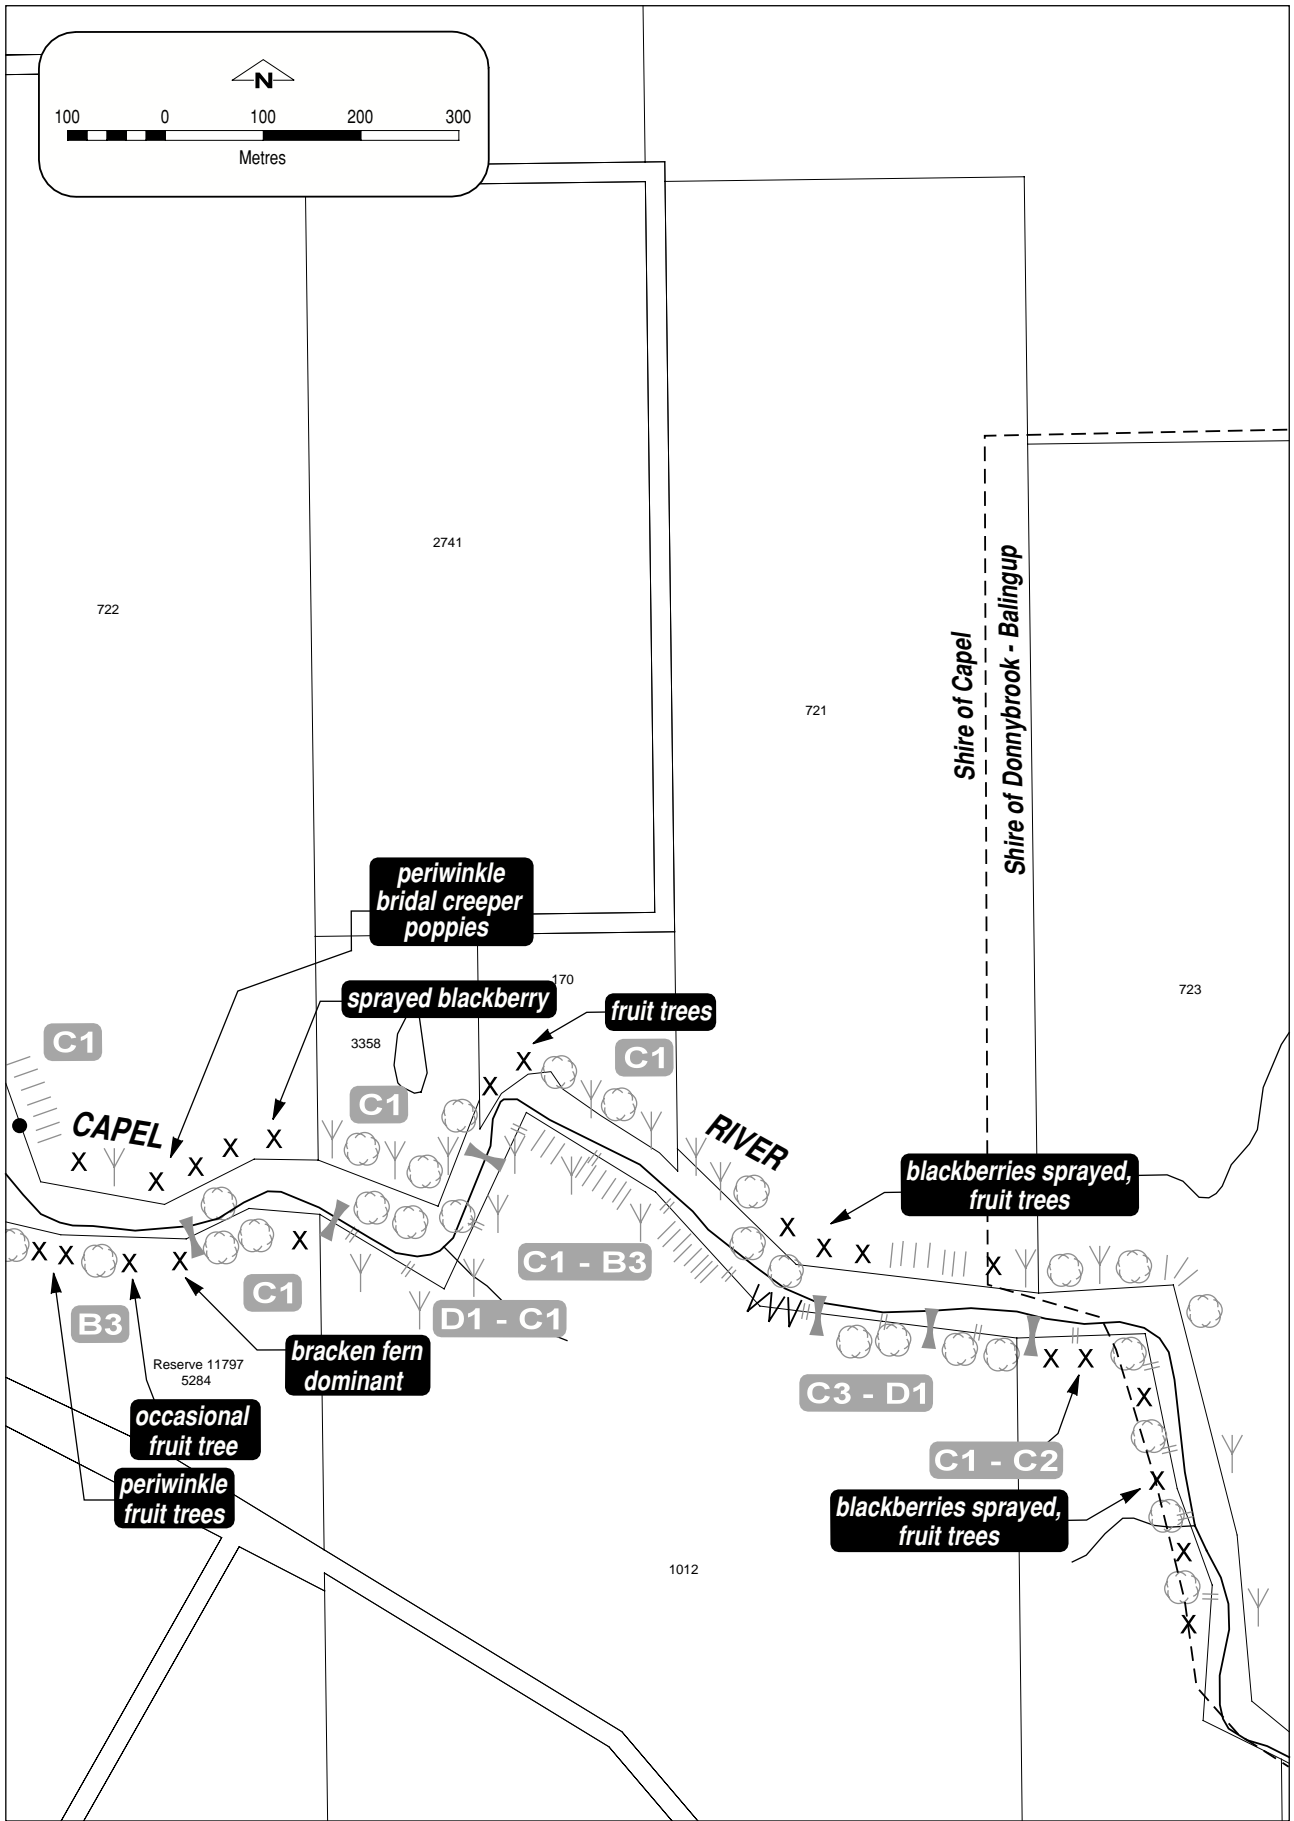
Capel River Map 18

Other management comments	Some control of blackberry and fruit trees during summer of 1997-98. This requires follow-up for effectiveness.	Bracken will also require control in some areas to allow diverse range of native understorey species to regenerate.
