## Foreshore and channel assessment of Jimperding Brook

Report No. WRM 48  
February 2008

Prepared by Viv Read & Associates for Department of Water  
and the Avon Waterways Committee

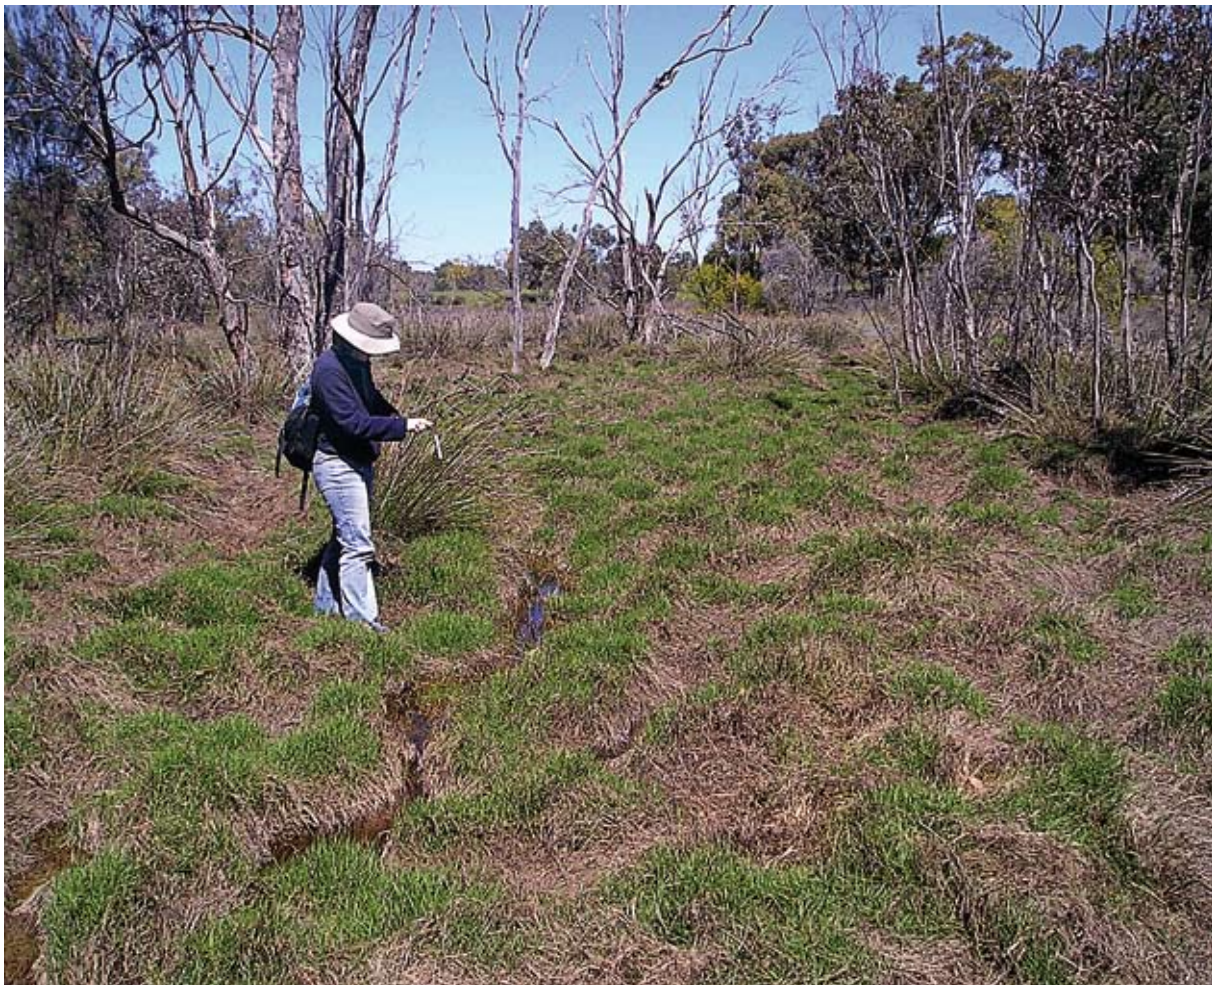
**Photo 1** Braided stream channel stabilised by couch grass in section JB003

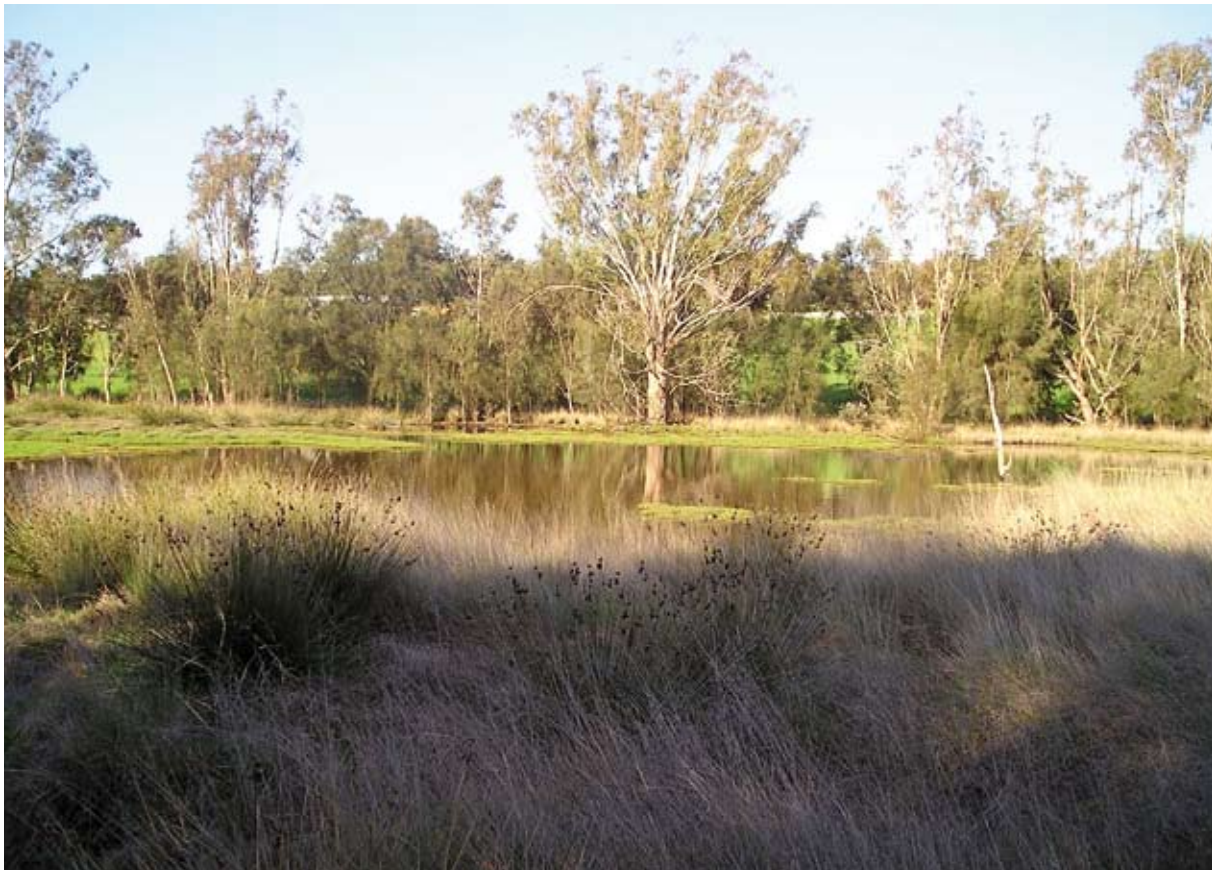
Only one survey section (JB003) had a significant wetland (Photo 3). This was a small area where surface water ponded on the LHS.

**Photo 3** Perched wetland adjacent to Jimperding Brook in section JB003

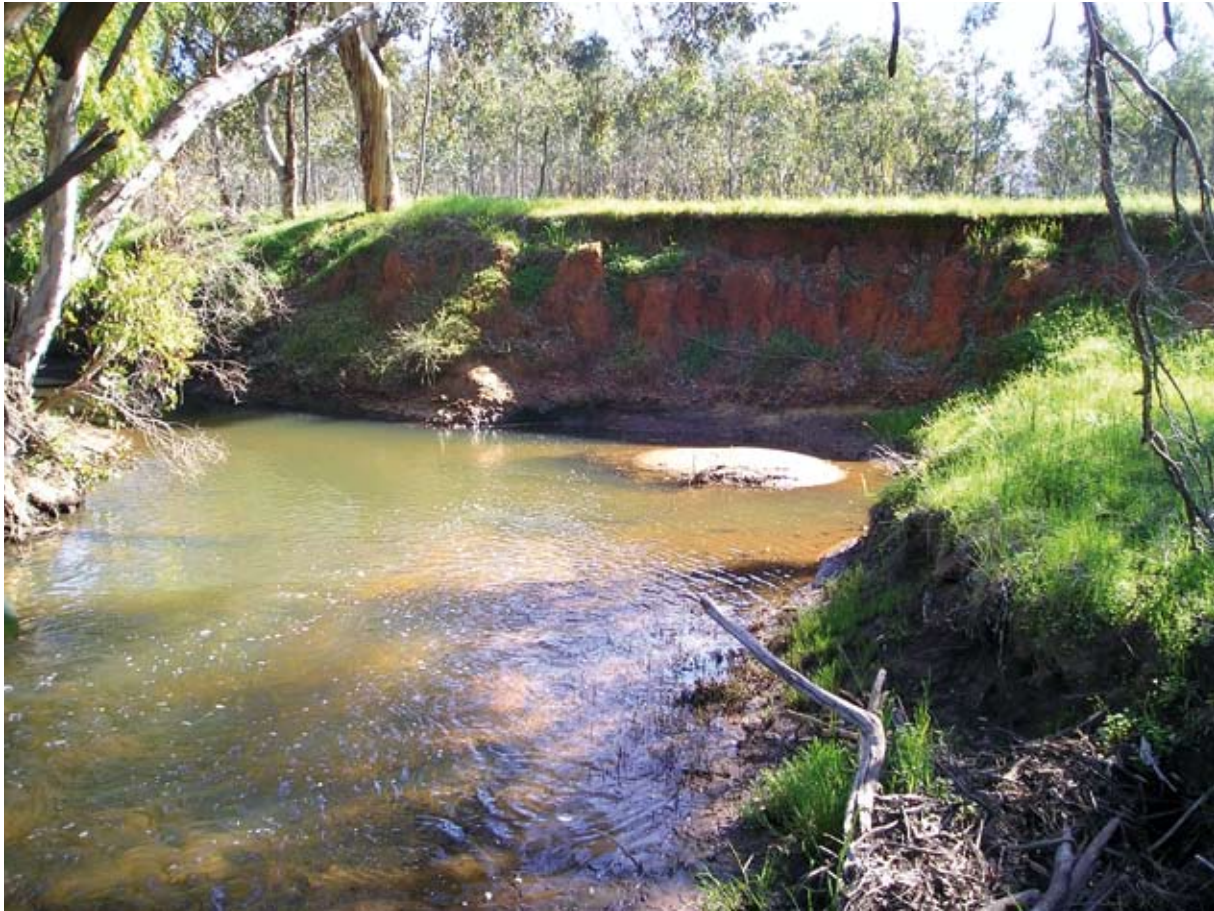
*Photo 5 Active bank erosion at the confluence of a major tributary (TR006)*

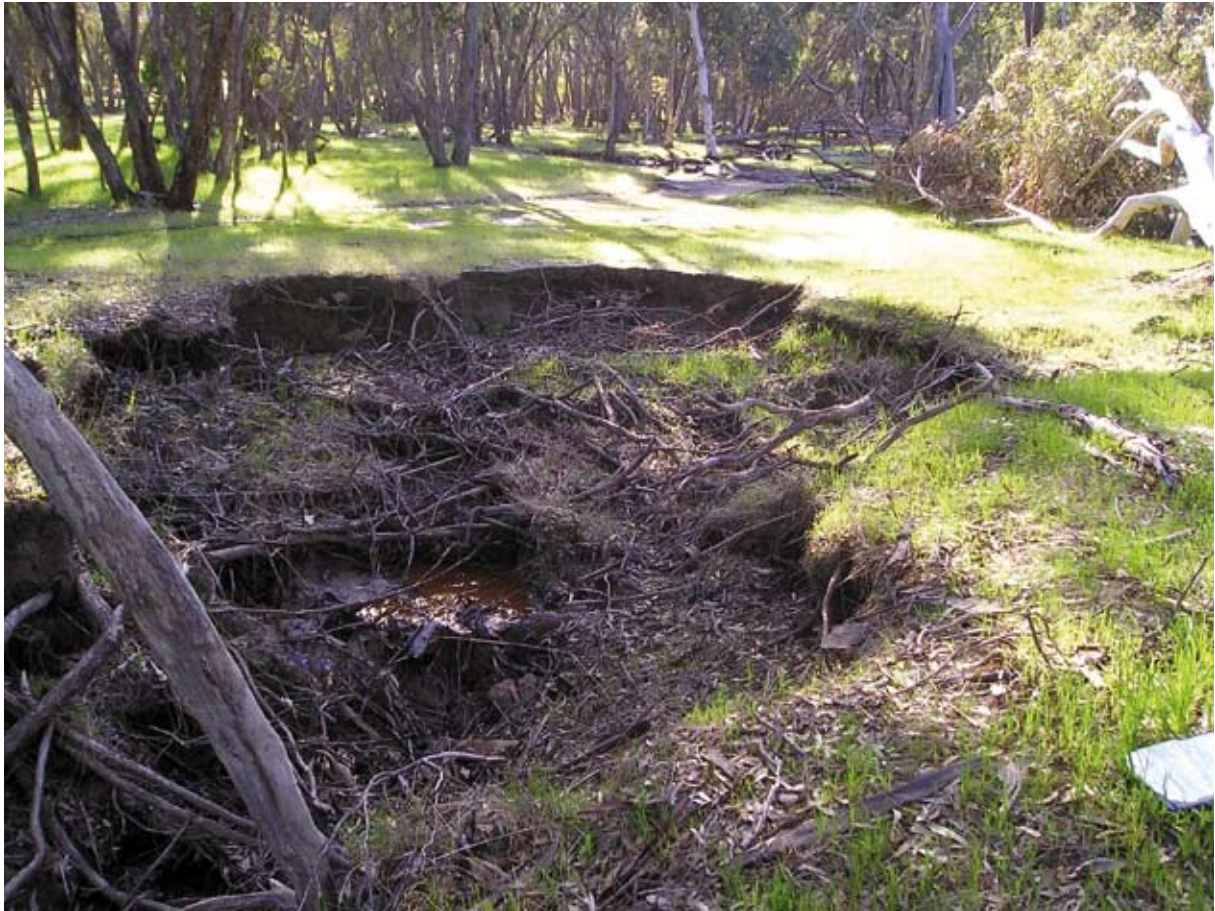
The erosion processes were best observed at section JB006 where gully head erosion was very active in the channel (photo 6). This section also had extensive salinity due to intrusive bedrock. This was further cause for reduced bank stability. The gully was one to two metres deep (photo 7) and had the potential to continue eroding upstream. It is noted that extensive sheet erosion also occurred in this section due to soil salinity (photo 8).

*Photo 6 Active gully erosion in section JB006*

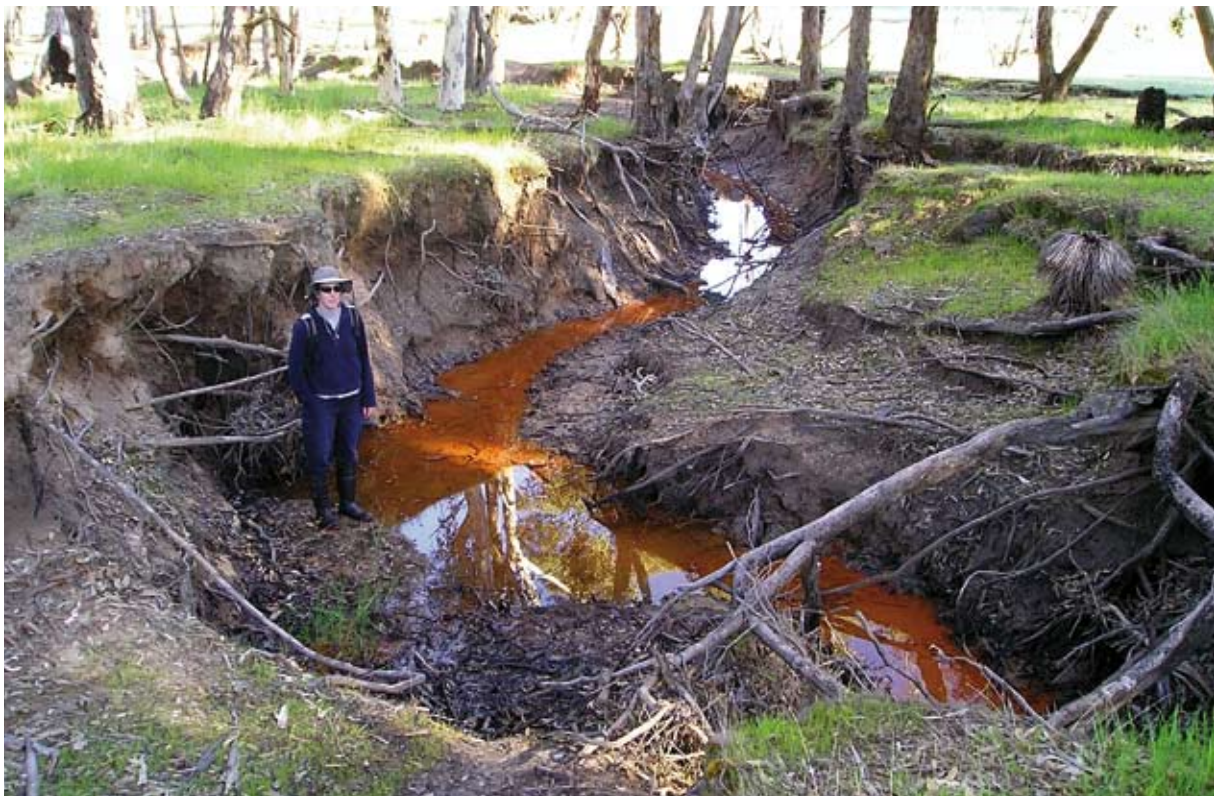
*Photo 7 Deep gully erosion in section JB006*

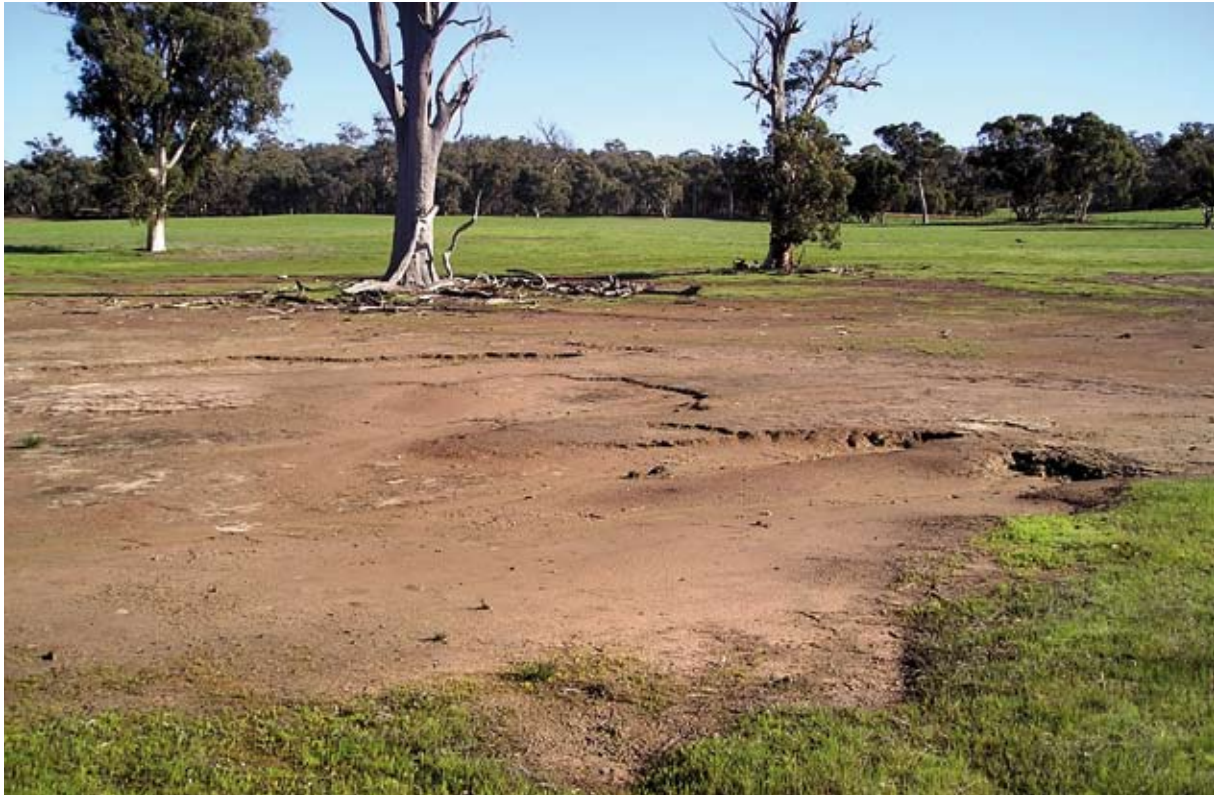
*Photo 8 Sheet erosion adjacent to Jimperding Brook in section JB006*

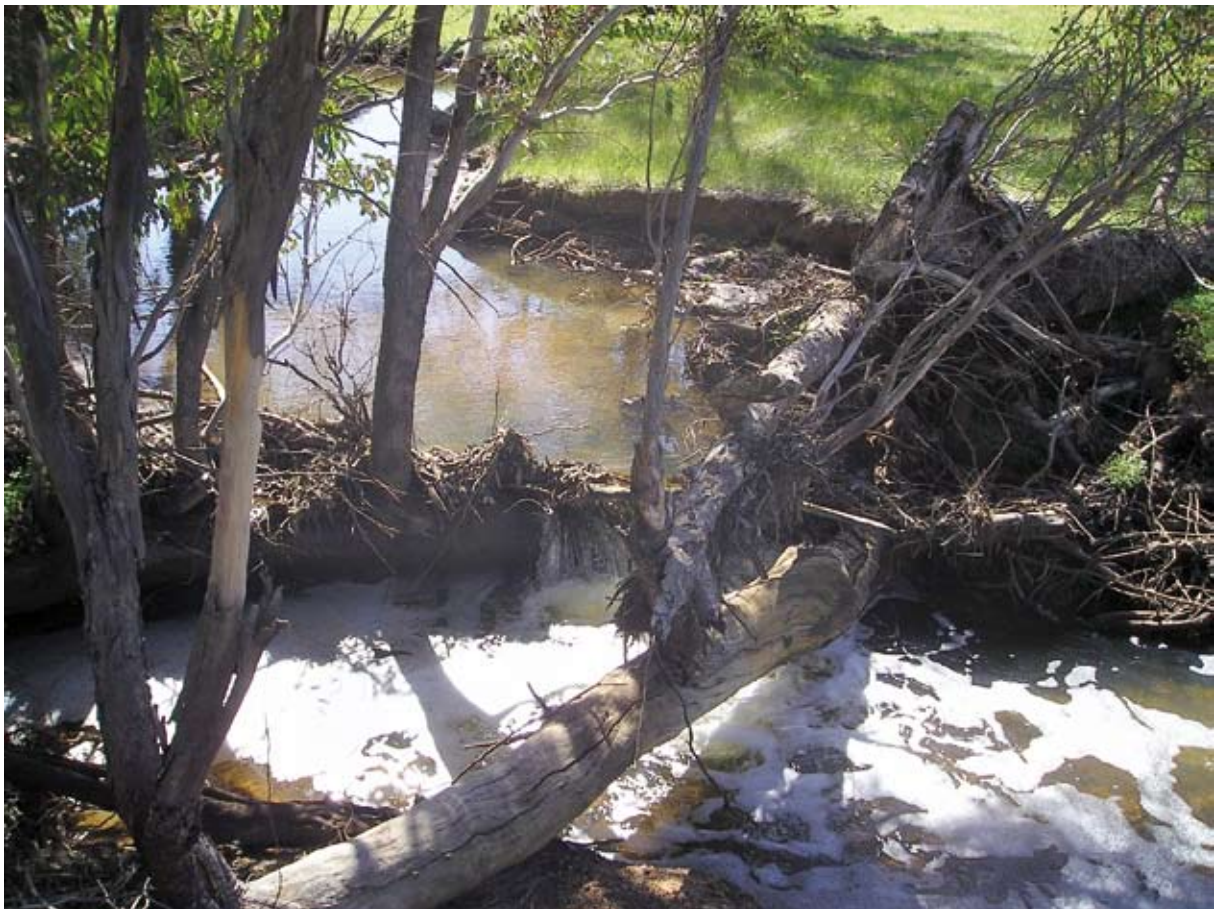
*Photo 9 Log jam controlling gully erosion in section JB013*

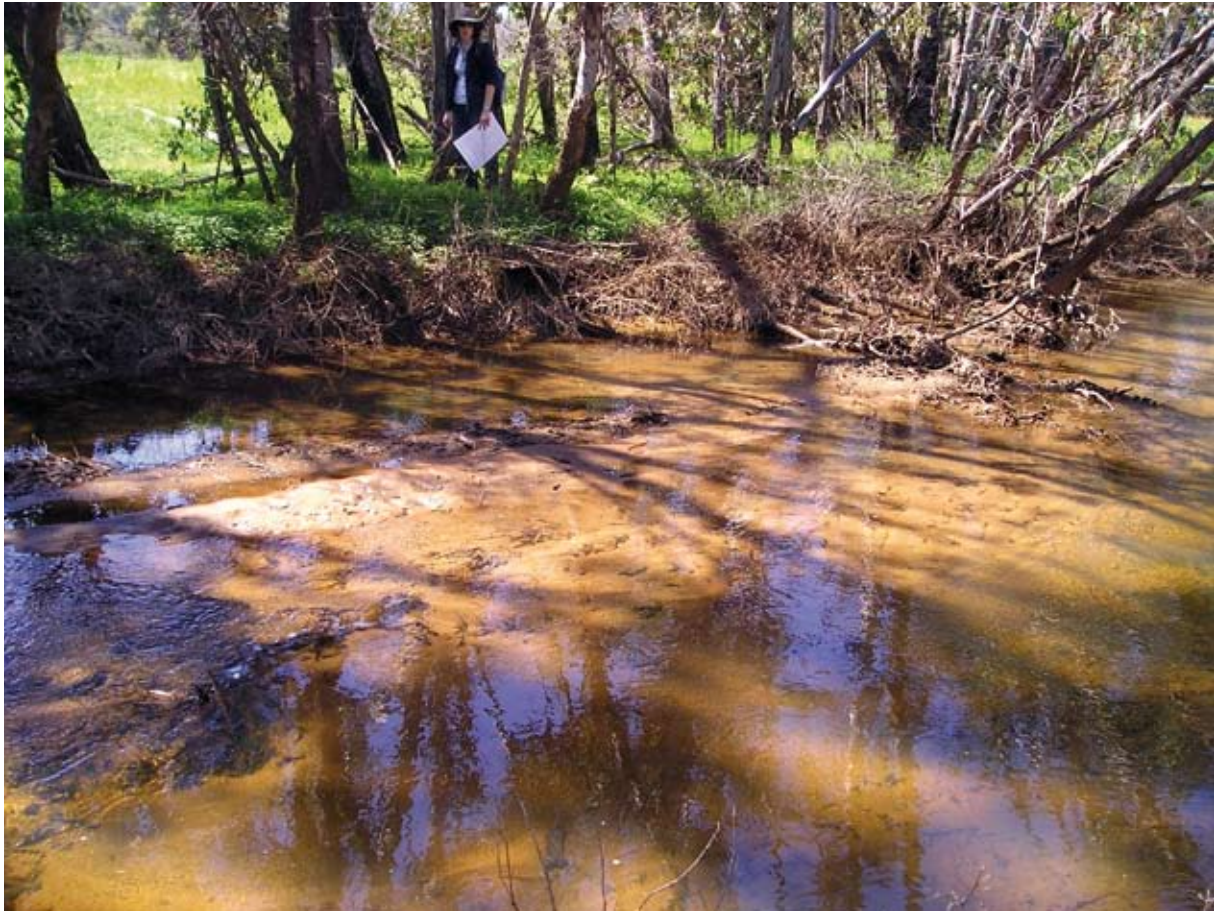
The processes of sediment transport were important. Coarse sediments were recorded only in sections JB021 (photo 10), JB025 and at the confluence with the Avon River (JB026). Most sediment was of a medium-to-fine texture. It was likely that most sediment was easily transported downstream and that the sediments observed were mostly temporary depositions. The highly mobile character of sediments provided explanation for there being so little sediment deposition compared with the high level of channel erosion that has occurred.

Photo 10 Coarse sand sediment deposit in section JB021

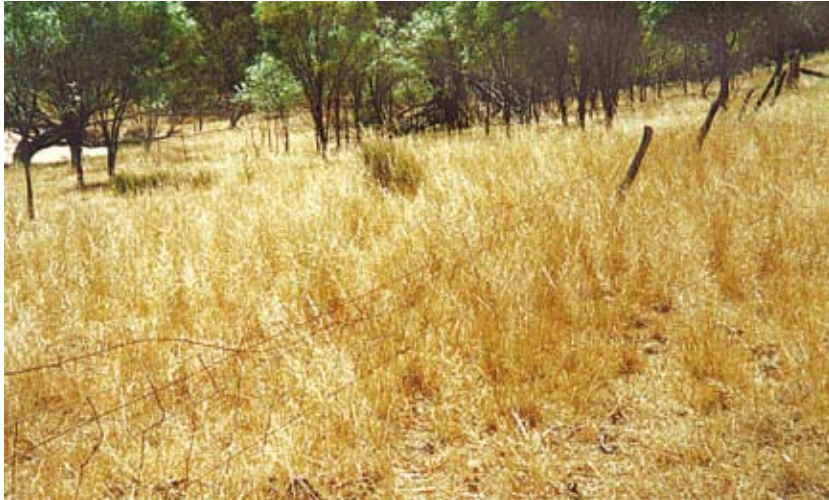
*Fence condition: POOR*

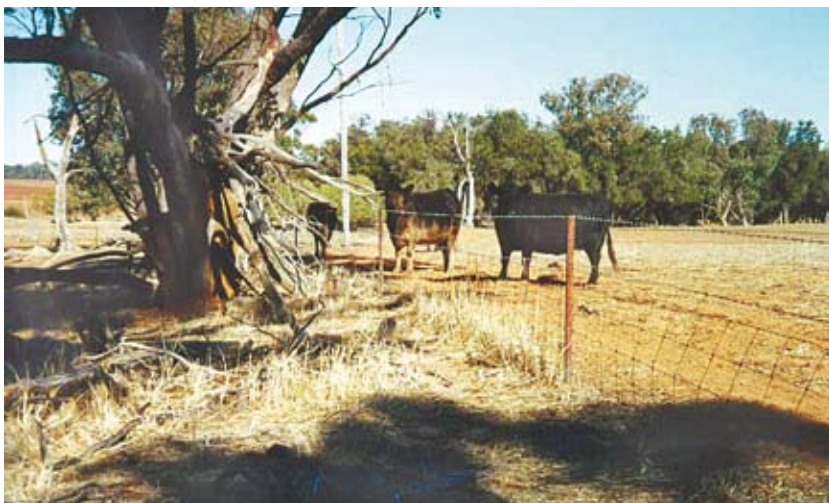
*Fence condition: MODERATE*

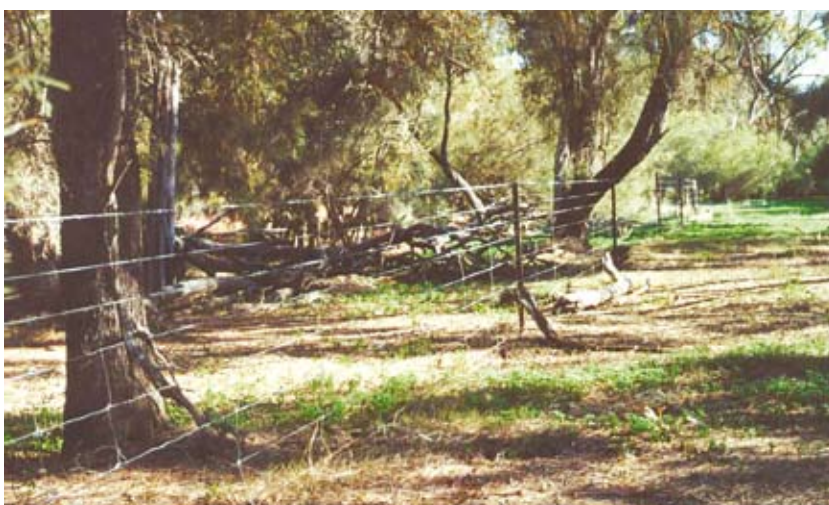
*Fence condition: GOOD*
