# FORESHORE AND CHANNEL ASSESSMENT OF THE TOODYAY BROOK

WATER AND RIVERS COMMISSION REPORT WRM 22

WATER AND RIVERS COMMISSION  
REPORT NO WRM 22  
FEBRUARY 2001

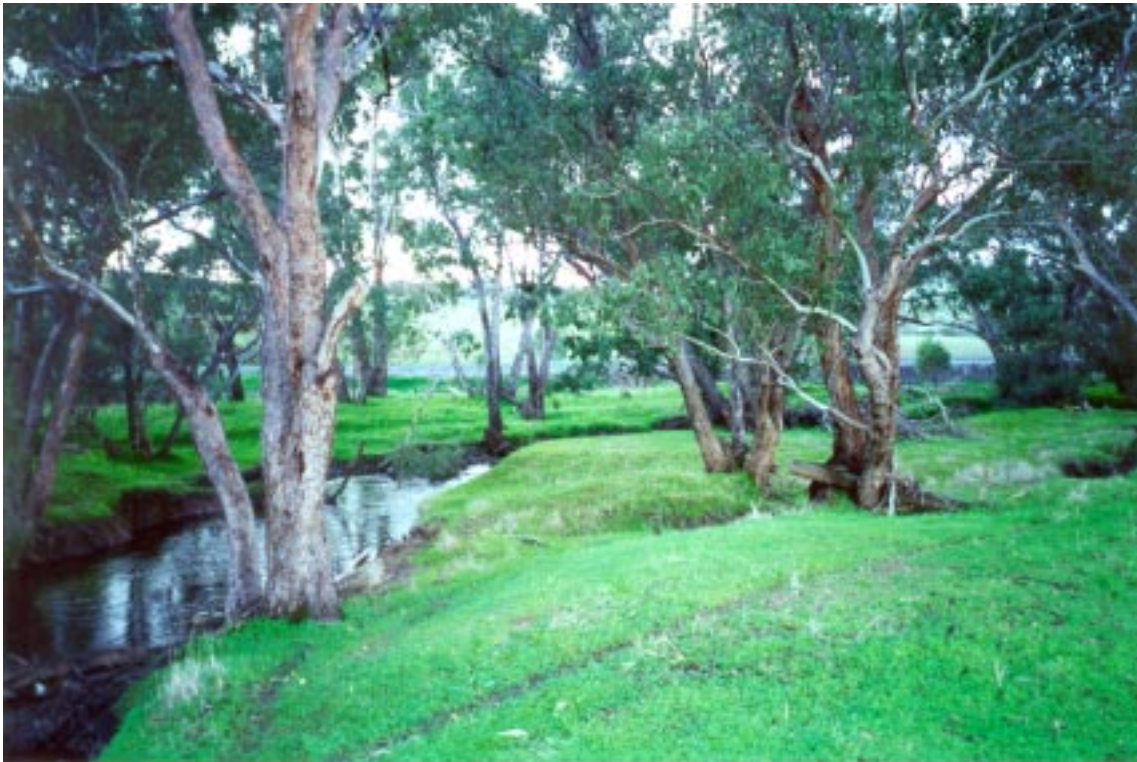
**Plate 1. Foreshore condition along Toodyay Brook**

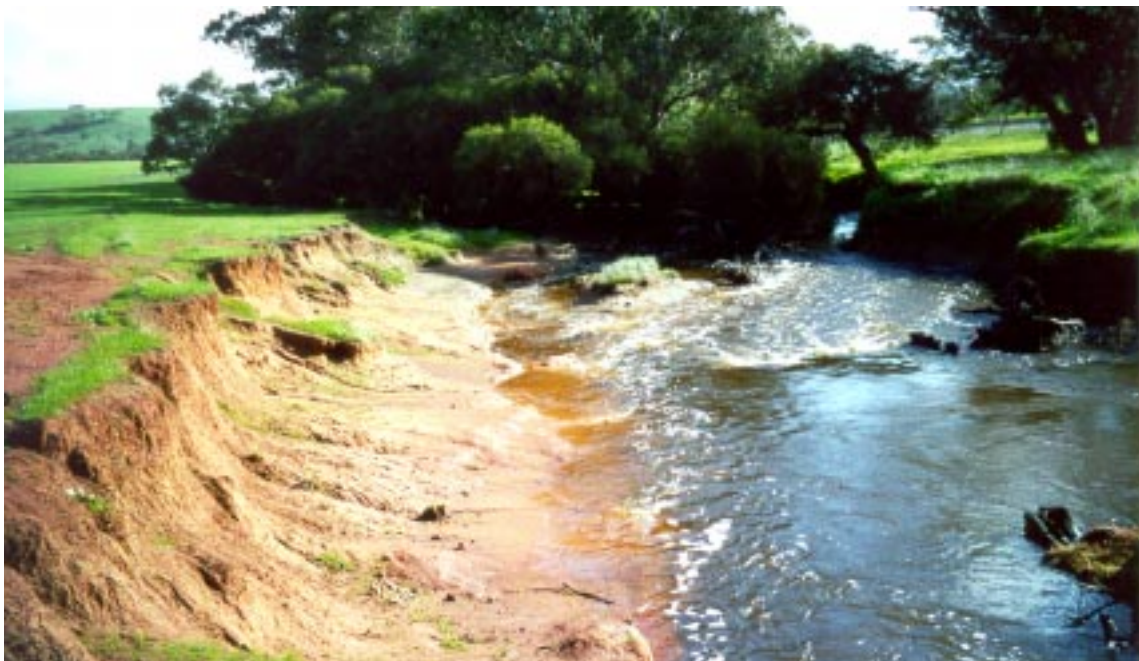
*Plate 2: Bank erosion along the Toodyay Brook*

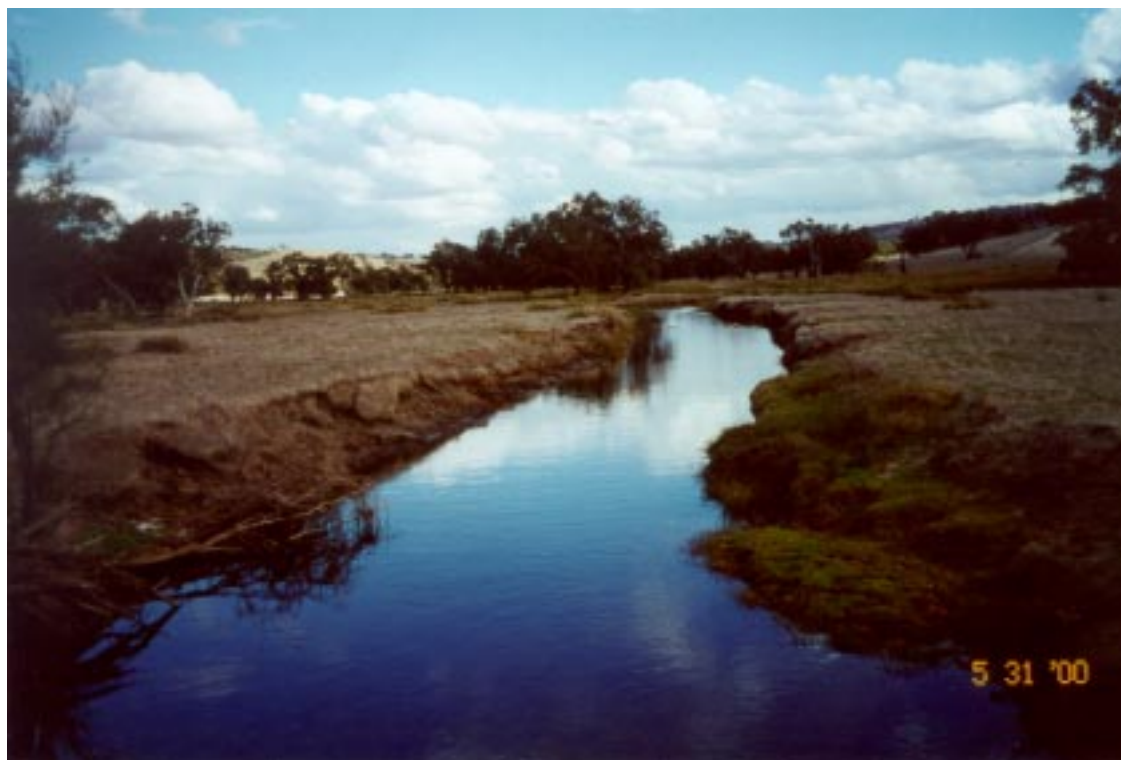
Map 7 shows the poorest foreshore conditions recorded along the waterway. The poorest foreshore condition recorded was a rating of D2, located upstream of Bindoon-Dewars Pool Road. This is defined as a freely eroding ditch where riparian vegetation has disappeared, and erosion is significant along with undercutting and subsidence. There are large sand slugs along the waterway (Pen and Scott, 1995). The majority of sites were given a poorest rating of C3 (eroded) and D1 (ditch – eroding) for foreshore condition.

*Plate 3. A typical D-grade foreshore*

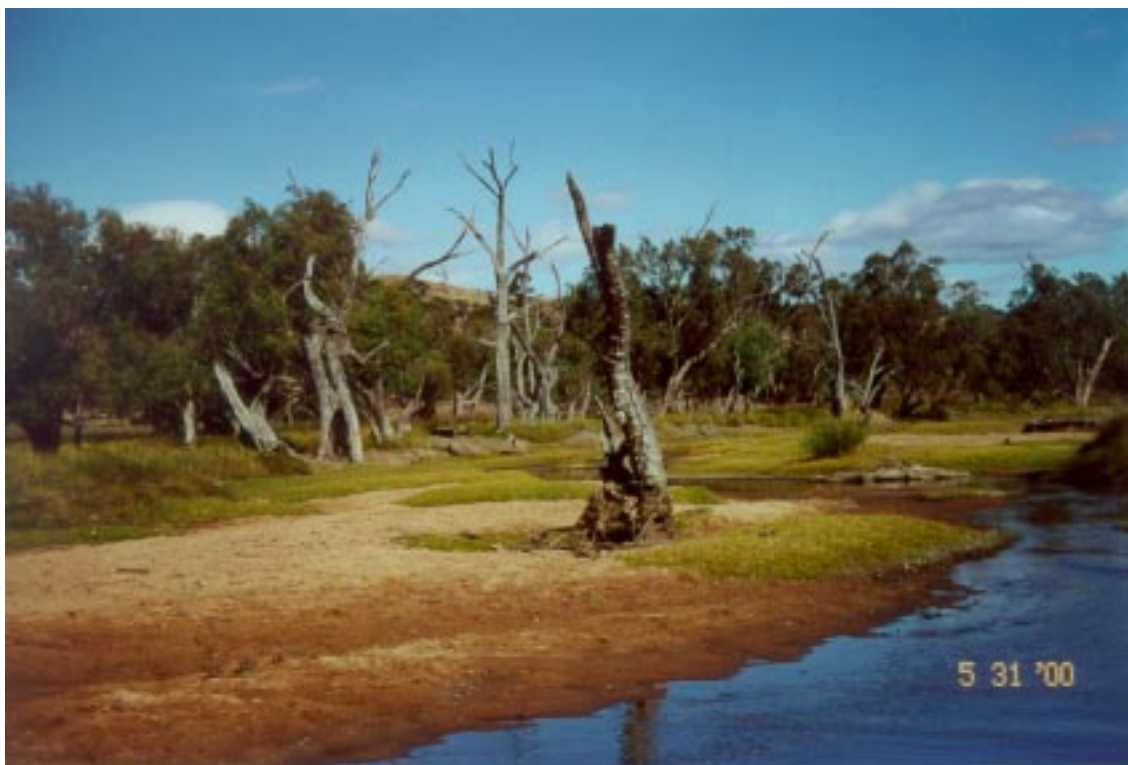
Figure 10 shows that the majority of sections surveyed along the Toodyay Brook had some dead trees. Of the surveyed sections 55% were recorded as having some dead trees, 34% as having some sick trees, and 11% as looking healthy.

Plate 4. Death of overstorey vegetation along the foreshore of Toodyay Brook

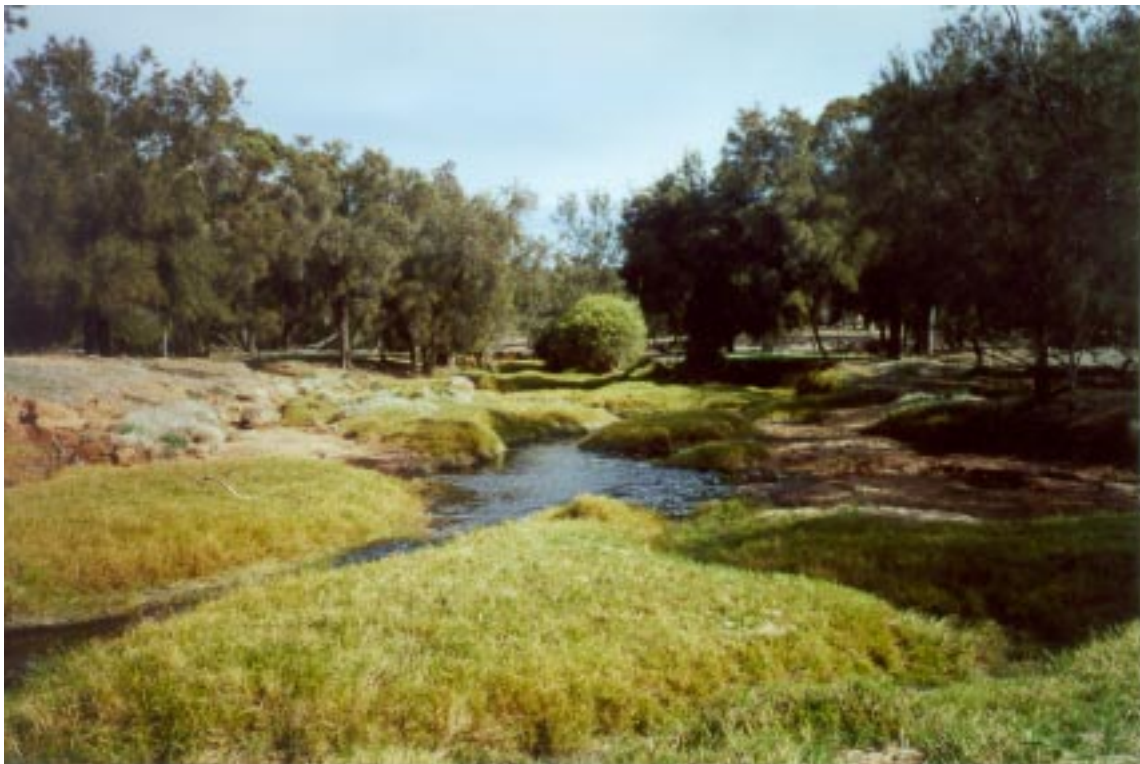
Results show that there are a high number of sand slugs which, combined with a low number of pools, indicates a decline in habitat diversity. In some areas the streambed was eroded down to the bed material which has also led to a loss of habitat.

*Plate 5. Severe erosion and sedimentation along the Toodyay Brook*

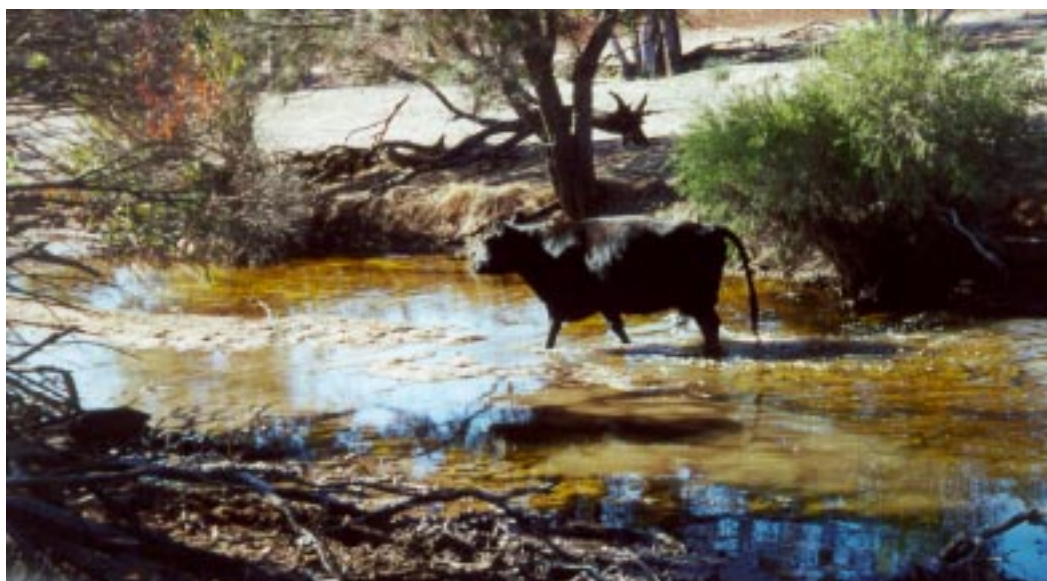
*Plate 6. Cattle crossing the waterway cause channel and bank erosion*
