Lower Avon river recovery plan: Incorporating foreshore and channel assessment

River recovery plan series

Report No. RRP 13
June 2008

Prepared by Viv Read & Associates for
Department of Water and the Avon Waterways Committee.

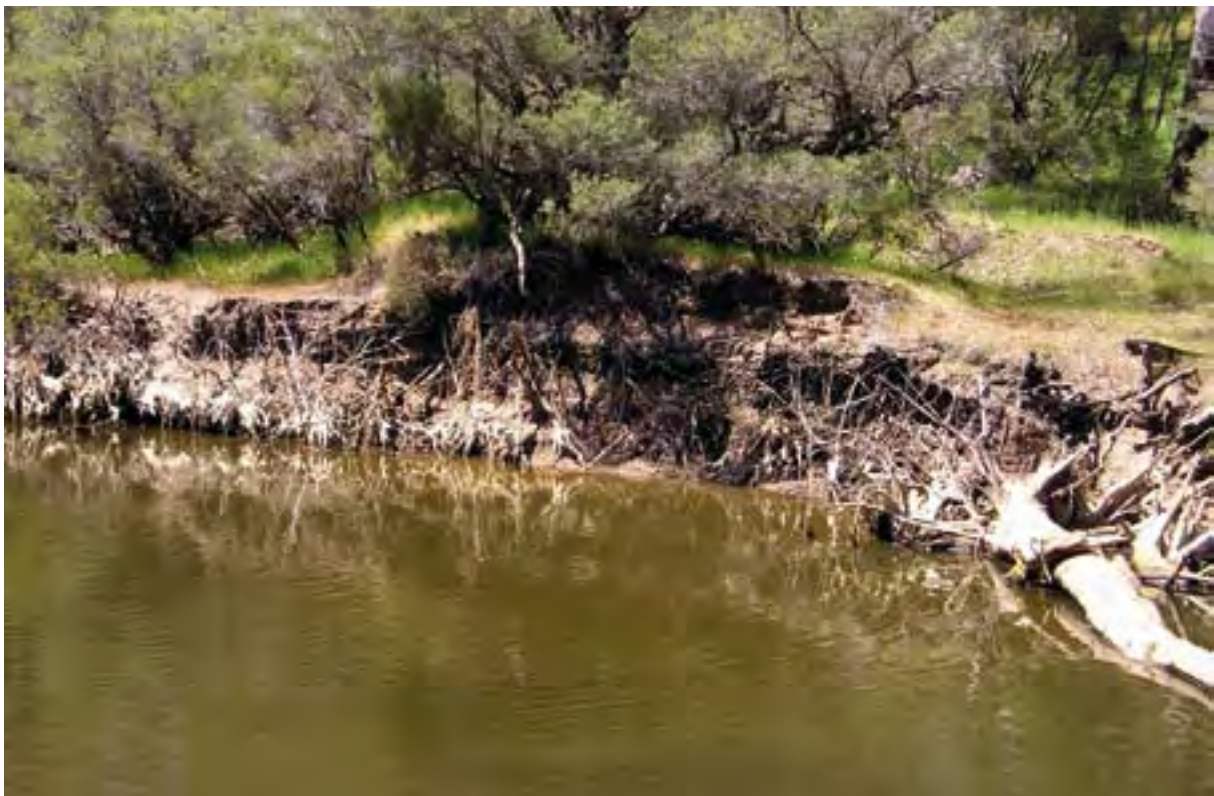
The sections that are stable have substantial rock outcropping or fringing vegetation is well established. There are sections where root exposure of the fringing vegetation is substantial however there is only one section (LA31) where tree fall has occurred due to bank erosion.

Photo 6 Bank erosion in section LA01

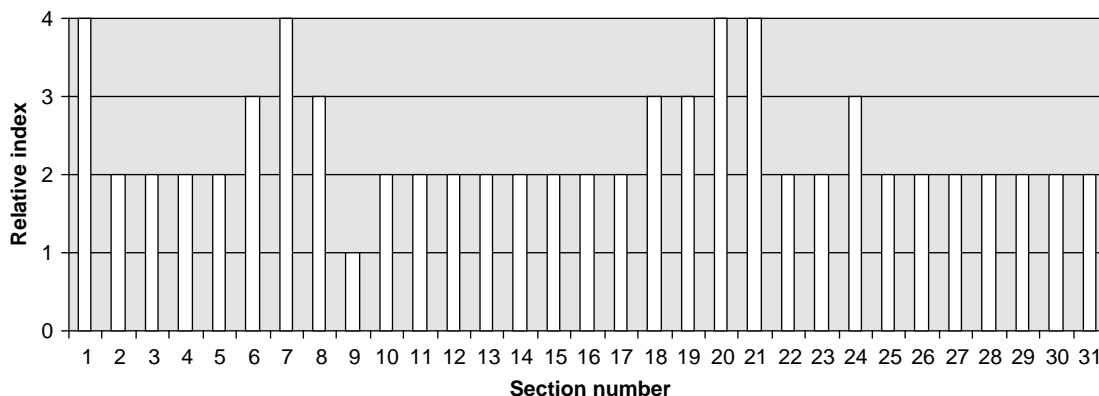
Figure 4.5 River bank erosion for survey sections of the lower Avon River

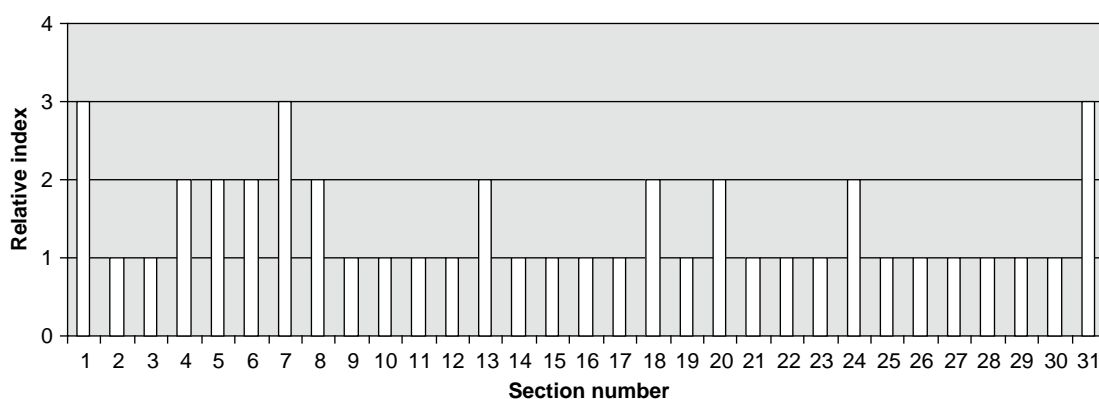
The processes of river bank slumping are due to saturated soil profiles caused either by poor soil drainage characteristics or groundwater seepage. Depositional soils in the banks and adjacent floodways are considered to be well drained and groundwater discharge within the valley is minimal, so increased river bank slumping is not expected to occur.

Figure 4.6 River bank slumping for survey sections of the lower Avon River

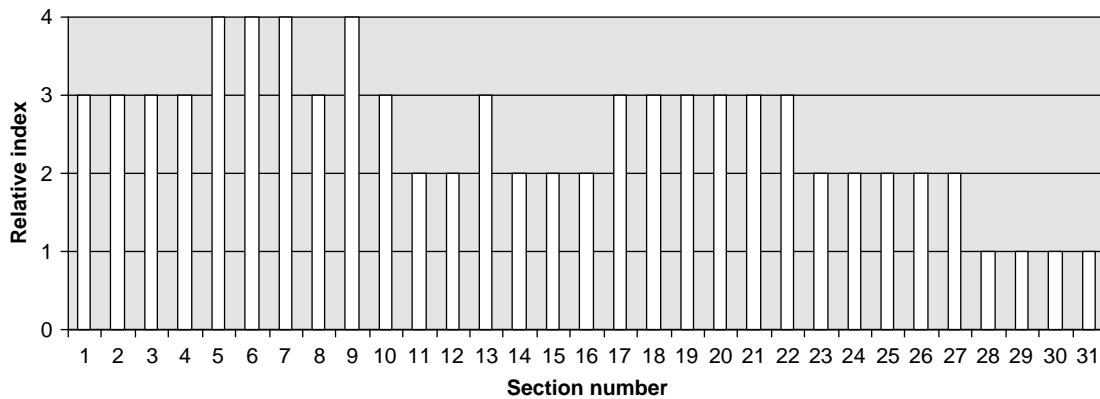
Figure 4.7 Soil disturbance caused by wild pigs in survey sections of the lower Avon River

Figure 4.7 shows that four river sections have severe soil disturbance and a further 13 sections have significant disturbance. Over 50% of the Lower Avon river section has significant or severe soil disturbance caused by pigs. Minimal disturbance occurs only in the four downstream survey sections (LA28–31).

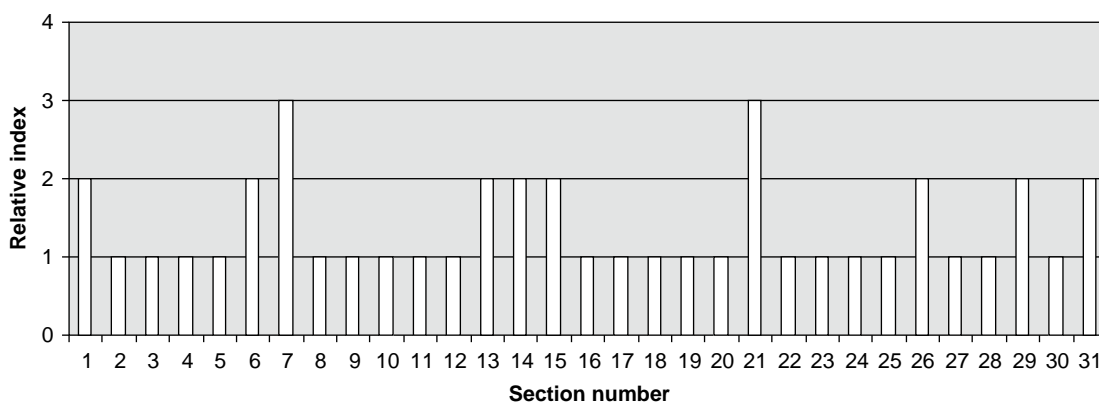
Coarse sand sediment was recorded for river sections during the survey. This occurred as small beaches on river banks, sand slugs within the channel or as a trailing deposition downstream from large rocks or small islands. Figure 4.8 provides a relative index of the occurrence of sediment deposition for the Lower Avon river section. Most survey sections had little or no sediment deposition recorded. Compared with sedimentation of the Avon River upstream from the Darling Scarp, the level of sedimentation is generally very low. The coarse sediments that were observed were most commonly as a small unconsolidated sand slug. This suggests temporary deposition.

Figure 4.8 Occurrence of sediment in survey sections of the lower Avon River

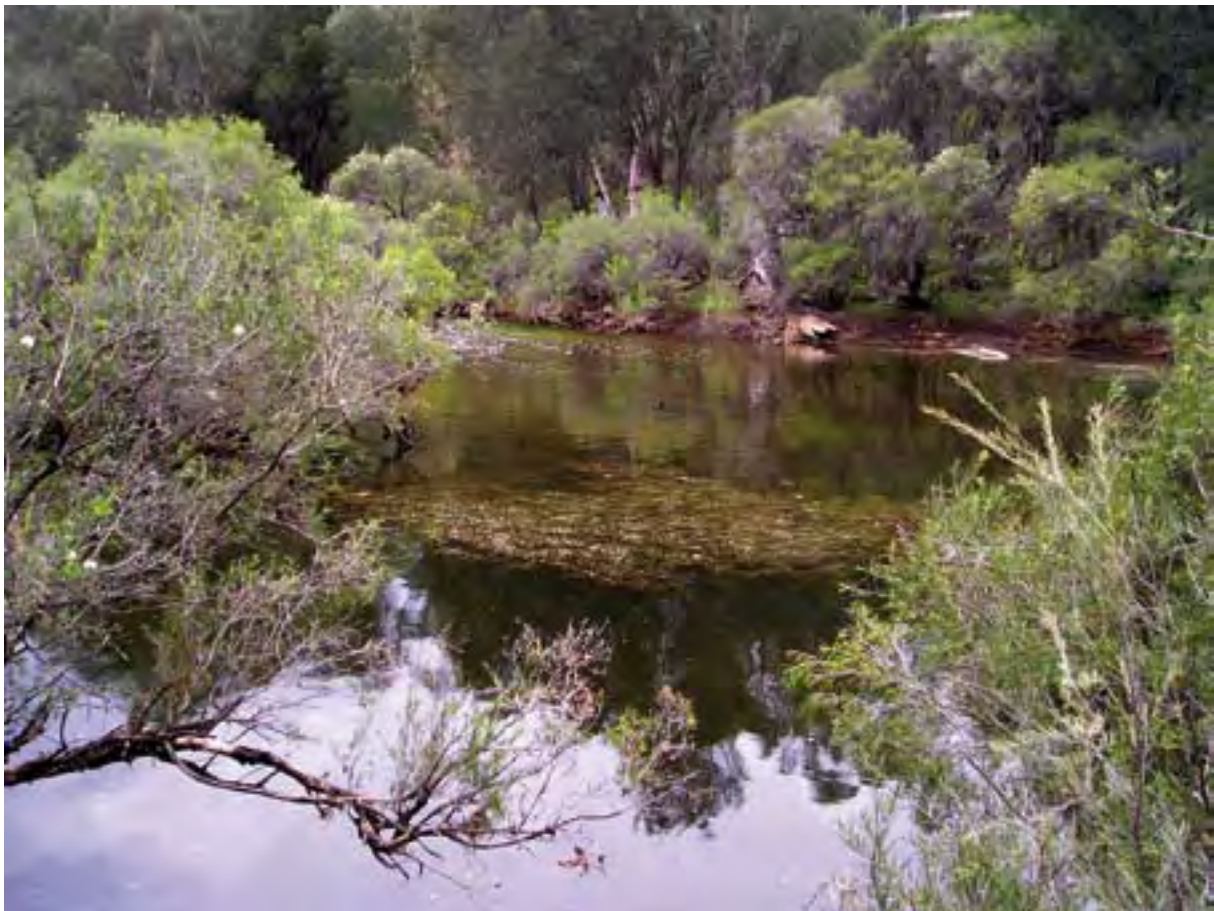
Boongarup Pool (Section 31) is a long river pool where the river gradient is decreasing. This pool is considered to be at moderate risk of sedimentation (Department of Water, 2008).

Photo 8 Ruppia species growing in Boongarup Pool, indicating shallow pool depth

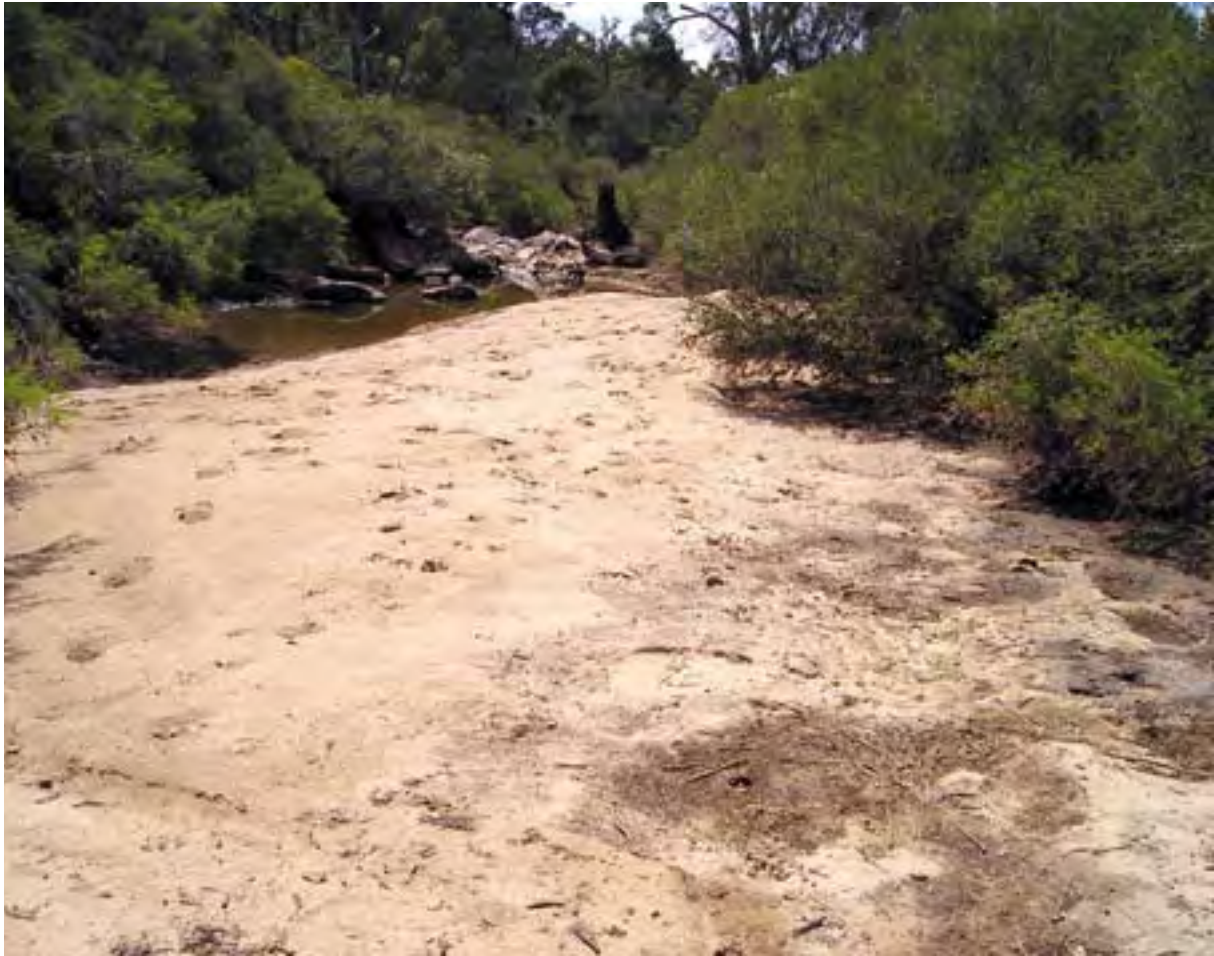
Photo 11 Coarse sand deposition
