River Recovery Plan, Foreshore and Channel Assessment Section 19 – Aldersyde-Kweda

REPORT NO. RRP 11
DECEMBER 2006

Prepared by
Viv Read & Associates
for Department of Water and
the Avon Waterways Committee

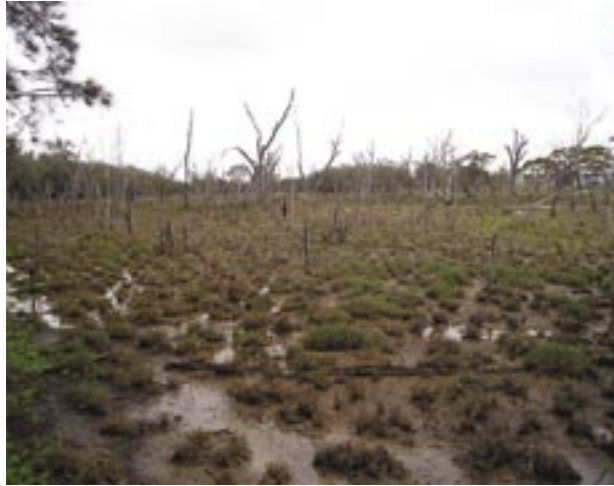
Photo 1: Samphire flats at Pt 115 in Photo Section 24

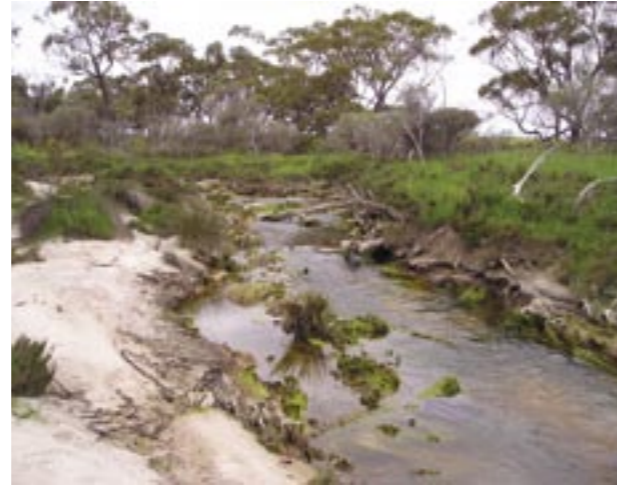
Photo 4: Unconsolidated sediments on banks in Photo Section 10

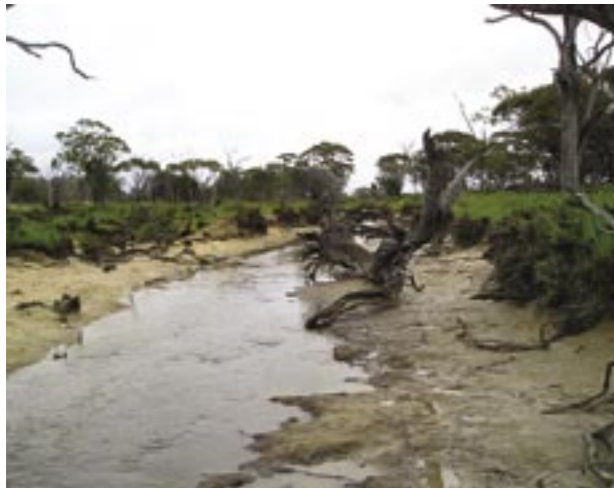
Photo 2: Active channel erosion in Photo Section 14

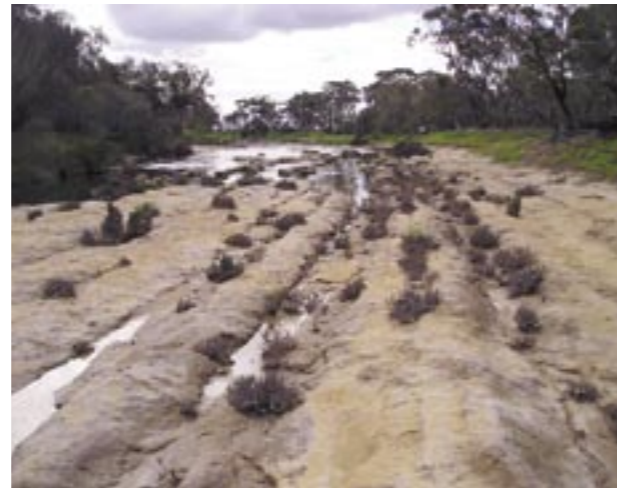
The river channel width ranges from being less than 5 metres to over 20 metres. Works undertaken as a part of the RTS before 1973 altered the channel characteristics. The extent of works were from Qualandary Crossing to Aldersyde. These works caused massive mobilisation of sediments as the channel has scoured to a depth of 1-2 m and a width of about 30 m leading to infill of river pools and sediment aggregation within the altered river channel (Photo 5). The sediment mobilisation processes within the lower reaches of this river section have been surveyed and analysed for management of Boyagarra Pool (UWA Centre for Water Research, 1999). This analysis shows that there is substantial aggregation of sediments in some locations forming lateral bars which lower channel gradient and slow stream flow. These aggregating processes are slowly forming a braided stream channel as existed before the RTS. Some parts of the channel are now deficient of sediment due to scouring processes so are unable to rehabilitate by sediment aggradation. This occurs downstream from Boyagarra Pool.

Photo 5: River bed scour resulting from River Training Scheme

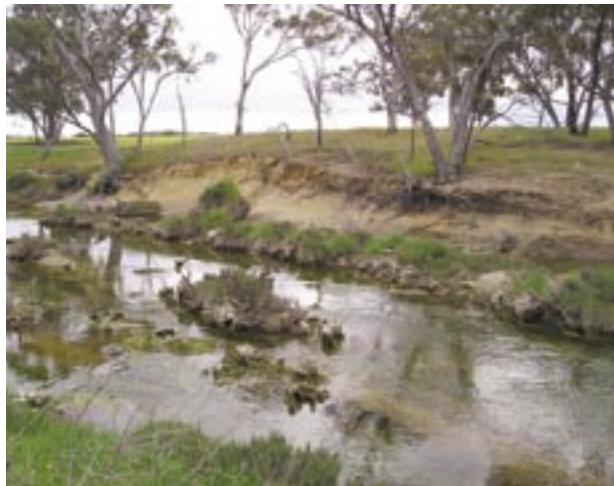
Photo 3: Erosion of 'sand lens' intersected by the river in Photo Section 11

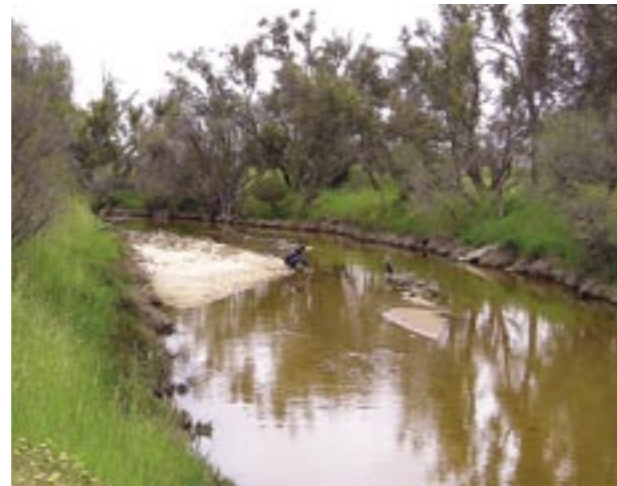
Sediments continue to be re-positioned within the river channel. Significant areas of deposition are identified as 'sand slugs' for each Photo Section (eg PS 9, Pt 38-39, PS 18, Pt 85-86) (Photo 6). It is difficult

Photo 6: 'Sand slug' in Photo Section 6

to identify which 'sand slugs' are unstable and are a risk downstream however many seem to be stabilising as vegetated islands. Unlike the bed of the Avon River downstream of Qualandary Crossing, salt water couch (*Paspalum vaginatum*) has only very limited distribution (eg Photo Section 2, Pt 9-10) and is not a major stabilising agent.

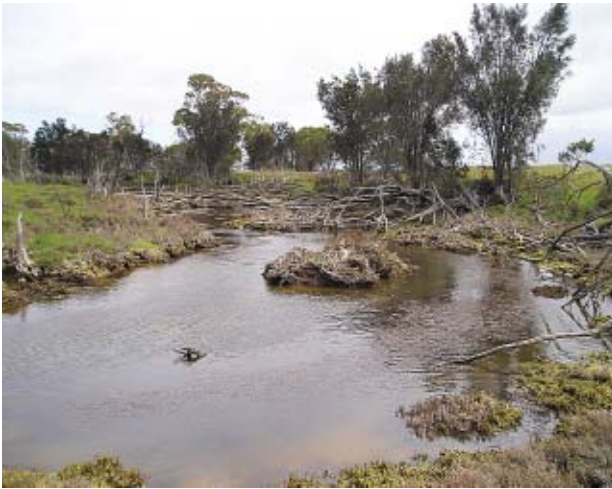
varies from none to a high level of logs and branches (Photo 7). Where it occurs, debris in the river adds to habitat value and is not considered to be a significant cause of flow constriction resulting in flooding.

Photo 7: Woody debris in the river channel at Pt 84 in Photo Section 18

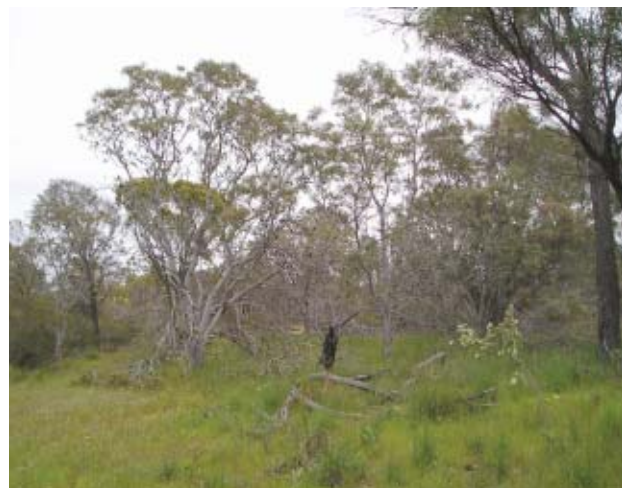
Photo 11: Senescent Banksia prionotes on LHS in Photo Section 6

Most of the riparian zone for the Aldersyde-Kweda Section has dominant vegetation that is senescent and in some places, most is now dead. Increasing salinity is the major cause of decline. The areas most affected are in Photo Sections 12-17.

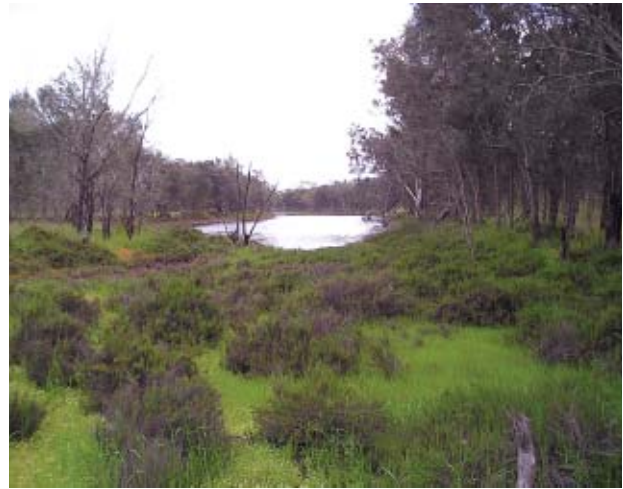
River pools are a significant characteristic of the Avon River. Until relatively recently, many of the larger pools in the Aldersyde-Kweda section were used for swimming and some were used for water supply or for the past practice of sheep-washing (eg at Stock Pool, PS22). Many pools were well known for the now illegal sport of duck-shooting. Dwarlacking Pool (PS22) was used through summer for family or community picnics. Remnants of a diving board and tennis courts indicate the previous social value of this pool (Photos 16 and 17).

Photo 16: Upstream end of Dwarlacking Pool at Pt 105 in Photo Section 22

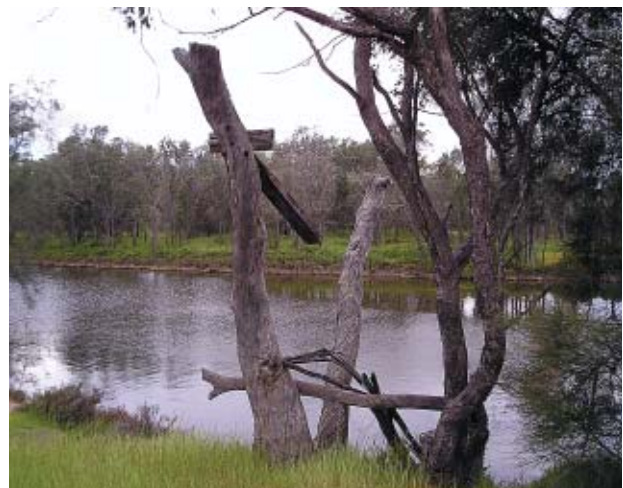
Photo 17: Diving board structure at Dwarlacking Pool in Photo Section 22

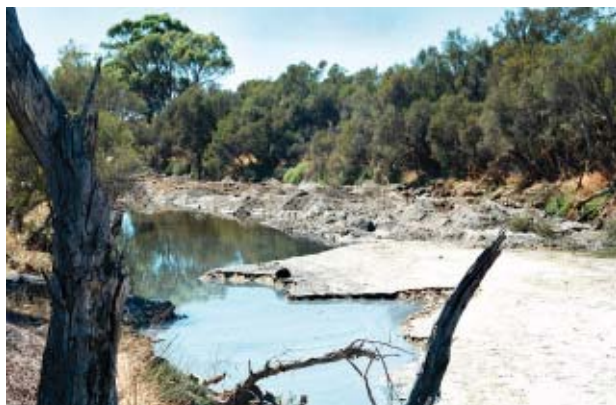
Photo 19: Boyagarra Pool prior to dredging, April 2002 (Department of Water)

The source of sediments in the pool is from the eroding river channel and from major tributaries. Nalyaring Gully is noted as having a high sediment load (UWA Centre for Water Research, 1999) however other tributaries also contribute to the river sediment load. It is also noted that the sediment load is depleted downstream of the Boyagarra Pool and this may limit the opportunity for channel rehabilitation.

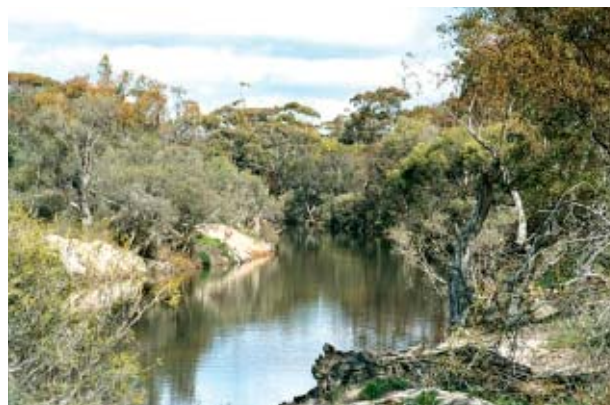
Photo 20: Boyagarra Pool following the removal of 6000 m³ of sediment, August 2002 (Department of Water)

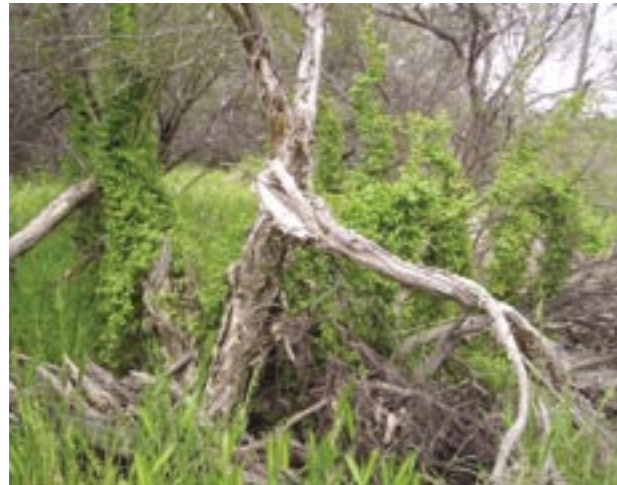
Bridal creeper is particularly significant as it is probably spreading rapidly within the river environment (Photo 21). Down-stream from the Brookton-Corrigin Road bridge, bridal creeper occurs as isolated plants, however up-stream of the bridge, there are extended sections where it is continuous both sides of the river. The occurrence of bridal creeper is substantially reduced up-stream from the Aldersyde Road bridge and was not observed further upstream than PS 13 (Pt 62-63).

Photo 21: Bridal Creeper in Photo Section 4

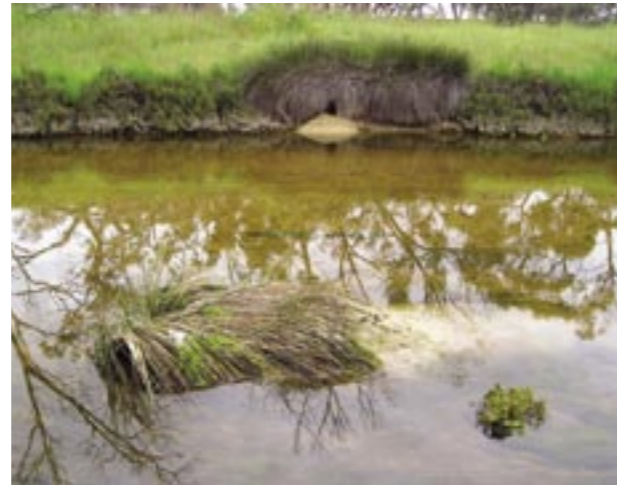
Foxes were noted at five locations during the survey by observation of active lairs (Appendix Five, Photo 23). Two of these occurred on the banks of the river at water level, others were in 'sand lenses'. These were noted at only four locations on the LHS of the river although it is expected that many more fox lairs occur where 'land lenses' intersect or are adjacent to the river.

Photo 23: Fox lair at water level in Photo Section 9

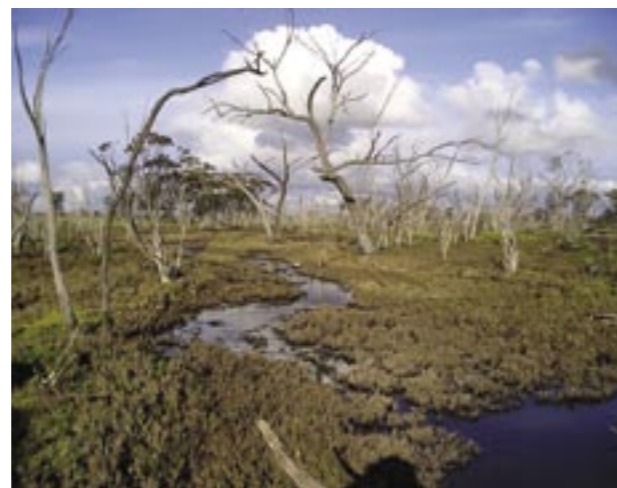
Photo 24: Broad salt-affected channel with dead trees in Photo Section 16

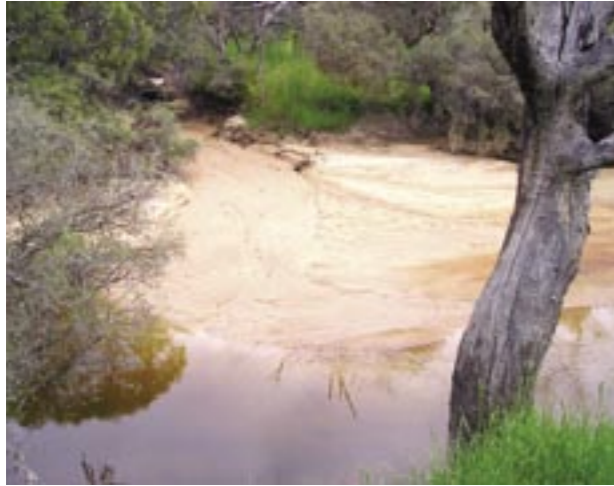
Photo 25: High sediment load from tributary on RHS in Photo Section 10

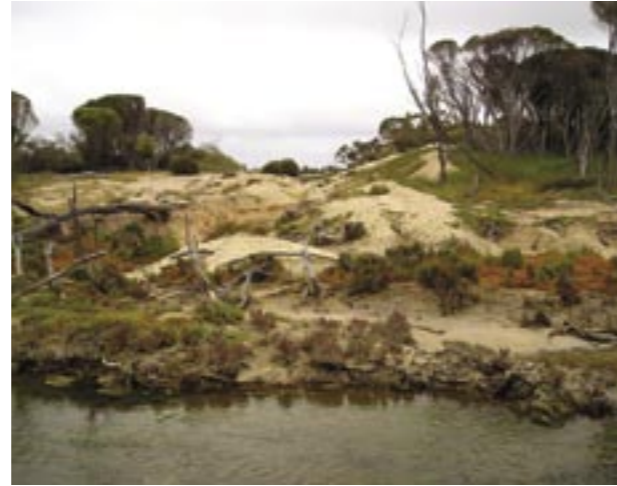
Photo 27: Drain confluence in Photo Section 23

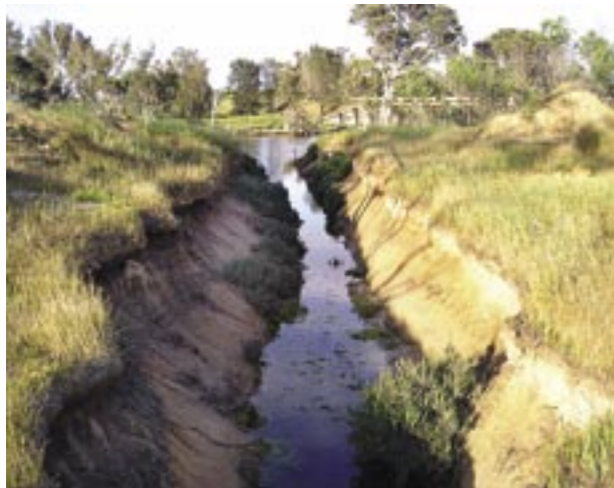
Photo 26: Drain confluence with Dwardadine Pool in Photo Section 16

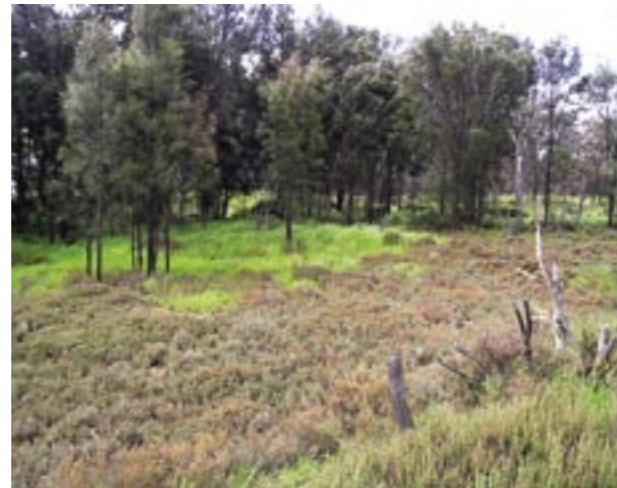
Photo 28: Confluence with drainage at Pt 84 in Photo Section 18

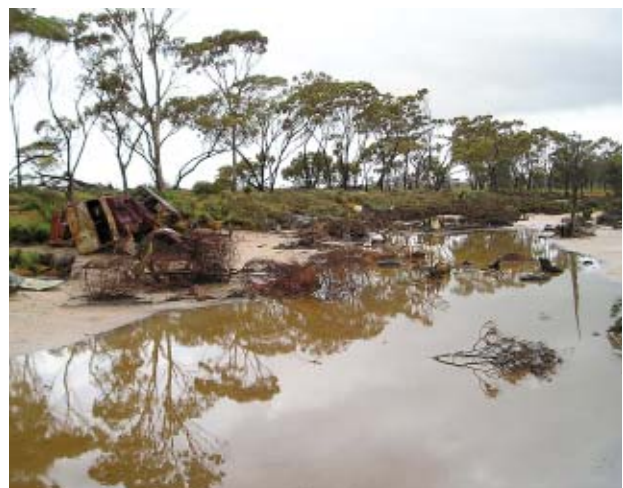
Locations where there is farm and household rubbish near the river are noted in the photo section notes (Photo 33). Most are discarded fencing materials. Almost all sites were old rubbish disposal sites and not in current use. While rubbish in the river environment may be considered to be unsightly, the major risk is if there is potential for contamination or dangerous flotsam during floods. Most rubbish noted was not a risk to the river environment.

Photo 33: Rubbish deposition in Section 20
