SUPPLEMENTARY REPORT

Perth Children's Hospital audit – fire walls

An audit of contractor and product
performance in the construction of fire walls
at the new Perth Children's Hospital

October 2017

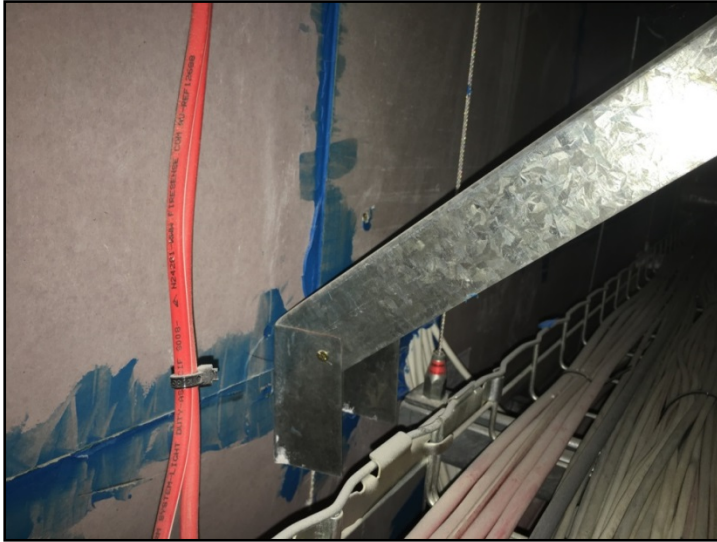
Photograph 1: Wall brace fitted to a plasterboard wall

No remedial work is required.

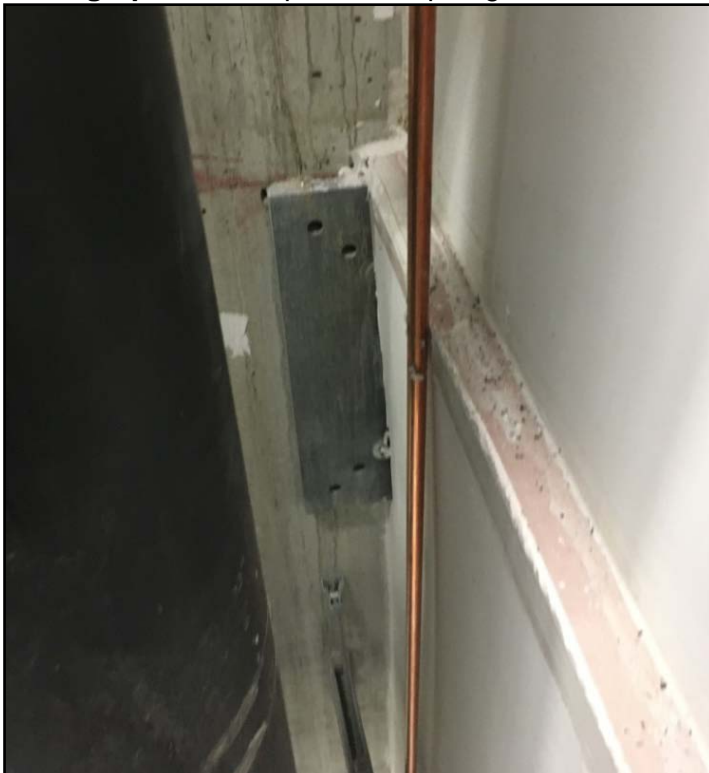
The Building Commission also received information from a worker who advised: “Several strips of fire rated plasterboard bulkhead had been used without proper fixings in multi-service riser 1. Strips of fire rated plasterboard appear to be glued on to steel beams and not fixed with screws as required by the manufacturer.”

Under fire conditions the strips of glued plasterboard could delaminate, resulting in premature failure of the fire protected bulk head.

Photograph 2: Example of a strip of glued-on fire rated plasterboard

To meet the DTS requirements the multi-layer plasterboard systems need to meet the manufacturer's recommendations set out in Knauf's 'Technical Manual – Plasterboard Systems' which provides approved fixing details for metal stud single and multi-layer fire rated plasterboard systems. These fixing details provide that only screws must be used.

Section 1.2 of Knauf's specification document, 'K-spec – John Holland – New Children's Hospital – Partition and Ceiling Information' also provides that internal steel wall partitions (single or multiple layers) are to be fixed using a 'screw only method' not glues.

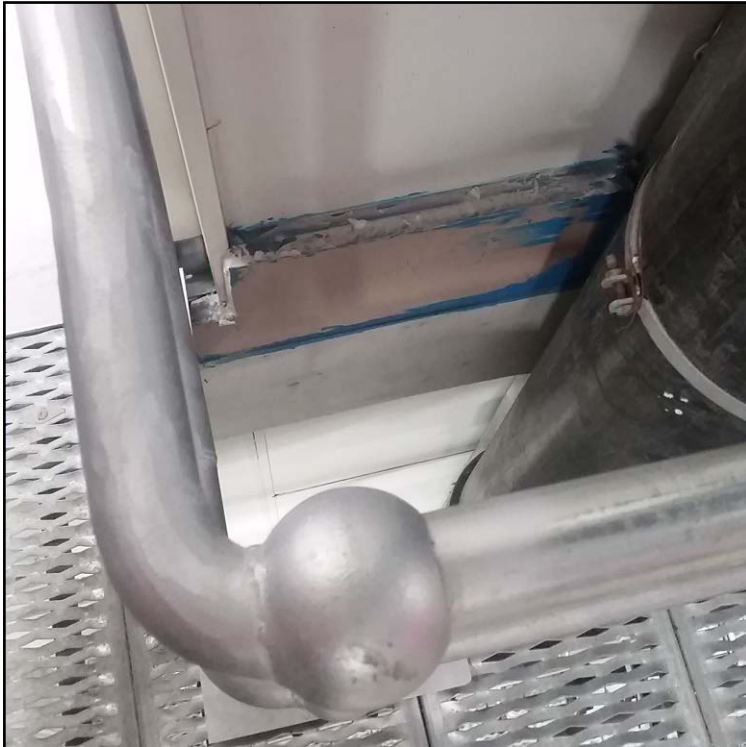
Photograph 3: Example of a strip of glued-on fire rated plasterboard

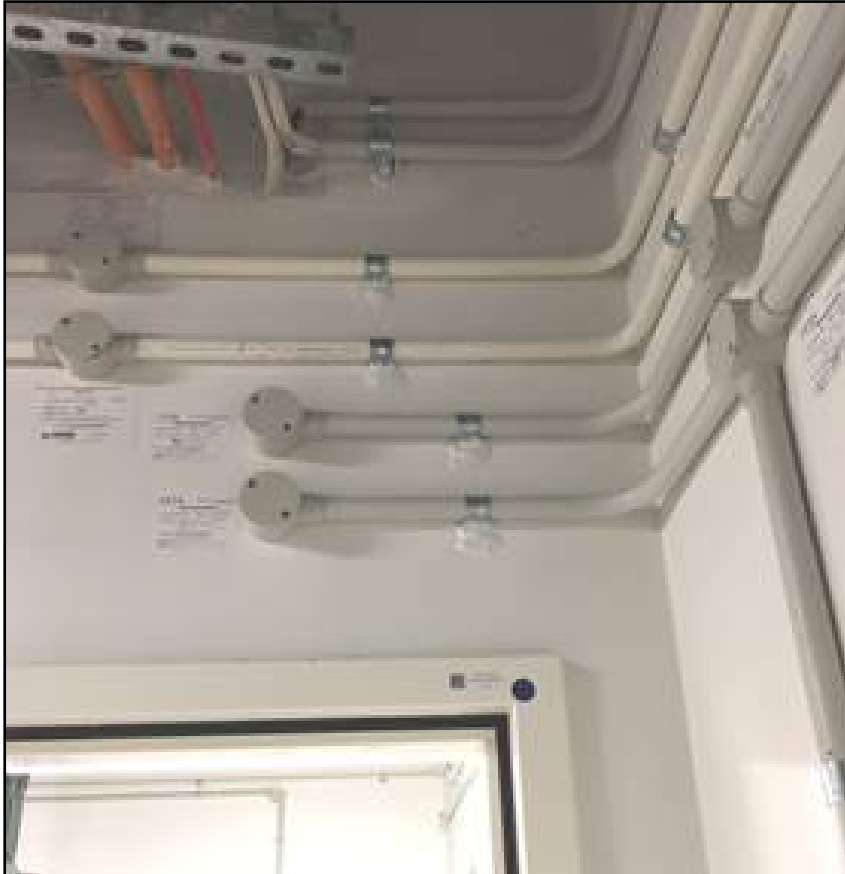
The Knauf plasterboard manufacturer recommendations do not include tested system results for the face fixing of conduits and the like with various proprietary hollow wall anchors.

Photograph 4: Example of hollow wall non-fire rated fixings in a fire rated wall

The fire rated walls with these additions may not achieve the fire resistance levels that would otherwise be achieved based on the manufacturer's tested system results.

To meet the DTS requirements single and multi-layer plasterboard systems need to meet the manufacturer's tested recommendations set out in Knauf's 'Technical Manual – Plasterboard Systems' which provides approved fixing details for single and multi-layer fire rated plasterboard systems.

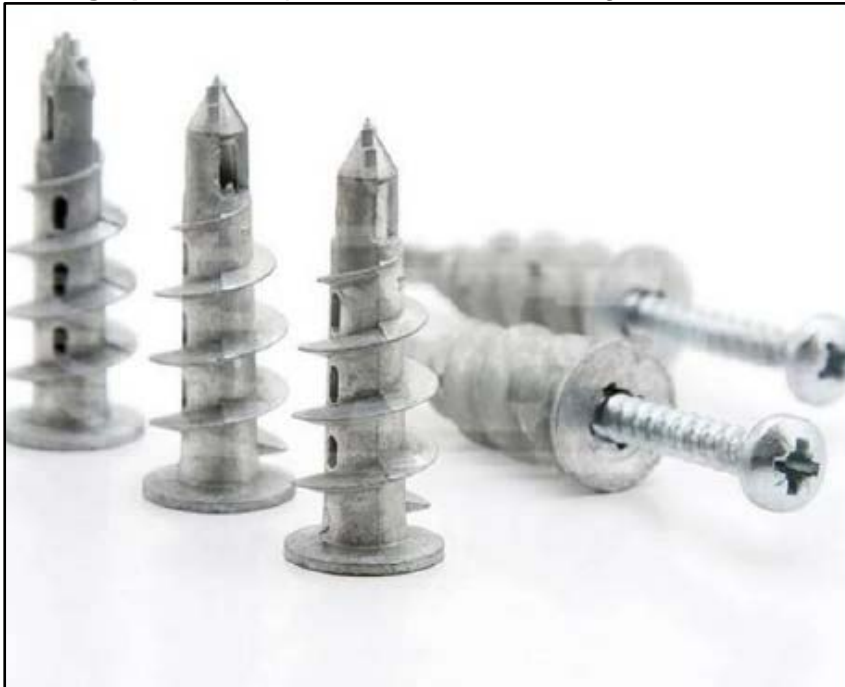
Photograph 5: Example of wall mates showing hollow core with central screws

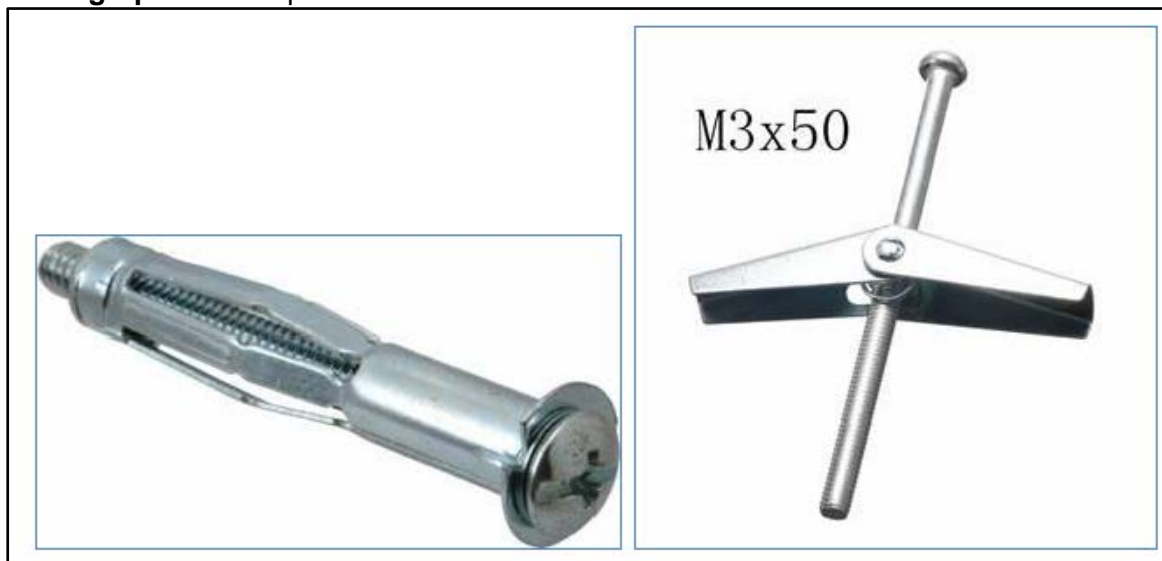
Photograph 6: Examples of hollow wall anchors

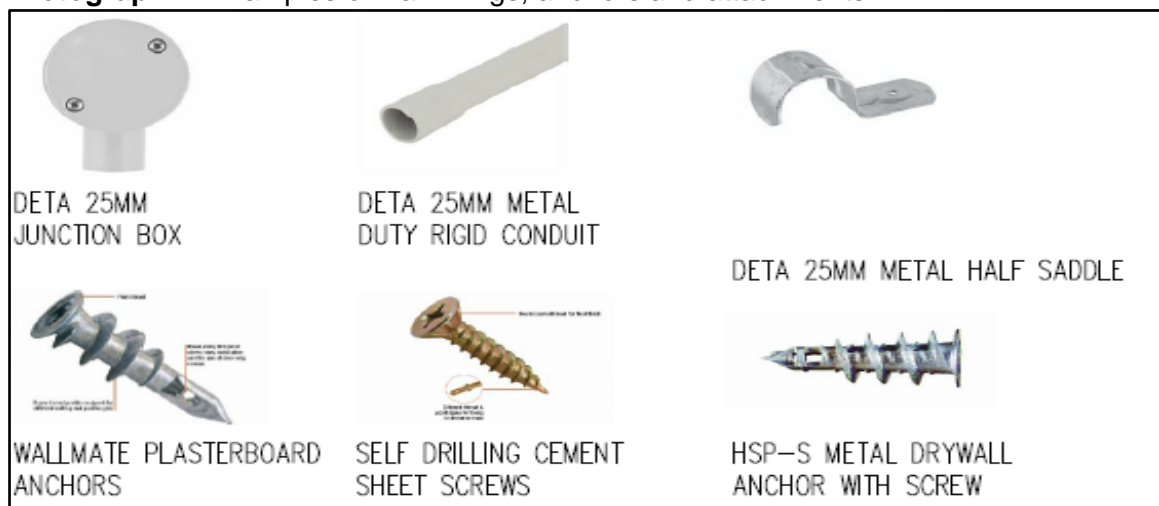
Photograph 7: Examples of wall fixings, anchors and attachments

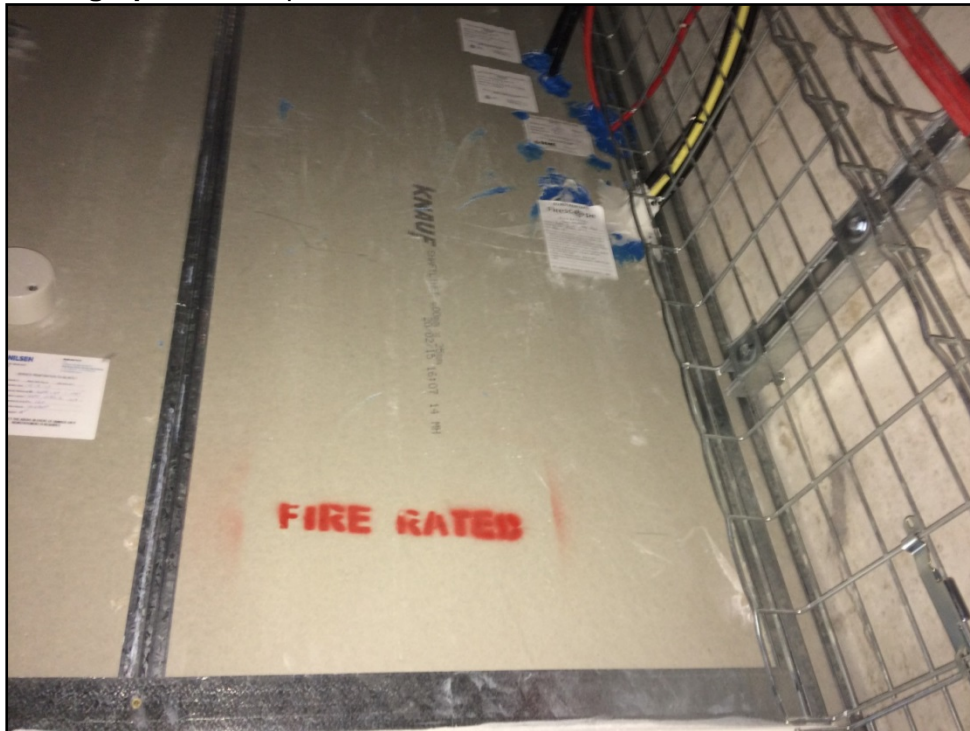
Labels and stencils provide important building data and if the stickers were to peel off or are obscured from view, or the fire stencils were missing, problems may occur maintaining the services and fire walls in the future.

Photograph 8: Example of labels and fire stencils

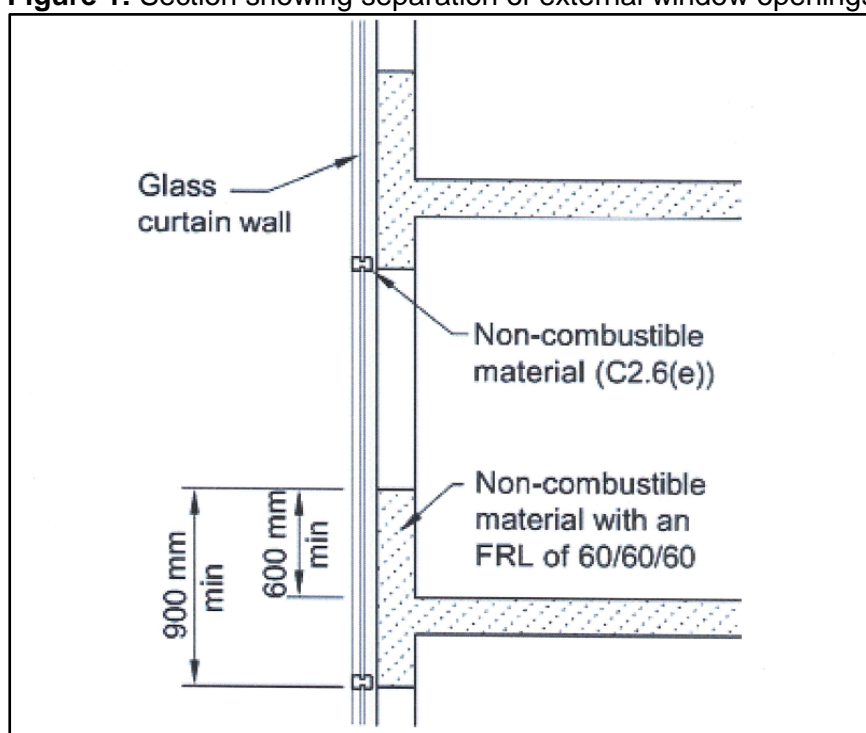
This fire protective measure is important to inhibit the spread of fire and smoke between floors in a Class 9a building (Hospitals).

Figure 1: Section showing separation of external window openings in a curtain wall

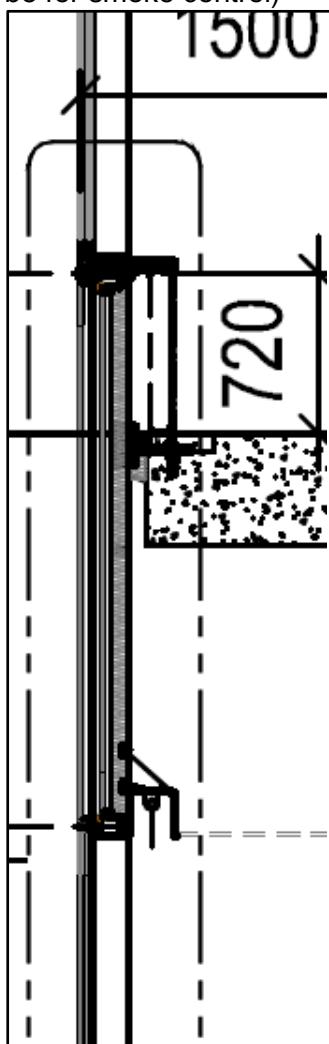
Figure 2: Typical extract of building plans showing non-combustible material (assessed to be for smoke control)

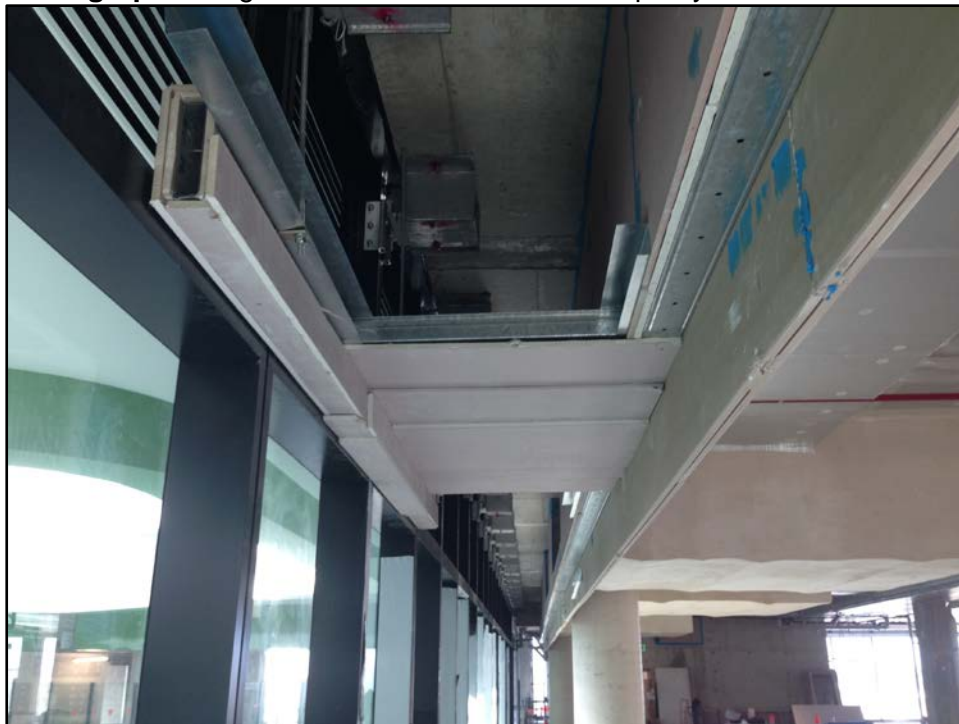
Photograph 9: High level louvre air intakes and partly constructed air duct

The Building Commission is satisfied that no further action is required.

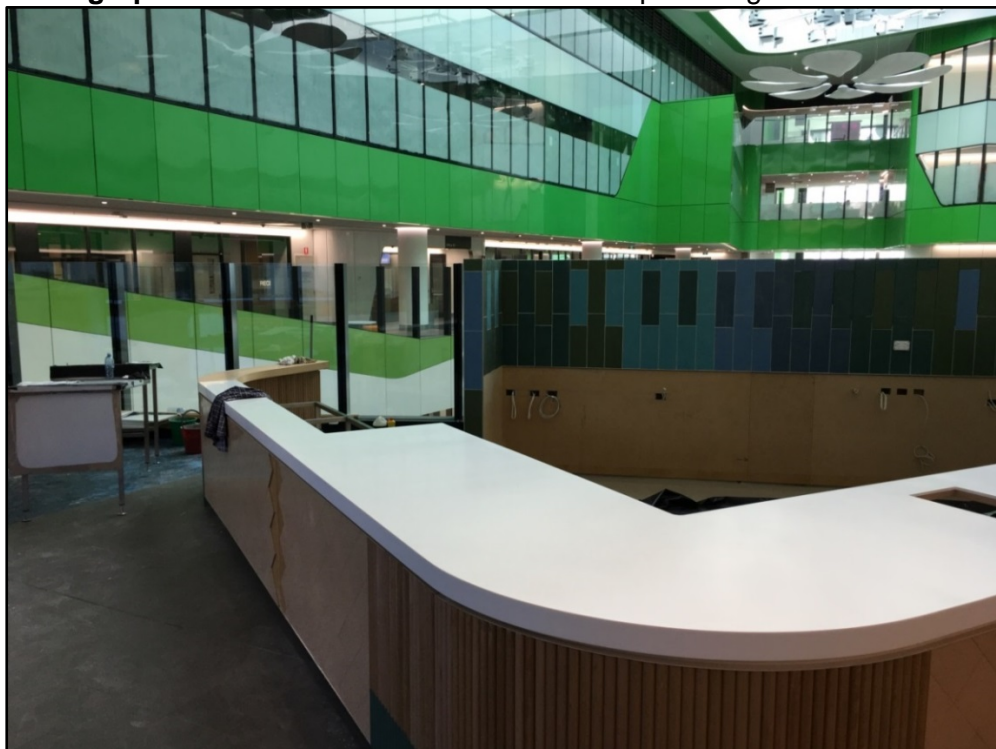
Photograph 10: PCH Atrium view with kiosk shop in foreground

No action required.

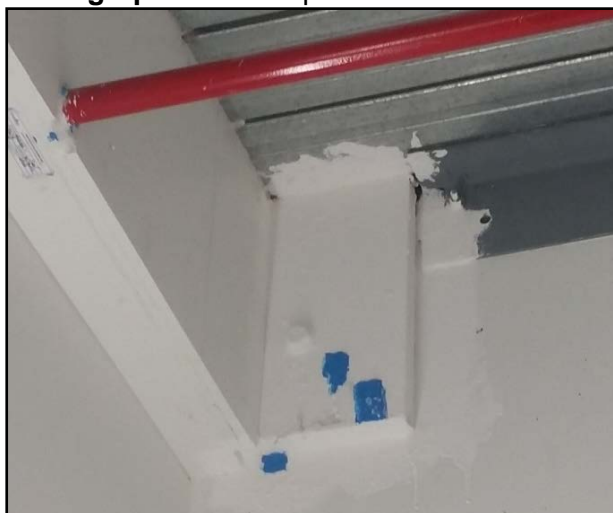
Photograph 11: Example of the use of intumescent paint on steel beam connection plate

Structural steel beams connection points requiring intumescent paint have been rectified by John Holland and no further action is required.

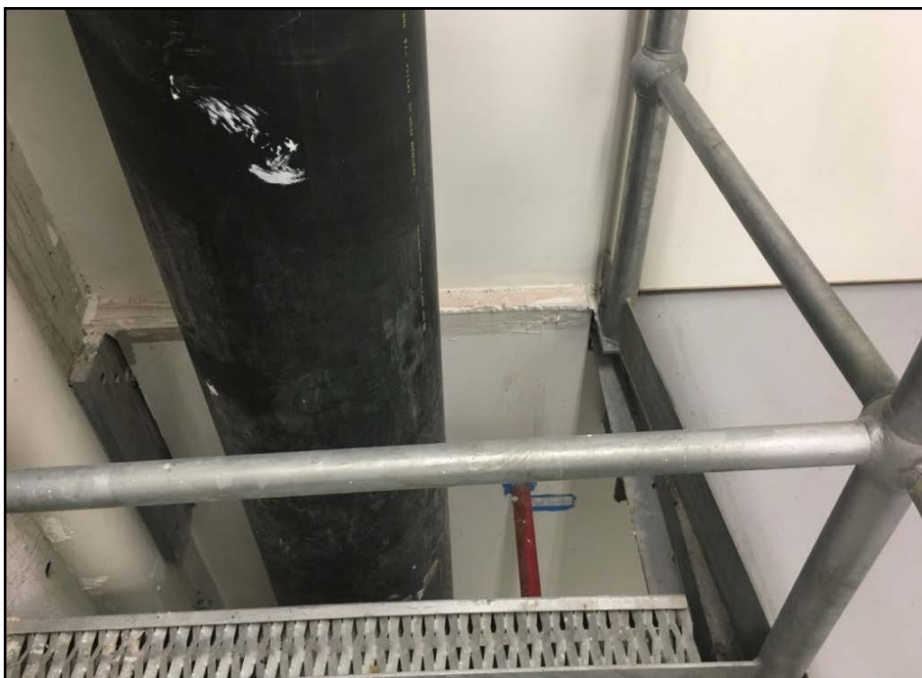
Building Commission inspectors found several steel safety barriers, of the AS1657 type, to have penetrated fire rated Knauf or Promat Promatect-H board bulkheads.

Photograph 12: Example of incorrect installation of steel safety barrier through a fire rated bulkhead

These defects have been acknowledged by John Holland and will be rectified.

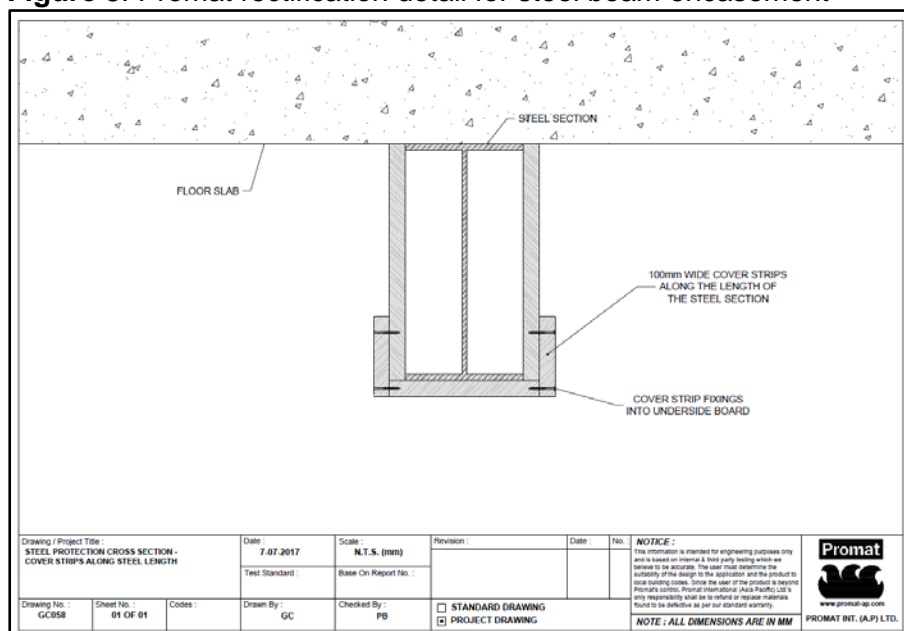
The Building Commission observed that some beams were not fully sheeted with either fire rated Knauf or Promat Promatect-H board and others were not sheeted at all. Potentially, compromising the integrity of the adjacent and related fire rated floor and wall systems in a number of locations (ie levels) within multi-service risers numbers 1 and 2.

Figure 3: Promat rectification detail for steel beam encasement

They do not meet the DTS requirements for fire resistance without rectification works.

“Originally thought to be layered plasterboard in fact was Promat board, the supplier has said that the directional corner laps are incorrect where the bottom board should be installed between the two side boards. The board supplier is investigating if the system has been tested this way and if not will assist JHG to come up with a solution that can be implemented over the coming weeks. All beams are accessible. This item will be recorded in BIM and closed out following due process. Please see attached manufacturer resolution, works are currently underway.”

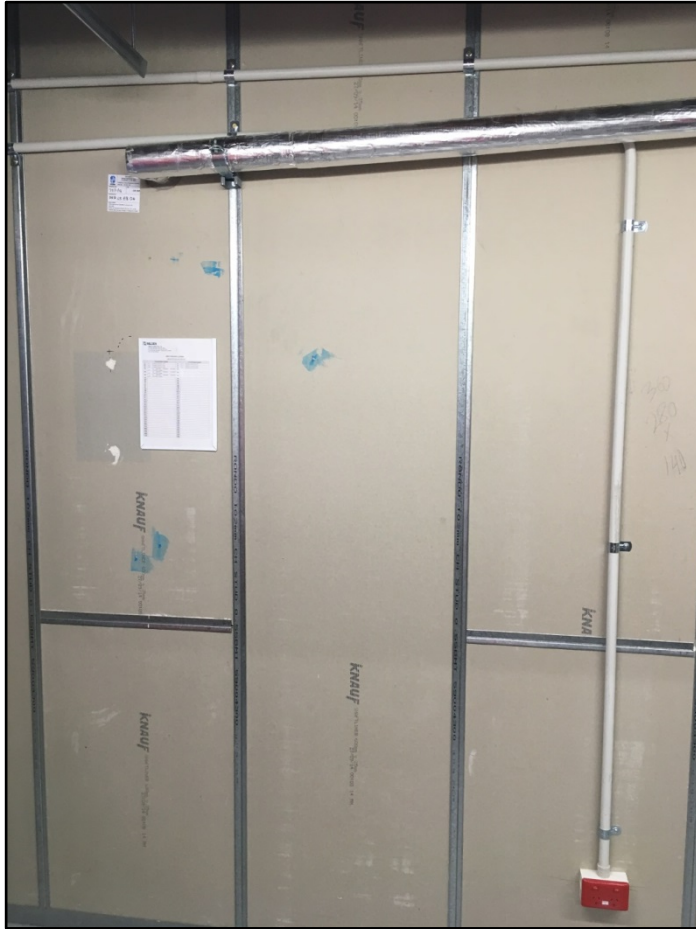
The Building Commission engaged RED fire engineers to review the use of fixings in fire rated walls and to provide written advice. This advice and the CSIRO testing observed by RED and addressed in Claim 11 satisfies the Building Commission that these fittings and fixings do not adversely affect the fire rating of the wall.

Photograph 13: Saddle clamp fixings to inside face of Knauf shaft wall
