Department of Mines, Industry Regulation and Safety

Wheal Ellen Mine Shafts and Open Pits Geotechnical Assessment and Remediation Methodology (DMIRS750620) Geotechnical Report

September 2020

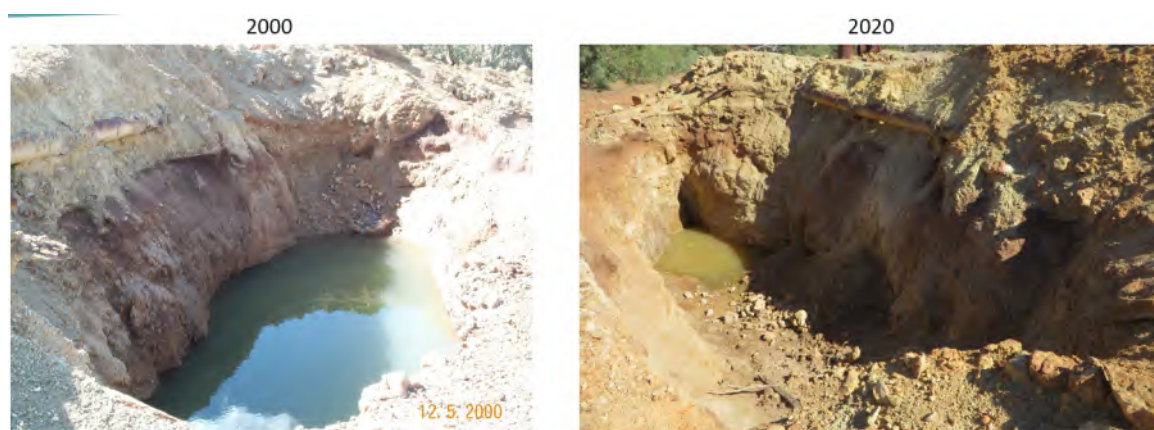
Image 7 S0113143: 2000 and 2020 comparison photos (DMIRS)

As shown in the below images, minor deterioration of spoil around the feature has occurred over the past 20 years. The main difference in these photos is the amount of water present. The water depth observed by GHD in August 2020 being similar to the 2000 image.

The unstable material around this feature, particularly along the pipe make it more hazardous. However, the feature is of limited depth and not so steep sided to make climbing out of it difficult.

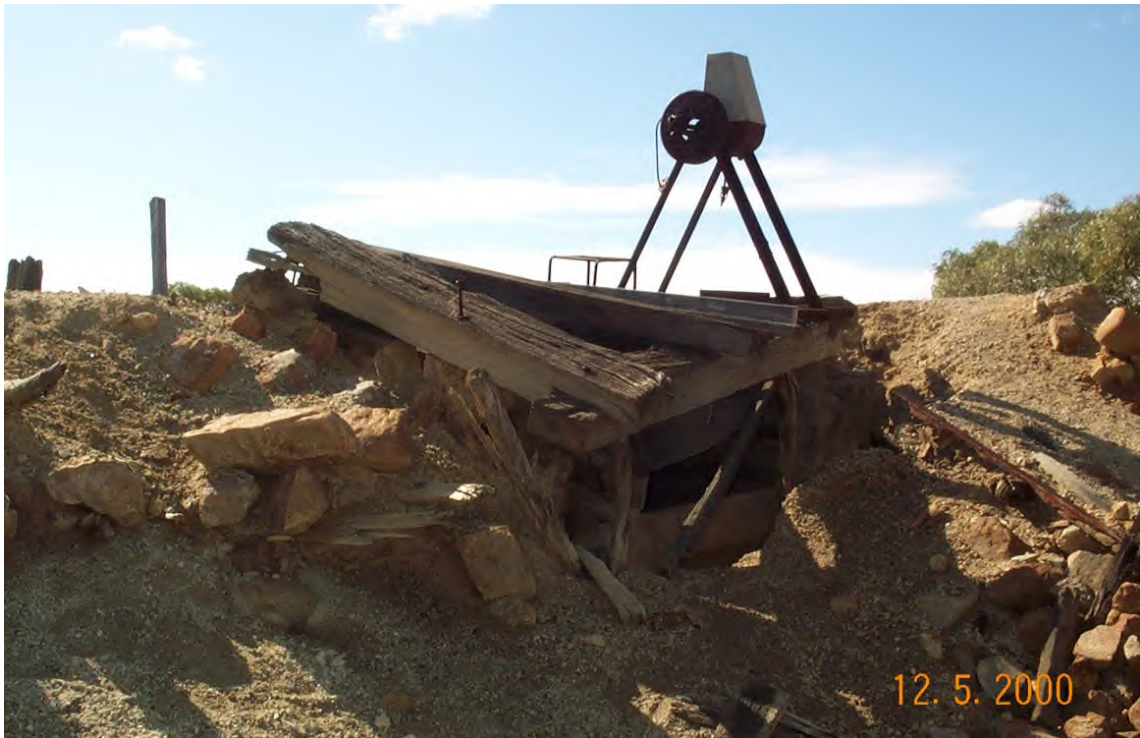
Image 8 S0113145: 2000 photo (DMIRS)

The shaft was partially collapsed with wooden beams at 3.2 m depth and loose spoil around the collar. Water was present at 3.1 m depth, measured from the void crest. The feature was dipped using a weighted tape to confirm the base where it was obscured by water. The backfilling in the shaft is at the same level as the adjacent pit (S0113143).

As shown in the below image from 2000 in comparison to the 2020 photos in Appendix C, the timber around the shaft collar has been removed or collapsed and the surrounding spoil fallen into the shaft to form a crater shape. Timber and steel remain in the upper portion of the shaft.

The unstable spoil material around this feature make it particularly hazardous and climbing out of it would be very difficult.

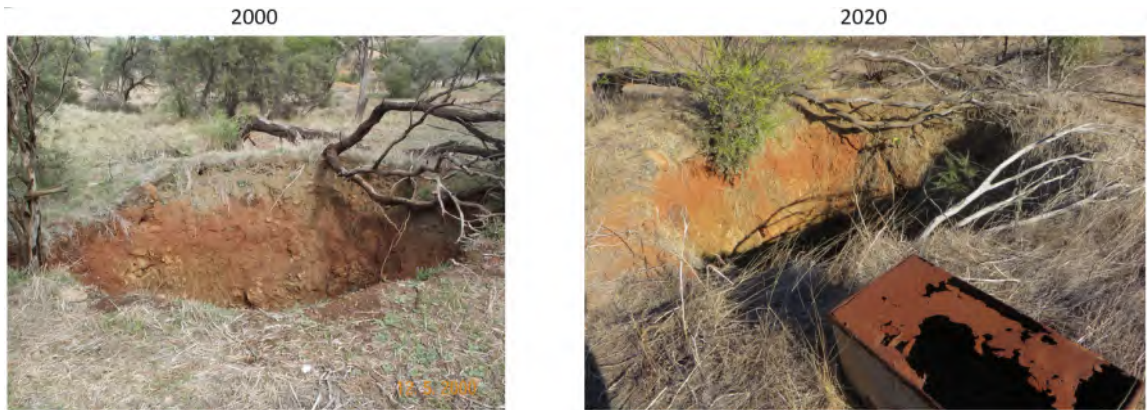
Image 11 S0113103: 2000 and 2020 comparison photos (DMIRS)

The pass has collapsed or been filled to a depth not exceeding 4.5 m. Erosion caused by surface water has resulted in the feature increasing slightly in size over the past 20 years although the sides have remained steep and the crest abrupt.

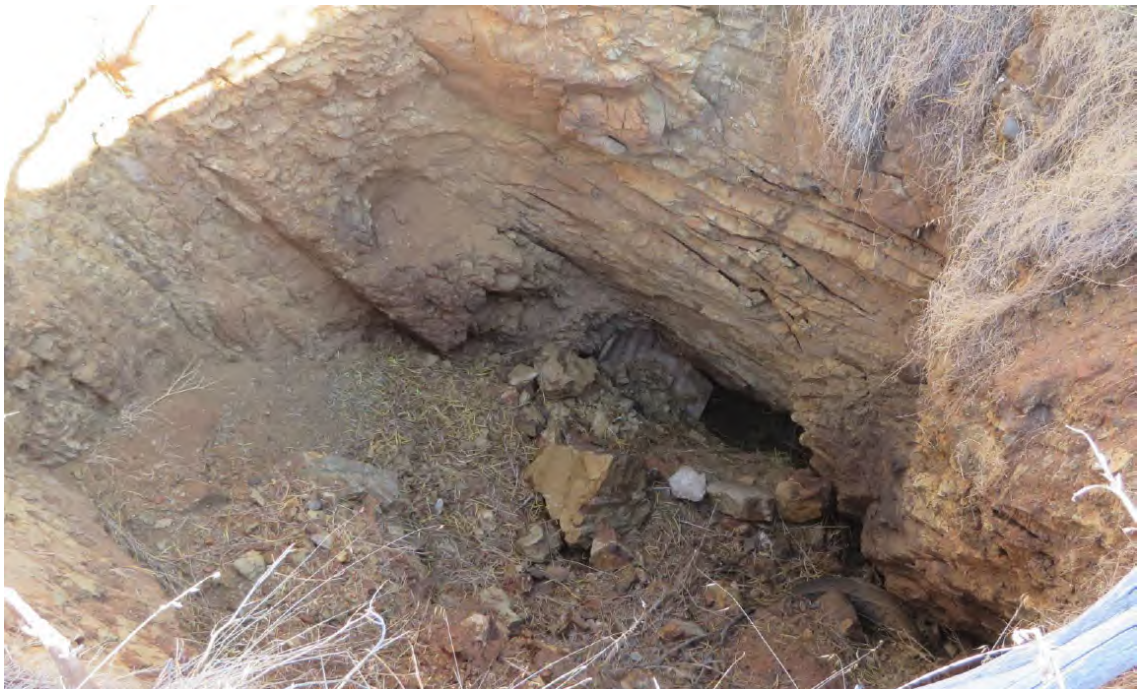
Image 12 S0113103: 2020 photo (DMIRS)

The dip of the lode can be seen in the below image with fretting of blocks from the hanging wall. Between the hanging wall and debris is a deeper area which was surveyed to about 5 m depth. It is likely this connects with deeper voids. The lack of fine grained sediment indicates water does not pond in the feature and there is strong hydraulic connection to voids below.

While an attempt to fill this pass may have been made, the fill appears to have washed underground. The resulting feature is likely to be the surface expression of the collapsed stope.

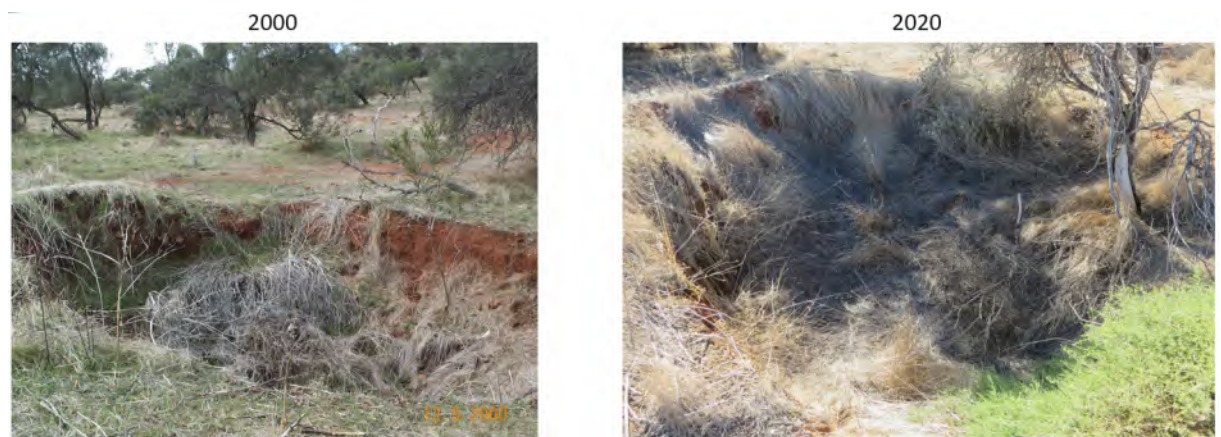
Image 13 S0113163: 2000 and 2020 comparison photos (DMIRS)

The pass has subsided to a depth of 1.1 m. Little evidence of surface erosion was observed during the walkover and comparison between the 2000 and 2020 images below show little change other than vegetation.

It appears this pass has been backfilled and the backfill subsided to form a depression with steep sides. Further subsidence or erosion of the fill does not appear to be occurring.

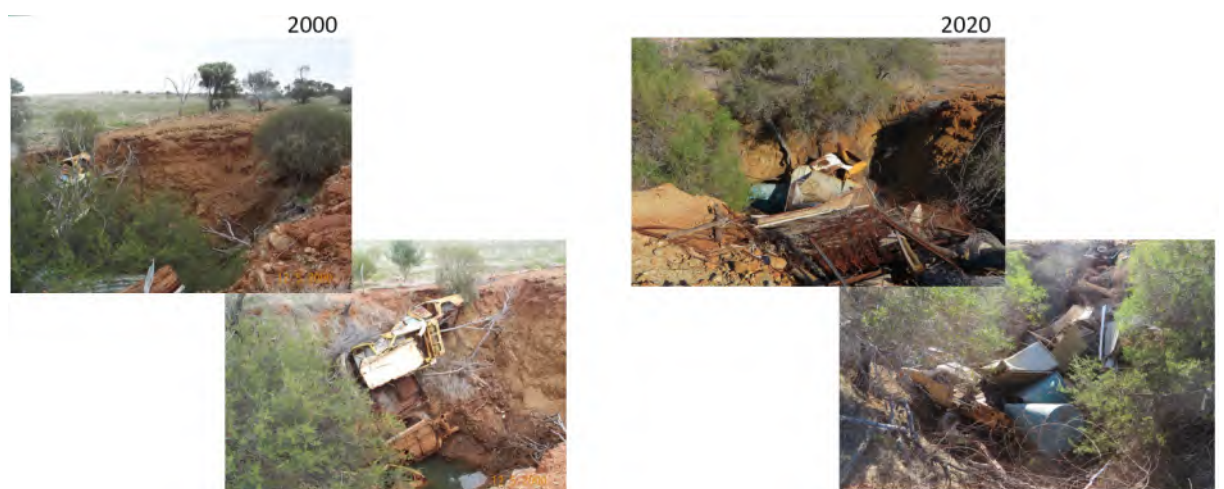
Image 15 S0113151: 2000 and 2020 comparison photos (DMIRS)

The base of the pit was obscured by waste such as sheet metal and car bodies. A small amount of water was observed in the base.

A tension crack about 10 m long was observed along the northern wall of the pit indicating instability of that wall. The crack may have been deepened and widened by erosion.

Comparison between photos from 2000 to 2020 show an increase in waste but generally not much change. The 2000 photo shows water in the base of the pit.

Given the depth of the pit and position along the lode sub-crop, it's likely the pit was excavated as an open cut and has not been backfilled. If connections to underground voids are present, they would be along the western wall (hanging wall) where the car bodies are piled in the 2000 photo above.

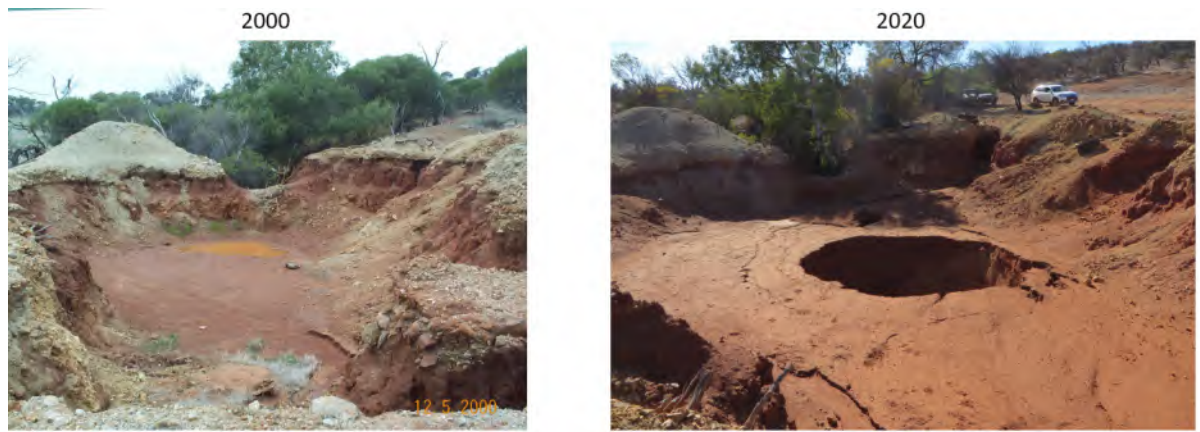
Image 20 S0113147: 2000 and 2020 comparison photos (DMIRS)

A comparison of the below photos between 2000 and 2020 shows a sinkhole formed within the fines since 2000.

As shown in the August 2020 photo in Appendix C, surface runoff from the east has caused significant surface erosion which has extended to the adjacent road. Despite this additional erosion, the sinkhole does not appear to have deepened significantly but rather increased in plan area. The 2020 drone footage shows only ponded water partially across the sinkhole base.

Based on the observed sinkhole formation and behaviour since, it appears that soil fines migrated into underground voids under the action of hydraulic gradient due to water ponding in the pit and seeping through the fines. The resulting piping failure allowed the pit to drain into the workings, providing relief from the hydraulic gradient and return to unsaturated conditions with the accompanying suctions increasing strength and halting growth of the sinkhole.

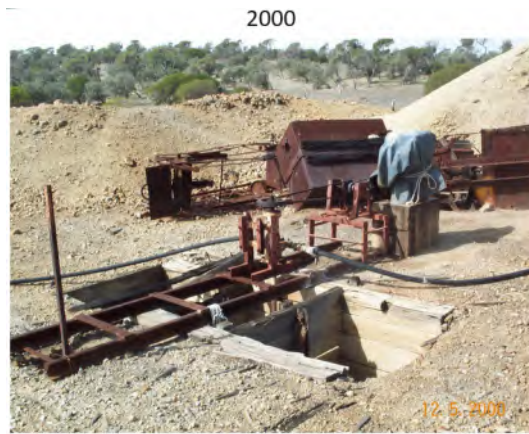
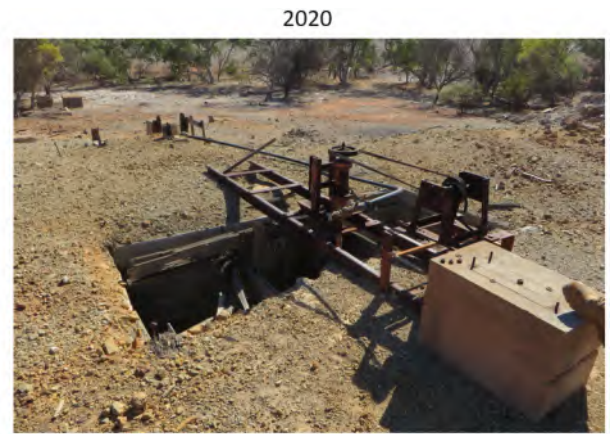
Image 21 S0113158: 2000 and 2020 comparison photos (DMIRS)

The condition of the shaft collar appears to have changed little from 2000 to 2020 as shown in the below photos.

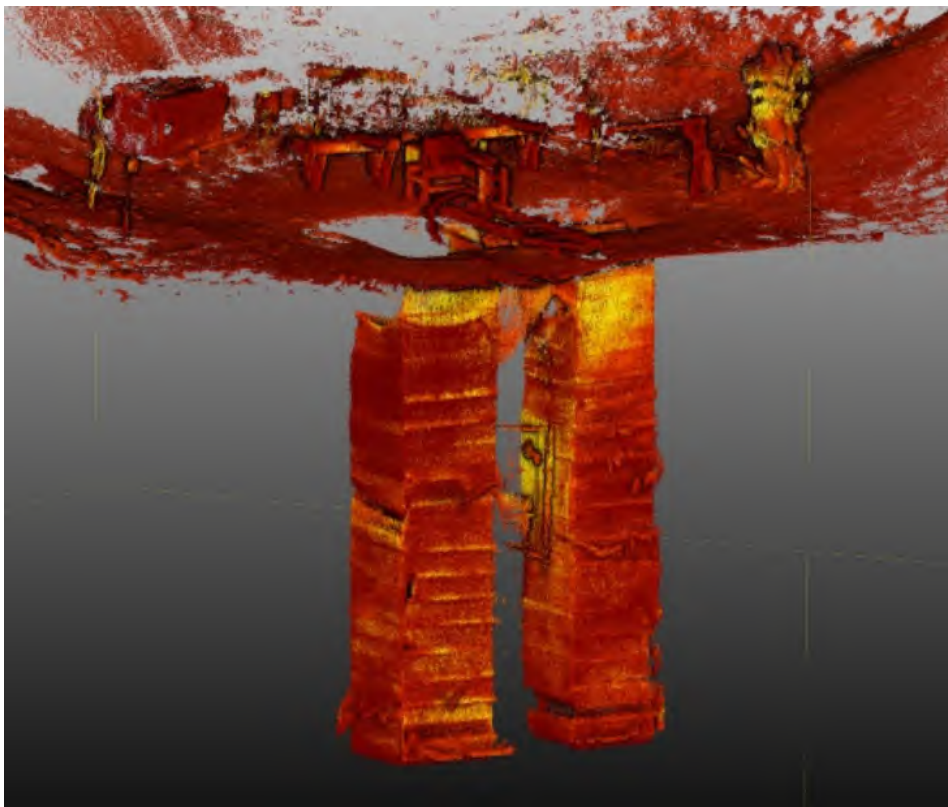
Image 22 Main Shaft (S0113158) point cloud

The three chambers are visible but the filling is not and is assumed to have subsided. A laser point cloud and video within both the western and eastern chambers shows timber boards extending to the water. Some of the boards have fallen away to reveal the rock behind.

The western and eastern chambers are open and unobstructed whereas the central chamber is partially obstructed with cross supports, pipe and hoses. Some of these obstructions are visible in the above point cloud image.

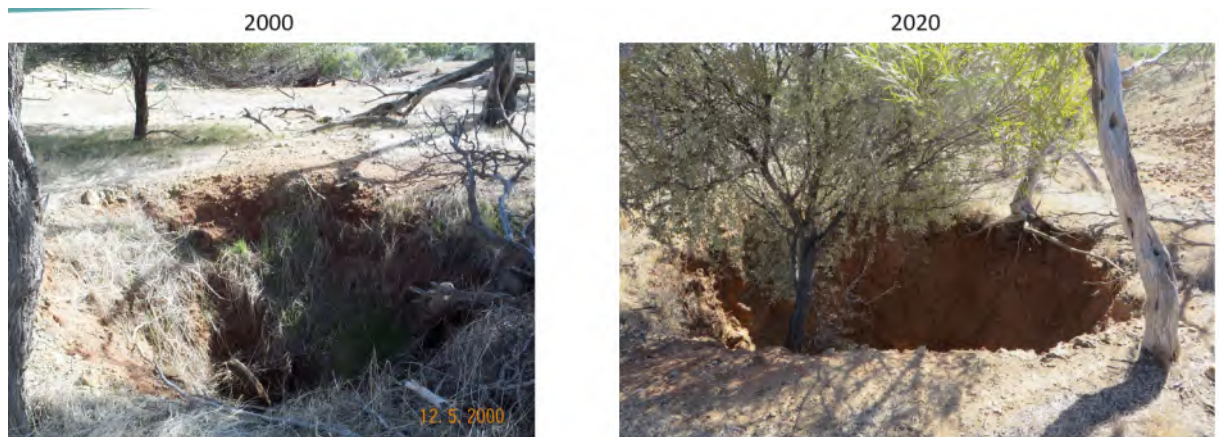
Image 23 S0113130: 2000 and 2020 comparison photos (DMIRS)

While only about 2.5 m in diameter, it is currently about 7 m deep with vertical sides and no water in the base. Erosion caused by surface water and fretting appears to have increased the diameter of the pass near the ground surface, making the crest more distinct and less vegetated as shown in the below image.

It appears that backfilling of the pass has subsided with the 2020 plan dimensions likely to be similar to the original pass.

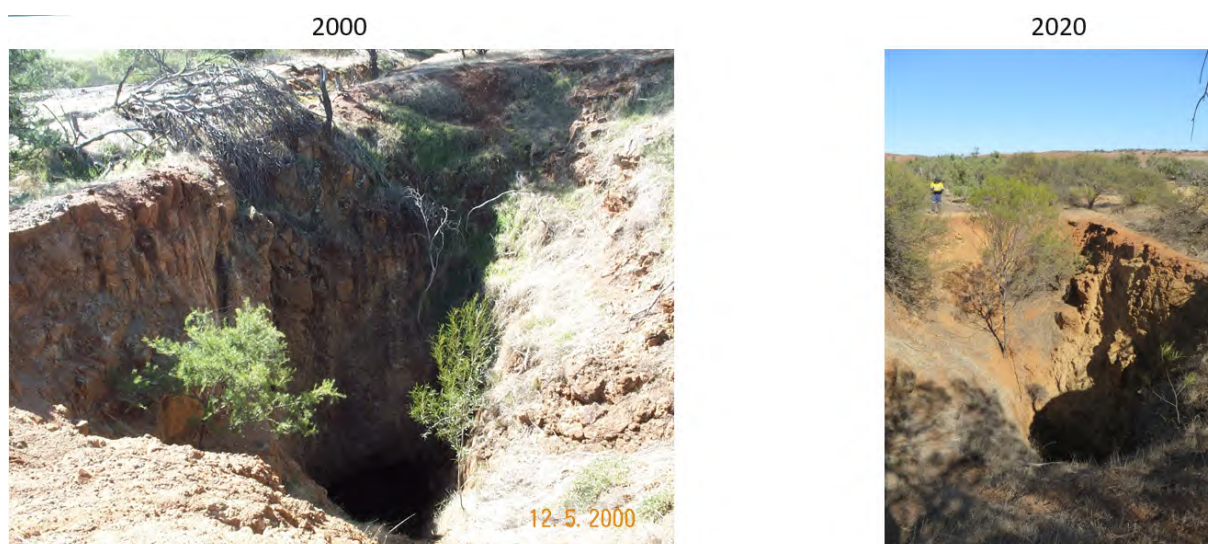
Image 24 S0113141: 2000 and 2020 comparison photos (DMIRS)

Evidence of surface erosion caused by water runoff from the east is present with finer materials being washed to the base of the feature. However, comparison of the below 2000 and 2020 images indicates only minor erosion.

It appears that backfilling of the pass has subsided although it is not clear to what extent the open cut was previously filled, if at all.

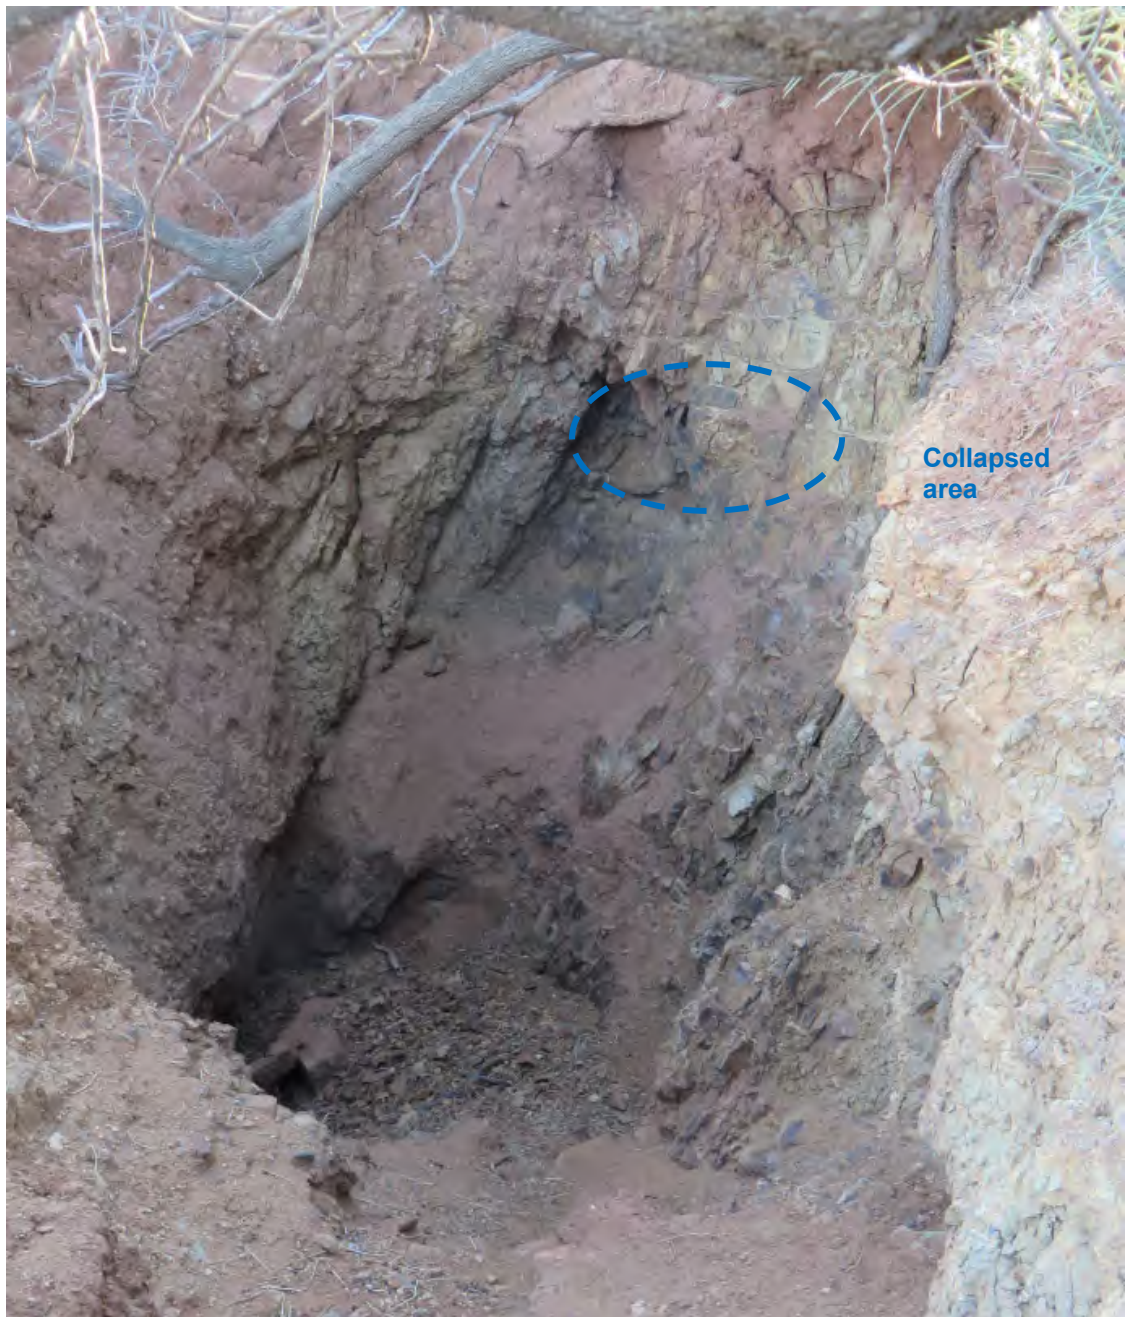
Image 30 S0113122: 2020 photo (DMIRS)

The pass may have been backfilled but this material has since subsided or been washed into a stope below. The resulting feature is likely the surface expression of the stope.
