Report on  
Geotechnical Investigation

Donnybrook Mine Shaft Condition  
Lot F27 Goodwood Road, Upper Capel

Prepared for  
Department of Mines, Industry Regulation & Safety

Project 96721.00  
June 2021

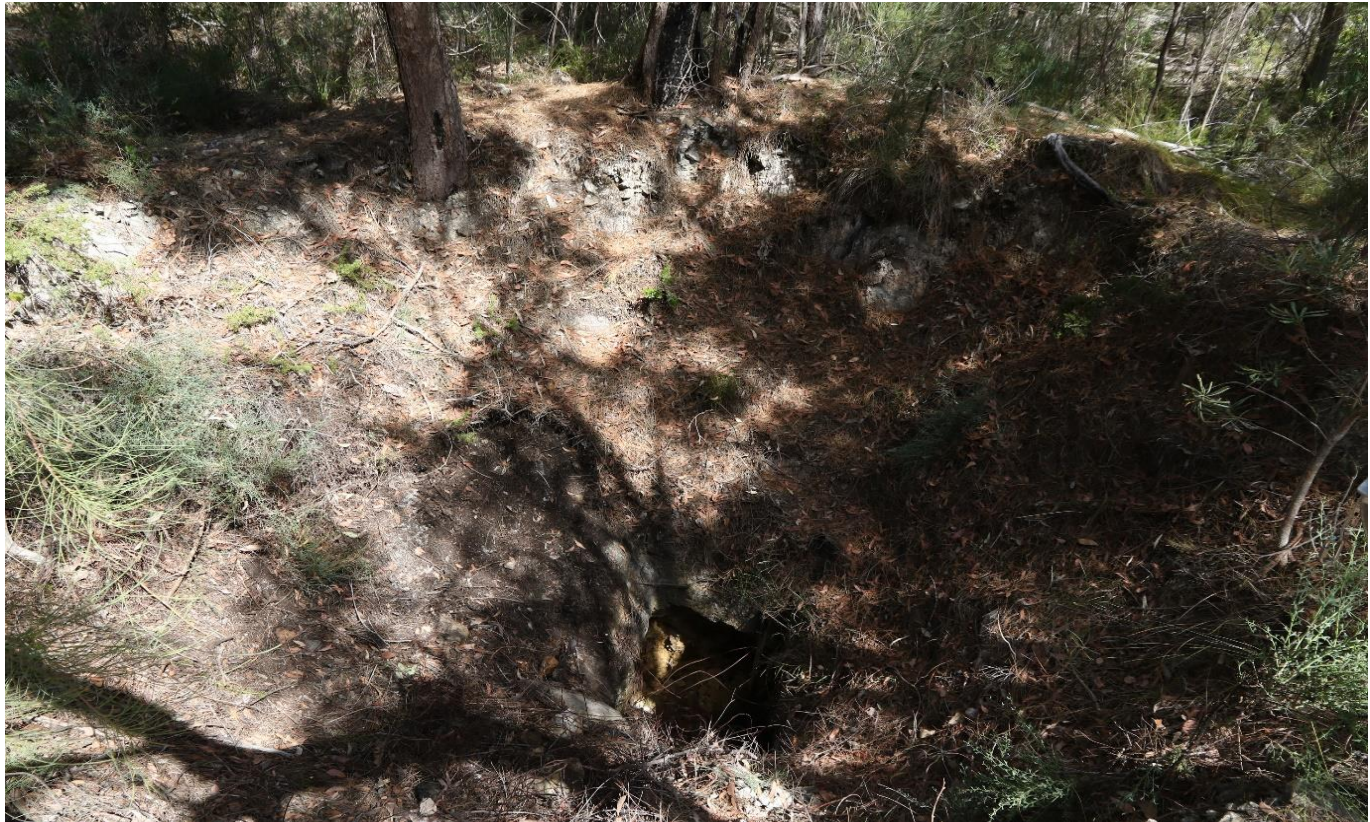
**Photograph 1: Feature 1**

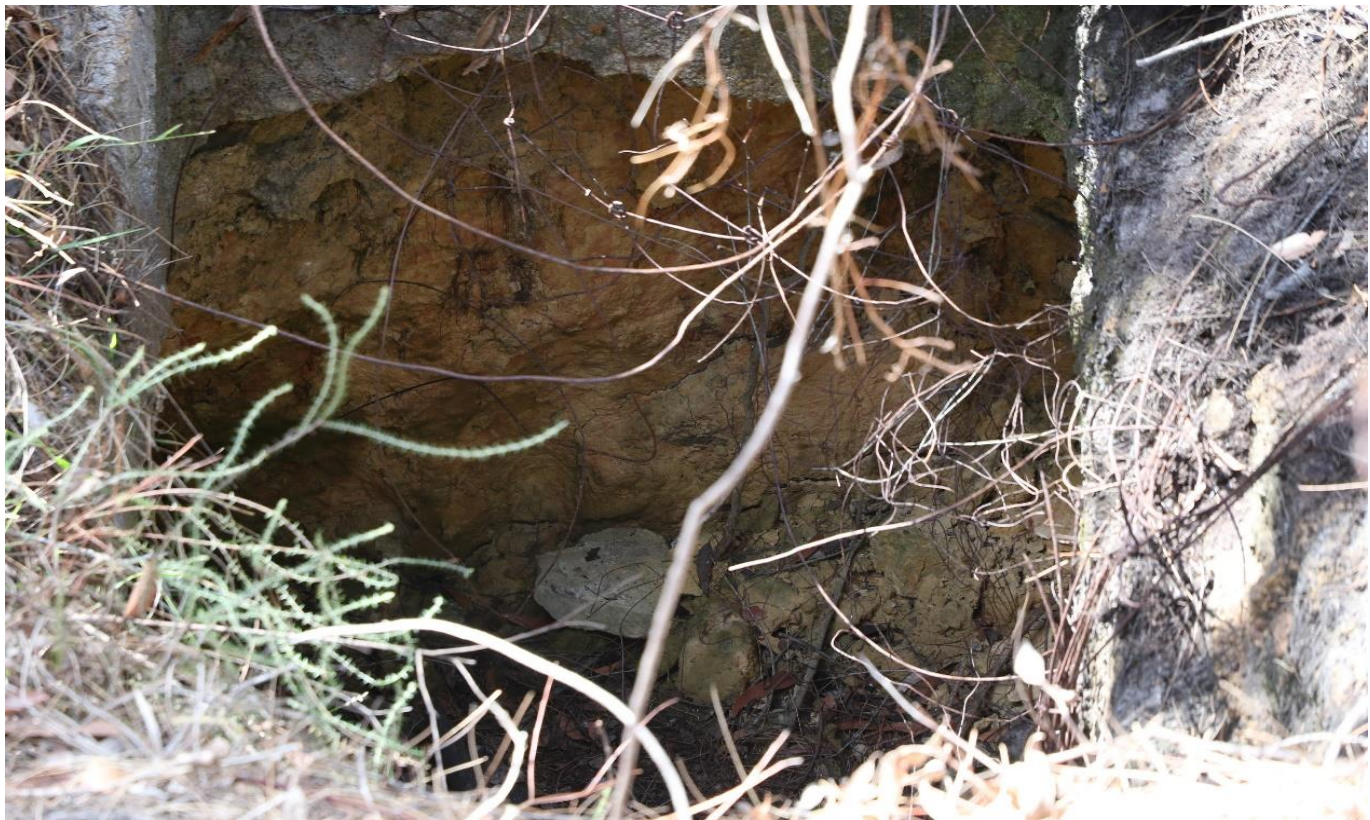
**Photograph 2: Feature 1 - base**

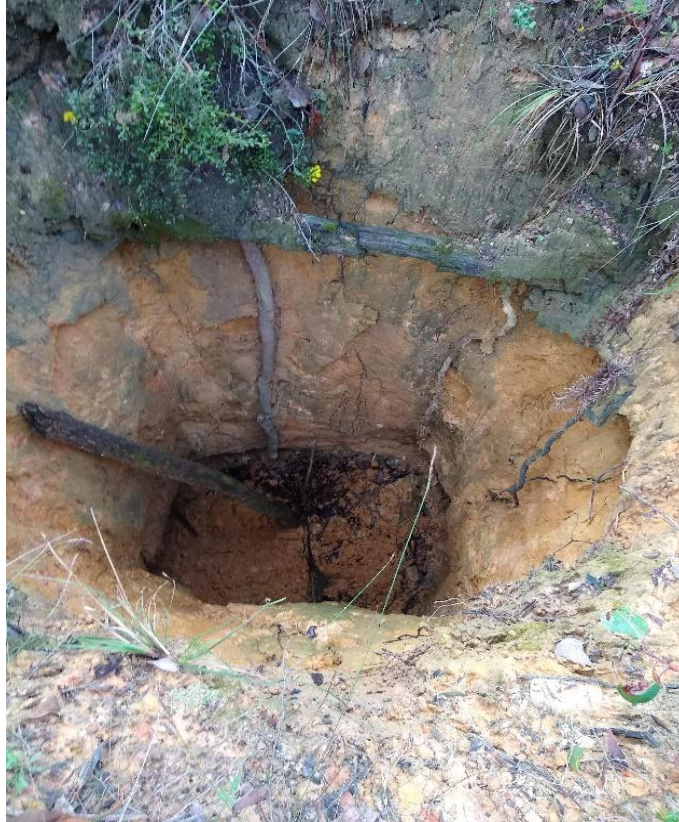
**Photograph 3:** Feature 2

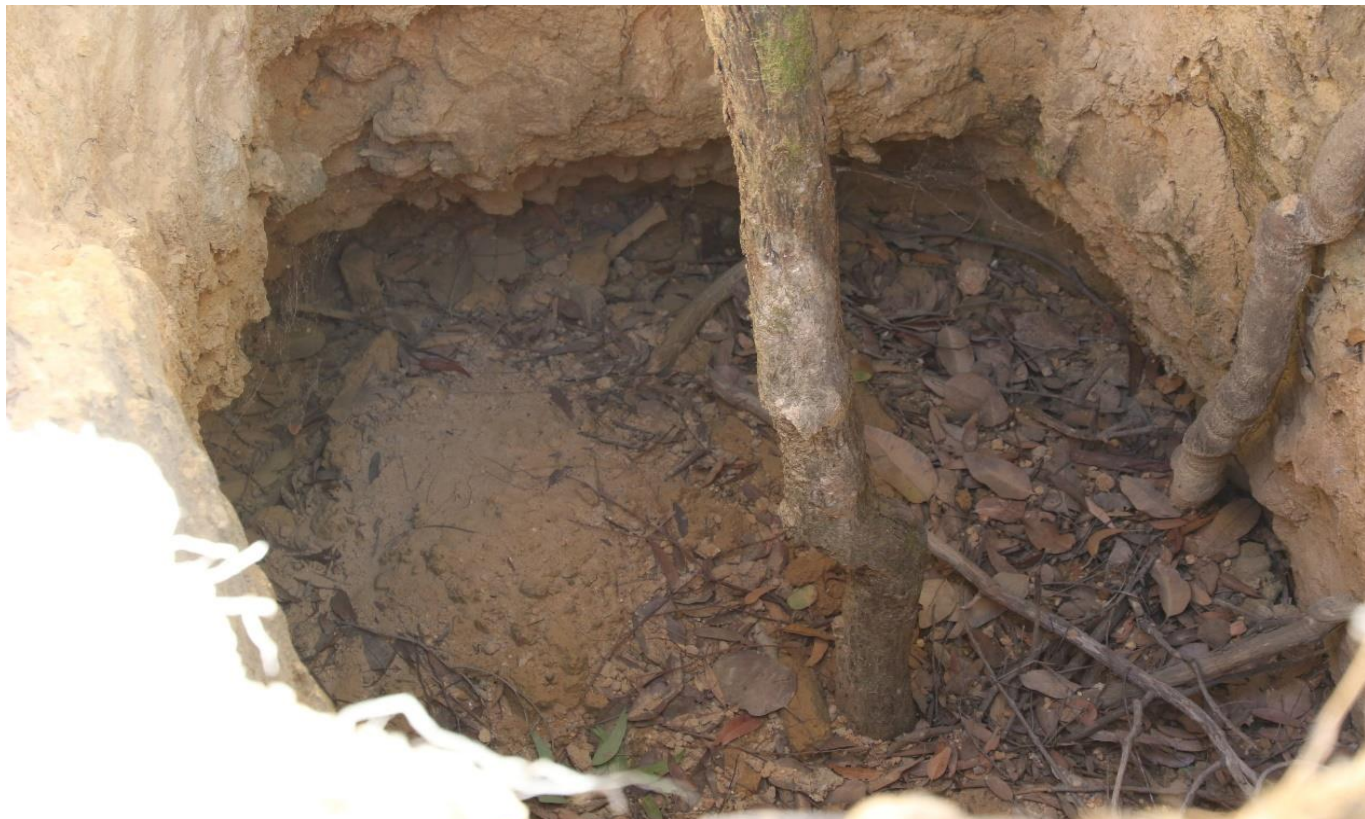
**Photograph 4:** Feature 2 - base

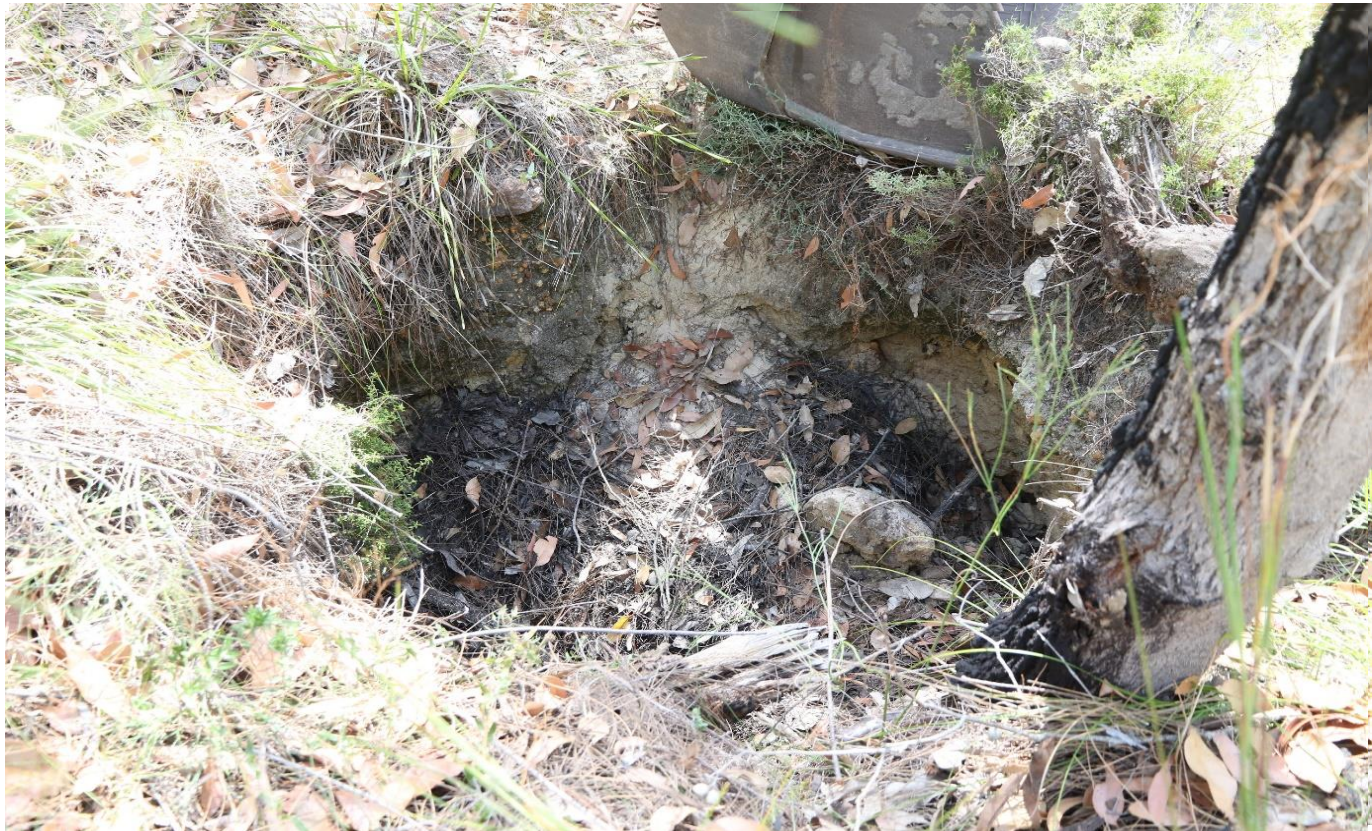
**Photograph 5: Feature 3**

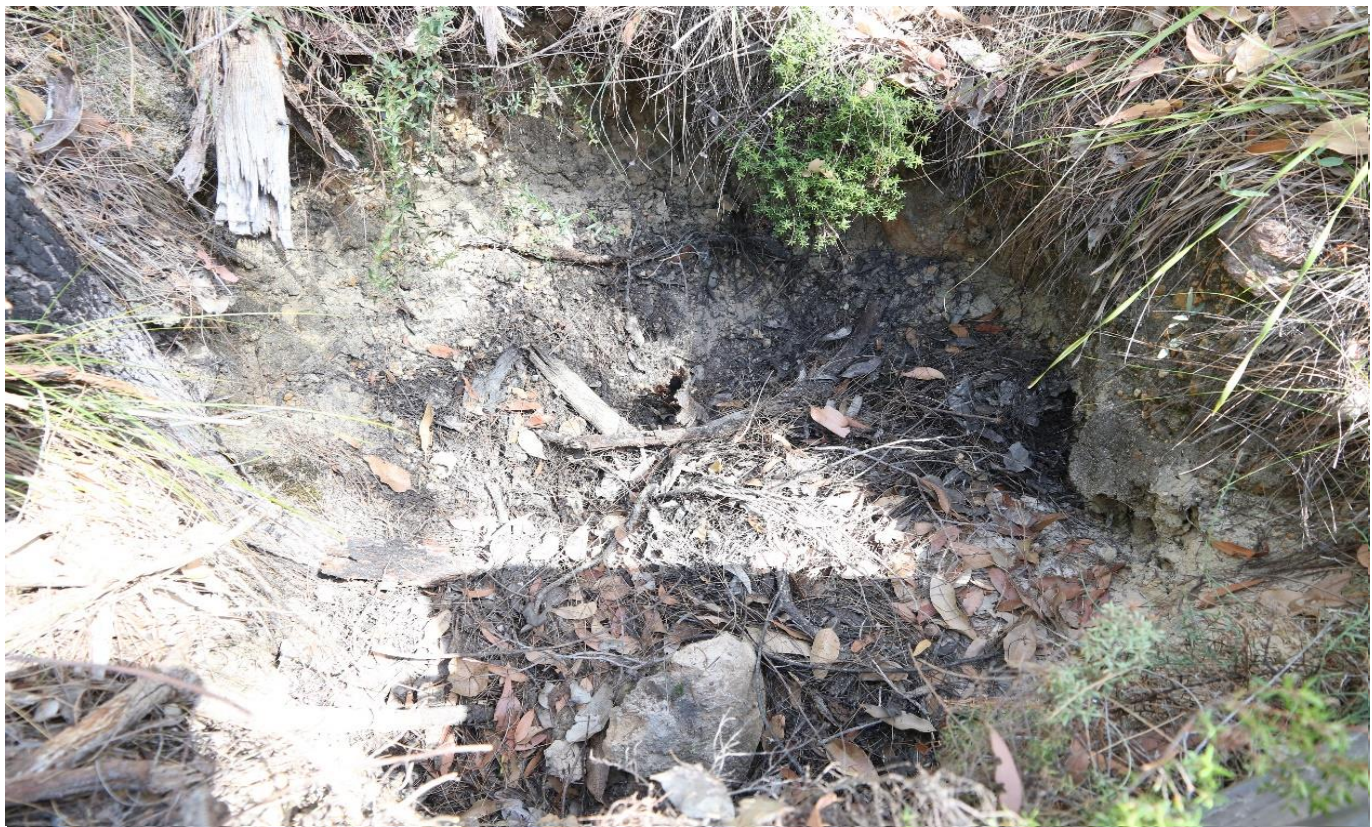
**Photograph 6: Feature 3 - base**

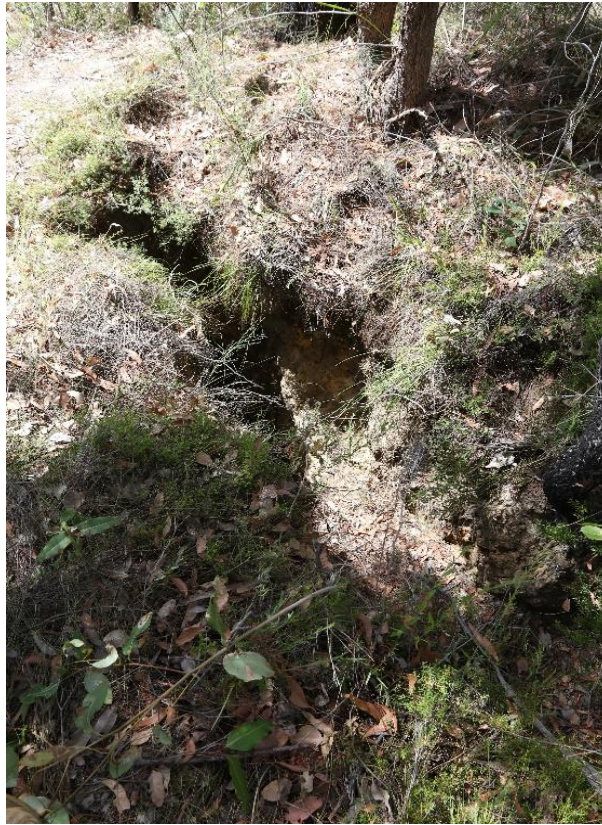
4	A trench excavation, approximately 7 m long with two depths: 1.5 m deep in the shallow western half and increasing to 3.3 m at the eastern extremity of the feature. A short horizontal continuation approximately 0.3 m to 0.5 m in length extends from the base of the 3.3 m deep section towards the track (to the east). Water was observed ponding in this continuation during a previous site inspection, suggesting no further continuation. The base appears natural and can support the weight of the 8 tonne excavator when bearing down on its bucket placed at the base of the feature. The side walls are near vertical and show no evidence of collapse.
5	A relatively square vertical shaft extending to 3.6 m depth. From the base of the shaft, an opening angles downwards in an easterly direction (bearing 110°). LiDAR captured data up to 4.6 m inside the angled opening, to a depth of approximately 10 m below ground surface. The lateral opening is on average 1 m wide. LiDAR data indicated a separation of approximately 7.5 m between the roof of the opening and the ground surface beneath the track. The side walls are near vertical and show no evidence of collapse.

**Photograph 7:** Feature 4

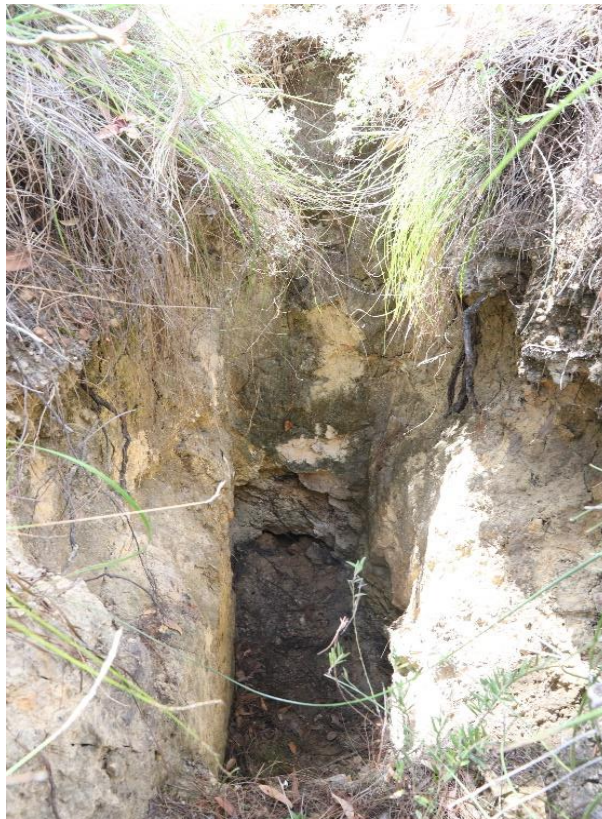
**Photograph 8:** Feature 4 - eastern face (deeper section of trench)

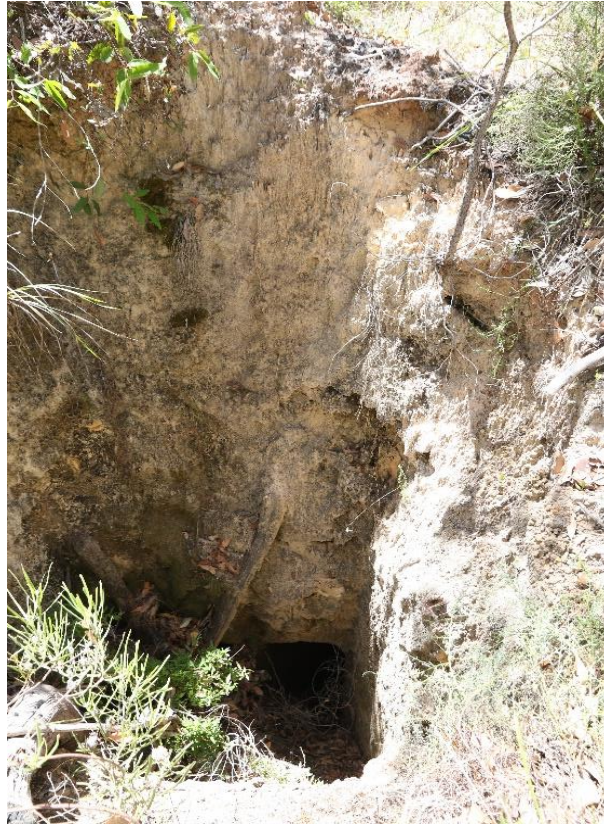
**Photograph 9:** Feature 5 - eastern face with visible lateral opening at base

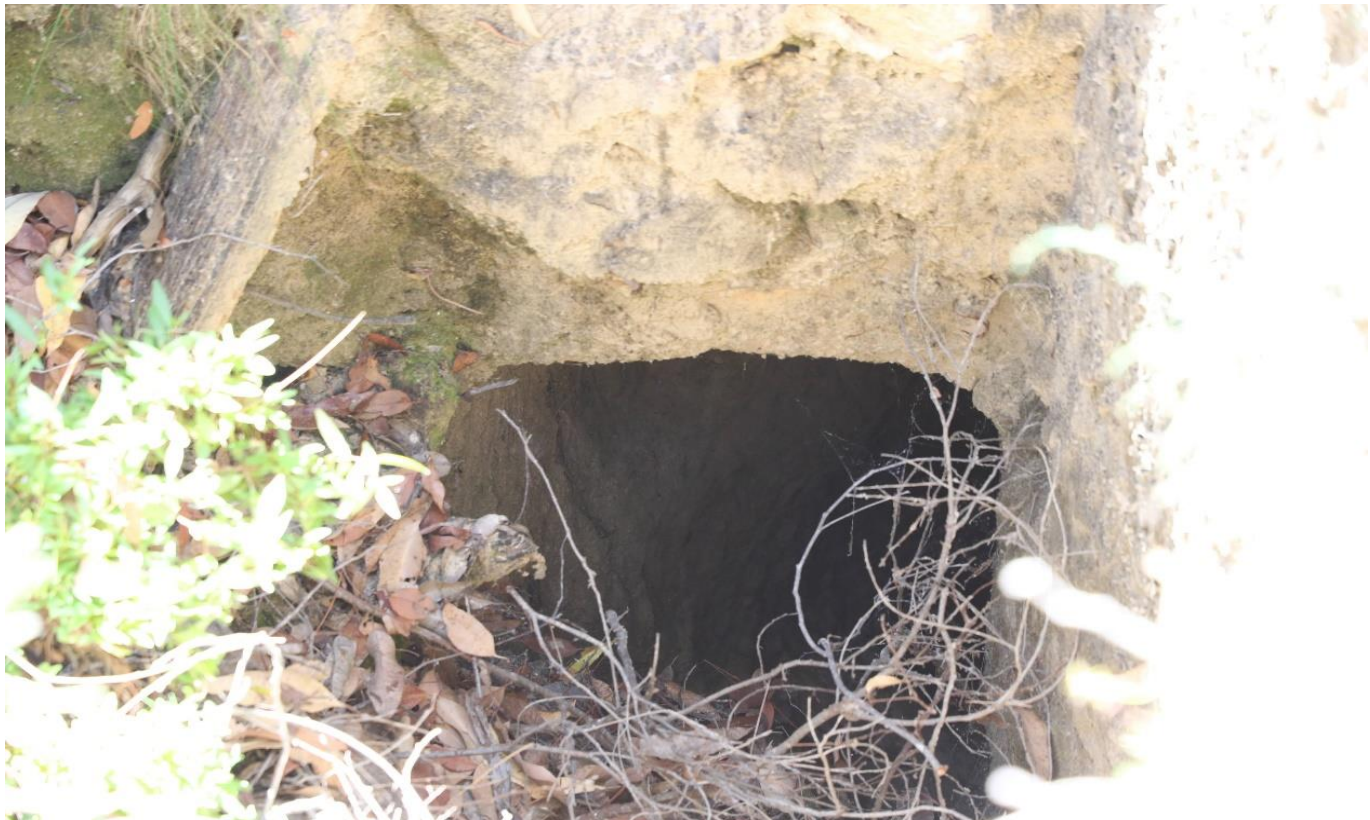
**Photograph 10:** Feature 5 - lateral opening

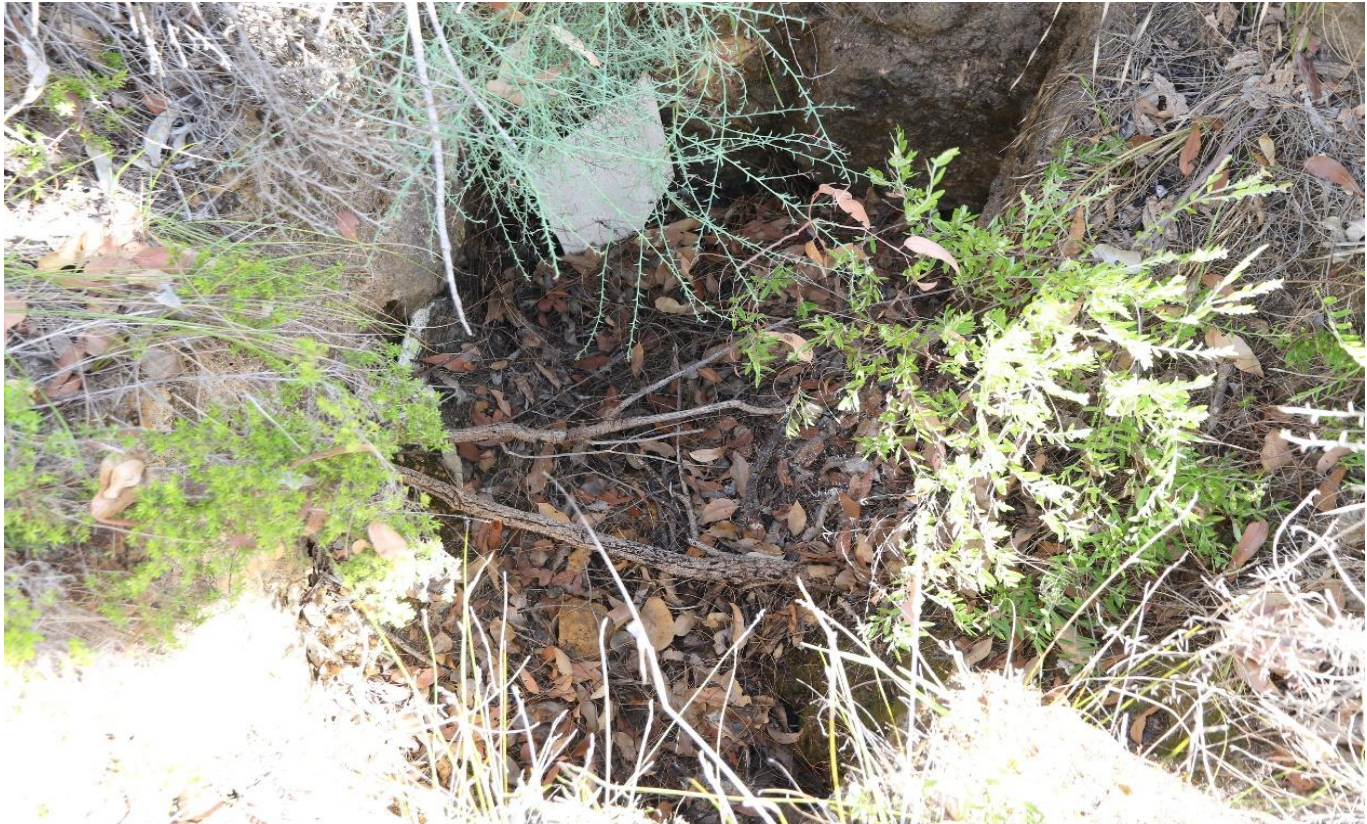
6	A roughly circular excavation with waste fill visible at a depth of 1.6 m. Placement of the excavator bucket on the fill compacted the material 0.3 m, indicating very loose backfill. A single bucket was excavated at this location due to the potentially asbestos containing material (PACM) encountered within the spoil excavated from Feature 6. Further assessment was abandoned during phase 1 for OH&S reasons. Phase 2 included pushing a 16 mm diameter steel rod ended with a 20 mm diameter cone (rod from a dynamic cone penetrometer) until refusal on what felt solid at a depth of 3.9 m, indicating that depth of this feature is possibly approximately 4 m, with a low level of confidence, although this depth would be consistent with several adjacent features. No horizontal openings were identified to the maximum depth of inspection (2.3 m).
7	This feature aligns with “No 1 Shaft” on the historical plan of the Queen of the South mine. It is a large depression that is potentially the pothole from a collapsed main shaft. It can similarly be hypothesised that this feature is a more recent excavation, using a large excavator for instance. During the investigation, excavation of the material from the base of the feature indicated some evidence of a filled/collapsed vertical shaft, of similar plan dimensions as Feature 8, within the southern part of the feature. Following further excavation in this part of the feature to about 4 m depth, tamping the base of the feature using the excavator bucket suggested competent ground. This further excavation also revealed a horizontal opening from near the base of the excavated feature on the southwestern side of the feature. The direction of the horizontal opening was difficult to assess from what could be exposed with the backhoe from the surface. The horizontal opening

**Photograph 11: Feature 6**

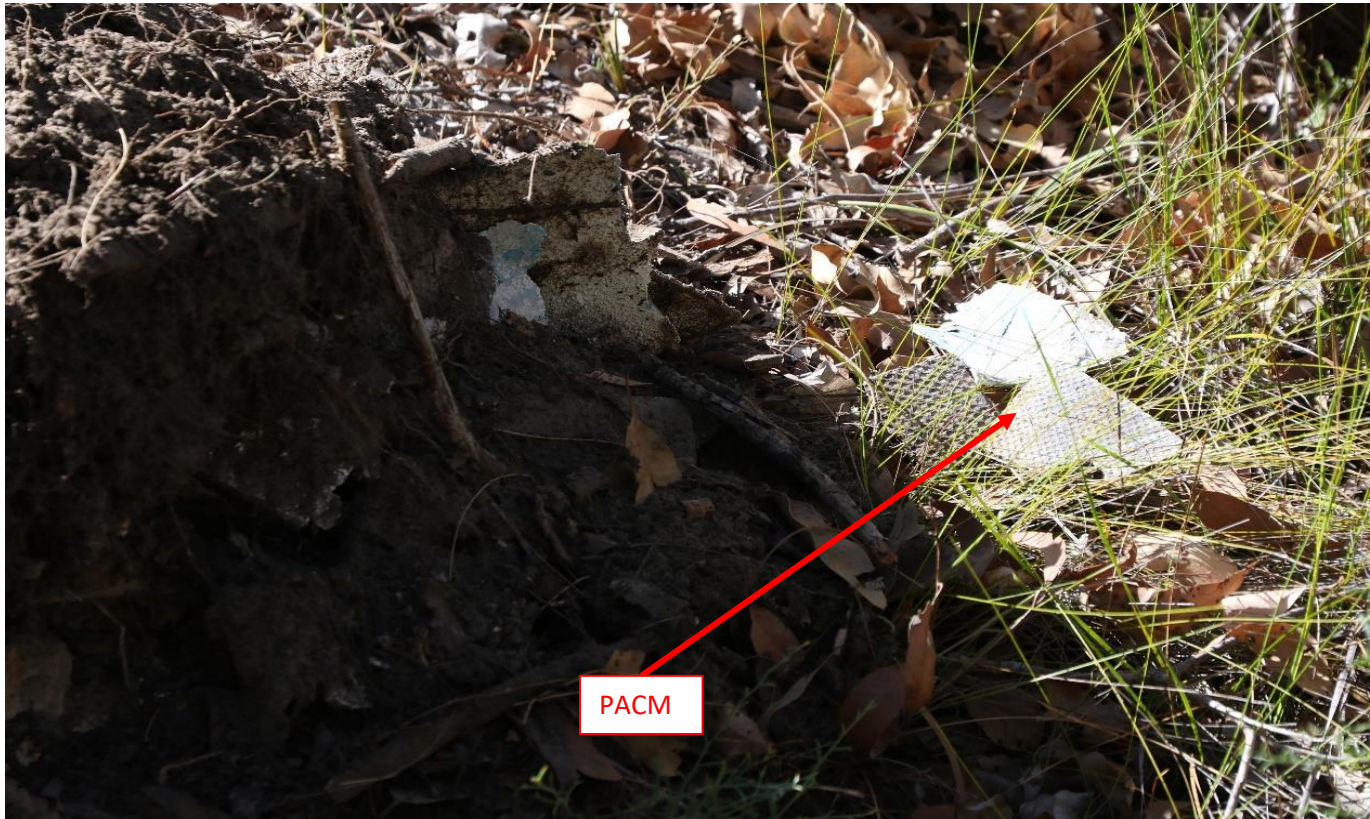
The condition of the base of Feature 6 is not known due to the PACM encountered within the hole, however based on the historical data and nature of the surrounding features, it is considered a reasonable assumption that this feature is an exploratory hole, similar to Feature 2.

**Photograph 12: Feature 6 - potentially asbestos containing material in spoil**

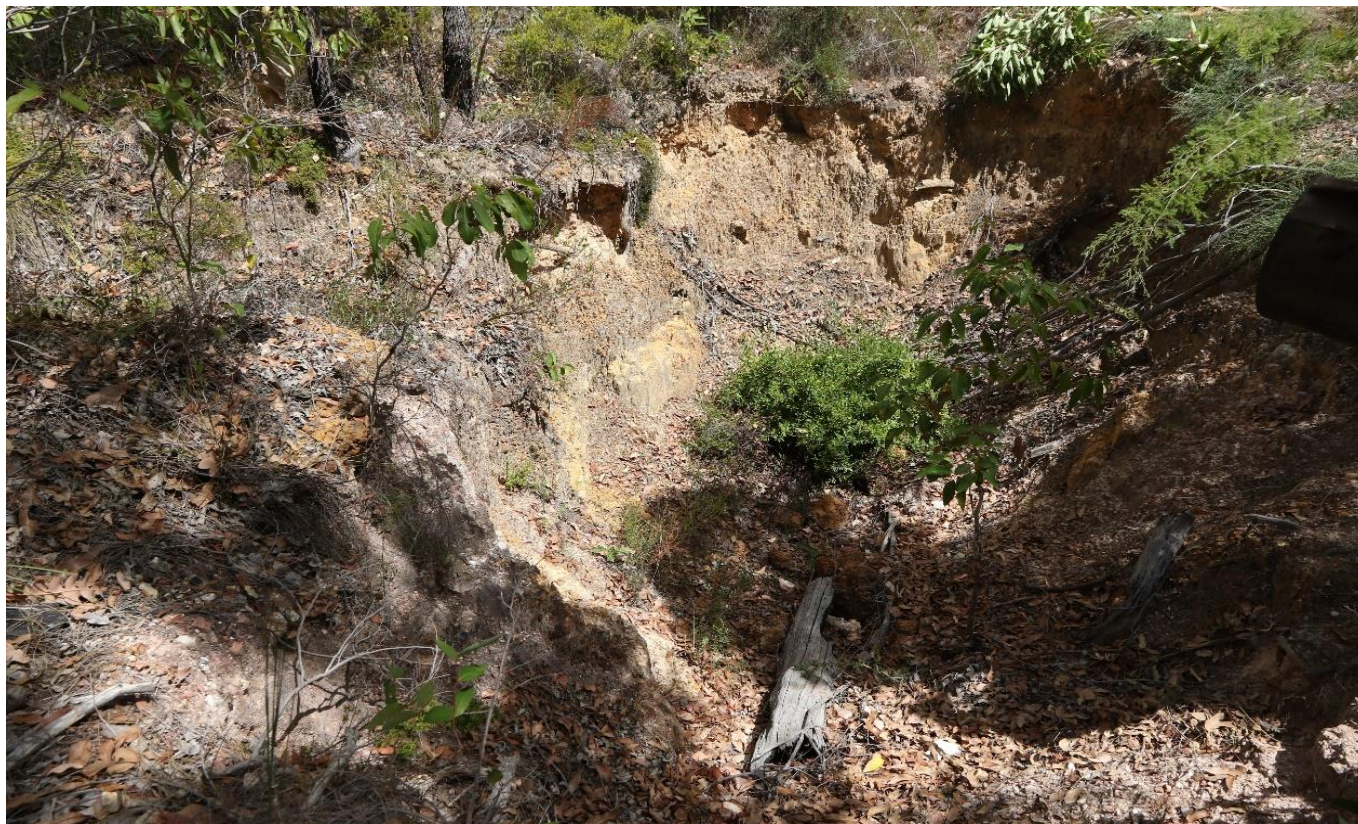
**Photograph 13:** Feature 7

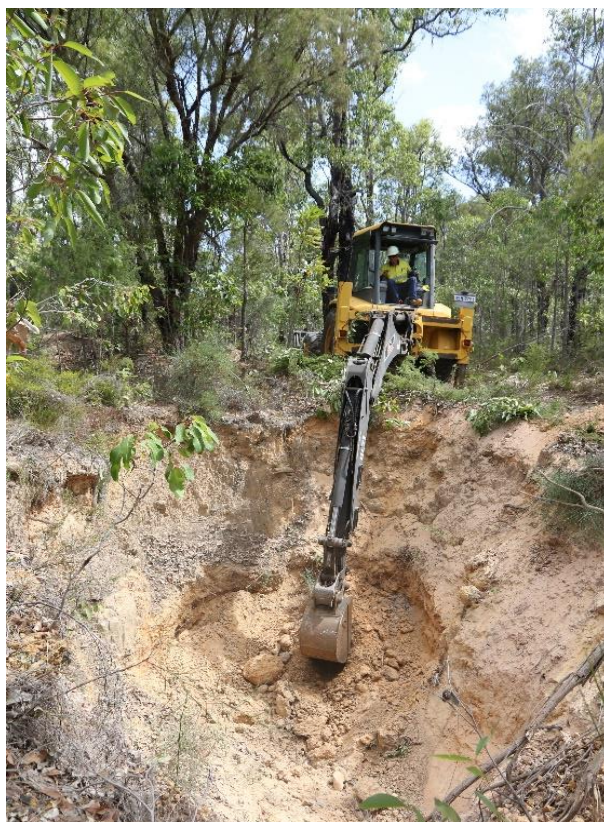
**Photograph 14:** Feature 7 - excavation of southern part

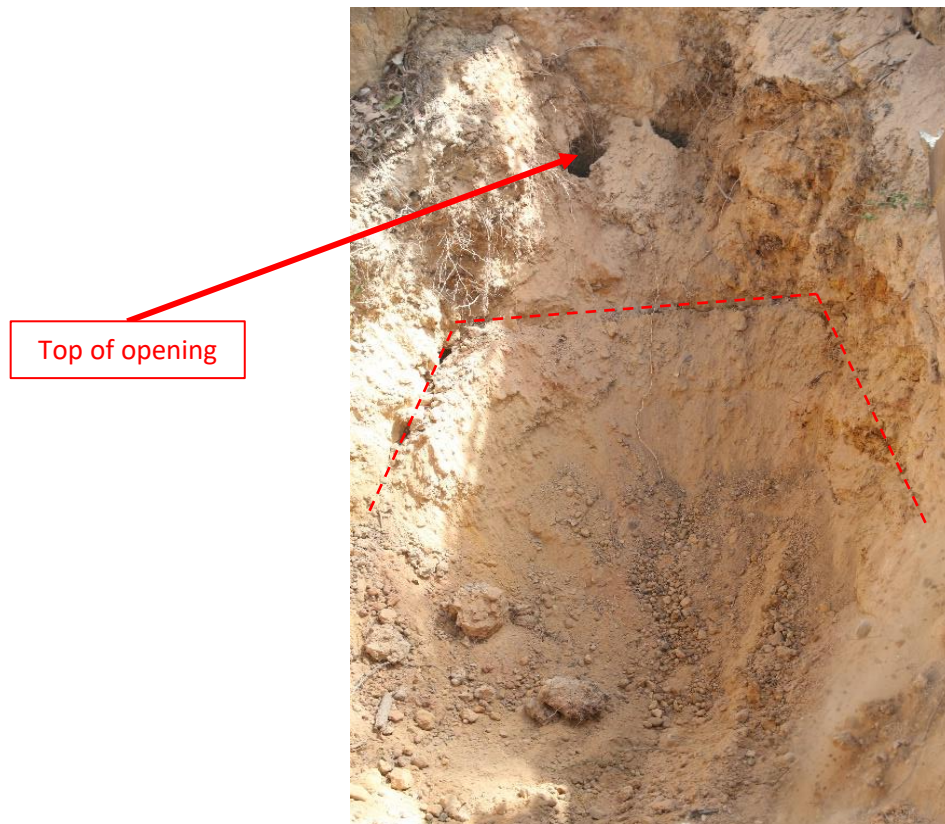
The location of Feature 7 suggests the potential for this feature to be associated with the No. 1 Shaft of the Queen of the South mine, however the investigation could not confidently ascertain that this is the case. Some evidence of a backfilled shaft was observed while excavating within the feature and at least one horizontal opening at a depth of approximately 3 m was identified. No evidence of shaft could be identified below the level of the horizontal opening, however, such evidence could have been masked during the investigation owing to disturbed soils by the investigation at the base of the feature and the maximum reach of the excavator limiting suitable exposure of the base. Assessment using the weight of the backhoe on its bucket pushed into the base at the potential shaft location indicated competent ground leading to the conclusion that this shaft might have ended at that depth or backfilled to approximately 4 m below the surface (i.e. the base of the Feature 7). Although speculation only but consistent field observations, the source of backfill was possibly the natural surficial soils immediately

**Photograph 15:** Feature 7 - possible evidence of backfilled shaft (red dotted line interpreted interface between backfill and natural ground)

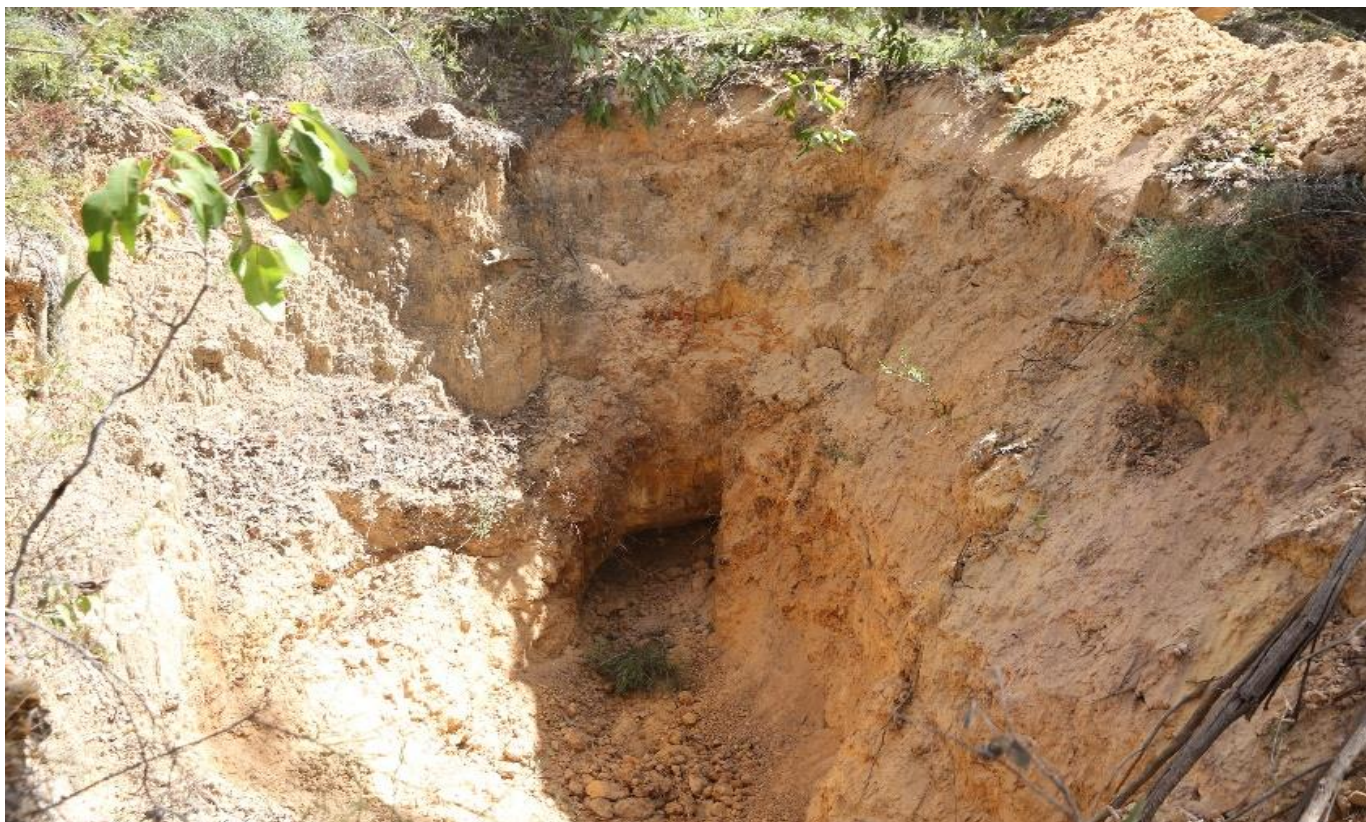
**Photograph 16:** Feature 7 - opening exposed following excavation

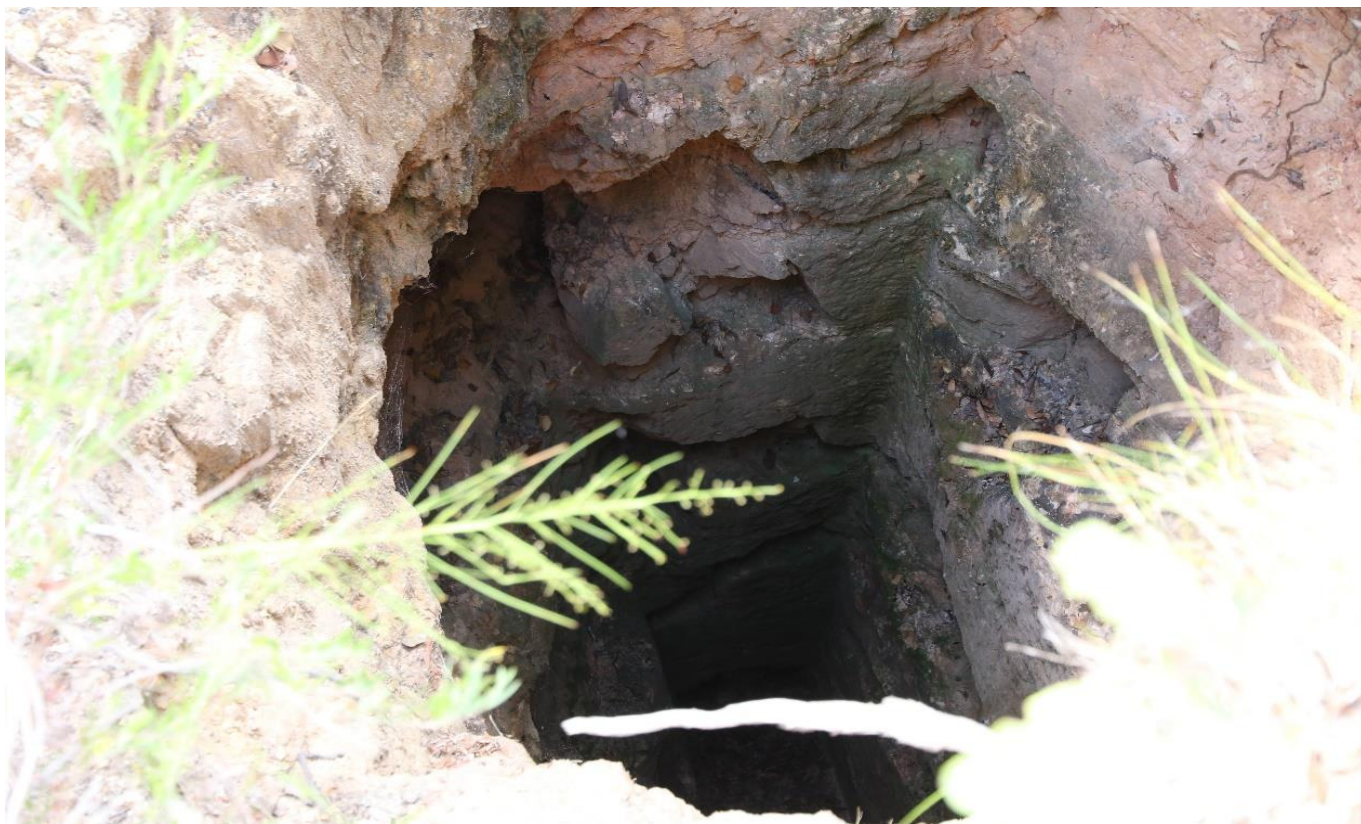
**Photograph 17:** Feature 8 - northern face

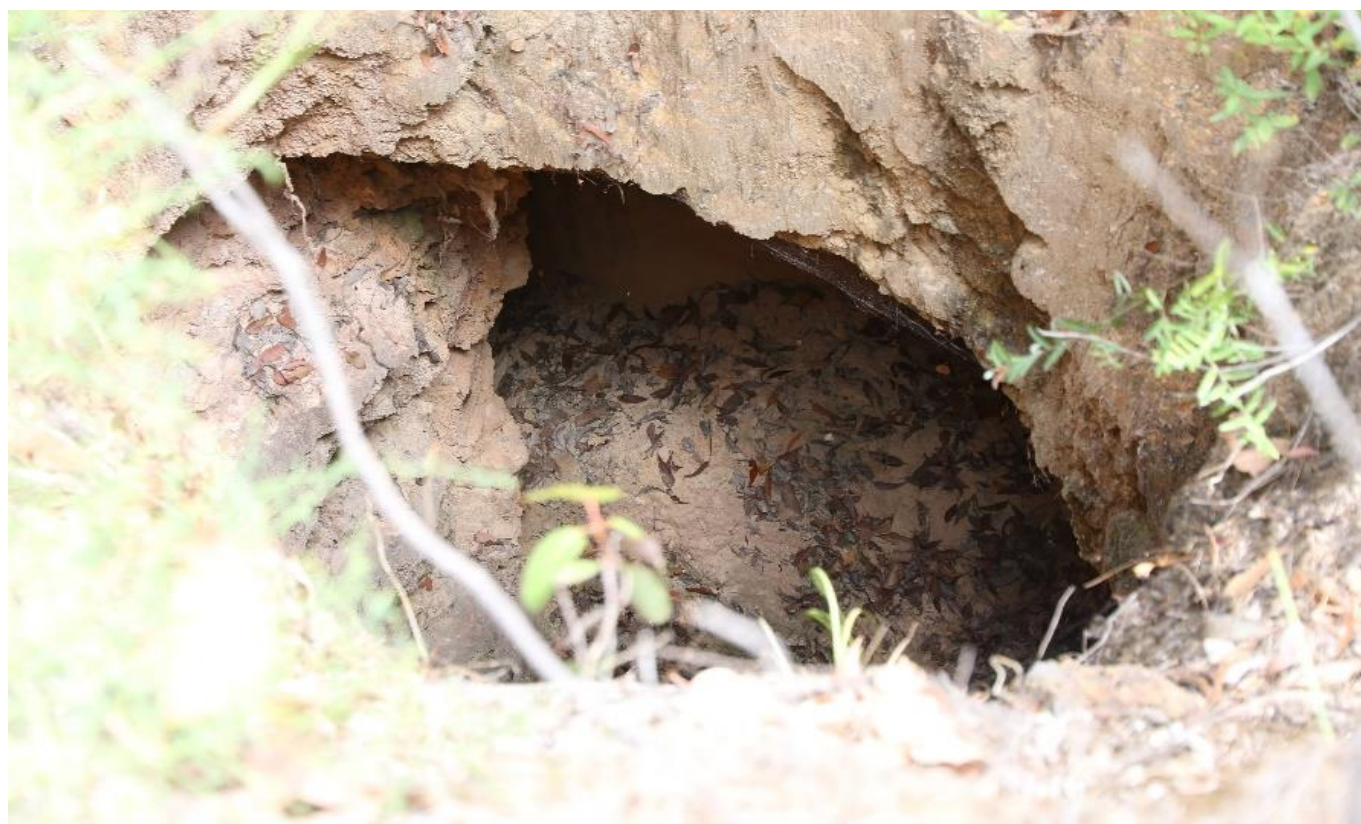
**Photograph 18:** Feature 8 - opening on western face approximately 6 m depth

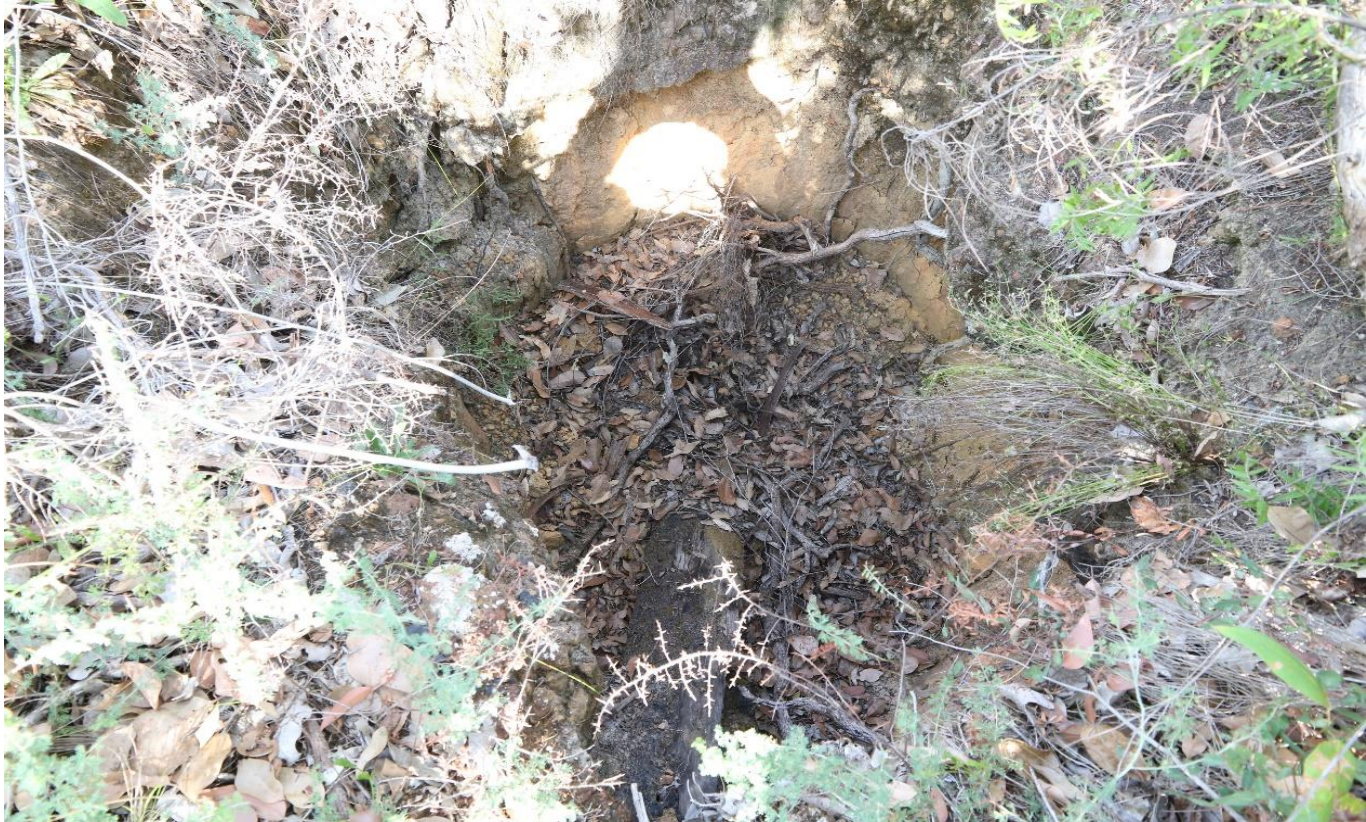
9	A roughly circular hole, 2.1 m deep. Following removal of forest debris collected at the base, natural material was observed at the base. The base could support the weight of the 8 tonne excavator when bearing on its bucket. No horizontal openings were identified.
10	A hole approximately 3.7 m in diameter and 1.6 m deep. Following excavation of approximately 0.6 m of collapsed material from the base of the hole, approximately 0.3 m of natural material was exposed. The base could support the weight of the 8 tonne excavator when bearing on its bucket.

**Photograph 19: Feature 9**

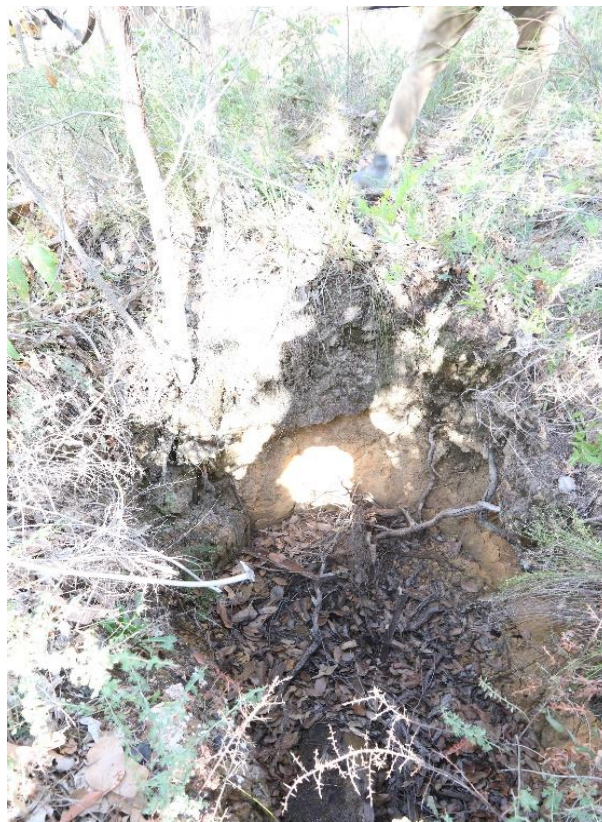
**Photograph 20: Feature 9**

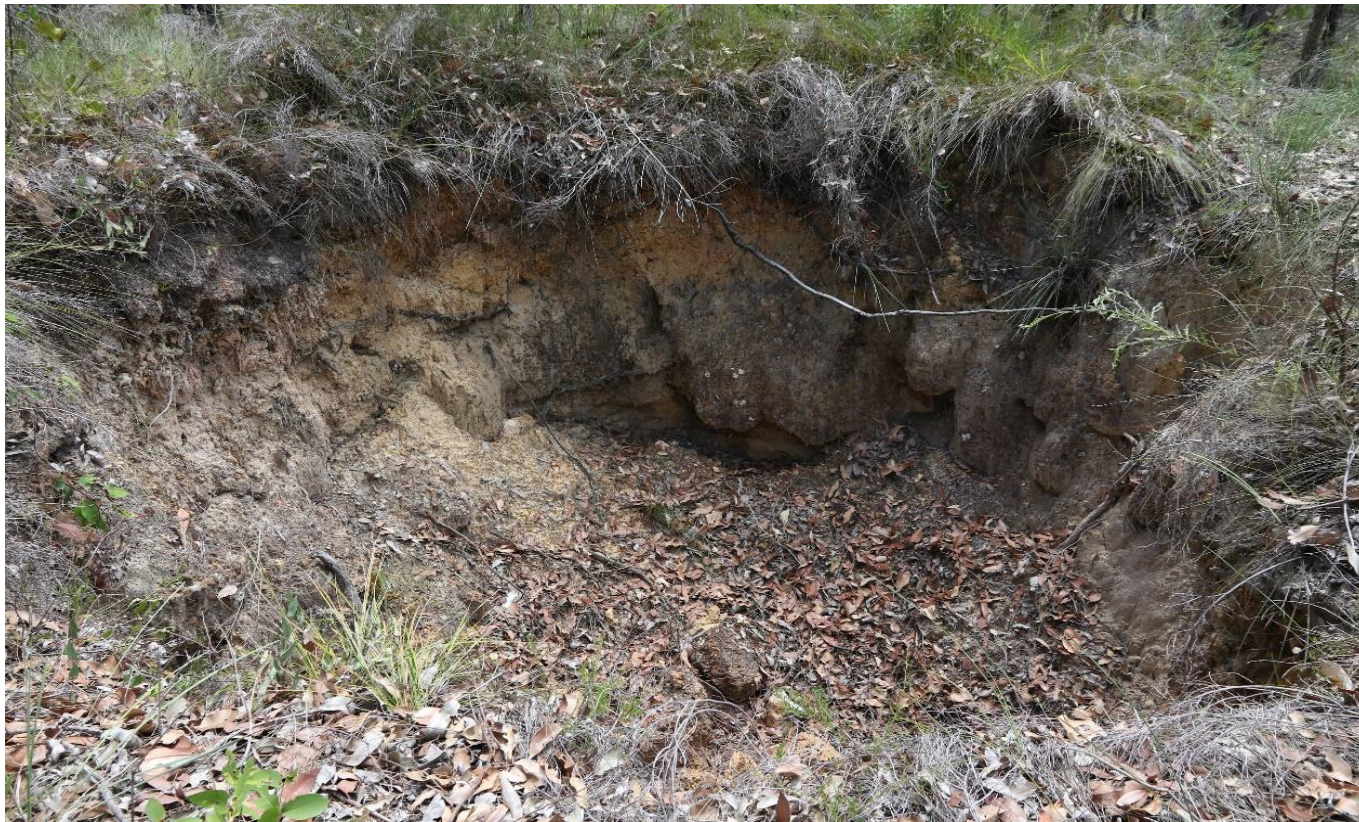
**Photograph 21:** Feature 10

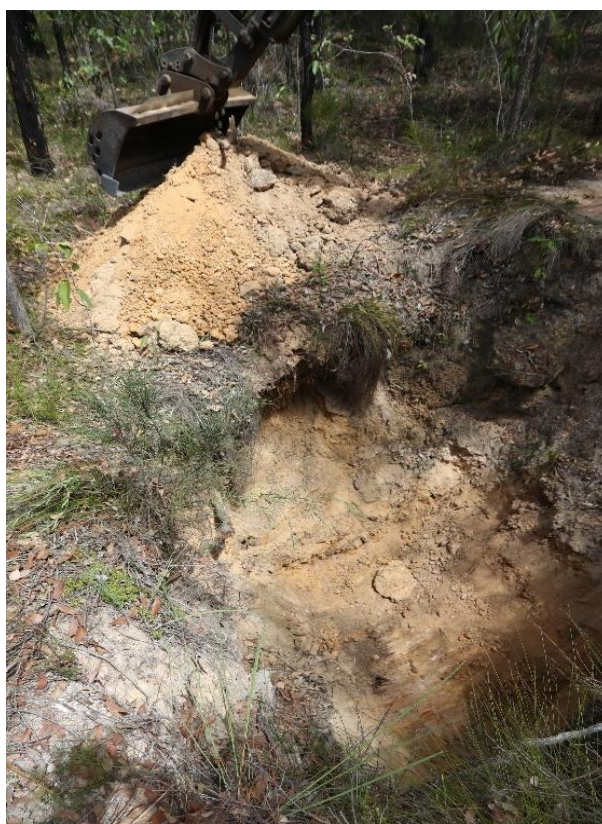
**Photograph 22:** Feature 10 - after excavation

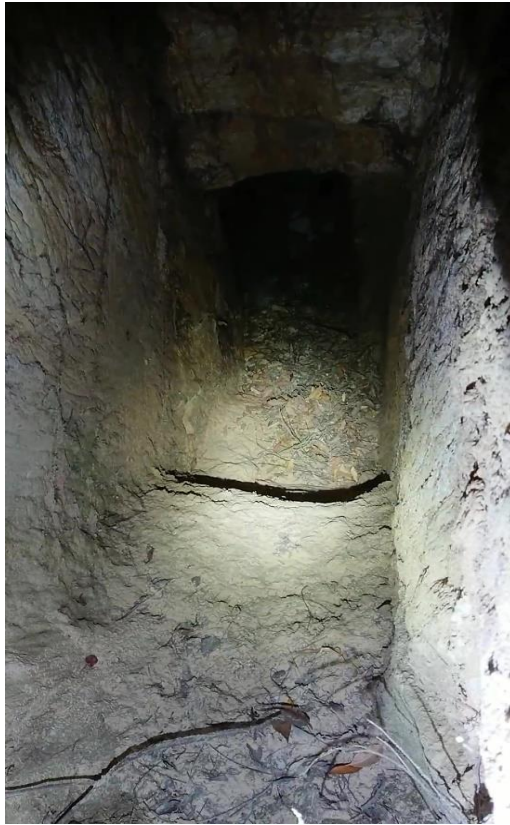
**Photograph 23:** Feature 5 lateral working - approximate bearing 110°

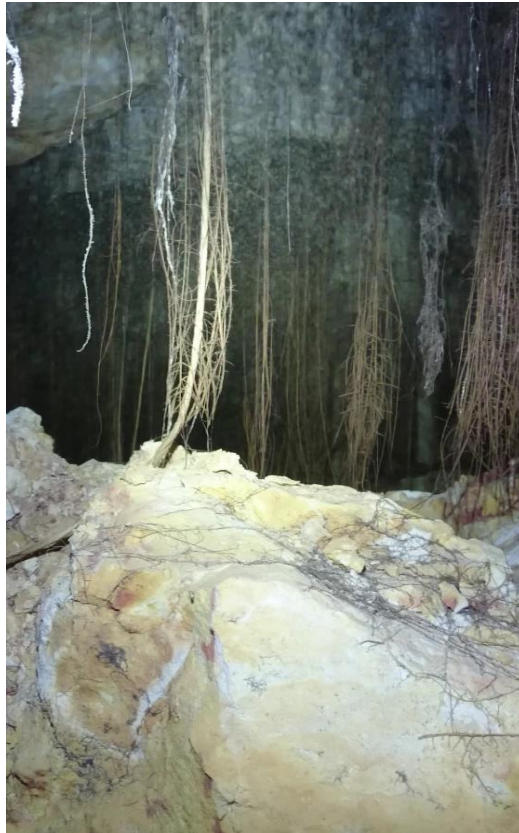
**Photograph 25:** Within borehole F7-4 - approximate bearing 250°

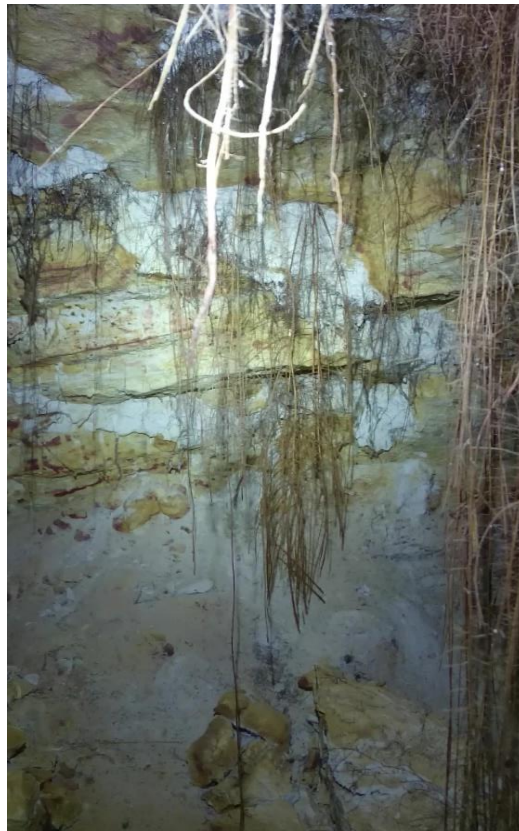
**Photograph 26:** Within borehole F7-4 - northern wall
