Report on  
Geotechnical Investigation

Donnybrook Mine Shaft Condition  
Lot F27 Goodwood Road, Upper Capel

Prepared for  
Department of Mines, Industry Regulation & Safety

Project 96721.00  
June 2021

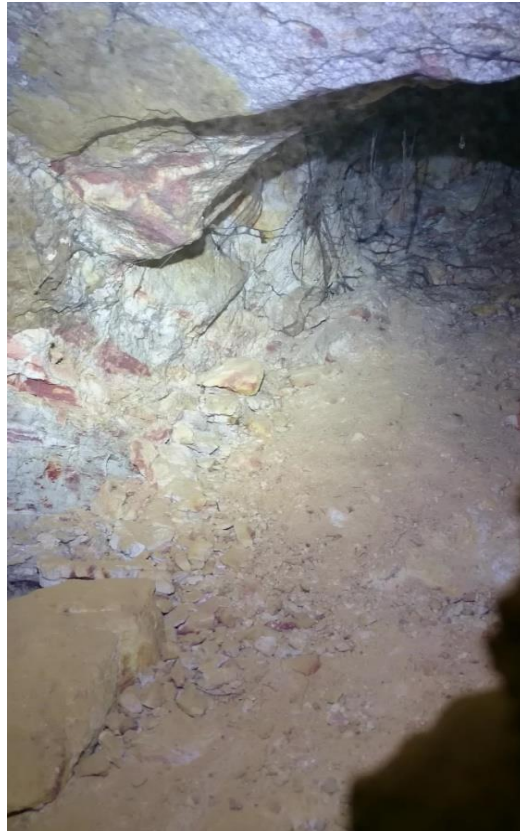
**Photograph 27:** Within borehole F8-1 - approximate bearing 245°

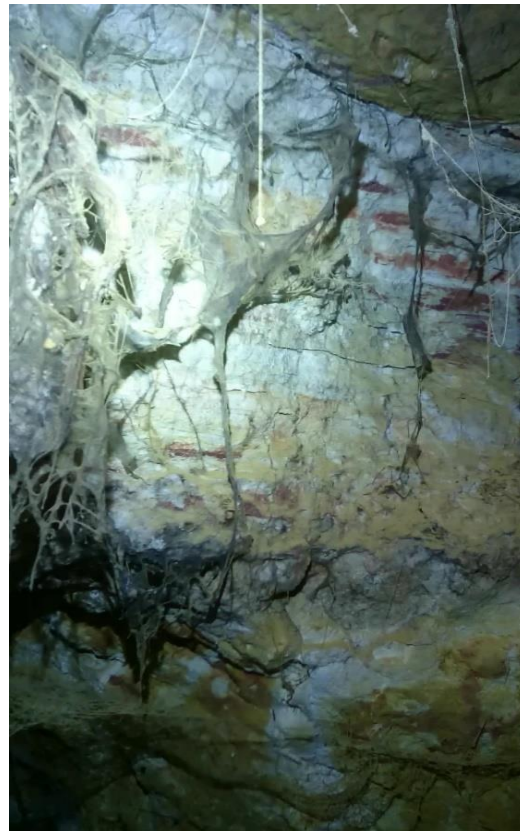
**Photograph 28:** Within borehole F8-1 - northern wall
