Report on Shaft Condition Assessment

**Reids Ridge Abandoned Mine Site
(Commodore and Reids North)**

Yalgoo-Ninghan Road, Paynes Find WA

Project 224768.00

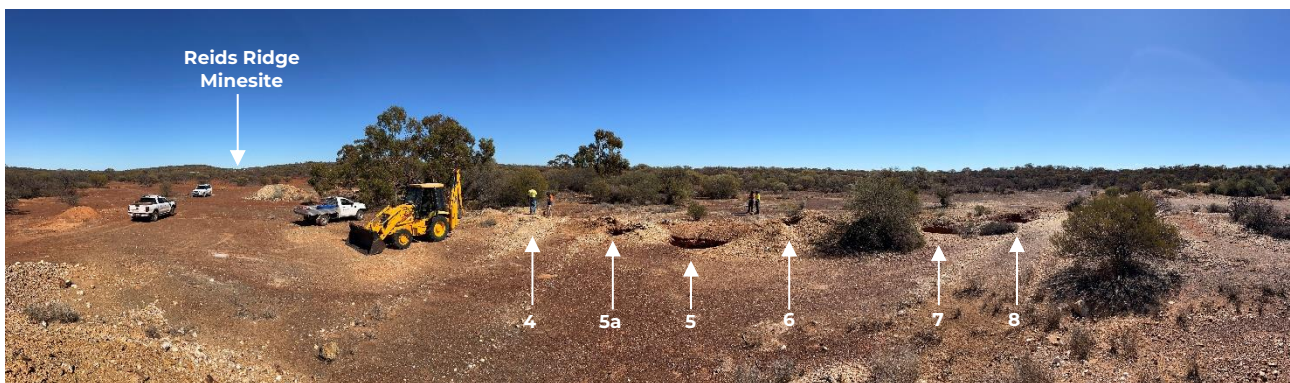
Figure 1: Commodore mining area (facing southwest – Features 4 to 8 visible)

A natural drainage line likely flowing intermittently intersects the line of features. Evidence of erosion and sediment transport towards and into some of the features, specifically into Features 4, 4a, 8 and 9, were noted during the 2024 field investigation by Douglas. Surface water possibly also intermittently enter Feature 11c, based on field observations.

Relatively shallow underground lateral workings were observed linking Features 5a-5-6 and Features 7-8-9. Field observations and their absence on a plan from 1985 (Carbon Gold Pty Ltd, 1985) suggest that the present Features 5 and 8 result from the likely collapse (or possible excavation) of shallow horizontal workings roof, sometimes between 1985 and present.

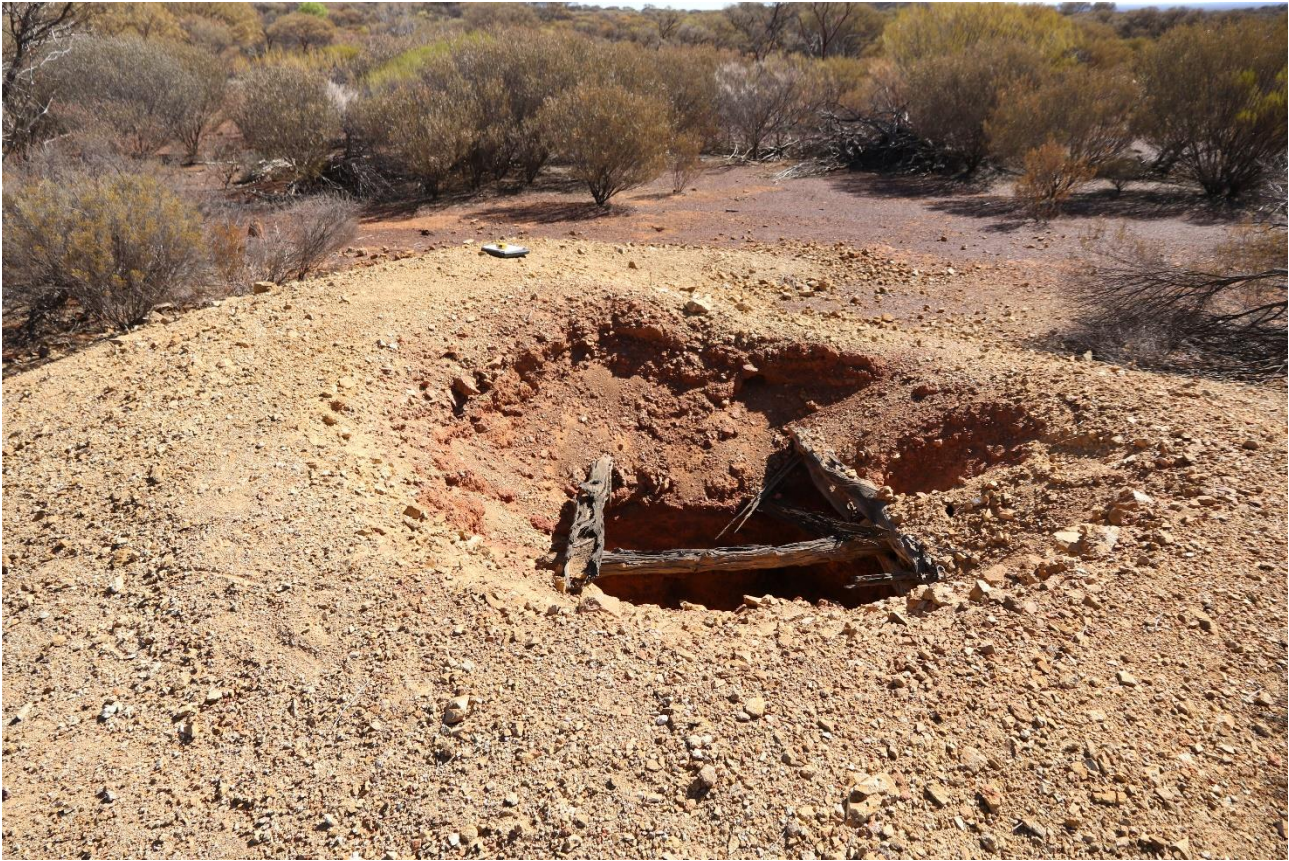
Figure 2: Reids North area. Feature 17 facing northwest.

The features are mostly shallow, vertical with observed depths ranging between 1 m and about 4 m. Each feature appears independent from another (ie with no evidence of lateral connections) nor was there any clear relationship between the feature locations. Some limited lateral continuation, further described in Section 4.1.1, can be seen at the base of Feature 14.

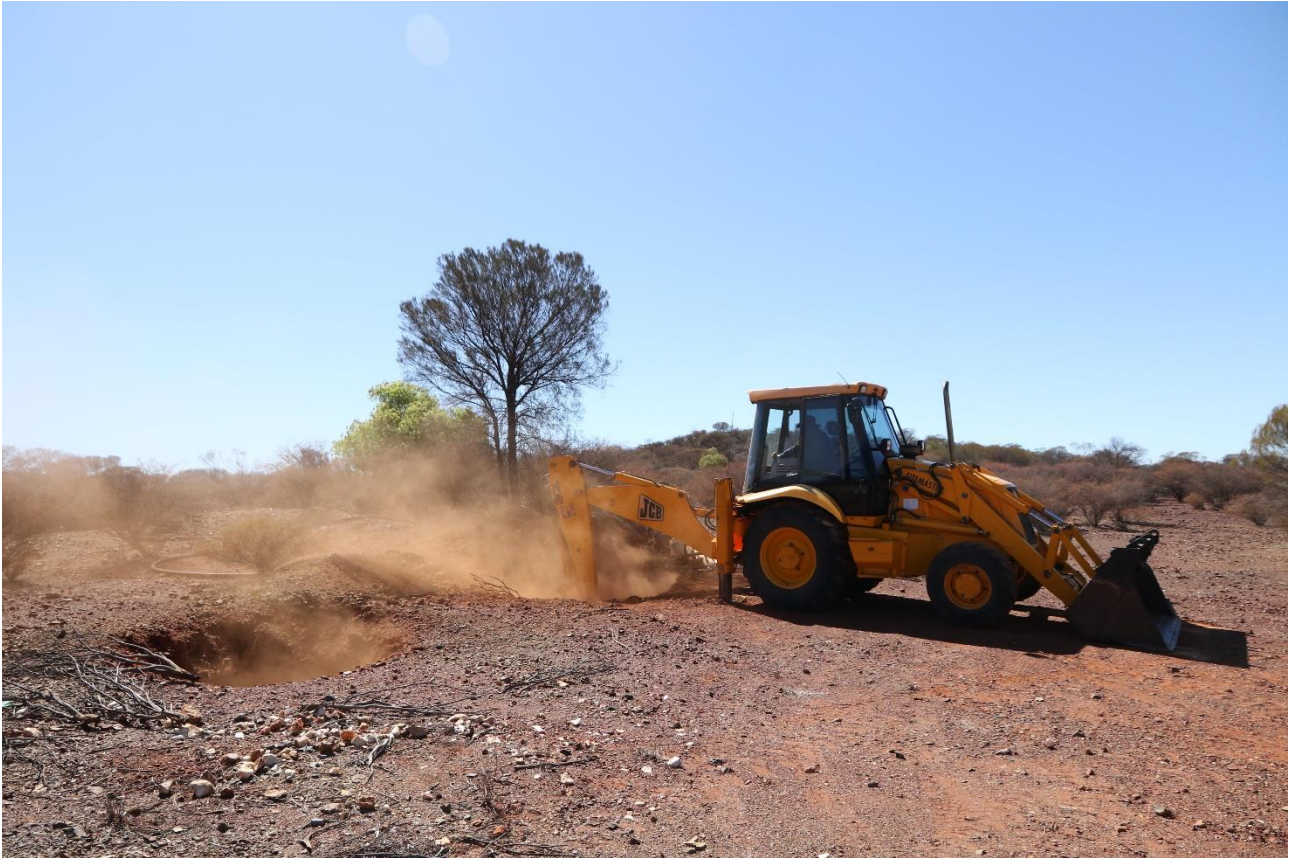
Figure 3: Features 20, 21 and 22 (facing north - excavation in progress within Feature 21)

At the time of the investigation, the three features and lateral workings were backfilled with rubbish, mostly to a level approximately 2.5 m below the natural surface, in turn preventing significant observation or measurement of these workings at greater depths. The visible base of these features at the time of the field work was up to 8 m, noting however that various desktop information suggests deeper historical shafts and lateral workings at this location, including an interpreted backfilled stope or shaft intercepted during exploration drilling at 23 m depth beneath the feature footprints.

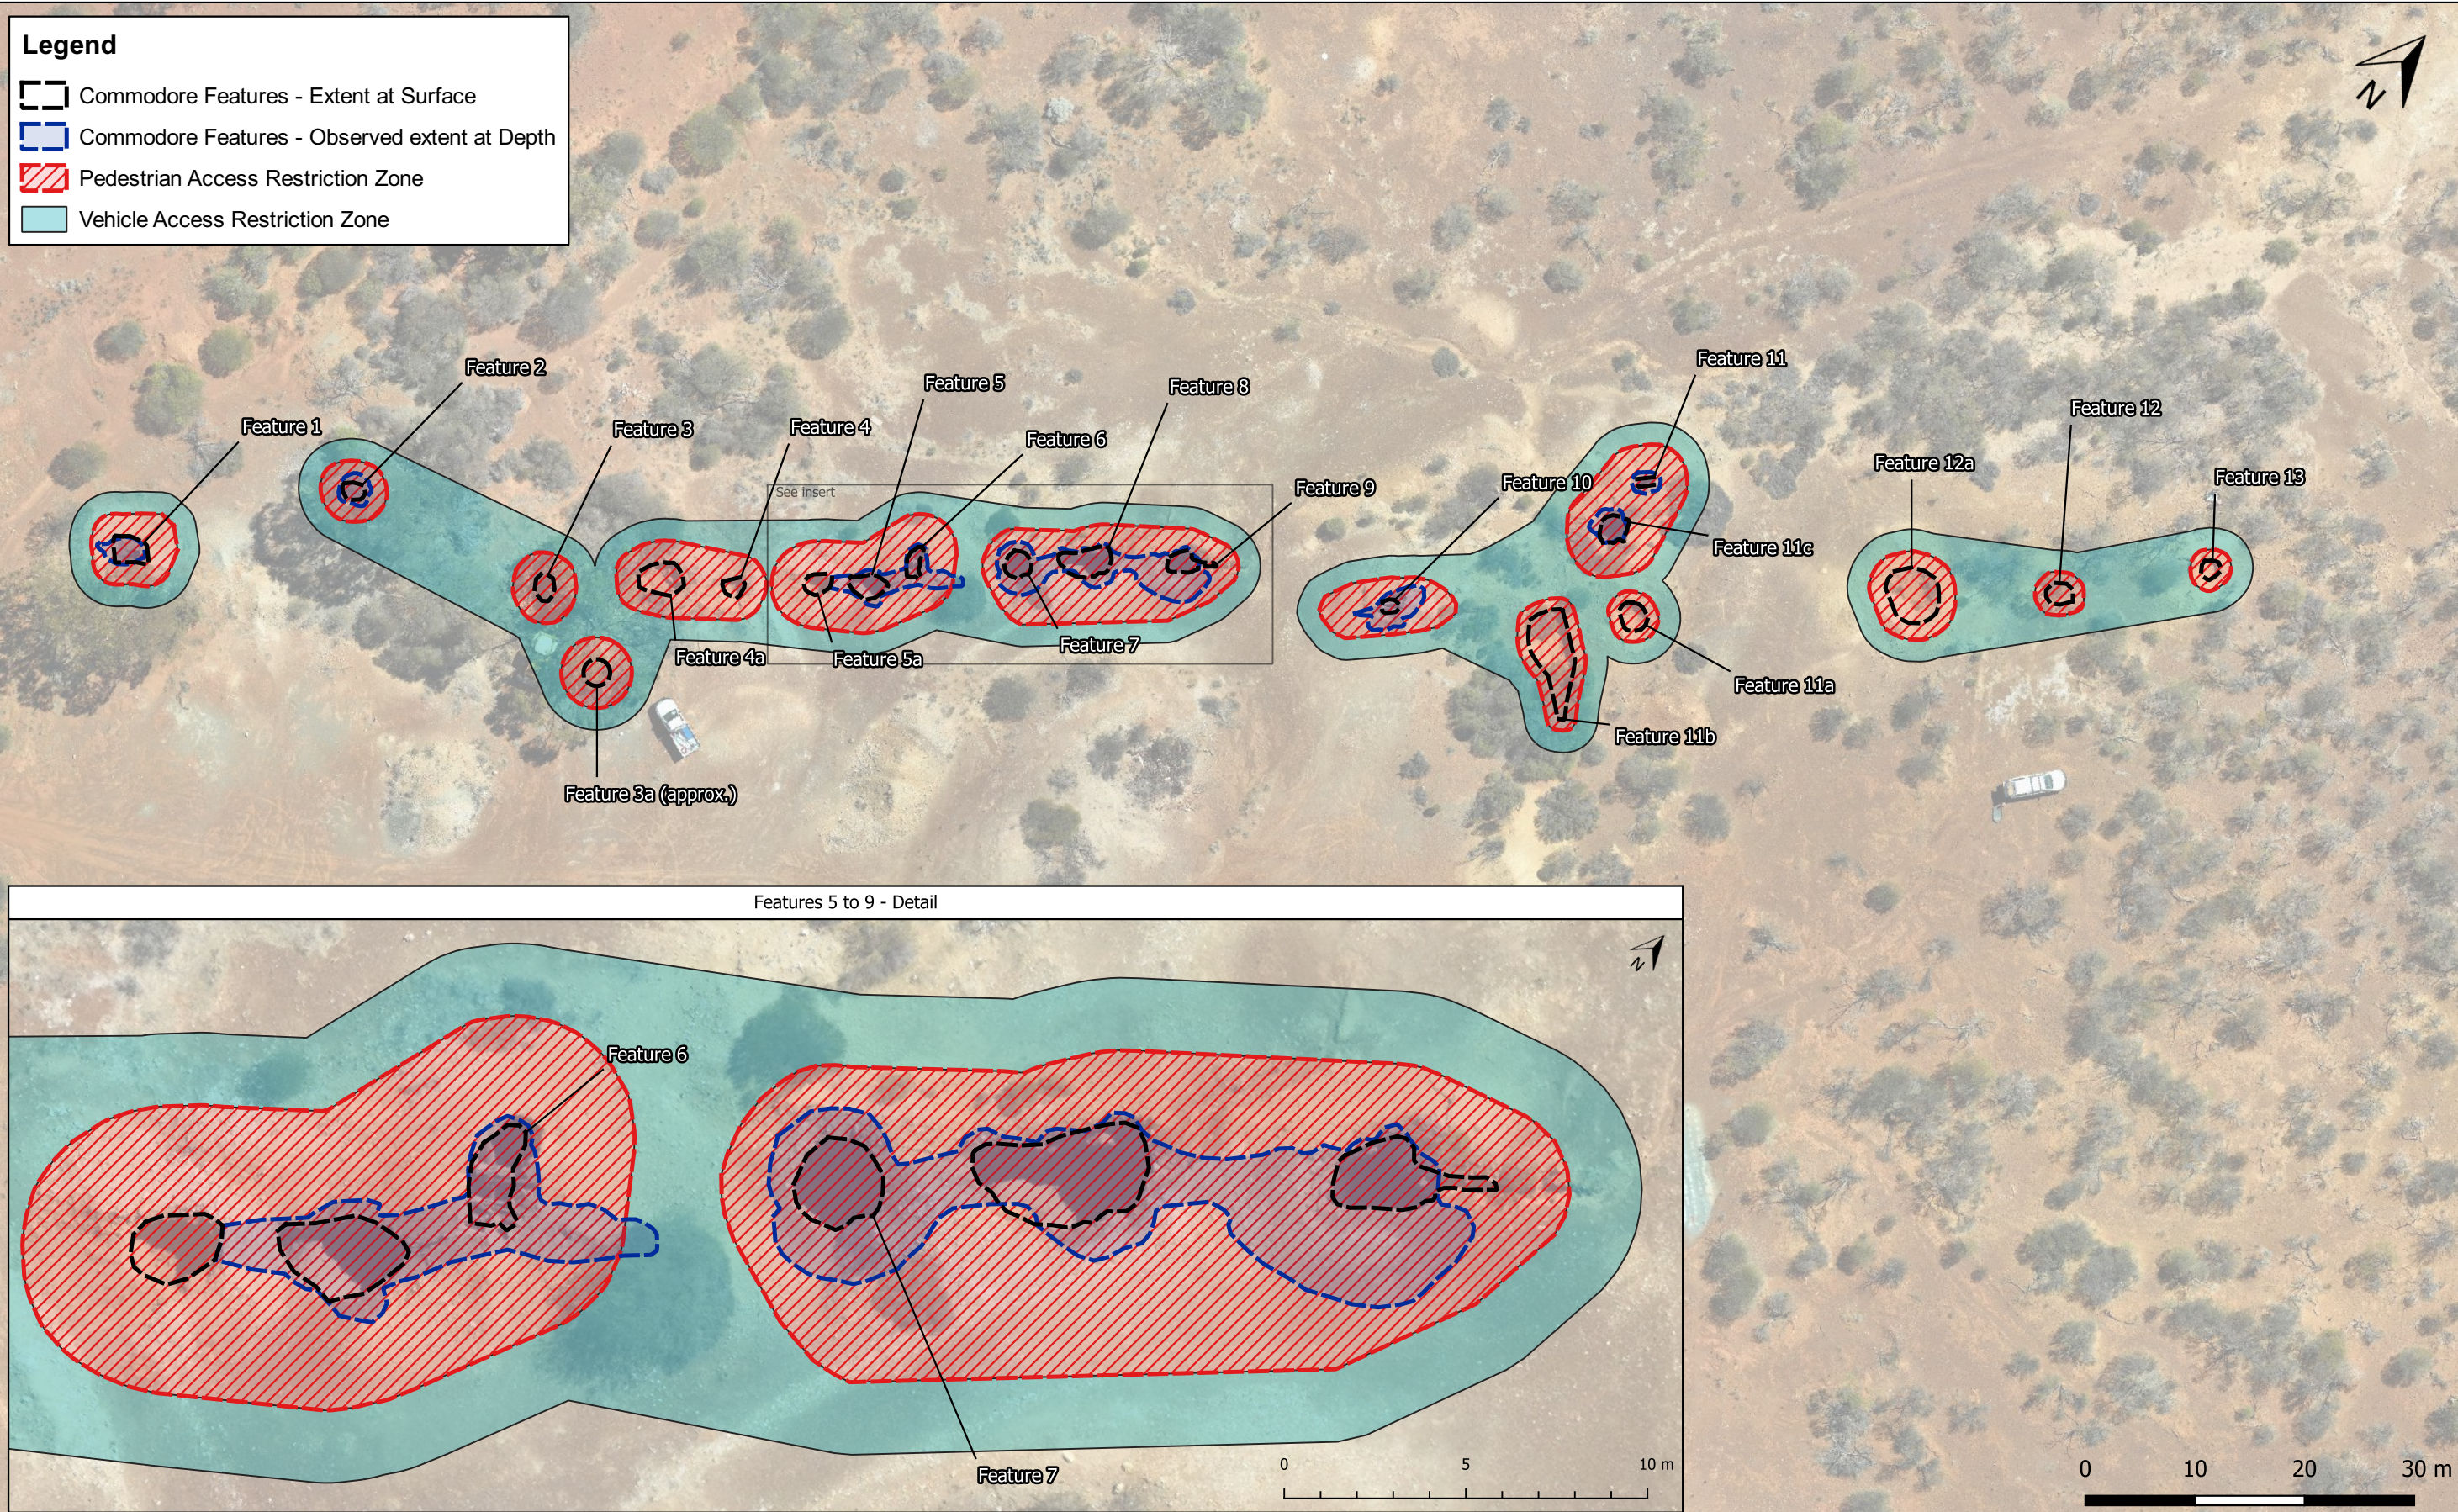
Commodore Features
Pedestrian and Vehicle Access Restriction Zones (refer to Sections 4.1.1 to 4.4.4 in Report)
Reids Ridge Abandoned Mine Site (Commodore and Reids North)

Observed scouring of some edges of these features (specifically 8 and 9) indicates that surface water occasionally flows into these features, which favours a future extension of the ground instability zone over time. It is suggested to assume that the zone of ground instability around these features could grow by say 1 m to 2 m every 5 years, largely depending on the intensity of rain events over the period.

This relatively deep feature shows evidence of wall instability, and therefore a clearance of 3 m is recommended from its opening, in most direction, extended to 4 m to the south. The ground beyond this zone is considered stable for pedestrian traffic.

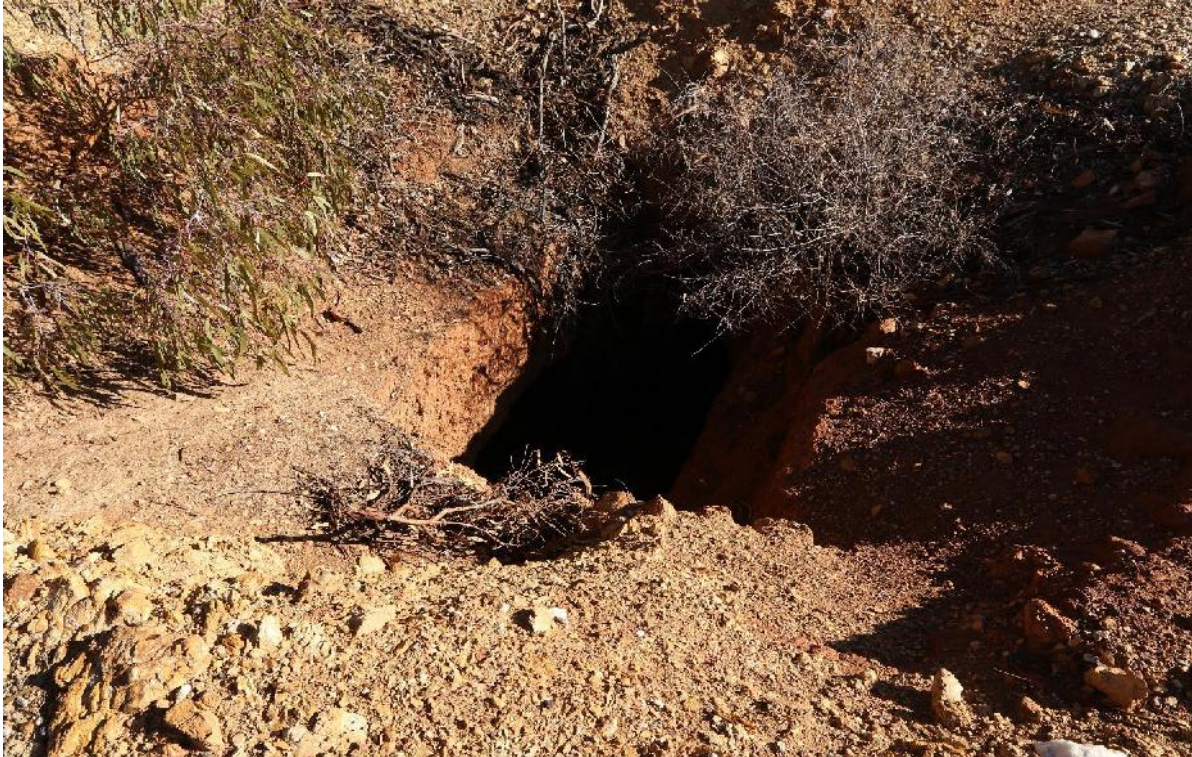
Photograph 1: Feature 1 at surface

A 16 m deep vertical shaft, 1.0 m x 1.5 m in plan view, mostly free of timbering reinforcement inside other than occasional stulls and a timber structure constructed on the northern wall of the shaft at the base. The purpose of the structure is not clear, however it appears to be retaining cobble sized rocks. No lateral working or interconnectivity with other features is visible. The original timber collar at ground surface has mostly decayed and collapsed, leaving a few remnant timbers in poor condition.

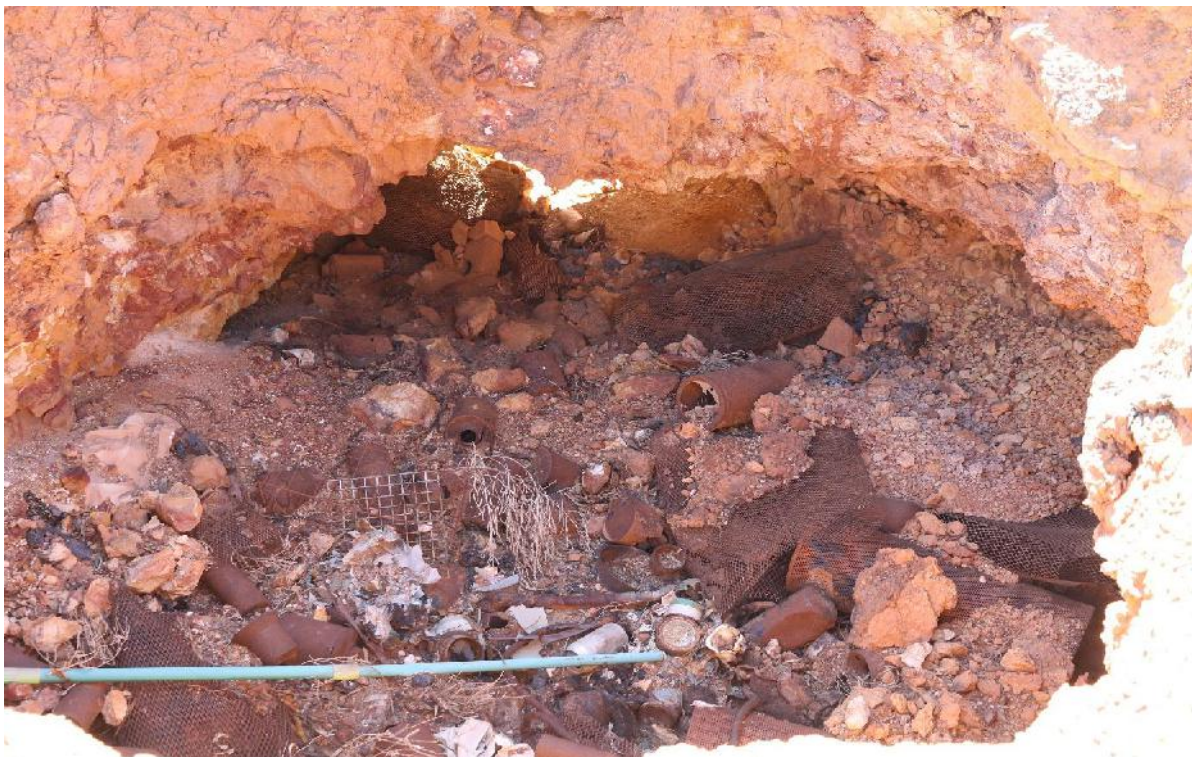
Photograph 12: Feature 5a, looking north showing link to Feature 5

A 1.9 m x 2.5 m wide, 2.0 m deep shaft, partially backfilled with refuse including burnt material, glass, tins, cardboard, plastic, rope brick and machine parts. A 1.2 m wide lateral working on the northern side links to Feature 5. LiDAR data and visual observation indicates that the roof of the lateral working is approximately 1.5 m thick.

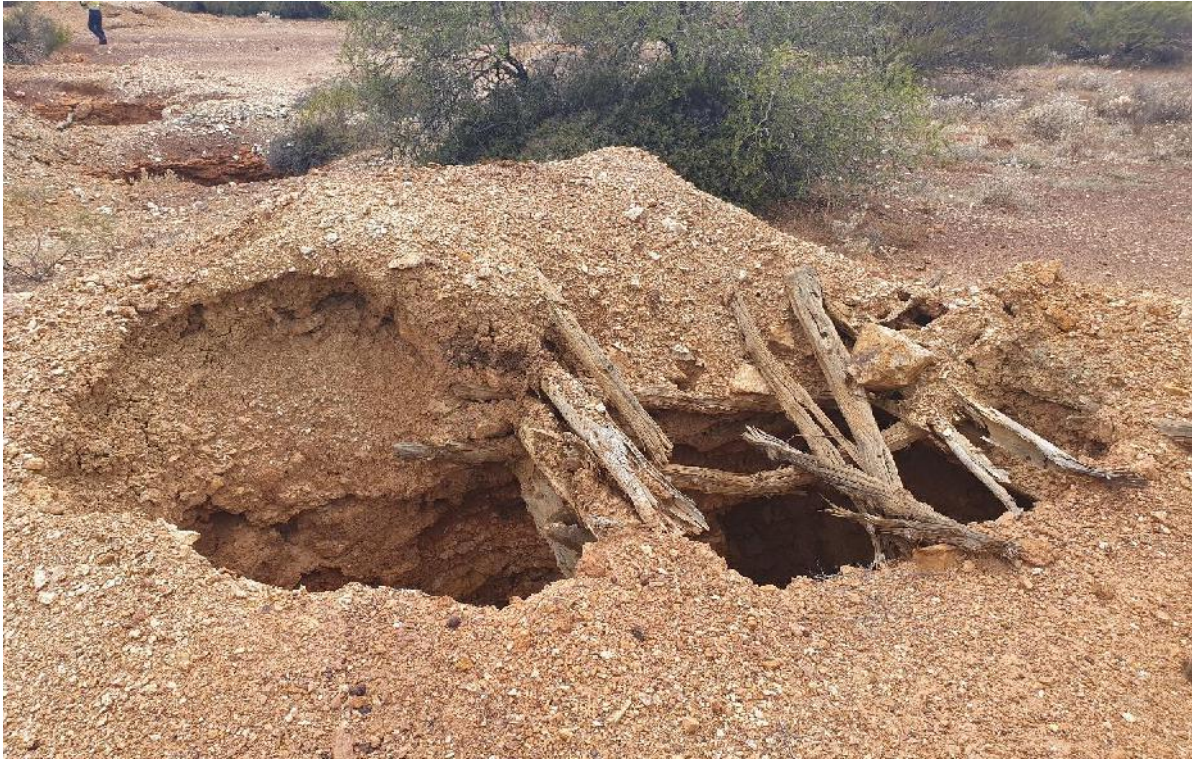
Photograph 15: Feature 6

A 1.2 m x 3.2 m at surface, narrowing to 0.6 m x 1.7 m, 5.3 m deep vertical shaft, with some dilapidated remnants of a timber shaft collar. Lateral working, 1.7 m wide and approximately 1.5 m in height on the southern side links to the base of Feature 5 to a point near the base of Feature 6, and a lateral working was observed to extend 3.9 m north from the base of the shaft, deepening the excavation an extra 0.9 m.

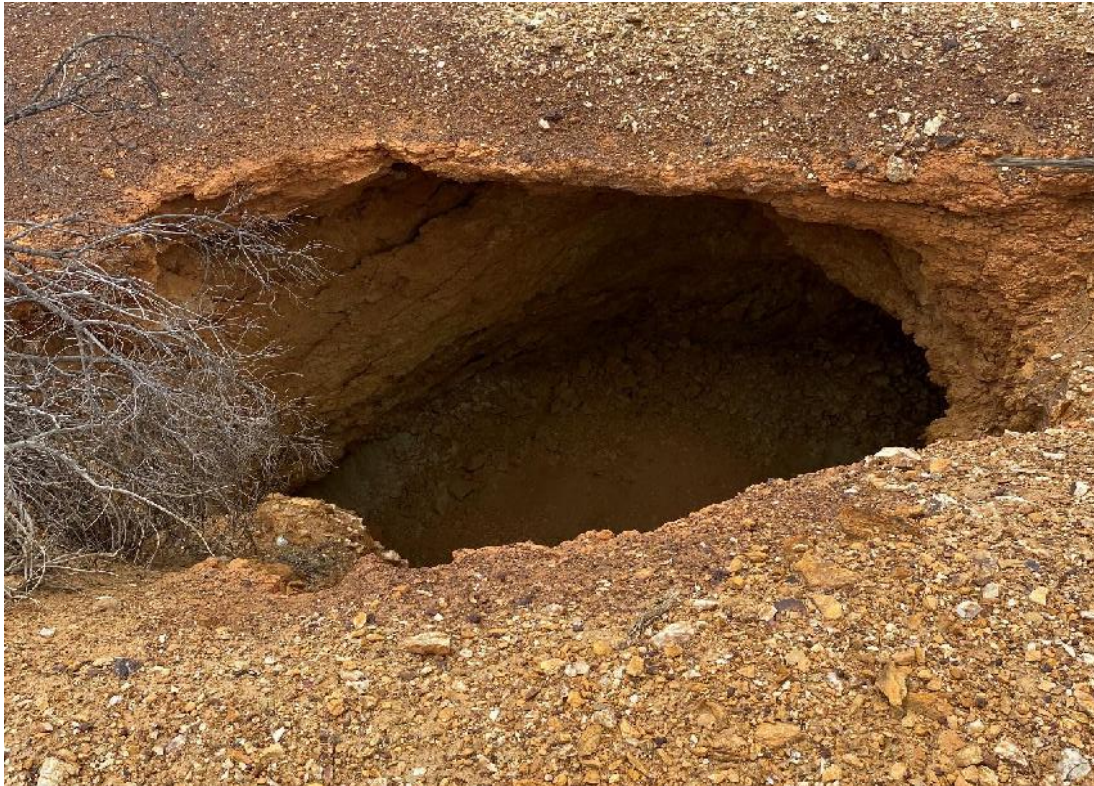
Photograph 21: Feature 9, facing south

Similar to Features 5, 5a and 6, Features 7, 8 and 9 are linked by a relatively shallow lateral working, and Feature 9 (not recorded in 1985) possibly results from a collapse of this void roof. It is also noted that surface run off is captured into these features, exacerbating possible instability, such as evidenced by relatively deep undermining of the features resulting in overhangs of up to 3 m with a very thin ground cover. As a result, the ground between the openings of Features 7 to 9 should be assumed to be unstable with risk of collapse, with or without pedestrian traffic, together with the thin cover of ground extending up to 4 m to the east of the features, and 2 m to the west of the features. The ground outside this zone is considered stable, with no risk of collapse under pedestrian traffic.

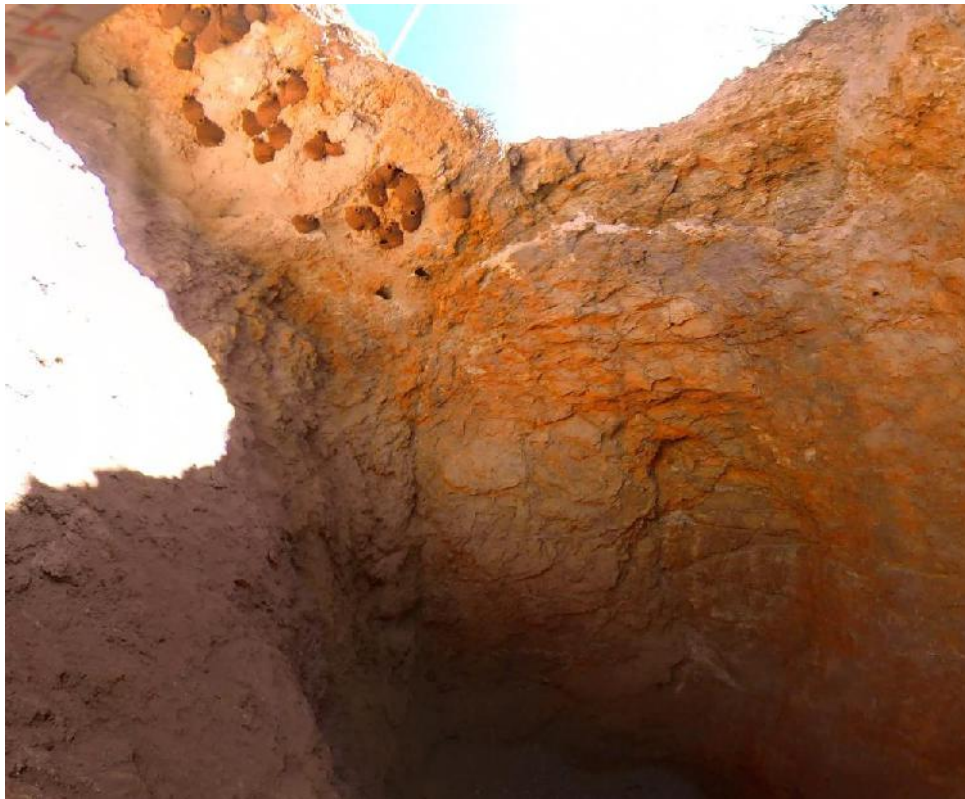
A 1.8 m x 2.5 m at surface, 4.1 m deep excavation, widening to 5.0 m x 6.1 m at the base (resulting in an overhang of up to 2.7 m). A 1.2 m wide lateral working links to Feature 8. Bird nests were observed on the underside of the overhang on the eastern side of the feature (photo 22 in Appendix C). No excavation was undertaken in this feature owing to the base being beyond the reach of the backhoe.

Photograph 33: Feature 11c, 2 m deep, facing west. Bird nests visible on overhang.

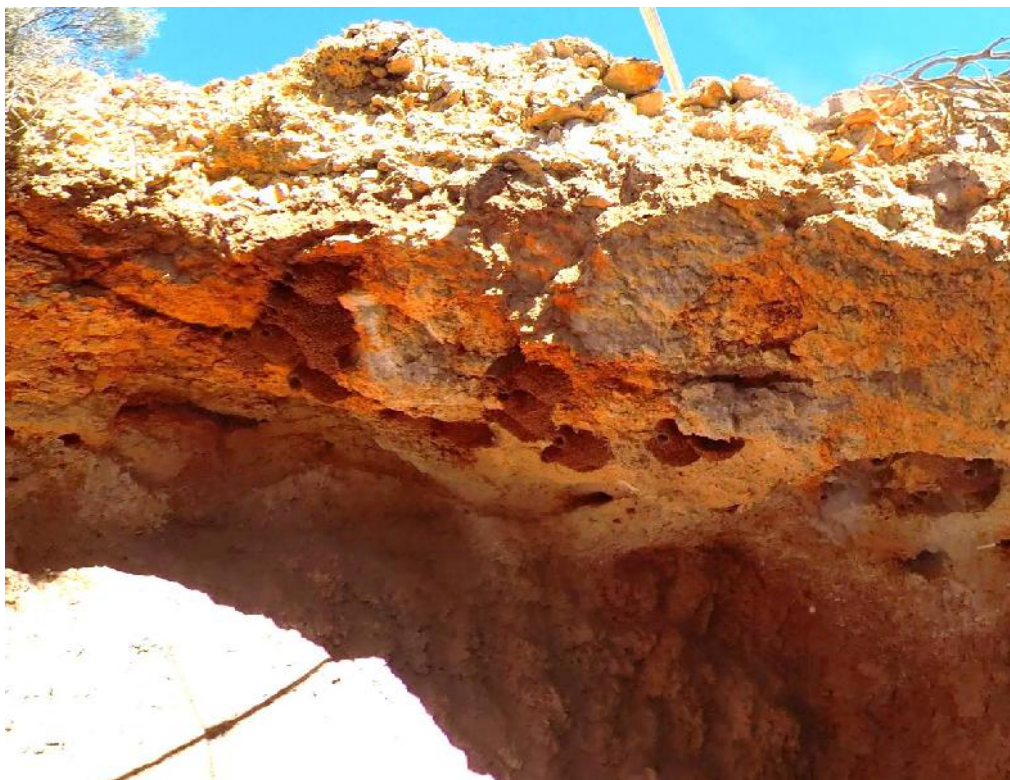
Photograph 34: Feature 11c. Bird nests
