## **Report on Shaft Rehabilitation Options**

**Reids Ridge Abandoned Mine Site  
(Commodore and Reids North)**

**Yalgoo-Ninghan Road, Paynes Find WA**

**Project 224768.00**

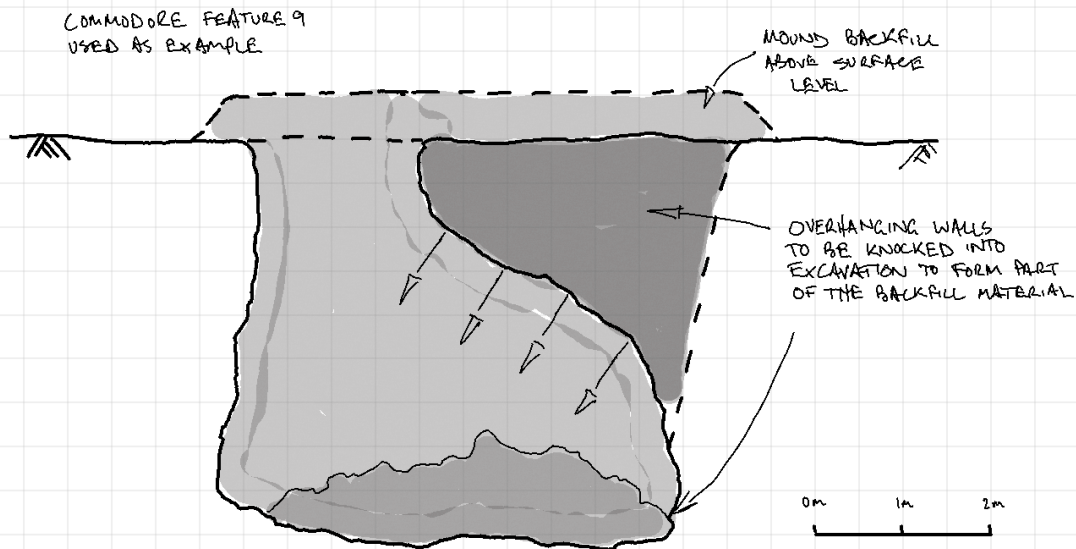
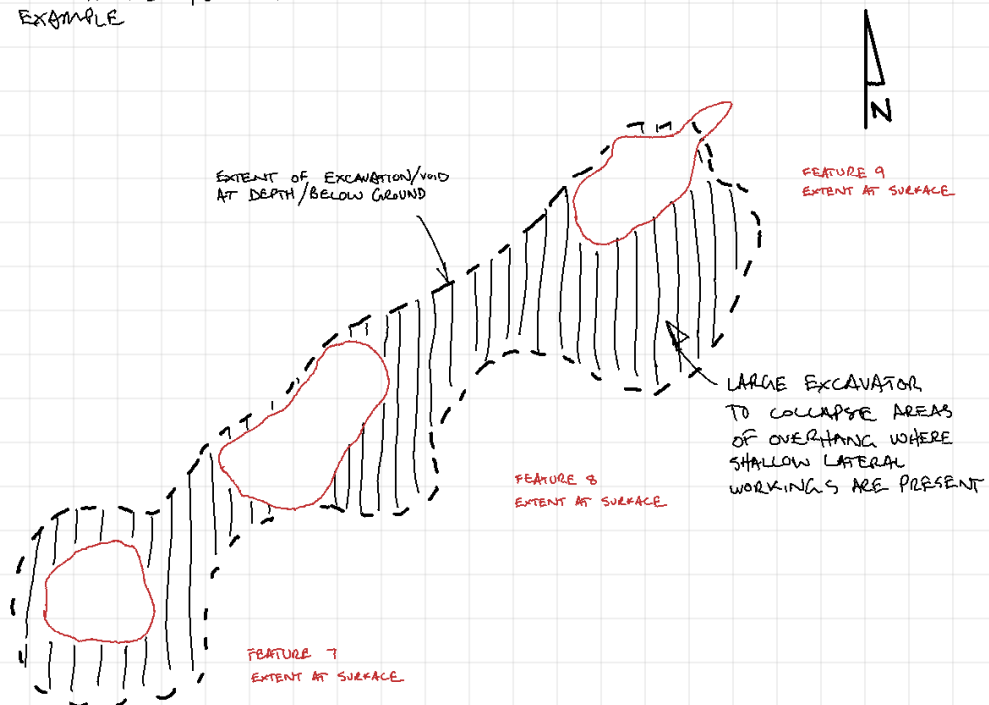
**Figure 1: Concept Schematic for Backfill**

Figure 1 (page 11) provides cross-section and plan view schematics for a feature typical to those found at Commodore and Reids North. The provided example is indicative of Feature 9, to assist in the demonstration of the intended management of overhanging edges.

COMMODORE FEATURES 7, 8 AND 9  
USED AS EXAMPLE

A large excavator, such as a 20 tonne machine should have suitable reach and power to undertake the work safely. It is recommended that initially, higher risk areas of unstable ground, such as overhangs (particularly the southern edge of Feature 9) and ground above shallow lateral workings are collapsed prior to placing other backfill. Some provision to equip the excavator with a ripping tyne or rock breaker attachment to assist with these works is suggested. A dozer and loader are also considered likely to facilitate the work with sourcing local material and the movement of fill around the site.

Backfilling can commence by initially pushing nearby mullock heaps and mine spoil into the features, followed by placement of additional material sourced elsewhere. A rigorous compaction control programme is not considered necessary, however it is recommended to tamp the placed backfill with the excavator bucket regularly to reduce post filling settlement. In addition to tamping, mounding of the fill is recommended to both account for some long-term settlement, erosion, and to restrict vehicles trafficking over the rehabilitated features.

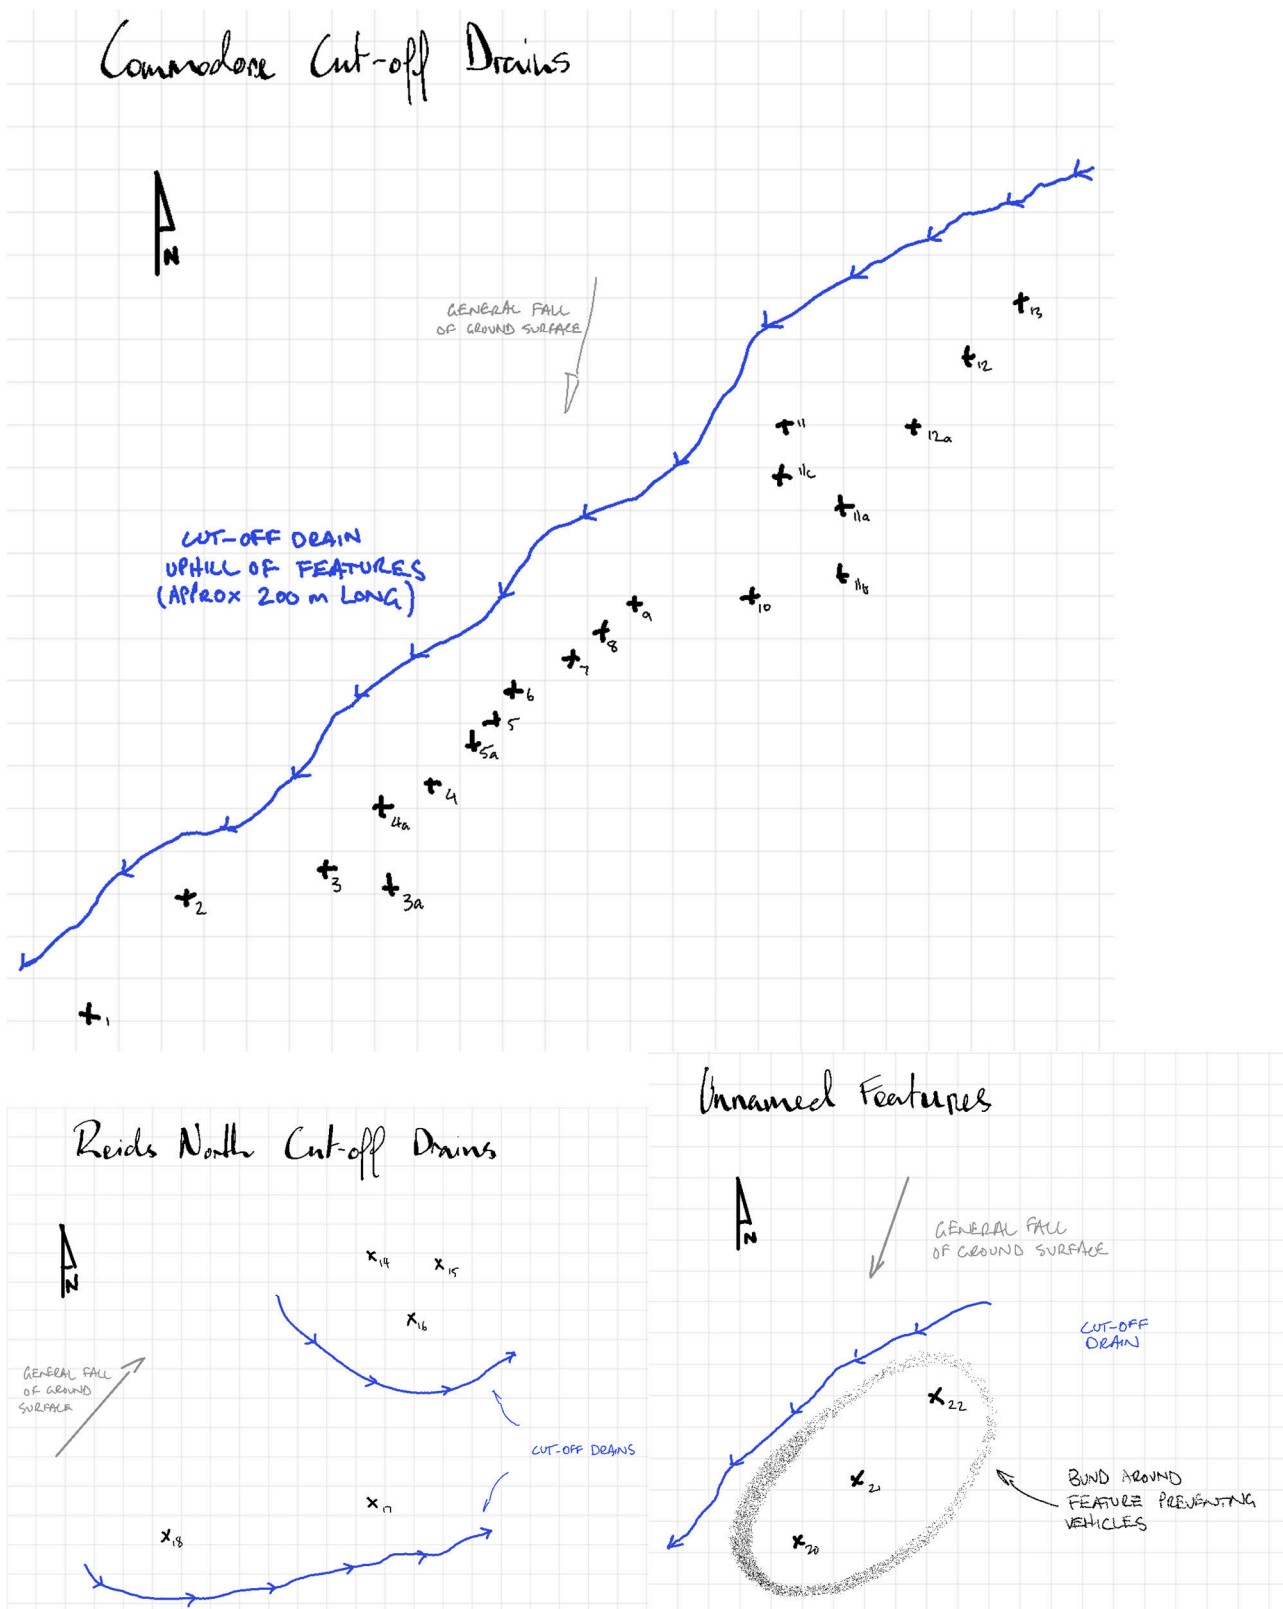
**Figure 3: Concept Cut-off Drains (if adopted) and Vehicle Prevention Bunds for All Areas**

Figure 3, next pages, shows the arrangement of cut off open drains upslope of the features.

To provide erosion protection across the entire rehabilitation area, surface water is suggested to be intercepted slightly upslope of the features into an open catch drain comprising a simple trench, say 1 m depth, with the materials excavated from the trench being placed and nominally compacted (say with an excavator bucket) along the downslope side of the drain. The purpose of the catch drain is to intercept the occasional water run-off upslope of the features, by-passing the rehabilitated features, and releasing the intercepted water downslope of the features, back into the minor natural drainage line that exists along the mining features. The impact of the proposed drain on surface water movement is expected to be minor and localised and because drain is not a critical component of the rehabilitation, a detailed hydrological study is not considered warranted. It is suggested that a preliminary selection of the location of the drain be based on a survey plan (if available), complemented if required by some adjustments during the geotechnical supervision during construction. It is noted that the bund associated with the trench will maintain the drain function in case of long-term siltation of the trench, if any occurs (noting the site is in a region of mostly low rainfall). Therefore, provided the bund is constructed using relatively gravelly clayey soils (as expected in the area), the trench and associated bund are anticipated to suitably divert surface water around the rehabilitated mining features for an estimated 50 to 100 years (noting that inferred century old mullock heaps around mining features are still in place), and thus no requirement for drain maintenance is anticipated.
