Assessment of the status of river pools in the Avon catchment

Water resource management series

Report No. WRM 47
December 2007

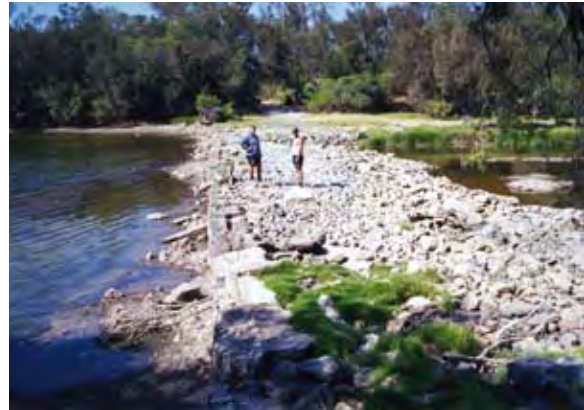
The original crossing at the downstream end of Glen Avon Pool was known as McDermott's Crossing. Last used in the 1920s, it was a natural rock bar which was raised by half a metre in the 1970s to protect Glen Avon Pool and the Katrine Bridge footings. The pool is maintained by this constructed weir. Removal of the weir would cause massive channel erosion that would destroy the pool and would probably mobilise sediments now contained within Katrine Pool. The weir has been damaged during past flood events and has been repaired on a number of occasions.

*Weir at the downstream end of Glen Avon Pool
(Photo courtesy Bernard Kelly)*

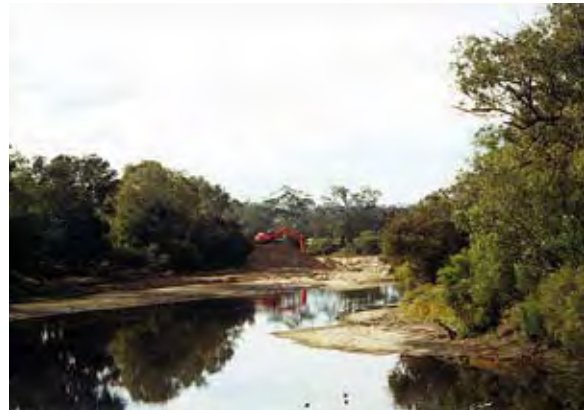
*Sediment removal from Katrine Pool looking
upstream (Photo courtesy Martin Revell)*

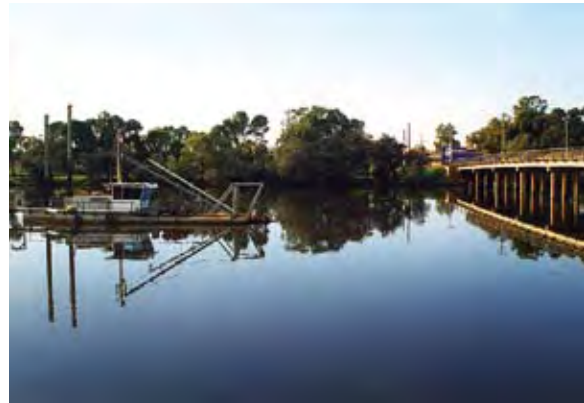
As a result of public concern for the pool and recommendations made in the management plan, a dredging project was undertaken by the Town of Northam in partnership with Department of Water, formerly Water and Rivers Commission. 50 000 m³ of sediment was removed from the Town Pool in August 2000 to deepen the pool and improve the overall health and aesthetics of the pool. Sediment was removed from the left hand side of the channel from the Avon bridge to the Peel St Bridge and the width of the channel was dredged downstream of the Peel Street bridge to the weir. The sediment removed from the pool was not suitable for resale and was stockpiled offsite.

*Dredge in Northam Town Pool downstream of the Peel Street Bridge, August 2000
(Photo courtesy Martin Revell)*

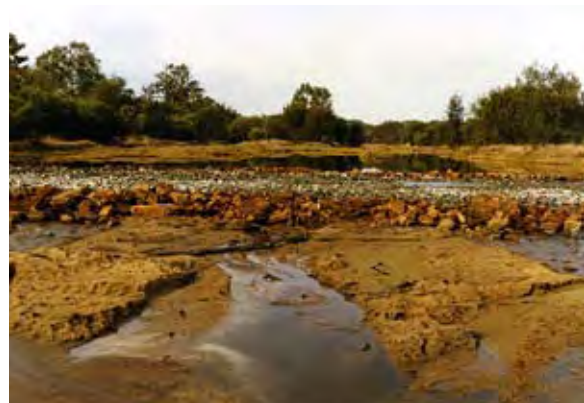
Riffle constructed upstream of Burlong Pool to trap sediment (Photo courtesy Bernard Kelly)

Sediment traps were constructed at the downstream end of the pool in the summer of 1997/1998 and a rock crossing/riffle was constructed at the upstream end of the pool in May 1998 to assist stabilisation of the bed sediment and control the sedimentation of the pool. The pool-management strategy allows for a dredging contractor to remove sediment each year (10 000 m³/yr) from the two sand traps, in the vicinity of the upstream and downstream ends of the former pool.

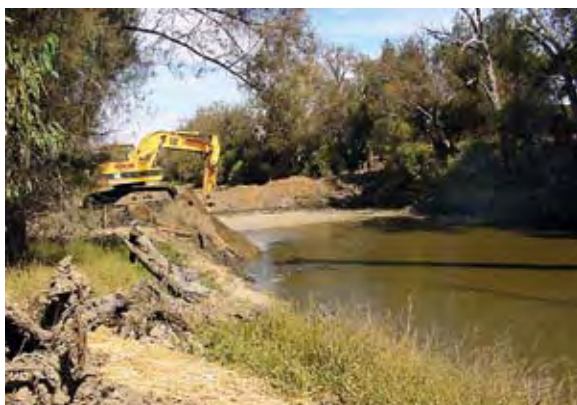
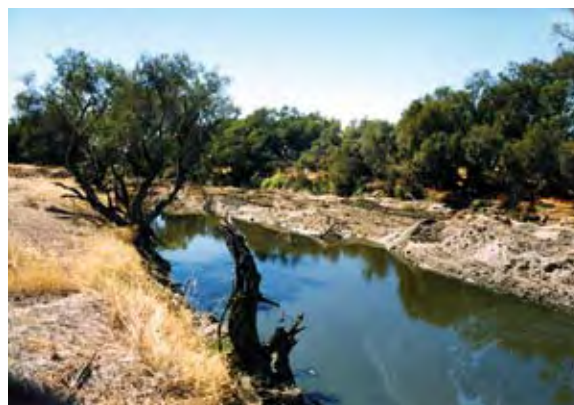
In April 2002, 100 m of the river pool was excavated on the upstream side of the railway bridge and 3300 m³ of coarse sediment was extracted from the pool. In April 2006 Department of Water surveyed the pool and observed a sand slug in the upstream section of the pool. Future work at this pool could include revegetation work to stabilise the banks that were disturbed during excavation.

*Excavation of Railway Pool in 2002
(Photo courtesy Nina King)*

*Restoring the depth to Railway Pool 2002
(Photo courtesy Nina King)*

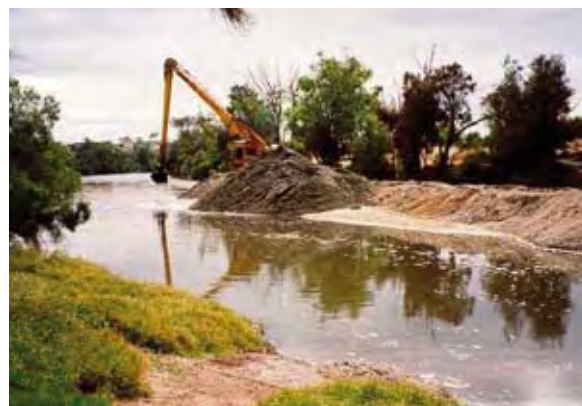
Removal of sediment from Gwambygine Pool, 1999 (Photo courtesy Peter Kata)

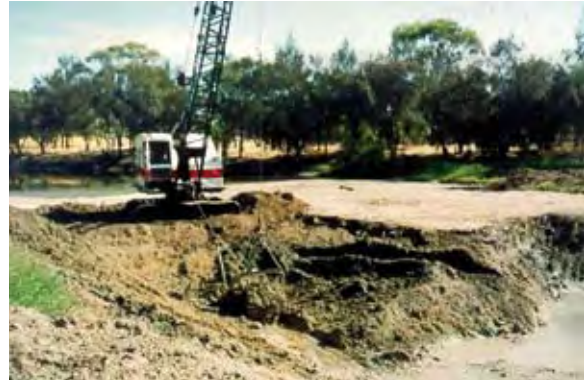
*A dragline removing sediment from Beverley Town Pool in 1993
(Photo courtesy Fred Bremner)*

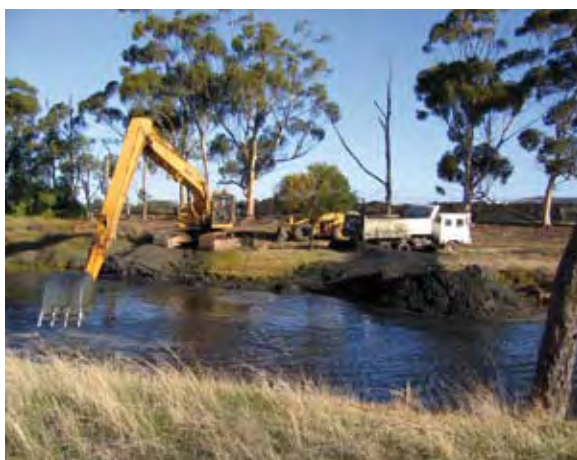
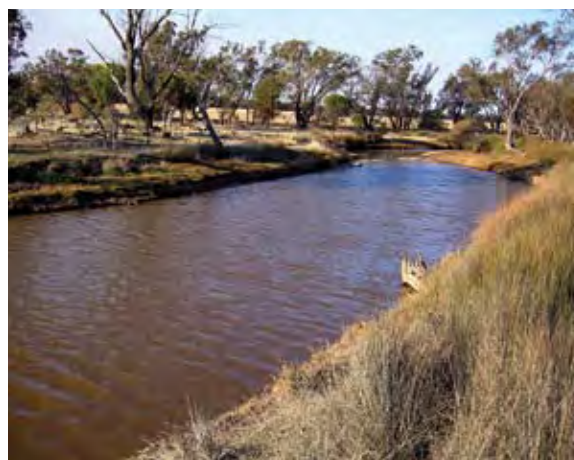
Long-reach excavator removing sediment from the pool. (Photo courtesy Michael Allen)

*One Mile Pool with depth restored after sediment removal
(Photo courtesy Michael Allen)*

With plans in place to minimise the impacts on water quality by waste-water being discharged from the treatment plant, recovery of One Mile Pool began in May 2007. Approximately 3000 m³ of coarse sediment was removed from the pool using a long-reach excavator in an effort to restore the depth and enhance the ecological and recreational values of the pool. The Department of Water has also developed a revegetation plan for this site. Planting began in July 2007 in partnership with the Seabrook Aboriginal Corporation.

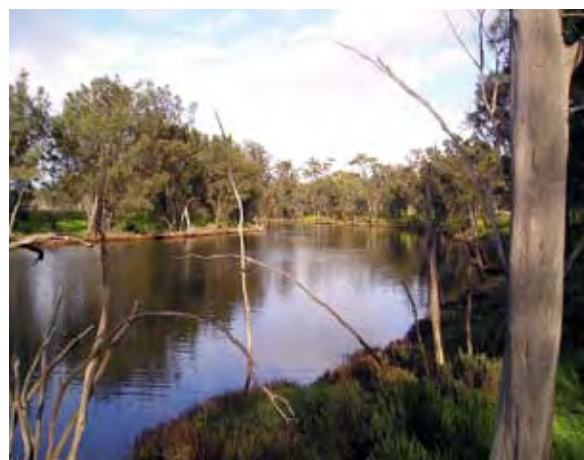
Jangerin Pool is located downstream of Squires Road crossing. Limited information regarding the condition of this pool is available. The pool appears to be deep with limited sediment infill (Viv Read & Associates, 2006a). The pool features a stabilised island that joins up with the Crown reserve on the left-hand side bank when the water levels are low. Livestock have access to the right-hand side of the bank, which is causing erosion, and the riparian vegetation is sparse.

Jangerin Pool (Photo courtesy Viv Read)

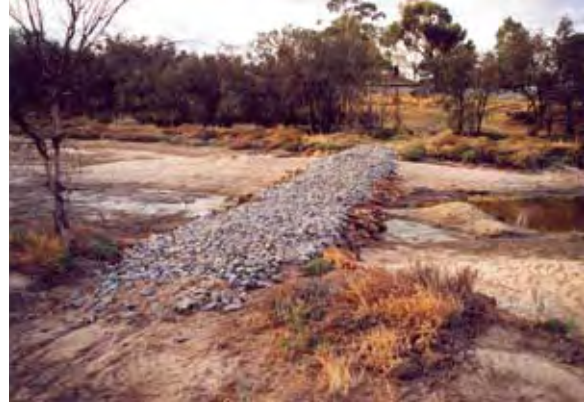
*Riffle constructed upstream of Beverley Town Pool to trap sediment
(Photo courtesy Bernard Kelly)*

In 1999 a Sediment Management Plan was developed for the pool. A riffle was also constructed upstream of the pool to trap sediments and minimise sedimentation to the main pool area.

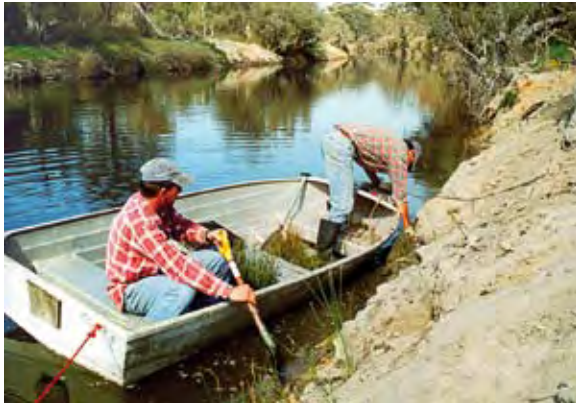
*Revegetation work on the edge of Boyagarra Pool to stabilise the banks
(Photo courtesy Brendan Oversby)*

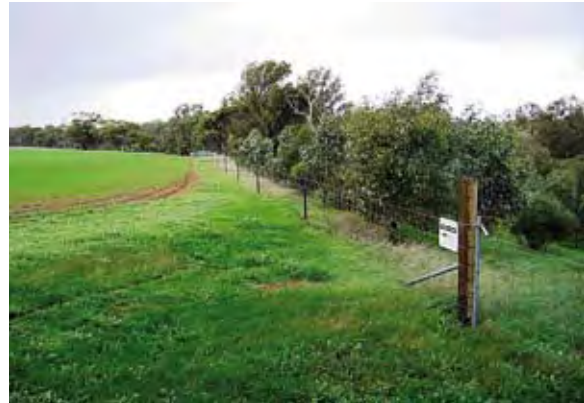
*Fencing at Boyagarra Pool to protect riparian vegetation and exclude stock
(Photo courtesy Bernard Kelly)*
