BREMER RIVER AND DEVILS CREEK RIVER ACTION PLAN

WATER AND RIVERS COMMISSION
WATER RESOURCE MANAGEMENT SERIES
REPORT NO WRM 25
JUNE 2001

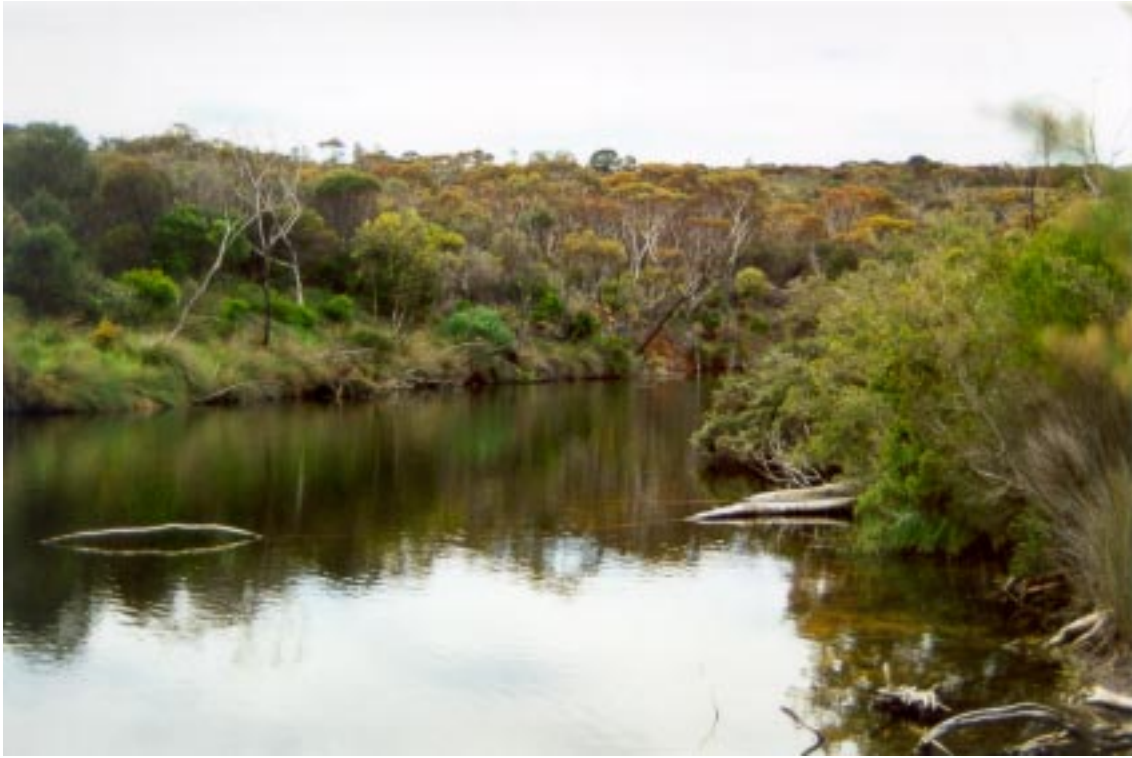
A Grade vegetation of the Bremer River – near pristine

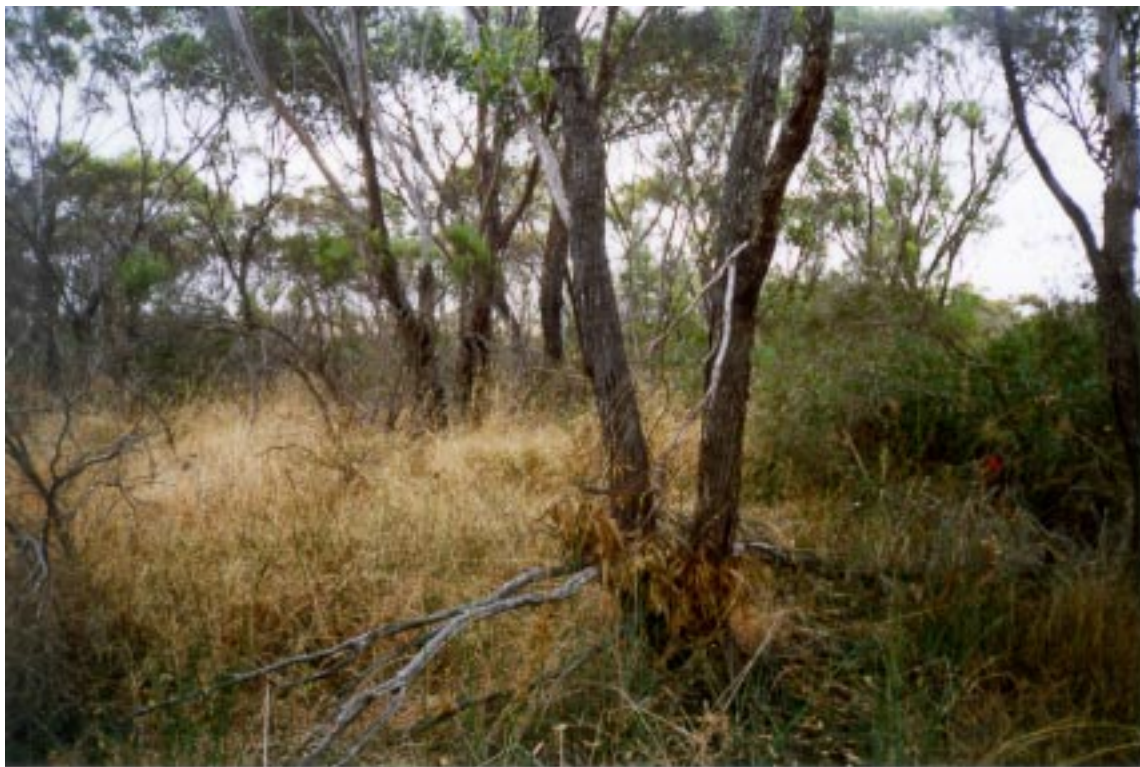
B Grade – note the weeds and slight disturbance in the understorey

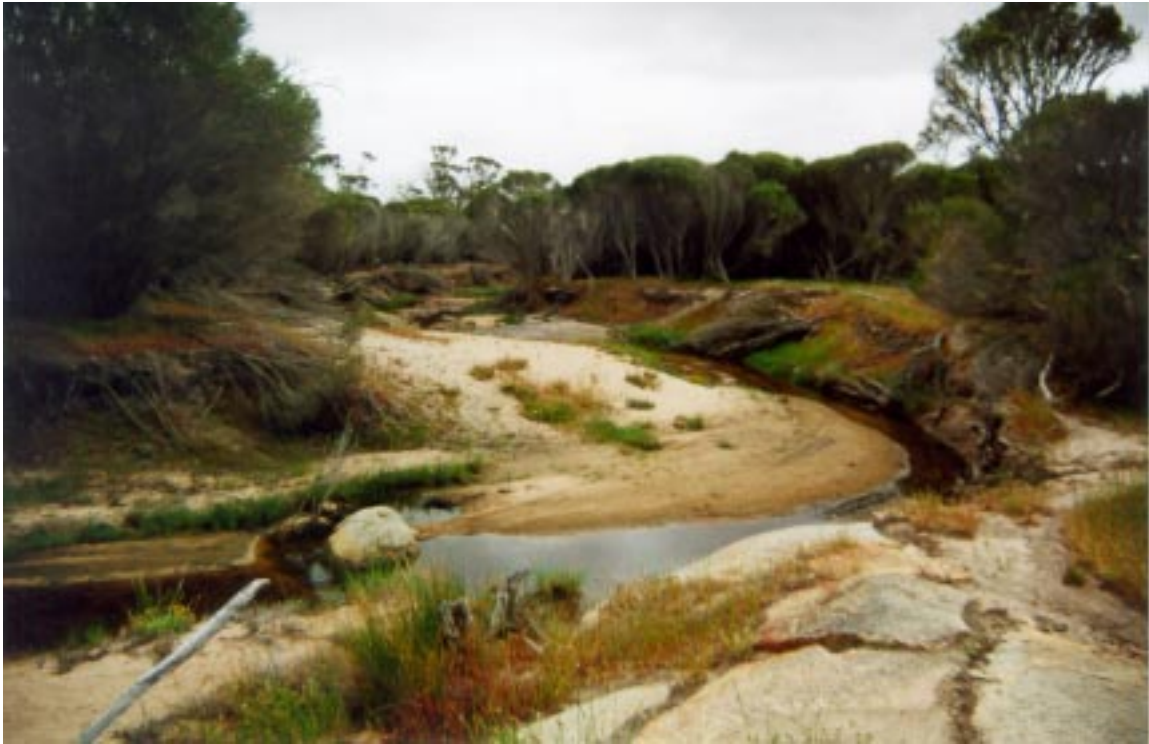
C Grade – note the soil disturbance, lack of native understorey and presence of weeds

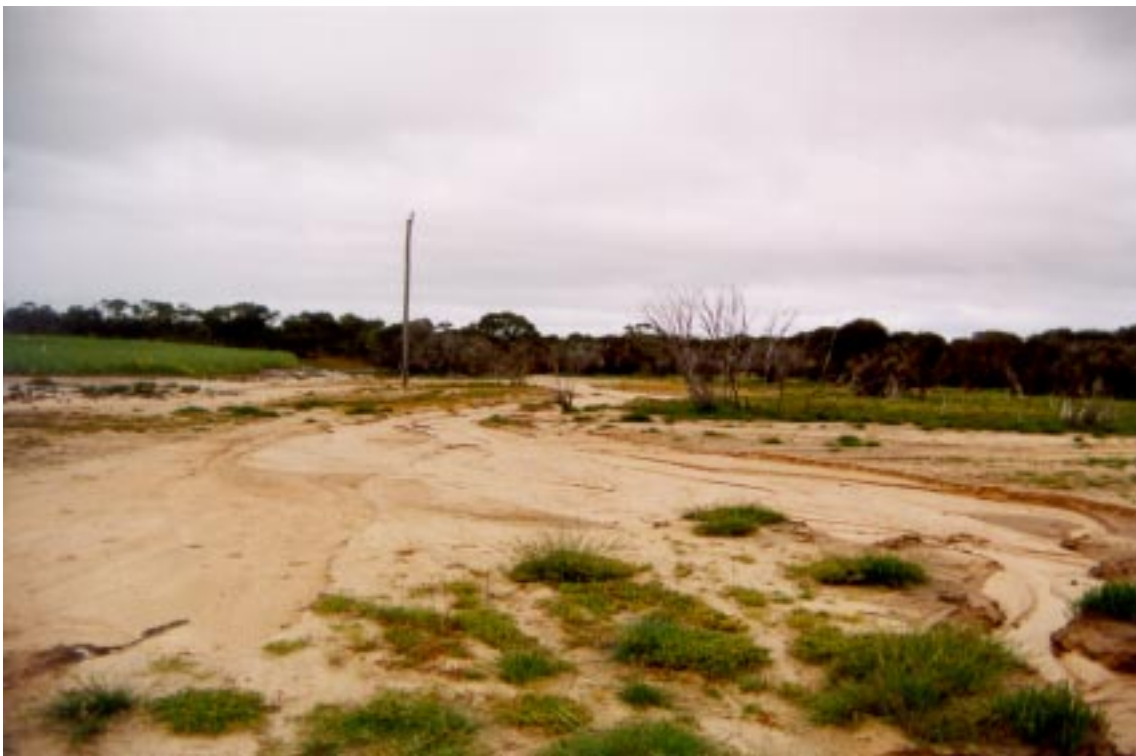
D Grade – note the erosion, lack of vegetation, visible salt and presence of salt tolerant plant species such as Samphires and saltbush

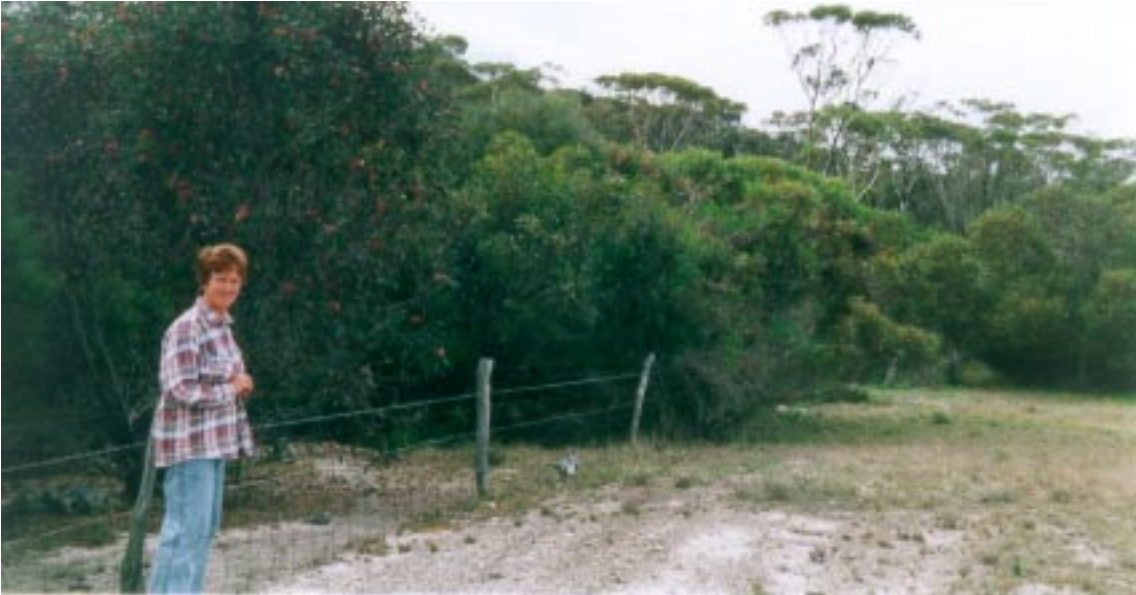
Thirty-year-old fencing at Kombi Creek (looking downstream)

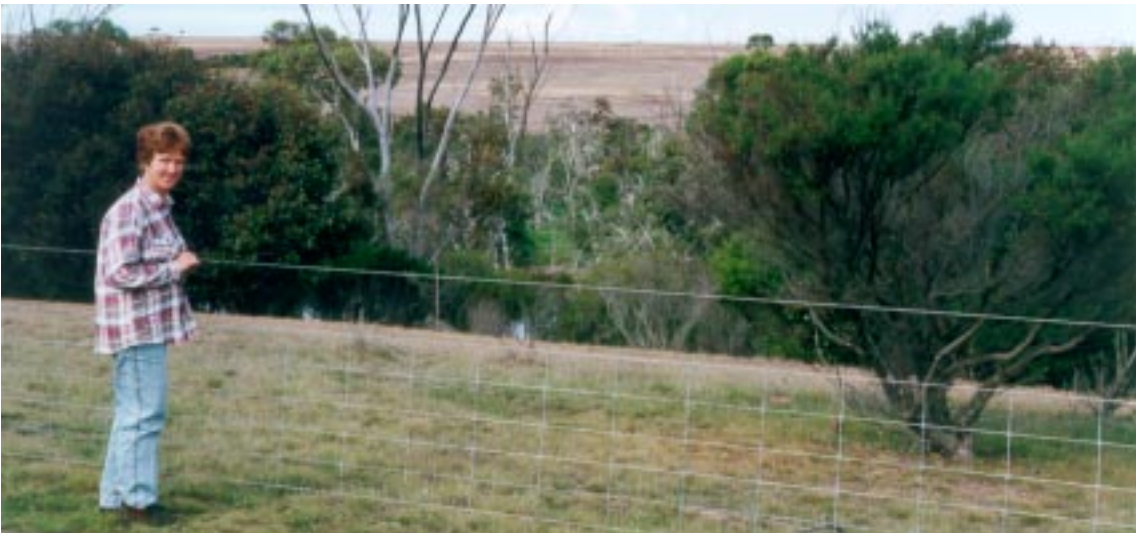
More recently fenced foreshore of Kombi Creek (compare the foreshore with the photo above)
