Foreshore and channel assessment of the Dale River South Branch

Water resource management series

Report No. WRM 50
June 2008

Prepared by
BlueSands Environmental for
Department of Water

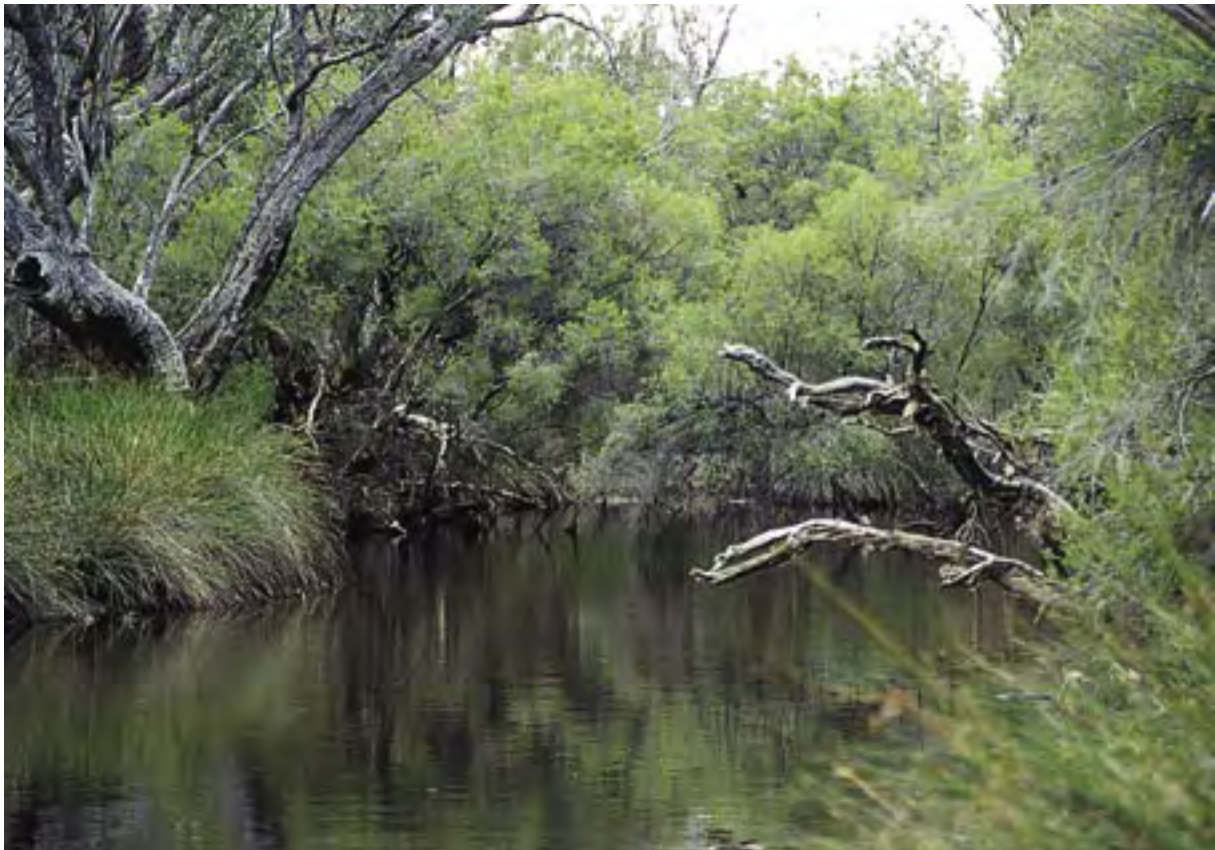
Photo 1 An A-grade reach of the Dale River (Photo: K. Gole, Department of Water)

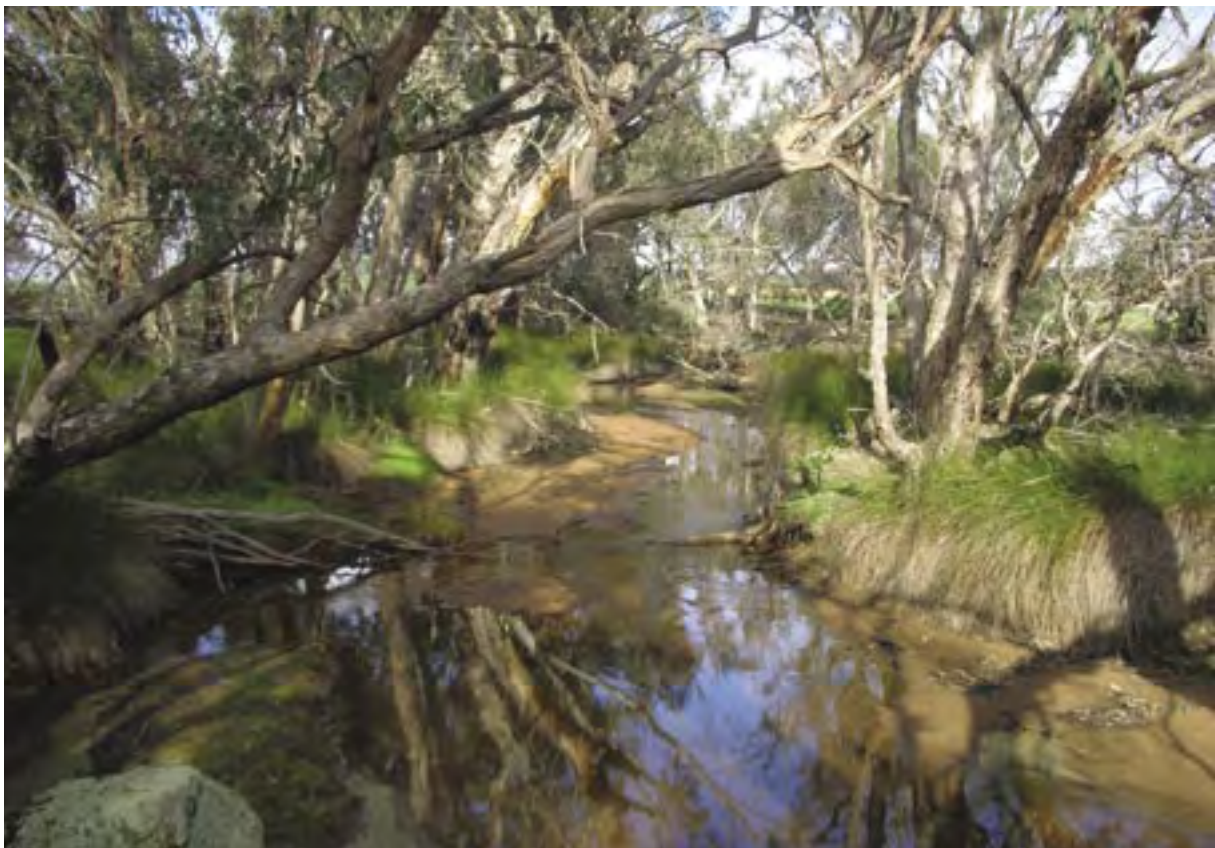
Photo 2 A B-grade reach of the Dale River South

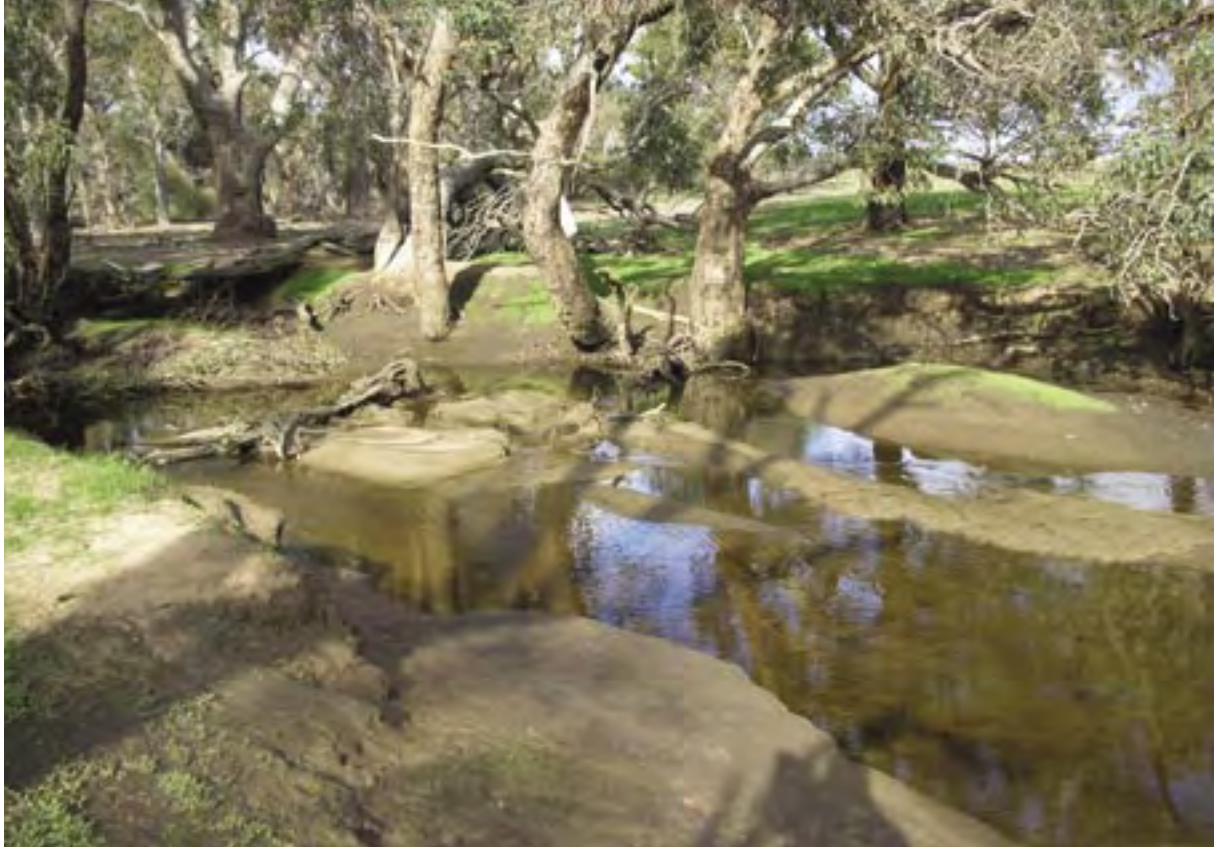
Photo 3 C-grade foreshore along the Dale River South

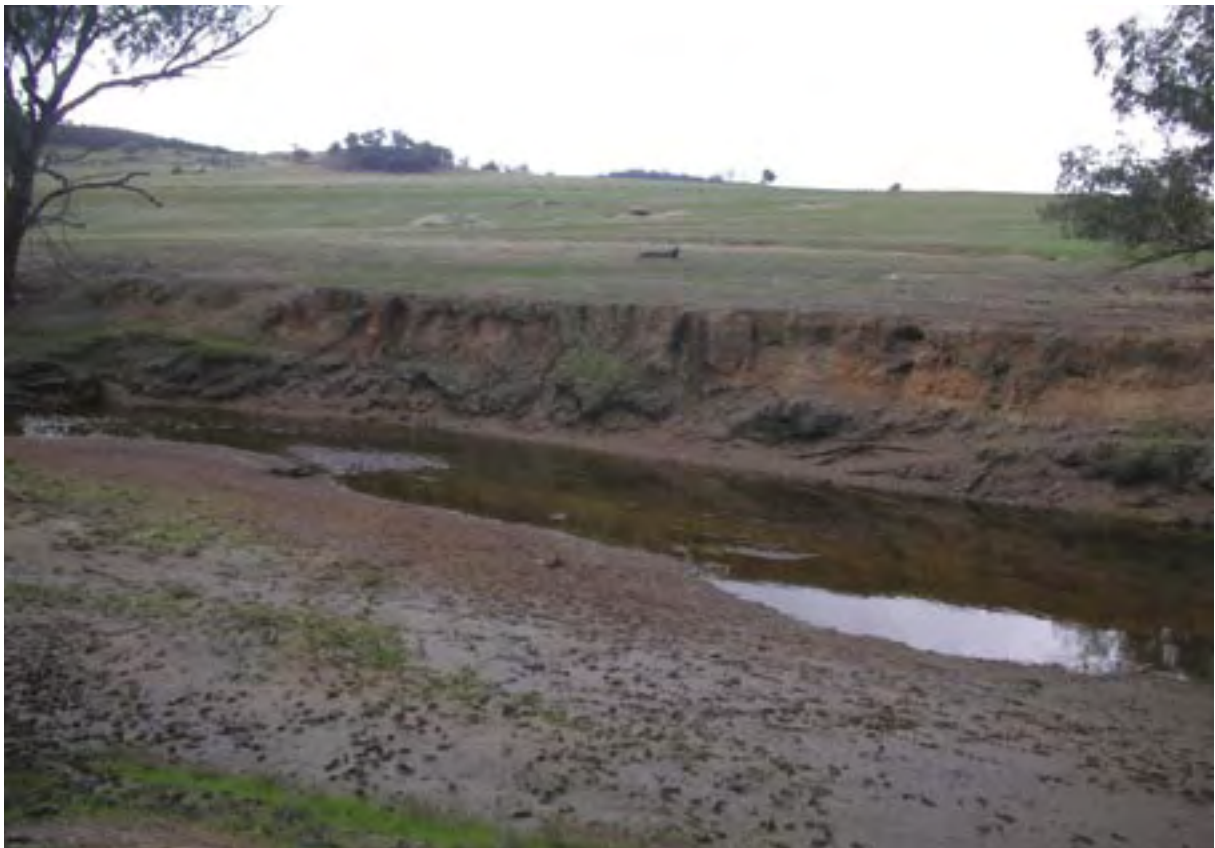
Photo 4 D-grade foreshore along the Dale River South

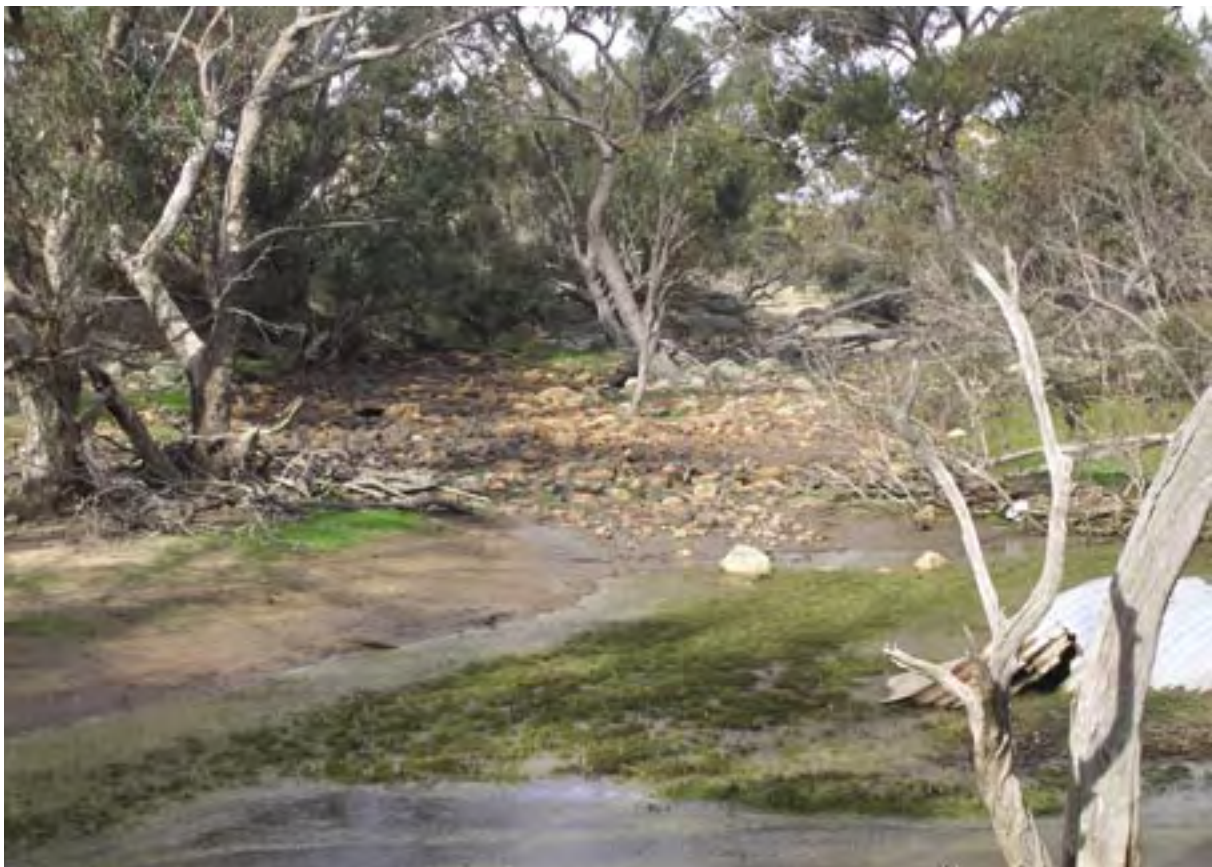
Photo 5 Significant riffle in survey section DRS26

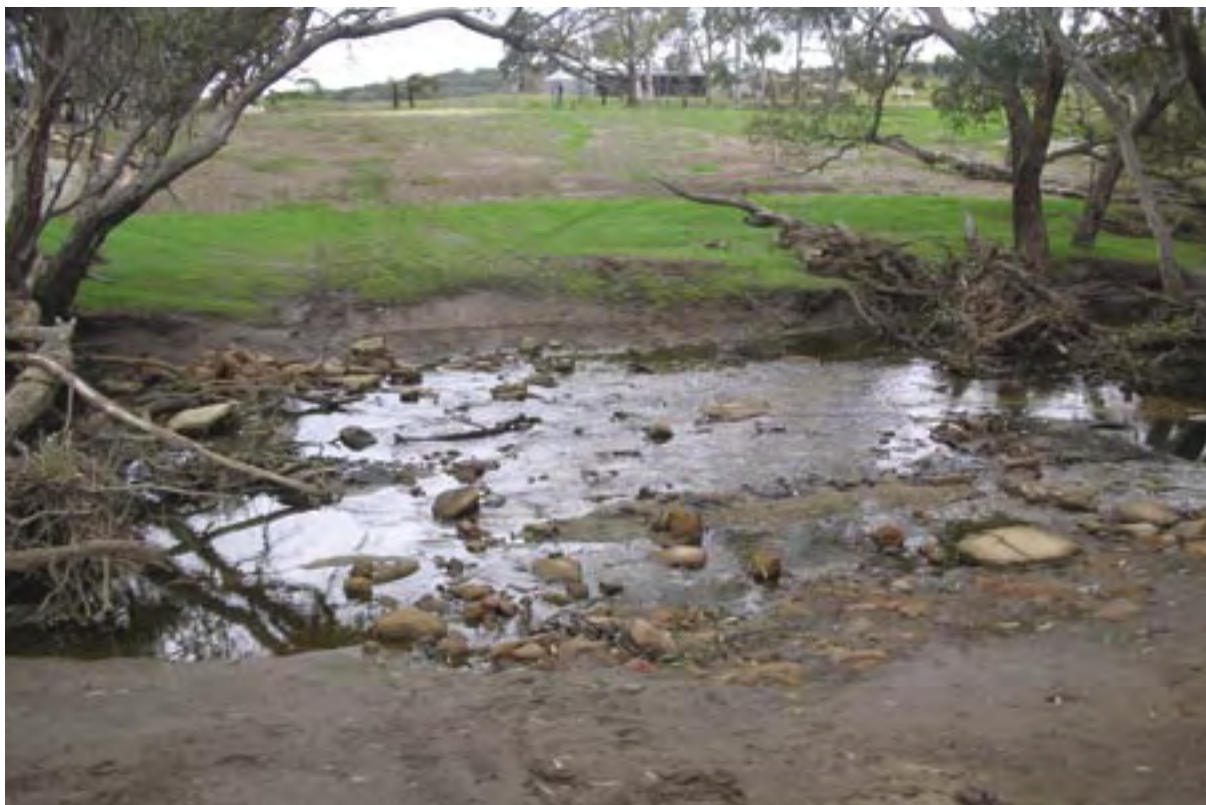
There were also numerous other farm crossings which were designed to enable stock and vehicle access. Many of these crossings have been stabilised with field stone, which means they double as a constructed riffle, allowing oxygenation of the water.

Photo 6 Farm crossing stabilised with field stone

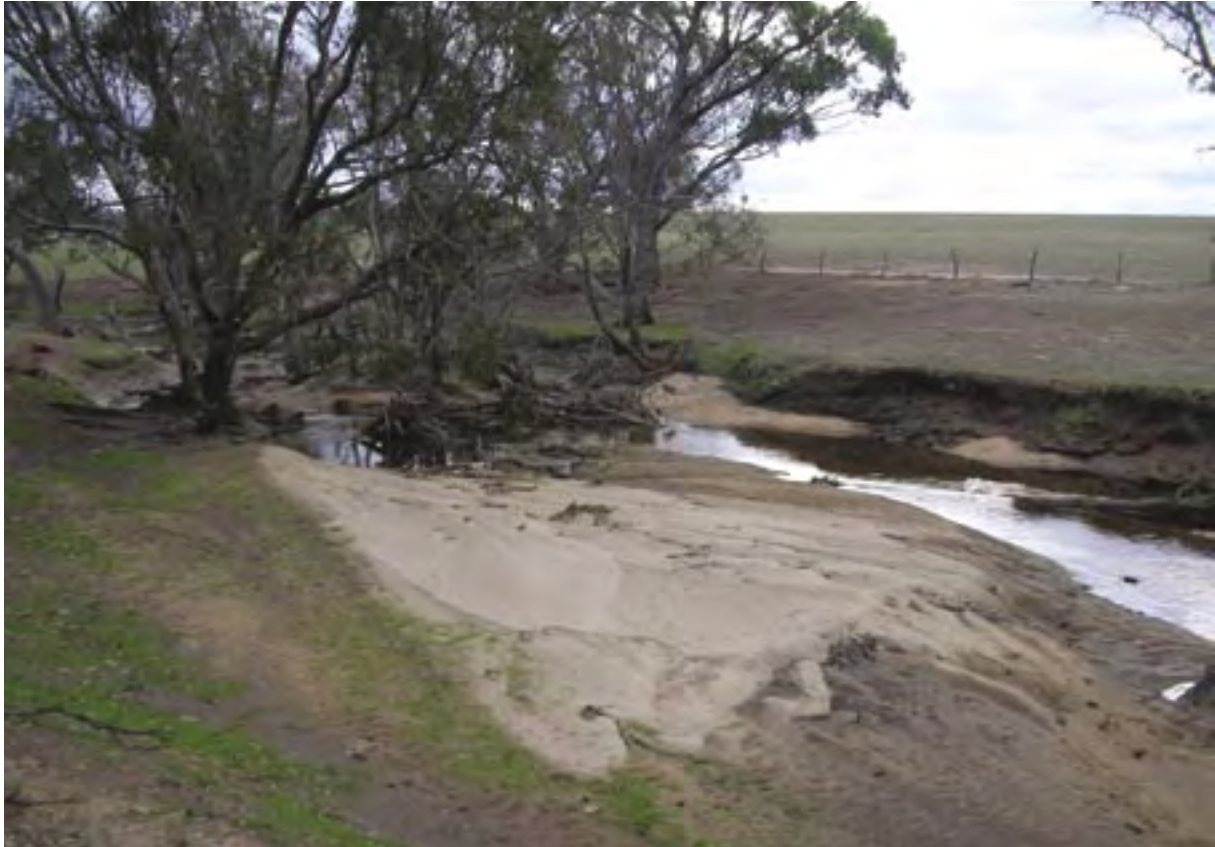
Photo 7 Sedimentation deposit in a degraded section of the Dale River South

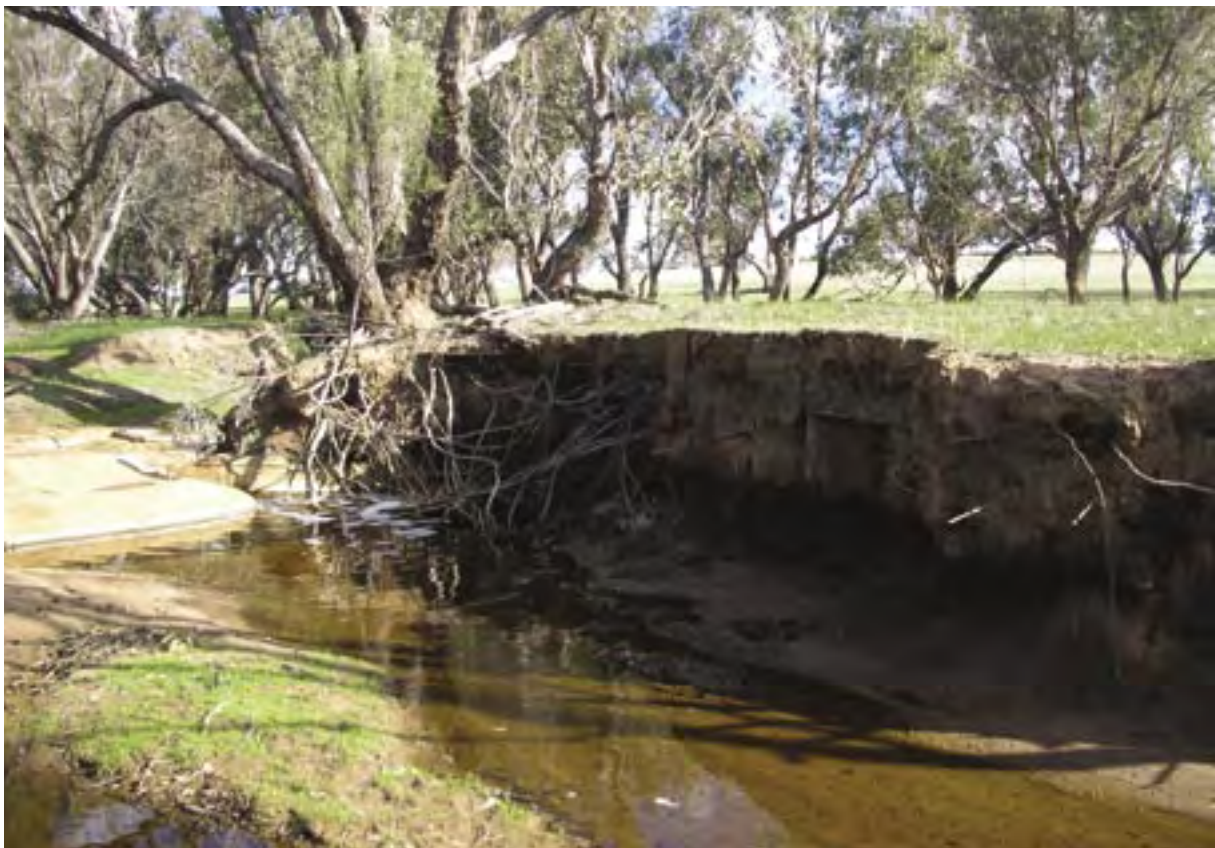
Photo 8 Significant undercutting of a flooded gum (Eucalyptus rudis)

The Dale River South has a high level of bank undercutting, in many instances near large trees, which over time will cause the trees to collapse into the channel. Sedimentation is also significant, which leads to the infilling of pools and smothering of aquatic habitat.

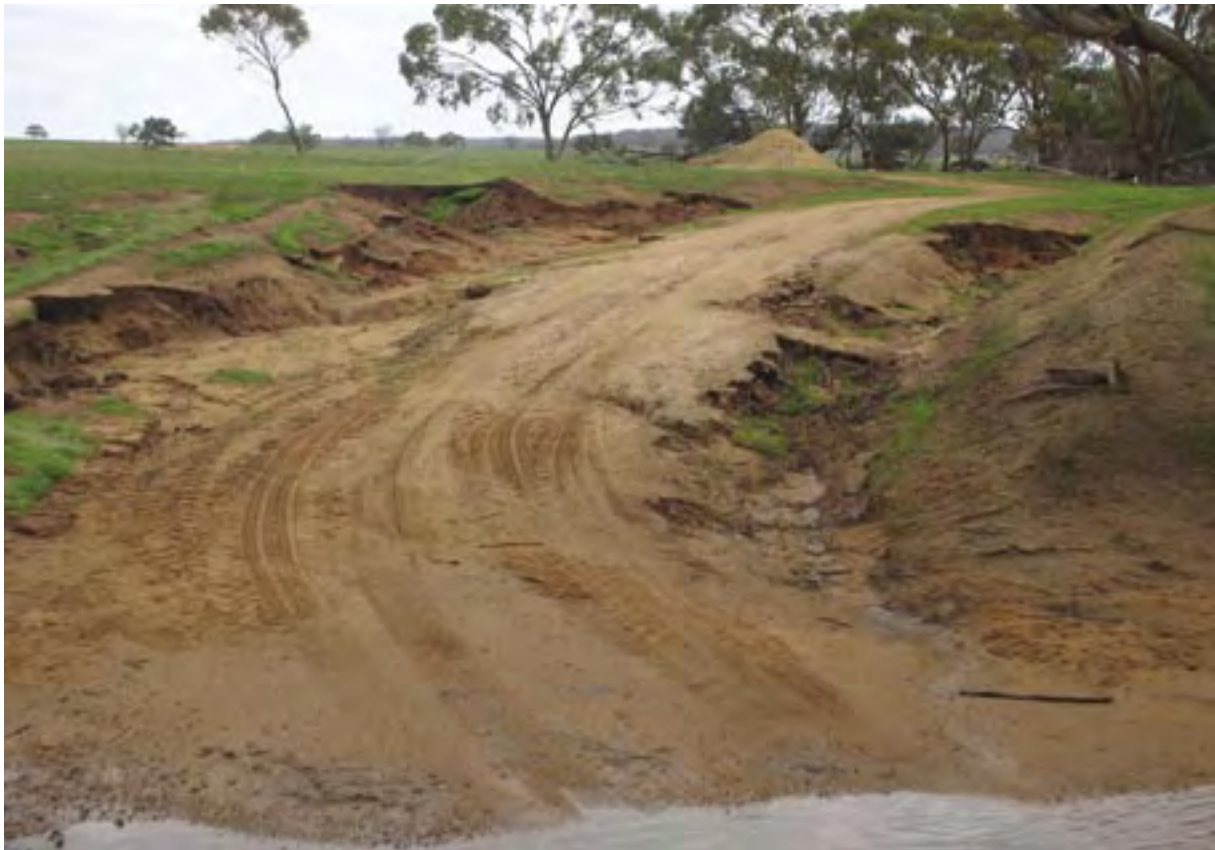
Track washouts and gully erosion were either absent or localised along all of the Dale River South. Most of the track washouts were restricted to a few farm crossings, where soil was soft along the sides of the track, and had been washed away. Gully erosion was restricted to the confluence of a few tributaries or within the tributaries themselves.

Photo 9 Erosion and washout of a track crossing the Dale River South

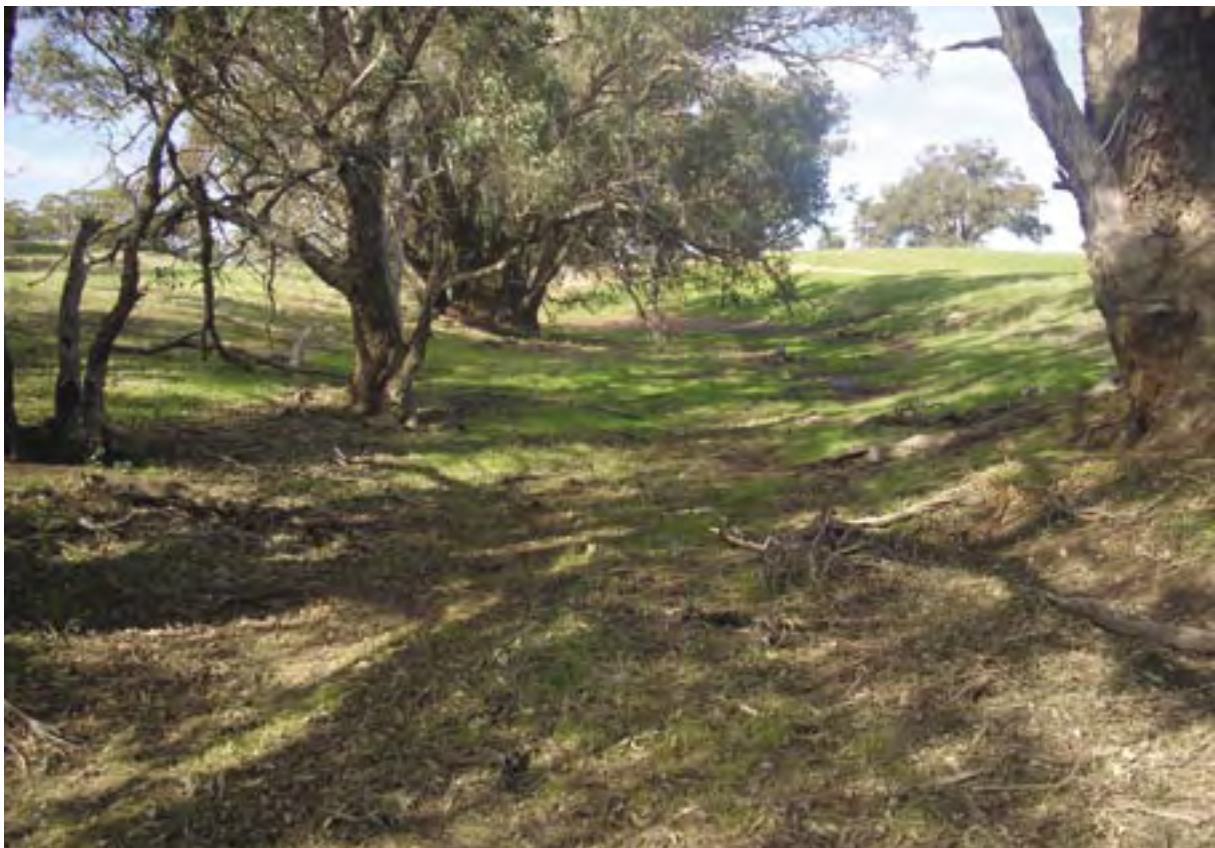
Photo 10 Tributary with moderately sloping, stable banks

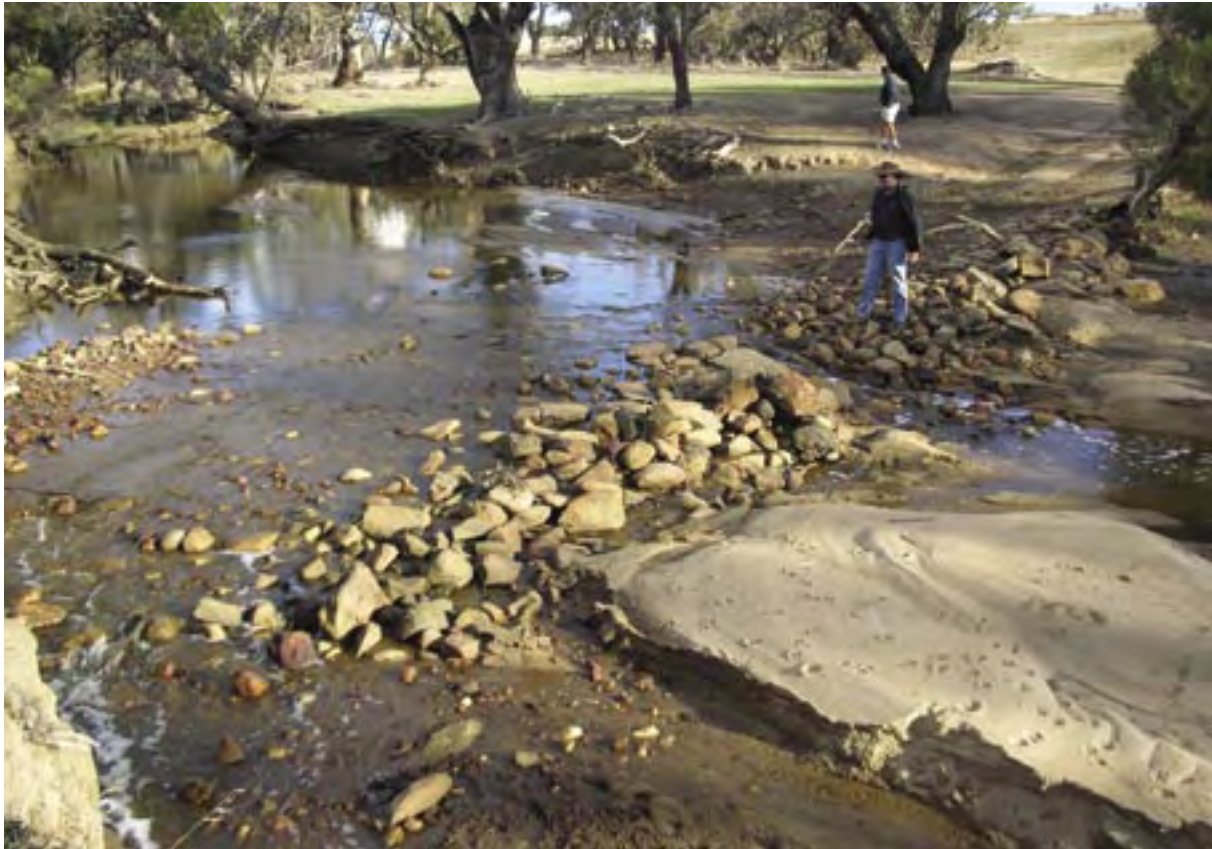
Photo 11 Vehicle crossing which doubles as a riffle

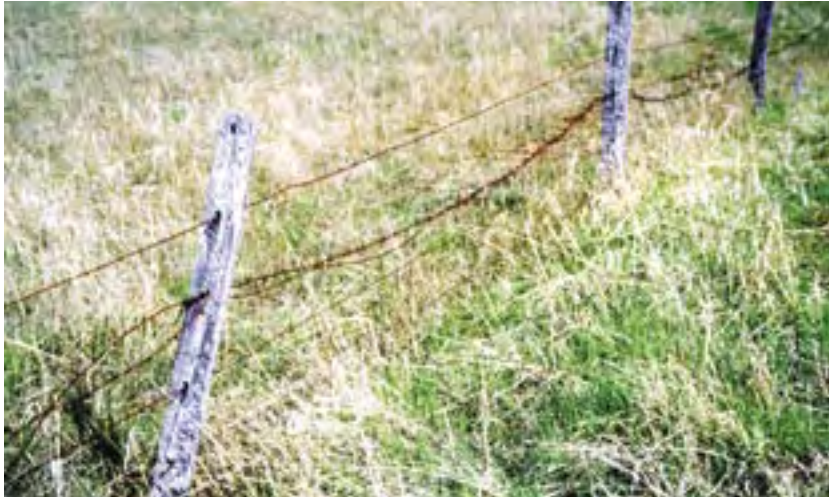
Fence in poor condition

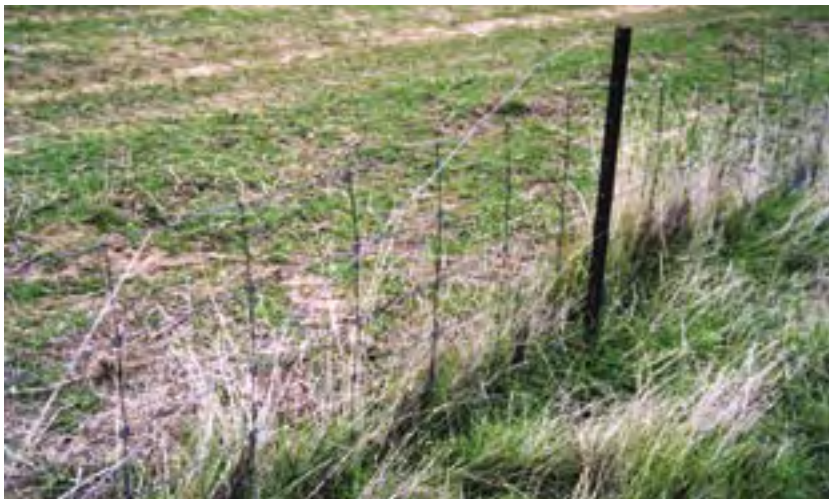
Fence in moderate condition

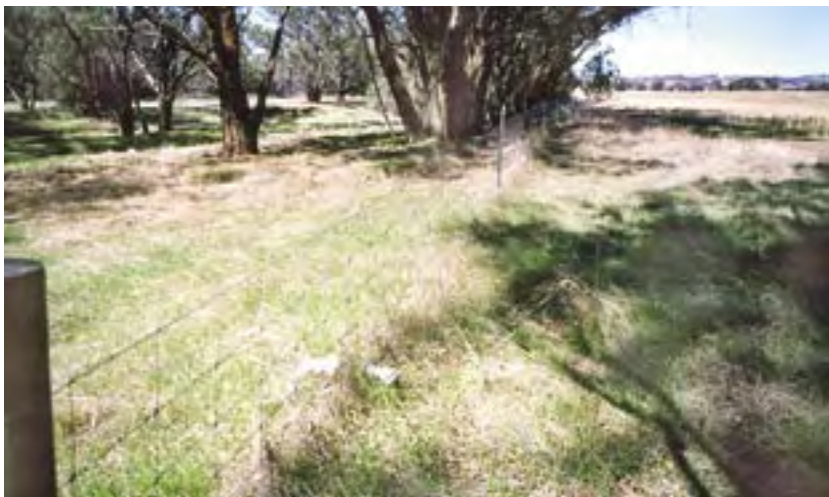
Fence in good condition
