# HUTT RIVER FORESHORE ASSESSMENT

Prepared by  
Regional Operations  
Department of Environment

DEPARTMENT OF ENVIRONMENT  
WATER RESOURCE MANAGEMENT SERIES  
REPORT NO WRM 45  
FEBRUARY 2005

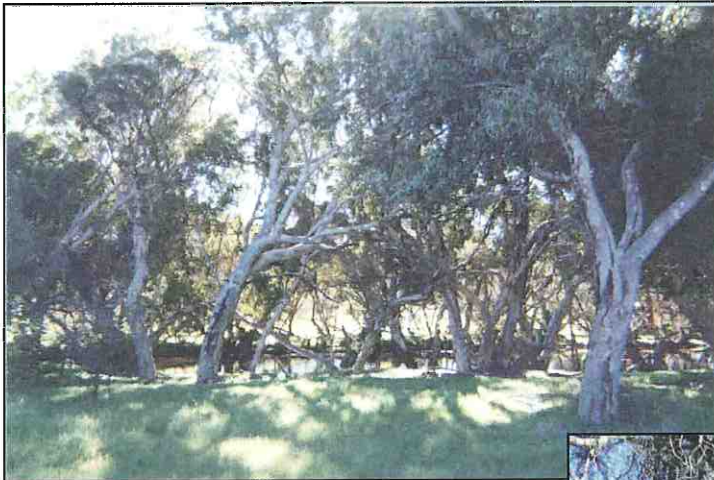
**C grade foreshore:** Trees remain though there is little evidence of regeneration. The shallow-rooted weedy understorey provides no support to the soil, making the banks vulnerable to erosion.

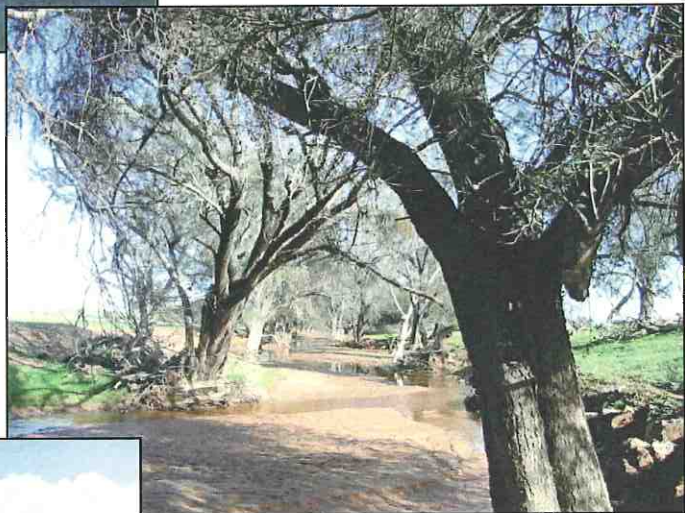
**C grade foreshore:** Soil is being washed away from between tree roots and the undermined trees are at risk of falling into the river. This will cause ongoing erosion problems.

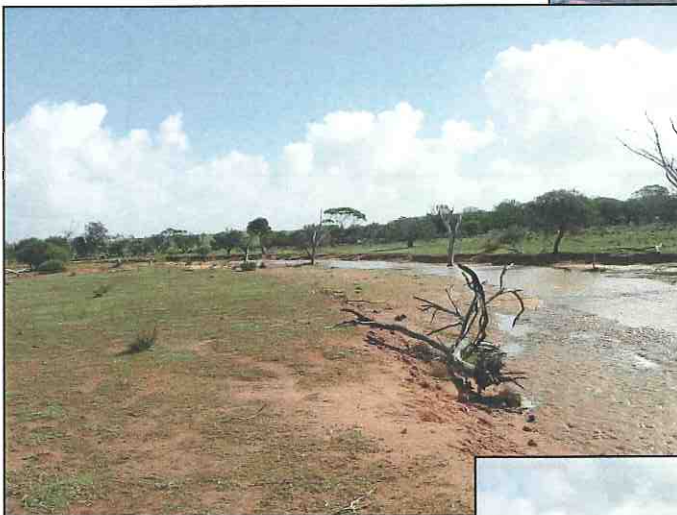
**D grade foreshore:** Deposits of sediment are accumulating along the river and the river channel is widening and eroding back into farmland.

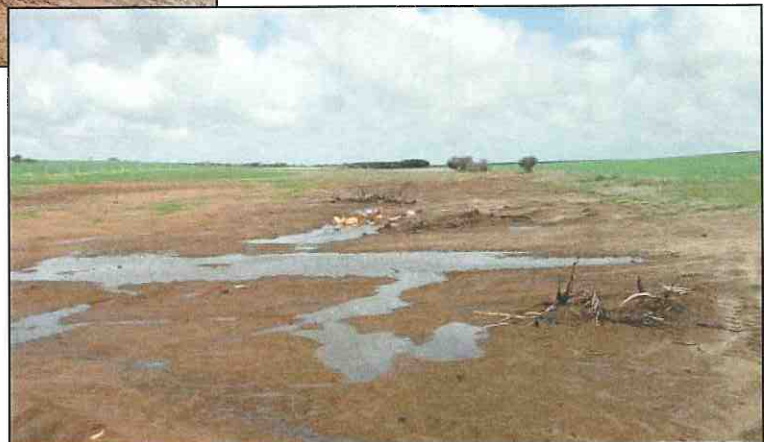
**D grade foreshore:** The waterlogged area is wide due to the lack of vegetation to confine and take up water.

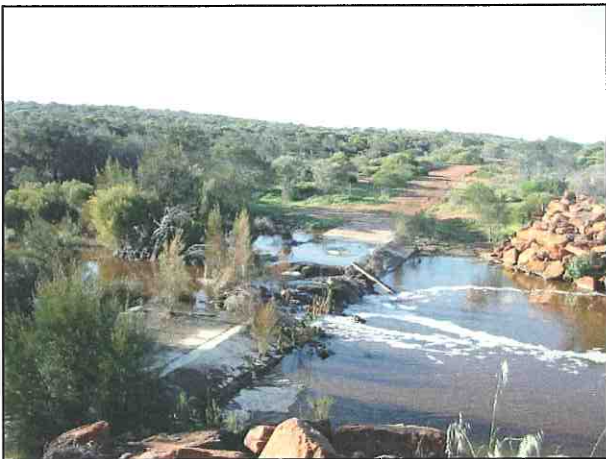
Photograph 3: The old Port Gregory Road crossing although slowly eroding away is still obstructing small to medium flows

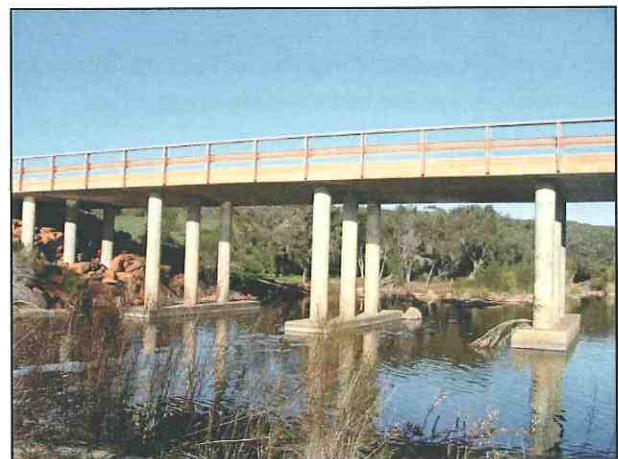
Photograph 4: The new Port Gregory Road bridge minimised disturbance to flow.

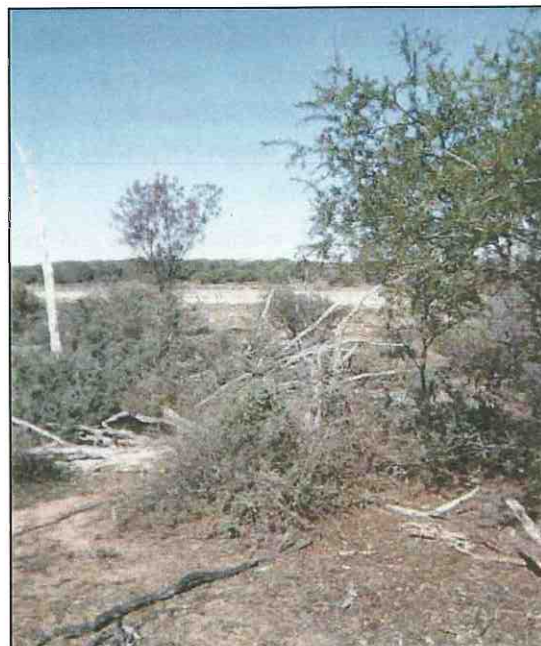
*Photograph 8: Where stock has been excluded the foreshore is graded B. Here the stream cover and fringing vegetation slows evaporation and provides habitat.*

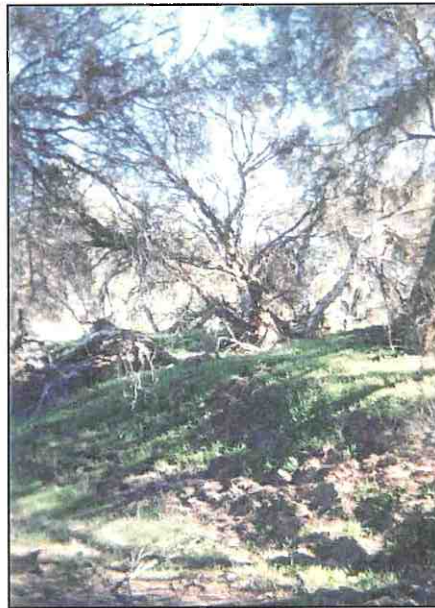
*Photograph 9: Stock movement in the river adversely affects water quality. Stock mobilise plant nutrients via their faeces, limit growth of understorey plants that are important to good water quality and promote erosion by breaking down the bed and banks.*

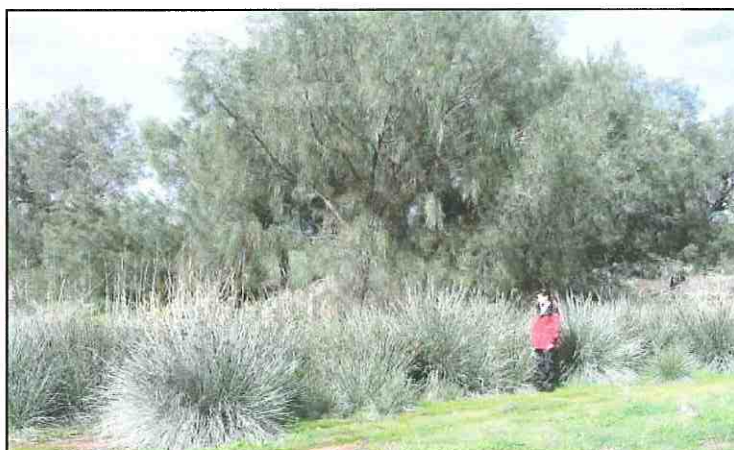
Photograph 10: Spiny rush (*Juncus acutus*) infestation along a tributary of the Hutt River. Spiny rush is an aggressive weed that is not readily eaten by grazing animals. Once established it covers an area and eliminates almost all other vegetation. Stands can become impenetrable to livestock and humans and the sharp spikes are a danger to animals' eyes.

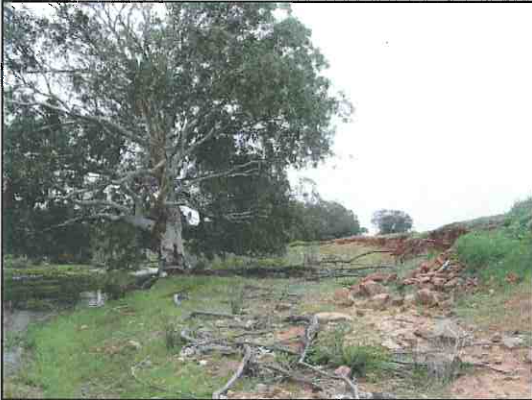
**Erosion:** Erosion leads to widening of the river, loss of adjacent land, disturbance of vegetation and increased sediment. Sediment then causes the river to get shallower, fills pools and covers rocks, vegetation and other habitat.

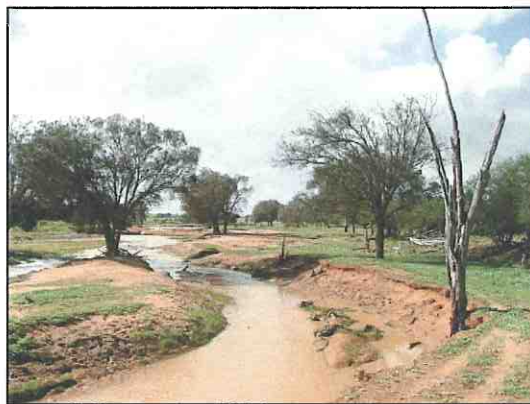
**Lack of vegetation:** Riparian vegetation protects the banks from erosion, provides shade and habitat and prevents nutrient and sediment runoff from adjacent paddocks reaching the river. Verge vegetation protects soil in the floodway from being washed away during large flow events.

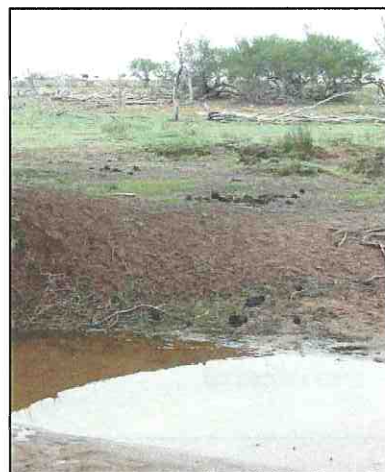
**Stock Access:** Stock movement in the floodway limits regeneration, disturbs the banks making them prone to erosion and mobilises nutrients.

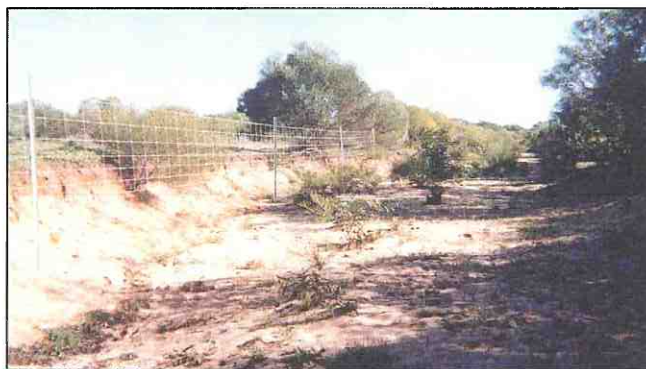
*Photograph 14: Fence too close to the floodway which was not protected from washouts in large flows*

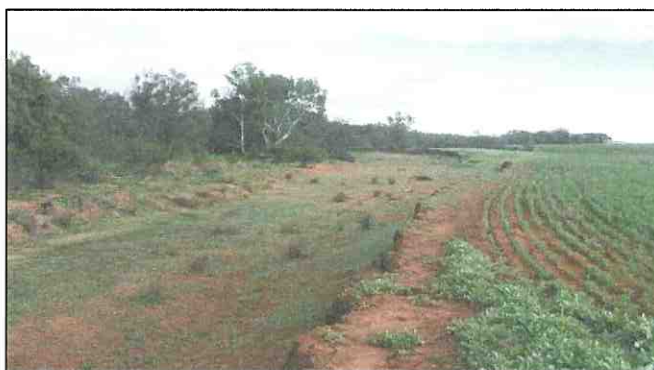
*Photograph 15: Thin band of riparian vegetation along the river has allowed large flows to go around and cause a large washout of vulnerable unprotected land. Resulting in a greater loss of cropping land.*
