Mitigating risks and ensuring the safety of pre-1990's brick buildings

Building and Energy | Department of Energy, Mines, Industry Regulation and Safety

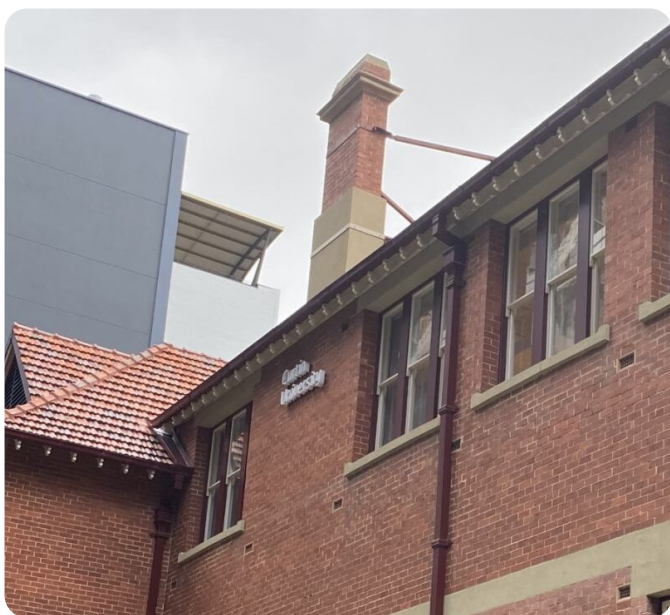
Older chimneys sticking out of roofs pose a threat to breaking off under sideways forces from strong winds or earthquakes.

An example of a strengthened chimney is provided below:

Common ways to restrain the chimney and prevent failure is to brace the chimney back to the roof structure. A strap or rod is also used to squeeze the chimney together, preventing cracks that can allow part of the chimney to separate due to bending caused by sideways forces.

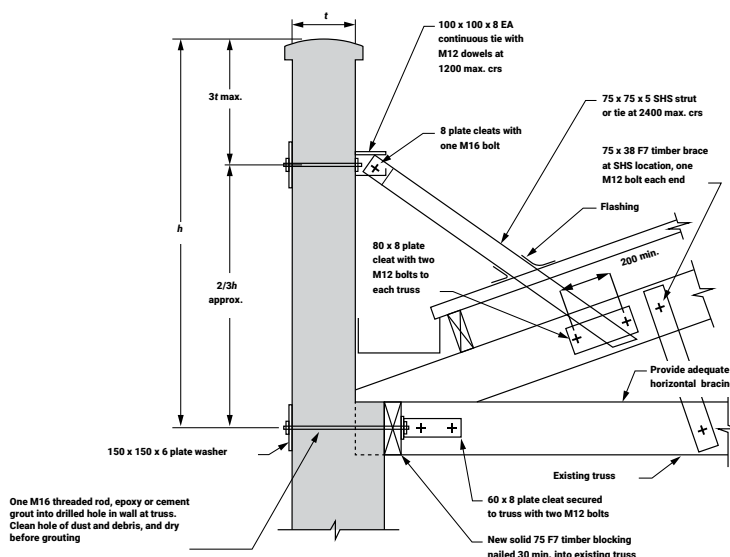
Building and Energy investigated the collapse of a gable wall onto the building's awning during a strong wind event. The awning also collapsed. Awnings collapsed by falling walls have resulted in loss of life in Australia, in Newcastle (1989) and Bathurst (1998).

Such failures are commonly prevented by tying the wall areas back to the roof and ensuring connections to the wall fix all the way through and use plates to spread the load out. Below is an indicative (only) example from the now withdrawn Australian Standard AS3826 - 1998.

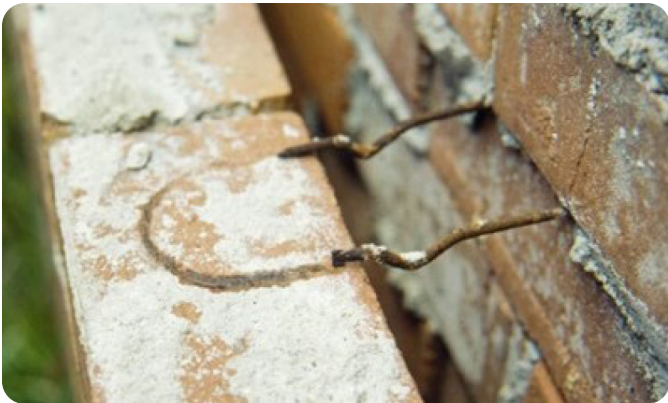
The corrosion of wall ties (the metal ties that are built into the brickwork to tie it to the stable structure behind) is a growing concern affecting the stability of brick buildings. There are resources available [online](#), particularly in the United Kingdom providing some history, background, and treatment methods for addressing this concern.

Corroded wall ties can be difficult to detect as they typically exhibit the heaviest corrosion within the mortar of the external brick wall leaf (see below for corrosion visible only after the removal of bricks).

Methods of identifying the condition of wall ties involve visual inspection through borescope cameras guided through the wall cavity. These look for corrosion in the exposed part of the brick tie but can underestimate how rusted the parts built into the mortar are. Another relatively inexpensive method involves removing bricks from the wall. How rusted the wall ties can become along their length will depend which wall on a building they are in, how exposed that part of the wall is and how wet/dry that wall stays. For this reason, adequate sampling around the full perimeter and height of the building is recommended.

Depending on the severity of corrosion and future building use, several options may be considered for rectification. These range from placement of new retrofit ties that are drilled through the walls, to the rebuilding of part or whole sections of walls, to demolition. Where corrosion of wall ties is advanced, as rusted steel can expand to several times its original volume, wall expansion may result in cracking, outwards bowing and the vertical movement of walls. Additional work will be required to fix such walls.
