# ABANDONED MINE FEATURES ASSESSMENT

## NORTHAMPTON – COMMONAGE & WANERENOOKA GEOTECHNICAL REPORT

11126-G-R-001 Public Document

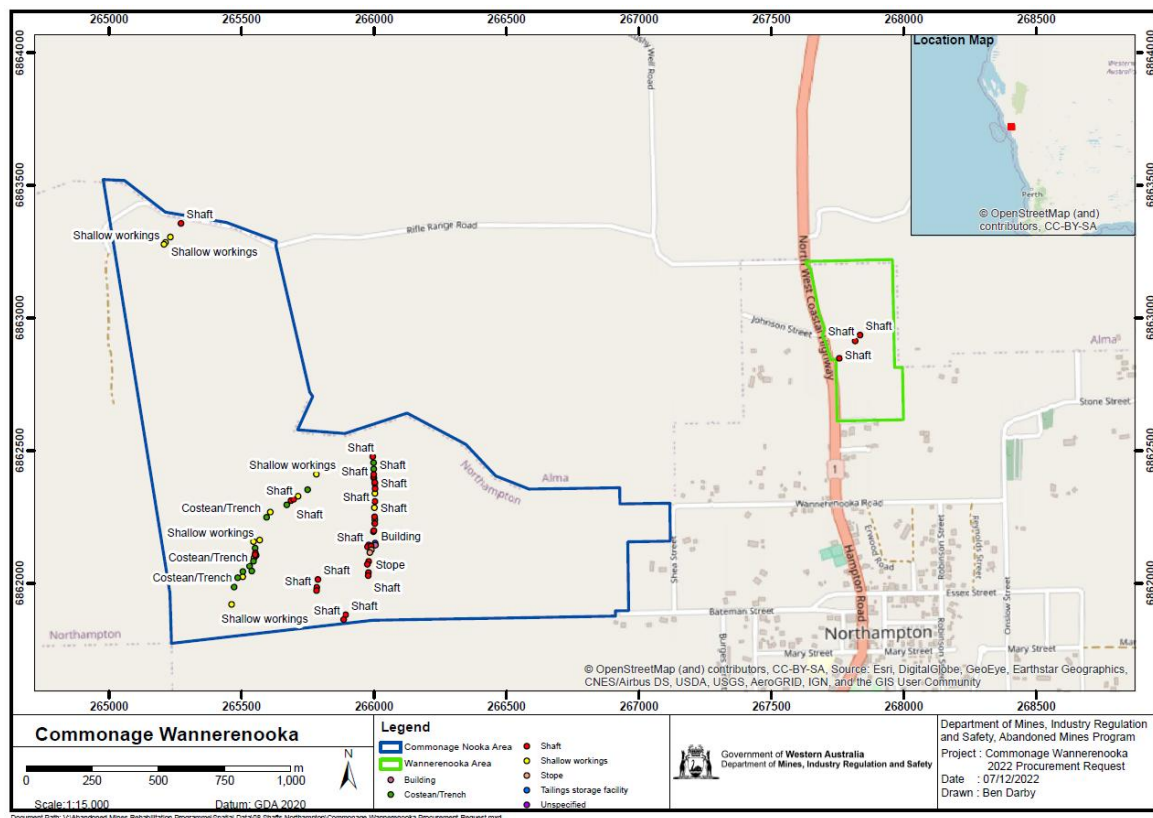
Figure 1: Commonage and Wanerenooka plan, prepared by DEMIRS

Location of the 57 Commonage and 3 Wanerenooka features are shown on the site maps, 11126-G-D-001 to -007, and are shown in the image below.

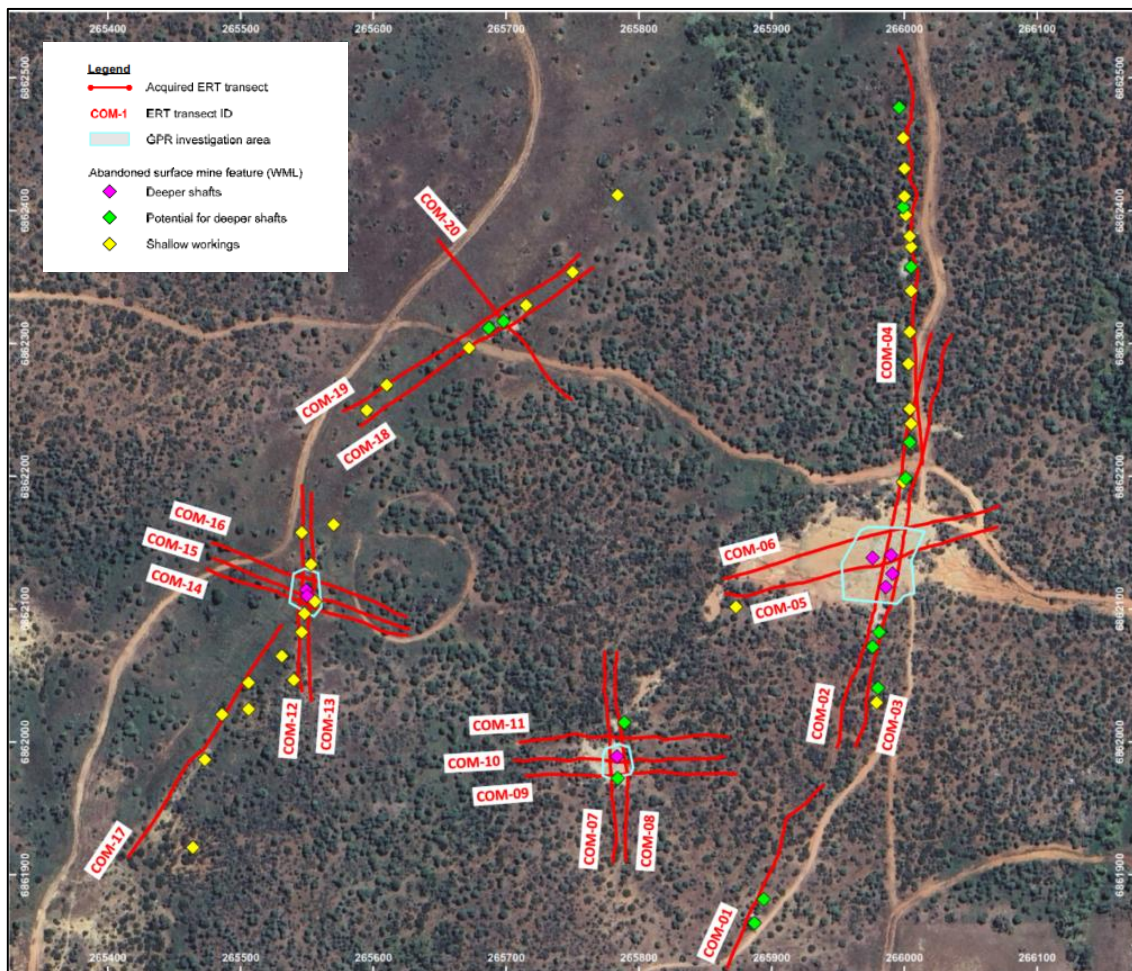
Figure 2: Geophysical test locations – Commonage

Anomalous subsurface features discovered via ERT testing have been labelled as targets and GPR testing indicated worked ground with voiding potential of subsurface material have been mapped. It should be noted that these detected abnormalities can be interpreted as either rocky material or void space (i.e. air), as both substances display high electrical resistivity properties. The larger targets may likely be interpreted as rocky material; WML have undertaken test pitting, borehole drilling, and ground prodding at selected target locations to confirm the presence of rock.

Where large targets have been identified outside of the main mining areas, as indicated by the available historical information, these are likely to be high strength rock; in many cases these have been investigated by test pitting or borehole drilling, which confirmed there exists no risk of voids at these targeted locations.

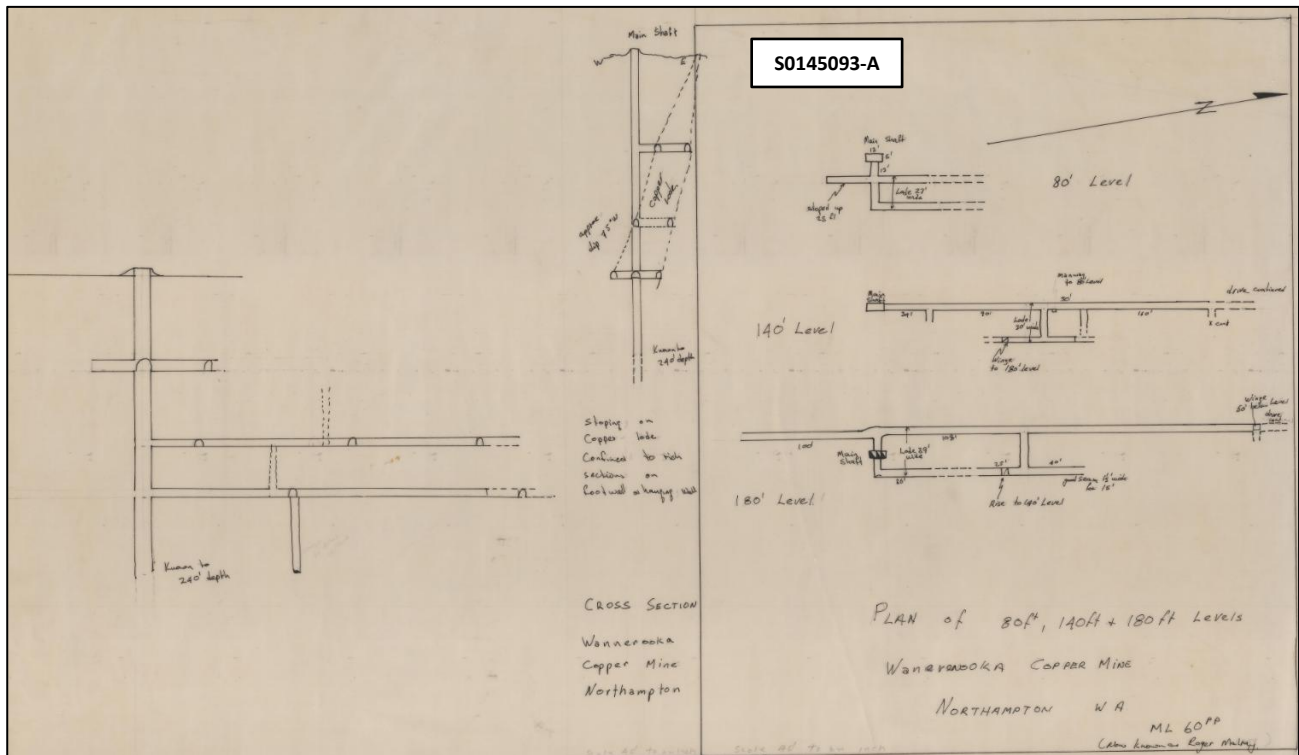
Figure 5: 984 Wanerenooka copper mine plan of levels (1957)

inches thick, in a lode 30 inches wide, which increases in thickness with depth of levels (from 8 m to 12 m wide). In the hanging wall were large veins and small pockets of copper ore, the veins pinching out and replaced with galena (lead). The copper veins were up to 15 cm wide, in siliceous breccia with fine grained disseminated pyrite, with 1 – 5 mm diameter galena fragments, copper-stained aplite and quartzose pegmatite, granulite, and vuggy quartz, coarse galena, and fine grained pyrite-chalcopyrite. Lead mineralization was only found on the hanging wall side, 11.8 m wide, while copper veins, 300 m wide, were found in both the hanging wall and footwall.

Based on the available historical information, it is unclear whether the underground mine workings have been backfilled or left as is.

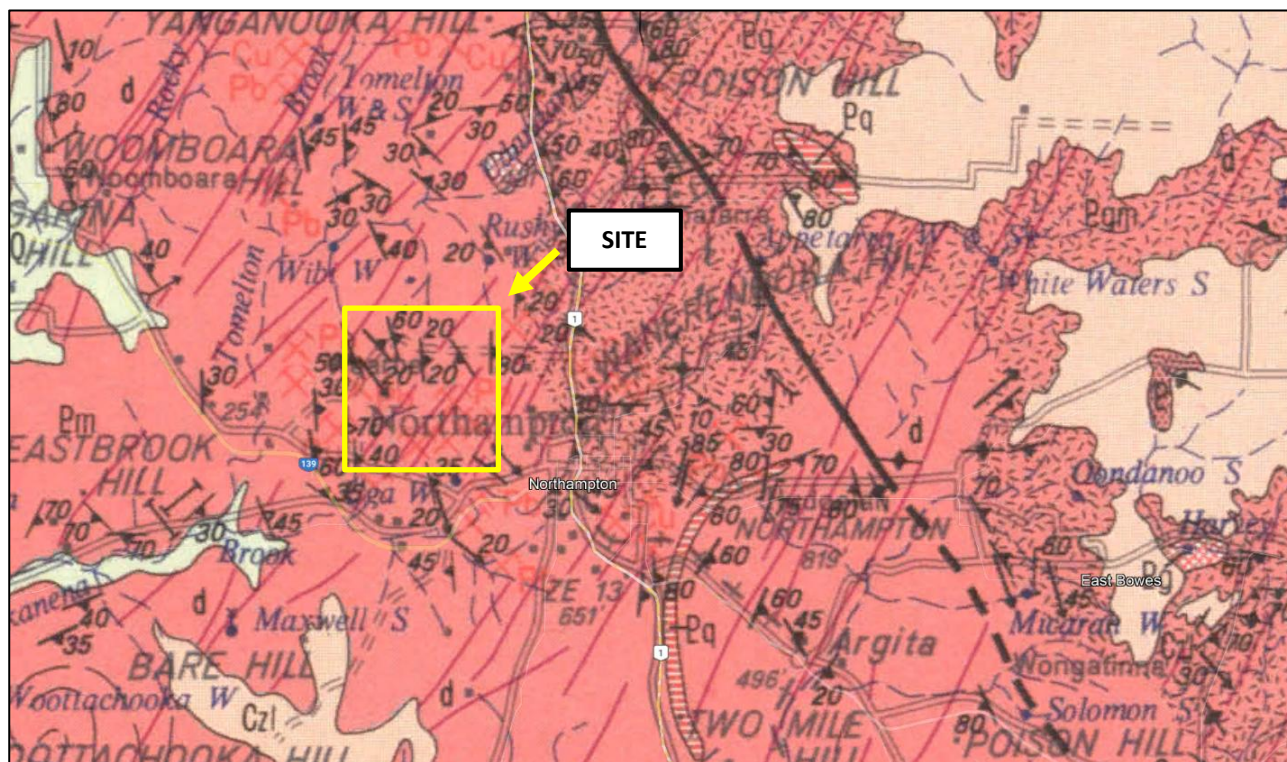
**Figure 7: Extract from the 1:250,000 scale Geological Map "Geraldton"**

The 1:250,000 scale Geological Map 'Geraldton' indicates that the site is underlain by the following geological unit:

- **Pm:** Granulite – including cordierite gneisses, predominantly metasedimentary.

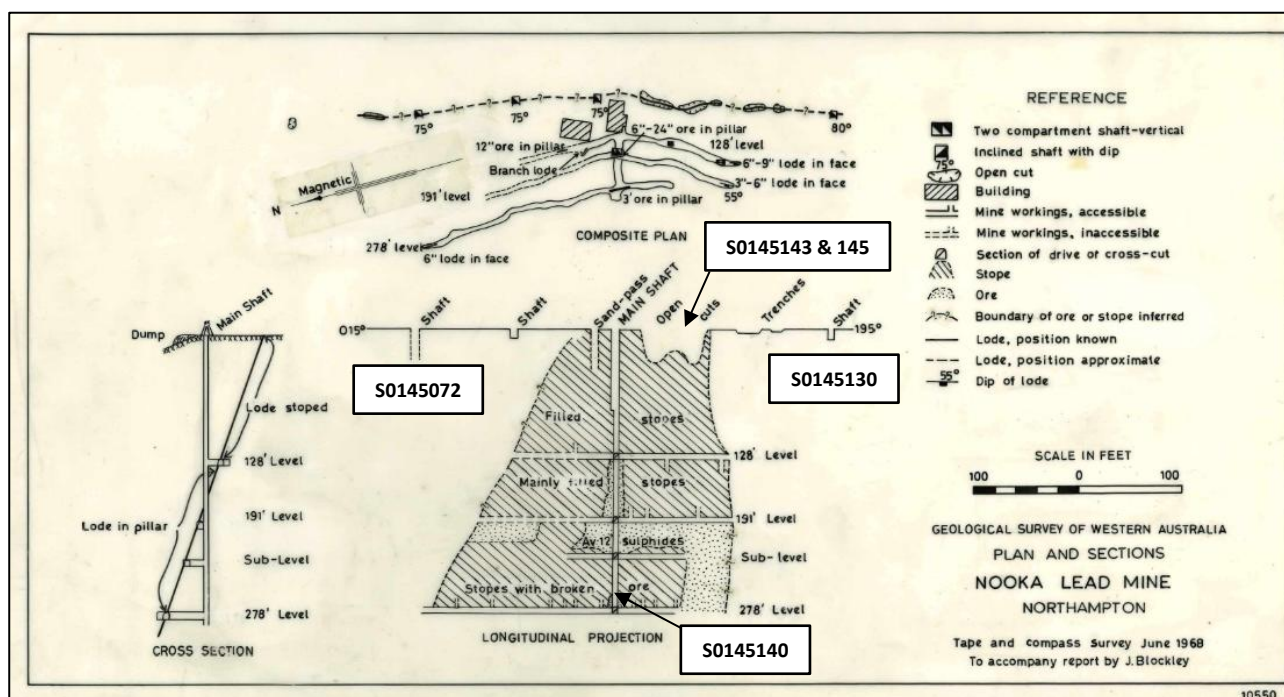
Figure 8: 10550 Nooka Lead Mine (1968)

Review of available historical information indicates the extent of mine working within the Nooka mine site, as shown in Figure 8. Figure 9 shows the location of the features observed and identified on site during the field investigation in relation to the historical maps of the mine. The 1968 plans show levels of lateral workings / drives; there are three levels of workings, some of which have been filled or partly filled, other areas exist as stopes, however, there is no indication in what condition these areas currently exist. These areas are likely as wide as necessary for one person to fit through as the lodes are shown to be between 8 cm – 22 cm wide. The plans indicate that the mine had been worked to a depth of 85 m, and the upper levels are located at 39 m and 58 m below ground level.

An inspection of the mine was undertaken in 1906 to determine the extent of workings; extensive but shallow workings following a distinct fissure vein were noted, with much of the lode altered dyke rock. The area had second class ore of quartz, galena, sphalerite, copper pyrites and carbonates of lead plentiful in weathered material. Sphalerite and copper staining was also common.

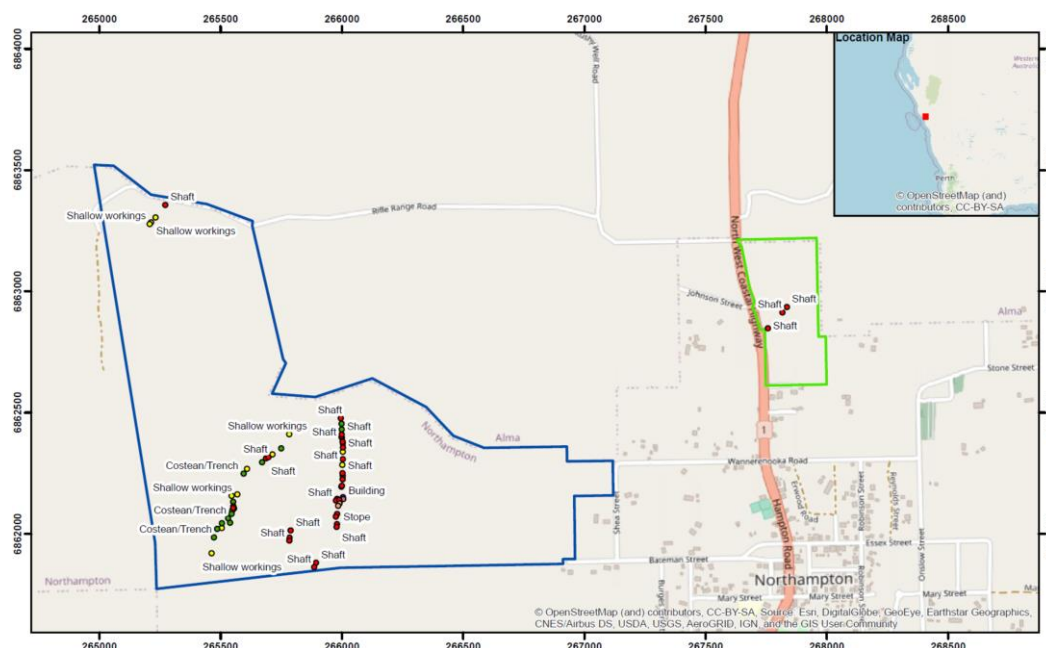
**Figure 1: Site map of Commonage (blue polygon) and Wannerenooka (green polygon) showing abandoned surface mine features (datum GDA2020). Drawing from DMIRS, 7 December 2022.**

The geophysical investigation was carried out at the Commonage and Wannerenooka sites within the Shire of Northampton Western Australia. An overview map of the sites with the locations of recorded abandoned surface mine features is shown in Figure 1.

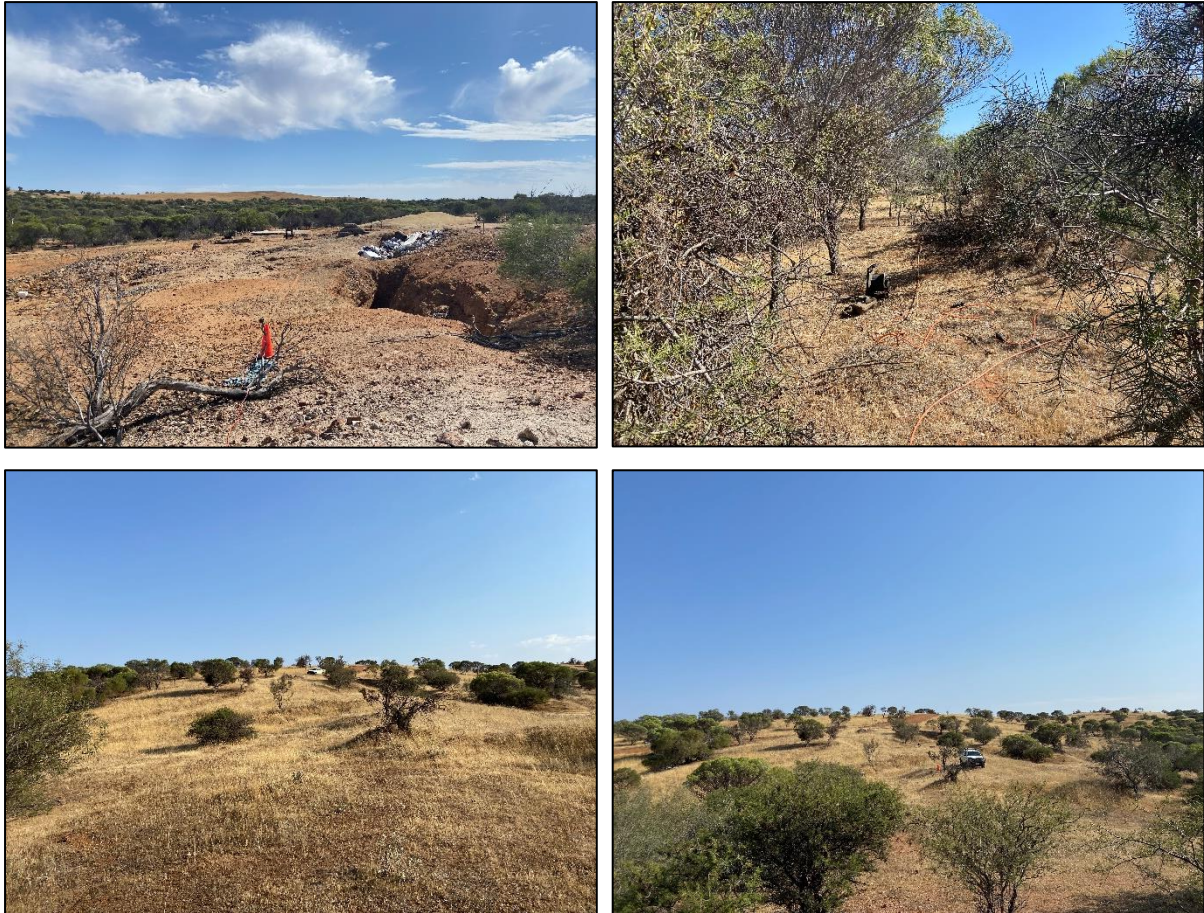
**Figure 2: Typical ground surface conditions at Commonage.**

Surface conditions at the sites were suitable for geophysical data acquisition and included sparse to moderate vegetation with low trees and open areas with remnant mining infrastructure. Photographs showing the typical site conditions are presented in Figure 2 for Commonage and Figure 3 for Wannerenooka.

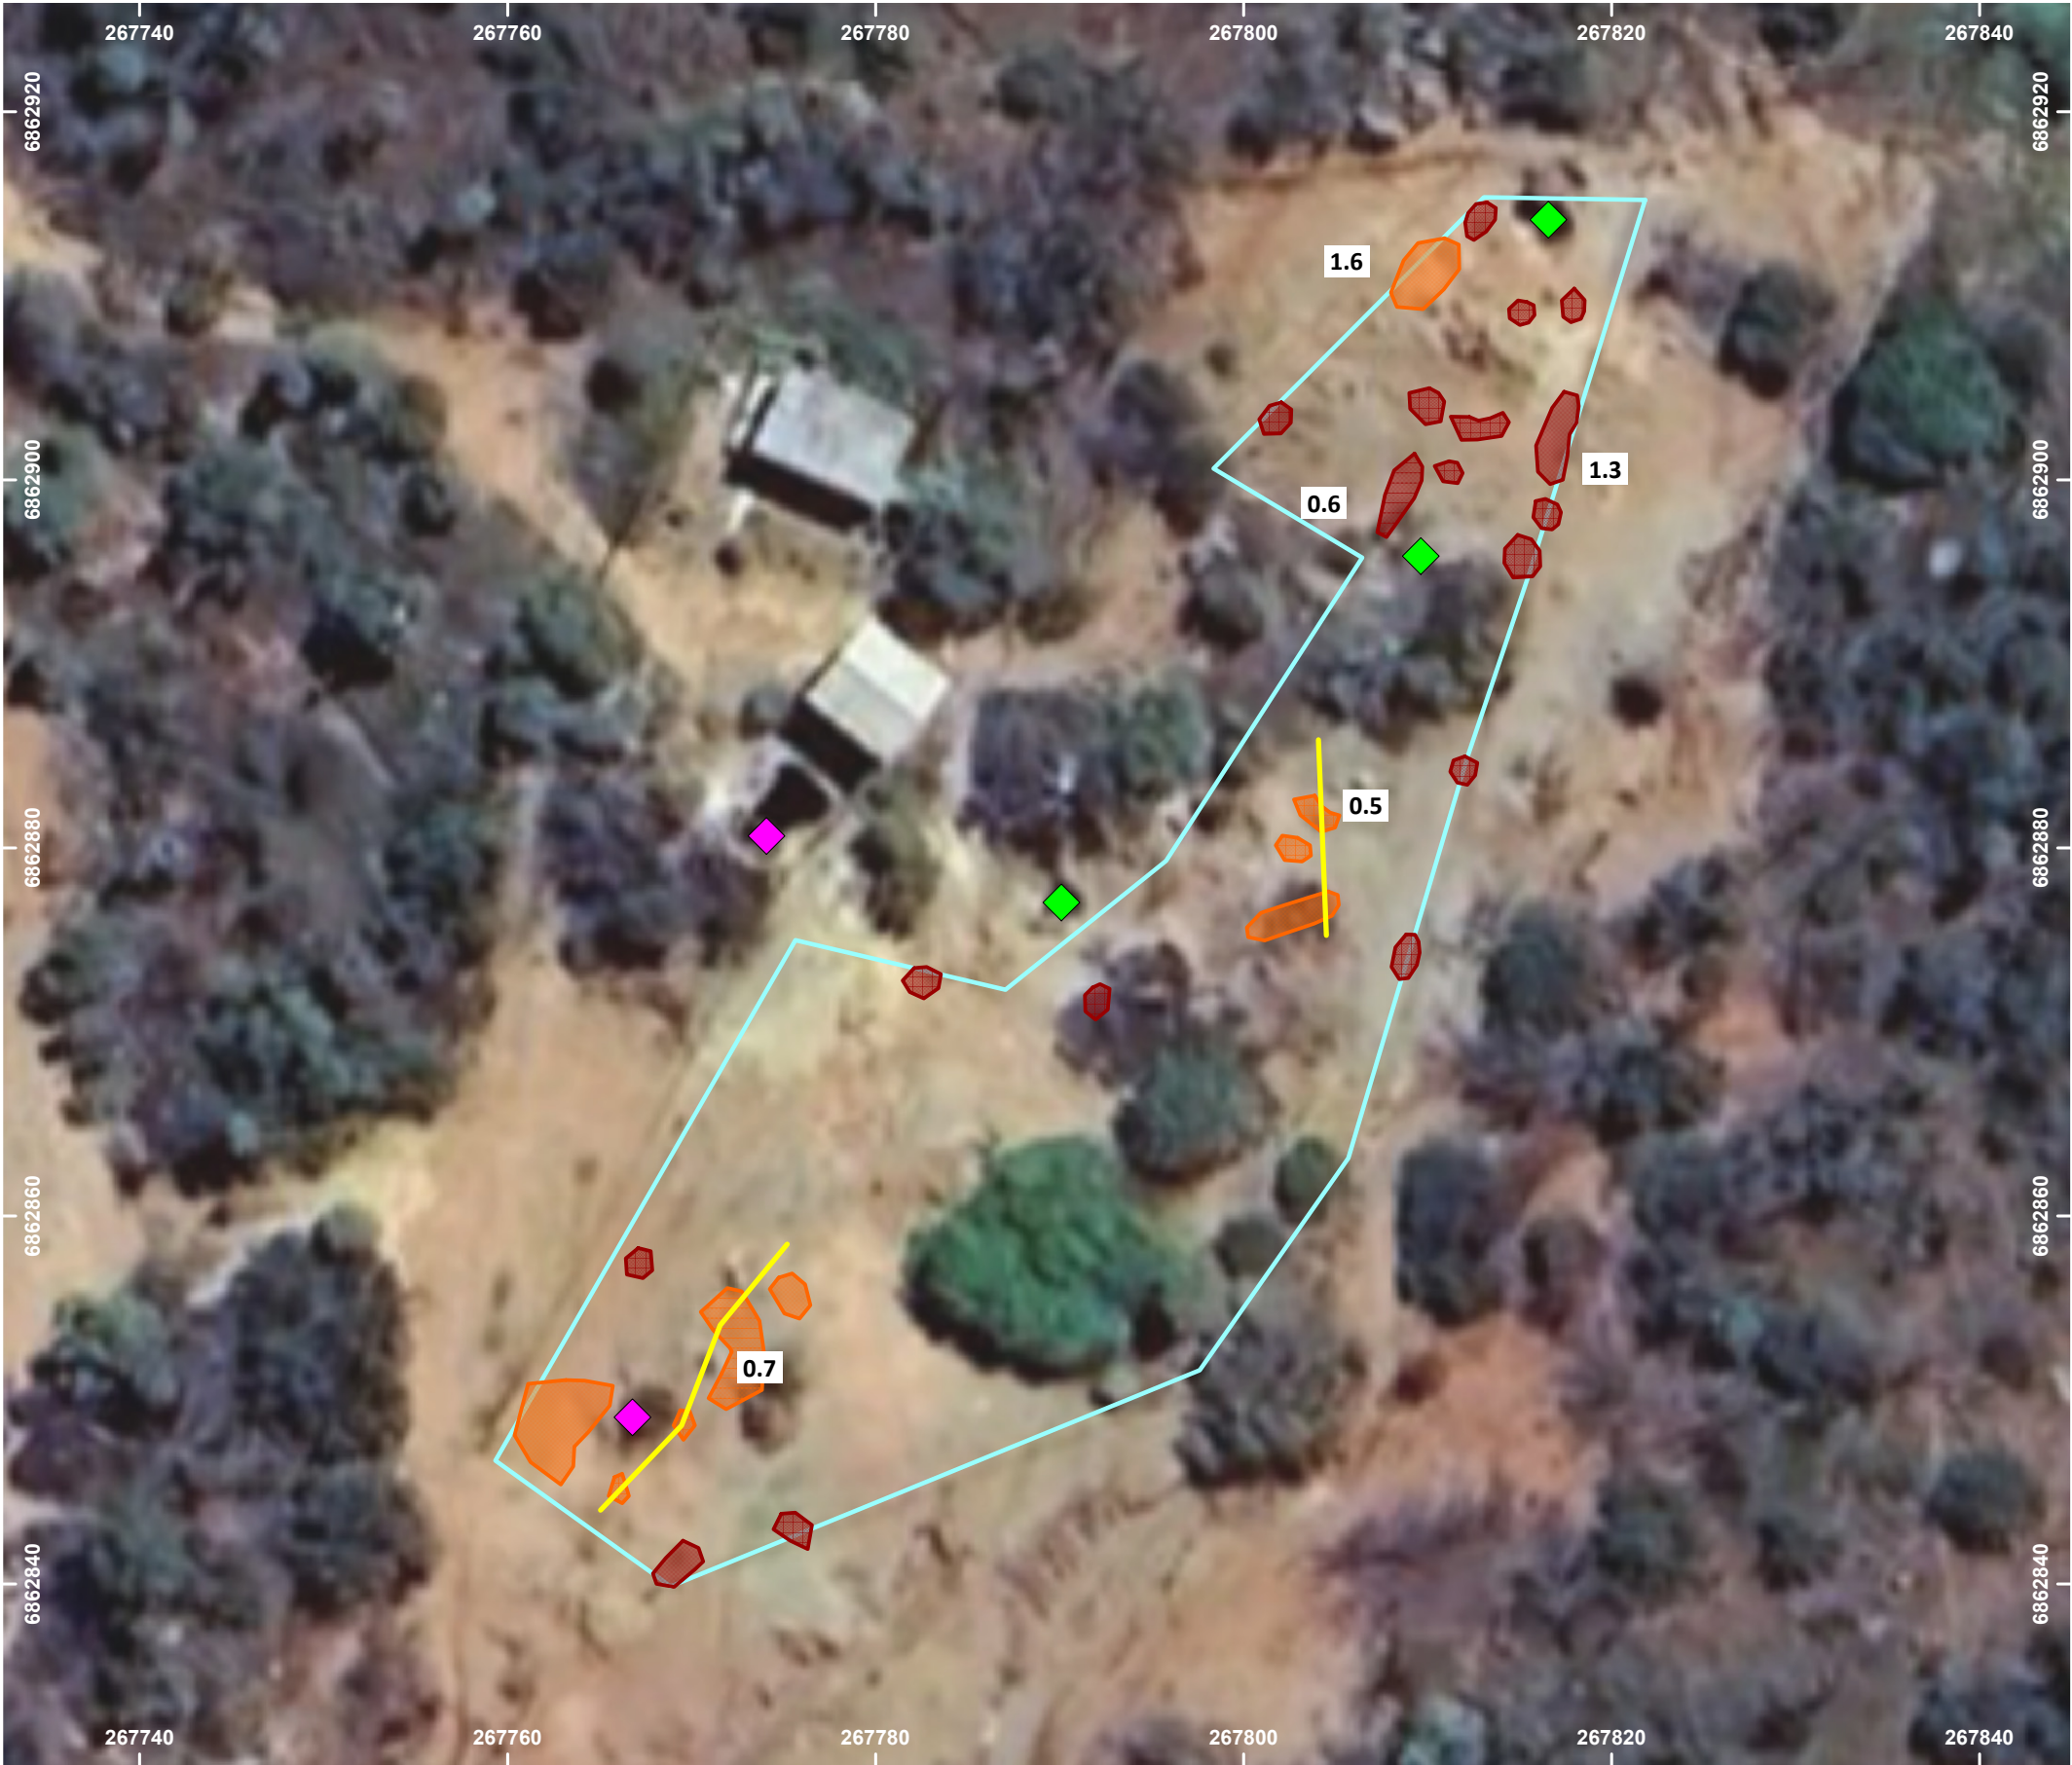
**WANNERENOOKA GPR INTERPRETATION**

- Legend**
- Potential shallow mine workings
  - Worked ground with low potential for voiding of subsurface material
  - Worked ground with high potential for voiding of subsurface material
  - 0.5 Depth to feature (mBGL)
  - GPR investigation area
- Abandoned surface mine feature (WML)
- Deeper shafts
  - Potential for deeper shafts
  - Shallow workings
