# Structure Plan

**Lot 601 Old Pinjarra Road,  
Greenfields**

Client Manager: Matt Young  
Report Number: PR 123894-1  
Version / Date: May 2016

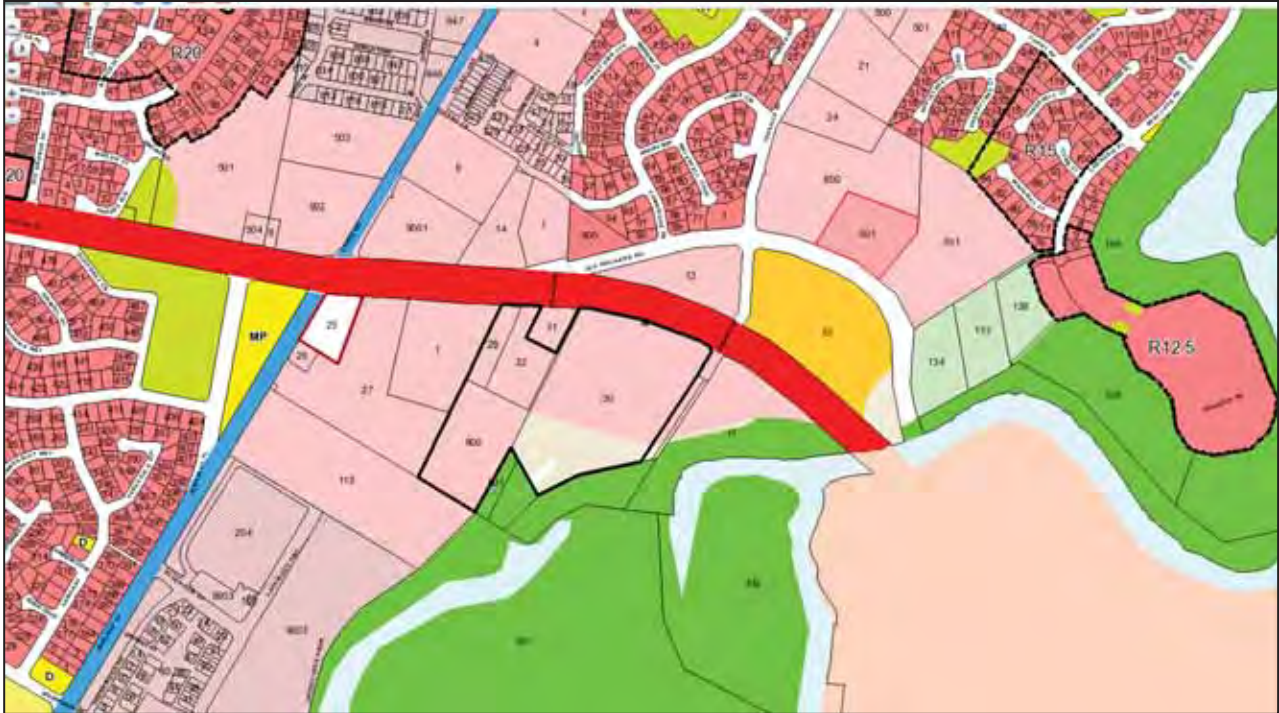
**Figure 3** – Zoning – City of Mandurah Town Planning Scheme No, 3 (Source: City of Mandurah Intramaps)

The City of Mandurah Town Planning Scheme No.3 provides the planning framework to achieve sustainable development in the locality, by integrating economic, social and environmental aspirations. The Scheme outlines the applicable zoning and related objectives for each zone, of which the subject site is zoned ‘Urban Development’ (refer **Figure 3**).

The ODP is considered consistent with the TPS3 zoning, and is required under section 7.11 of the Scheme.

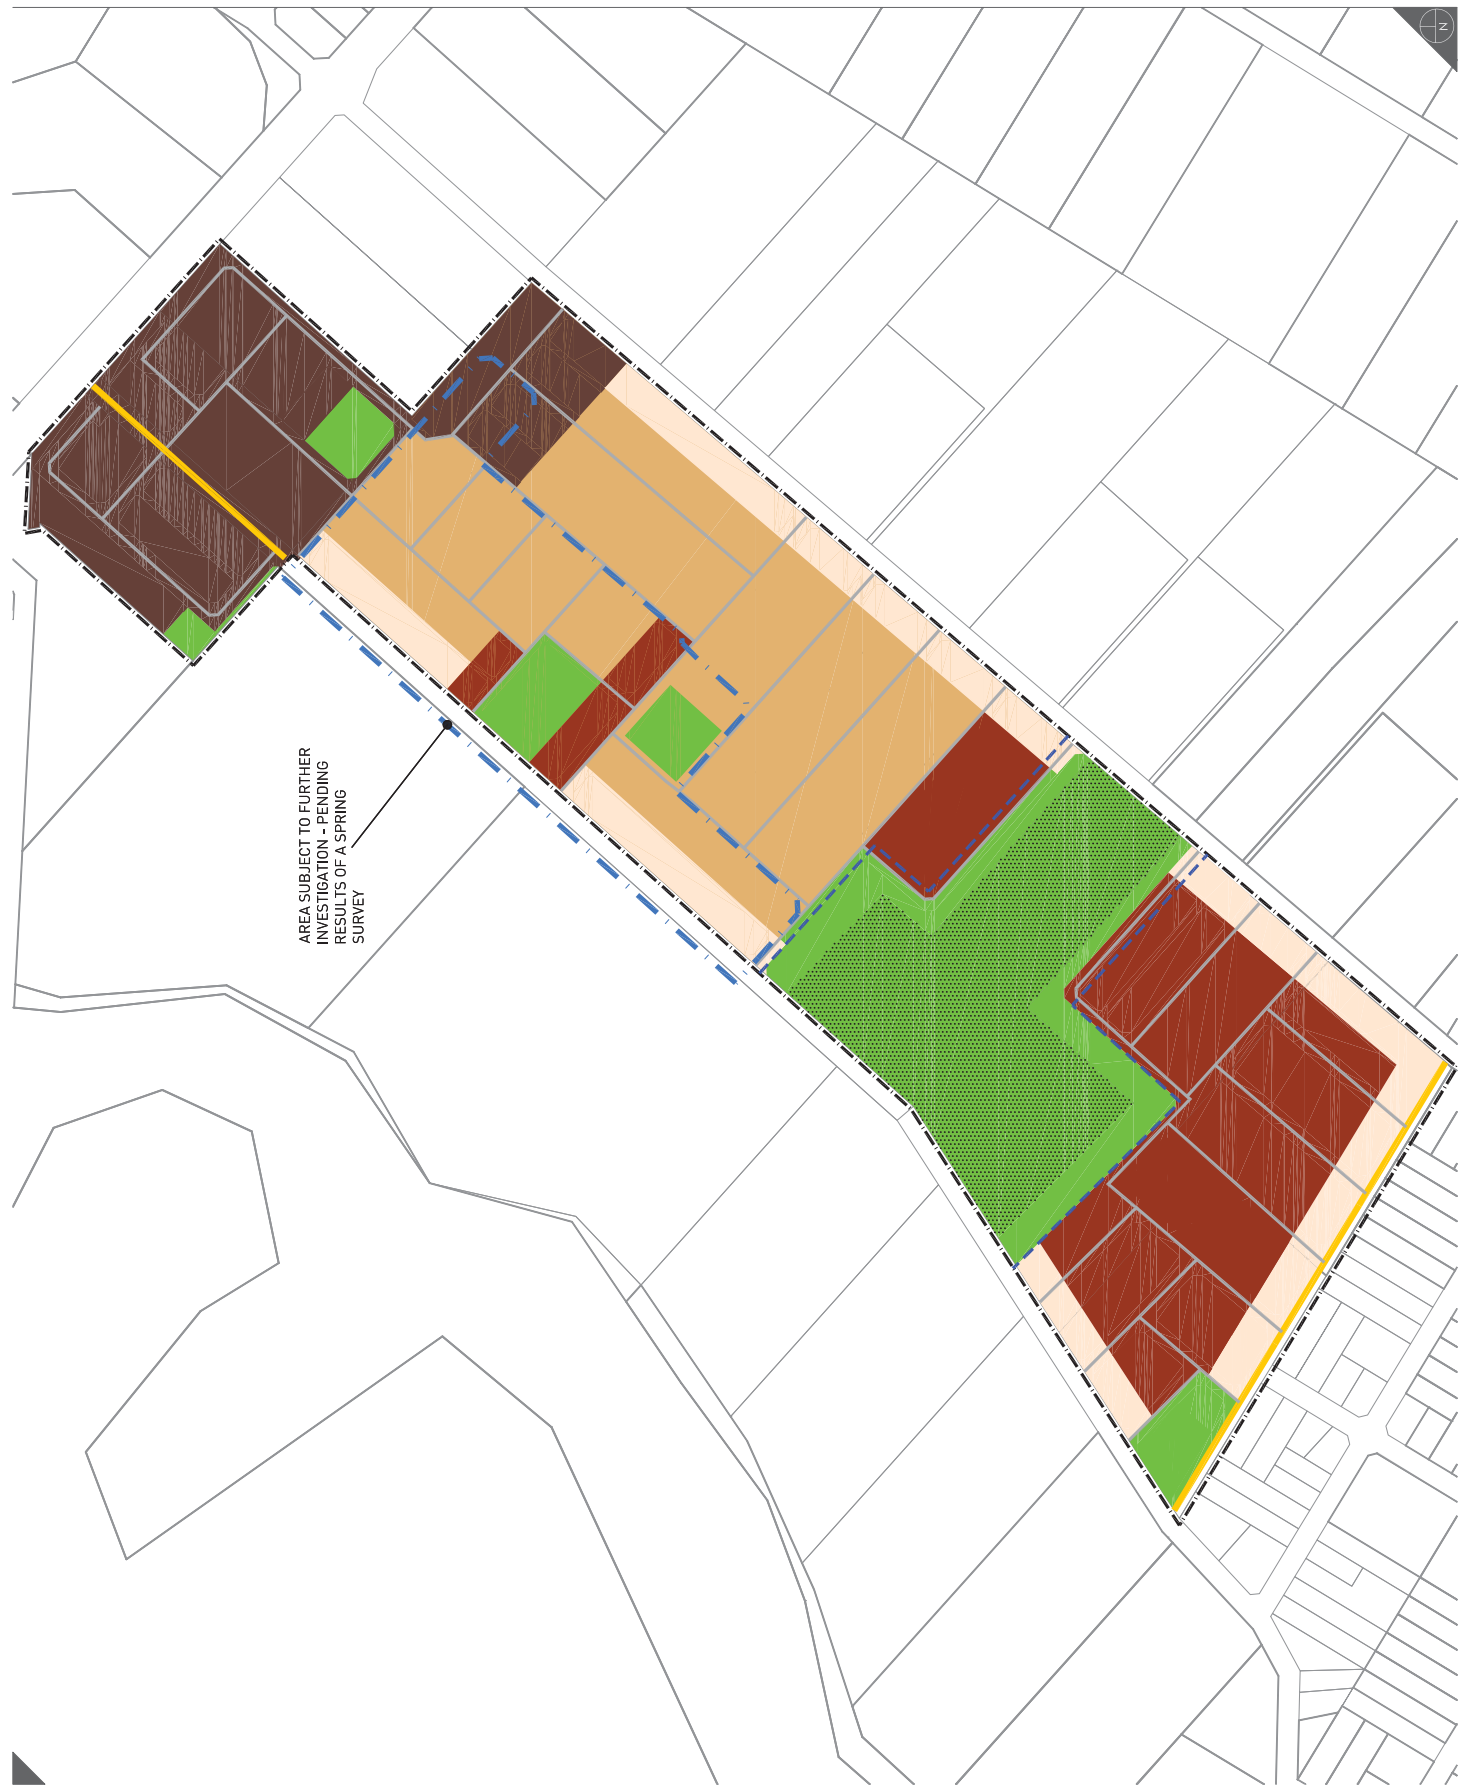
Furnissdale West (Figure 12)

# Outline Development Plan

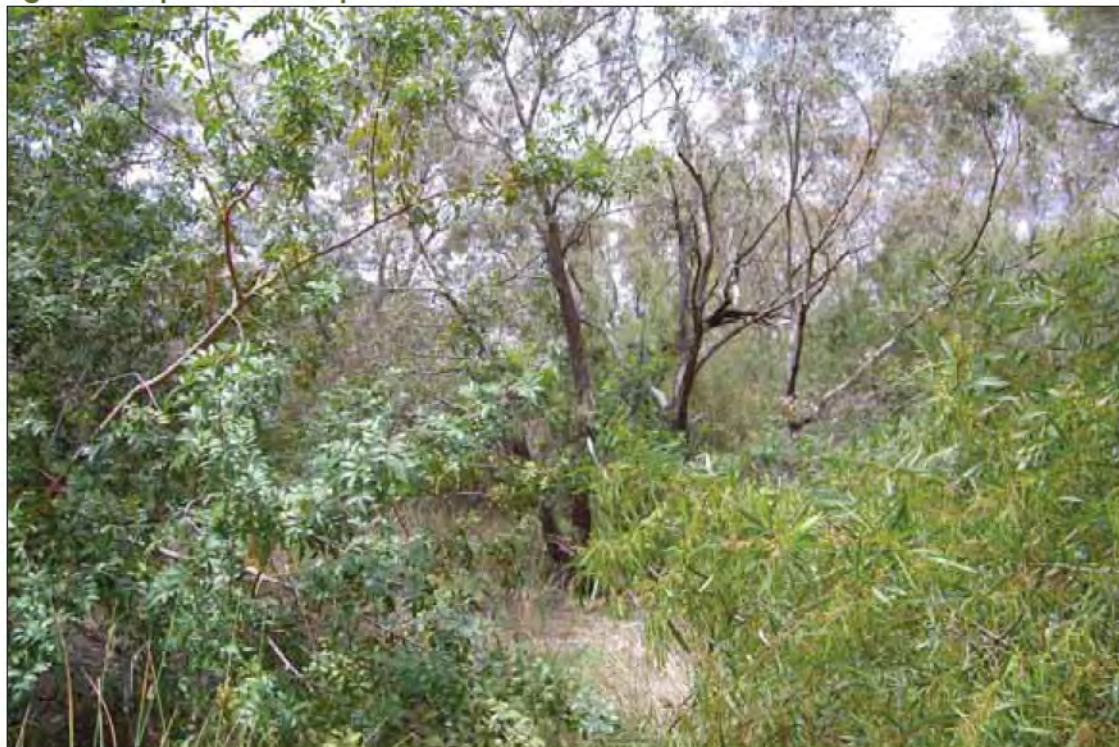
Figure 2: Vegetation Community 1 – Note Victorian Tea Tree and Sydney Wattle.

- Vegetation Community 1 (3,556 m<sup>2</sup>) (Figure 2) – Low Woodland of *Eucalyptus rudis* (Flooded Gum) over Tall Shrubland of *Acacia longifolia*\* (Sydney Golden Wattle) and *Leptospermum laevigatum*\* (Victorian Tea Tree) over Open shrubland of *Viminaria juncea*, over scattered sedgeland of *Juncus pallidus*, over grassland of *Avena barbata*\*, *Ehrharta calycina*\*, *Eragrostis curvula*\* over dense areas of *Lotus subbiflorus*\*. Other species present in this section include *Melaleuca raphiophylla*, *Hypochaeris spp*, and *Lupinus cosentinii*\*. The area is dominated with introduced plant species including a significant number of highly invasive Environmental Weeds. Note that the *E. rudis* species present within all of the site, is the standard variety and not the larger fruited *cratyantha* sub species.

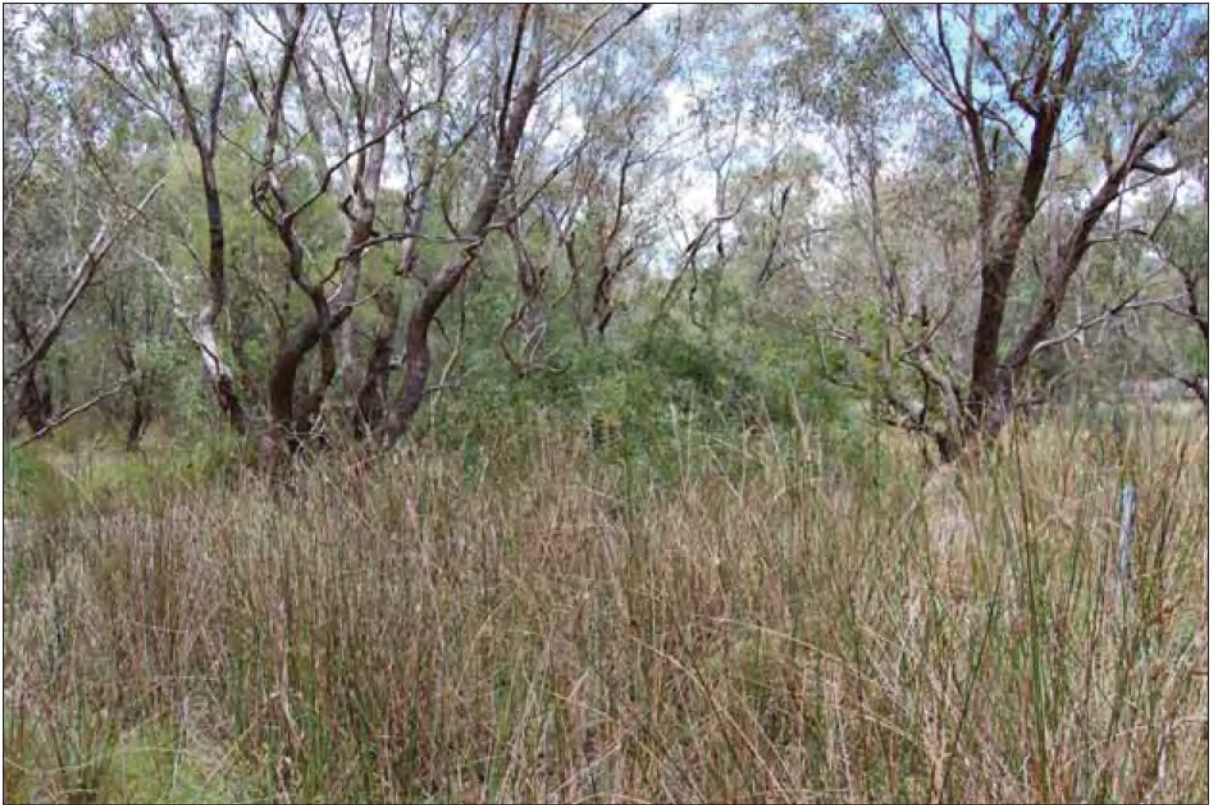
**Figure 3: Vegetation Community 2**

- Vegetation Community 2 (243 m<sup>2</sup>) (Figure 3) – Low Woodland of *Eucalyptus rudis* (Flooded Gum) over Tall Shrubland of *Acacia longifolia*\* (Sydney Golden Wattle) and *Leptospermum laevigatum*\* (Victorian Tea Tree) over Closed Sedgeland of *Juncus pallidus*. Other species present include *Lepidosperma squamatum*, *Briza maxima*\*, *Desmocladius fasciculatus*, *Arctotheca calendula*\* and *Monadenia bracteata*\*. Apart from the few *E. rudis* and pale rushes, the area's mid and understory is dominated by introduced weed species.

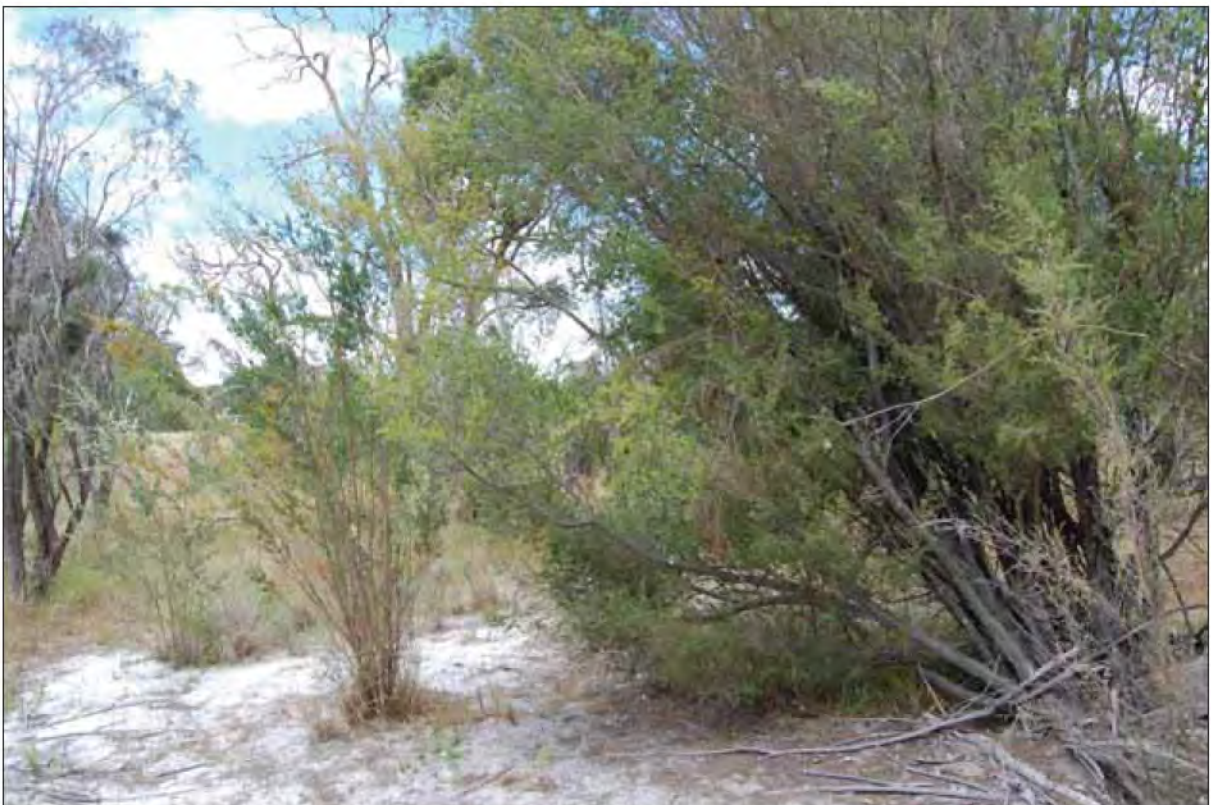
**Figure 4: Vegetation Community 3, northern section/**

- Vegetation Community 3 (1,309 m<sup>2</sup>) (Figures 4) – Tall Open Scrub of *Kunzia ericifolia* and *Jacksonia furcellata* over grassland to closed grassland of *Briza species*, *Avena barbata*\*, *Ehrharta calycina*\*, *Eragrostis curvula*\* and *Lotus subbiflorus*\*.

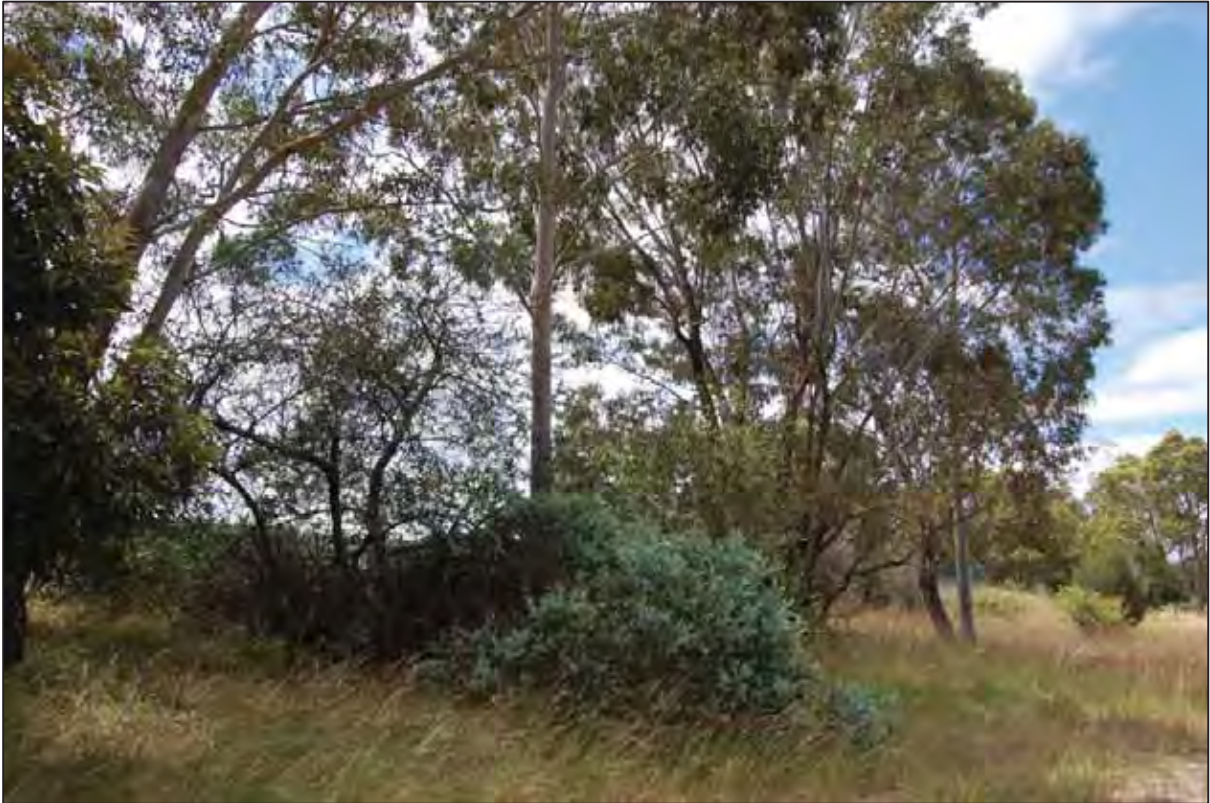
**Figure 5: Vegetation Community 4, mainly planted eucalypts.**

- Vegetation Community 4 (660 m<sup>2</sup>) (Figure 5) – this is an area near the existing house where mixed plantings of Eucalypt species have been established along with a few native trees. It is described as Low Open Woodland of *Corymbia calophylla*, *E. rudis* and planted ornamental eucalypts (for example *E. maculata*) over weedy grassland of *Avena barbata*\*, *Ehrharta calycina*\*, *Eragrostis curvula*\* and *Pennisetum clandestinum*\*.

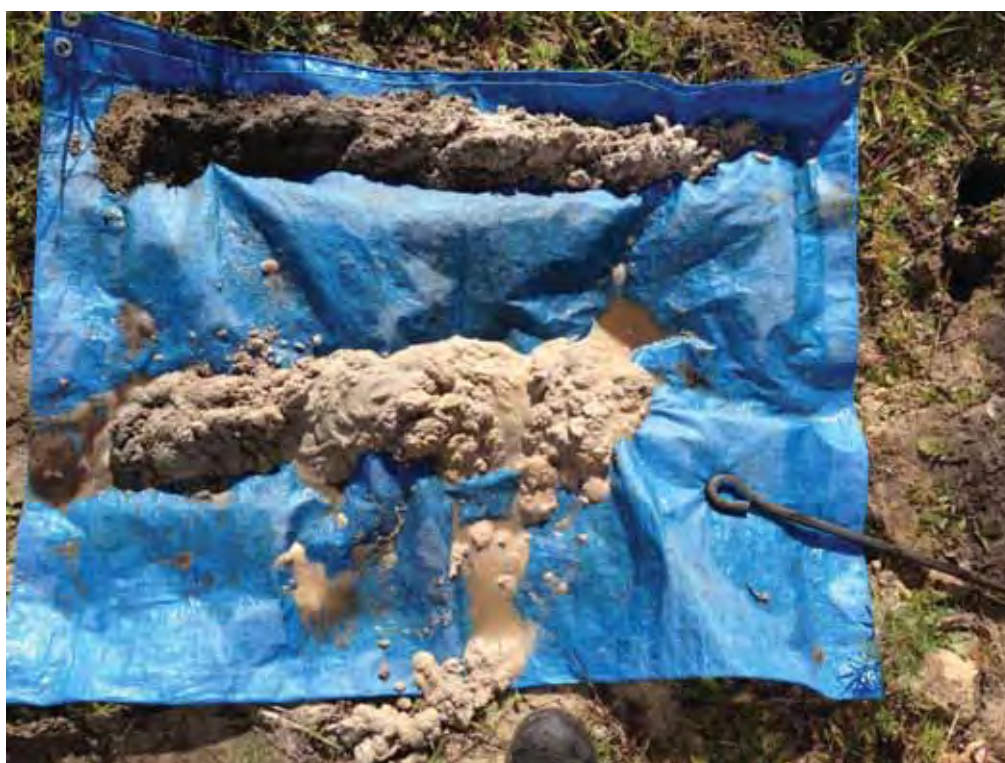
**Photograph 4: Typical hand auger spoil**

- SAND (SP), fine to coarse grained, sub angular to sub-rounded, grey at surface, becoming white, locally pale brown, localised trace organic fines/rootlets/roots (up to 50mm) in top 150mm to 300mm, generally loose to medium dense, moist to wet, present from surface down to the maximum depth of investigation of 2.3m.

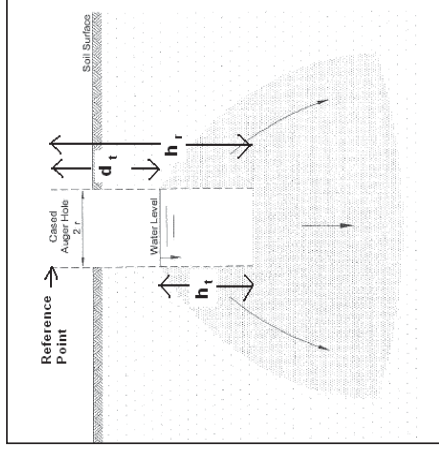
## Test 1

$$K = 1.15r \frac{1}{t - t_0} \log_{10} \left( h_0 + \frac{1}{2}r \right) - \log_{10} \left( h_t + \frac{1}{2}r \right)$$

t (s)	d <sub>w</sub> (m)	h <sub>t</sub> (m)	K (m/s)	K (m/day)
0	0.19	0.42		
30	0.37	0.24	3.9E-04	33.8
60	0.425	0.185	2.8E-04	24.5
90	0.465	0.145	2.4E-04	21.0
120	0.5	0.11	2.3E-04	19.5
<b>AVERAGE</b>			2.9E-04	24.7

Tests undertaken as part of this study show that the sandy soil on the site is relatively permeable, however, on-site disposal of stormwater over the majority of the site (in its current state) is not advisable due to its relatively low elevation and the shallow depth to groundwater. If the ground elevation was raised to 1.2m above the average annual maximum groundwater level (AAMGL), disposal by on site infiltration would be acceptable.

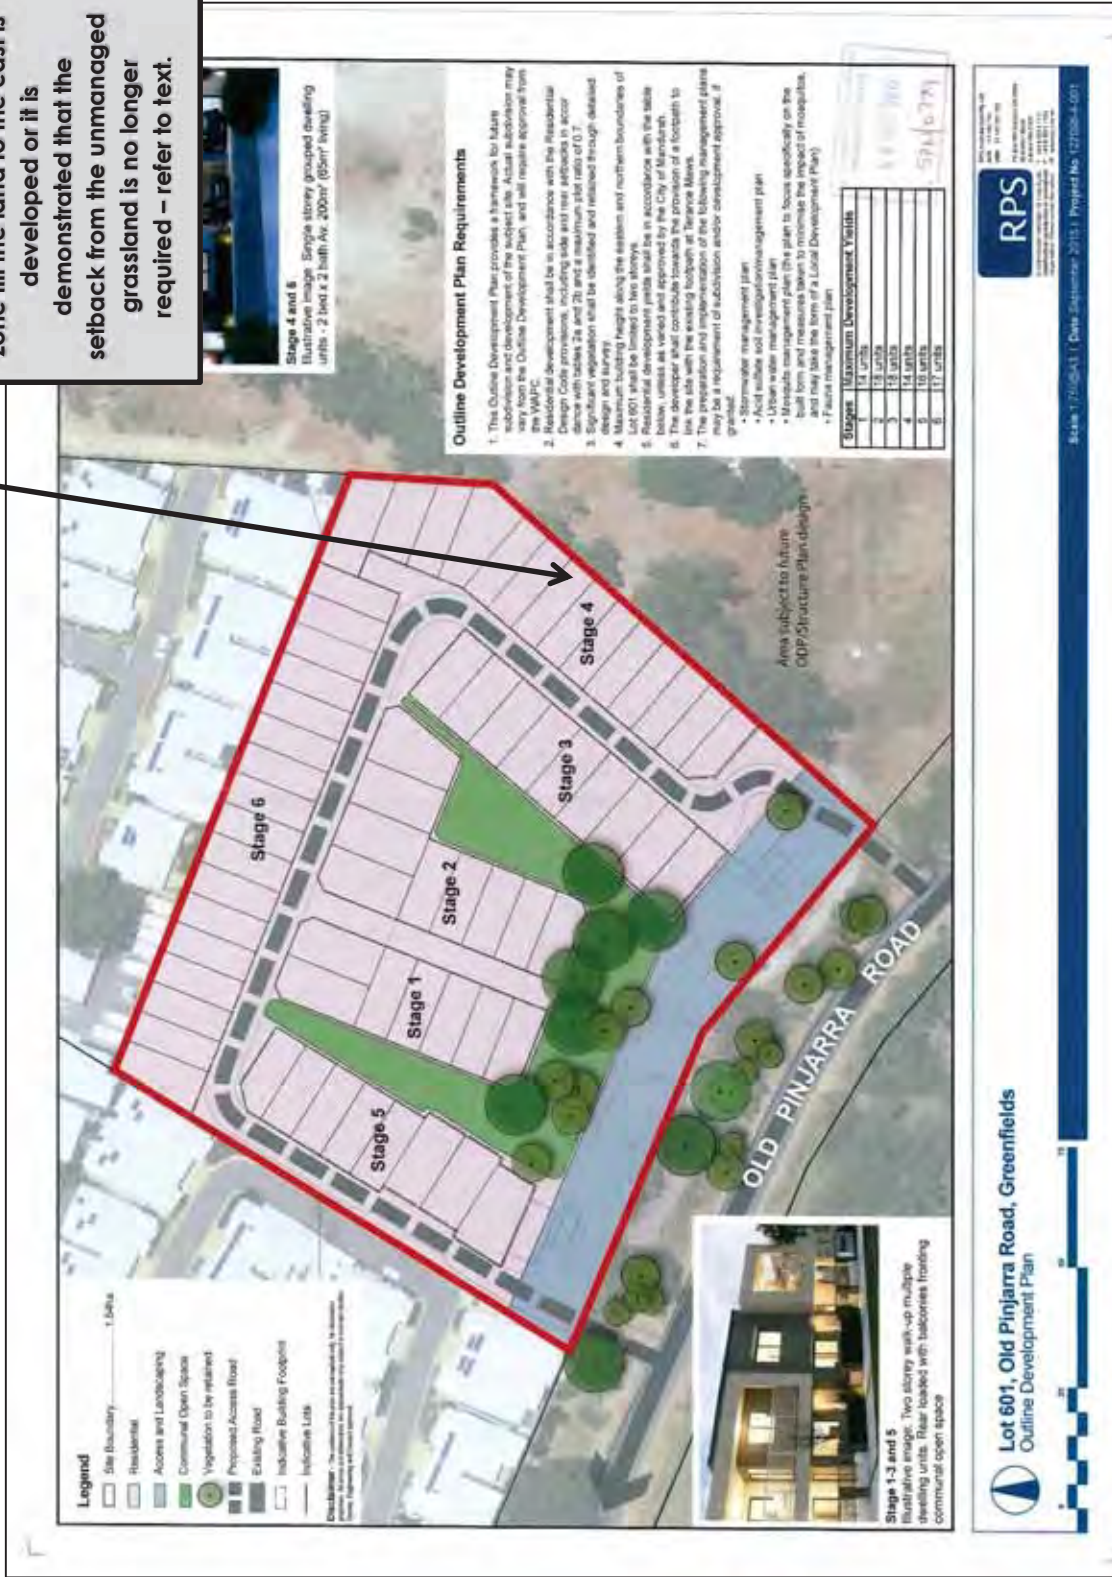
Figure 1: Development Guide Plan for Lot 601 Old Pinjarra Road, Greenfields Refer to Notes on Staging

No Development within this zone fill the land to the east is developed or it is demonstrated that the setback from the unmanaged grassland is no longer required – refer to text.

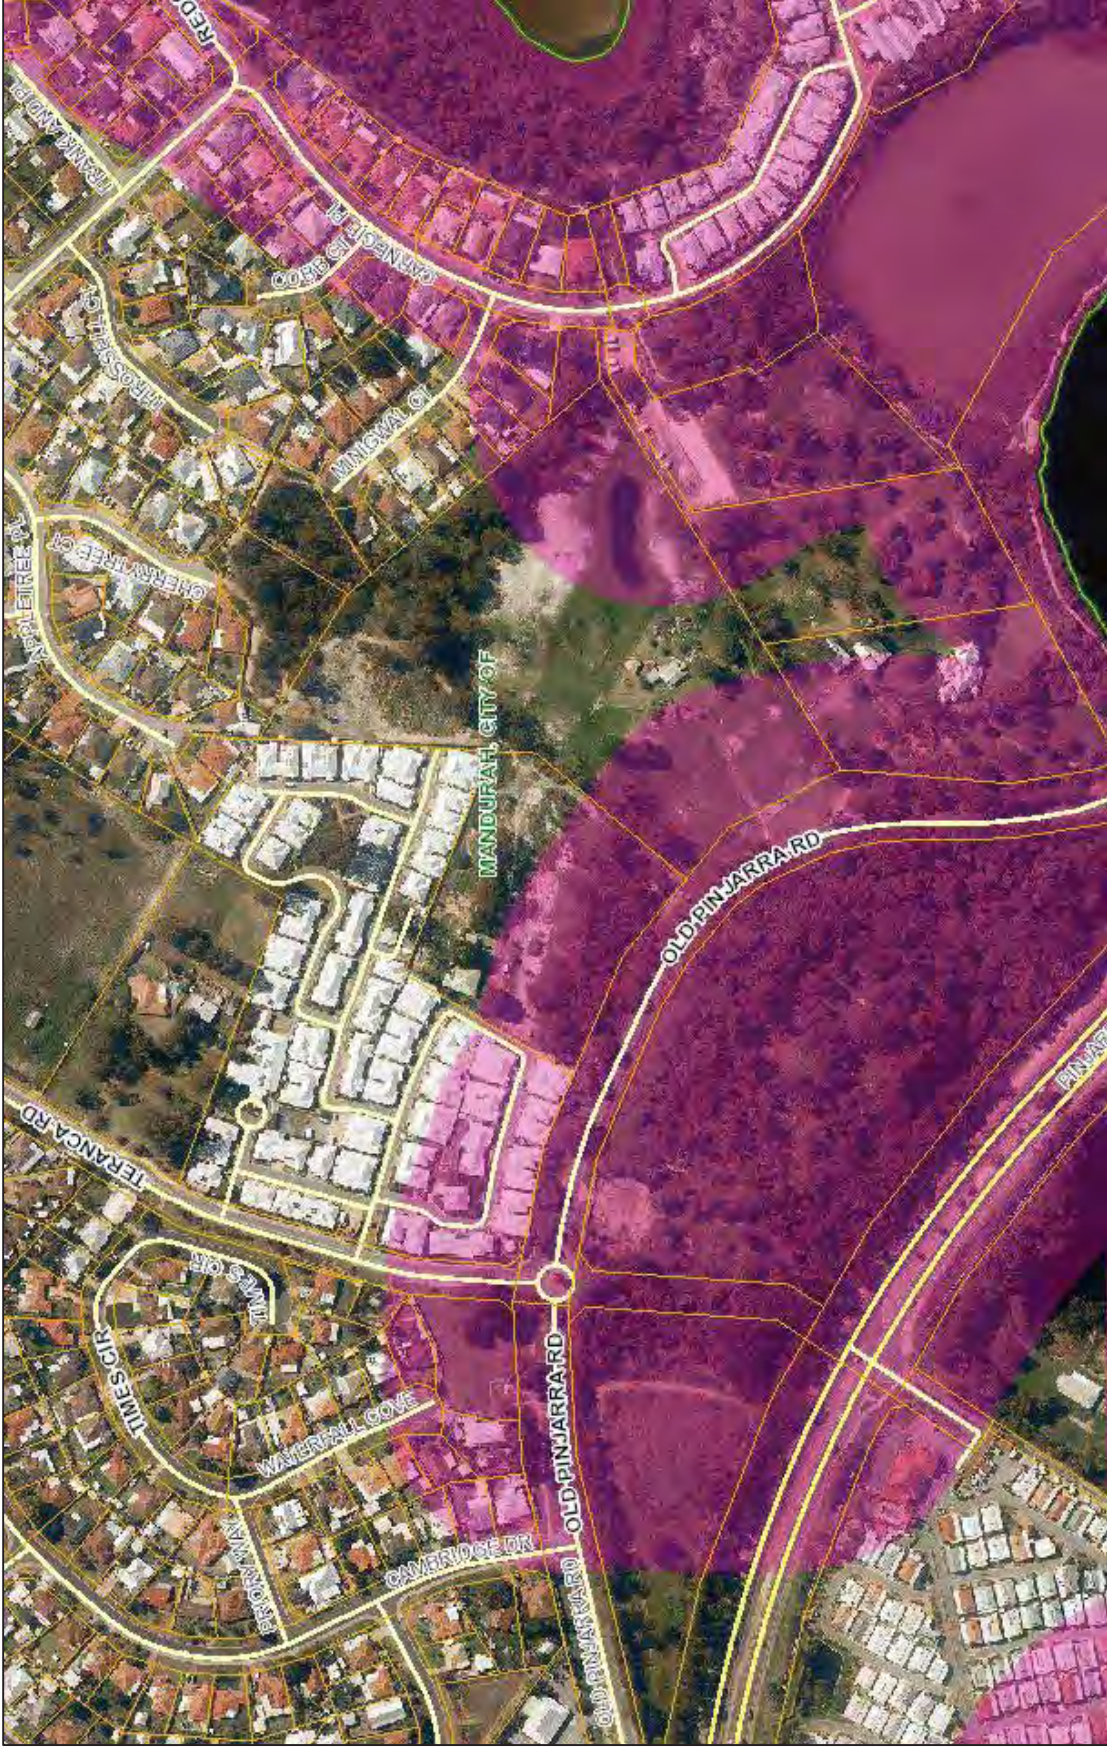
Figure 2: State Bushfire Risk Map over site and surrounding landscape.

The State's Bushfire Hazard Mapping shows that the southern portion of the site is classed as Bushfire Prone (Figure 2).

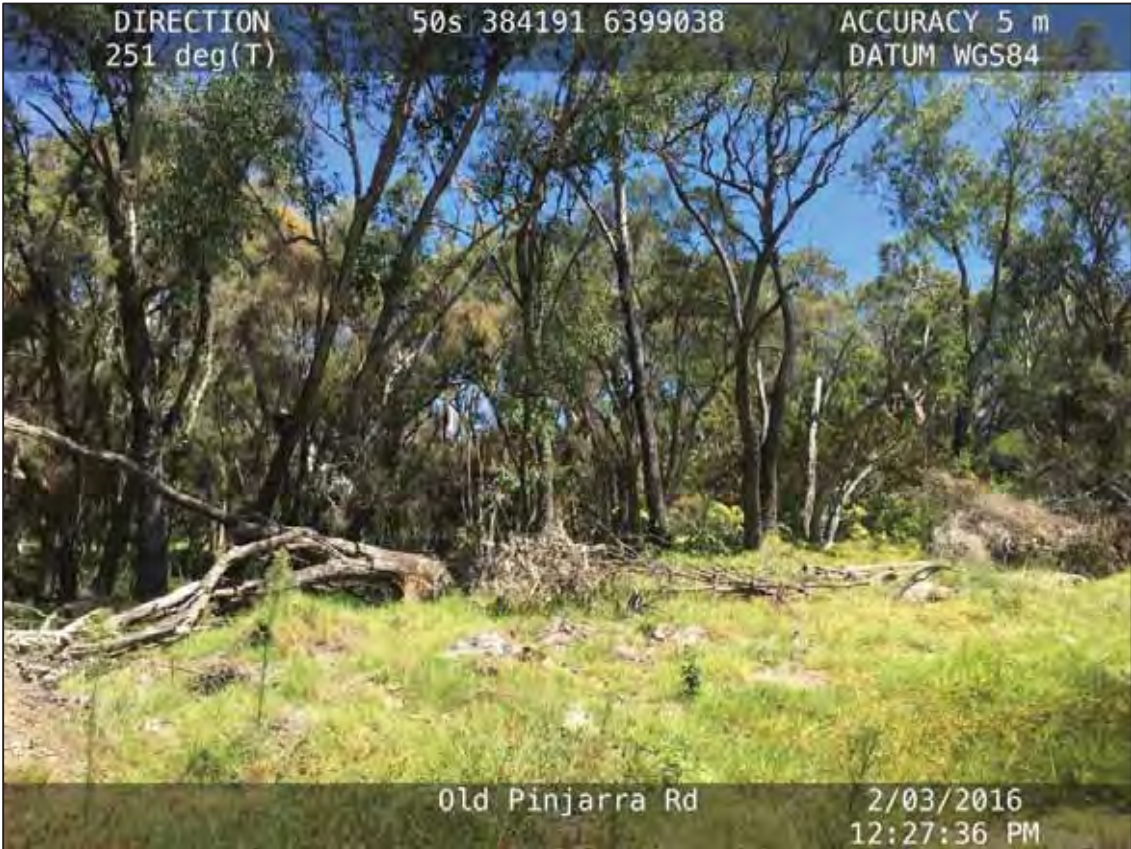
Figure 3: Woodland vegetation in Lot 10 to the south.

from assessment under AS 3959 under Section 2.2.3.2 (f). The main fire hazard vegetation is to the south of the site, located in Lot 10 (Map 2, Figures 3 & 4).

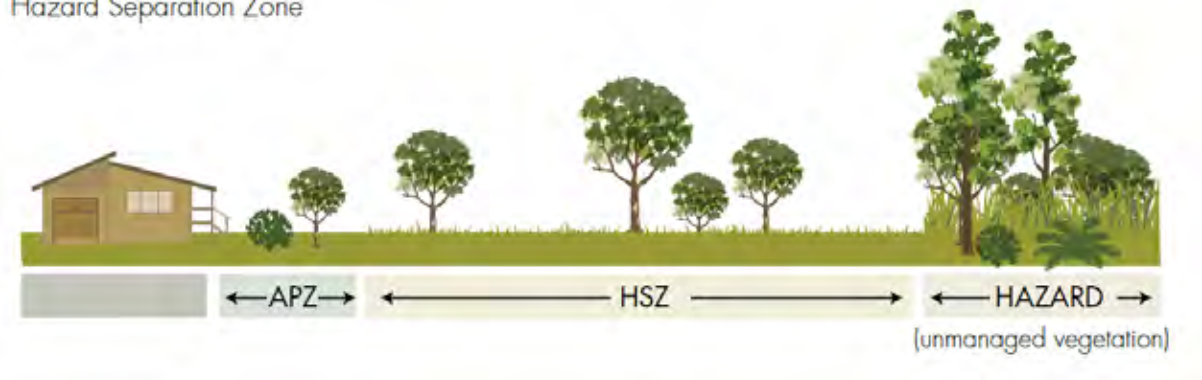
**Figure 5: Cross section of the Asset Protection Zone and Hazard Separation Zone (WAPC, 2015)**

The WAPC (2015) states that the Asset Protection Zone (APZ) is a low fuel area immediately surrounding a habitable or specified building, and is designed to minimise the likelihood of flame contact with buildings. A Hazard Separation Zone (A2.2) is required in addition to the APZ. All of the requirements prescribed in A2.1 are essential and must be achieved to ensure compliance. A cross section of the Asset Protection Zone and Hazard Separation Zone (Figure 12 from Guidelines for Planning in Bushfire Prone Areas (WAPC, 2015)) is shown in Figure 5 below:

Non-flammable features such as driveways, lawns, landscaped gardens and vegetable patches can form part of the APZs. Isolated trees and shrubs may be retained within APZs.

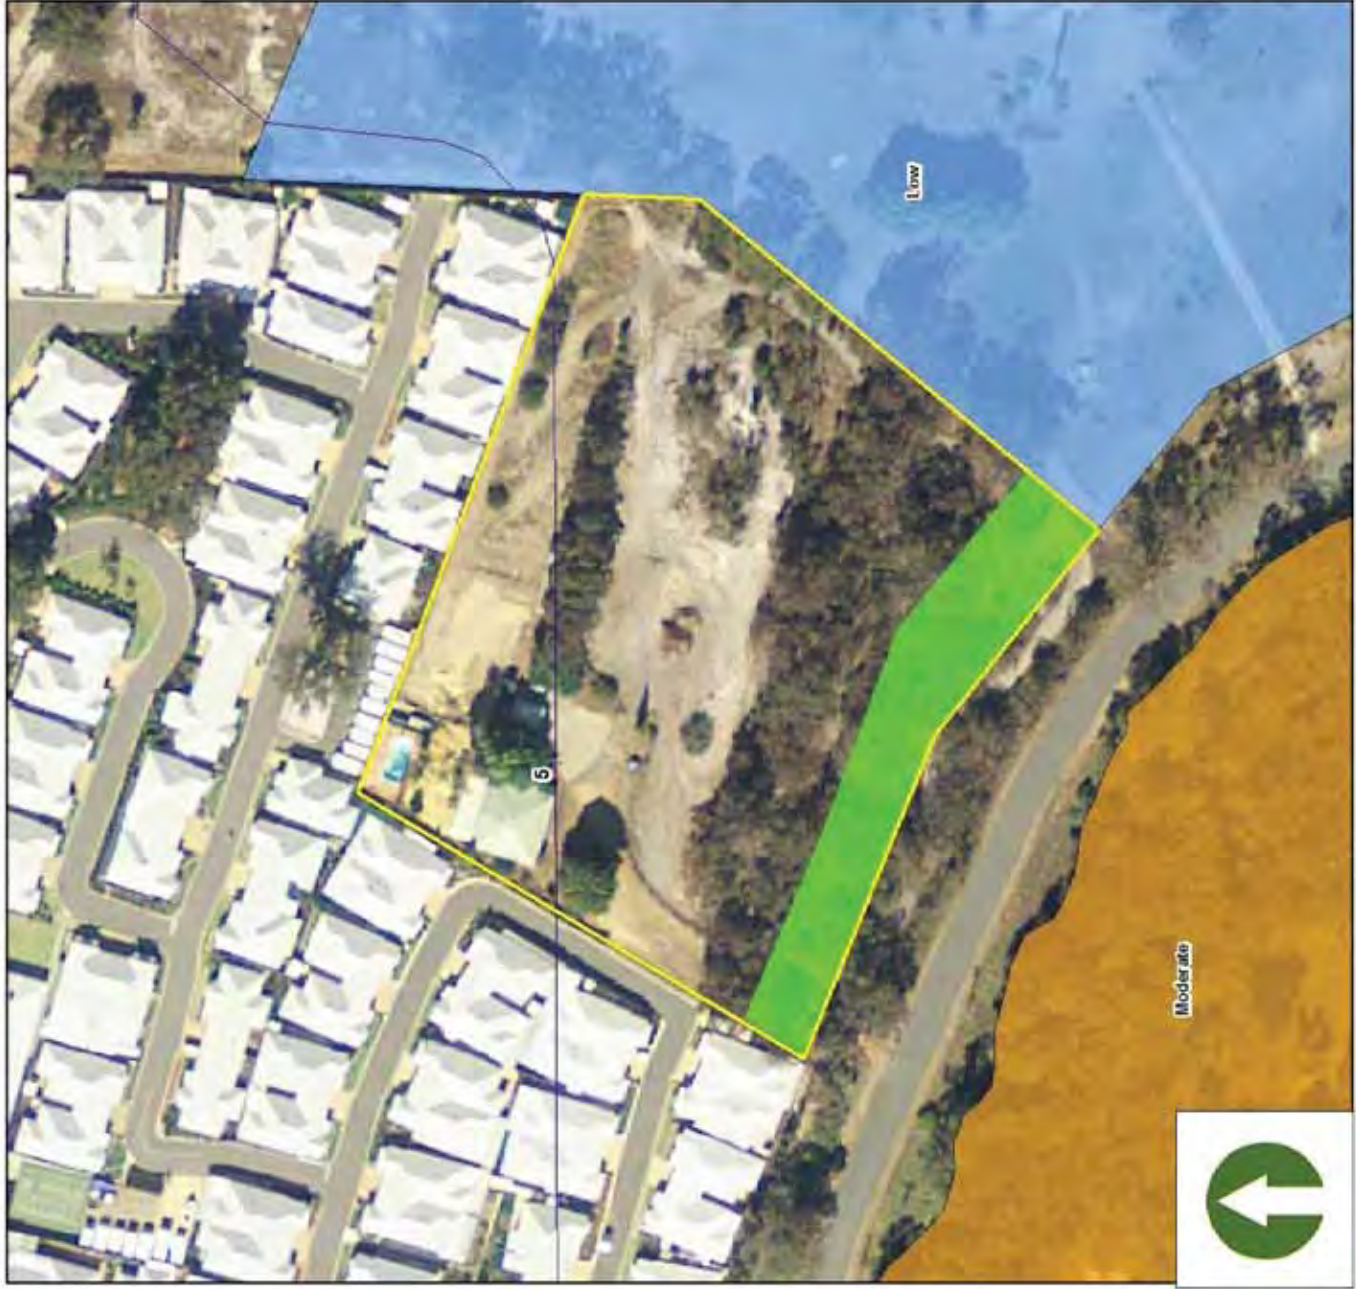
**Map 3**

**Bushfire Hazard**

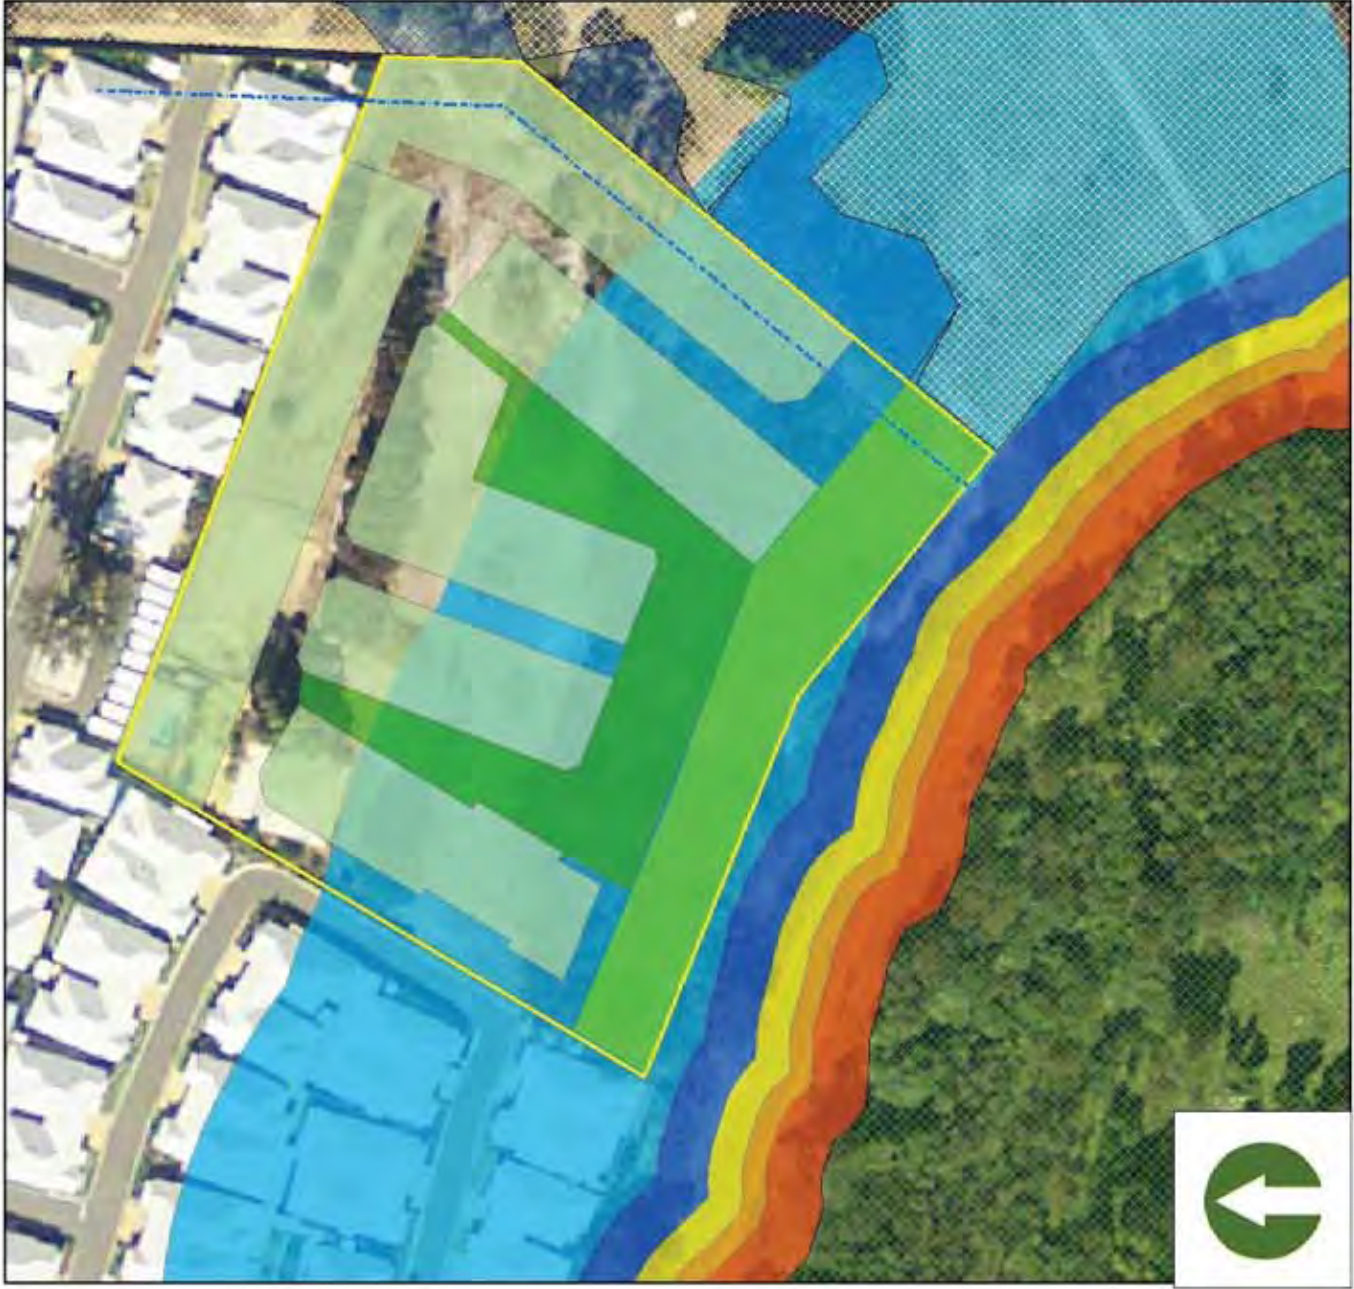
Site	Lot 601 Old Pinjarra Rd Greenfields
Project	Bushfire Attack Level
Client	Property Edge WA Pty Ltd
Scale	1: 800

- Legend**
- Study Area
  - Residential R60
  - Commercial Open Space
  - Access and Landscaping
  - Grassland BAL-29 limit
  - Hazard
  - Excluded 2.2.3.2(c)
  - Group B Woodland
  - Unmanaged Grassland
- Woodland-FireUpslope BAL Contour**
- <10m: BAL-FZ
  - 10-14m: BAL-40
  - 14-20m: BAL-29
  - 20-29m: BAL-19
  - 29-100m: BAL-12.5
