LOCAL STRUCTURE PLAN

Report Number Draft for Council Consideration – 24 May 2016

STRUCTURE PLAN - PART ONE: IMPLEMENTATION

WILUNA SOUTHERN RESIDENTIAL DISTRICT

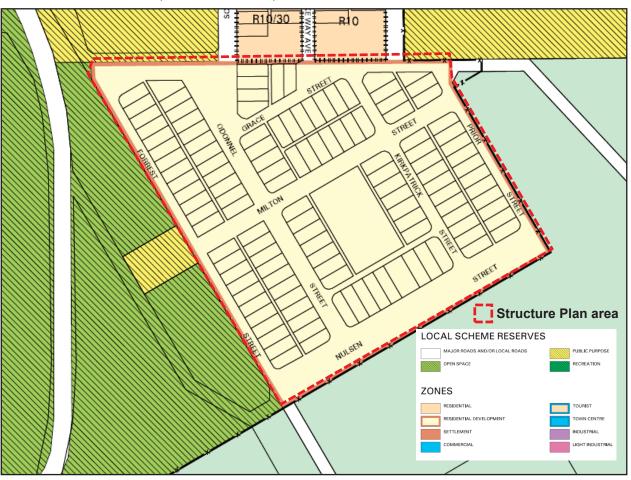
FIGURE 3 - ZONING EXTRACT (SOURCE: WAPC 2016)

The Structure Plan area is currently zoned 'Residential Development' under LPS 2, and accordingly requires the preparation of a structure plan to comprehensively guide subdivision and development. The current zoning of the Structure Plan area is illustrated in Figure 3 below.

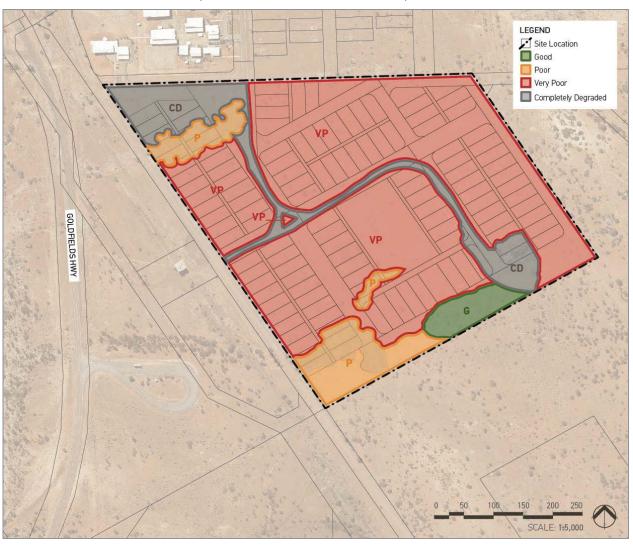
FIGURE 4 - VEGETATION CONDITION (SOURCE: 360 ENVIRONMENTAL/URBIS)

The Structure Plan area contains a discrete area of open shrubland within the southern boundary of the site which is considered to be in 'good' condition. The vegetation condition of the site is illustrated in Figure 4 below.

A total of 4 vegetation unit associations are included within the structure plan area as identified below.

- Drainage Line Low woodland.
- Plain Mixed scattered shrubs/low scattered trees.
- Low Rise Open shrubland.

Overall, the condition of these vegetation units are considered to range from 'good' to 'completely degraded', it is noted the majority of vegetation within the Structure Plan area is rated 'very poor' due to the historical clearing associated with the former housing development over the subject area.

- Vegetation Condition within the Structure Plan area ranges from Completely Degraded to a small pocket of Good vegetation with the southern portion (refer Figure 4).

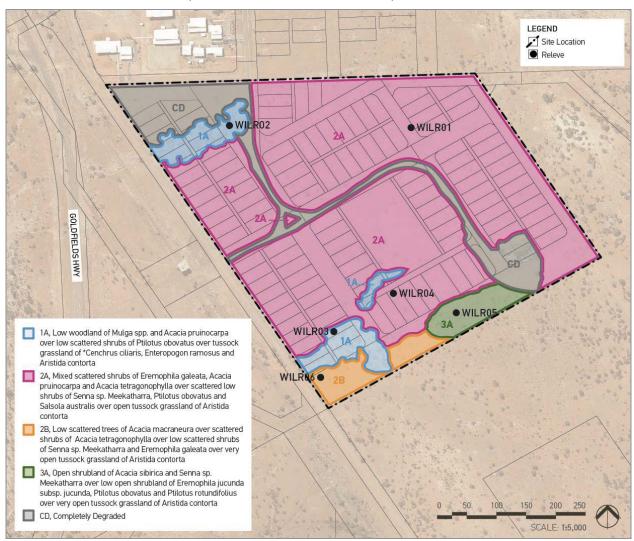
FIGURE 5 – VEGETATION SPECIES (SOURCE: 360 ENVIRONMENTAL/URBIS)

The preliminary flora assessment identified 1 conservation significant flora species (*Eremophila arguta*) as 'likely' to occur within the Structure Plan area. The survey was undertaken during the detectable period for this species however it was not recorded on site. The species therefore is not considered to occur on site. The vegetation species contained within the site is illustrated in Figure 5 below.

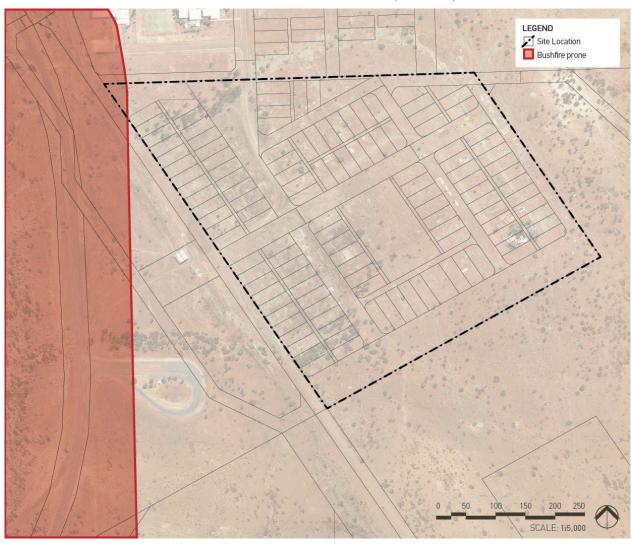
FIGURE 7 - DEPARTMENT OF FIRE AND EMERGENCY SERVICES MAPPING (DFES 2016)

The subject site is not perceived to be at a high risk of bushfire hazard (refer Figure 7). A bushfire prone buffer exists over the area designated as public open space, which will incorporate low-threat vegetation being a maintained public reserve and parkland, and currently is completely degraded. Given the location of the POS, and as reflected in the Guidelines for Planning in Bushfire Prone Areas - Appendix 2 Bushfire Hazard Level Assessment, the site is identified as having a low hazard rating and BAL-Low rating.

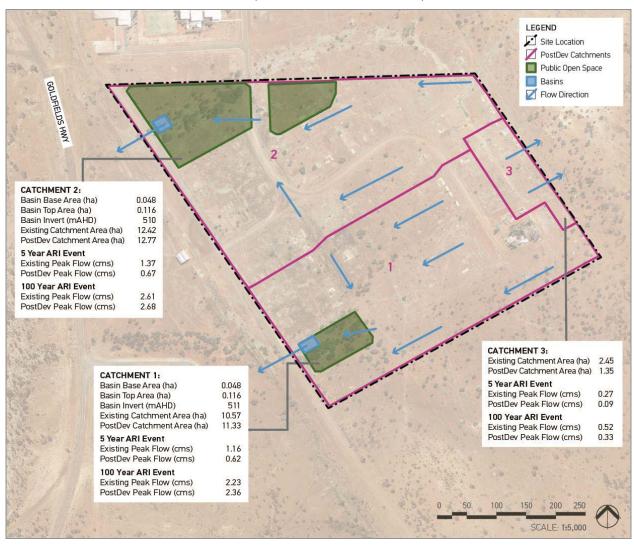
FIGURE 8 - CONCEPTUAL STORMWATER PLAN (SOURCE: 360 ENVIRONMENTAL)

The conceptual water management plan is provided at **Figure 8**, which illustrates the water management requirements of each of the 3 catchment areas.

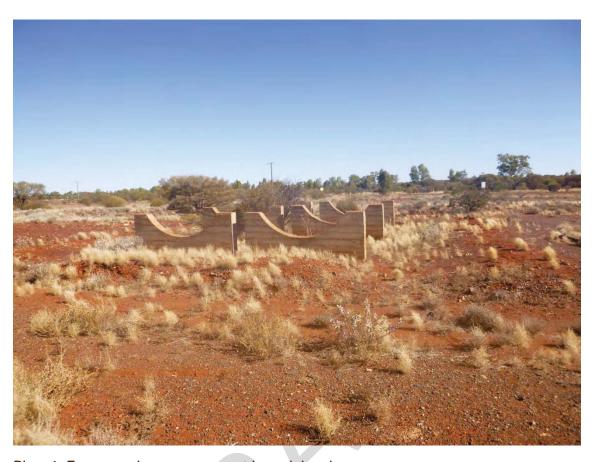
Plate 1. Former tank storage area with earth bund

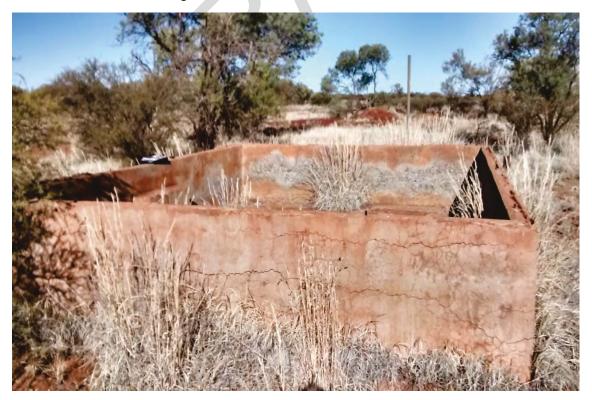
Plate 2. Concrete bund

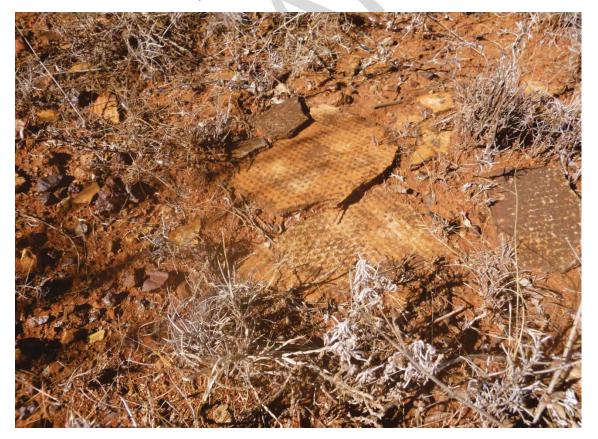
Plate 4. Widespread asbestos contamination on the surface soils of the site. Photograph is of sample location S1 in the north-west of the site.

In addition, 360 Environmental recommend that an Asbestos Management Plan is prepared in order to detail requirements for the removal of ACM from the site. We note that Shire of Wiluna is obligated to report asbestos contamination at the site to DER.

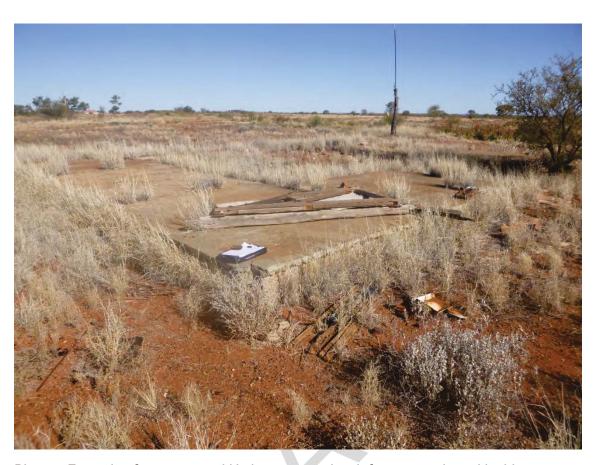
Plate 5: Example of concrete pad likely associated with former residential building

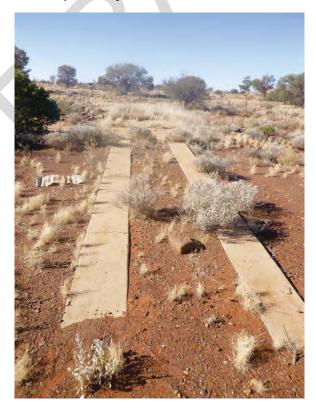
Plate 6: Example of concrete pad potentially associated with light industrial landuse

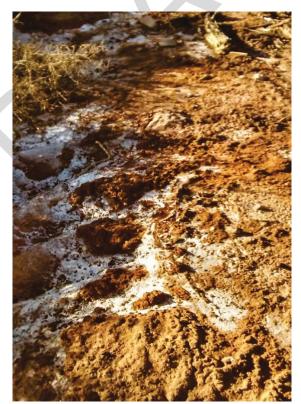
Plate 8: Salt staining in vicinity of former battery storage area

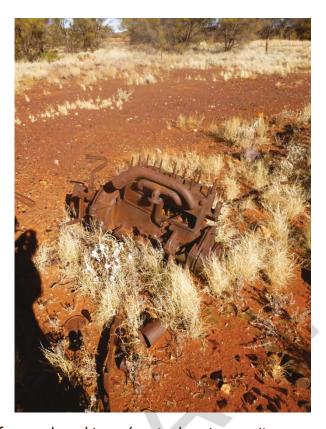
Plate 9: Example of general machinery/waste dumping on site

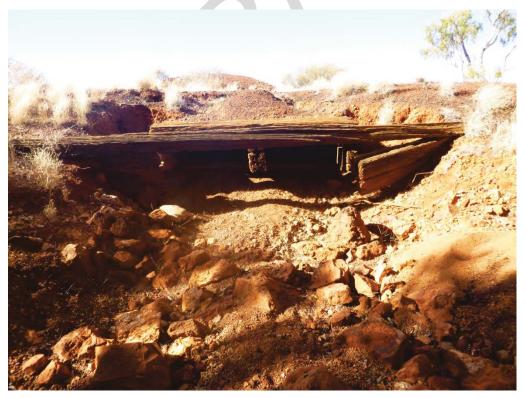
Plate 10: Off- site drainage culvert beneath former railway line

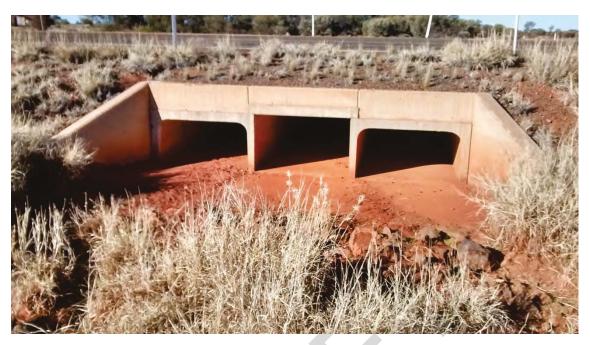
Plate 11: Off-site drainage to Goldfields Highway
