Lot 126 Caves Road,  
Burnside

Local Structure Plan

Client Manager: Joanne Cousins  
Report Number: PR126662-3  
Version/Date: Revision 6, 7 March 2018

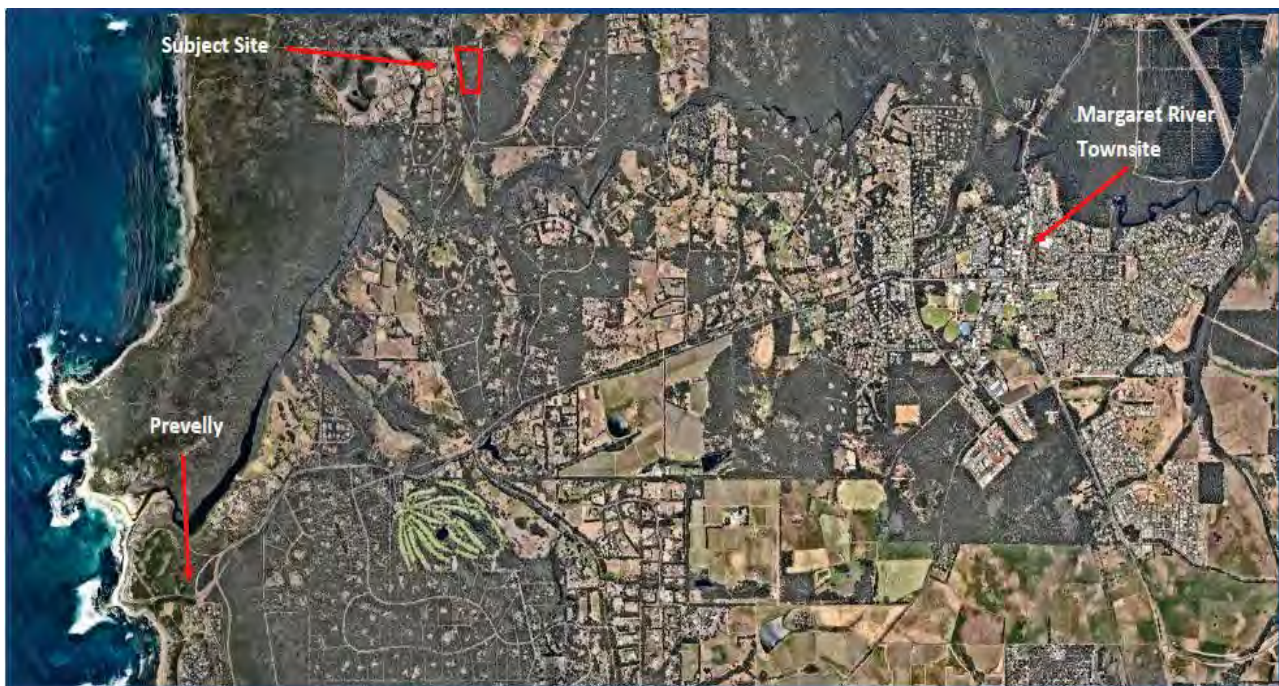
Figure 1: Location Plan

The subject site is located approximately 5km north west of the Margaret River Townsite, on the eastern side of Caves Road, directly adjacent to its intersection with Kilcarnup Road. The site sits within a broader agricultural and rural residential landscape that ranges from cleared pasture to heavily vegetated land holdings.

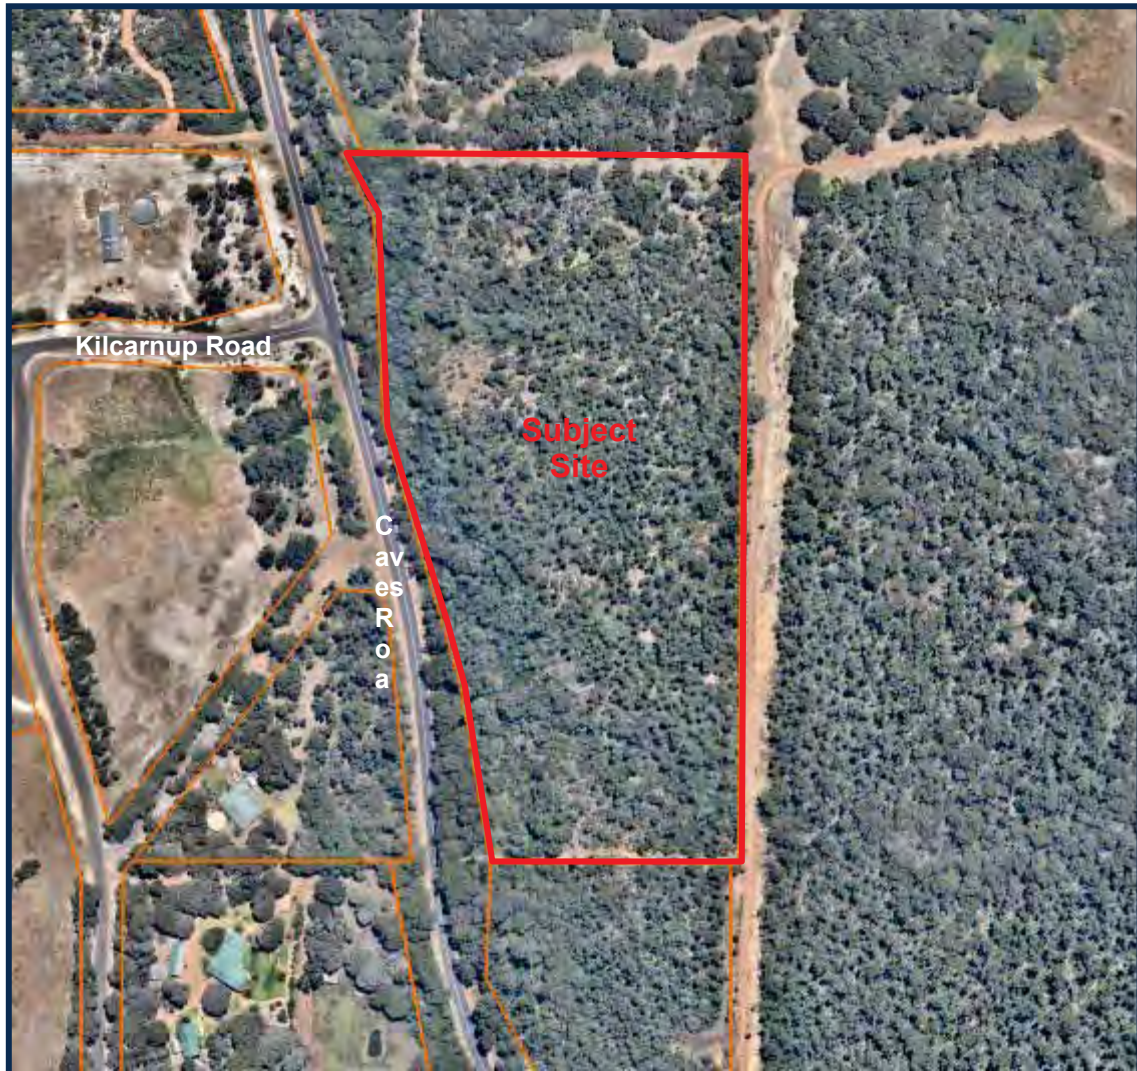
Figure 2: Aerial Photograph

The subject site has a total area of 5.5982 ha and is currently undeveloped and not utilised for any particular purpose. The majority of the subject site is covered by native vegetation comprising mainly an overstorey of Marri with Peppermints and Grass Trees and mixed Acacias in the understorey.

The Study Area slopes down towards the south west, with the highest point being the north east corner at approximately 65 m above sea level Australian Height Datum (AHD). The lowest area is the south west along a creek line section that sits at approximately 45m AHD.

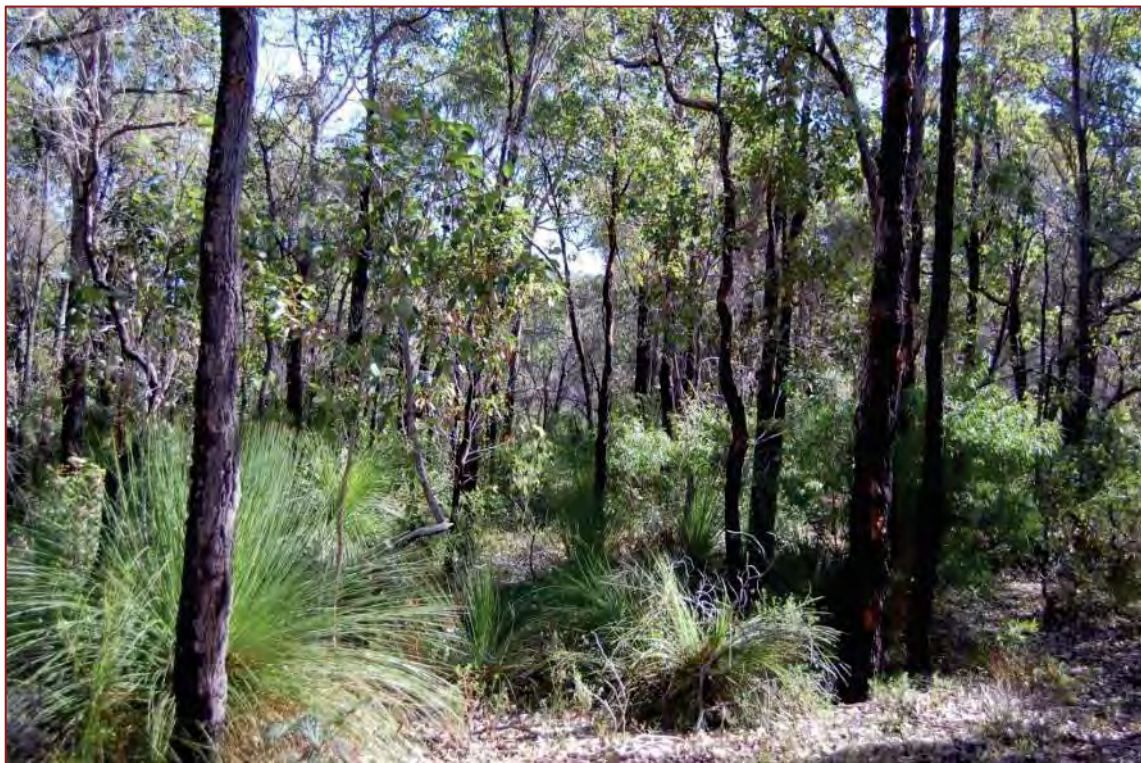
*Figure 2: Vegetation Type One – Marri trees with an understorey of Peppermints, Grass Trees and mixed Acacia species.*

Based on AS 3959-2009, Vegetation Type One would be classified as Class A - Forest. Vegetation Type Two would be classified as Class B - Woodland.

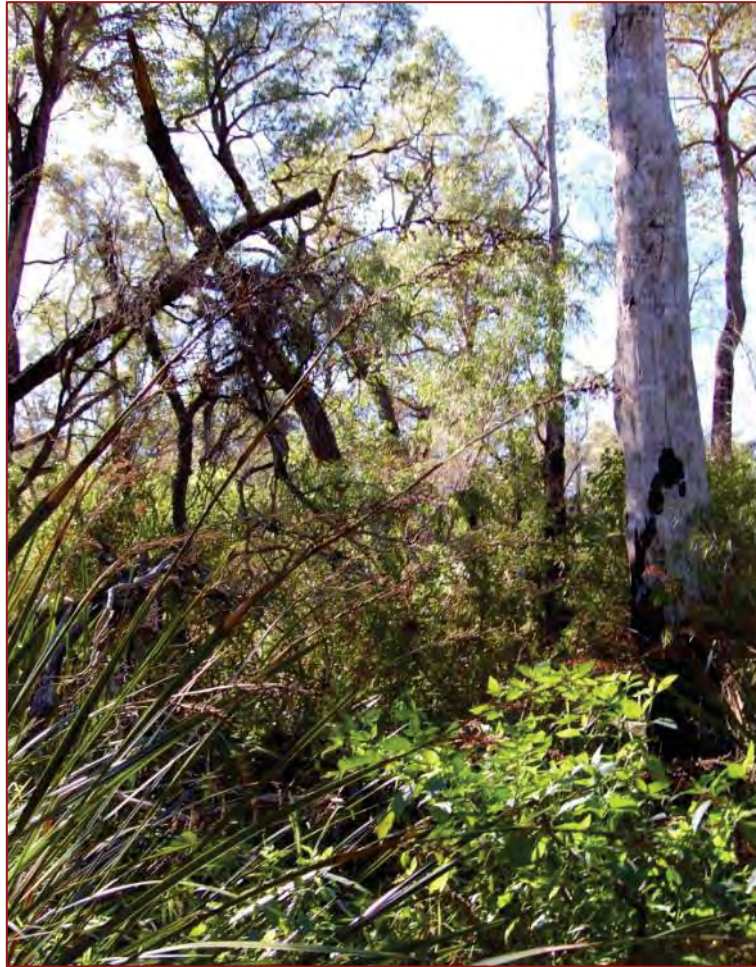
*Figure 3: Vegetation Type Two – Scattered Marri trees with an understorey of Peppermints, sedges, pasture grasses and climbers.*

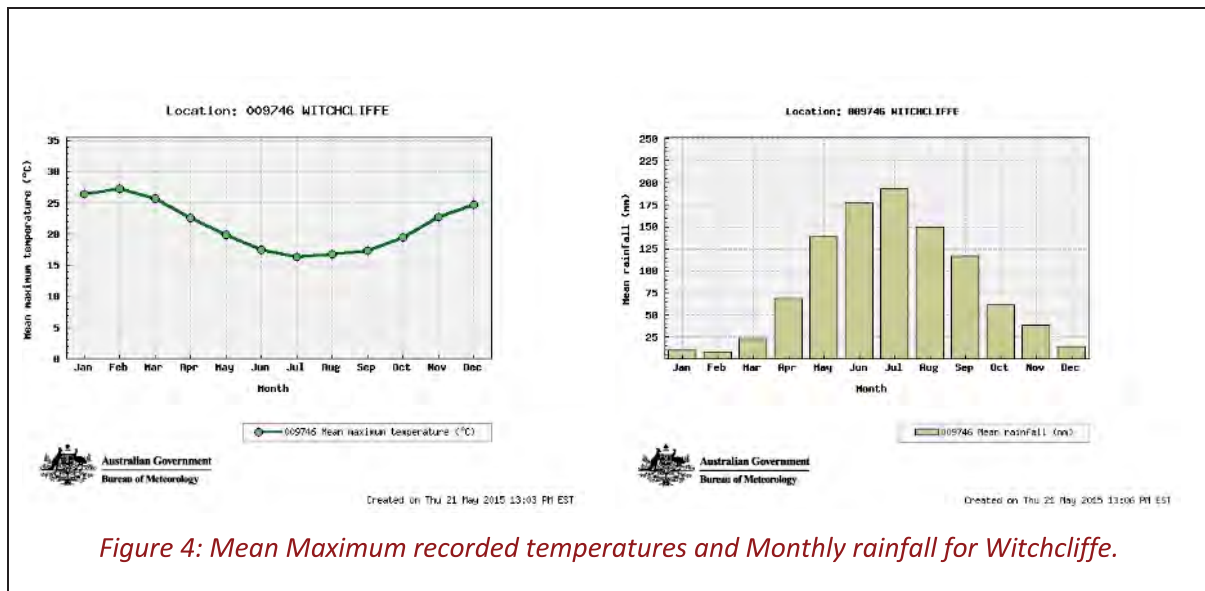
Data from the Bureau of Meteorology at Witchcliffe (approximately 12 kms to the south-east of the Site) confirms that the Site experiences hot dry summers with an average December to February temperature of 25-27°C and 11 mm of rain per month over summer. Winters are cooler with a mean maximum temperature through June, July and August of 17°C and an average July rainfall of 190mm (Figure 4 - BOM, accessed May 2015).

Figure 4: Mean Maximum recorded temperatures and Monthly rainfall for Witchcliffe.

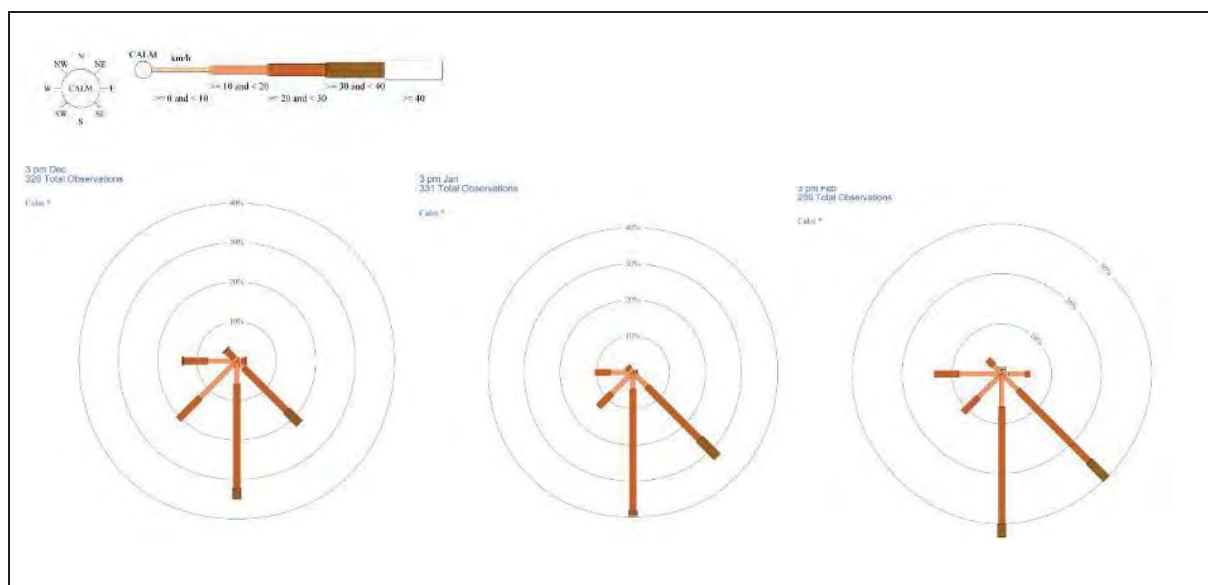
The 3pm December wind rose for Witchcliffe shows that the afternoon sea breeze from the south and south-east dominates at 40 % of the time. This is similar for January, however south-easterly winds increase later in summer, occurring between 20-30 km/h approximately 10% of the time (Figure 5).

Figure 5: Wind Rose for Witchcliffe in km/h for December, January and February

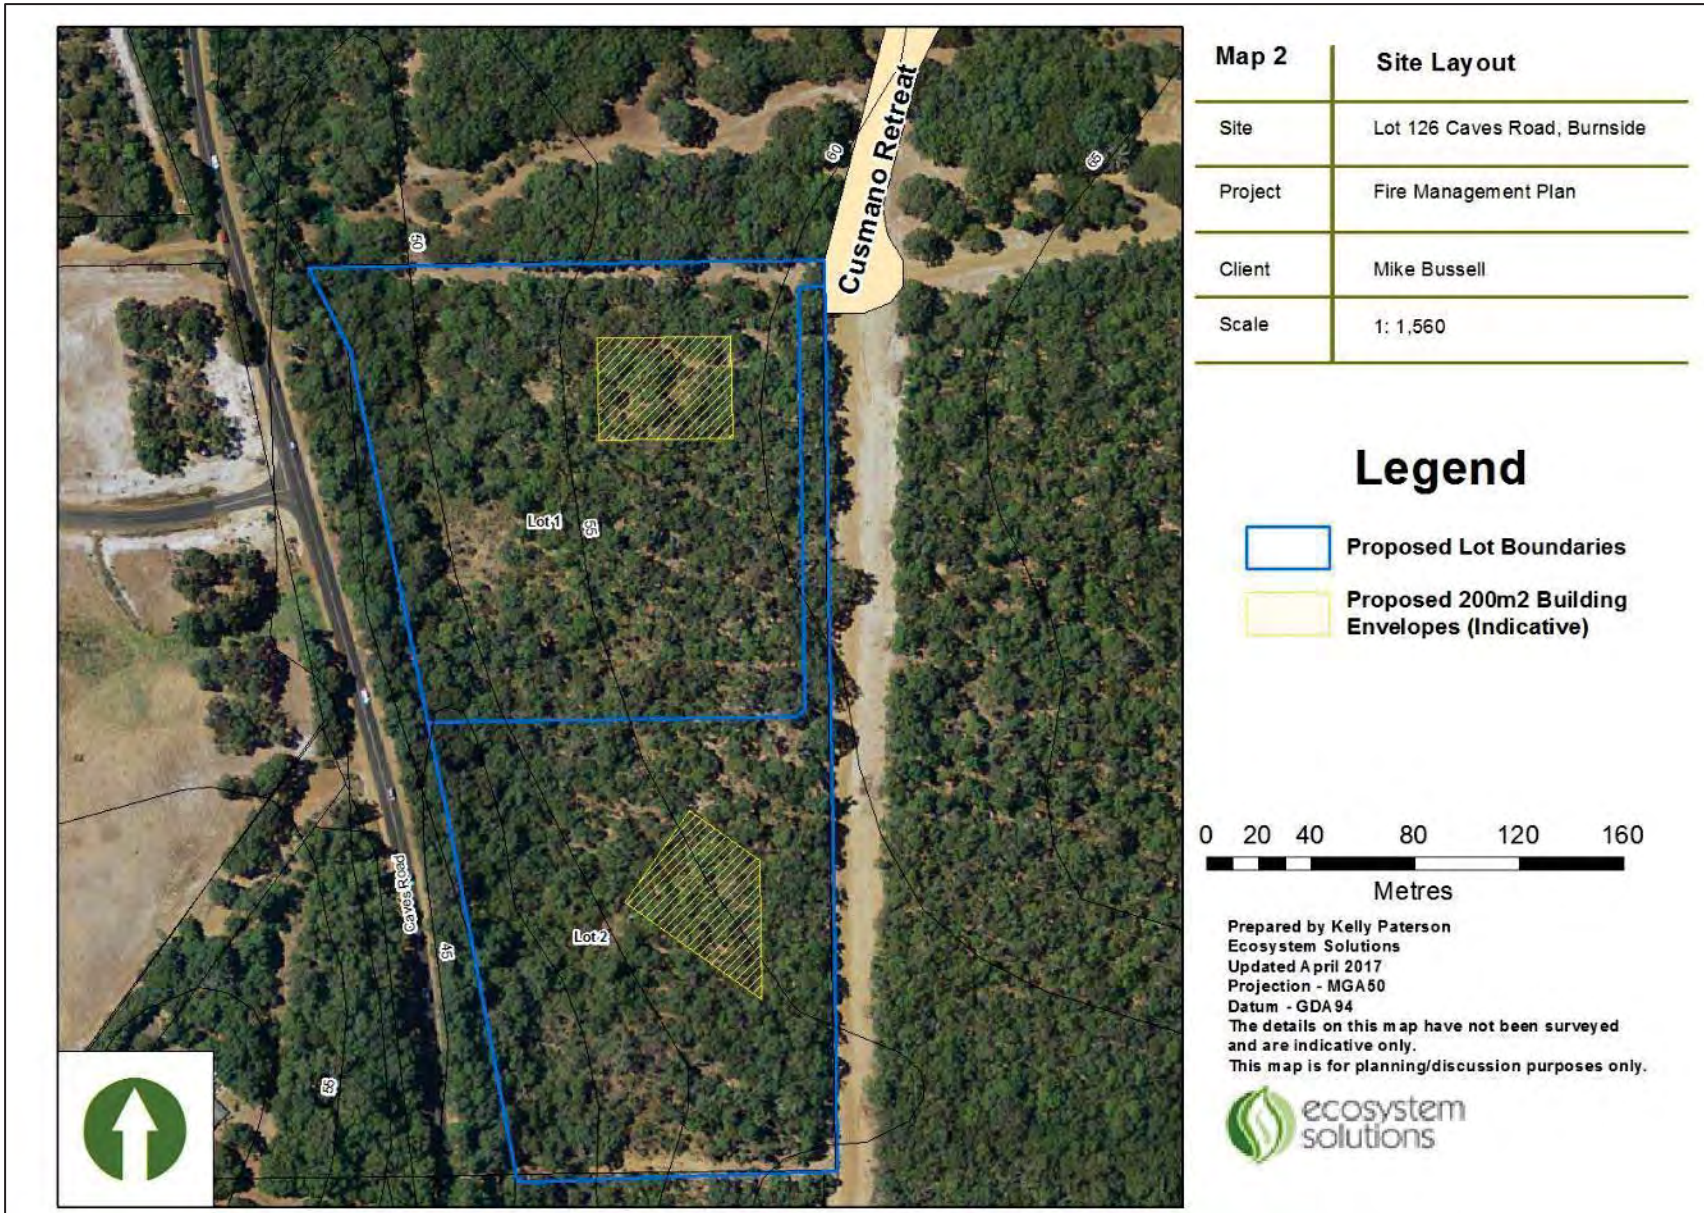
| Map 2 | Site Layout |

The proposal is to subdivide the property into two rural residential lots, Proposed Lot One to the north (2.584 ha) and Proposed Lot Two in the south (2.598 ha) (Figure 1 & Map 2). There is a proposed 2000m<sup>2</sup> building envelope for each lot (Figure 1 & Map 2).

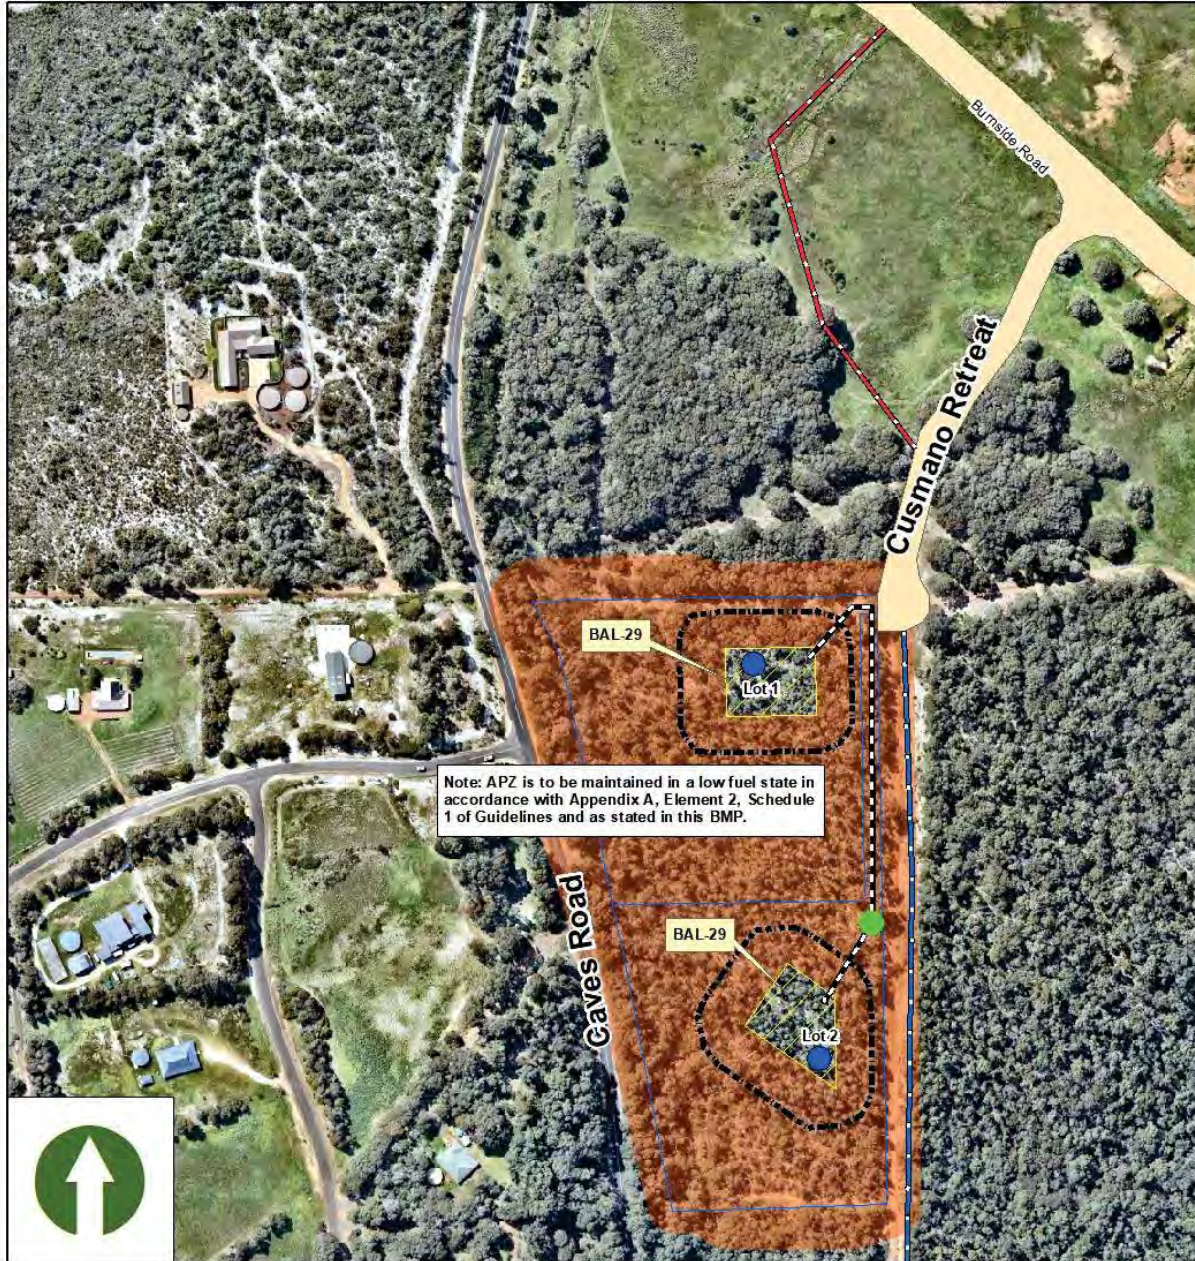
**Map 8**

**Bushfire Management Plan Elements**

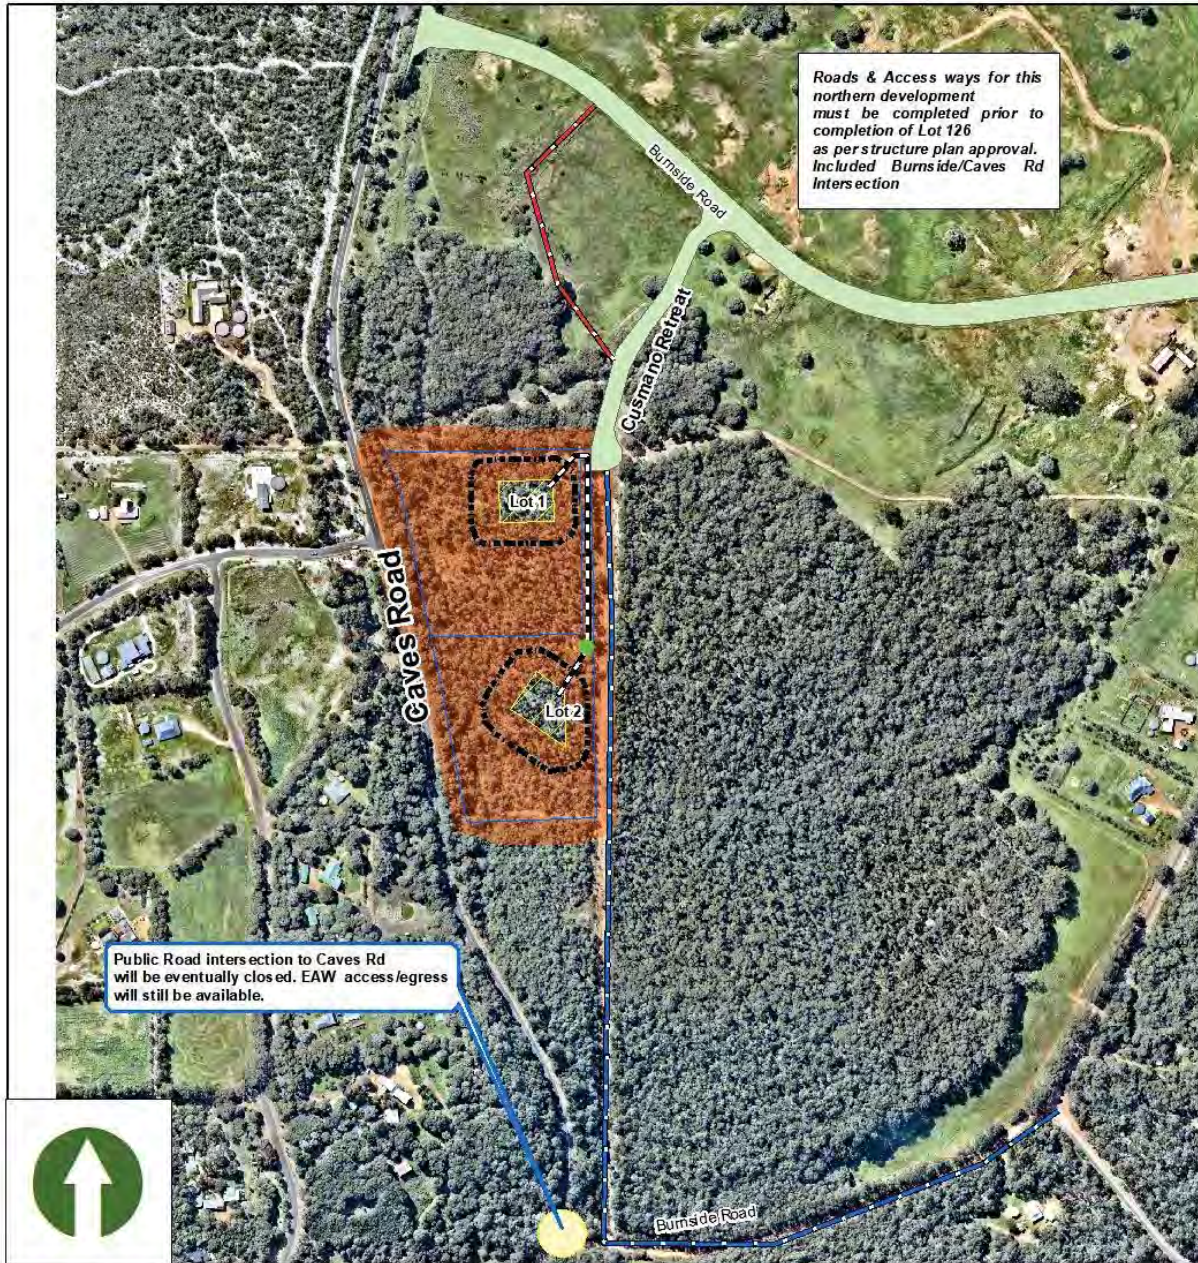
Roads & Access ways for this northern development must be completed prior to completion of Lot 126 as per structure plan approval. Included Burnside/Caves Rd Intersection

Public Road intersection to Caves Rd will be eventually closed. EAW access/egress will still be available.

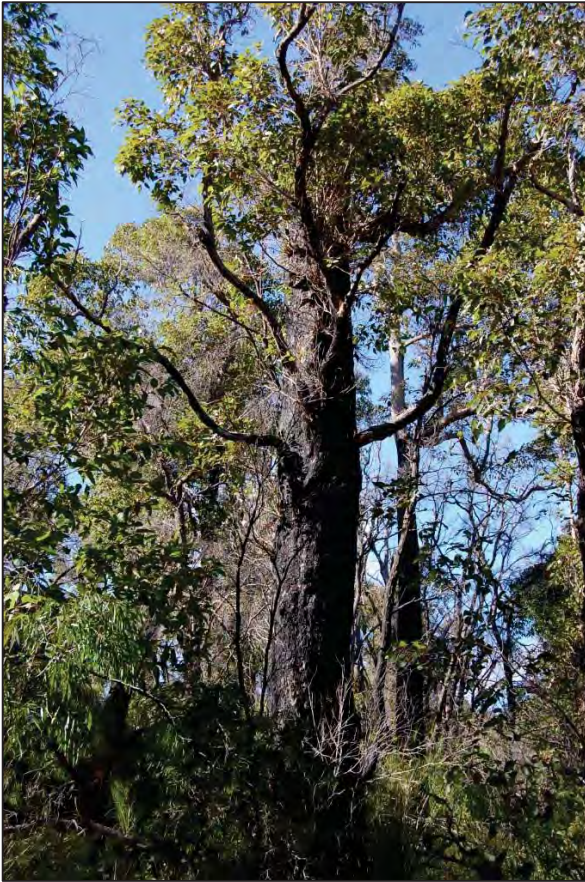
Figure 1: Chimney Hollow in a Marri with full scorch marks up in excess of 7m.

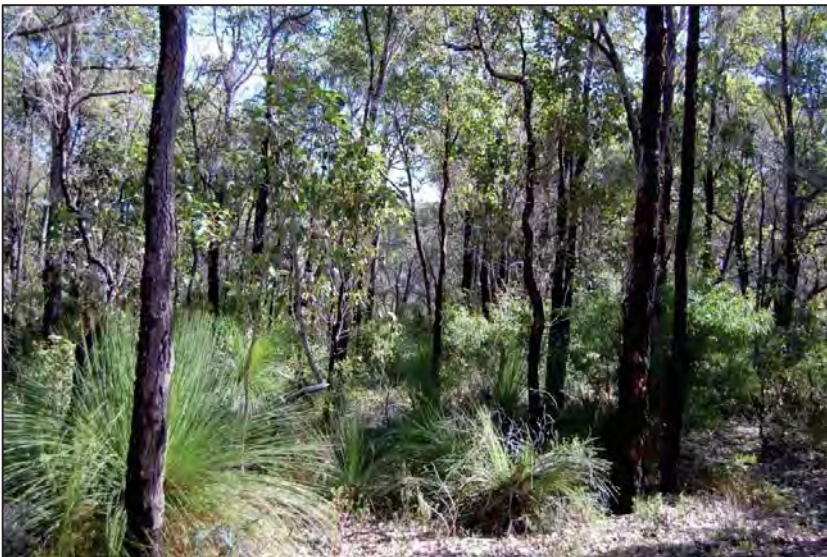
- Vegetation Community 1 (4.93 ha) (Figure 2) –Open Woodland of *Corymbia calophylla*, over Low Woodland of *C. calophylla*, over Tall Shrubland of *C. calophylla* and *Agonis flexuosa*, over Open Heath of *Xanthorrhoea preissii*, *Acacia pulchella* and *A. divergens*, over Low Shrubland of *Hovea chorizemifolia*, *Hibbertia hypericoides*, *A. flexuosa* and *Kennedia spp* over Very Open Grassland of annual pasture grasses and *Briza spp*.

Figure 2: Vegetation Type 1.

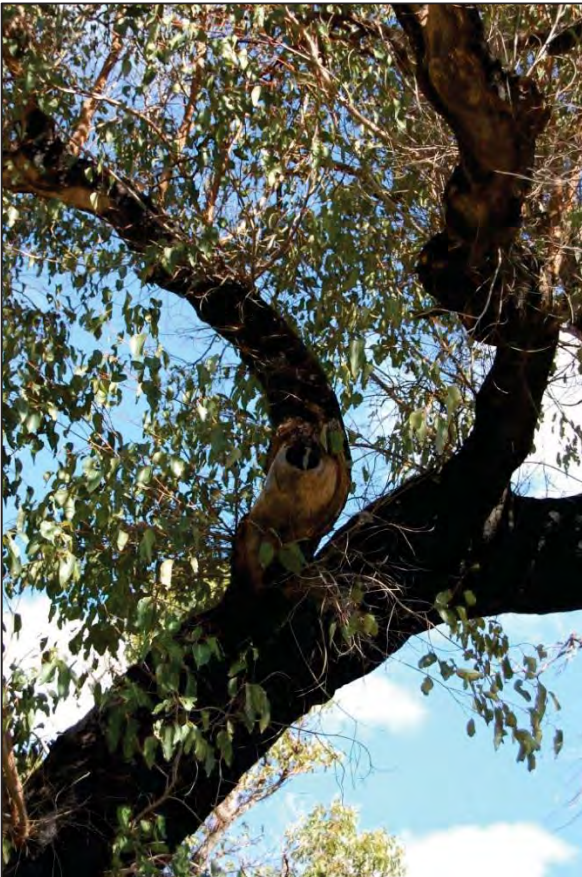
Twelve trees were found that had a diameter in excess of 550 mm and had potential hollows that meet the criteria. These are listed in Table 6 and an example shown in Figure 4. Height was determined using a Sunto Clinometer and the Diameter at Breast Height (DBH) and other elements were directly was measured and recorded. Their location is shown in Map 6.

**Figure 4: Hollow in burnt Marri**

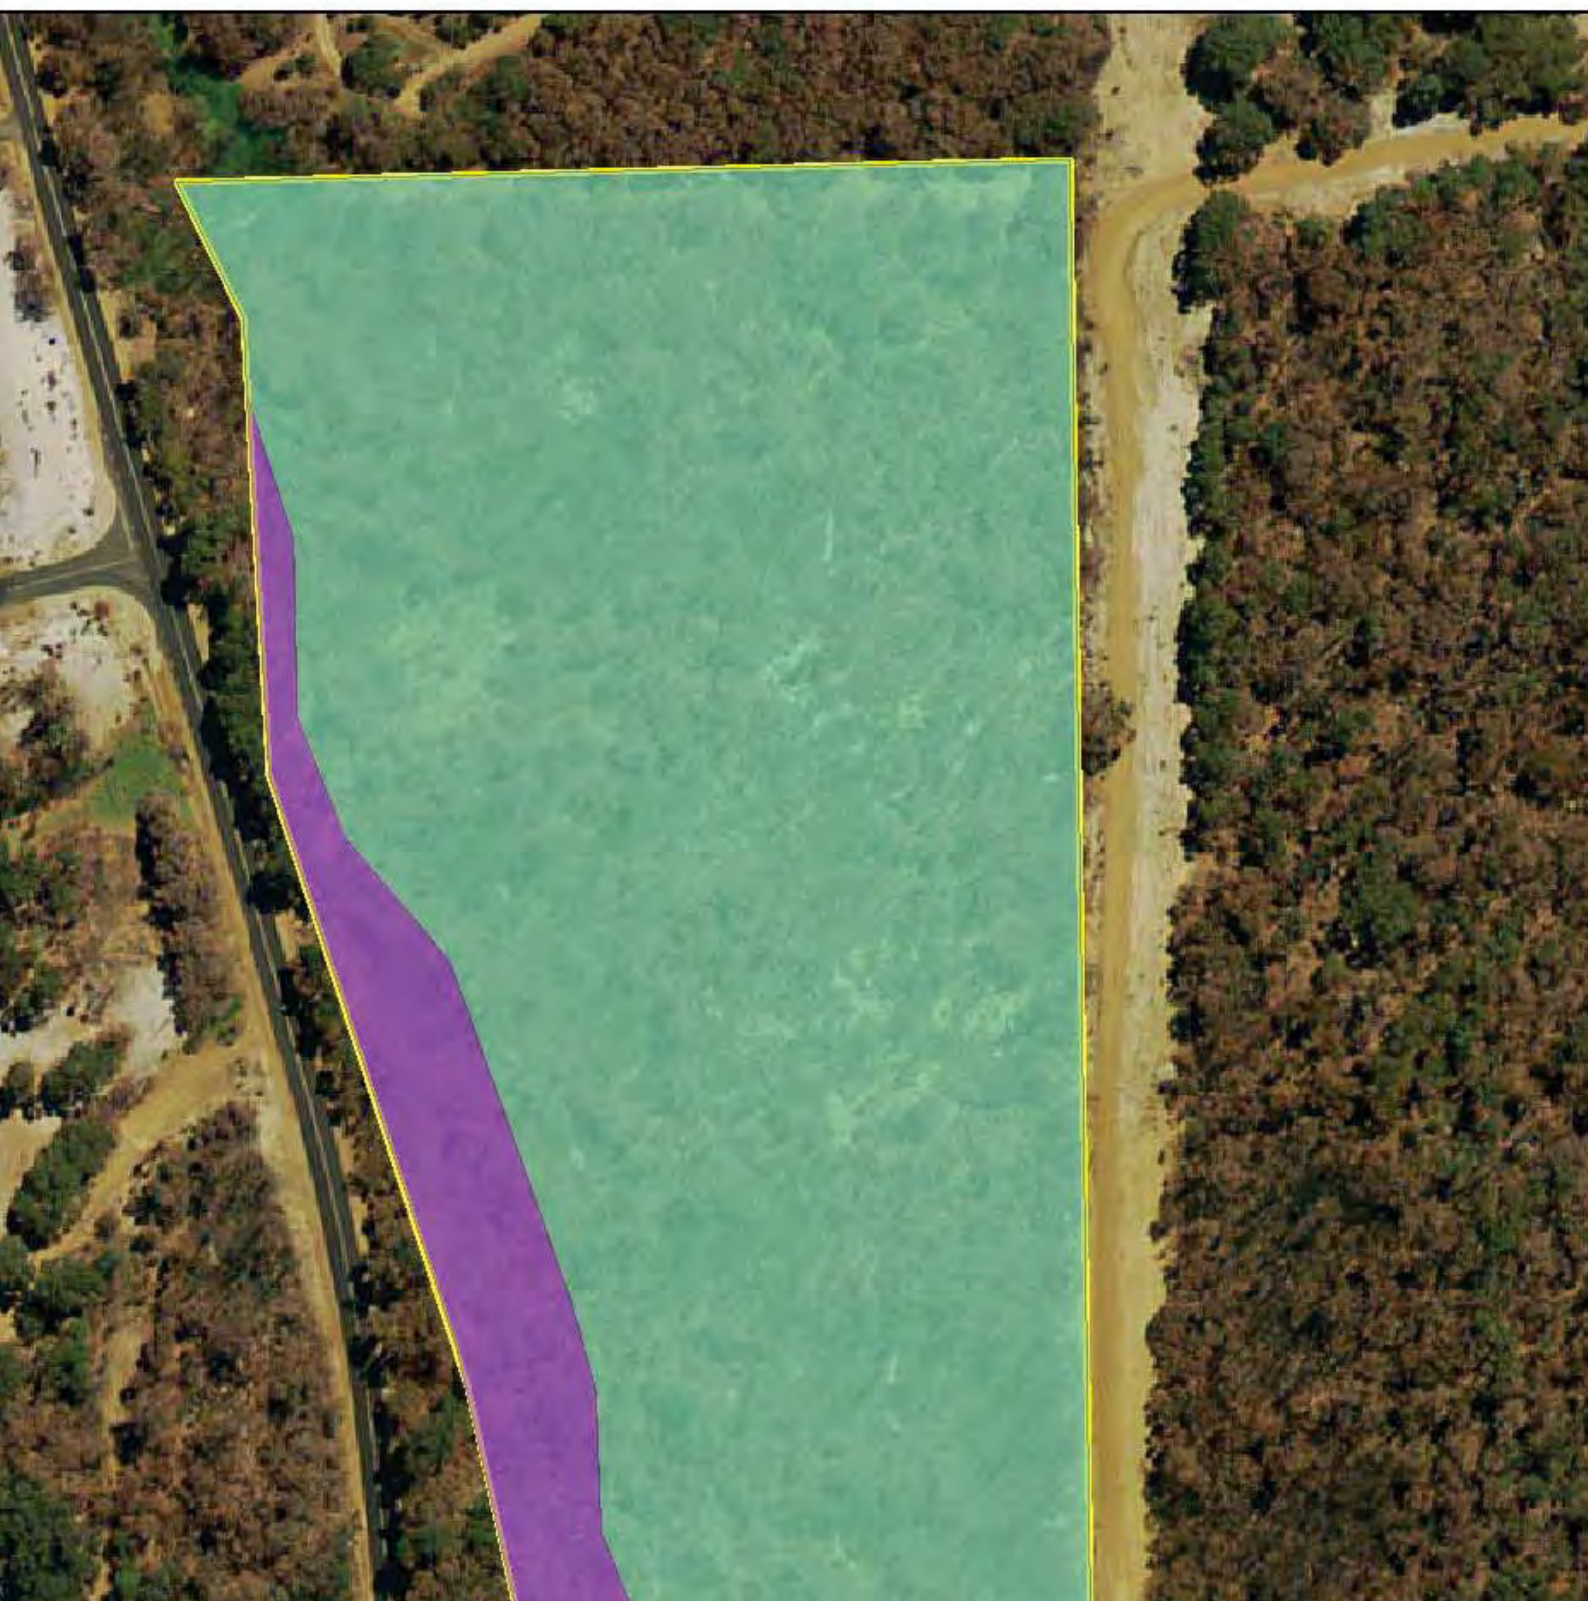
## Map 4 | Mapped Vegetation

Note that the vegetation within the Study Area was significantly impacted by the November 2011 bushfires that occurred in the Margaret River/Kilcarnup area. The tree species all had scorch marks up over 5m in their trunks (Figure 1) and the understory areas were dominated by dense areas of primary coloniser species such as *Acacia pulchella* and *A. divergens*. This made differentiating the communities difficult, however the indicative break in the communities is shown in Map 4.
