**SHIRE OF RAVENSTHORPE**  
**LOCAL PLANNING SCHEME No. 6**

**LOCAL STRUCTURE PLAN**

**SPECIAL USE - SU7**  
**RURAL RESIDENTIAL – RR5**  
**LOT 8 HOPETOUN - RAVENSTHORPE ROAD, HOPETOUN**

# Bushfire Management Plan

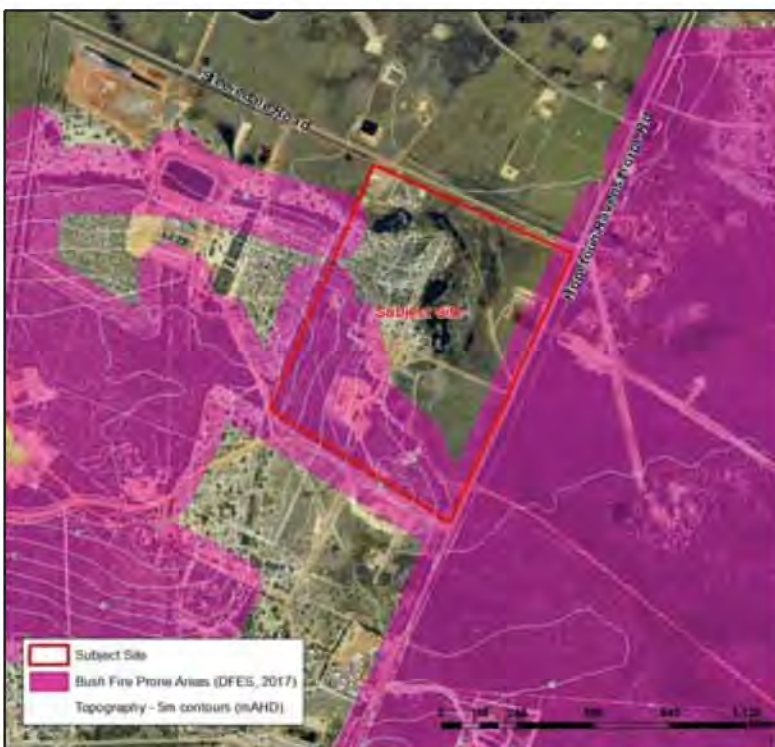
**Figure 2: Bushfire Prone Area Mapping**

The publicly released Bushfire Prone Area Mapping (DFES, 2017) shows that approximately half of the Subject Site is located within a Bushfire Prone Area (situated within 100m of >1 ha of bushfire prone vegetation). Bushfire Prone Area Mapping is shown on Figure 2.

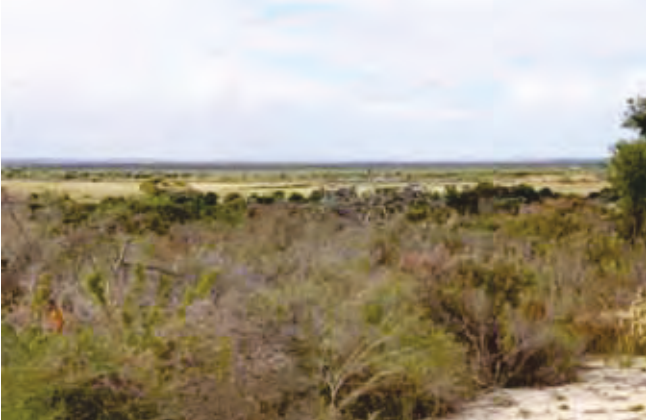
Plot	1	Classification or Exclusion Clause	Shrubland Type C

<p><b>Location:</b> Internal to site in the north-western portion of Subject Site.</p> <p><b>Separation distance:</b> 0m. Internal to site.</p> <p><b>Dominant species &amp; description:</b> Continuous vegetative structure consisting of <i>Acacias</i> and native shrubs with the occasional <i>Banksia</i> and Christmas tree &gt;3m. Low coastal heath.</p> <p><b>Average vegetation height:</b> 2m.</p> <p><b>Vegetation Coverage:</b> &gt;30 %.</p> <p><b>Available fuel loading:</b> 15t/ha.</p> <p><b>Effective slope:</b> Downslope &gt;0 to 5 degrees.</p>		
<p>Photo Id 1: View looking north-east across Shrubland Type C in Plot 1.</p>			
Plot	2	Classification or Exclusion Clause	Scrub Type D

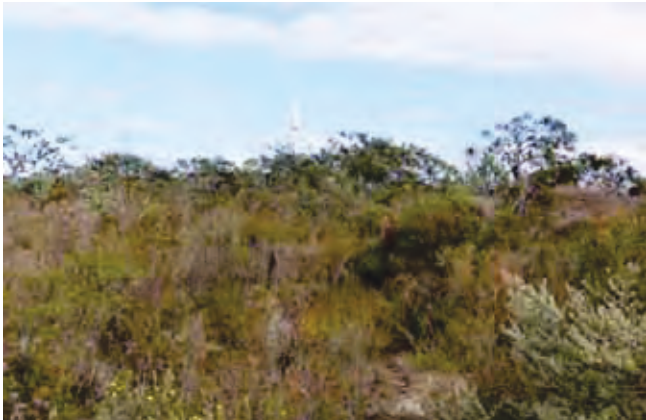
<p><b>Location.</b> Internal to site in the south-western corner of site extending to adjacent private property to the south-west.</p> <p><b>Separation distance:</b> 0m. Internal to site.</p> <p><b>Dominant species &amp; description:</b> Closed scrub consisting of <i>Banksia</i>, <i>Acacia</i> and occasional <i>Mallee</i>.</p> <p><b>Average vegetation height:</b> 2-4m.</p> <p><b>Vegetation Coverage:</b> &gt;30 %.</p> <p><b>Available fuel loading:</b> 15 – 25t/ha.</p> <p><b>Effective slope:</b> Upslope.</p>

<p>Photo Id 2: View looking south-west from Subject Site towards wind turbine.</p>			
Plot	3	Classification or Exclusion Clause	Shrubland Type C

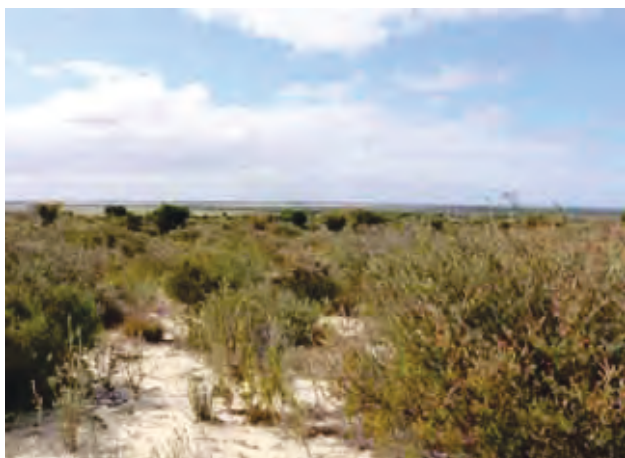
<p><b>Location:</b> Located between lot boundary and western extent of assessment zone in adjacent private property.</p> <p><b>Separation distance:</b> 0m.</p> <p><b>Dominant species &amp; description:</b> Continuous vegetative structure consisting of <i>Acacias</i> and native shrubs with the occasional <i>Banksia</i> and <i>Melaleuca</i> (&lt;2m). Occasional Christmas tree (approx. 3m).</p> <p><b>Average vegetation height:</b> 2m.</p> <p><b>Vegetation Coverage:</b> &gt;30%.</p> <p><b>Available fuel loading:</b> 15t/ha.</p> <p><b>Effective slope:</b> Upslope.</p>		
<p>Photo Id 3: View looking east from western boundary of assessment zone down slope to Subject Site.</p>

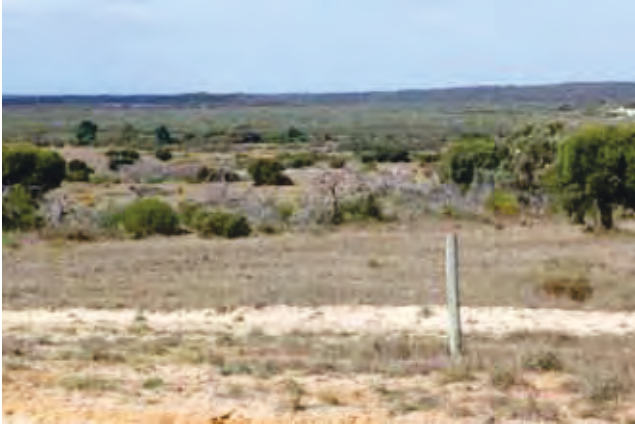
Plot		Classification or Exclusion Clause	
4			<b>Grasslands Type G</b>

<p><b>Location:</b> Situated between the southern extent of the assessment zone and Leschenaultia Drive.</p> <p><b>Separation distance:</b> 30m.</p> <p><b>Dominant species &amp; description:</b> Patchy pasture grasses, occasional <i>Banksia</i> and W.A. Christmas tree.</p> <p><b>Average vegetation height:</b> 100-300mm.</p> <p><b>Vegetation Coverage:</b> 90%.</p> <p><b>Available fuel loading:</b> 4.5t/ha.</p> <p><b>Effective slope:</b> Downslope &gt;0 to 5 degrees.</p>	
<p>Photo Id 4: View looking southeast along Leschenaultia Drive.</p>			
5			<b>Shrubland Type C</b>

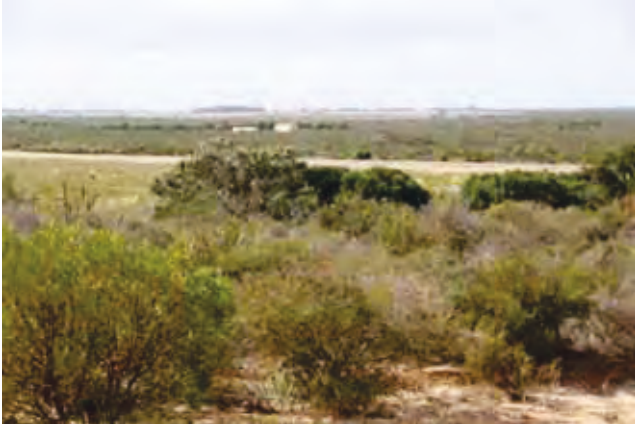
<p><b>Location:</b> Internal to Subject Site in the southern corner.</p> <p><b>Separation distance:</b> 0m.</p> <p><b>Dominant species &amp; description:</b> Predominately <i>Banksia</i> scrub with the occasional <i>Eucalypt</i>.</p> <p><b>Average vegetation height:</b> 2m.</p> <p><b>Vegetation Coverage:</b> 30%.</p> <p><b>Available fuel loading:</b> 15t/ha.</p> <p><b>Effective slope:</b> Upslope.</p>

<p>Photo Id 5: View looking north east across to the Hopetoun / Ravensthorpe Road</p>			
6			<b>Grasslands Type G</b>

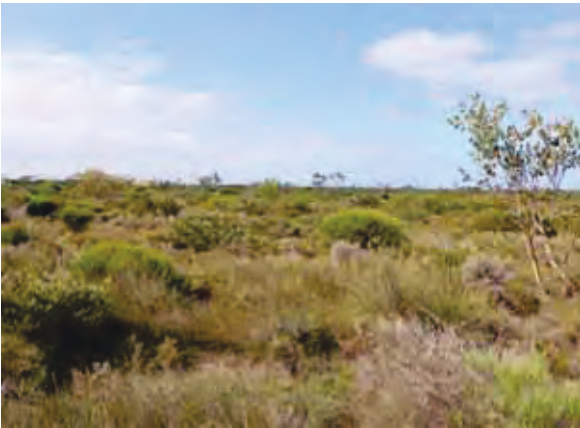
Plot	7	Classification or Exclusion Clause	Shrubland Type C

<p><b>Location:</b> Situated between the Hopetoun-Ravensthorpe Road and the eastern boundary of the assessment zone.</p> <p><b>Separation distance:</b> 25m.</p> <p><b>Dominant species &amp; description:</b> <i>Grevillea</i>, <i>Acacias</i> and low shrubs (1.2m) under occasional <i>Mallee</i> and <i>Banksia</i>.</p> <p><b>Average vegetation height:</b> 1.2 – 2m.</p> <p><b>Vegetation Coverage:</b> &lt;30%.</p> <p><b>Available fuel loading:</b> 15t/ha.</p> <p><b>Effective slope:</b> Downslope &lt;0 to 5 degrees.</p>
<p><i>Photo 1d 7: View looking east across shrubland from Hopetoun-Ravensthorpe Road.</i></p>			
Plot	8	Classification or Exclusion Clause	Low fuel or non-vegetated areas 2.2.3.2 (e)

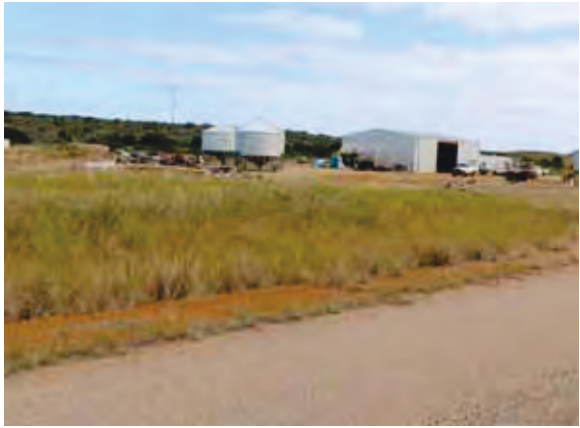
<p><b>Location:</b> Located in the northern corner of the Subject Site and three small areas in the south-western portion of the site.</p> <p>Includes the light industry commercial buildings and hardstands in the north.</p> <p>Includes the sand mine activities in the south-west.</p> <p>Includes Ravensthorpe-Hopetoun Road, Leschenaultia Drive, wind farm access and Steeredale Road.</p> <p><b>Separation distance:</b> 0m.</p>

<p><i>Photo 1d 8: View of light industry sheds on northern boundary of lot along Steeredale Road.</i></p>

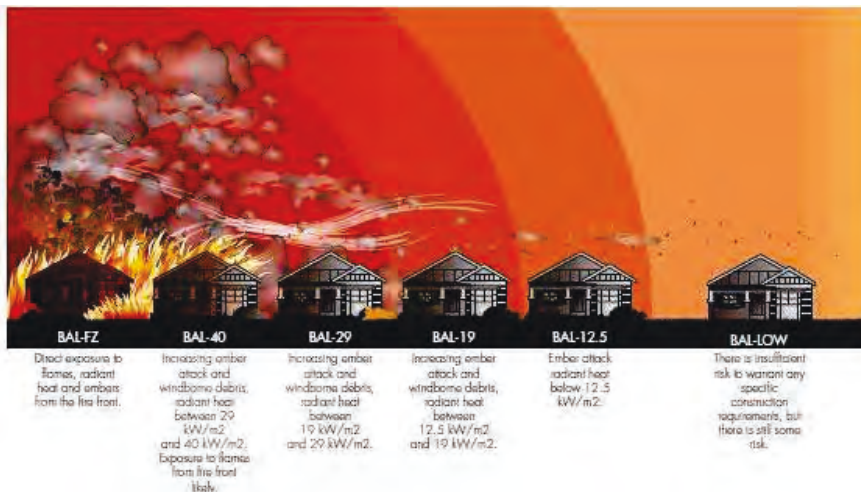
**Figure 4: Building to BAL**

Bushfire Attack Level (BAL) is the process in AS3959-2009 for measuring the severity of a building's potential exposure to ember attack, radiant heat and direct flame contact. The threat or risk of bushfire attack is assessed by an accredited BAL Assessor. BAL rating determinations are of 6 levels BAL-LOW, BAL-12.5, BAL-19, BAL-29, BAL-40, BAL-FZ. Building is generally not recommended in BAL-40 or BAL-FZ areas. The BAL rating is determined by the distance of the building to vegetation, slope and vegetation type adjacent to the dwelling. Refer to Figure 4.

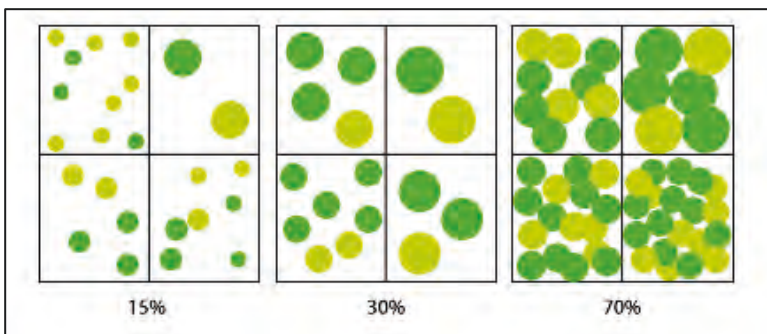
**Figure 6: Tree Canopy Coverage – ranging from 15 to 70% at maturity (WAPC, 2017)**

**Trees (> 5 metres in height):** Trunks at maturity should be a minimum distance of 6 metres from all elevations of the building, branches at maturity should not touch or overhang the building, lower branches should be removed to a height of 2 metres above the ground and or surface vegetation, canopy cover should be less than 15% with tree canopies at maturity well spread to at least 5 metres apart as to not form a continuous canopy. See Figure 6 (WAPC Figure 16, Appendix 4) below.

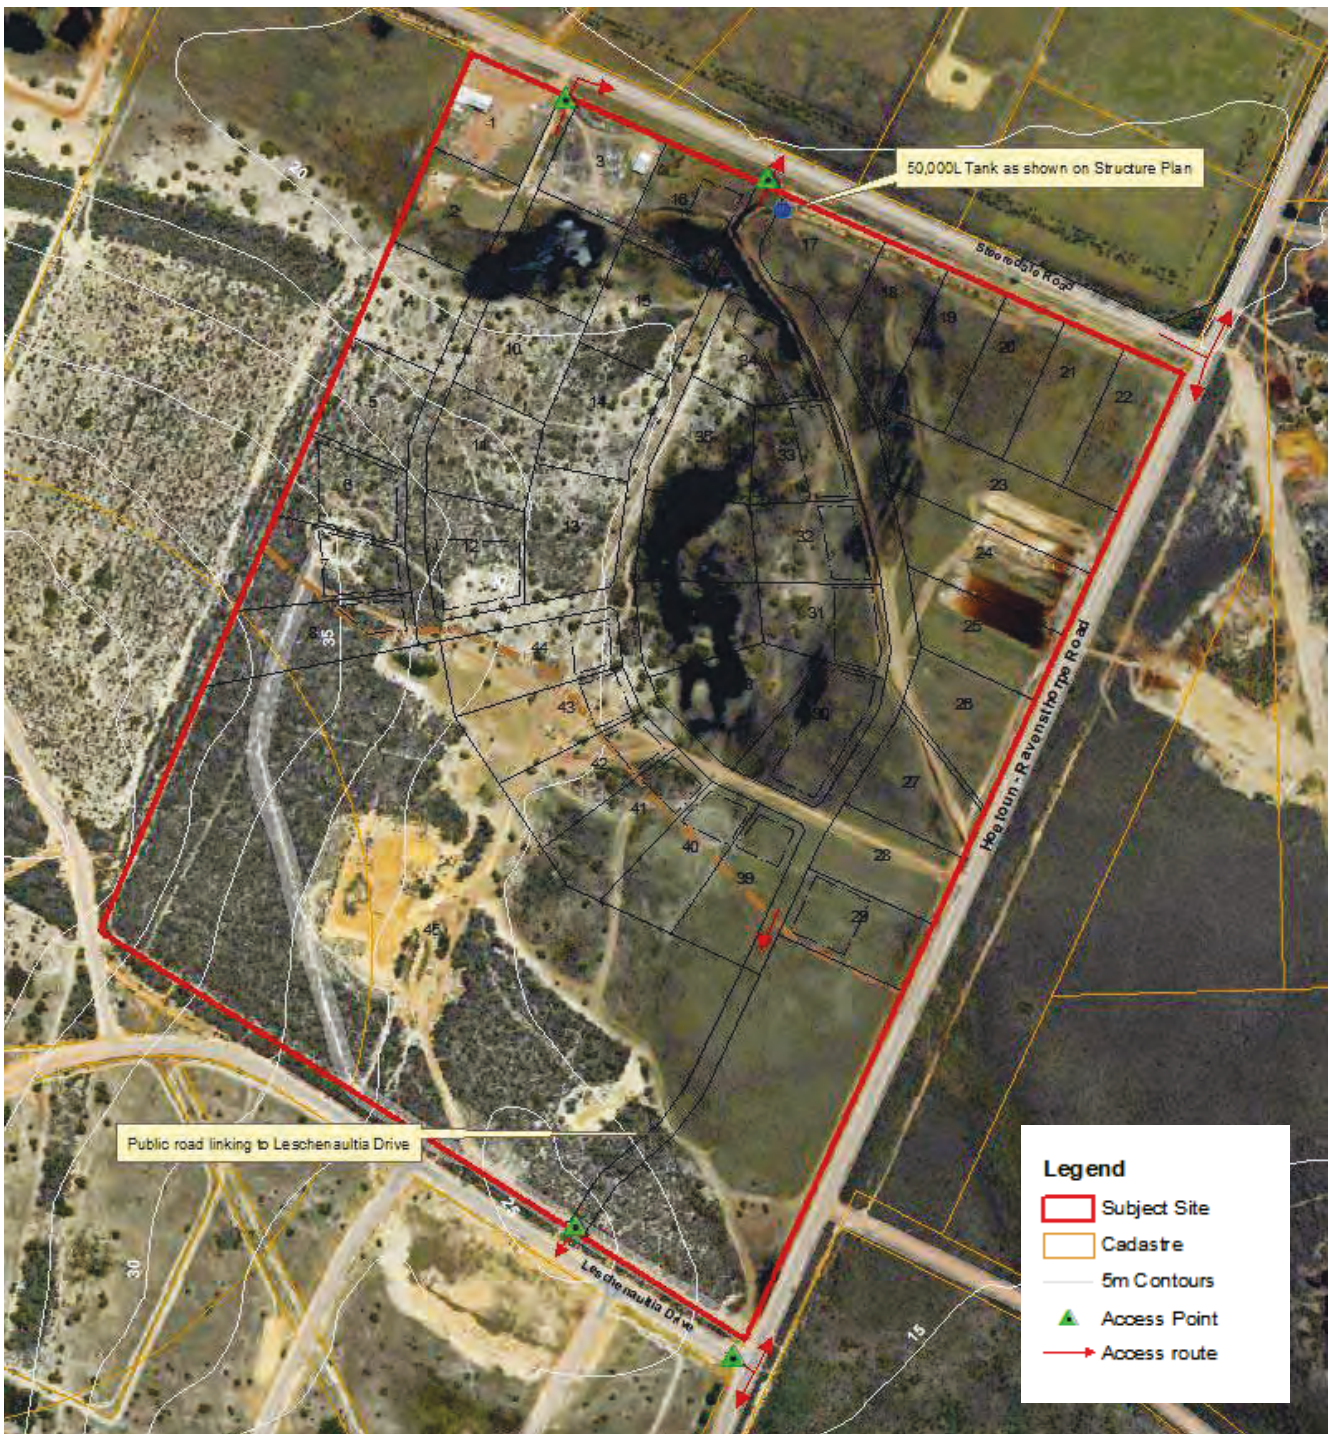
**Figure 7: Access Plan**

**A3.1 Two access routes:** The Local Structure Plan shows two exit/entry points via public roads onto Steeredale Road to the north and Leschenaultia Drive to the south. This provides two alternative access points to alternative directions as required by the guidelines. The balance of Lot 8 which has frontage to Leschenaultia Drive is zoned General Agriculture and is currently being used to mine sand. It is anticipated that once the sand resource has been removed, application will be made under the provisions of Local Planning Scheme No 6 to rezone the land to create additional lots within cleared areas and the public road providing access to Lot 29 will be extended to Leschenaultia Drive. See Figure 7. Subject site deemed compliant with A3.1

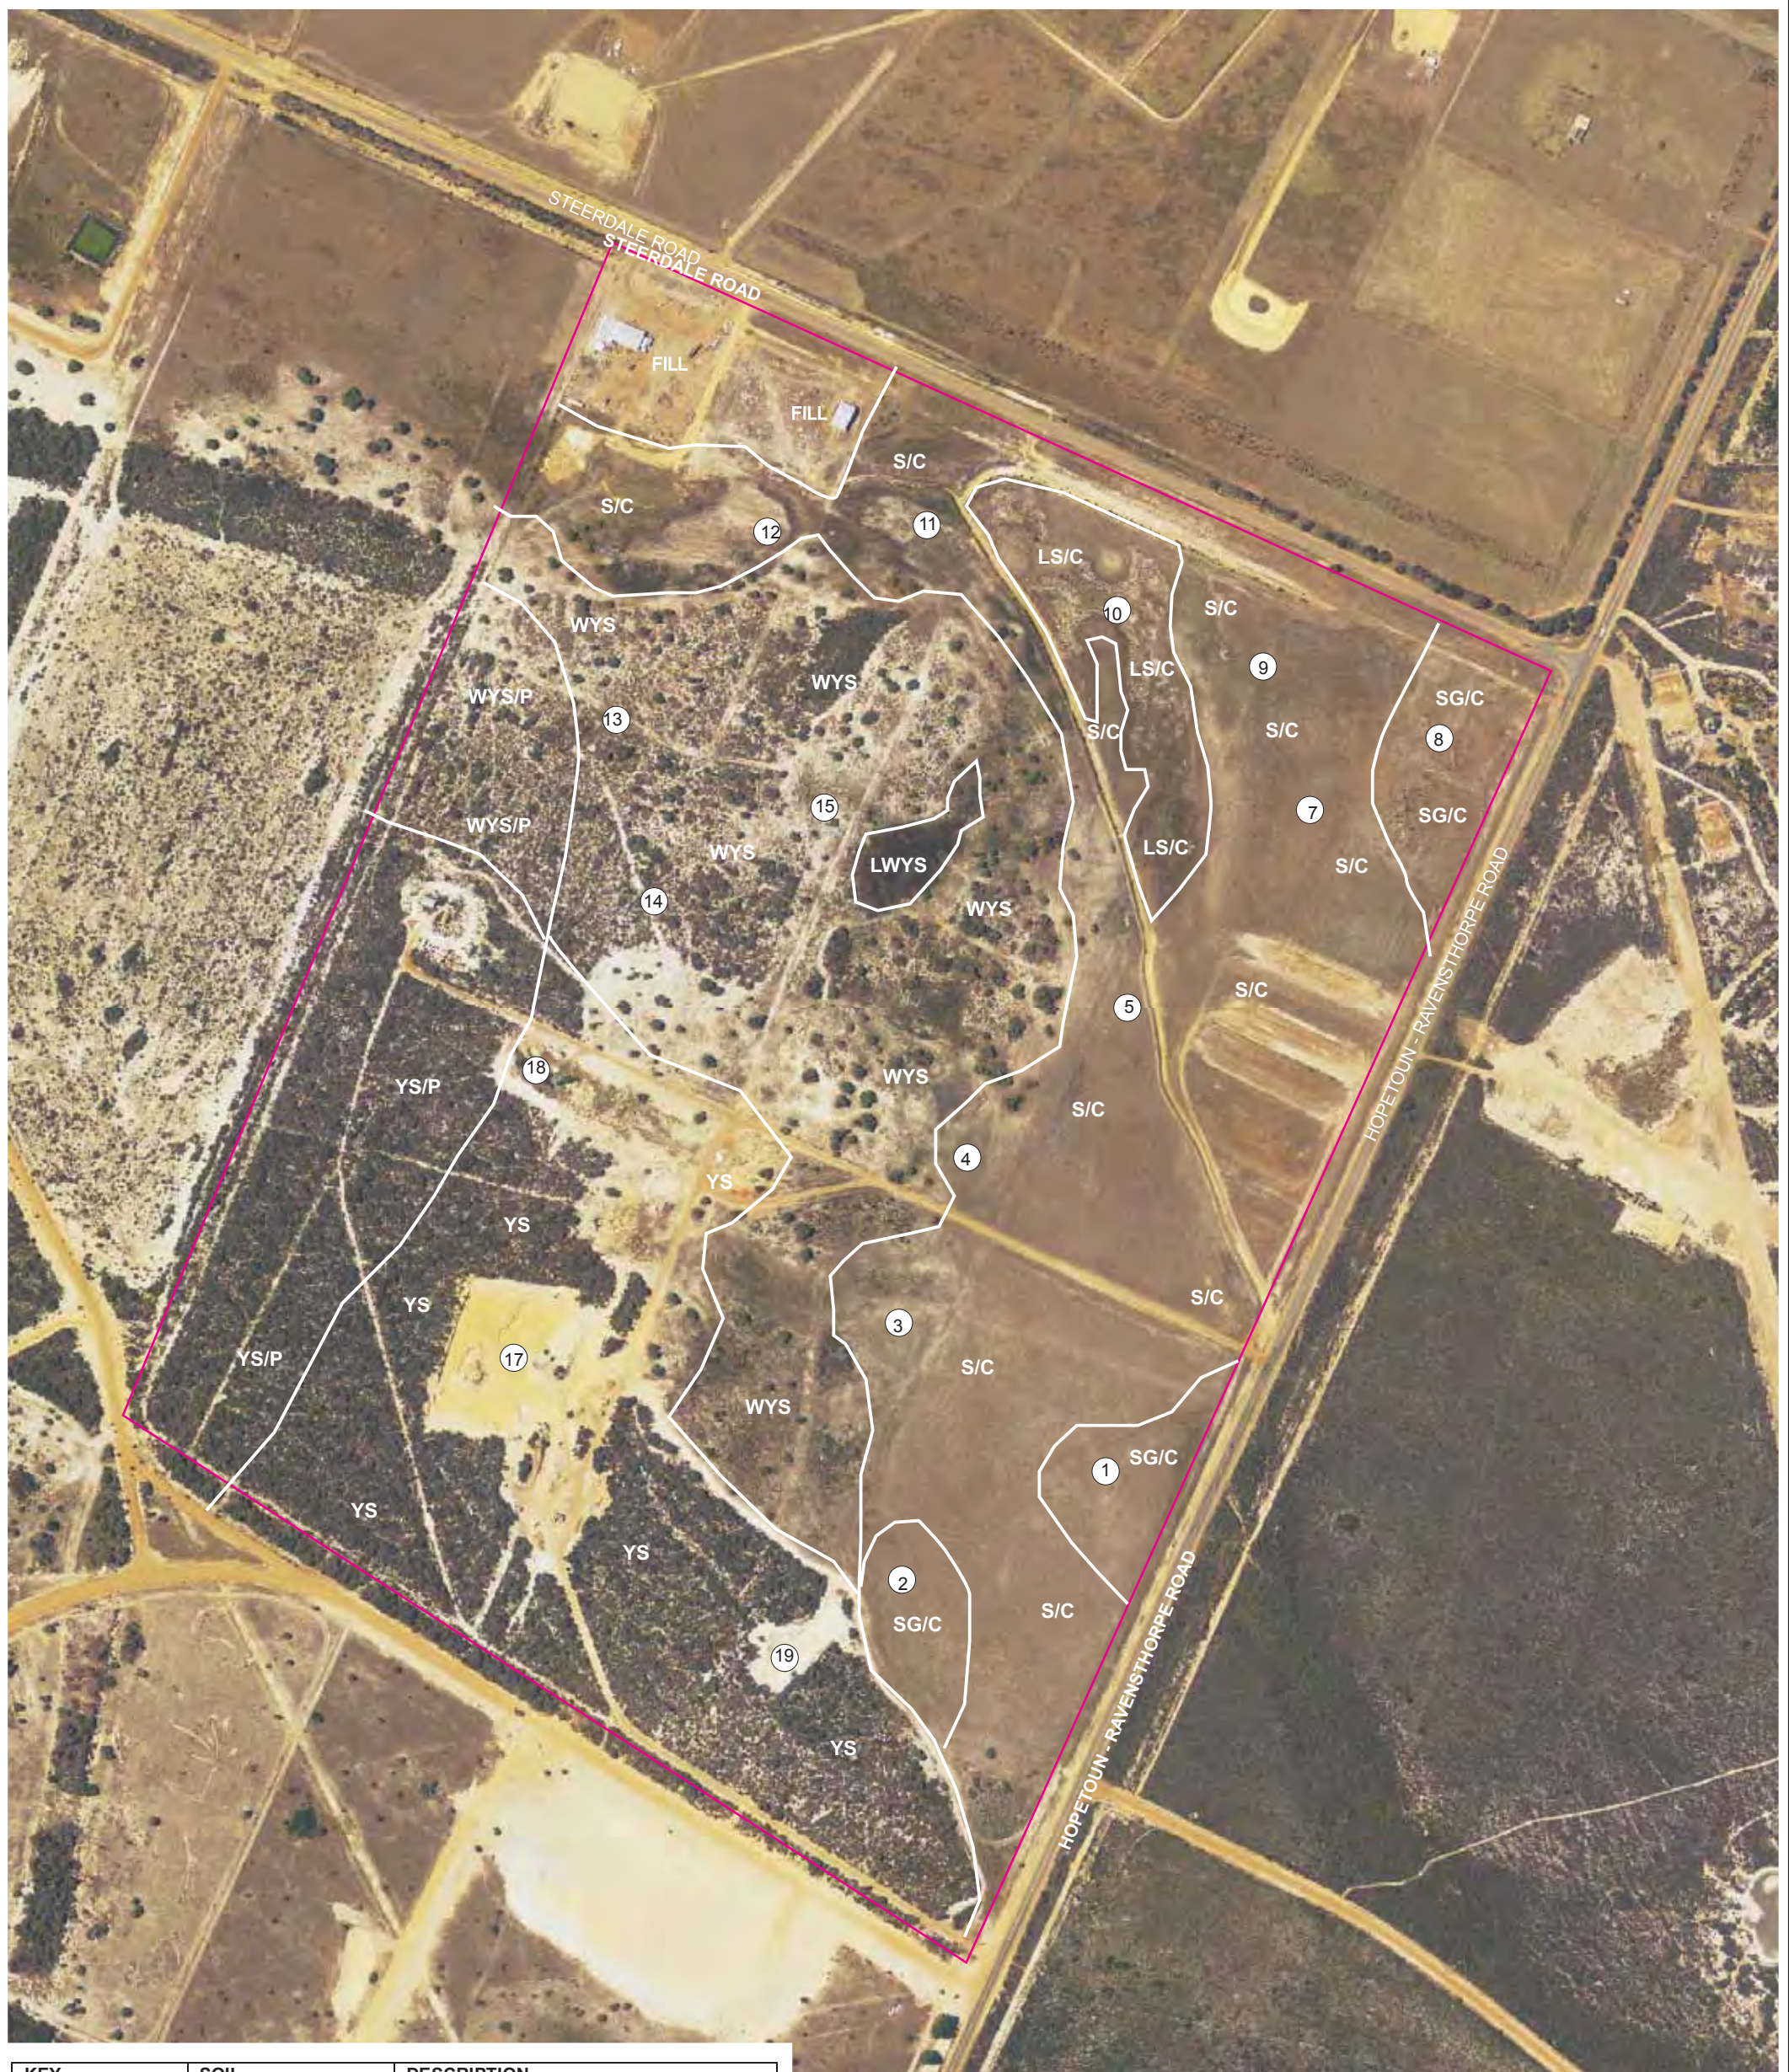
KEY		SOIL	DESCRIPTION
S/C	S/C	Sand over clay	Brown sand to depths to 500 mm over yellow sandy and loam clay. At depths of 650 – 850 the clay becomes lighter.
	SG/C	Sand/gravel over clay	Sand over clay as above but with gravel developed at the clay interface and generally thinner sand sheet.
	LS/C	Lower sand over clay	Brown sand over yellow sandy clay with a thinner sand layer. Subject to winter wet conditions.
YS	YS	Yellow sand	Deep pale yellow sand grading to darker earthy yellow sand at depths of 100 – 500 mm.
	YSP	Yellow sand over limestone	As above but with limestone pinnacles at 1 – 3 metres on limestone.
WYS	WYS	White sand grading to yellow sand	Same as the Yellow Sand but with a deeper leached surface horizon and white to pale yellow sand extending to depths of 1 plus metre.
	LWYS	Low white sand grading to yellow sand	Same as the leached white sand over yellow sand but at a lower elevation where the vegetation changes slightly.

⑥ Soil test hole

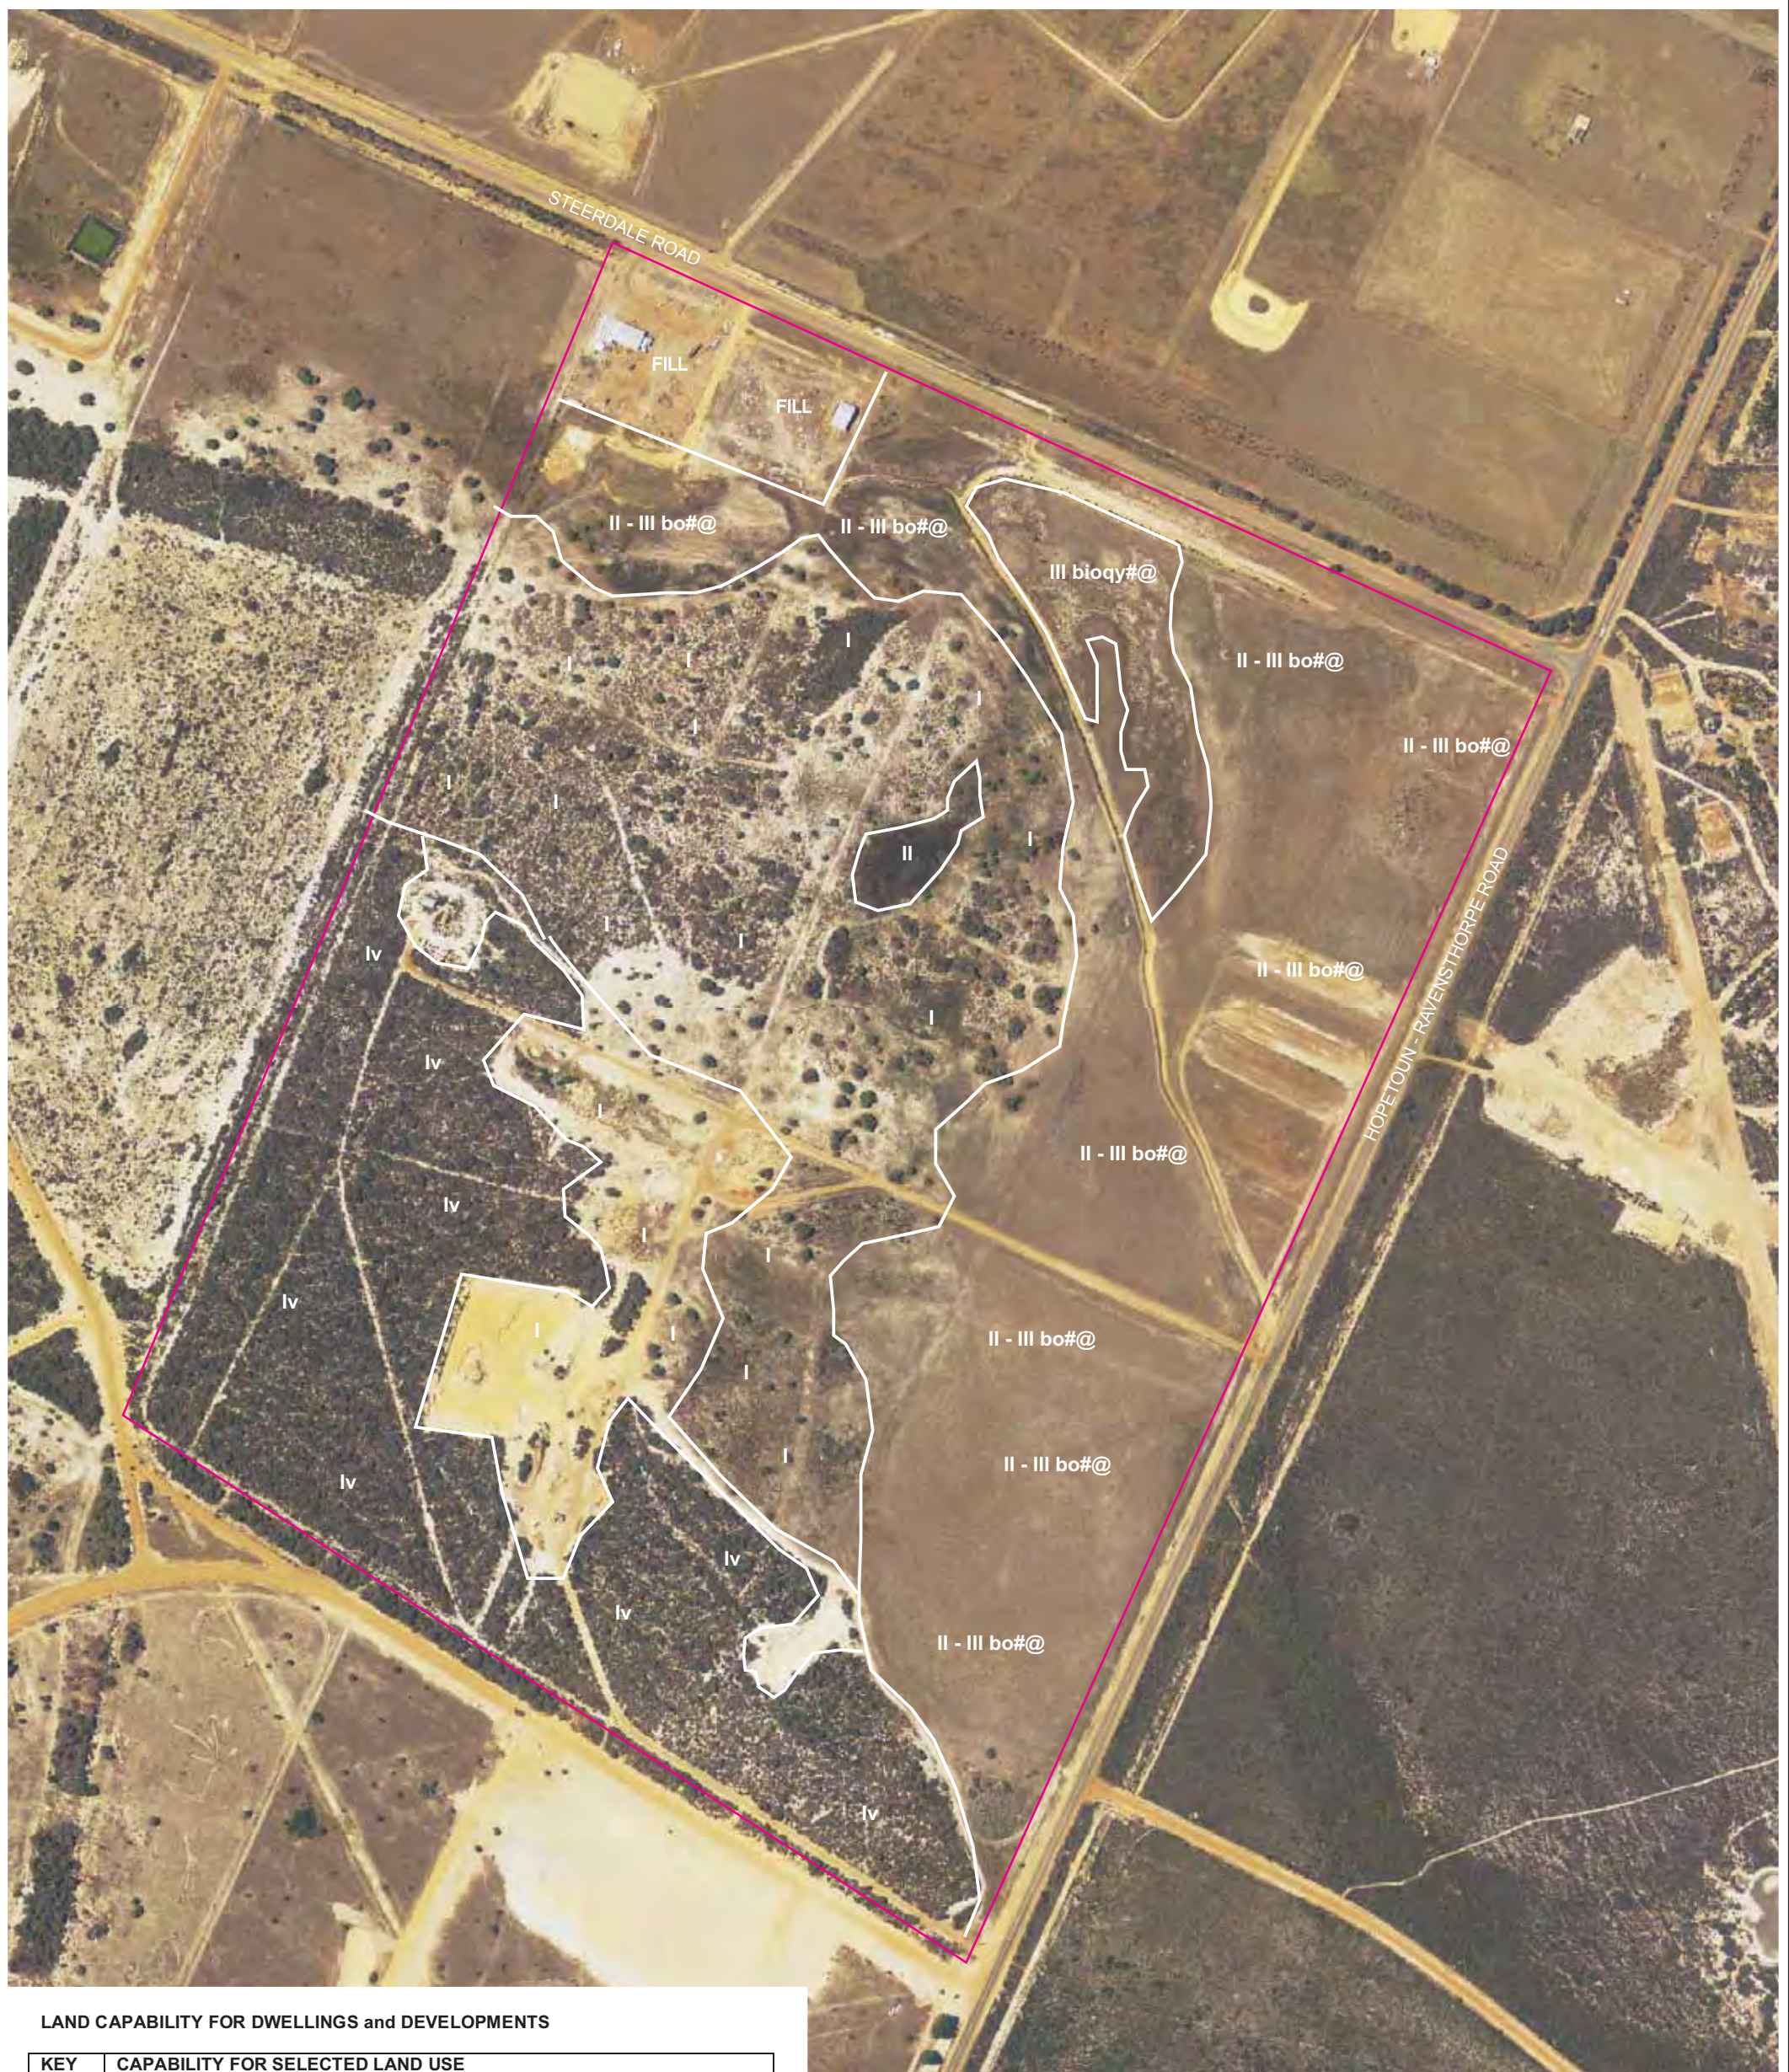
**LAND CAPABILITY FOR DWELLINGS and DEVELOPMENTS**

KEY	CAPABILITY FOR SELECTED LAND USE
I	<ul style="list-style-type: none"> <li>Very high capability with few physical limitations.</li> </ul>
II	<ul style="list-style-type: none"> <li>High capability with minor physical limitations that can be overcome by planning and minor site modifications.</li> </ul>
III	<ul style="list-style-type: none"> <li>Fair capability with moderate physical limitations. The cost of development can be managed by the design of subdivision layout, lot size foundations.</li> <li>Consideration during planning will be required.</li> <li>Some site modification may be required.</li> </ul>
IV	<ul style="list-style-type: none"> <li>Lower capability with a number of smaller management actions required or there is one significant factor that will require management.</li> <li>Subdivision or development design can be used to contain additional costs.</li> <li>Additional site works may be required; retaining walls, drainage, increased rock removal, heavier foundations, cut and fill, general fill, flood mitigation, increased costs or the presence of significant saline soil - acid sulfate.</li> </ul>

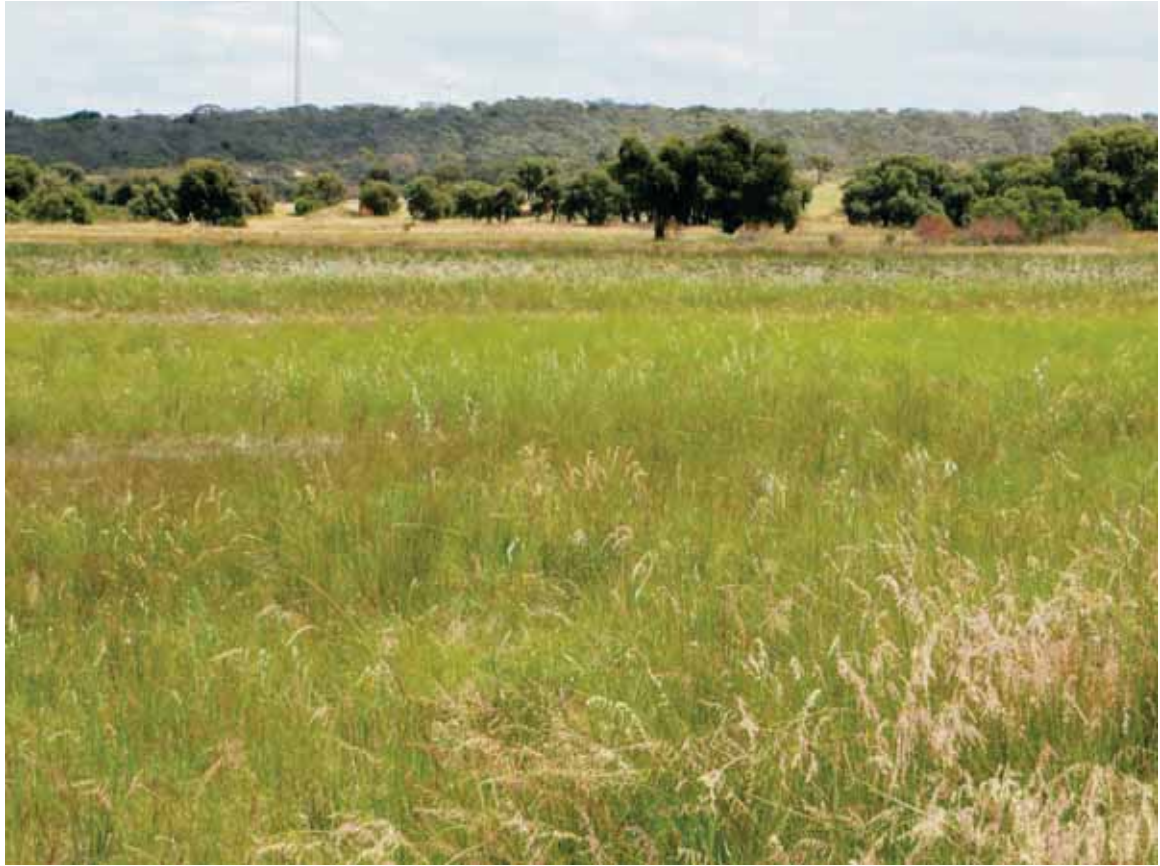
General view from east to west, showing the higher sand ridge in the west

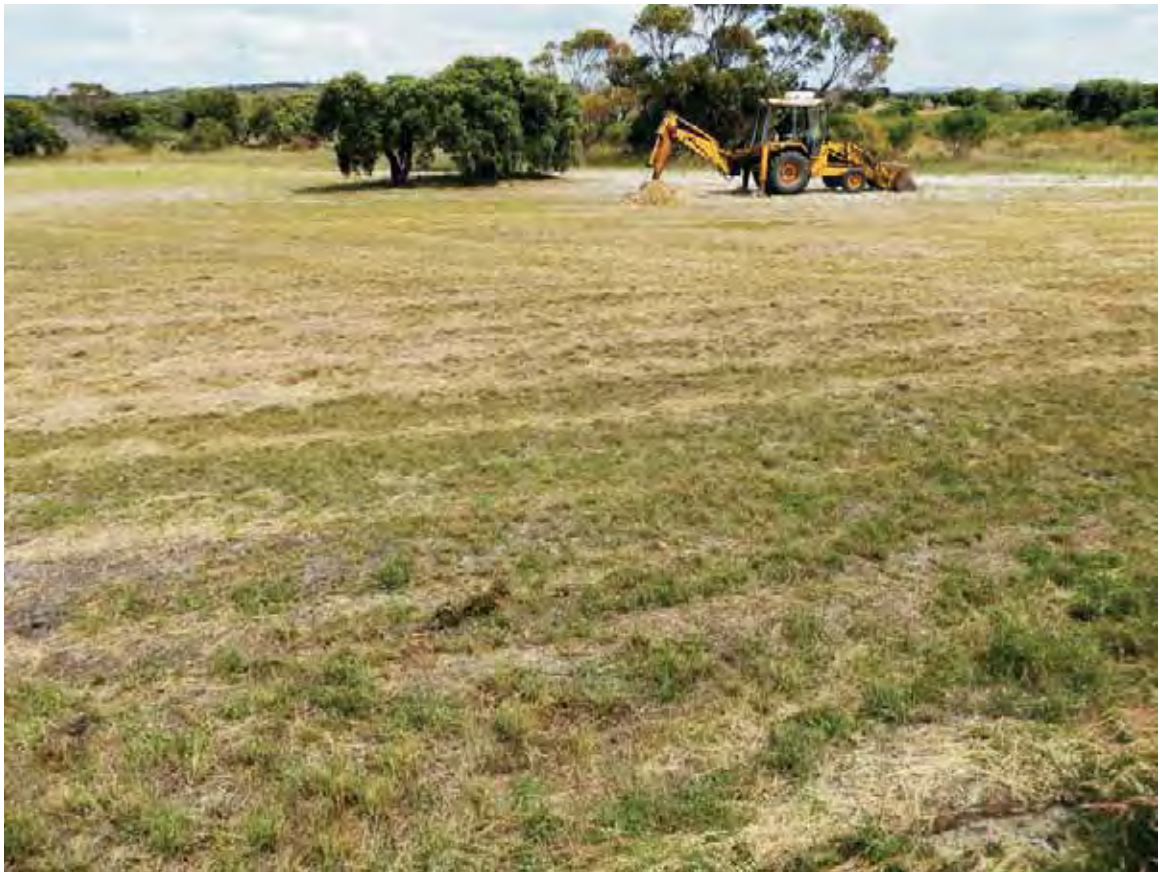
General view in the location of Hole 9
