Local Structure Plan Lot 34 Third Street, Harvey

(August 2019)
Ref: 17-05-VER

Prepared For
Mr B. Versaci
&
The Shire of Harvey

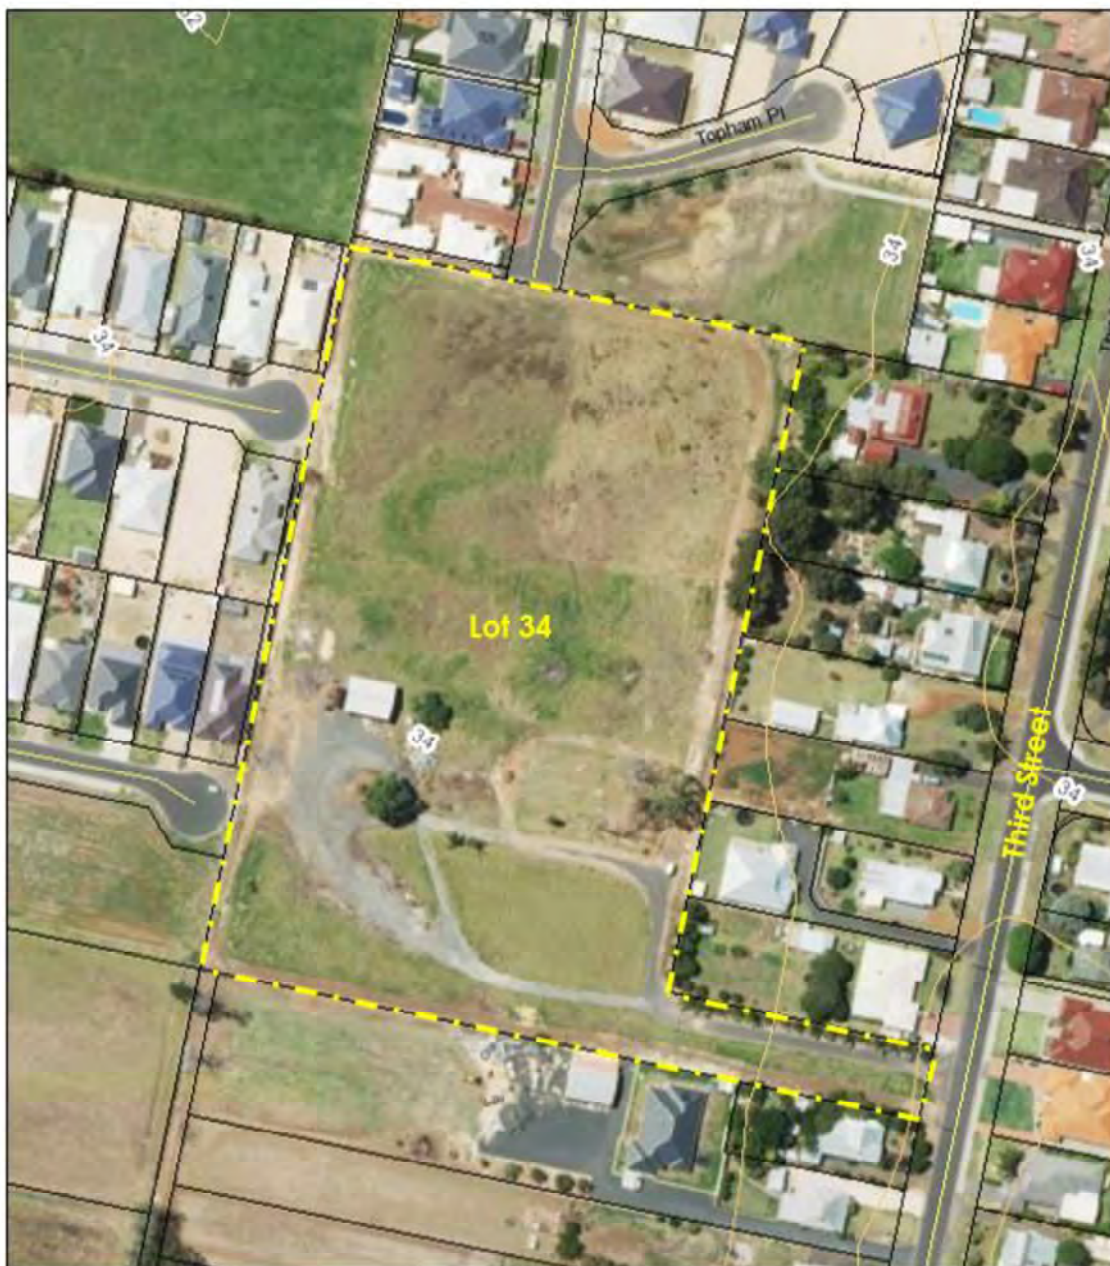
Figure 2
Lot 34 Third Street Local Structure Plan Area

The boundaries of the structure plan area include that portion of the Local Government district of the Shire of Harvey as shown on **Figure 2** – Lot 34 Third Street Local Structure Plan Area. The subject land is owned by Mr Biaggio Versaci.

The Structure Plan area is adjacent to relatively recent residential subdivisions to the west and north. To the east, the land abuts large existing residential lots and to the south, land has generally been fragmented into narrow and long semi-rural lots.

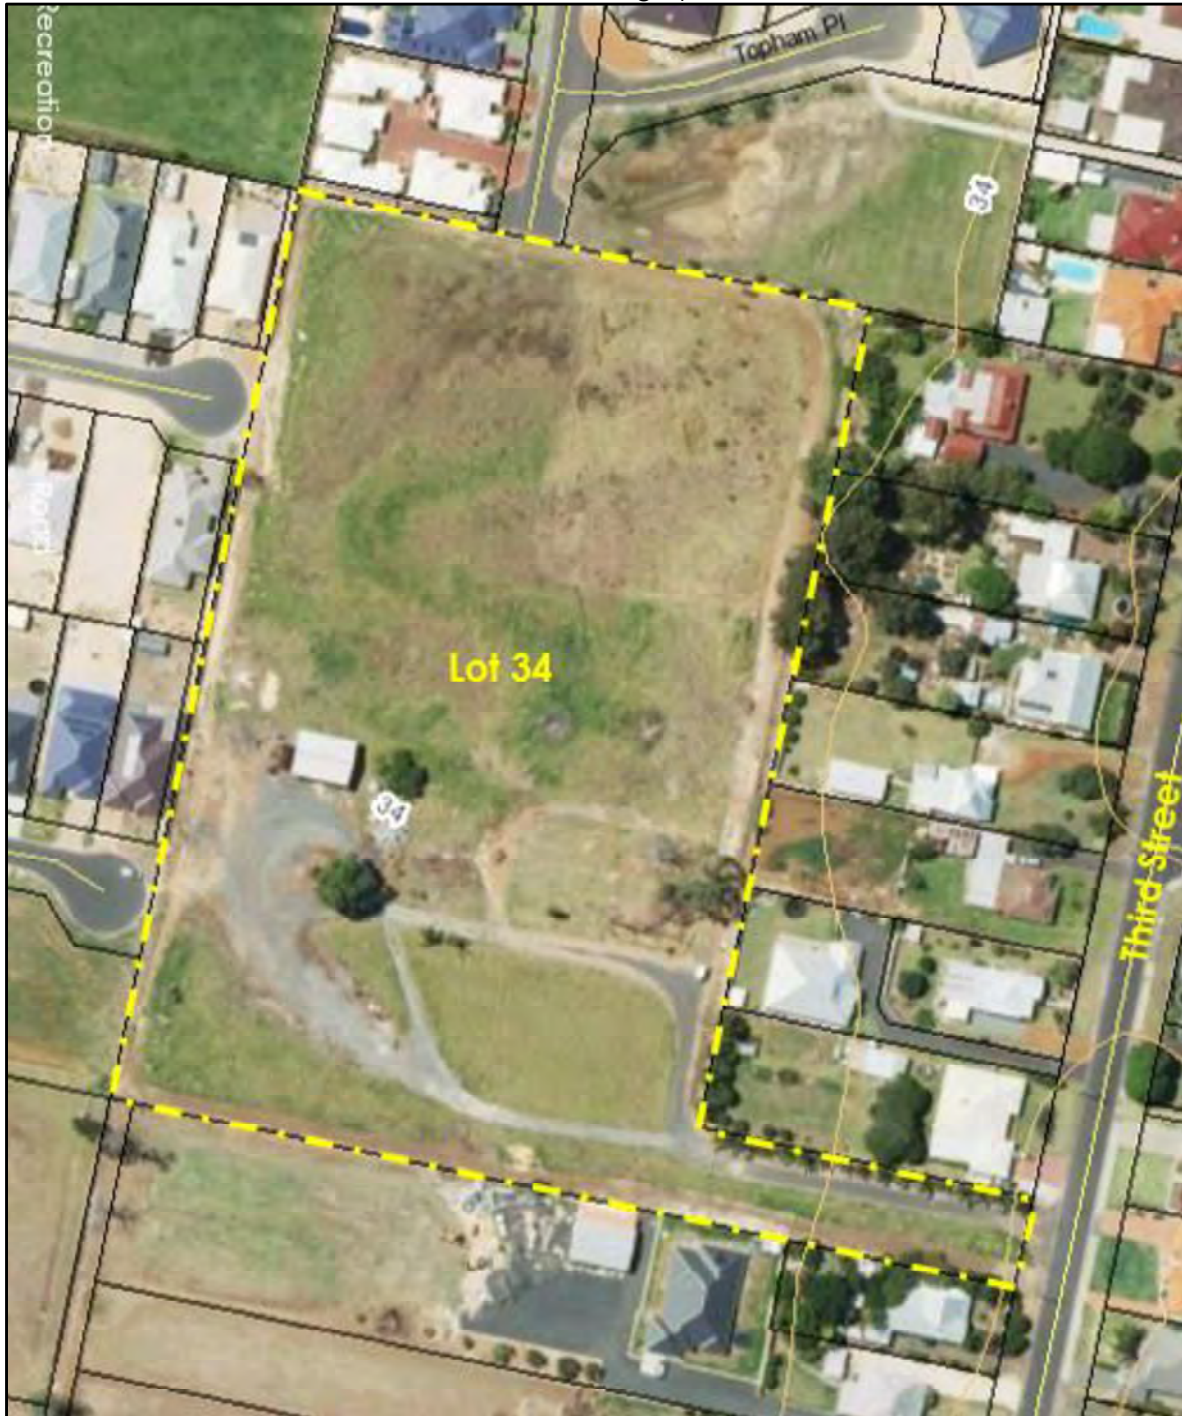
Figure 5
Aerial Photograph

Much of the subject land, due to its previous rural use, is generally cleared with some intermittent trees. **Figure 5** depicts the predominantly cleared nature of the land. It should be noted that the shed that appears on the land within Figure 5 has been removed.

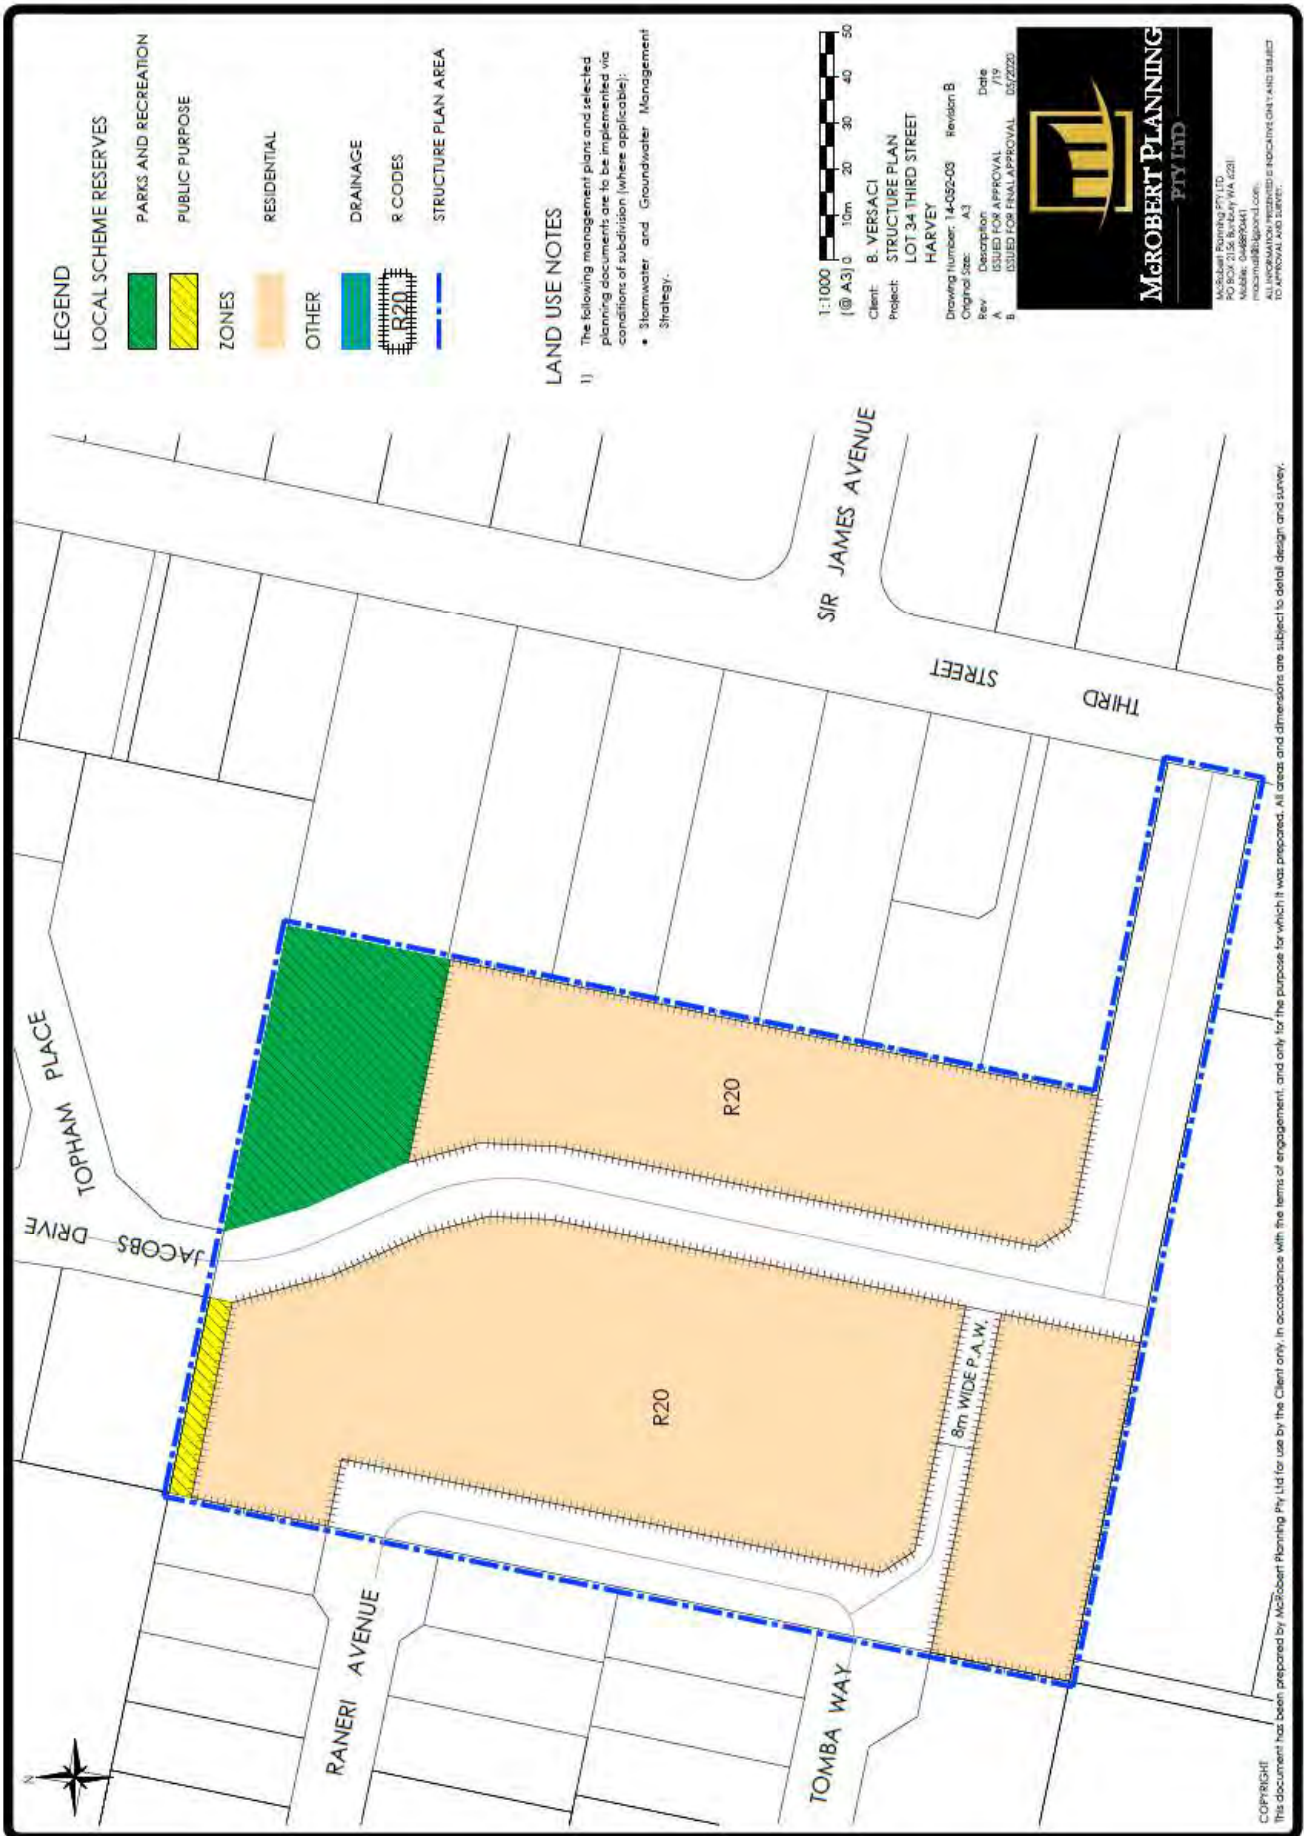
The Structure Plan area is highlighted by a blue line in **Figure 3** and **Attachment 1**.

The Lot 34 Third Street Local Structure Plan Map (refer to Figure 3 and Attachment 1) outlines the proposed 'Residential' portions of the land and the associated R20 density coding to be applied to those areas. In addition, the structure plan identifies the areas proposed to be reserved (eg recreation and drainage) and outlines the relevant land use notes applicable to the structure plan area.

The provision of public open space (POS) is to be achieved in accordance with the WAPC's Liveable Neighbourhoods. Public Open Space is to be provided generally in accordance with **Table 2** and Figure 3.

Calculation of Gross Subdivisible Area & Public Open Space Provision
(refer to Figure 3)

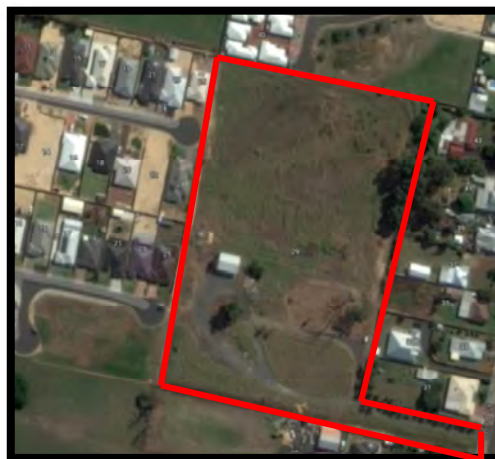
Figure 2 – Aerial Photo

The latest aerial photograph of the site, courtesy of Google Maps is provided as Figure 2 below, to illustrate the site condition and proximity to prominent topographic features.

As can be noted from the aerial photograph the site is largely devoid of extensive vegetation. The use of the property for general farming and storage has resulted in the larger vegetation being removed.

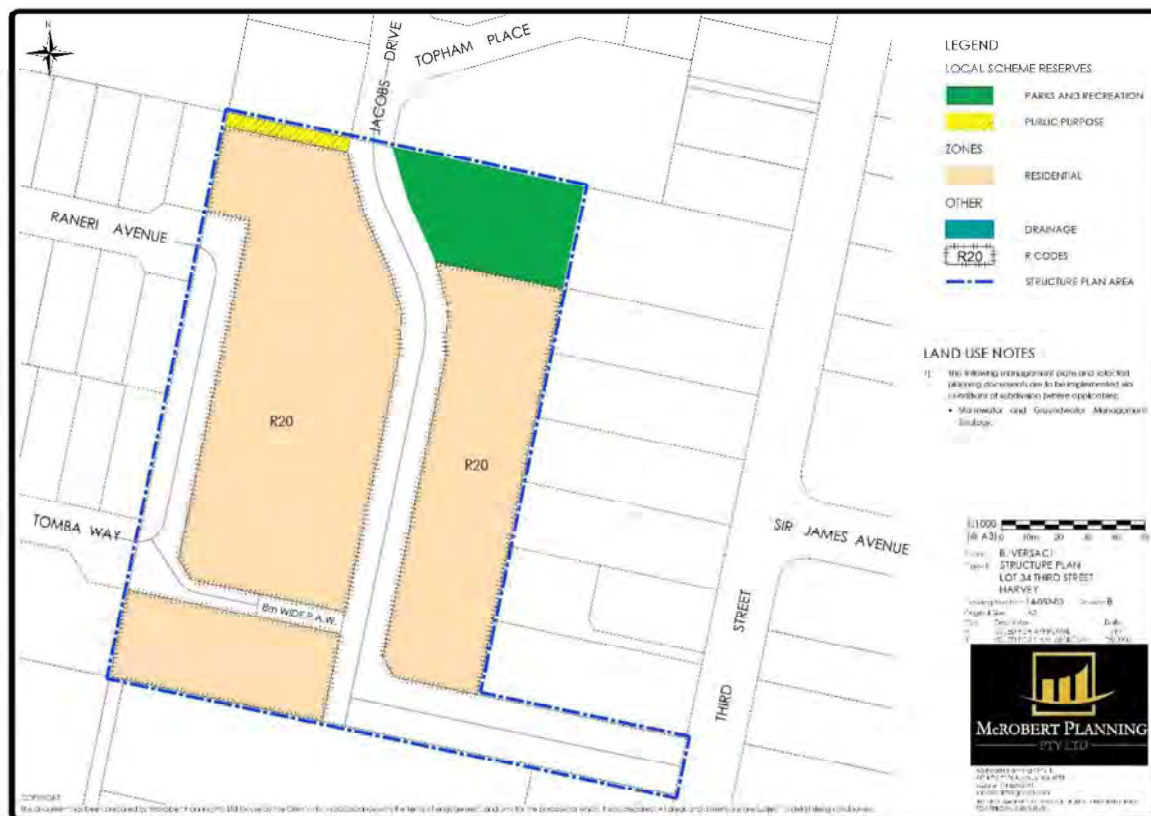
Figure 3
Amended Structure Plan

The proposed Structure Plan as lodged by McRobert Planning for approval was requested to be amended in May 2020 by the Western Australian Planning Commission (WAPC), this has resulted in the need to create revision 3 of this Stormwater and Groundwater Management Plan. The amended Structure Plan including the requested amendments by the WAPC is shown below, with an A3 version included as Attachment 1.

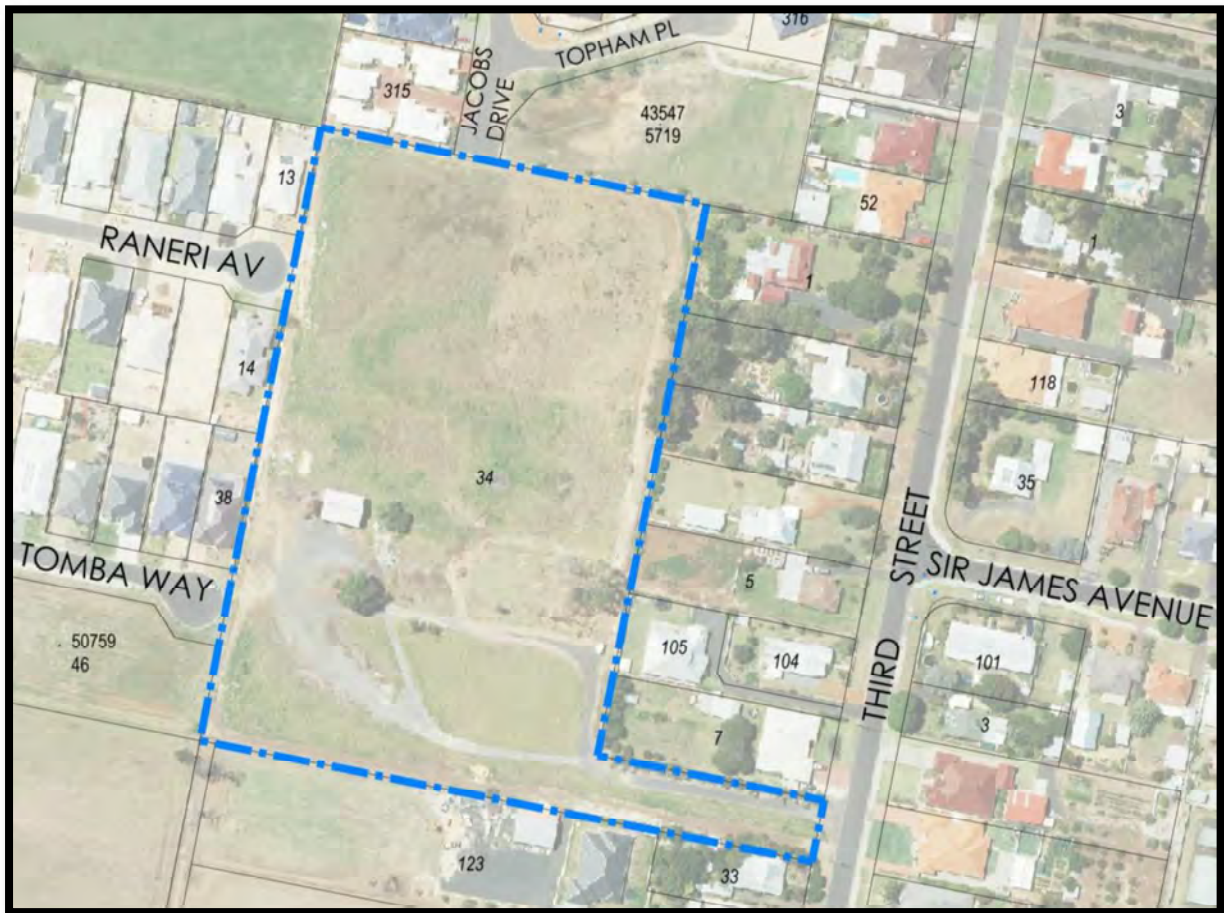
Figure 4
Aerial Photograph with Cadastral Overlay

The following aerial photograph with cadastral overlay (refer to Figure 4) depicts the predominantly cleared nature of the land.

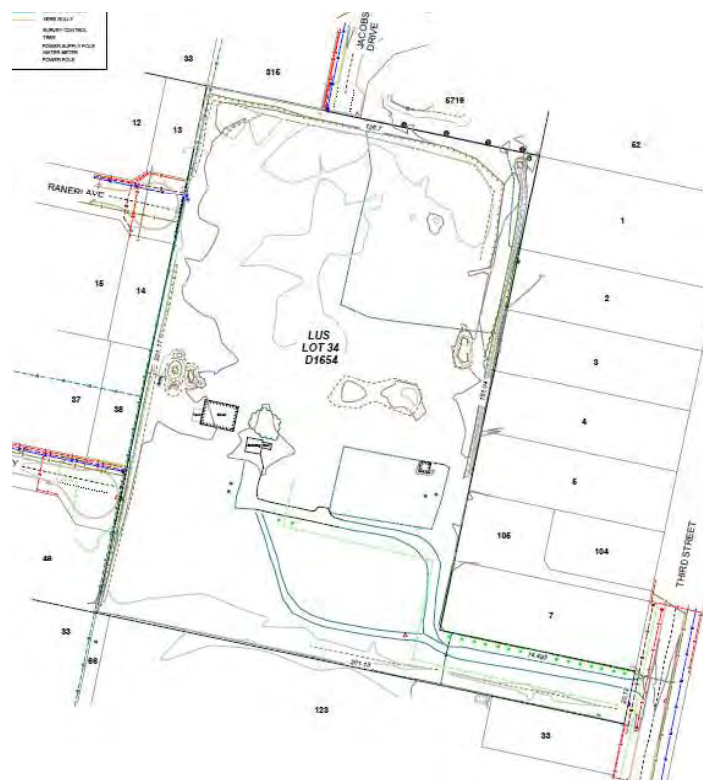
Figure 6
Topography

The structure plan area is best described as relatively flat with levels ranging from RL 34 metres AHD to RL 34.5 metres AHD. A copy of the feature survey plan is included below, as Figure 6 and included in A3 size as Attachment 3.

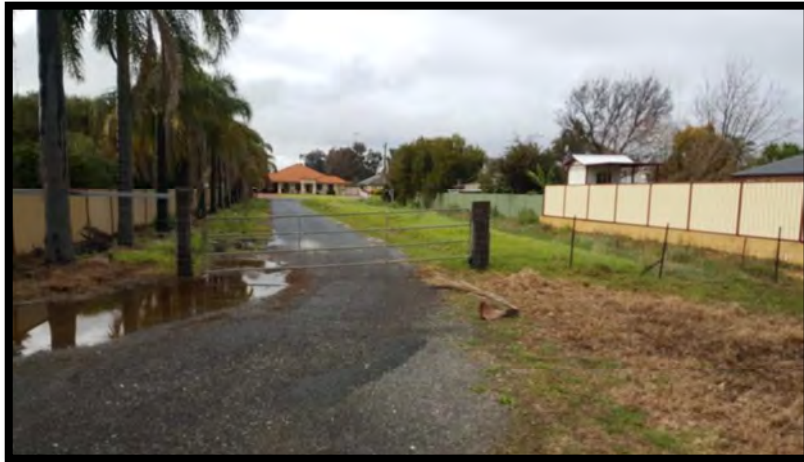
Figure 7

A visual representation of the sites surface water hydrology is included below as a series of photographs taken of the site in August 2016, following and during a rain event.

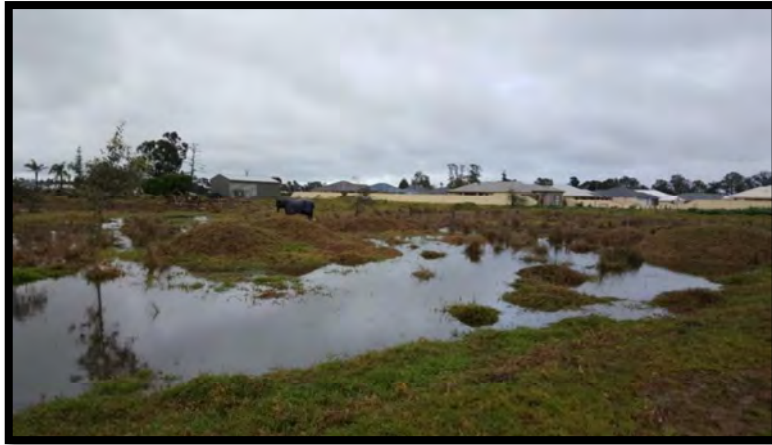
Figure 10

Property Picture (surface water ponding in northern portion of site)

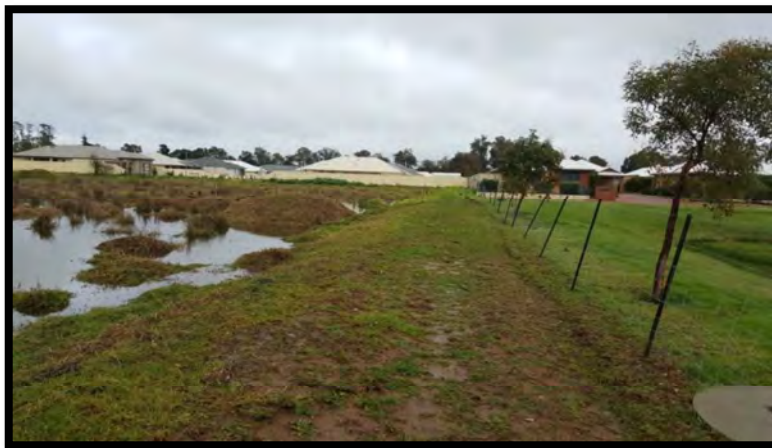
Figure 11

Property Picture (looking west along northern boundary)
Note: Existing Drainage basin to north and existing grated pits

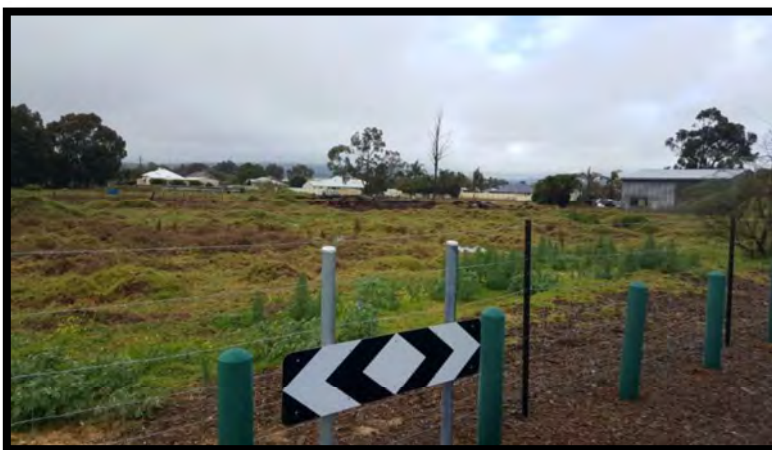
Figure 12

Property Picture (looking south east from the existing end of Raneri Ave)

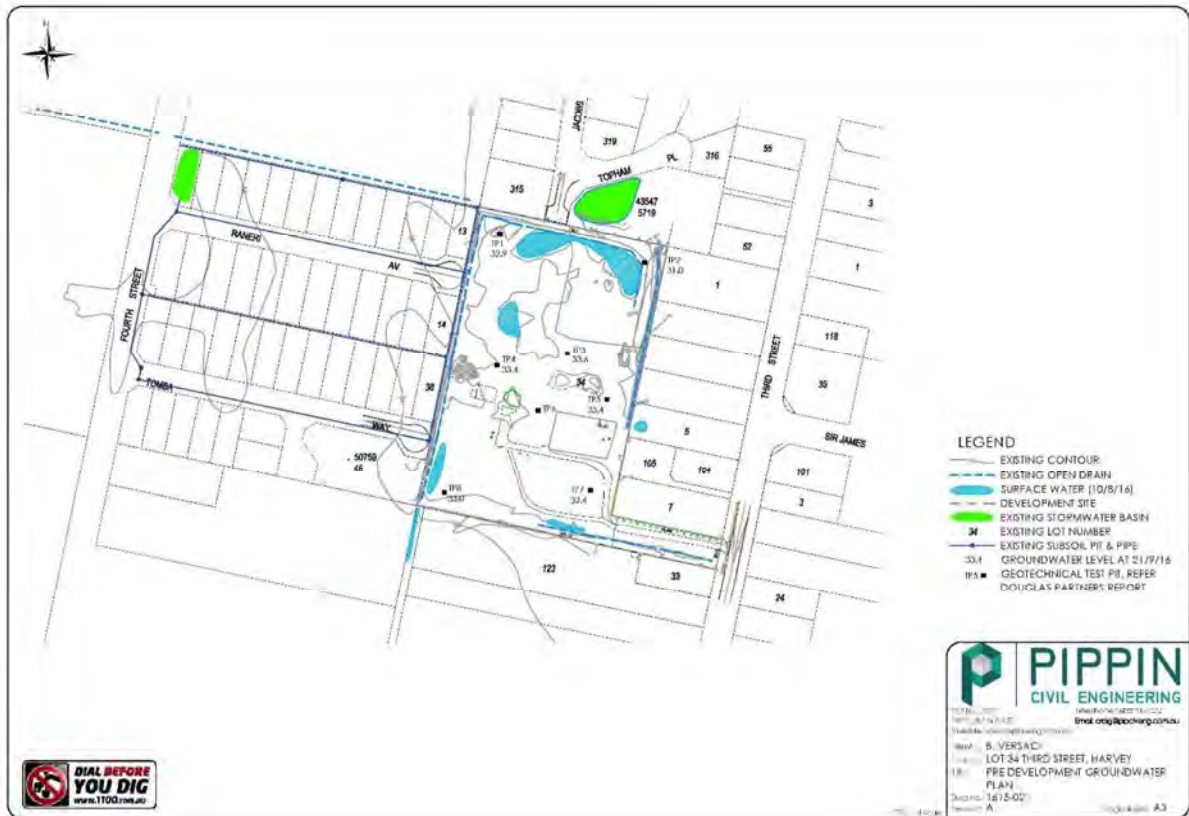
The geotechnical investigation was completed on the 21st September 2016. The investigation included the excavation of 8 test pits across the entire site, of which all but 1 pit noted groundwater seepage. A plan of the test pits locations is included on the Predevelopment Groundwater Plan as included below as Figure 14 and within Attachment 6.

As can be noted from the Predevelopment Groundwater Plan the existing groundwater surface profile varies from 0.6m to in excess of 2.0m deep, however surface water ponding occurs in several areas across the development site and covers an extensive area along the northern boundary.

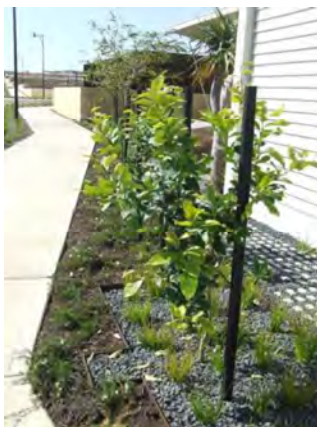
4.3 RAINGARDENS

The detention of stormwater within the lots will be a requirement of this development and the Shire of Harveys standard guidelines. It can occur through the implementation of controlled outflow pits with suitably sized on-site detention, which is generally implemented by subsurface storage or concrete pits. The use of private raingardens can also provide the on-site detention and controlled outflow in addition to providing treatment of stormwater at source.

A raingarden collects and filters stormwater run-off from impervious surfaces within the lot, including the home, driveway and paved areas. It is a vegetated area that is constructed with a detention volume and an amended soil profile to remove litter and excess nutrients from entering downstream stormwater systems and ultimately our waterways.

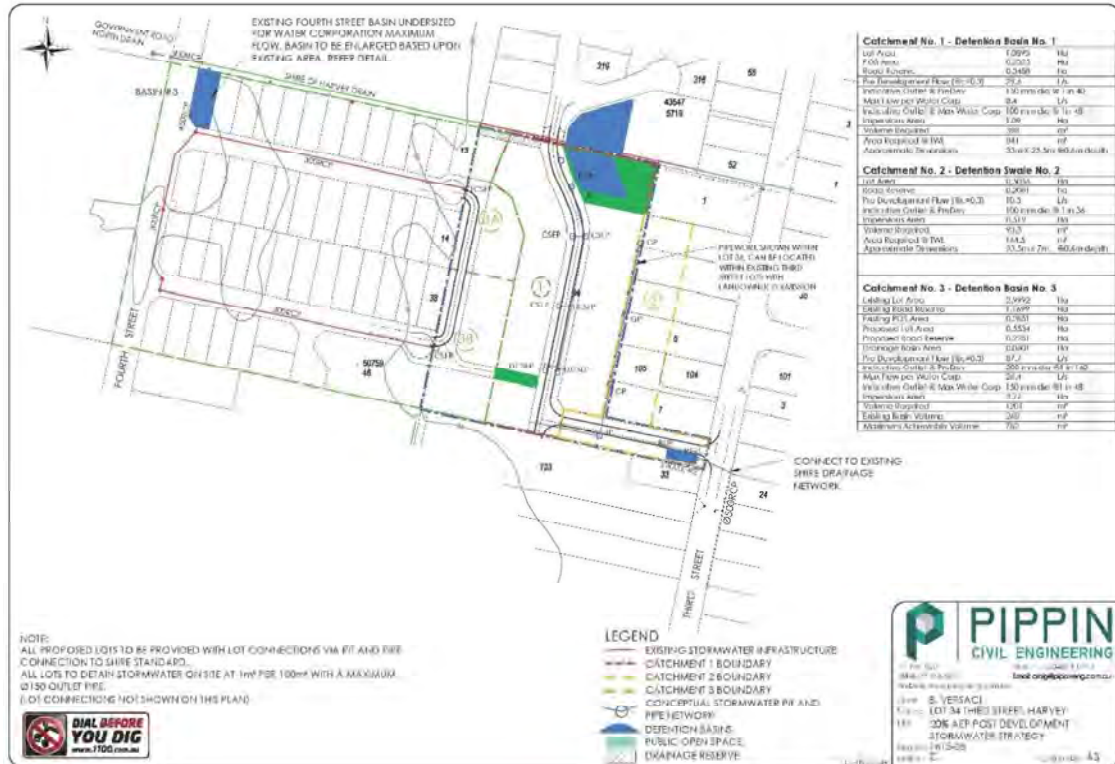
Figure 20
Large Storm – 20% AEP Stormwater Strategy

The detailed design of the pit and pipe network will form part of the UWMP condition of subdivision development however a conceptual design, including catchments and detention basin/swales is shown as Figure 20 below and in more detail within Attachment 9.

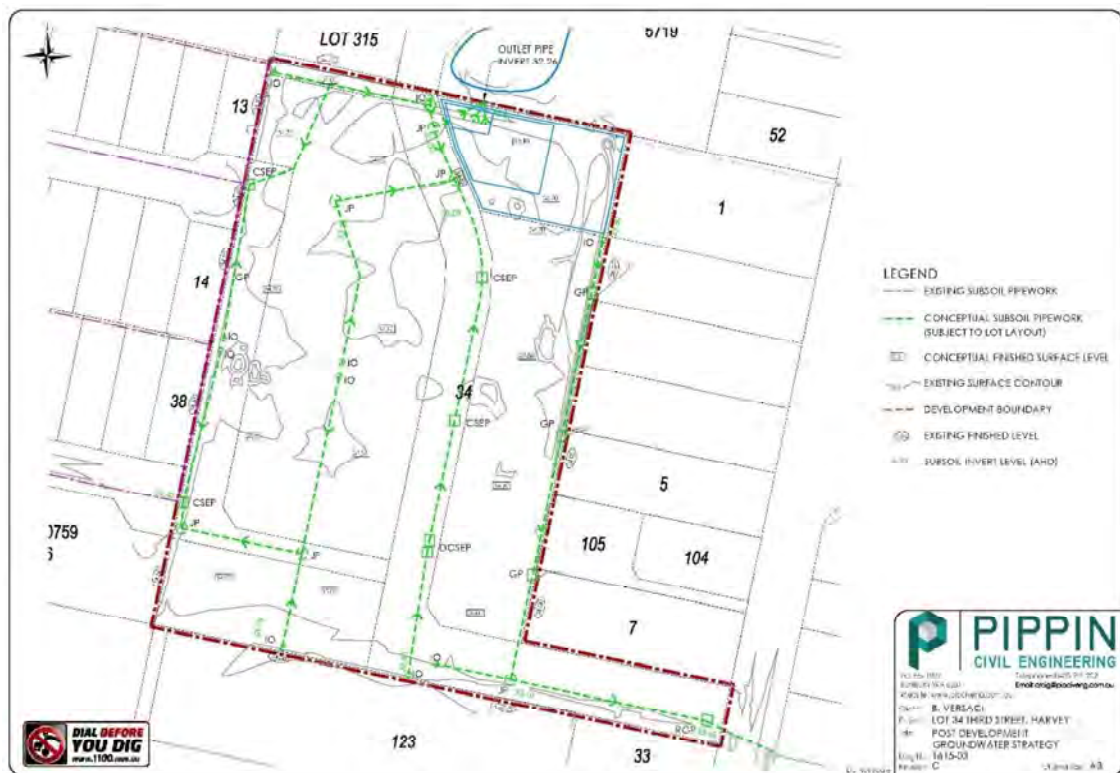
Figure 25
Post Development Groundwater Strategy

The indicative post development groundwater strategy is provided in Attachment 11 including approximate inverts of the proposed subsoil network, existing groundwater levels, existing surface levels and the proposed network. A reduced scale strategy plan is included below as Figure 25.

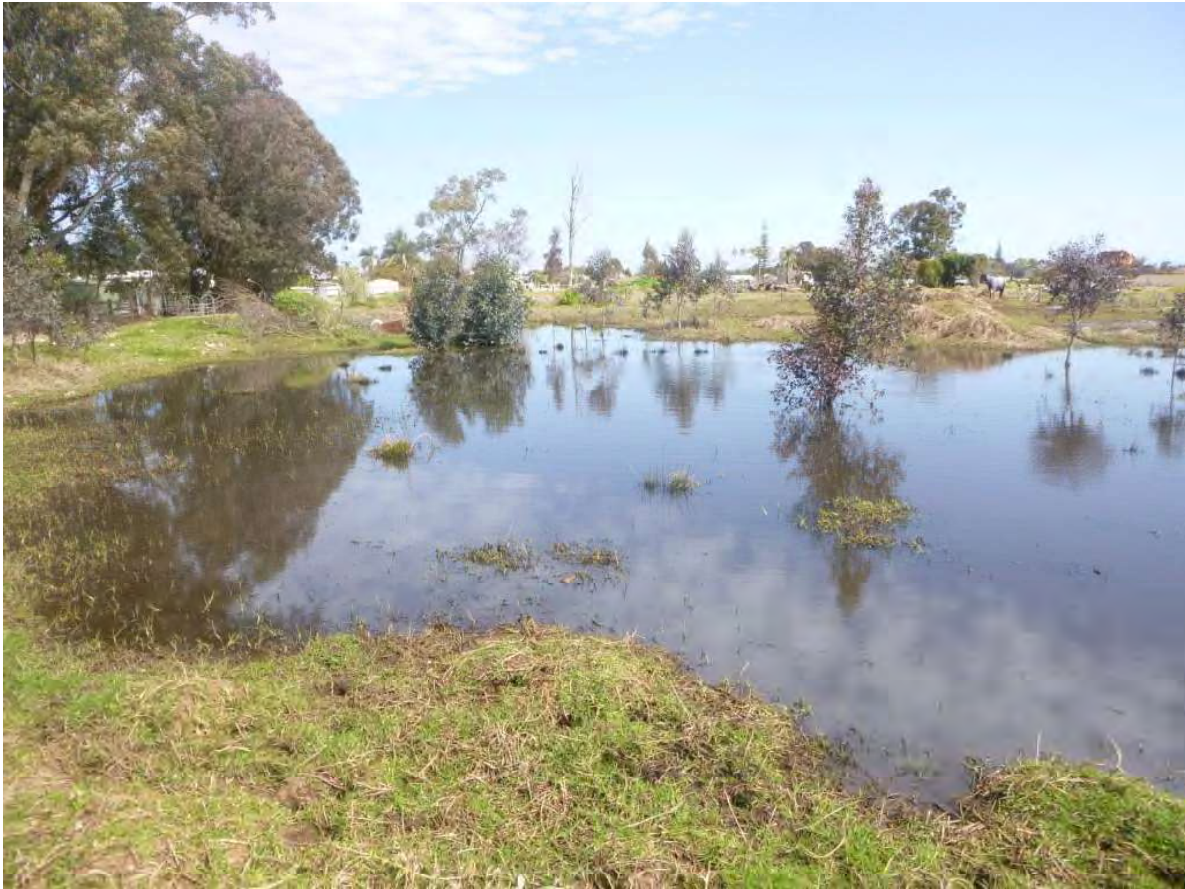
Figure 1: View of the Site During Field Work Looking Southwards from the North East Corner

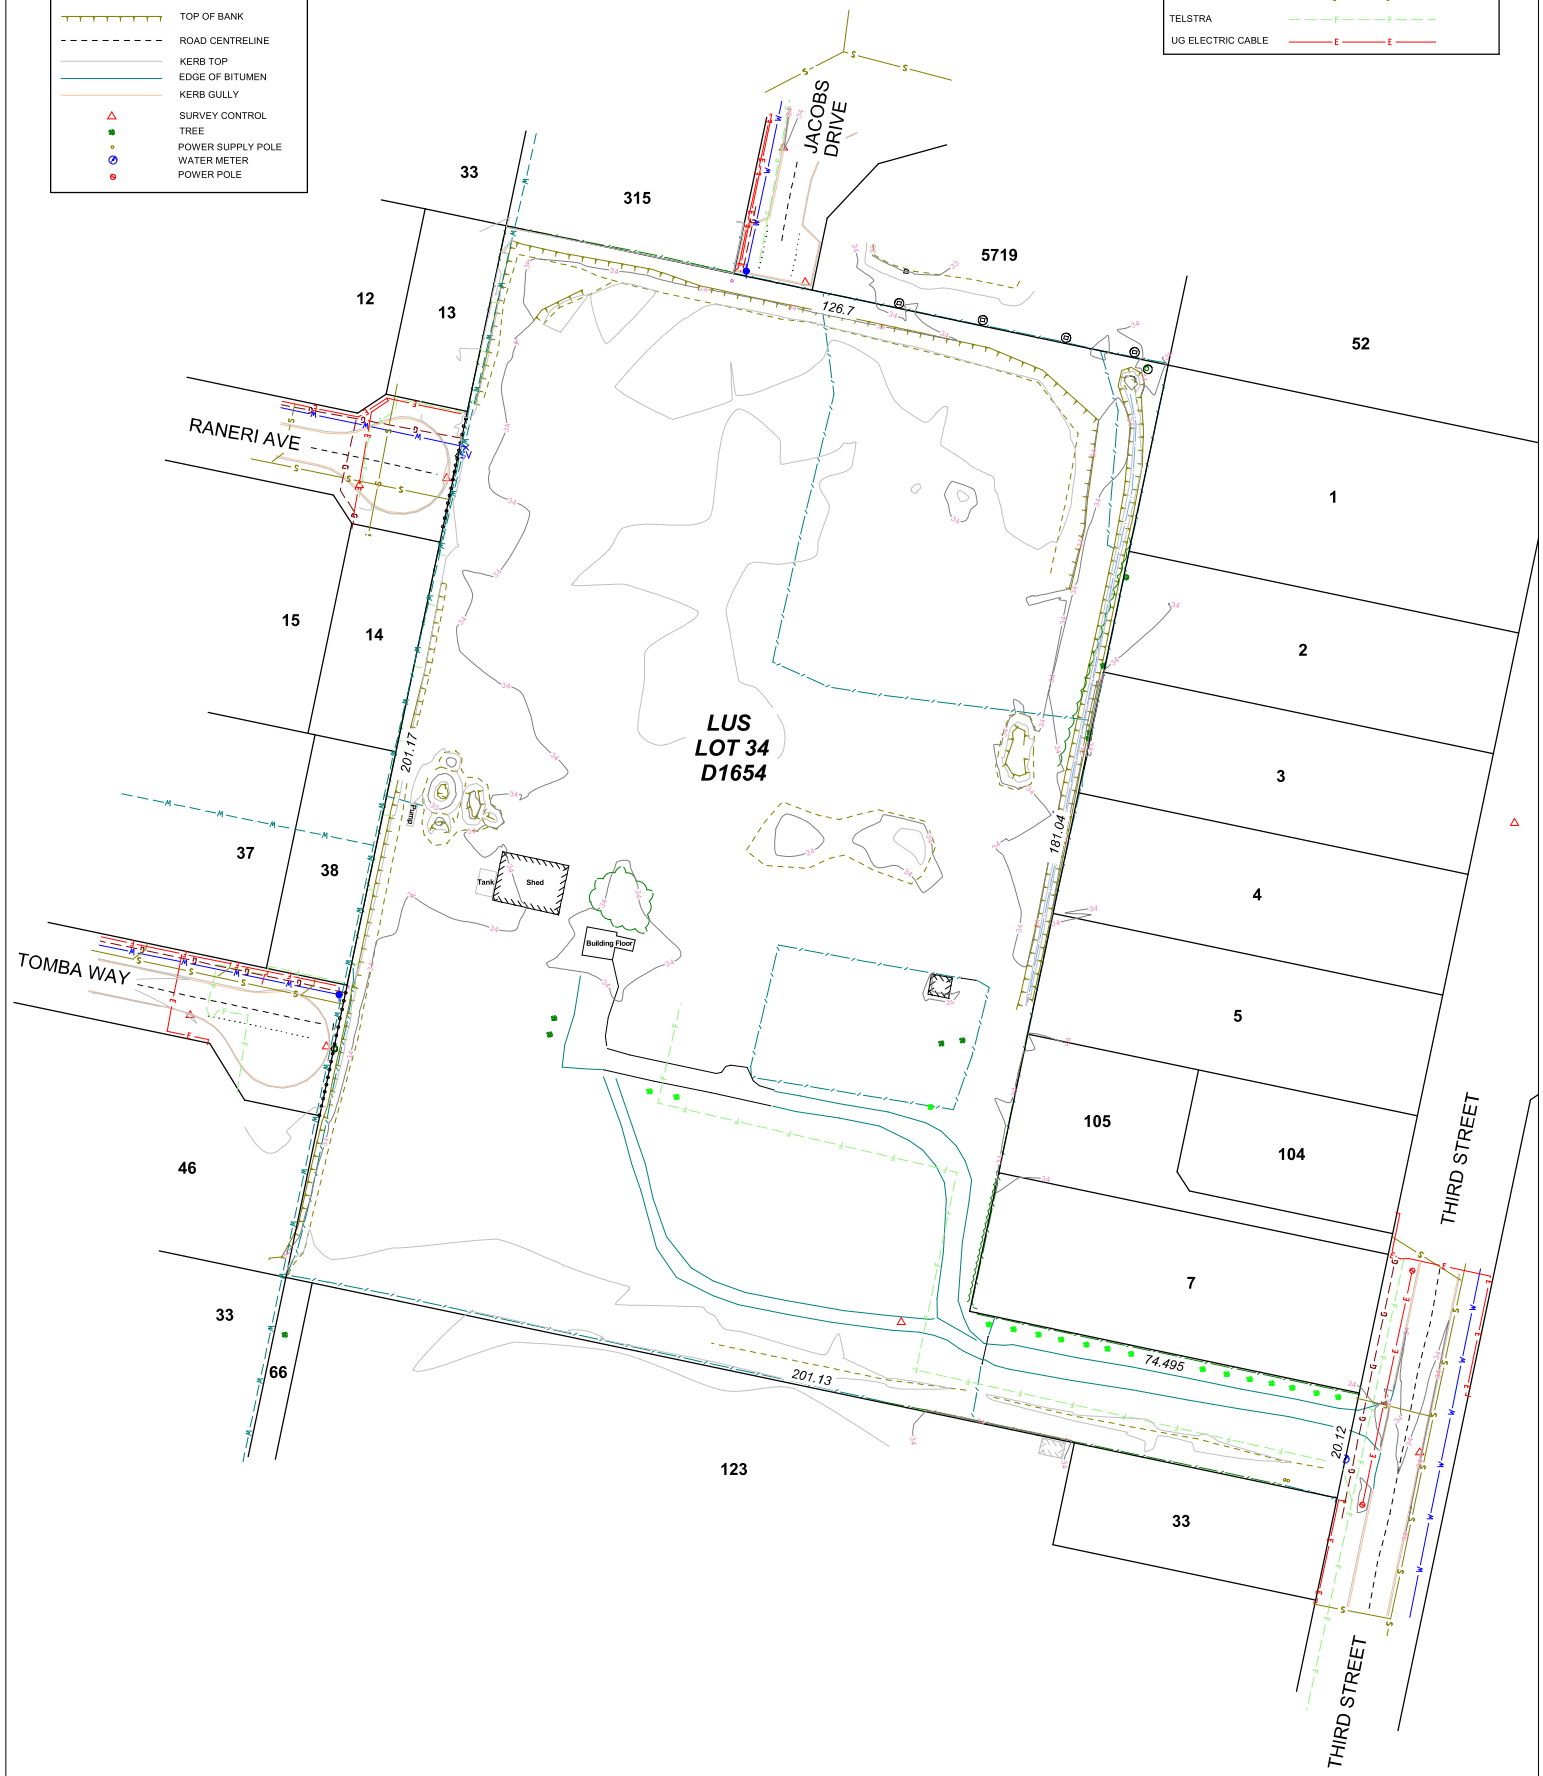
COORDINATES
HORIZONTAL: PC094
VERTICAL: AHD
CONTOUR INTERVAL: 0.5m

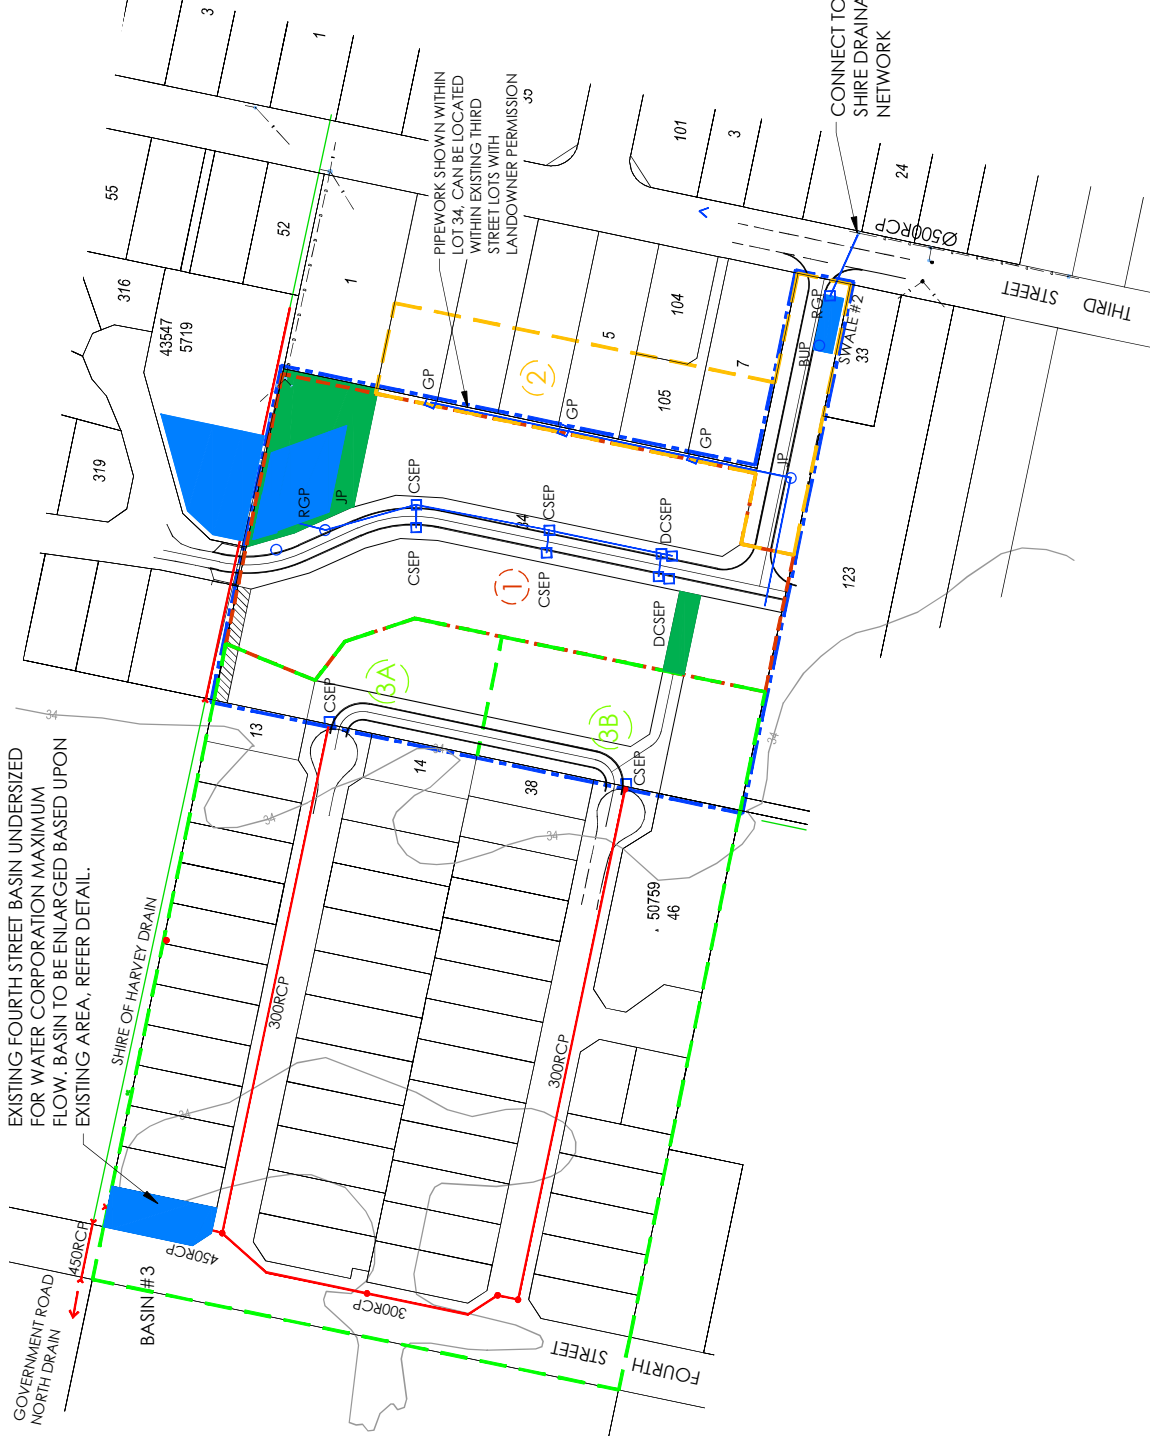
Based upon the scale of development proposed it would be intended that all amendments to this strategy can be undertaken at UWMP stage.

EXISTING FOURTH STREET BASIN UNDERSIZED FOR WATER CORPORATION MAXIMUM FLOW. BASIN TO BE ENLARGED BASED UPON EXISTING AREA. REFER DETAIL.

Lot Area	1,0893	Ha
POS Area	0.2925	Ha
Road Reserve	0.3488	ha
Pre Development Flow (@c=0.3)	29.6	L/s
Indicative Outlet @ PreDev	150 mm dia @ 1 in 40	L/s
Max Flow per Water Corp	8.4	L/s
Indicative Outlet @ Max Water Corp	100 mm dia @ 1 in 48	L/s
Impervious Area	1.09	Ha
Volume Required	398	m³
Area Required @ TWL	841	m²
Approximate Dimensions	33m X 25.5m @0.6m depth
