ROWE
GROUP
DESIGN

STRUCTURE PLAN

LOT 50 (NO. 193) BARFIELD ROAD
HAMMOND PARK

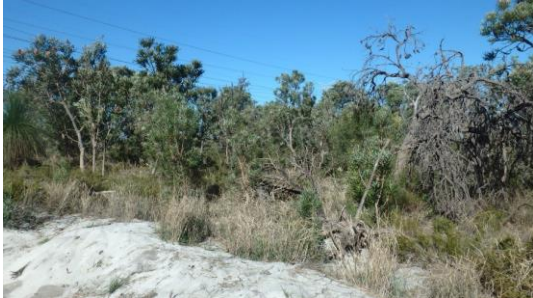
<p>Photo location 5: Scrub vegetation located in the north-eastern portion of the site</p>

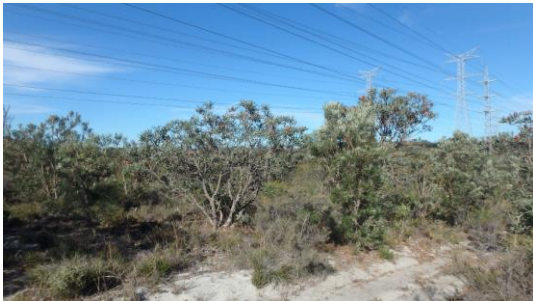
<p>Photo location 9: Scrub vegetation located to the east of the site</p>

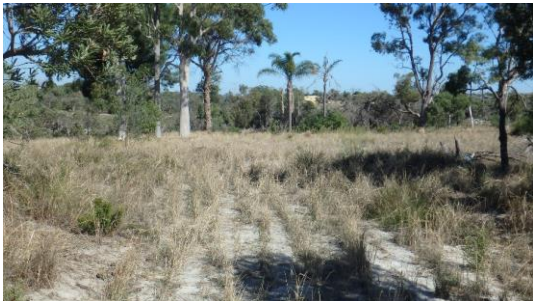
<p>Photo location 13: Grassland vegetation located within the central portion of the site</p>

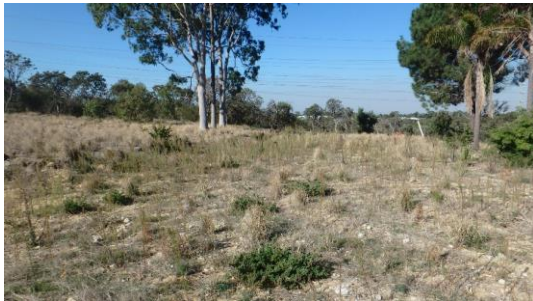
<p>Photo location 16: Grassland vegetation located within the central portion of the site</p>	7 - 8	<p>AS 3959 classification (Figure 4): Grassland</p> <p>Effective slope (Figure 5): Flat/upslope</p> <p>Grassland vegetation located to the west of the site within the Barfield Road reserve (Plot 7) and within the area of future POS in Vivente Estate (Plot 8) will not be removed as part of future development within the site, and will therefore remain a long-term bushfire hazard to the site.</p>

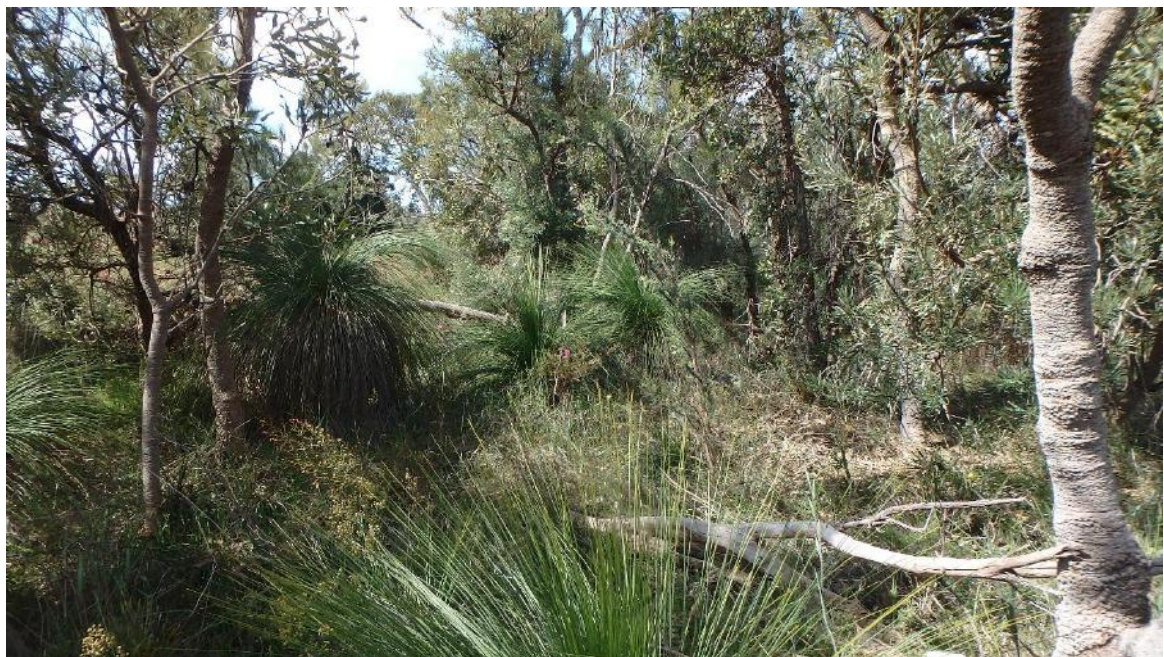
Plate 1: Plant community **BaBm** in very good condition.

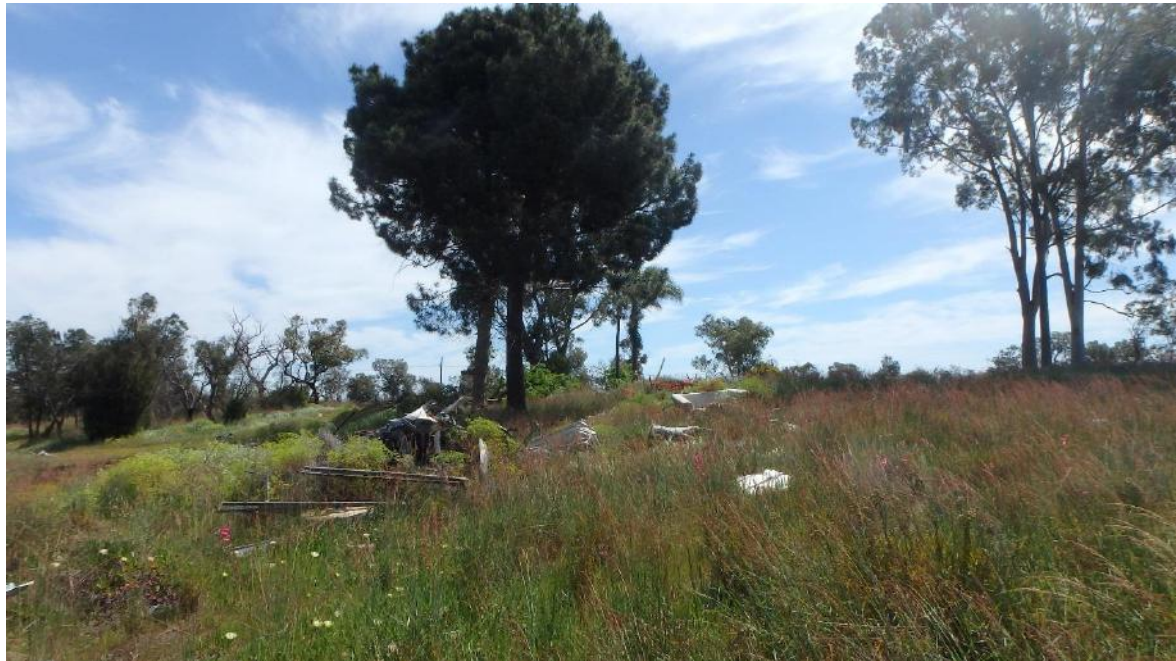
Plate 2: Non-native/planted vegetation throughout the centre of the site.

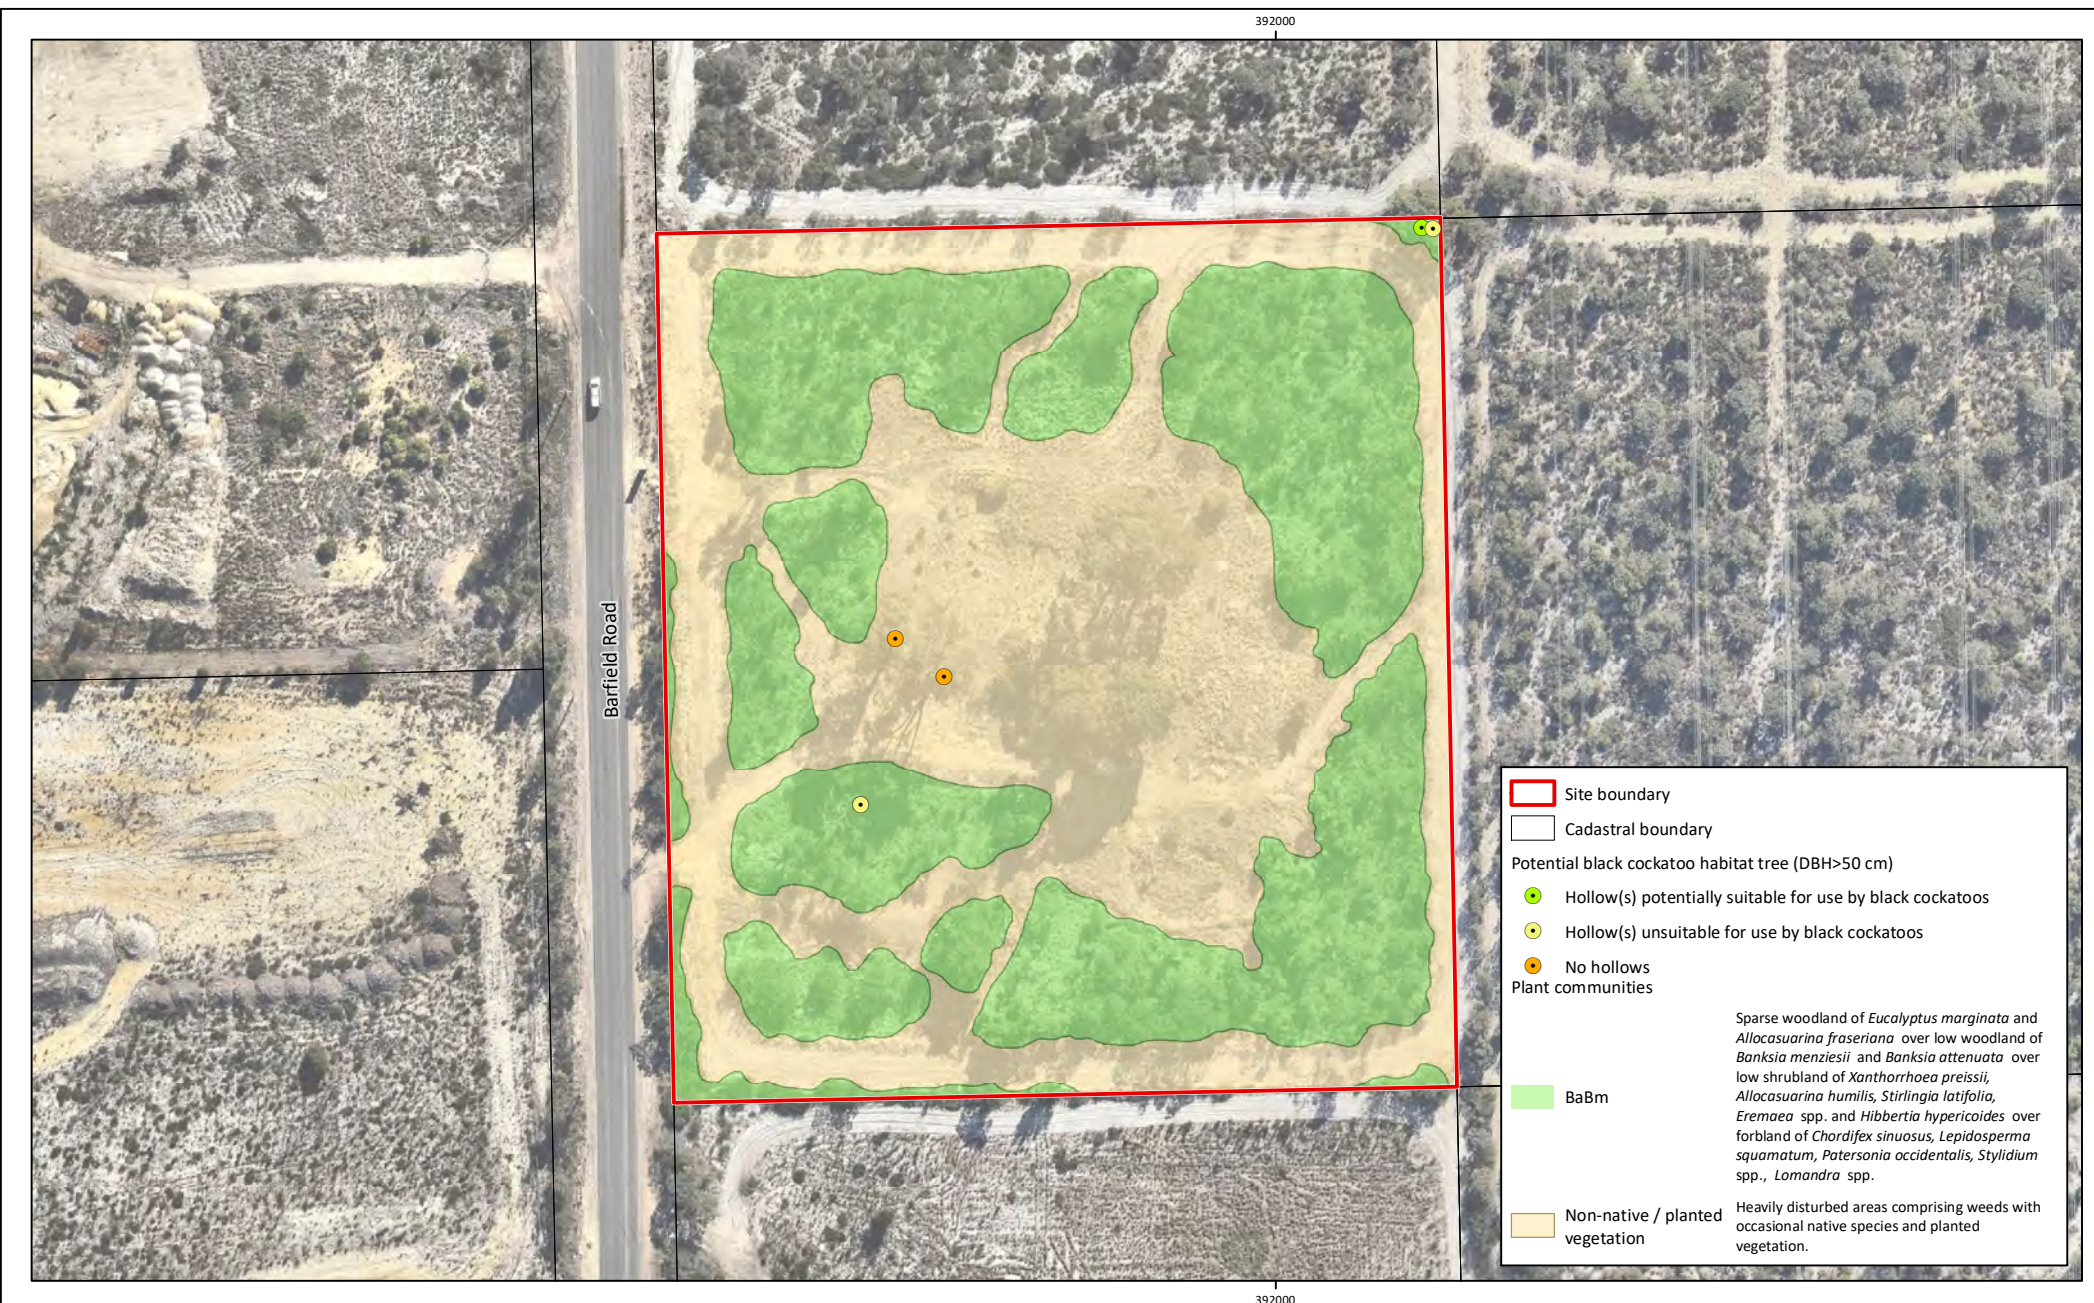
Figure 6: Vegetation Communities and Potential Breeding Habitat Trees

Based on the findings from the flora and vegetation survey (Emerge Associates 2018a), one native plant community was recorded in the site, as described in **Table 1** and shown in **Figure 6**. Plant community **BaBm** exists in a number of patches around the edges of the site and extends over a total area of 0.84 ha. The remainder of the site (1.02 ha) contains non-native vegetation with bare soil, weeds or planted vegetation including **Pinus pinaster* (pine tree), **Eucalyptus* sp. and **Corymbia citriodora* (lemon scented gum). Two tuart trees are located in the centre of the site and appear to also have been planted, based on available historical aerial photography. Representative photos of each plant community are provided below in **Plate 1** to **Plate 2**.

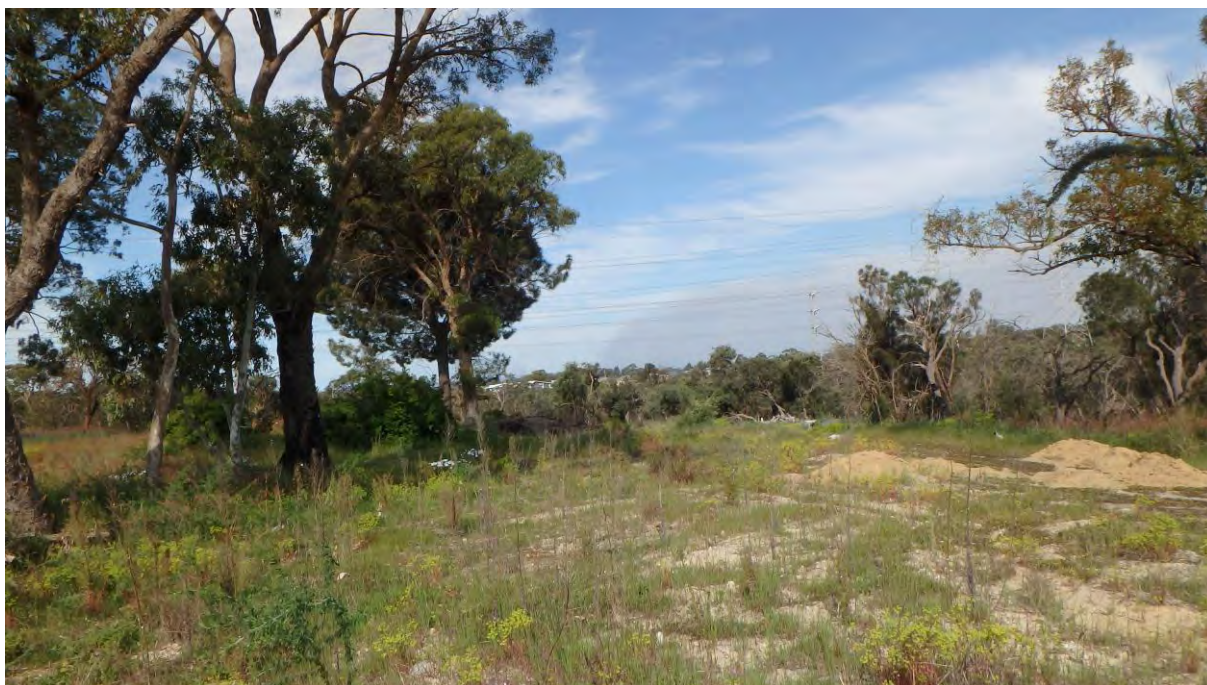
Plate 1: Cleared area in the centre of the site, with planted trees.

The site comprises a south facing slope, with intact remnant vegetation concentrated around the north, eastern and southern edges. The centre of the site previously contained a house, sheds and associated driveways. These structures were removed in 2016, leaving the area cleared with some remaining debris, and a number of planted native (including two *Eucalyptus gomphocephala* (tuart) trees) and exotic trees and shrubs (**Plate 1**). Weeds are also widespread throughout the cleared portions of the site. The soils within the site comprised a thin layer of light grey sand over deeper brown sands.

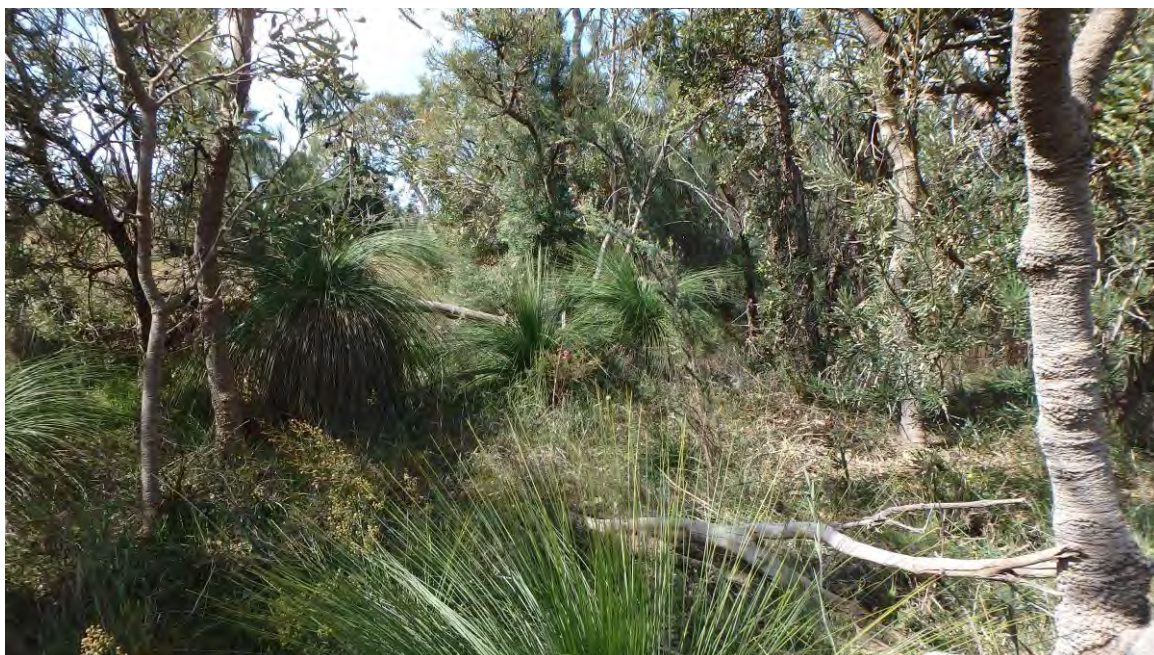
Plate 2: Plant community **BaBm** in very good condition, taken at Q3.

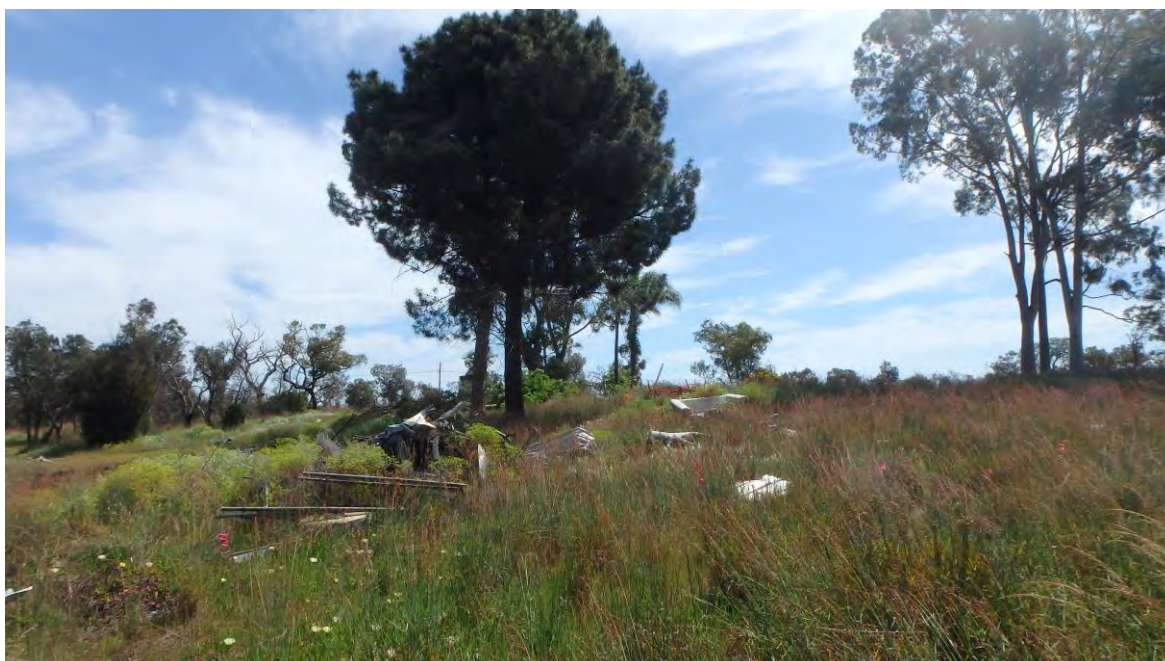
Plate 3: Non-native/planted vegetation throughout the centre of the site.

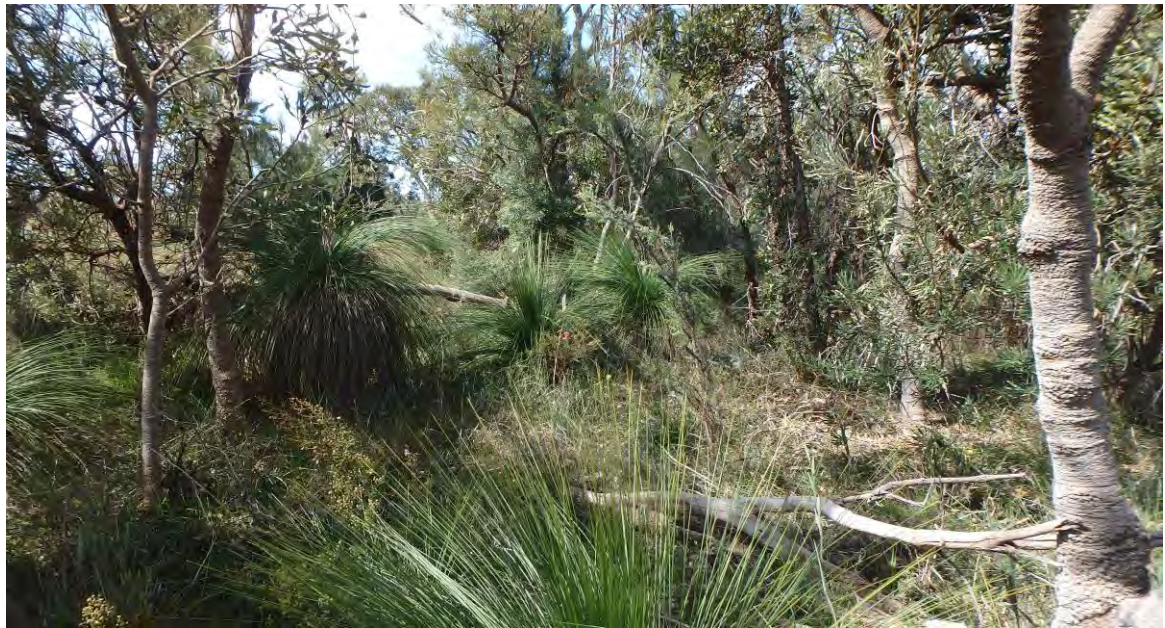
Plate 1: Plant community BaBm in very good condition. Ground cover and understorey largely intact and some microhabitats such as logs, rocks and leaf litter present.

The site provides several patches of black cockatoo foraging habitat, comprising jarrah, banksia, tuart, lemon scented gum and pine trees.

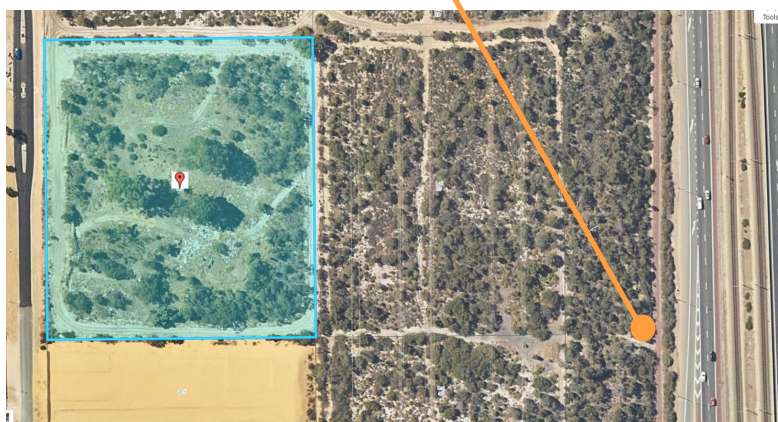
Figure 3-1 Photograph and Location of Noise Logger

The instrument used was an ARL Type 316 noise data logger (S/N: 15-301-468), located 25 metres from the edge of the northbound on-road, with the microphone 1.4 metres above ground level (refer *Figure 3-1*). The logger was programmed to record hourly L_{A1} , L_{A10} , L_{A90} , and L_{Aeq} levels. This instrument complies with the instrumentation requirements of *Australian Standard 2702-1984 Acoustics – Methods for the Measurement of Road Traffic Noise*. The logger was field calibrated before and after the measurement session and found to be accurate to within ± 1 dB. Lloyd George Acoustics also holds current laboratory calibration certificate for the loggers.

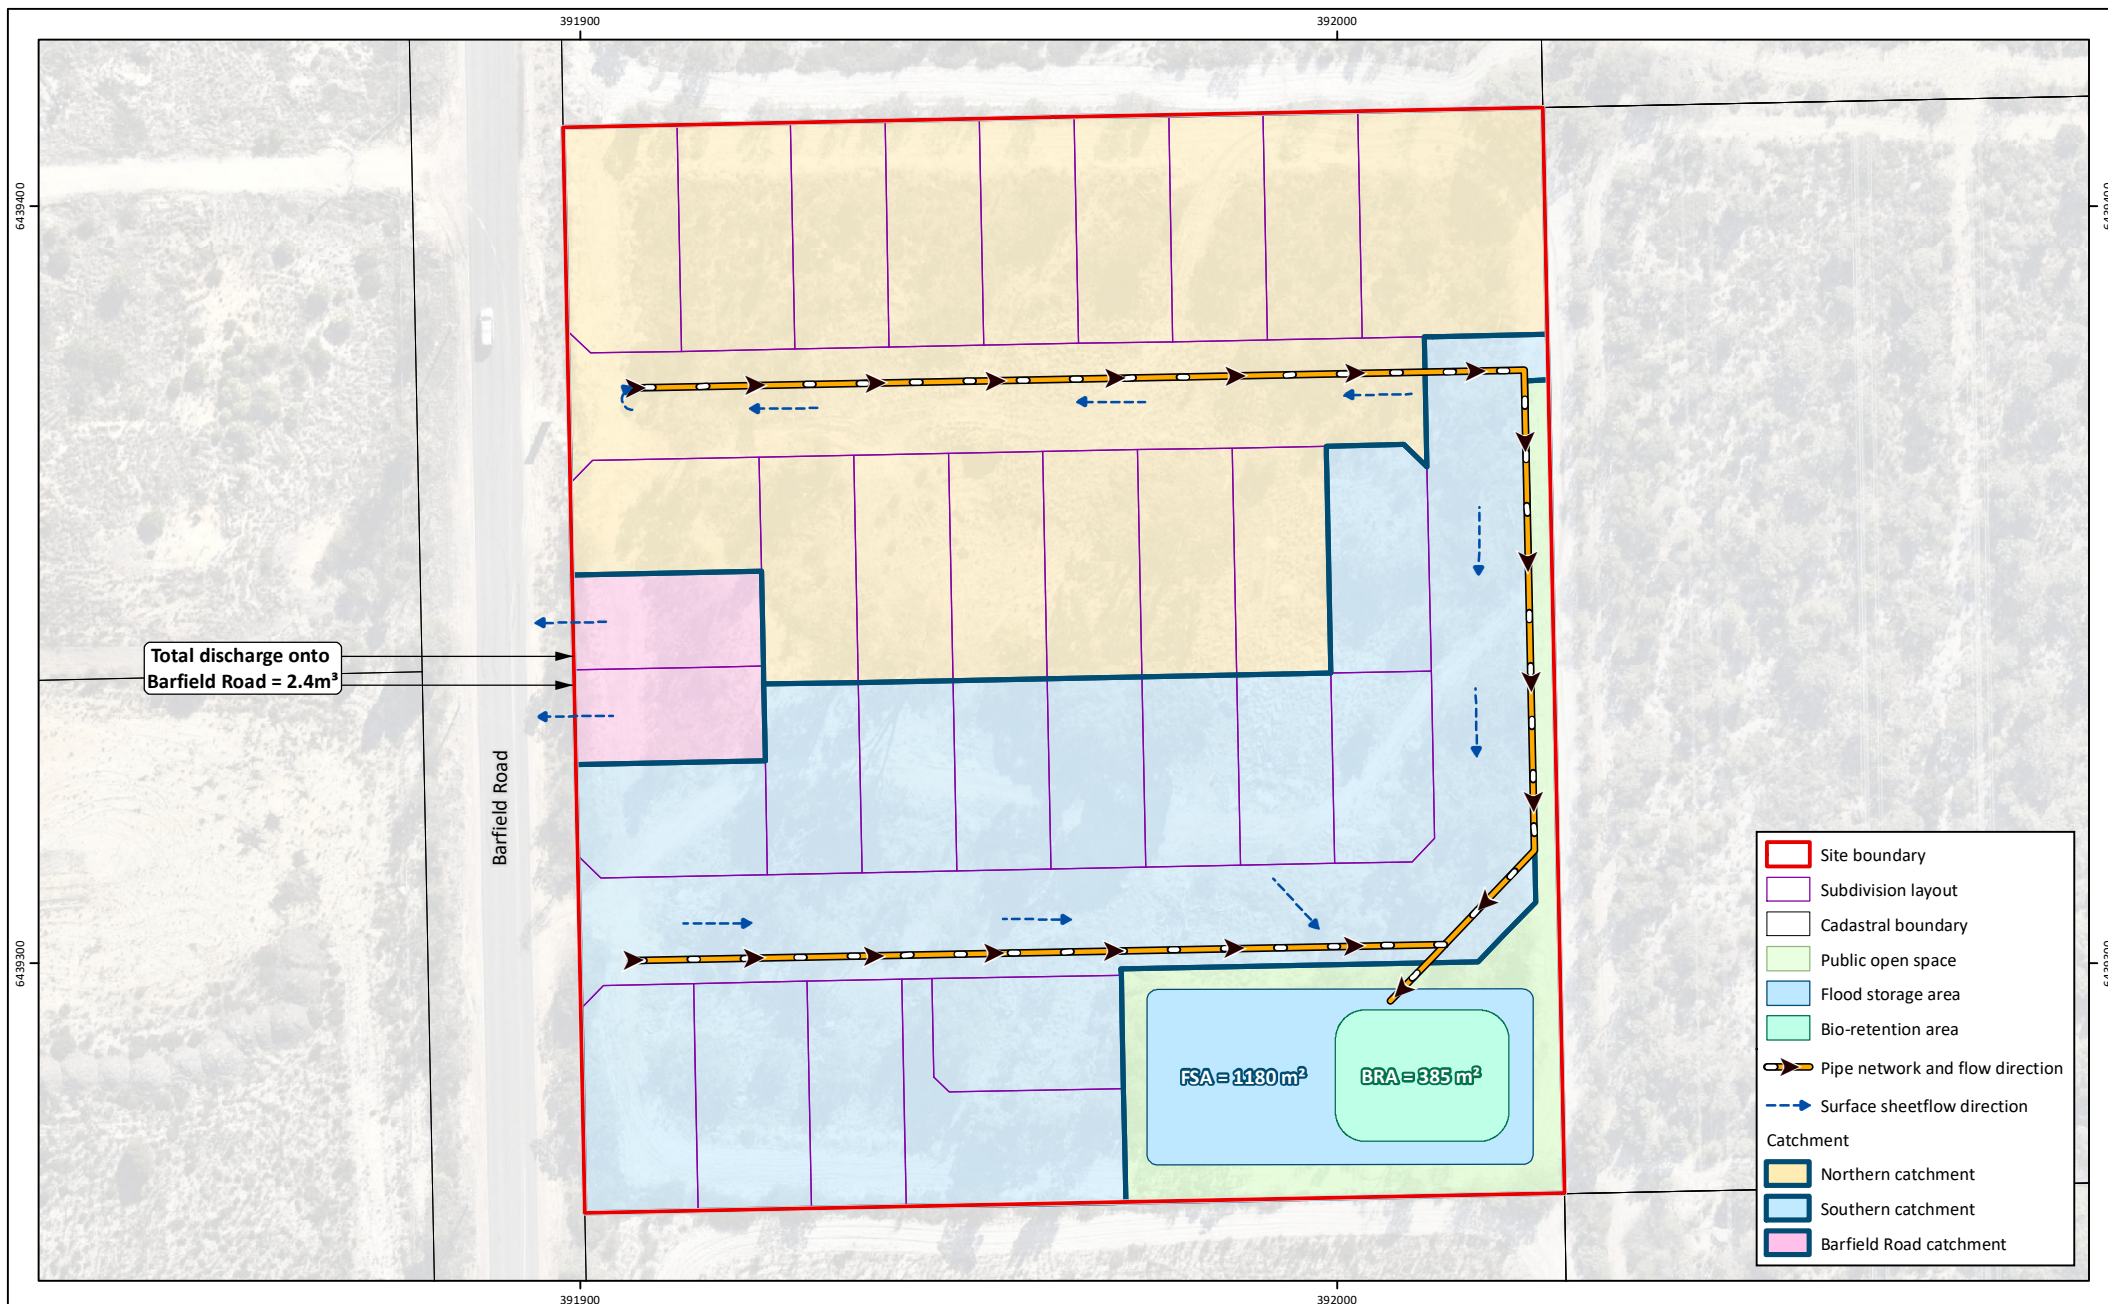
Figure 5: Stormwater Management Plan

Groundwater management will include the use of imported fill to maintain sufficient clearance to groundwater in lower areas of the site. Groundwater quality will be managed through the appropriate treatment of surface runoff prior to infiltration to groundwater, and management of landscape management practices (i.e. minimising fertiliser use).

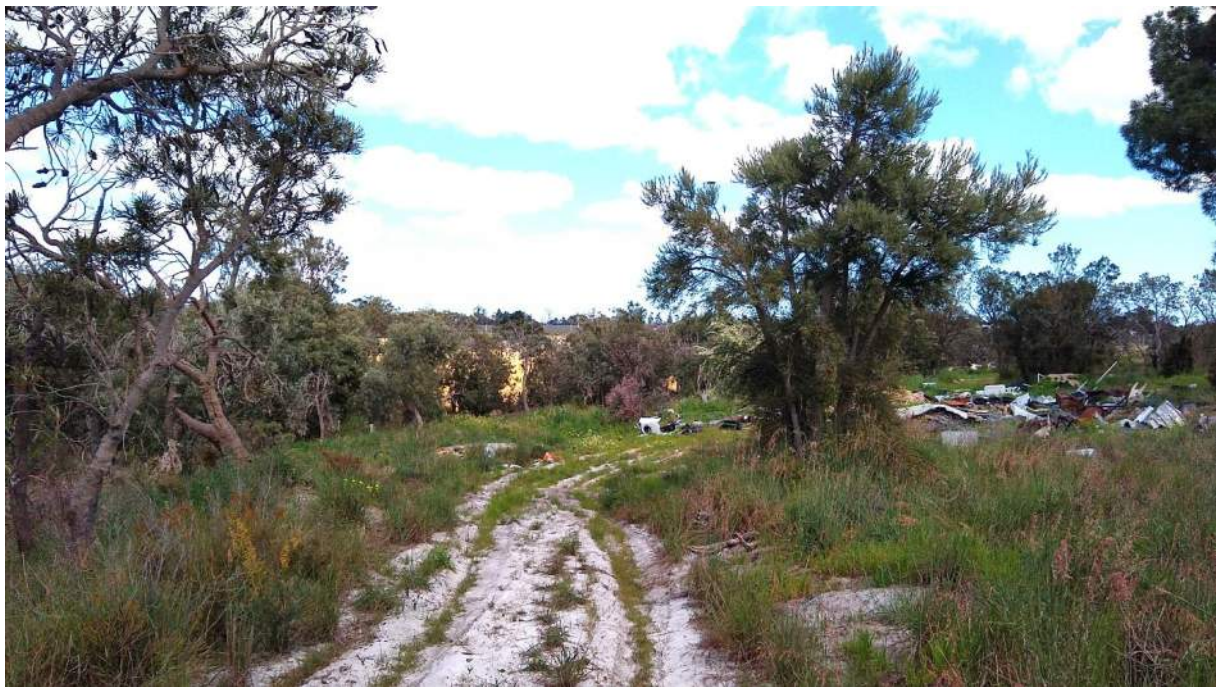
Photo 1: View of the site from test location 4 looking southwest.

At the time of investigation, the site comprised a vacant portion of land (bushland), with several sand tracks crossing the site in an east to west direction and along each boundary (see Photo 1 below).

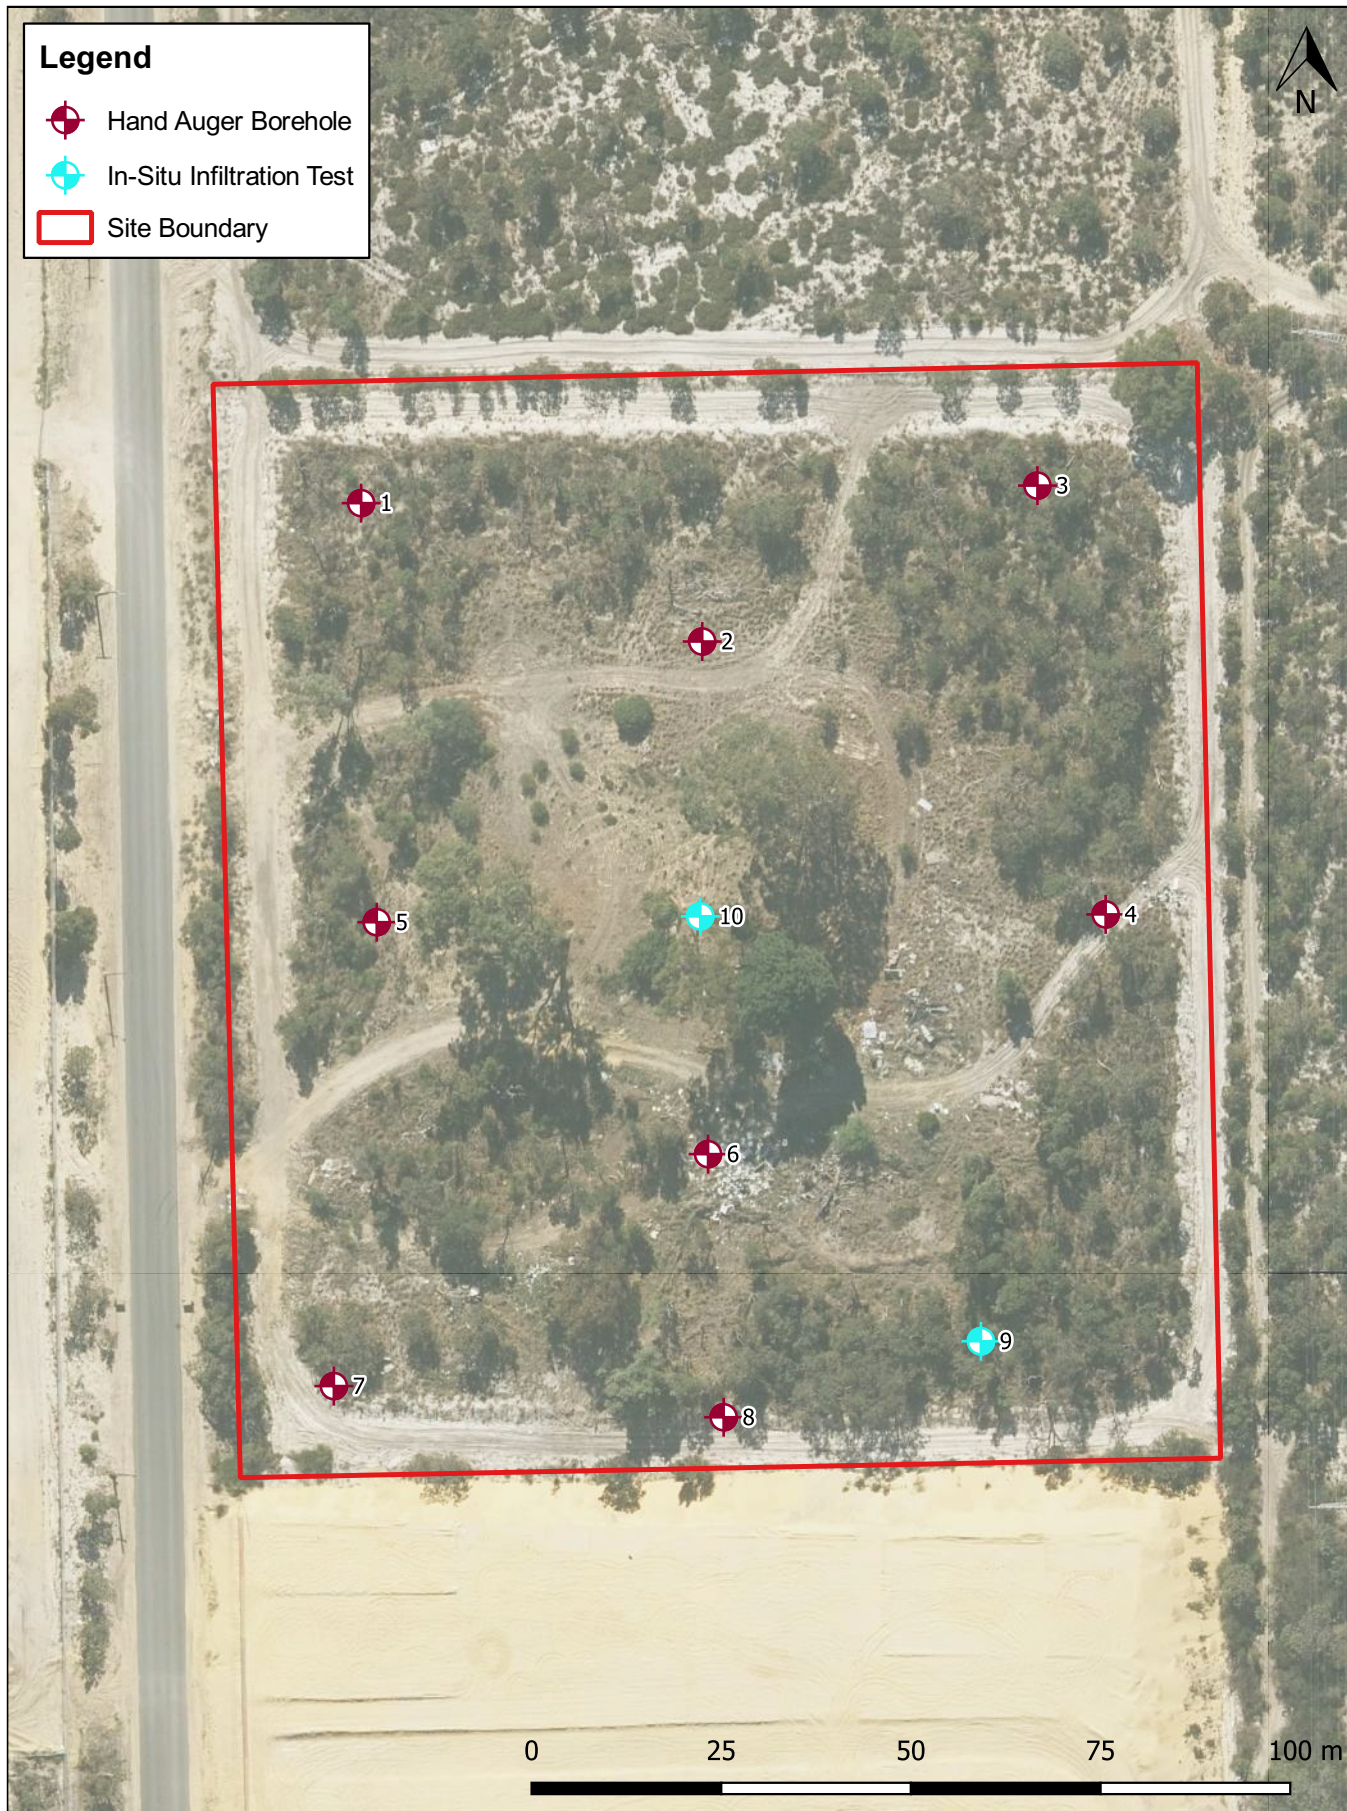
Douglas Partners <small>Geotechnics Environment Groundwater</small>	Test Location Plan		PROJECT: 96711.00
	Proposed Residential Subdivision		Drawing No: 1
	Lot 50 Barfield Road, Hammond Park, WA		REV: 0
	CLIENT: Glenbrook Civil Engineering Contractors Pty Ltd		DATE: 27/8/2020

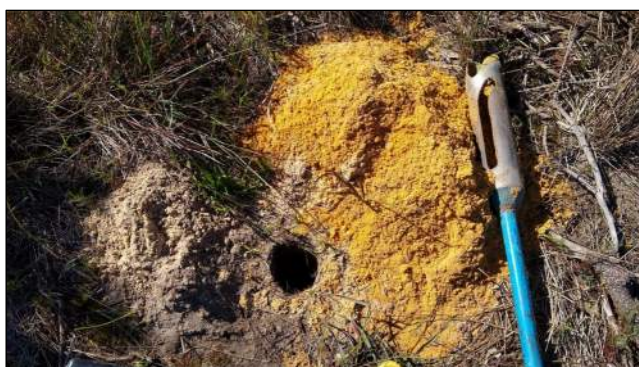
RL	Depth (m)	Description of Strata	Graphic Log	Sampling & In Situ Testing				Water	Dynamic Penetrometer Test (blows per 150mm)			
				Type	Depth	Sample	Results & Comments		5	10	15	20
	0.05	TOPSOIL/SAND SP-SM: fine to medium grained, grey-brown, with silt and rootlets, moist. SAND SP: fine to medium grained, light yellow-brown, trace silt, moist, loose.										
	1											
	2											
	3											
	3.0	Bore discontinued at 3.0m (Target depth)

RIG: 110 mm diameter hand auger

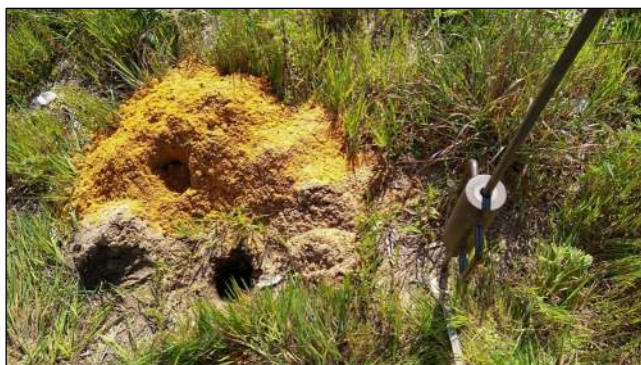
RL	Depth (m)	Description of Strata	Graphic Log	Sampling & In Situ Testing				Water	Dynamic Penetrometer Test (blows per 150mm)			
				Type	Depth	Sample	Results & Comments		5	10	15	20
	0.05	TOPSOIL/SAND SP-SM: fine to medium grained, dark grey-brown, with silt and rootlets, moist.										
		SAND SP: fine to medium grained, grey-brown, trace silt, moist, loose.										
		- becoming medium dense from 0.3 m depth.										
		- becoming yellow-brown from 0.4 m depth.										
	1	- becoming loose between 0.9 m to 1.35 m depth.										
	2											
	3											
	3.0	Bore discontinued at 3.0m (Target depth)

RIG: 110 mm diameter hand auger

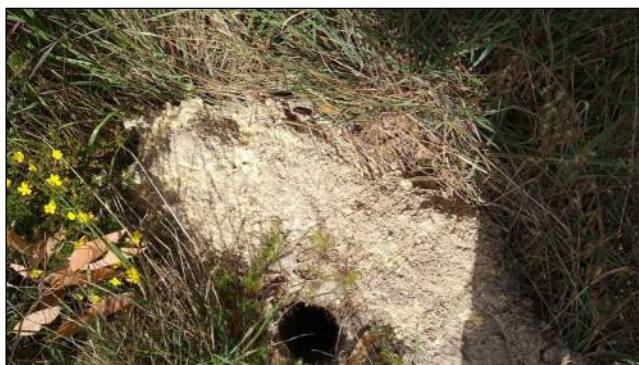
RL	Depth (m)	Description of Strata	Graphic Log	Sampling & In Situ Testing				Water	Dynamic Penetrometer Test (blows per 150mm)			
				Type	Depth	Sample	Results & Comments		5	10	15	20
	0.05	TOPSOIL/SAND SP-SM: fine to medium grained, dark grey-brown, with silt and rootlets, moist. SAND SP: fine to medium grained, grey-brown, trace silt and roots, moist, very loose to loose.										
				D	0.4							
	1	- becoming light grey-brown from 1.0 m depth. - becoming medium dense from 1.2 m depth. - becoming light yellow-brown from 1.5 m depth.										
	2											
	3	Bore discontinued at 3.0m (Target depth)

RIG: 110 mm diameter hand auger

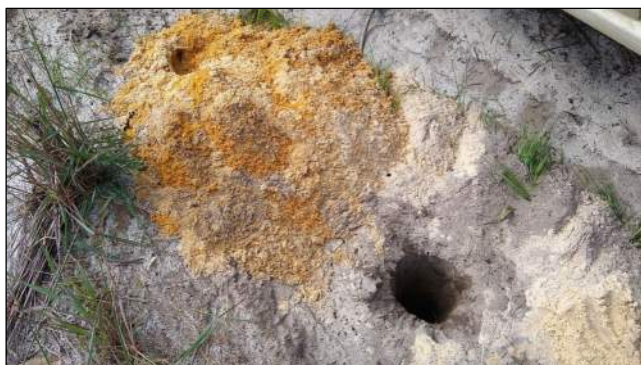
RL	Depth (m)	Description of Strata	Graphic Log	Sampling & In Situ Testing				Water	Dynamic Penetrometer Test (blows per 150mm)			
				Type	Depth	Sample	Results & Comments		5	10	15	20
32.0		SAND SP: fine to medium grained, grey-brown, trace silt, moist, loose.		D	0.5							
		- becoming light yellow-brown, medium dense from 0.45 m depth.										
31.0	1	- becoming yellow-brown from 1.5 m depth.										
30.0	2											
29.0	3	Bore discontinued at 3.0m (Target depth)

RIG: 110 mm diameter hand auger

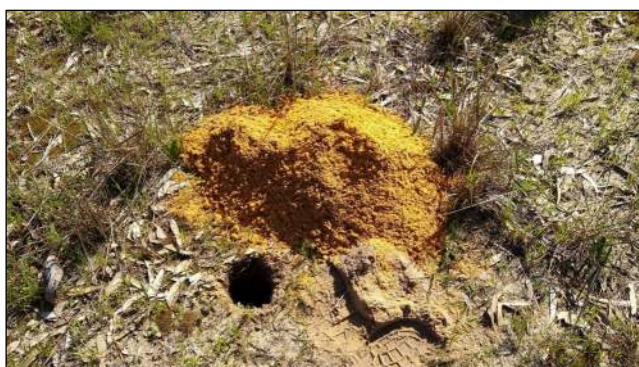
BORE No: 5
PROJECT No: 96711.00
DATE: 26/8/2020
SHEET 1 OF 1

RL	Depth (m)	Description of Strata	Graphic Log	Sampling & In Situ Testing				Water	Dynamic Penetrometer Test (blows per 150mm)			
				Type	Depth	Sample	Results & Comments		5	10	15	20
33.05	0.05	TOPSOIL/SAND SP-SM: fine to medium grained, grey-brown, with silt and rootlets, moist.		D	0.3							
		SAND SP: fine to medium grained, grey-brown, trace silt, moist, loose.										
		- becoming yellow-brown from 0.5 m depth.										
32.0	1	- becoming medium dense from 1.05 m depth.										
31.0	2											
30.0	3	Bore discontinued at 3.0m (Target depth)

RIG: 110 mm diameter hand auger

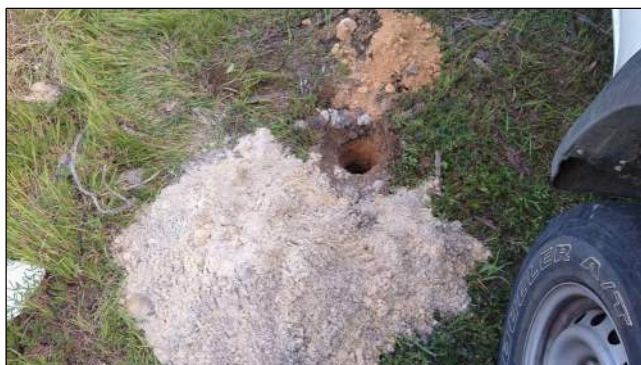
27.60	1.0	FILL/SAND SP-SM: fine to medium grained, dark grey-brown, with silt, trace gravel, moist, very dense.										
27.50	1.5	SAND SP: fine to medium grained, light grey, trace silt, moist, dense to very dense.

27.40	2.0	- becoming medium dense from 1.05 m depth.										
27.30	2.5	- becoming light yellow-brown from 2.0 m depth.										
27.20	3.0	Bore discontinued at 3.0m (Target depth)

RIG: 110 mm diameter hand auger

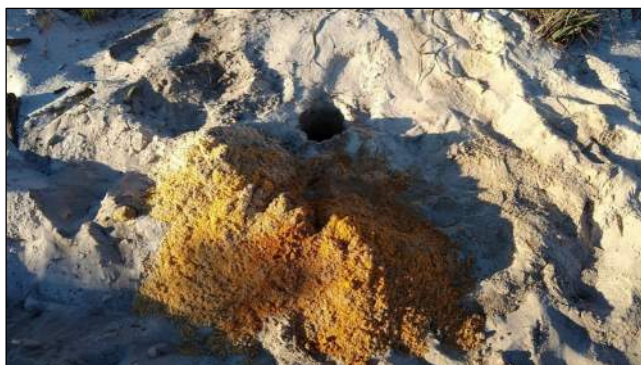
BORE No: 7
PROJECT No: 96711.00
DATE: 26/8/2020
SHEET 1 OF 1

RL	Depth (m)	Description of Strata	Graphic Log	Sampling & In Situ Testing				Water	Dynamic Penetrometer Test (blows per 150mm)
				Type	Depth	Sample	Results & Comments		
30		SAND SP: fine to medium grained, light grey-brown, trace silt, moist, very loose to loose.							
		- becoming medium dense from 0.6 m depth.							
29	1								
		- becoming yellow-brown from 1.4 m depth.							
28	2								
		- trace of very weakly cemented sand gravel from 2.5 m depth.							
27	3	Bore discontinued at 3.0m (Target depth)

RIG: 110 mm diameter hand auger

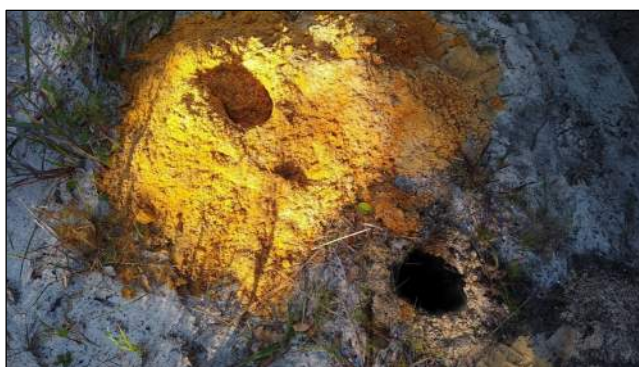
BORE No: 8
PROJECT No: 96711.00
DATE: 26/8/2020
SHEET 1 OF 1

RL	Depth (m)	Description of Strata	Graphic Log	Sampling & In Situ Testing				Water	Dynamic Penetrometer Test (blows per 150mm)			
				Type	Depth	Sample	Results & Comments		5	10	15	20
27		SAND SP: fine to medium grained, grey-brown, with rootlets to 0.05 m depth, trace silt, moist, loose.										
		- becoming light yellow-brown, medium dense from 0.3 m depth.										
1												
		- becoming yellow-brown from 1.2 m depth.										
2												
25												
3	3.0	Bore discontinued at 3.0m (Target depth)										
24

RIG: 110 mm diameter hand auger

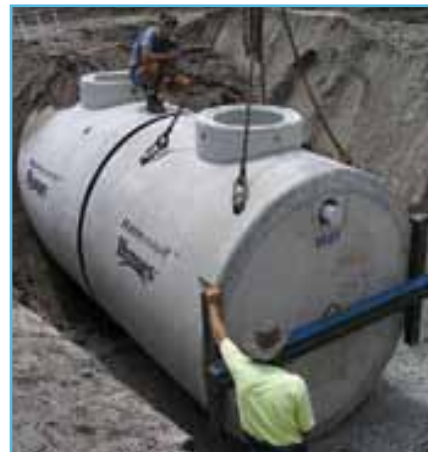
Concrete underground tank

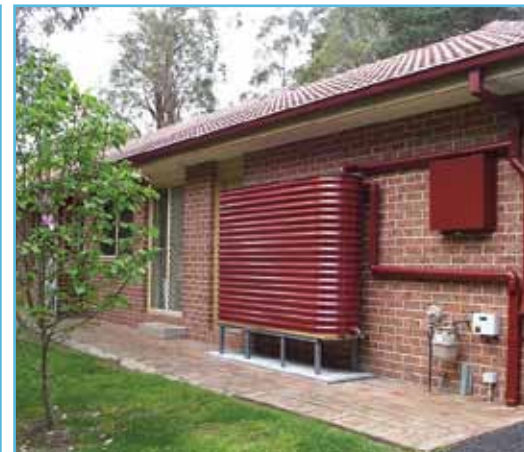
Slimline domestic rainwater tank

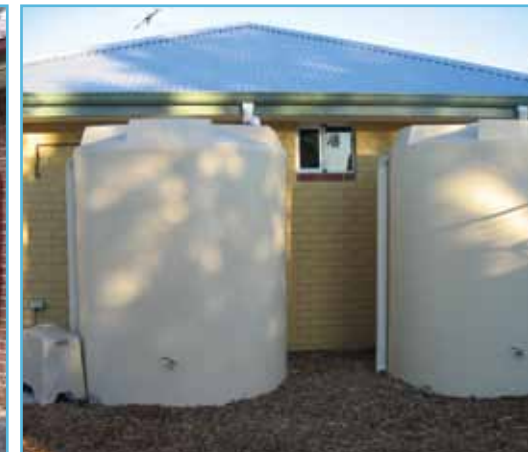
Poly domestic rainwater tanks
