Perth Shallow Groundwater Systems Investigation

Egerton Seepage

Hydrogeological record series

Report no. HG53
July 2011

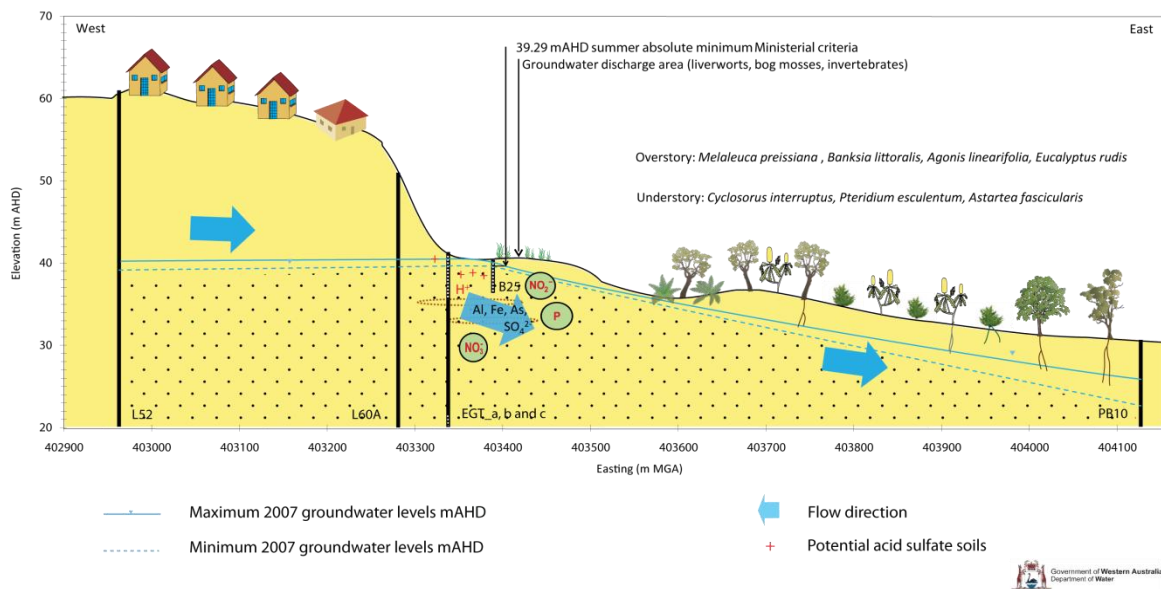
An improved conceptual model of the relationships between the geology, hydrogeology, chemistry and the wetland ecosystem of Egerton was developed during the study (see below). This model, discussed in detail in section 6 (see figure 24), provides a basis for improved management strategies.

Conceptual model of the relationships between the hydrogeology, chemistry and the wetland ecosystem of Egerton

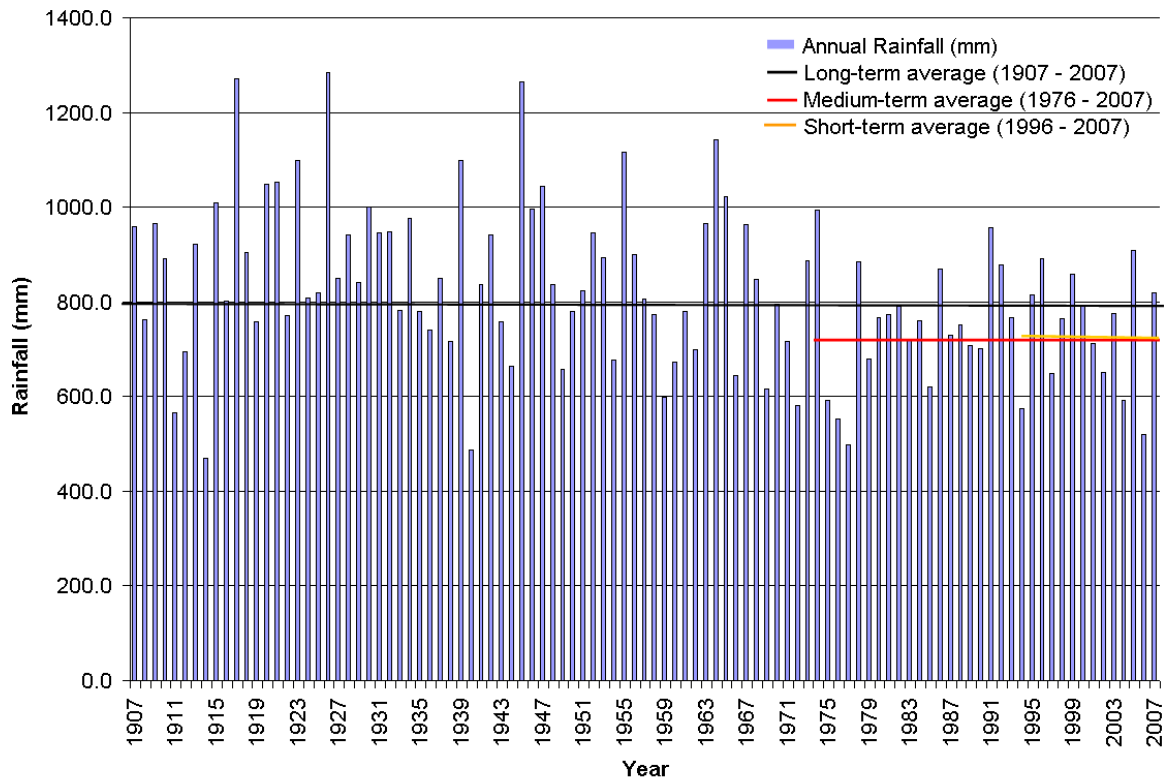
Figure 2 Annual rainfall for Wanneroo, showing long-term, medium-term and short-term averages

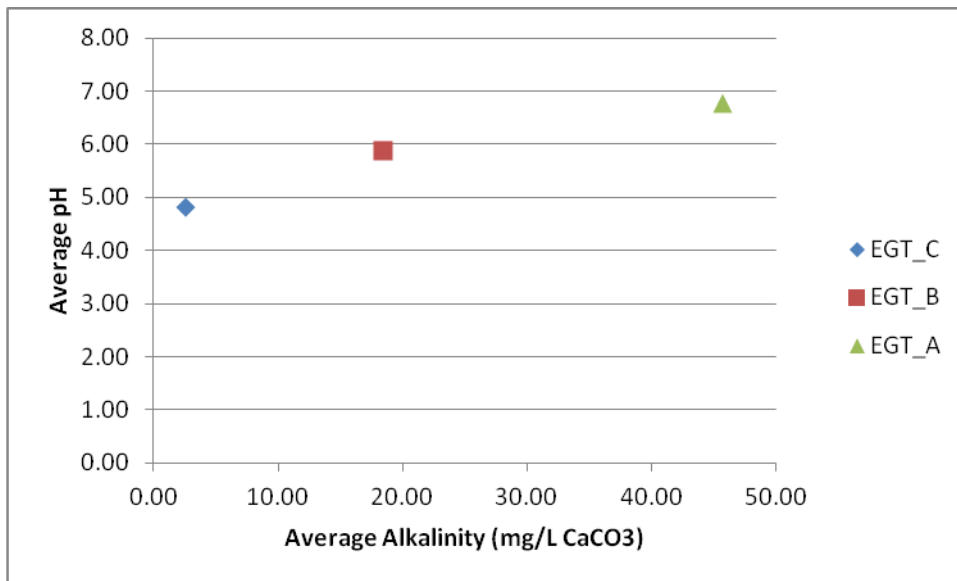
Figure 20 Average pH and average alkalinity of Egerton bores

The alkalinity of water is essentially its acid-neutralising capacity (ANC). Analysis of alkalinity can give greater insight into the characteristics of water and its possible behaviours than pH measurements alone, which only determine H^+ activity. Total alkalinity as calcium carbonate of groundwater from the Egerton bores was lowest in the shallow bore, ranging between <1 mg/L and 15 mg/L CaCO_3 , and increased with depth. Total alkalinity of the deep bore ranged from 19 to 110 mg/L CaCO_3 . A comparison of pH and alkalinity of groundwater (Figure 20, as an indication of alkalinity and buffering capacity of sediments) indicates that EGT_C had the least buffering capacity of all groundwater samples.

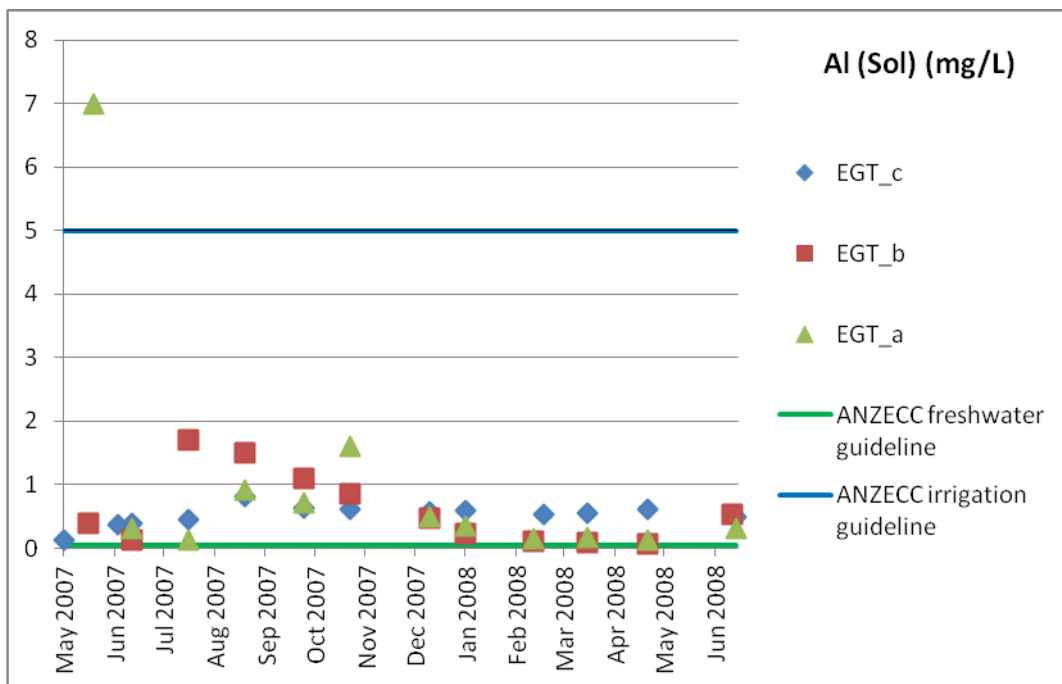
Figure 21 Soluble aluminium levels recorded at the Egerton bore cluster

Soluble aluminium concentrations ranged from 0.12 mg/L (May 2007) to 0.82 mg/L (September 2007) in the shallow zone, from 0.076 mg/L (May 2008) to 1.7 mg/L (August) in the intermediate zone and from 0.12 mg/L (August 2008) to 7 mg/L (June 2007) in the deep zone (Figure 21). All concentrations measured in the investigation exceeded the ANZECC guideline for freshwater ecosystems (0.055 mg/L).

Concentrations also exceed the *Australian drinking water guidelines* (0.20 mg/L) but are below the ANZECC guidelines for long-term irrigation use (5 mg/L).

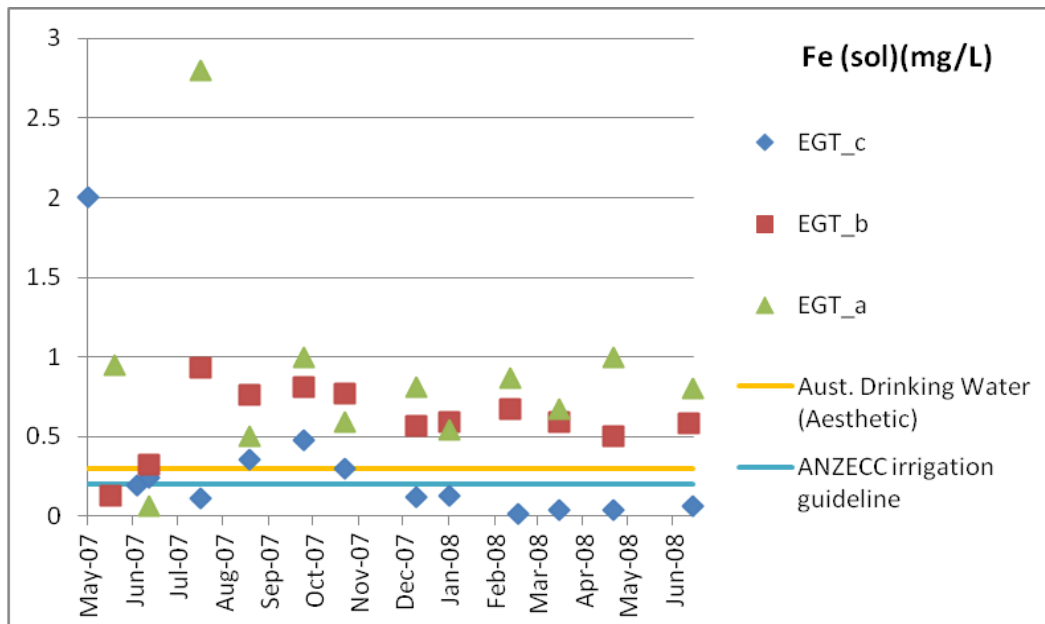
Figure 23 Soluble Iron levels recorded at the Egerton bore cluster

Soluble iron concentrations ranged from 0.017 mg/L (March 2008) to 2 mg/L (May 2007) in the shallow zone, from 0.13 mg/L (June 2007) to 0.93 mg/L (August 2007) in the intermediate zone, and from 0.068 mg/L (July 2007) to 2.8 mg/L (August 2007) in the deep zone. Concentrations exceed the ANZECC long-term irrigation trigger-value (0.20 mg/L) and the trigger value for drinking water (0.30 mg/L) (Figure 23).

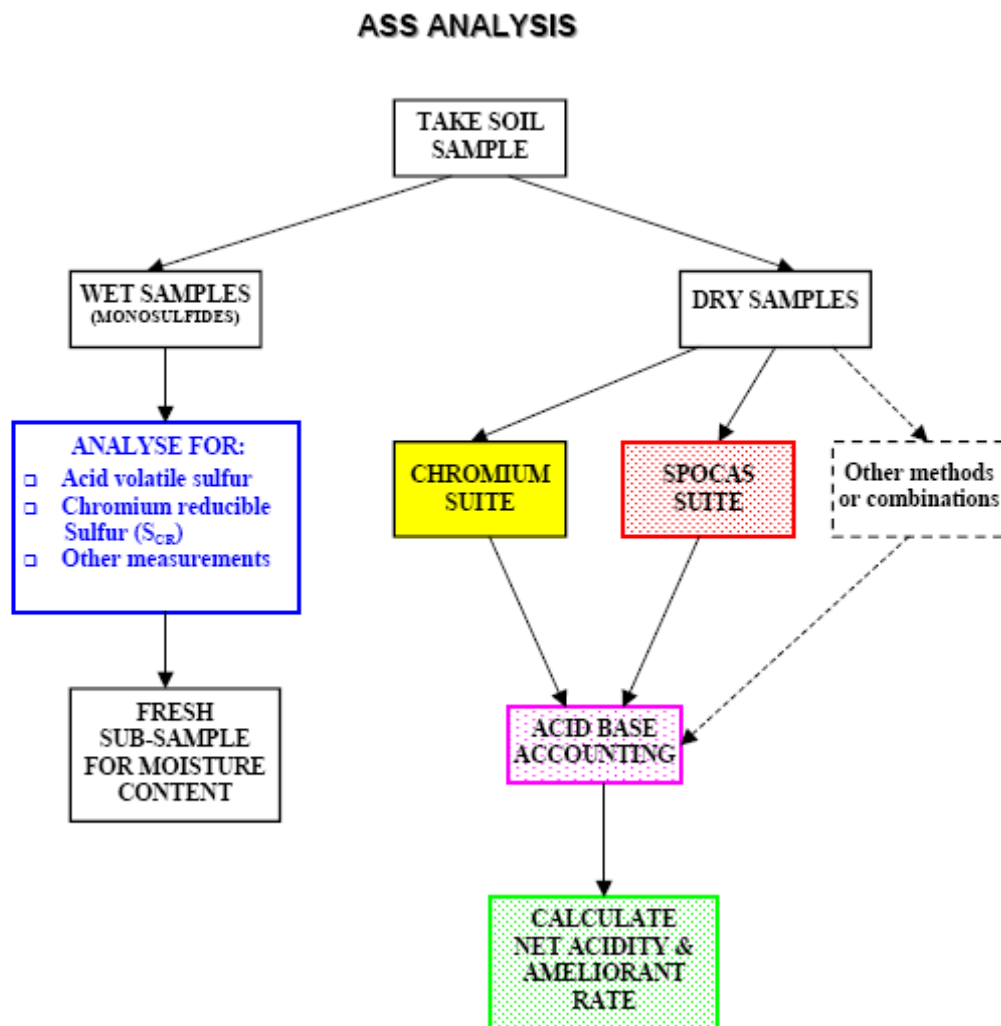
Flow diagram representation of methods followed when analysing acid sulfate soils. For full method description, refer to Ahern et al. (2004).

Figure 1 Flow diagram for overall methods used in the quantitative analyses of ASS
