Protection of drinking water sources

Groundwater quality threats from urbanisation

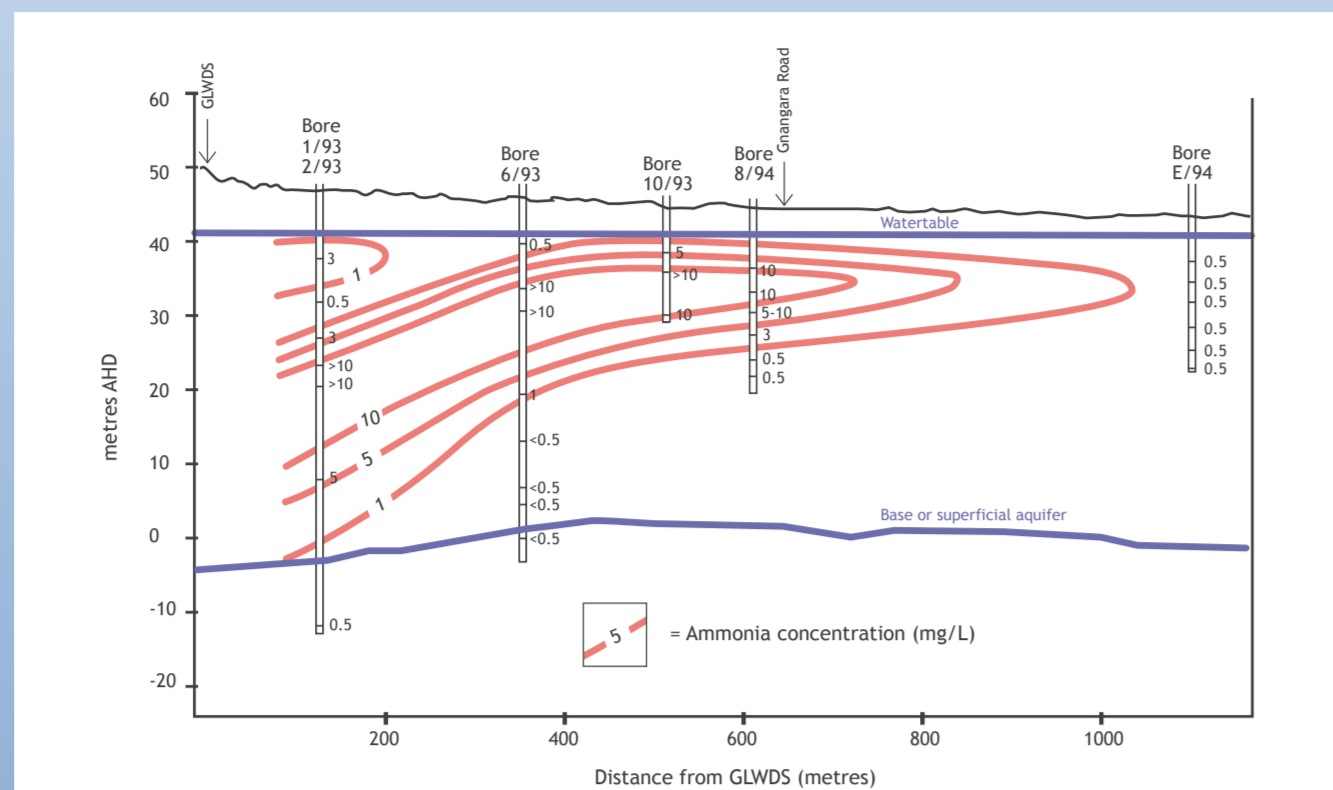
Extent of groundwater contamination from Gngangara Liquid Waste Disposal Site (indicated from Water Authority, 1994).
Source: Water Authority (1994) Investigation of groundwater contamination from the Gngangara Liquid Waste Disposal Site, Report No W/189, Water Authority, Perth, Western Australia.

- Ammonia plume found to extend from the site, with concentrations ranging from 0.3 to 27 mg/L (average 12 mg/L).
- High concentrations of bacteria recorded, with heterotrophic plate counts at 35°C ranging from 60 to 4000 cfu/mL.
- Investigation recommended relocation of proposed drinking water supply bore.
- This site is located in a P1 area of Gngangara PDWSA. Wastewater treatment and disposal would now be considered incompatible in P1 and P2 areas, however would be

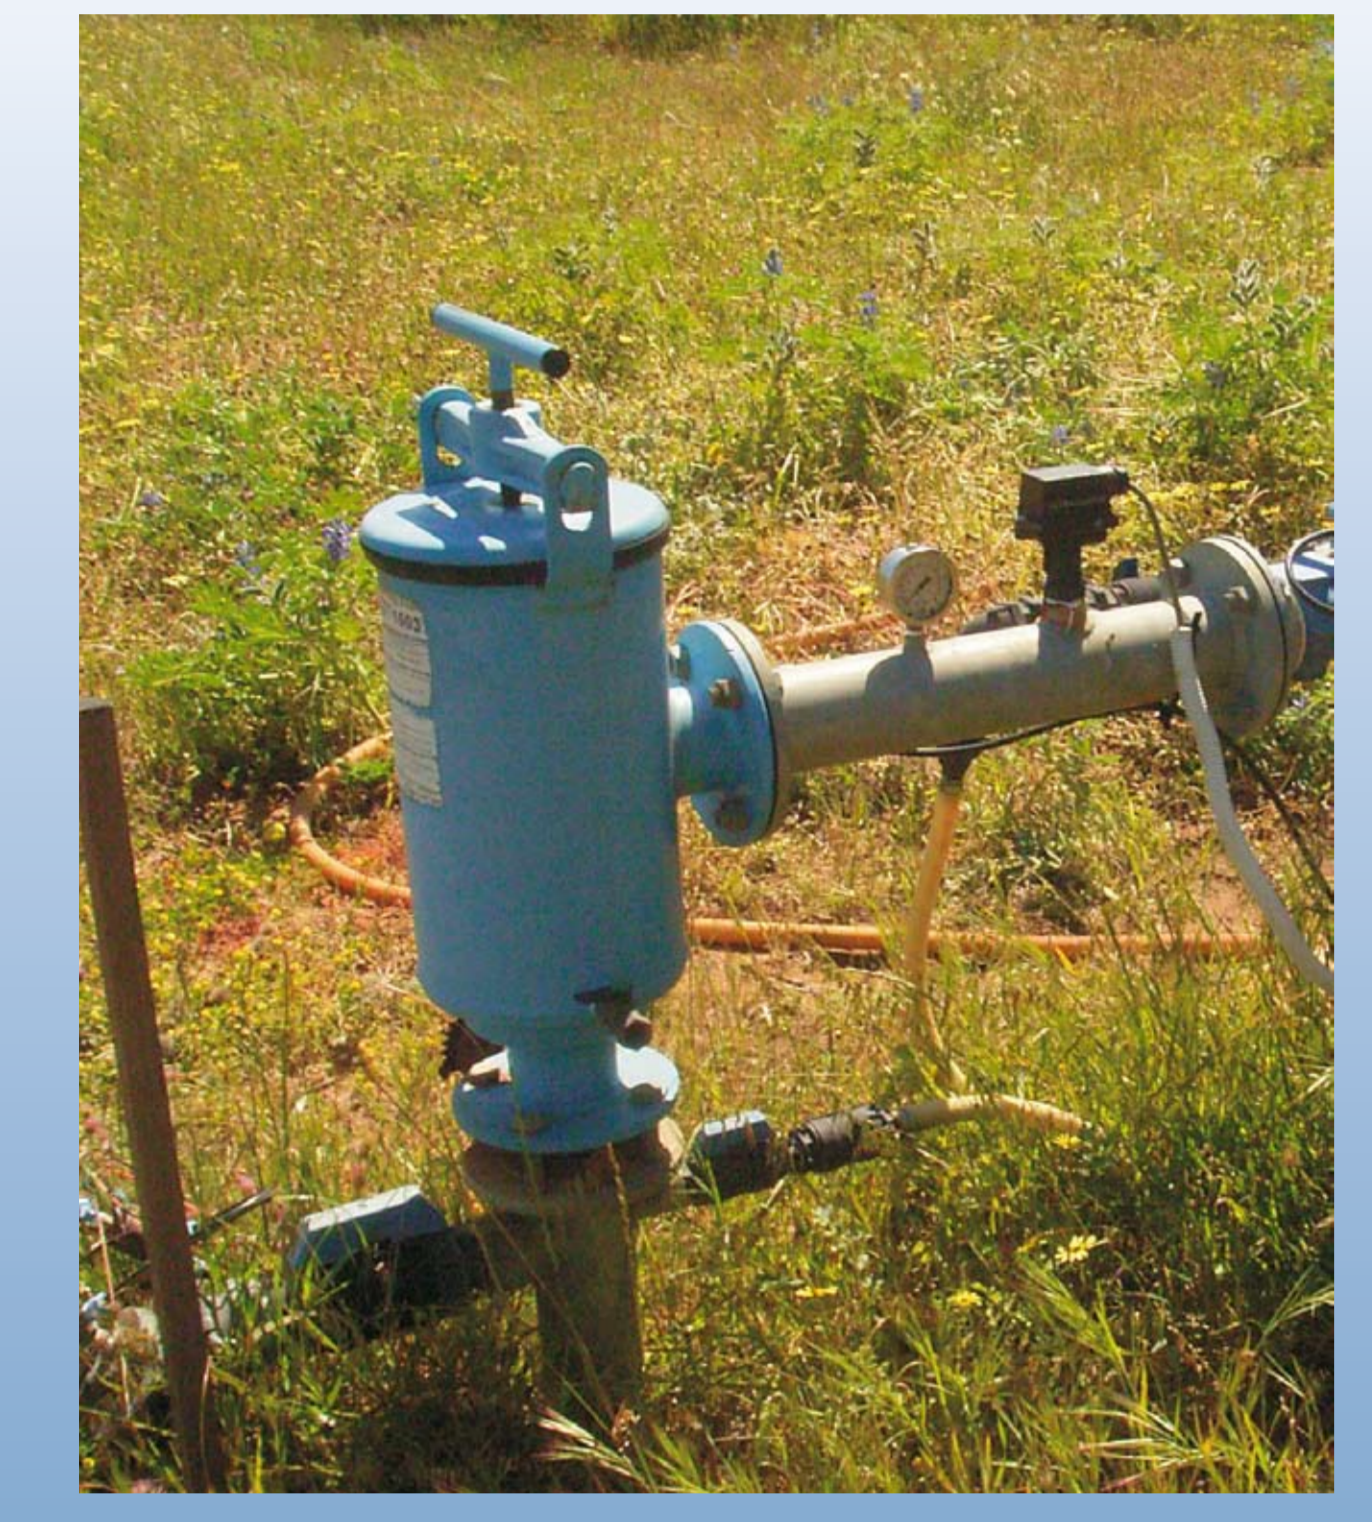
- Analysis of ~40 domestic bores (some in Gwelup PDWSA) found:
 - NO₃-N concentrations ranged from <1 to 15 mg/L with high concentrations generally associated with unsewered areas
 - Pathogen presence indicative of faecal contamination in five bores where septic tanks were nearby.
- Septic tanks are "incompatible" to P3 areas. New residential development requires connection to deep sewerage, however, many older residential areas (some in P3 areas) still have septic tanks.

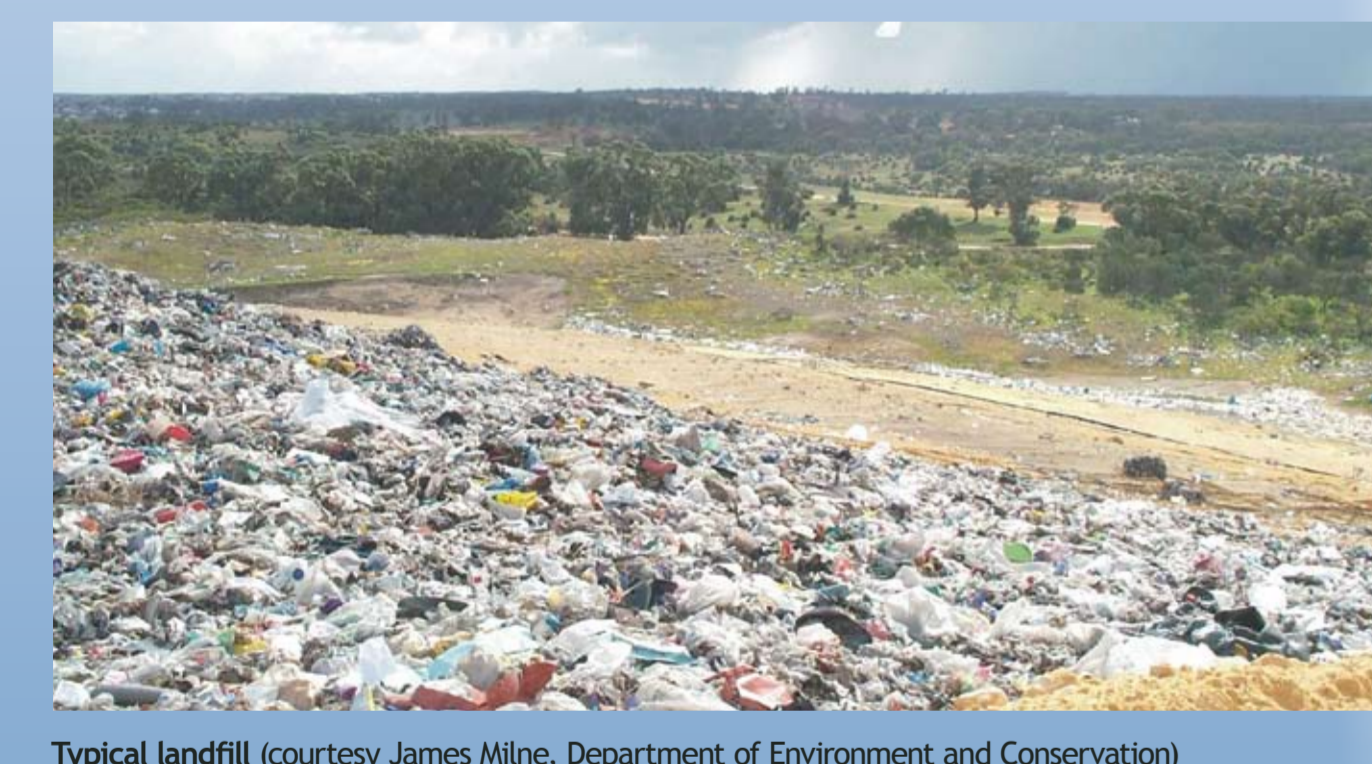
Typical landfill (courtesy James Minto, Department of Environment and Conservation)

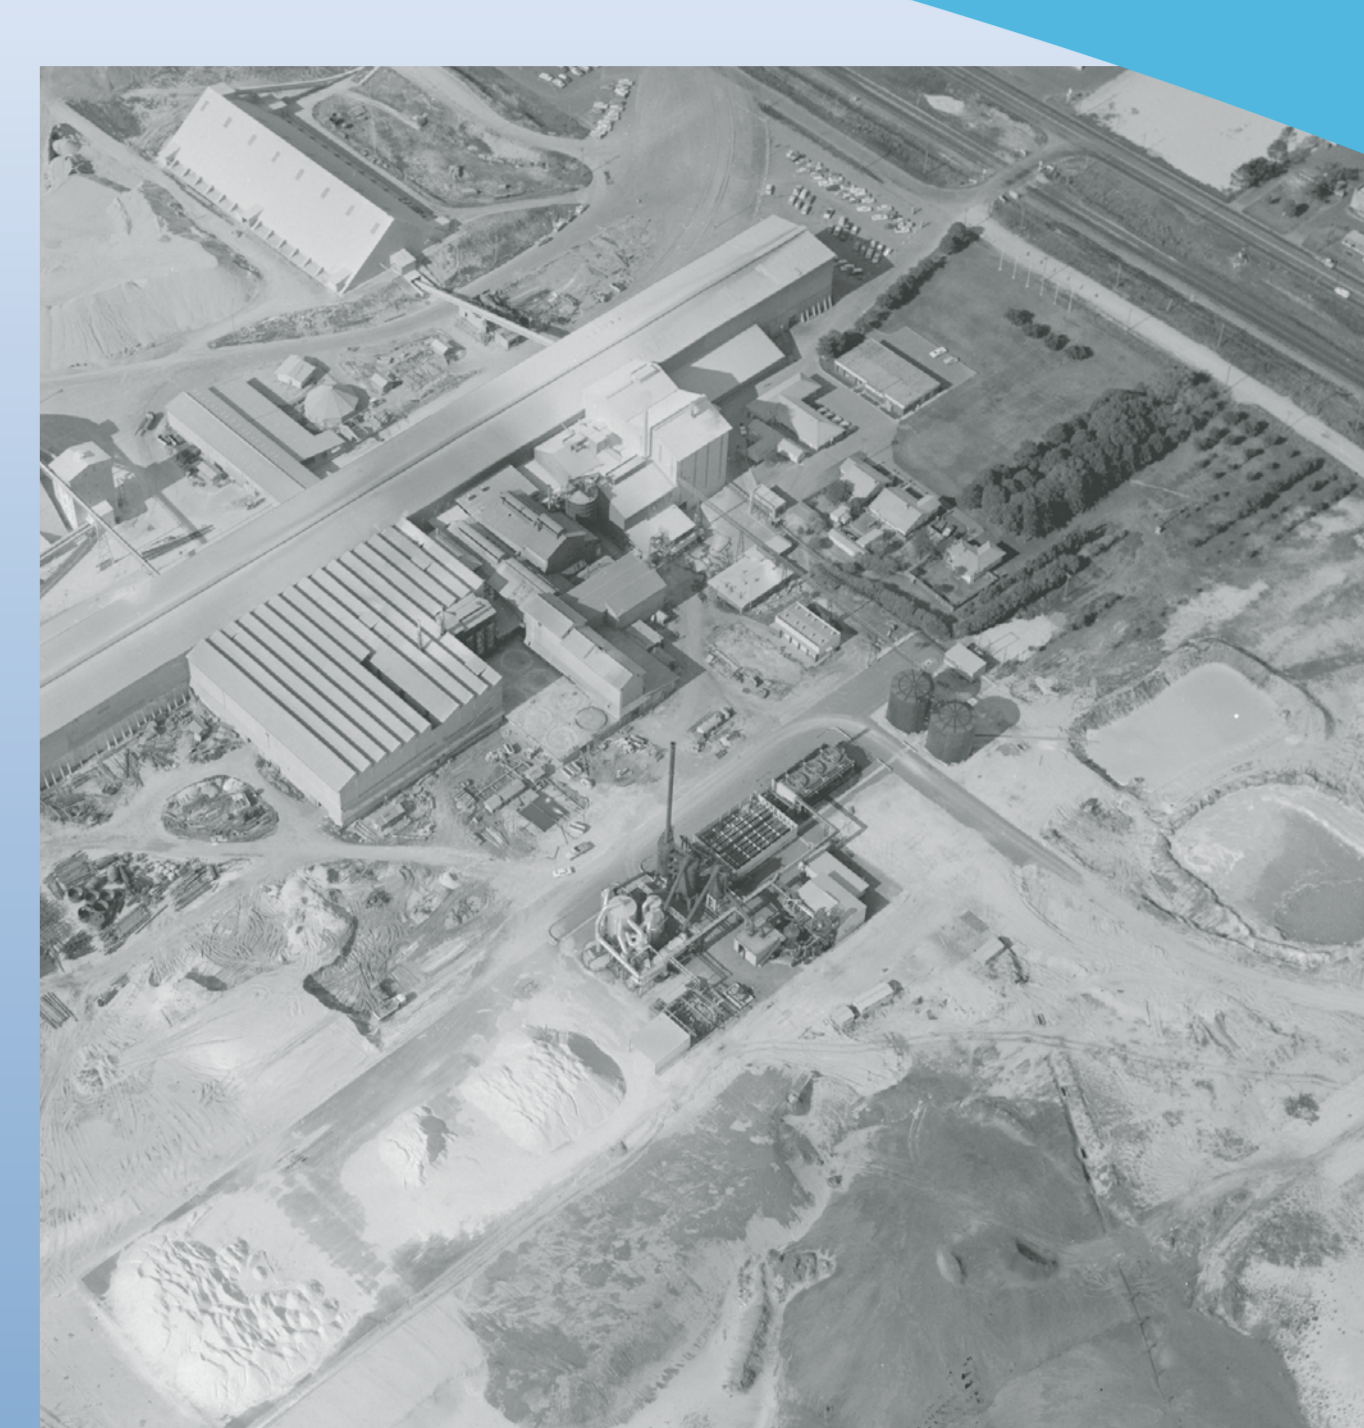
Former fertiliser manufacturing site, Bayswater

Source: Parsons Brinckerhoff (2004) Final remediation works for the former Cresco site, Bayswater - Public Environmental Review, CSBP Limited, Perth.
Aerial photograph of the premises, 1969 (courtesy Batye Library 3054790).

- Site used for fertiliser manufacturing and hydrochloric acid production since the 1920s.
- Continued and extensive groundwater contamination exists, including:
 - high acidity and sulphate
 - a suite of heavy metals exceeding ADWG by 10 times or more.
- Health warning was issued to surrounding private bore owners.
- This site is not located within a PDWSA, however, fertiliser manufacturing is "compatible with conditions" in P3 areas.

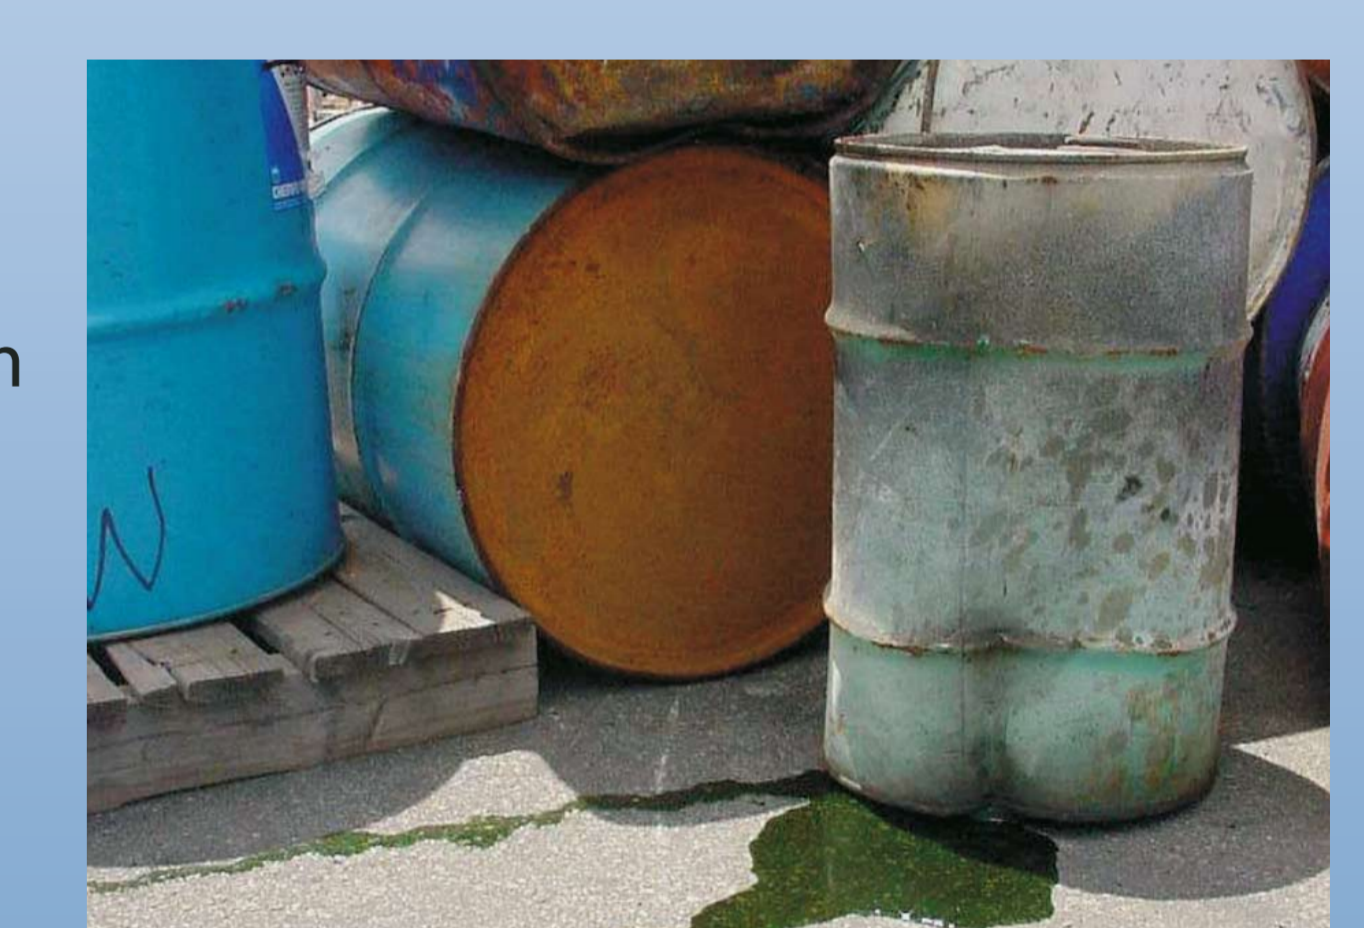
Leaking chemicals due to poor storage (courtesy of Department of Environment).

- Operated from 1987 until 2001 when a large fire destroyed the premises.
- Historical practices and the fire has resulted in two plumes, in which contaminants greatly exceed ADWG criteria:
 - a mixed plume containing chlorinated benzenes, BTEX (benzene, toluene, ethyl benzene and xylene) and chlorinated solvents
 - a chlorinated solvent plume.
- This site is not located within a PDWSA, however, above ground chemical storage is "compatible with conditions" (such as bunding) in P2 and P3 areas.

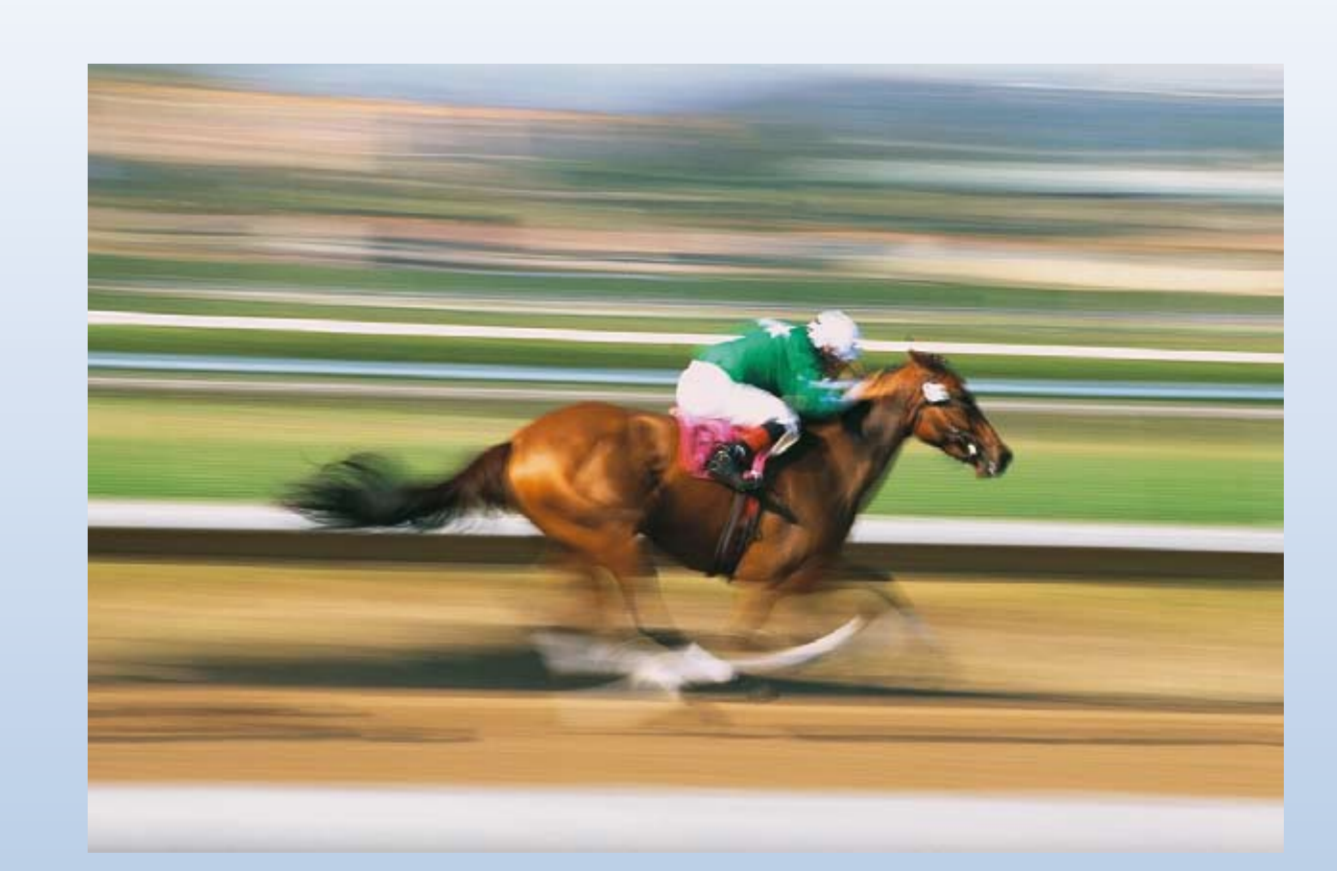
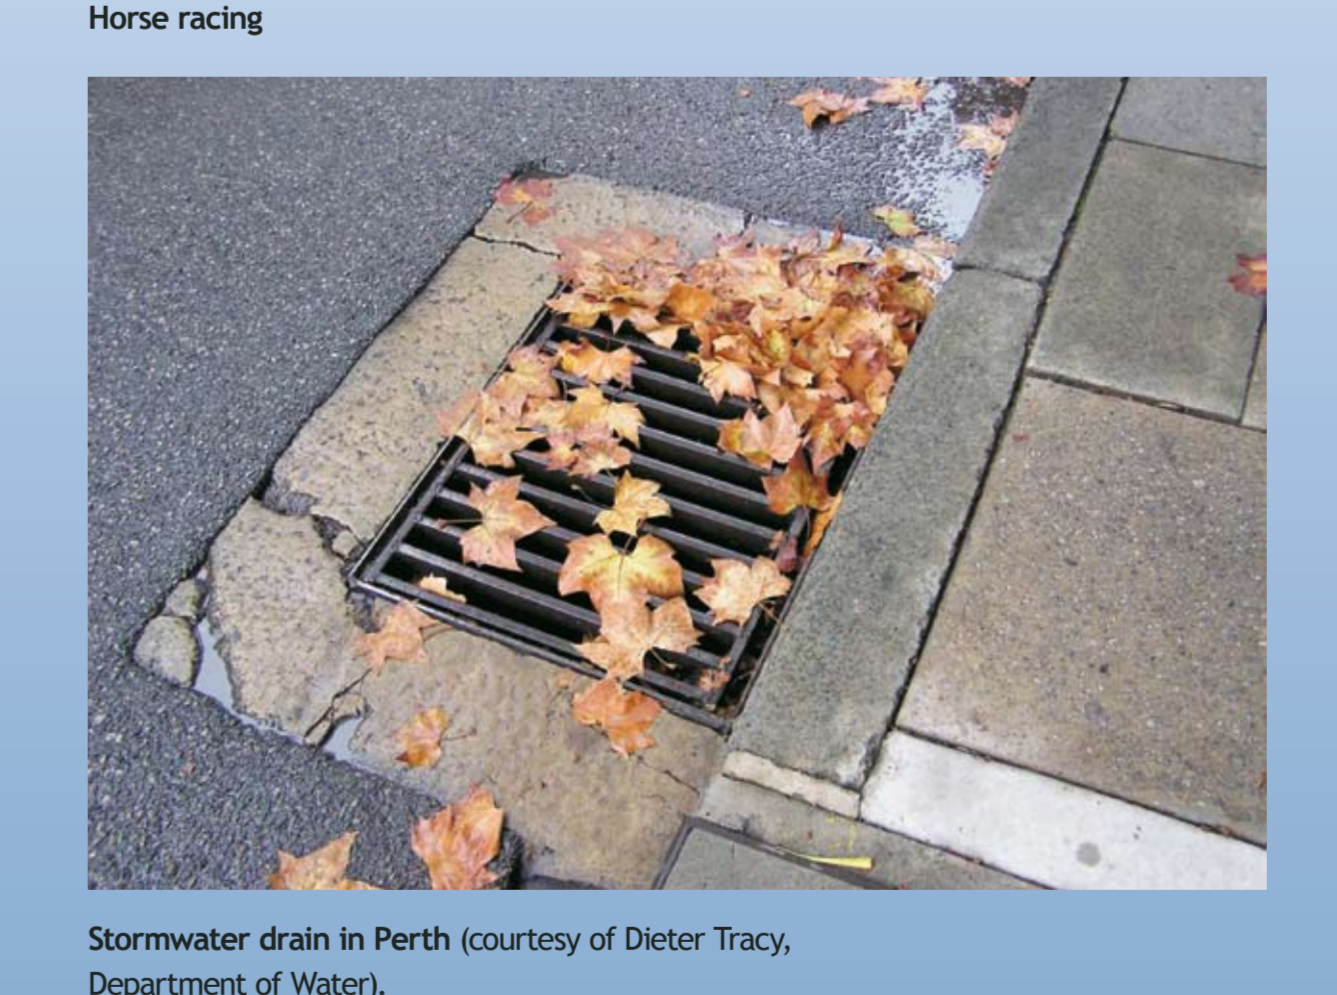
High density urban area, City of Belmont

- Mix of residential, commercial, industrial and recreational uses.
- Stormwater monitoring indicates:
 - elevated nitrate levels (average 14.7 mg/L NO₃-N) as a direct result of a racecourse and horse stables
 - detections of hydrocarbons and heavy metals, with lead (average 0.034 mg/L) exceeding ADWG criteria (0.01 mg/L).
- This area is not located within a PDWSA, however, residential housing, light industry, horse stables and irrigation of recreational areas are all "compatible with conditions" in P3 areas.
