# Antifouling biocides in Perth coastal waters:

a snapshot at select areas of vessel activity

Report no. WST 1  
May 2009

Department of Water  
Water Science Technical Series  
Report No.1  
December 2008

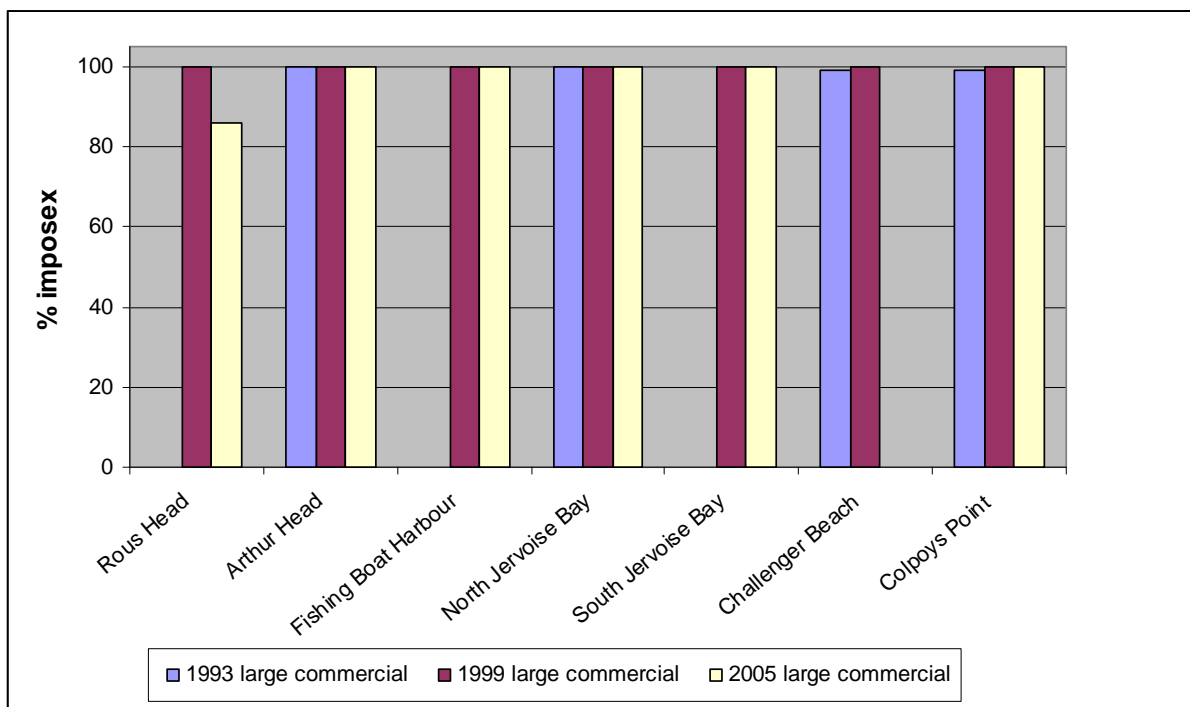
**Figure 2** Imposex in *Thais orbita* at sites in Perth coastal waters that are dominated by commercial vessel activity: 1993 to 2005

Figures 2 and 3 below show the incidence of imposex at sites in Perth coastal waters using data from 1993, 1999 and 2005 (Reitsema et al. 2003; M Gagnon [Curtin University] 2007 pers. comm.). Areas dominated by commercial shipping and larger vessels continue to have around 100 per cent imposex, whilst areas of recreational vessel activity have seen a reduction in incidence of imposex since the introduction of restrictions on the use of TBT to vessels > 25 m.

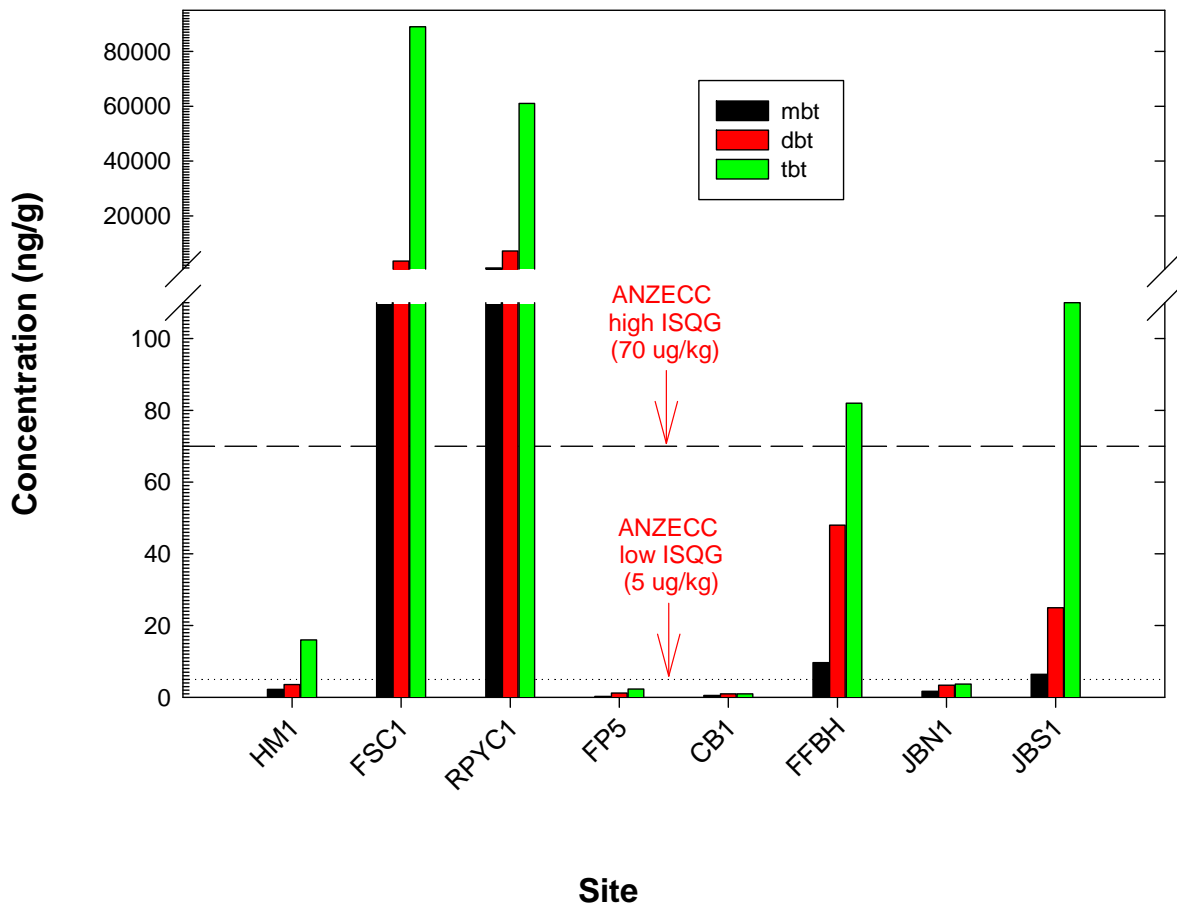
**Figure 6 Concentrations of butyltins in sediment from Perth coastal waters (using only core 1)**

In general, concentrations of monobutyltin (MBT) and dibutyltin (DBT) were lower than TBT in all cores, with maximum concentrations of 1500 and 7200 ng/g respectively, both at Royal Perth Yacht Club (Figure 6).

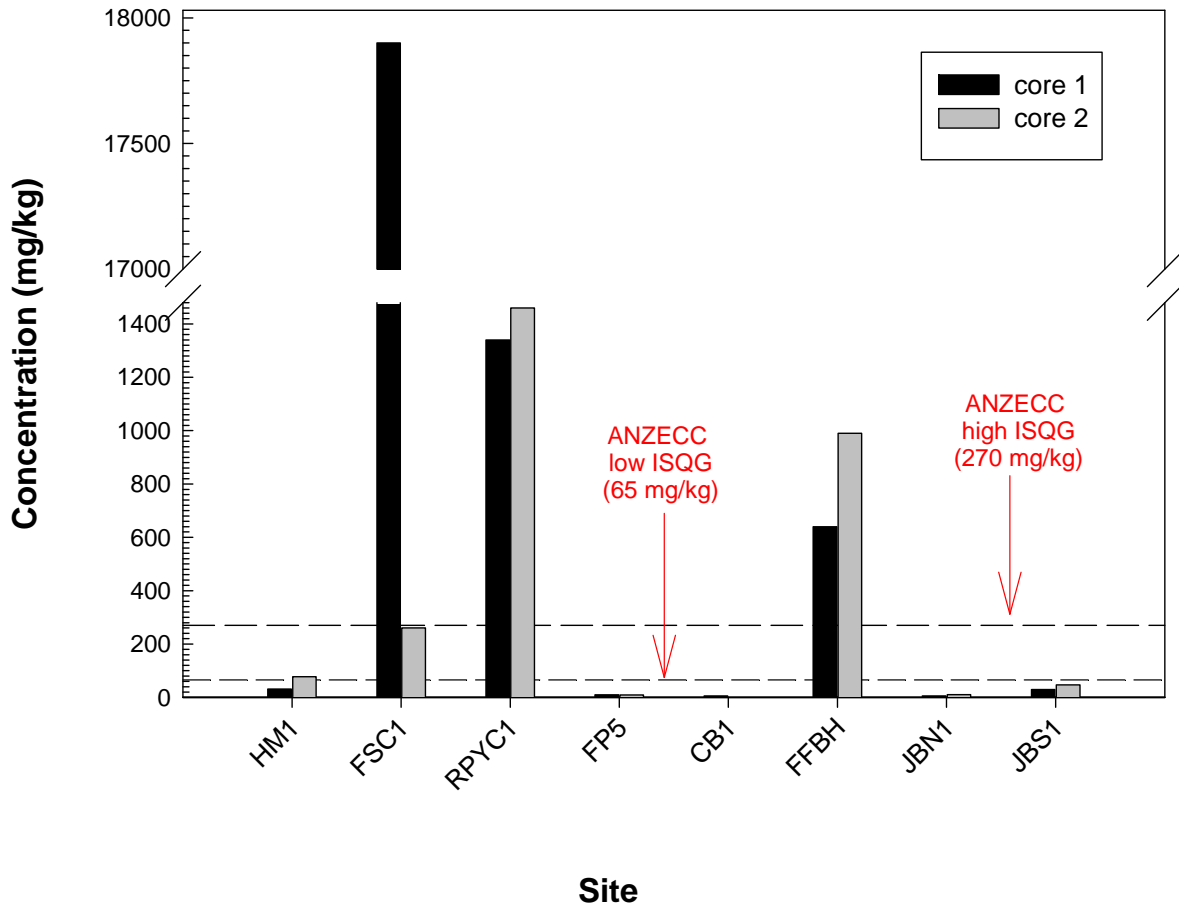
Figure 9 Concentrations of copper in sediment from Perth coastal waters

Copper concentrations in sediment (as shown in Figure 9) ranged from 1.5 mg/kg in a core from Careening Bay through to 17 900 mg/kg at Fremantle Sailing Club. That particular core from Fremantle Sailing Club was also the highest for zinc at 6490 mg/kg. Those concentrations were more than an order of magnitude higher than the next highest concentrations which were found in cores from Royal Perth Yacht Club. The ANZECC guideline (ISQG low) for zinc is 200 mg/kg, sediments exceeded that concentration at three sites: Royal Perth Club, Fremantle Sailing Club, and Fremantle Boat Lifters (Figure 9). The guideline (ISQG-low) for copper in sediment is 65 mg/kg. This was exceeded at the same three sites as well as Hillarys Boat Harbour.

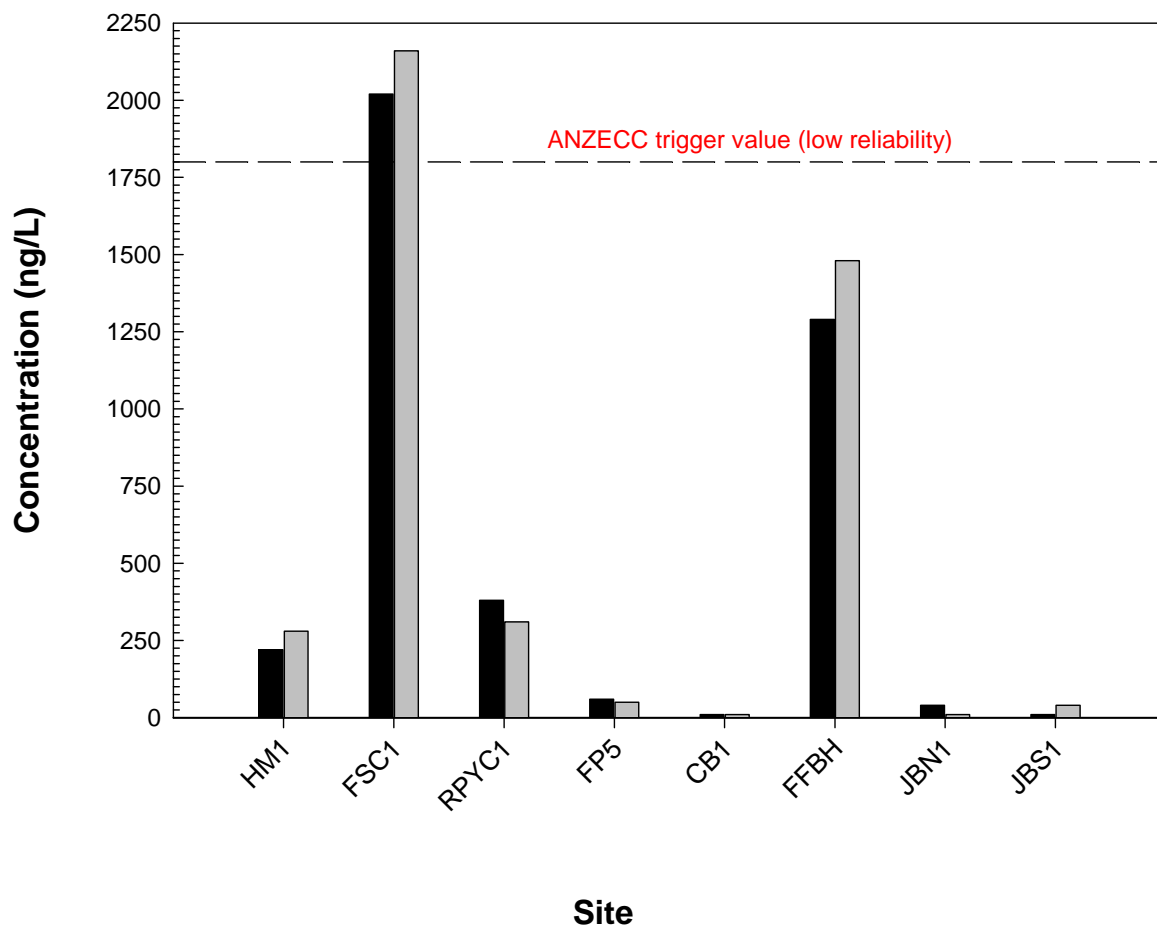
**Figure 11 Concentrations of diuron in water at sites in Perth coastal waters**

Diuron was detected in all water samples, with a range of 20 ng/L at Careening Bay, through to 2160 ng/L at Fremantle Sailing Club (the only sample above the ANZECC low reliability trigger value of 1.8  $\mu\text{g/L}$ ). Data is presented below in Figure 11. Irgarol 1051 was detected in water samples from Fremantle Sailing Club (both samples 5 ng/L) and Fremantle Boat Lifters (one sample at 6 ng/L). All other samples were below the limit of detection, which was 5 ng/L.
