Assessment of ecological health and
environmental water provisions in the Harvey River
(between Stirling Dam and Harvey Reservoir)
February to May 2011

Water Science
technical series

Report no. WST 44
July 2012

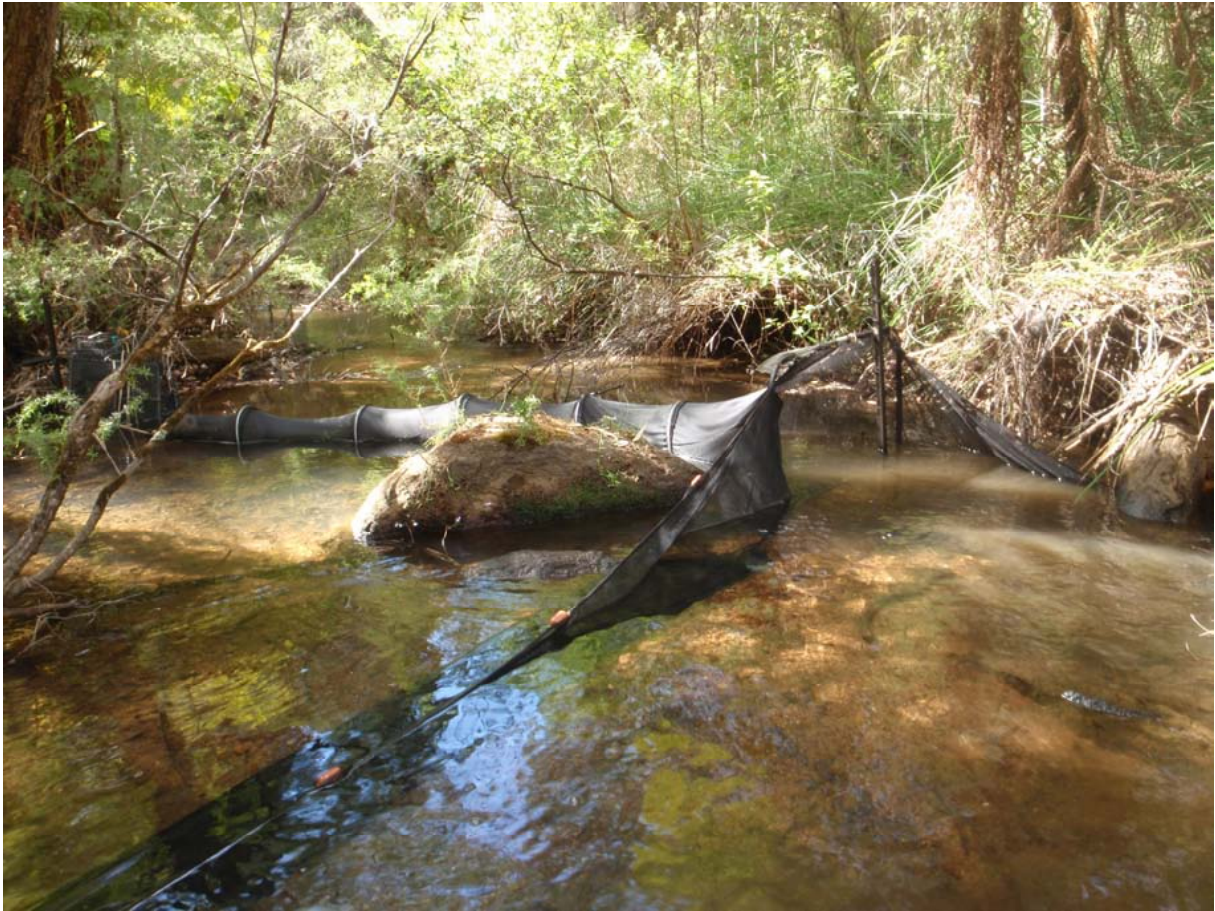
Figure 9 *Fyke net (deployed at the upland pool site)*

Fish and crayfish sampling was conducted using a combination of fyke nets, large box traps and small box traps (Figures 9 and 10). The dimensions and deployment conditions are summarised in Table 5.

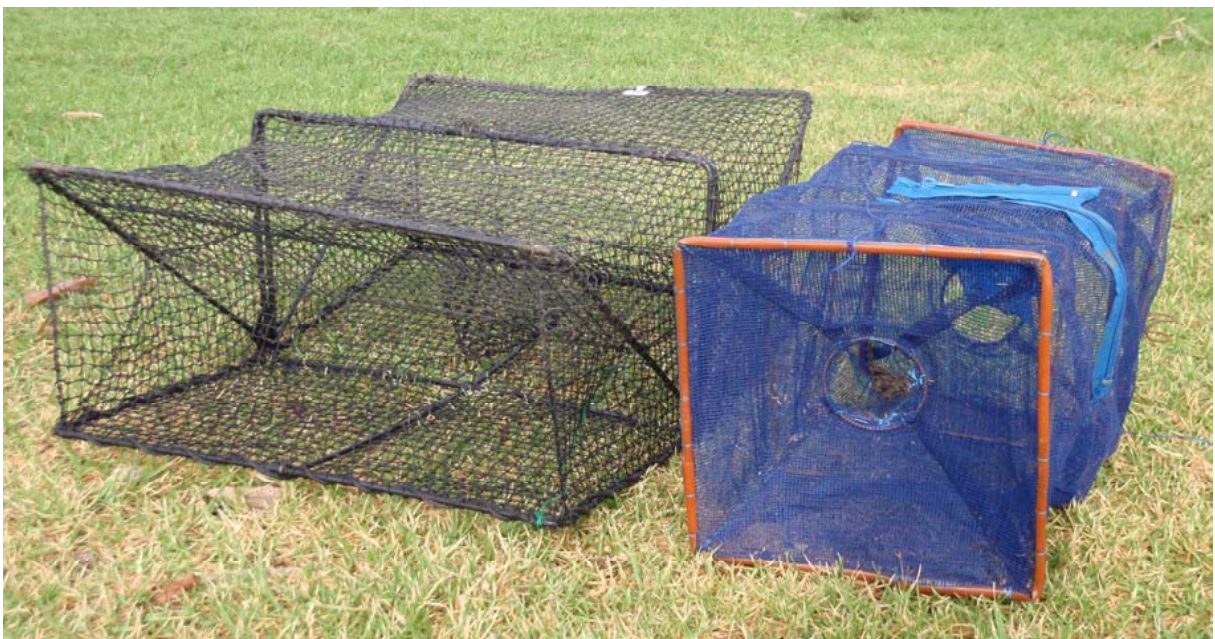
Figure 10 *Box traps (large and small size)*

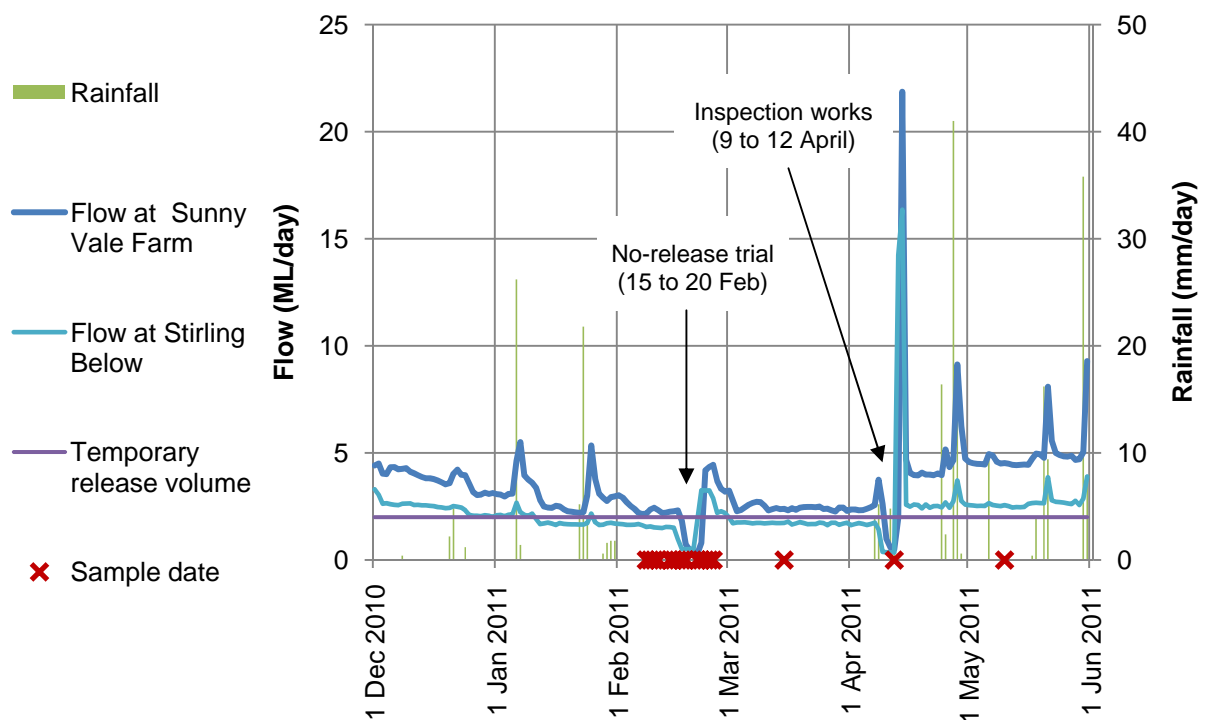
Figure 11 Daily rainfall recorded at Harvey (in millimetres), daily flow recorded at Sunny Vale Farm and Stirling Below gauges (in megalitres), temporary minimum release volume (in megalitres) and sample dates

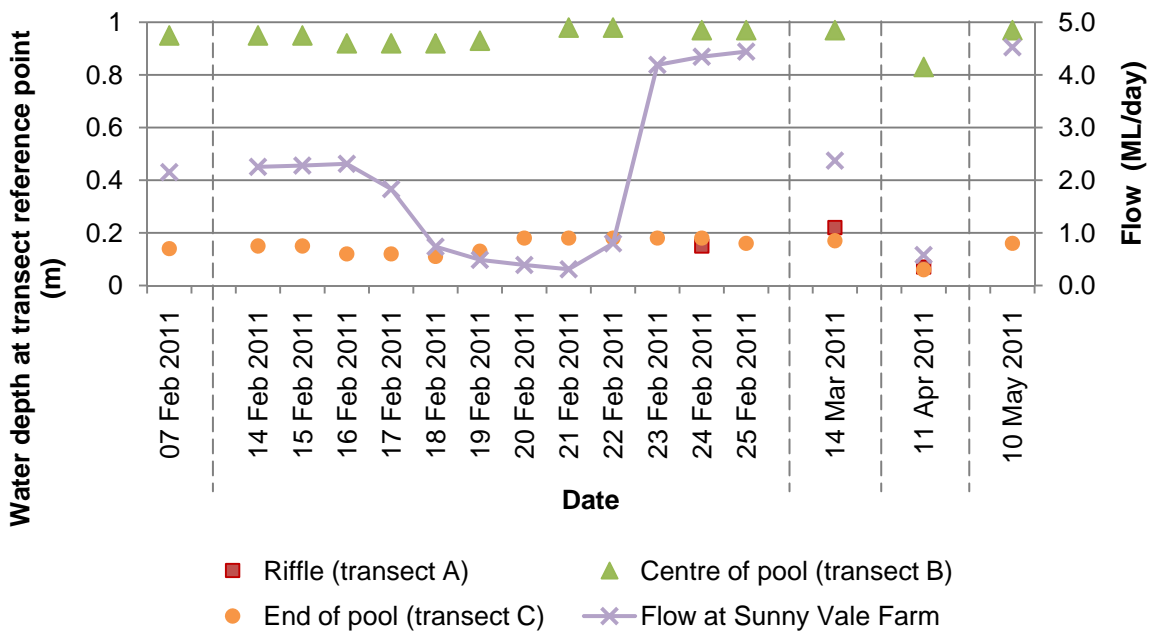
Figure 13 Water depth (metres) at reference points at the upper site and flow at Sunny Vale Farm gauge (megalitres/day)

Water width and depth at the upper site, as measured at the habitat transects and associated depth reference points (on various dates, refer to Section 3.7), fluctuated in response to the volume of flow recorded at Sunny Vale Farm gauge (Figures 13 and 14). At each depth reference point the water depth varied by 0.15 m during the course of the study. The water depth near the centre of the pool (transect B) ranged between 0.83 and 0.98 m; and between 0.06 and 0.18 m at the end of the pool (transect C). At the riffle reference point (transect A) the depth ranged between 0.07 and 0.22 m. Water width at the riffle (transect A) varied by 6 m, while at the pool transects water width varied by between 0.4 m (transect B) and 2.2 m (transect C).

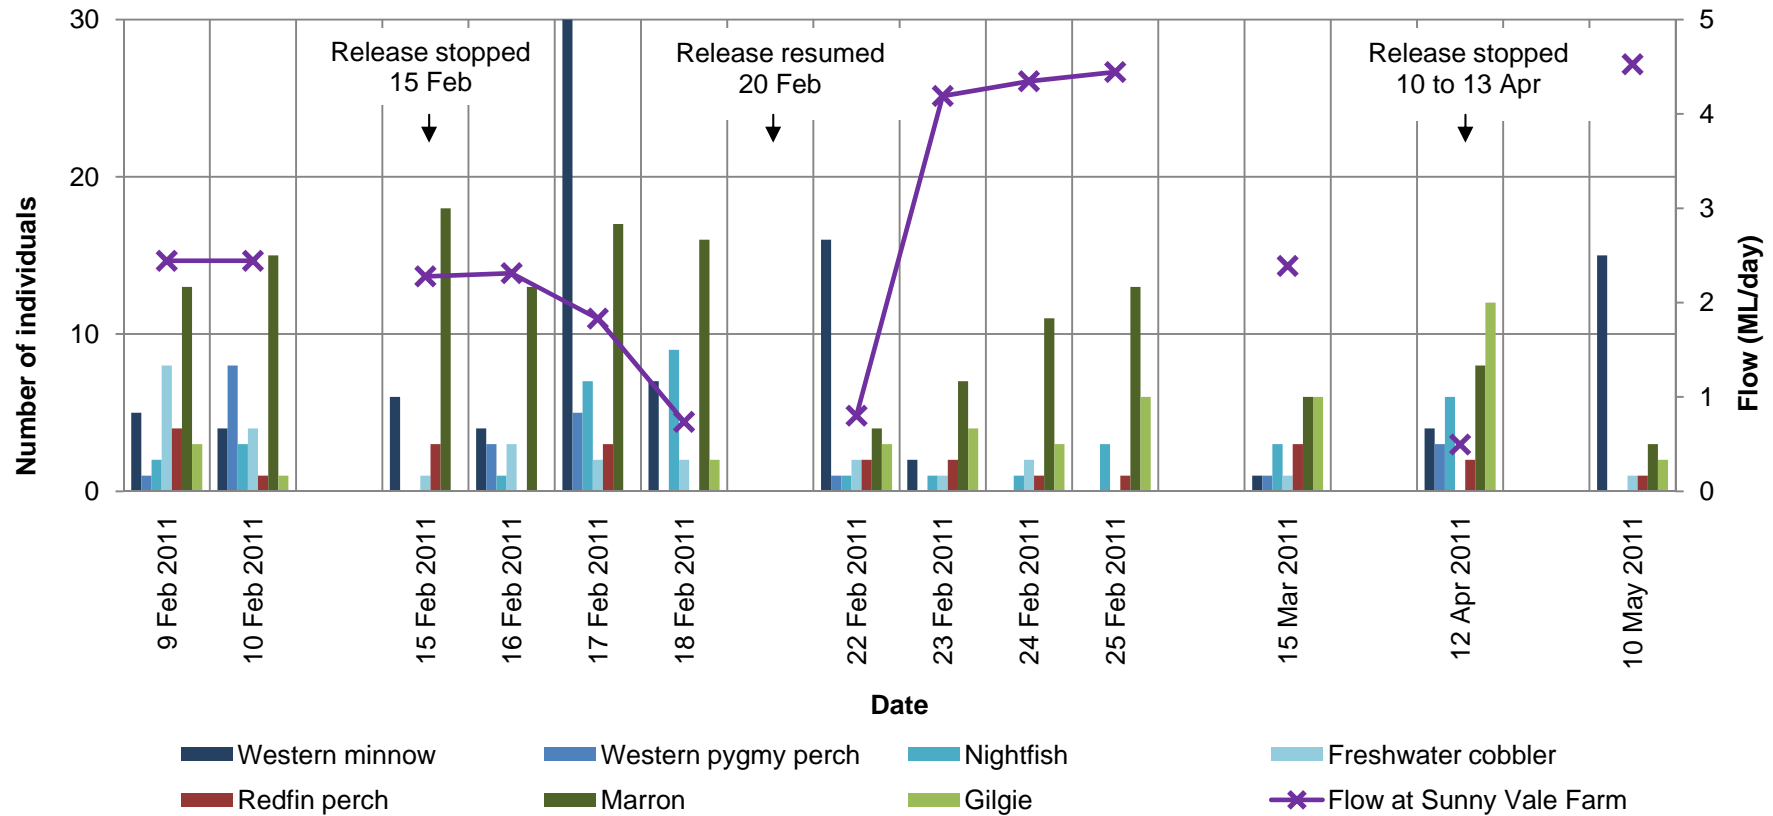
Figure 18 Abundance of fish and crayfish (collected in fyke nets) at the upper site and flow at Sunny Vale Farm gauge

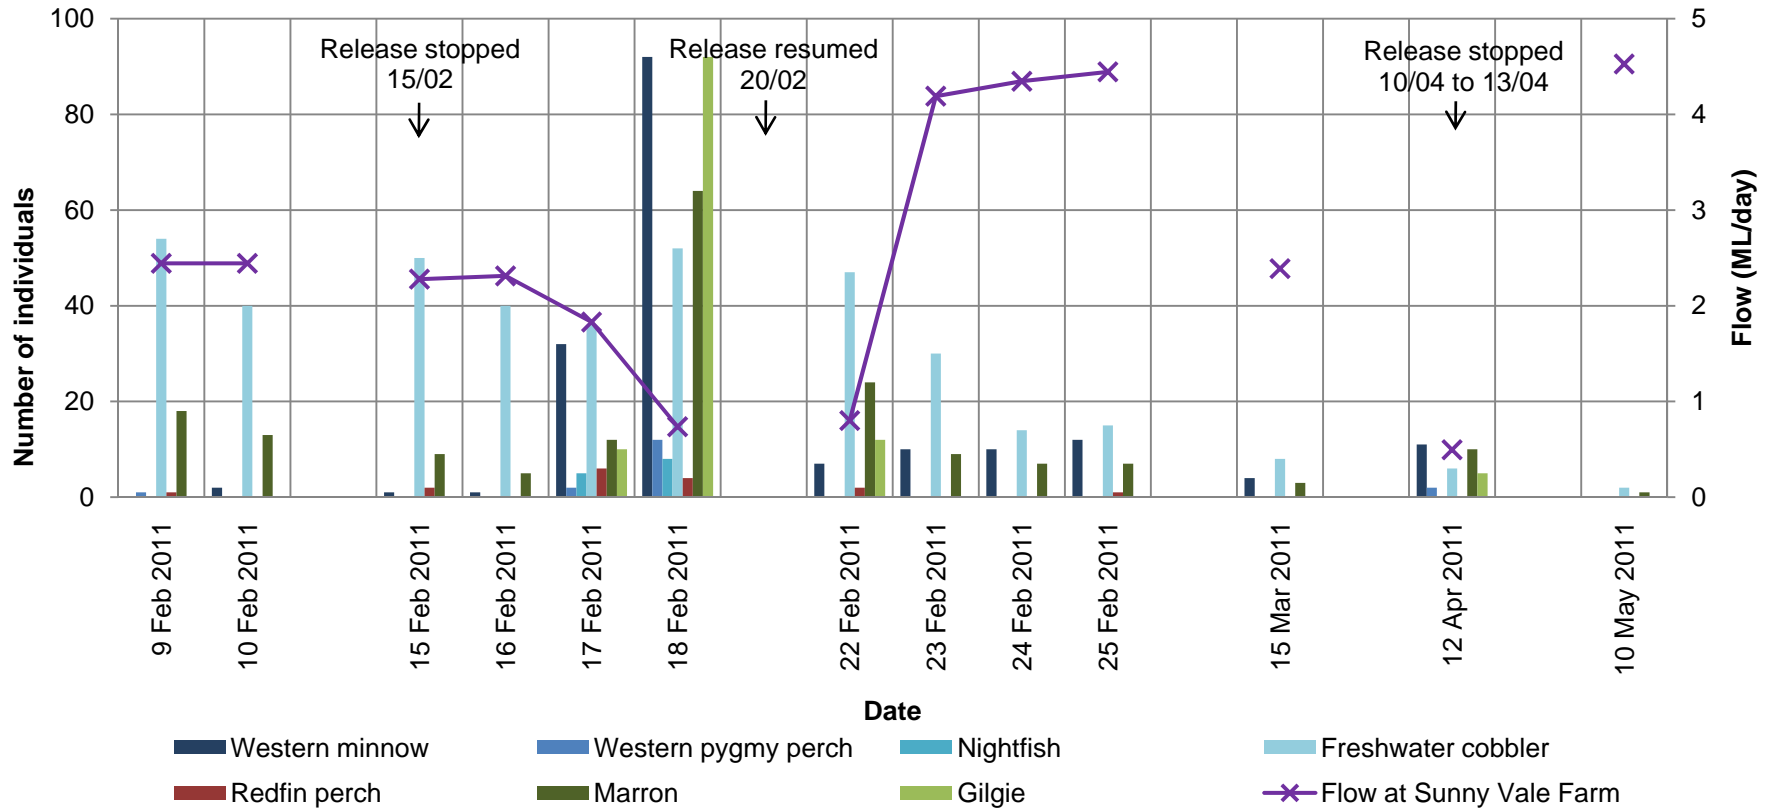
Figure 20 Abundance of fish and crayfish (collected in fyke nets) at the lower site and flow at Sunny Vale Farm gauge
