BUAYANYUP RIVER ACTION PLAN

Prepared for the Geographe Catchment Council (GeoCatch)

By Gemma Mincherton | December 2010

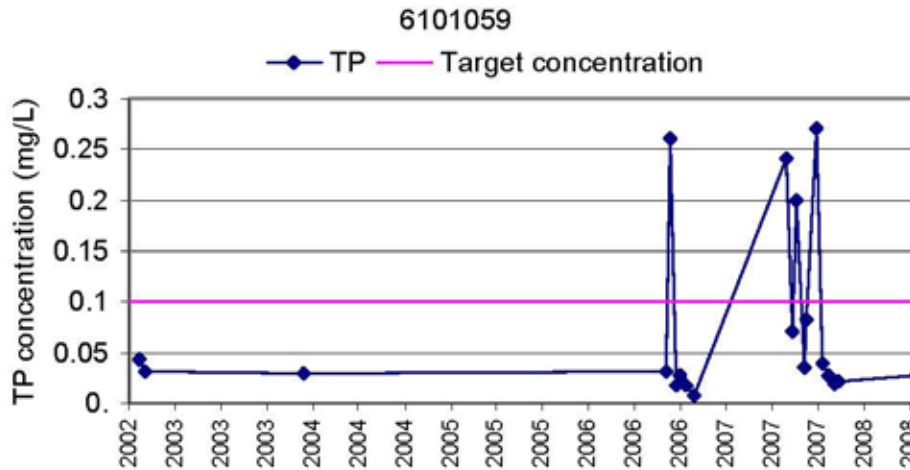
Figure 7 Levels of total phosphorus in the Buayanyup catchment 2002 to 2008

The winter median concentration for total nitrogen (TN) for the Buayanyup catchment is 2.05 mg/L which is classified as ‘very high’, and 0.04 mg/L for total phosphorus (TP), which is classified as ‘moderate’ (based on figures in *the Vasse Wonnerup wetlands and Geographe Bay water quality improvement plan*). The following graphs show the monitoring results since 2002 for total phosphorus and 1998 for total nitrogen.

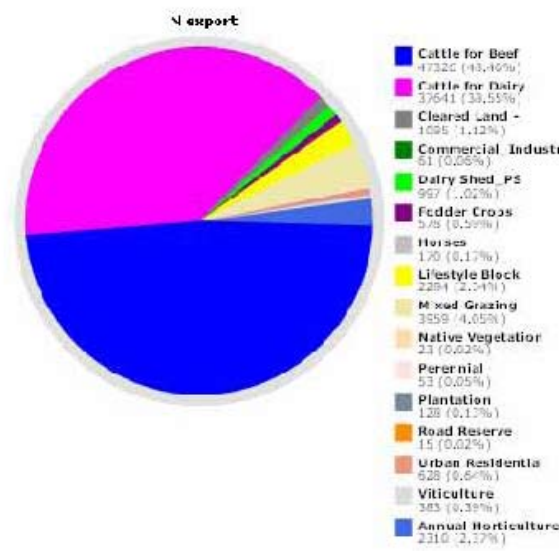
Figure 9 Pie chart showing land uses contributing to total phosphorus in the Buayanyup catchment

Nutrient modelling undertaken by the Department of Water was used to determine the sources of nutrients in the waterways. As Figures 9 and 10 show, the largest sources of both phosphorus and nitrogen in this catchment are dairy farms, followed by horticulture and then beef cattle farms. Nutrient loads into the waterway are also predicted to increase due to the expansion of the Vasse Newtown urban development. Department of Water modelling suggests that phosphorus and nitrogen may increase by 40% and 10% respectively, primarily as a result of urban expansion (Hall 2009), although these predicted increases may be reduced by the implementation of water sensitive urban design in future developments.

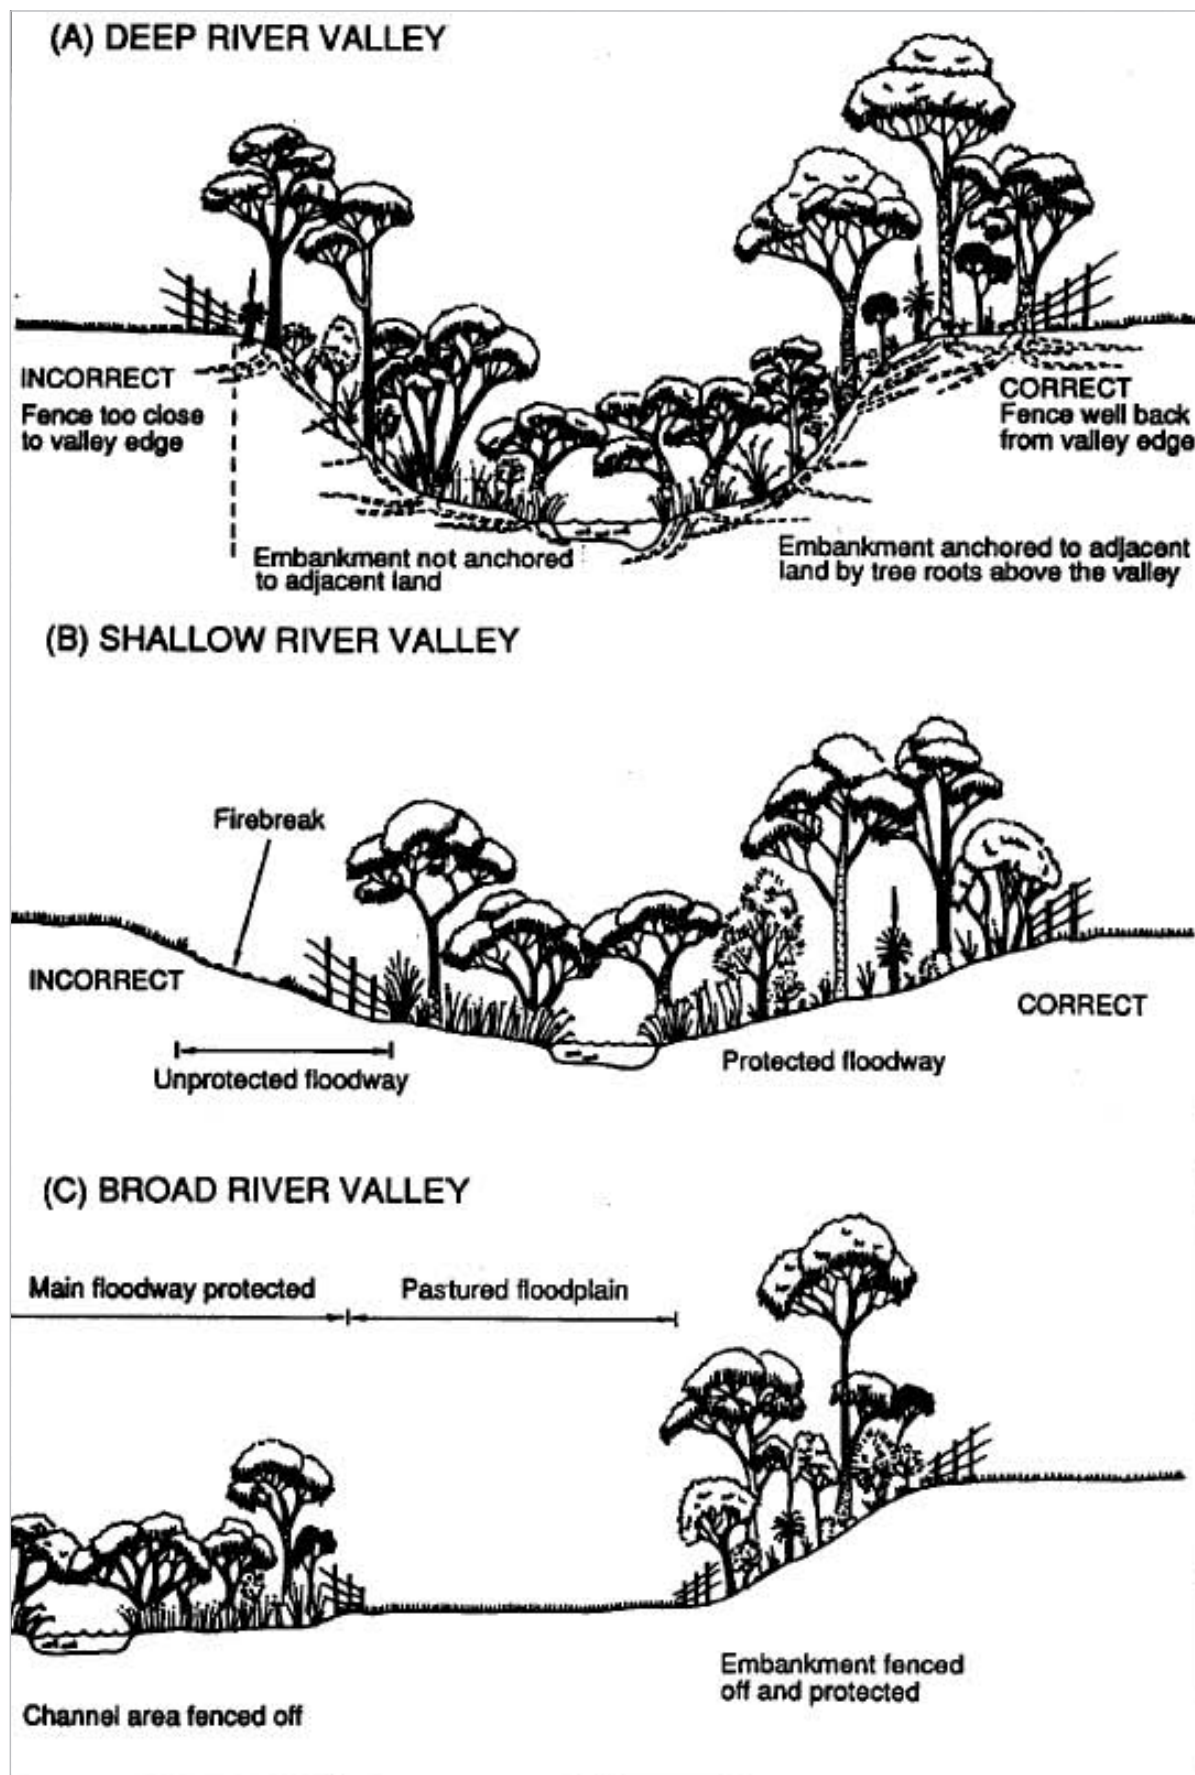
Figure 11 Recommended placement of fencing in a river valley
 (a) the deep river valley, (b) the shallow river valley and (c) the broad river valley
 (Water and Rivers Commission 2000)

- Broad flood plains. If the river valley is particularly broad and flood plains have been cleared for grazing, fencing them off may mean sacrificing good farmland. In this case it is necessary that only those areas that are prone to water erosion or stock damage, such as embankments and secondary river channels which only flow strongly at times of flood, need to be fenced off (see Figure 11c). Some of these fence-lines will be prone to flood damage, but this can be minimised if fences run, as much as possible, parallel to the direction of floodwaters.

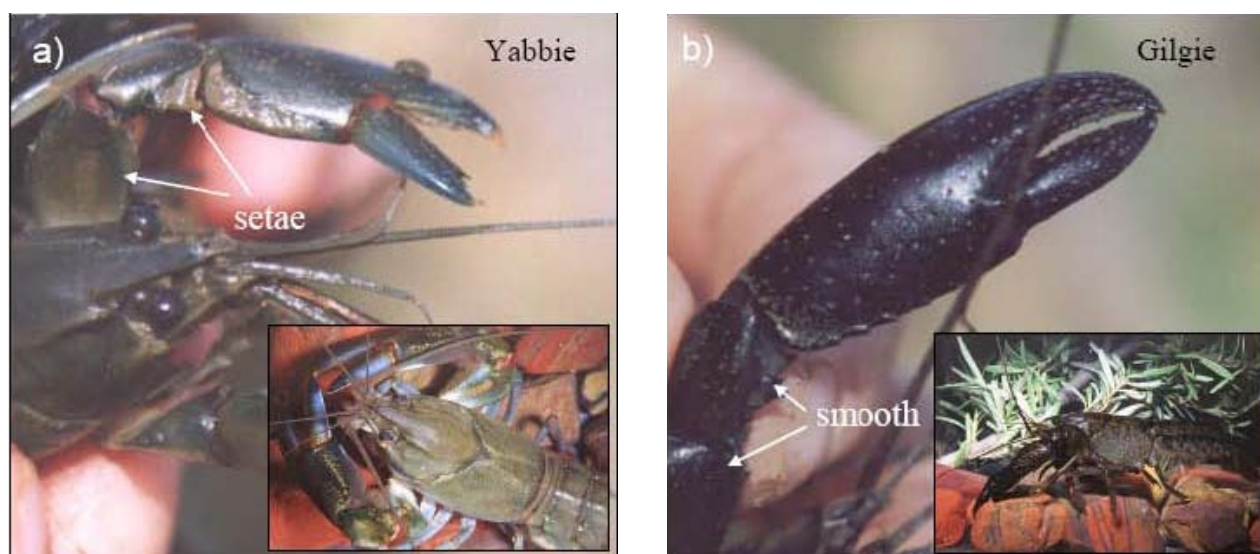
Figure 12 Comparison of a yabbie claw and gilgie claw

a) Yabbie claw showing the location of the fine hairs and b) Gilgie claw which is smooth as are all other native crayfish. If unsure, go to the link at <[www.fish.wa.gov.au/Identifying freshwater crayfish in South West WA](http://www.fish.wa.gov.au/Identifying_freshwater_crayfish_in_South_West_WA)>.

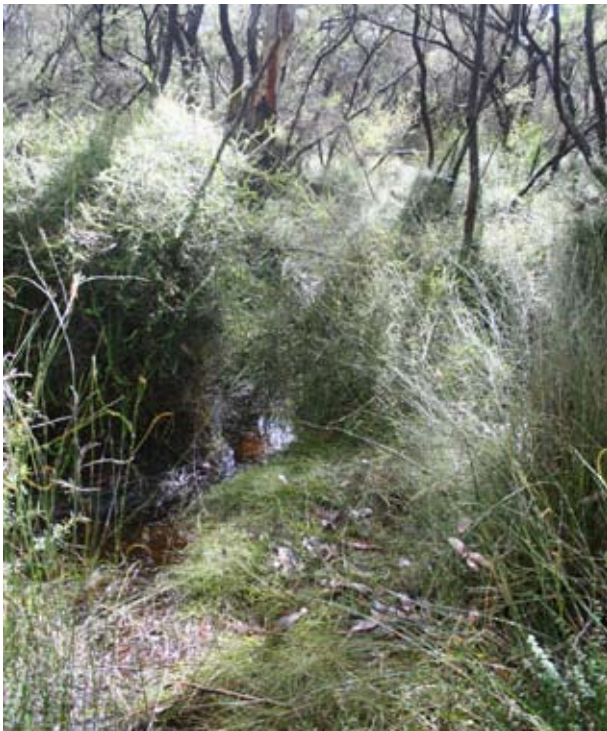
Photo 1 *A2 grade foreshore*

A2 grade foreshore is near pristine with a few weeds. Riparian vegetation like this is as good as will be found today.

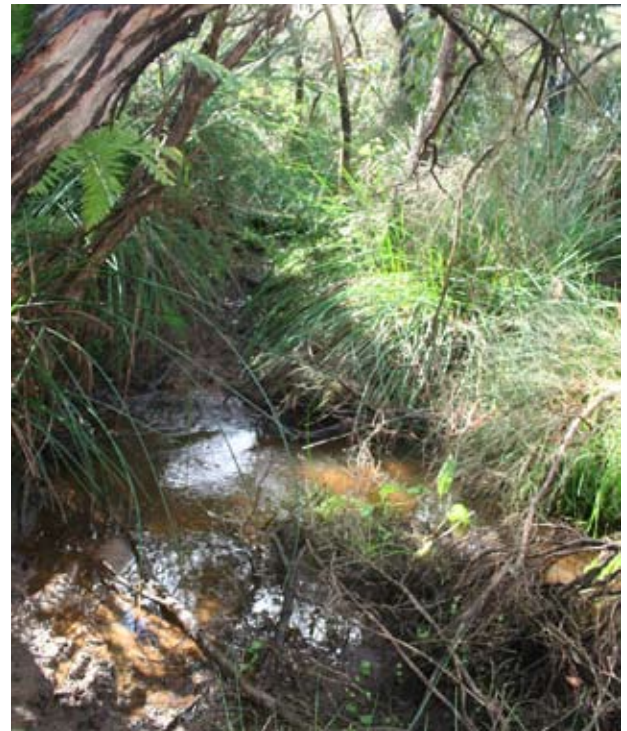
Photo 2 *A3 grade foreshore*

A3 grade foreshore shows the native vegetation is slightly disturbed with some dense patches of weeds.

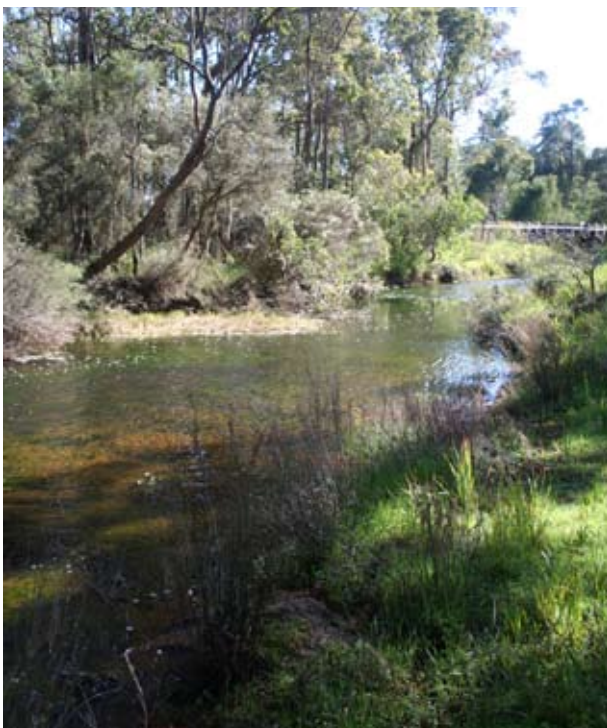
Photo 3 *B1 grade foreshore*

B1 grade foreshore shows some of the natives in the understory have been displaced by weeds.

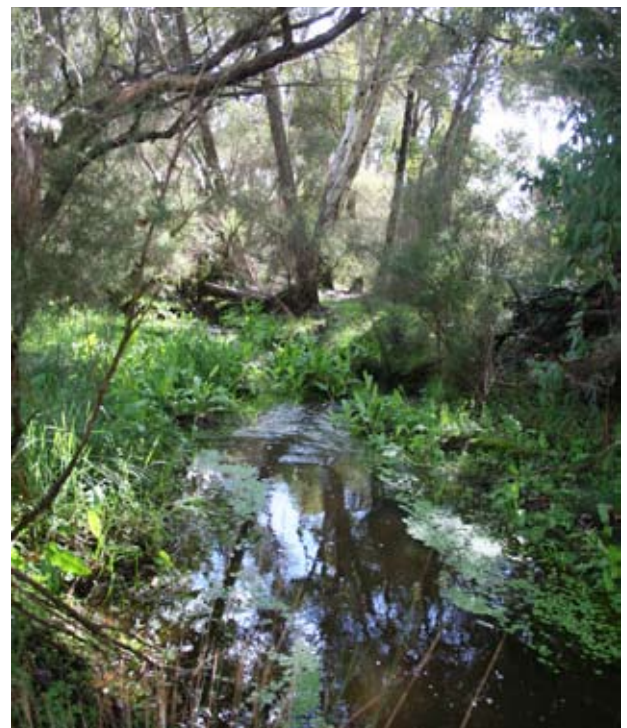
Photo 4 *B2 grade foreshore*

B2 grade foreshore shows heavy weed infestations in the understory.

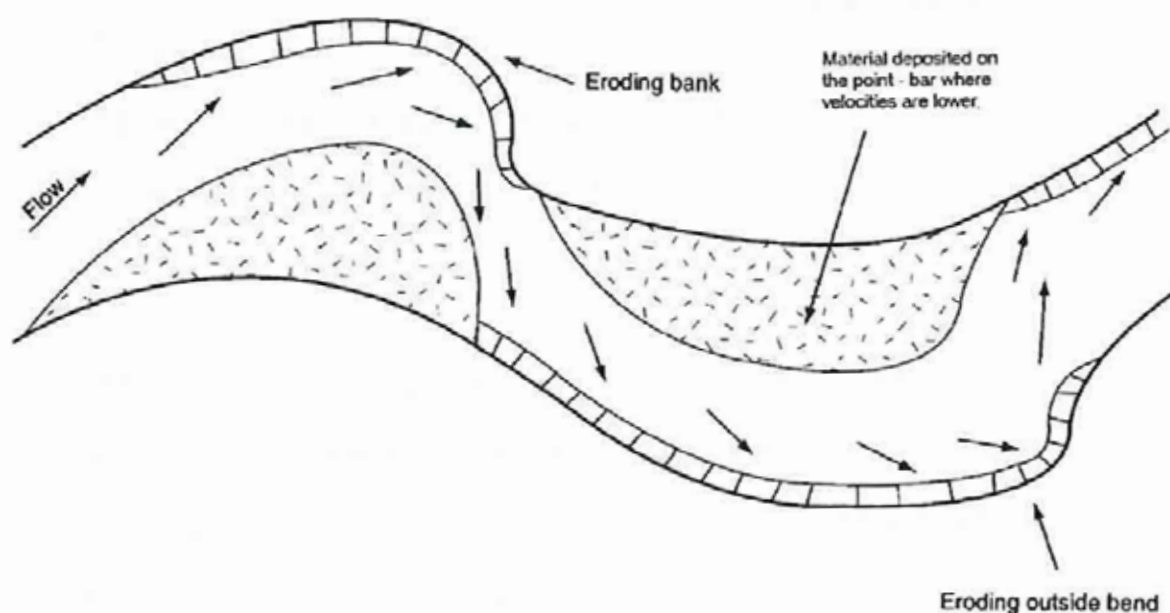
Figure 28 *Outside bend bank erosion*

Removal of point bars may sometimes be needed in order to halt the progression of the erosion down-stream. Generally, this should be undertaken in conjunction with other forms of restoration and care must be taken not to exacerbate the disturbance to the river channel. As discussed previously, a detailed river geometry survey of the problem areas is essential before this type of restoration procedure should be contemplated.

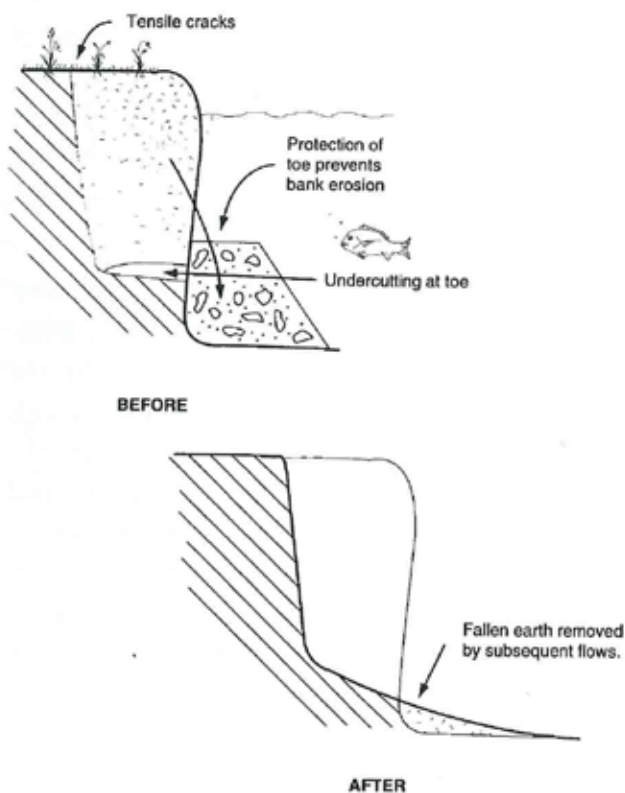
Figure 29 *Undercut bank and rock toe*

Undercutting often occurs in conjunction with the formation of point bars. Material is scoured from the toe of the bank, resulting in loss of bank support; this often results in slumping as illustrated in Figure 30 (Raine & Gardiner 1995). Previous experience has shown that supporting and protecting the toe of the bank can prevent undercutting. Generally undercutting will occur where there is a meander. If this is the case, only the outside bends need to be supported as the flow velocity on the inside bend is much lower. Once an outside bend is stabilised, the corresponding inside bend will usually adjust its width to cater for the change in flow.

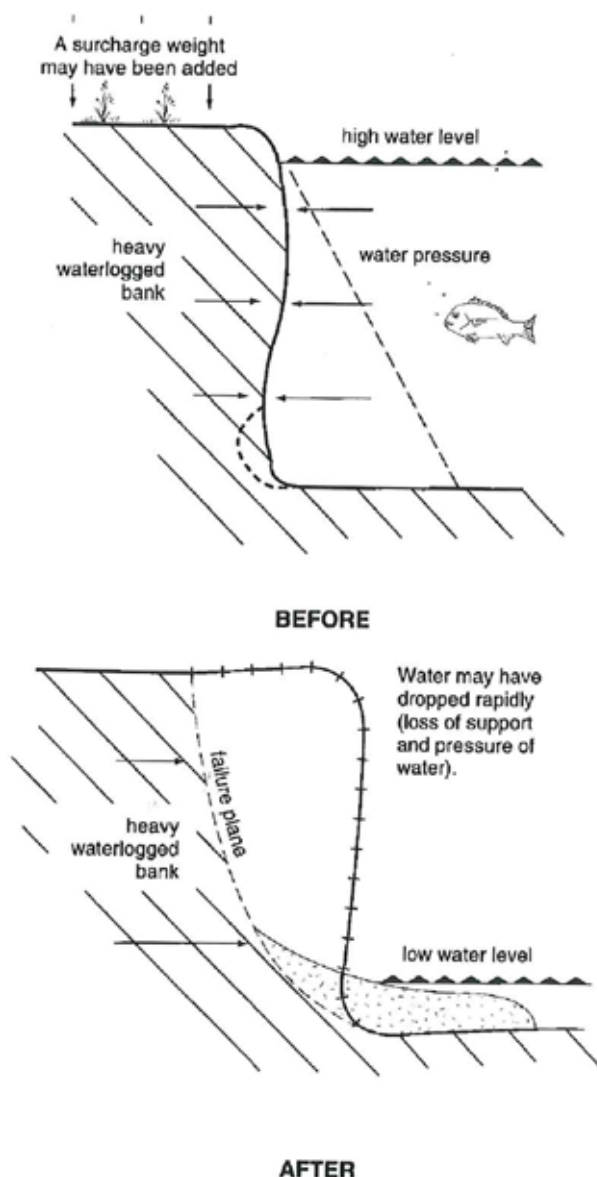
Figure 30 Bank slumping

- replant the toe with species that can withstand high flow velocities (e.g. native sedges). This replanting should be dense with spaces between plantings of less than 1 metre
- replant the middle to upper bank areas with fast growing, deep-rooted trees and large shrubs. These will hold the bank together, enhance drainage and remove excess moisture through transpiration
- vary the species that are planted to ensure differing root structures
- extend plantings from the toe to the flood plain. If a narrow band of trees is planted, this may serve only to add to the weight of the bank without providing the necessary network of root support.
