# FORESHORE ASSESSMENT IN THE CANNING CATCHMENT

WATER AND RIVERS COMMISSION REPORT NO. WRM 15  
1999

# Foreshore assessment in the Canning Catchment

Prepared by  
Kelly Shepherd and Nicole Siemon  
Ecosystem Management Services

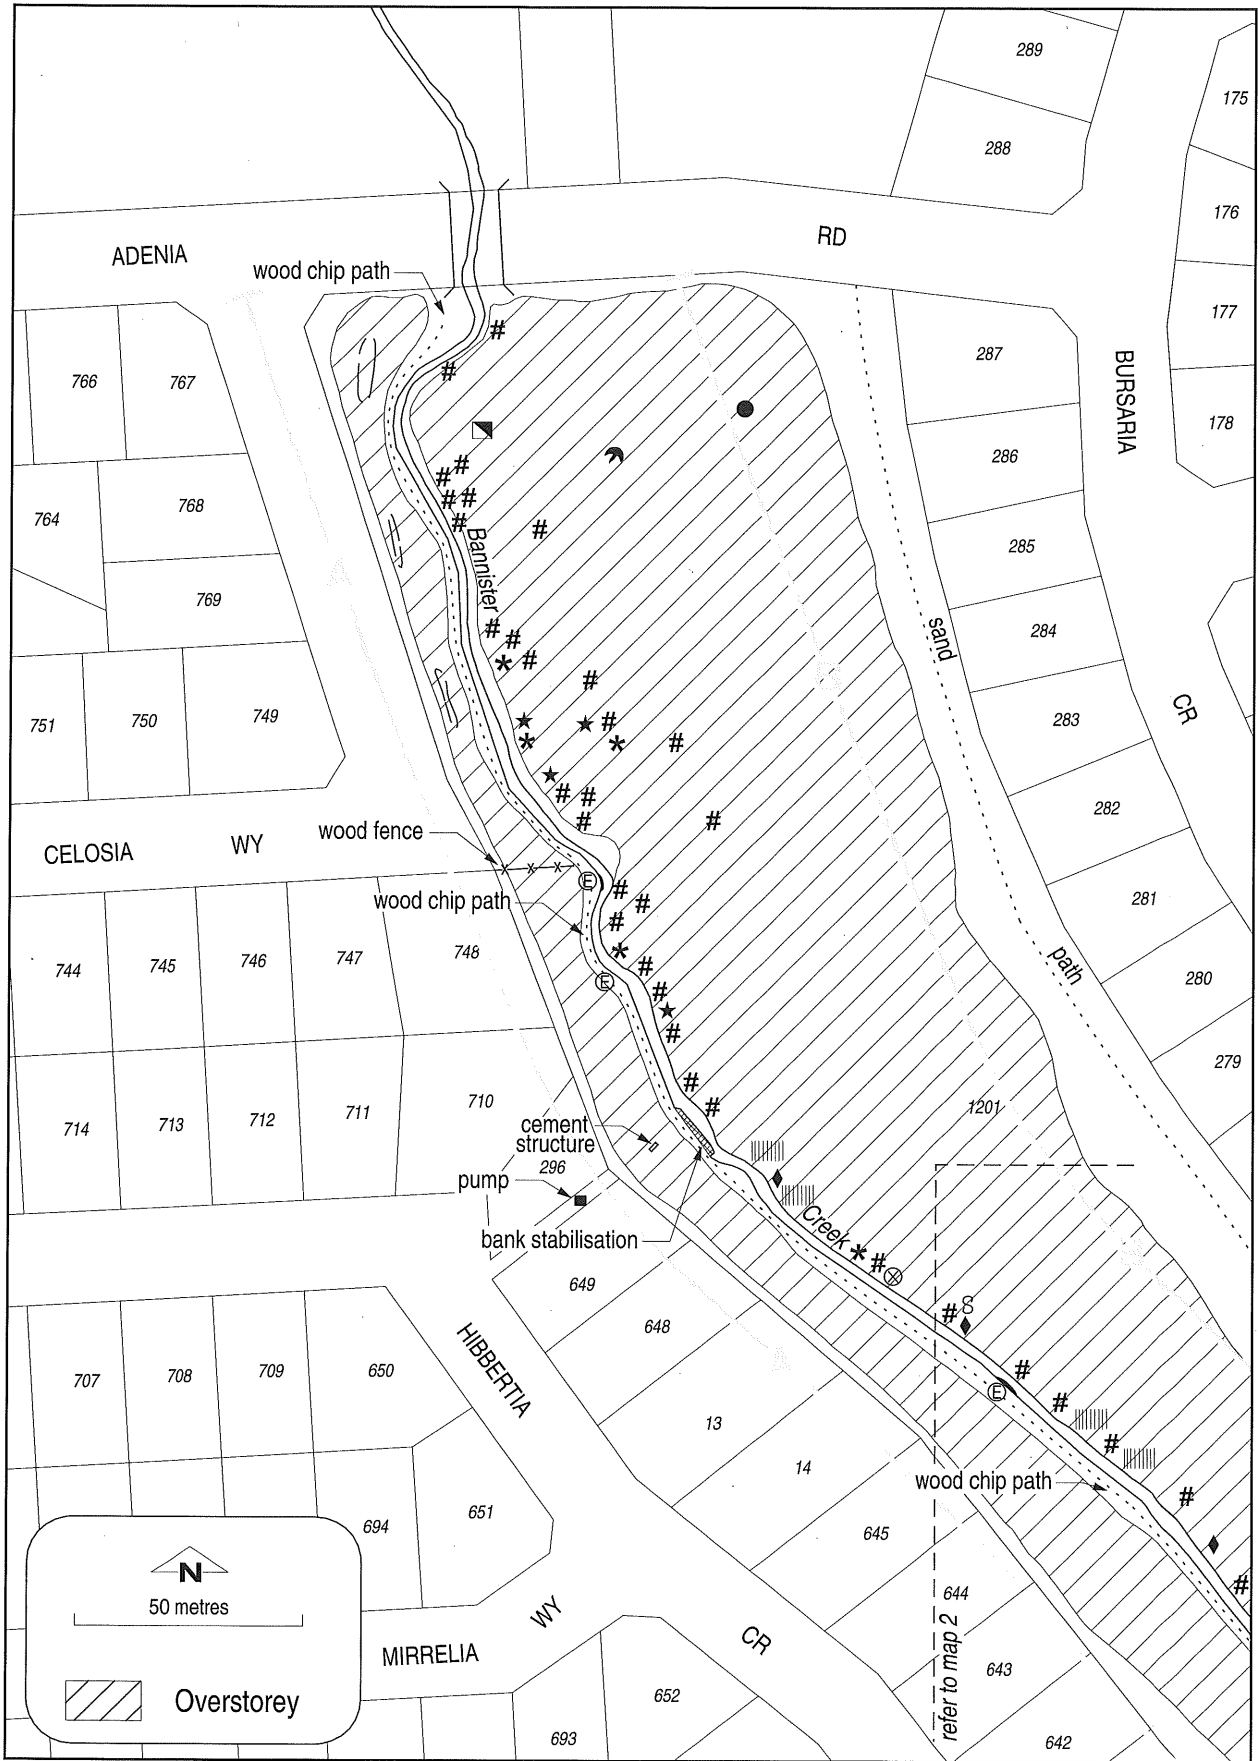
Bannister Creek Map 1

Bank Stability	Foreshore Vegetation	Stream Cover	Habitat Diversity	Stream Condition
Yellow	Red	Yellow	Red	Red
Moderate	Poor	Moderate	Poor	Poor
4	2	4	2	12

**Bank stability:** The main creek channel is 2 - 3 m wide. The left bank is lower than the right bank and rises to a height of < 1 m. Localised areas of erosion occur along 5 - 20% of the foreshore bank particularly near the base of trees growing immediately along the foreshore. Evidence of slumping and bank collapse was not observed along the foreshore area. Sedimentation is occurring along 0 - 5% of the river channel accumulating along the inside bends of the river meanders.

<ul style="list-style-type: none"> <li>• Inject herbicide into Japanese pepper and Poplars at 10 cm intervals around the truck in spring. Monitor and poison any re-growth from suckers. Remove when dead.</li> <li>• Control introduced grass species to minimise the fire hazard in the dryland areas of the reserve.</li> <li>• Maintain a buffer adjacent to the streamline until instant replacement of native plants following weed removal is possible. Alternatively clear in nodes along the foreshore and use stabilization methods to ensure bank stability while planted seedlings establish.</li> </ul>
<ul style="list-style-type: none"> <li>• Maintain continuous tracts of vegetation through reserves to provide shelter and a corridor for fauna passage.</li> <li>• Remove Blackberry in sections and replace immediately with dense plantings of understorey rushes to reduce the level of re-invasion, provide instream cover and ensure bank stabilization.</li> </ul>

<ul style="list-style-type: none"> <li>• Liaise with Water Corporation and Water and Rivers Commission to monitor water quality.</li> <li>• Implement Draft Bannister Creek Reserve Management Plan recommendations to improve water quality.</li> <li>• Liaise with Water Corporation to obtain agreement to leave branches and vegetation within creek where it does not represent a threat to bank stability.</li> <li>• Increase vegetation establishment after weed control to improve cover on stream banks.</li> </ul>

- Stabilise the sand track adjacent to the housing area by mulching.
- Increase awareness amongst local residents about the impacts of dumping lawn clippings, garden refuse and general waste on the reserve.

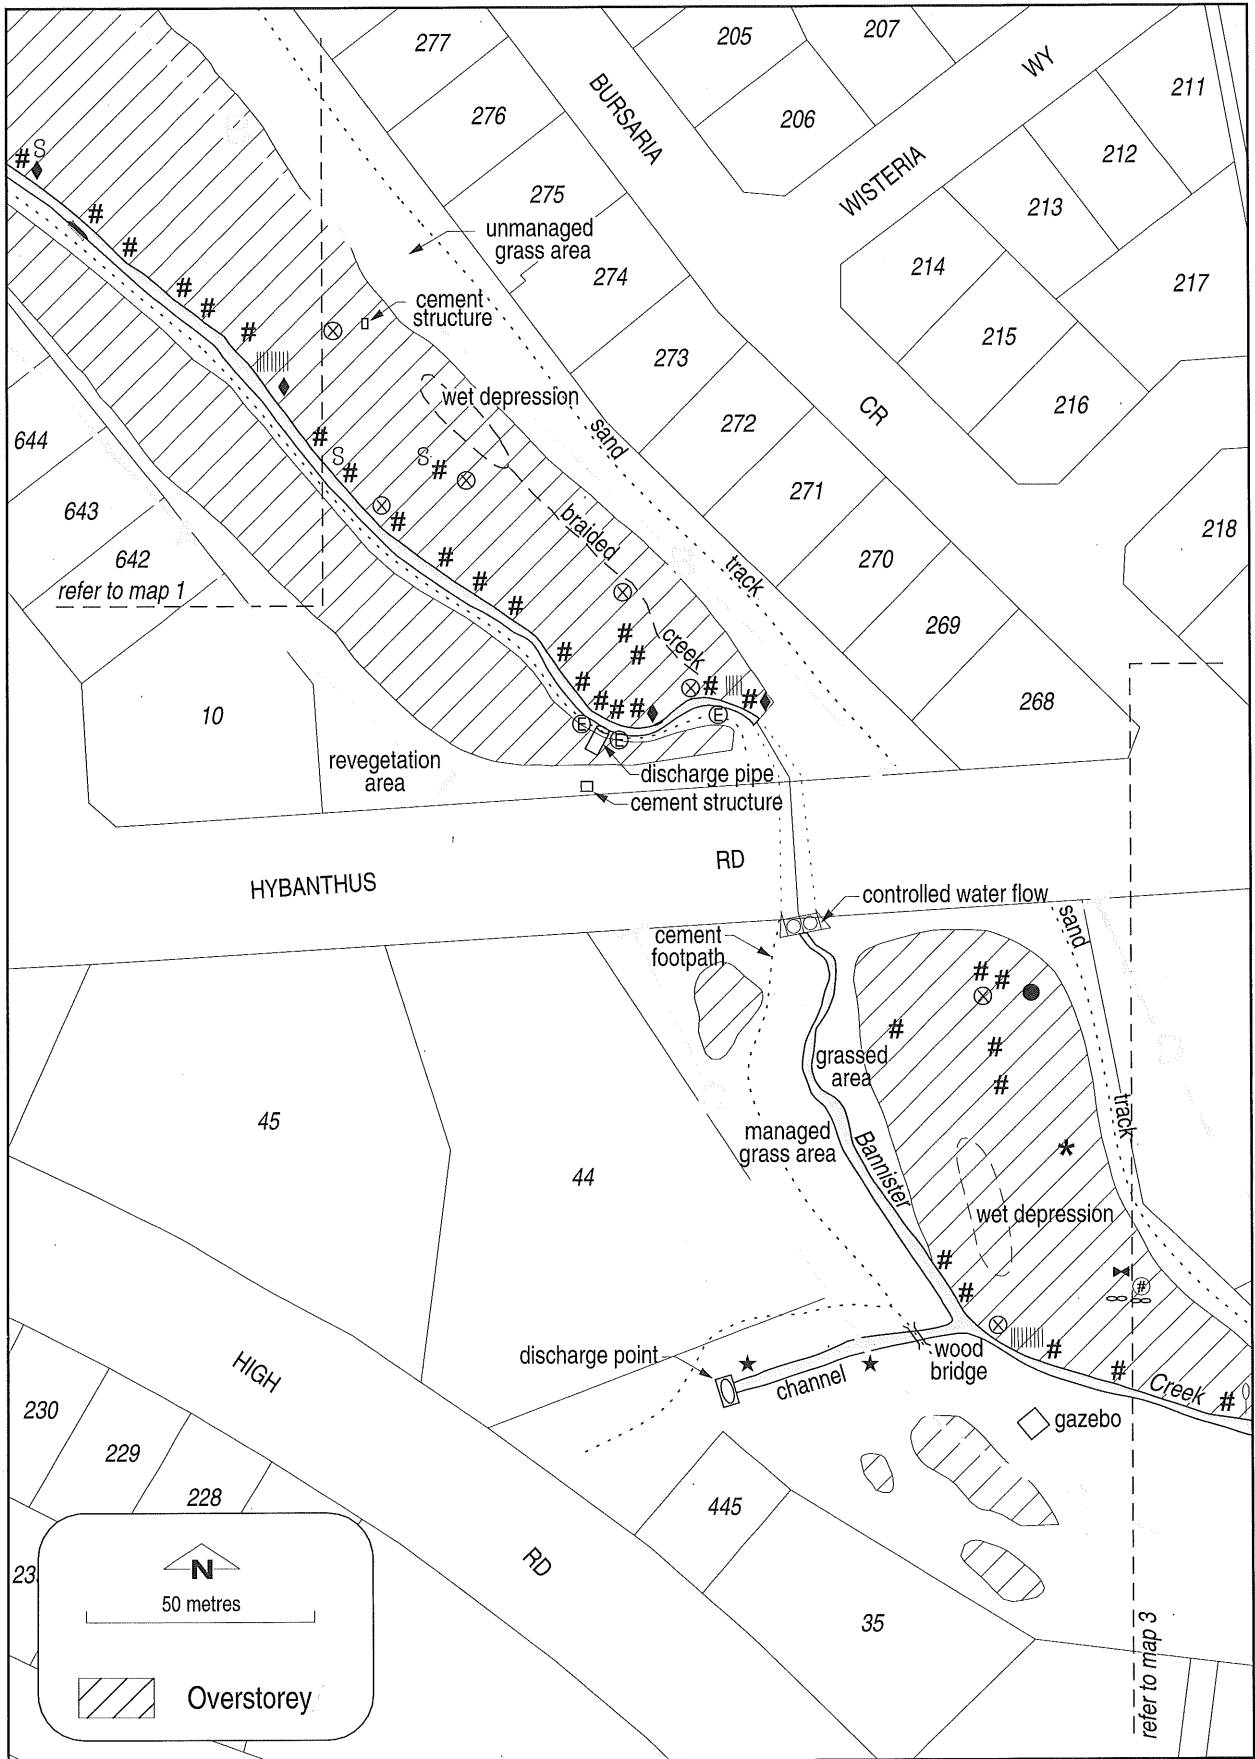
Bannister Creek Map 2

Bank Stability	Foreshore Vegetation	Stream Cover	Habitat Diversity	Stream Condition
Red	Black	Black	Black	<b>Black</b>
Poor	Very Poor	Very Poor	Very Poor	<b>Very Poor</b>
2	0	0	0	2

<p><b>Other issues:</b> This is a high use recreational area with open lawns, established walkways and a Gazebo. Also discharge pipes increase potential for erosion damage and hydrological disturbance.</p>	<ul style="list-style-type: none"> <li>• Assess level of recreational use and main activities undertaken in park.</li> <li>• Determine practicality of establishing dense, low vegetation immediately adjacent to the Creek with a clearly defined barrier between lawn and revegetation zones.</li> <li>• Assess the need for information signs about the reserve, the Creek and the works being undertaken to improve the level of awareness within the community.</li> </ul>

Bank Stability	Foreshore Vegetation	Stream Cover	Habitat Diversity	Stream Condition
Yellow	Red	Yellow	Red	<b>Red</b>
Moderate	Poor	Moderate	Poor	<b>Poor</b>
4	2	4	2	<b>12</b>

- Ensure the impact on bank stability is considered when undertaking weed control activities.
- Remove dense Blackberry weeds in nodes and immediately replace with deep rooting middlestorey and understorey species recommended in Appendix 3.
- Determine if erosion control devices are required while vegetation re-establishes.

- Stabilise access track by mulching.
- Control any introduced grasses or annual species established along the track to minimise the fire hazard to the reserve.

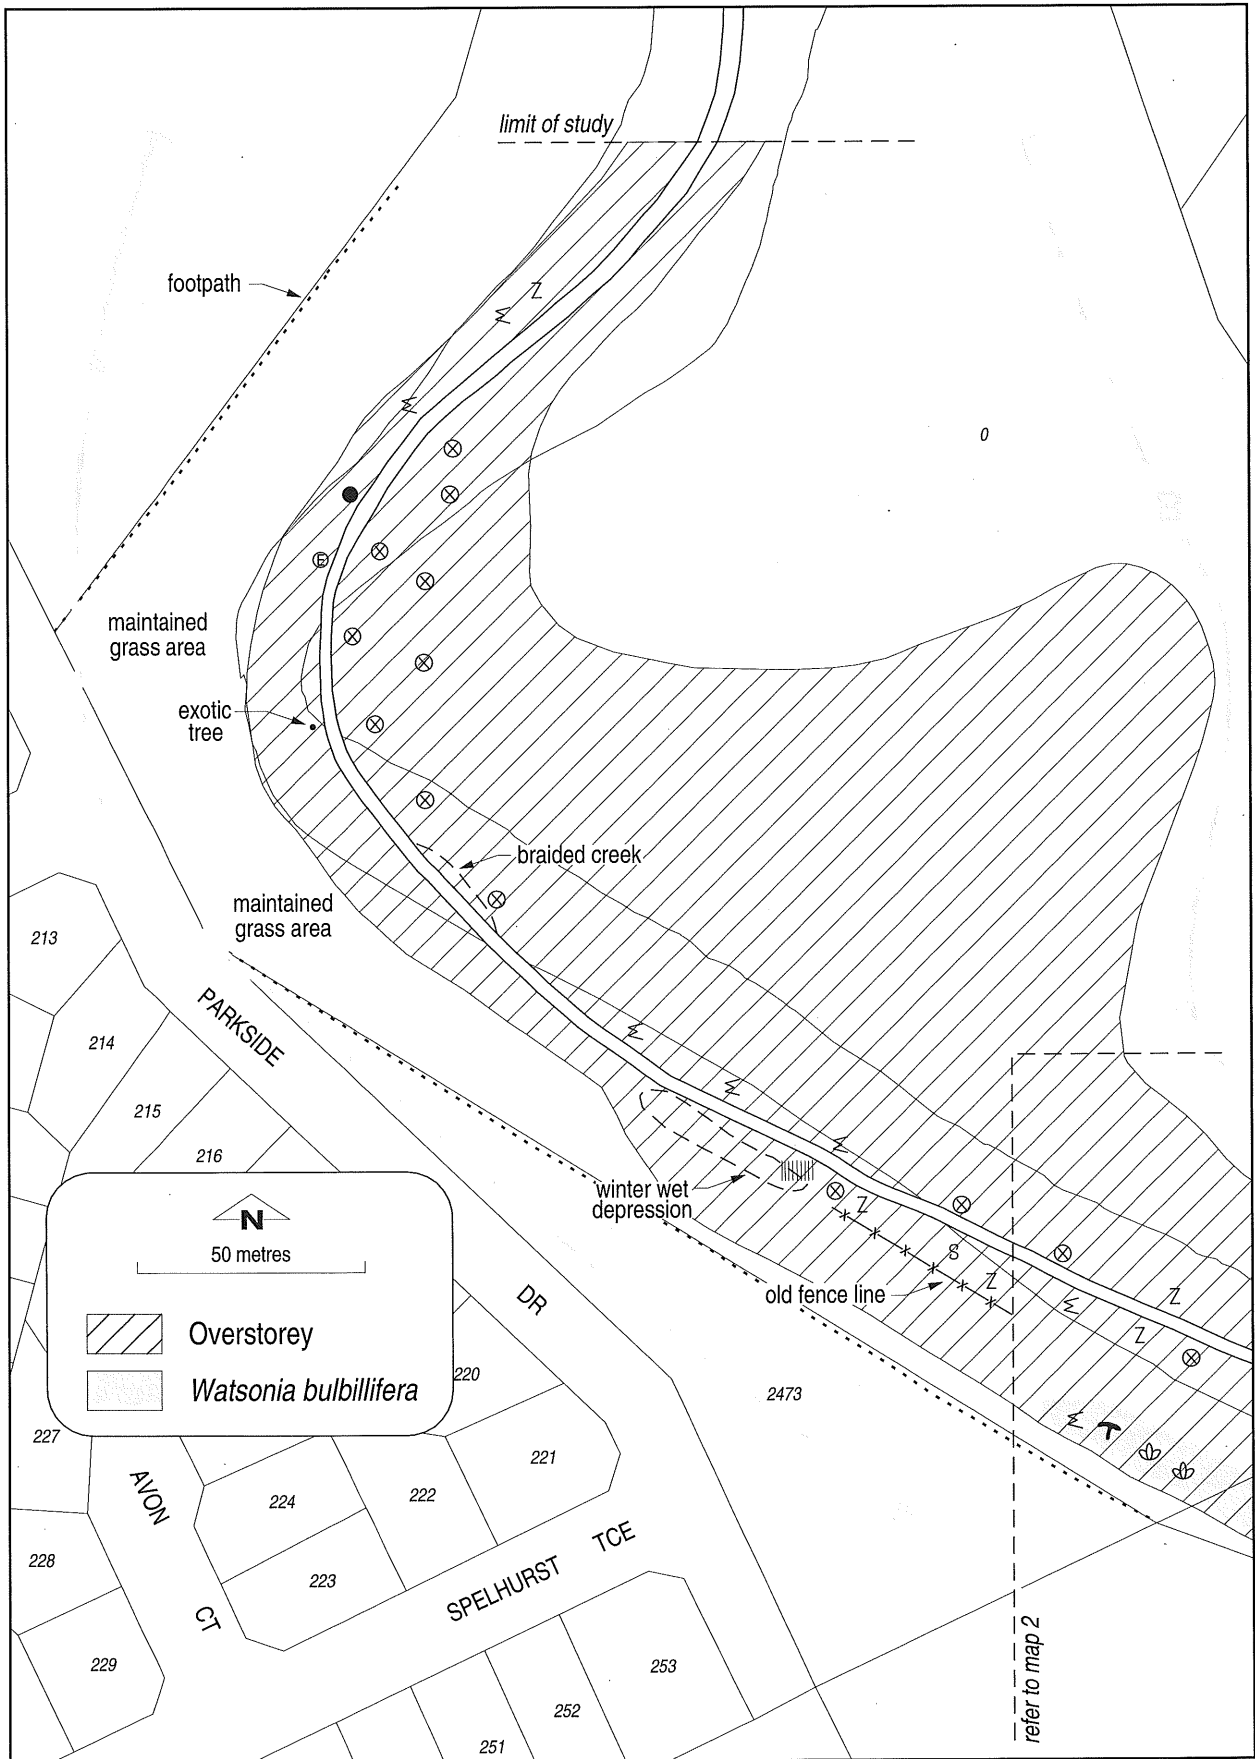
Canning River Map 1

Bank Stability	Foreshore Vegetation	Stream Cover	Habitat Diversity	Stream Condition
Yellow	Red	Yellow	Red	<b>Red</b>
Moderate	Poor	Moderate	Poor	<b>Poor</b>
4	2	4	2	<b>12</b>

<p><b>Stream Cover:</b> Native vegetation overhangs the main river channel providing intermittent patches of permanent shade. The presence of infrequent logs and branches and large rocks provides occasional instream cover.</p>	<ul style="list-style-type: none"> <li>• Focus weed control to manageable nodes and replace plants immediately with deep rooted native understorey and middlestorey species.</li> <li>• Liaise with the Water Corporation to obtain an agreement to leave branches and vegetation within the river where it does not exacerbate erosion along the foreshore.</li> <li>• Assess opportunities to create a riffle zone to slow water movement and provide greater instream cover.</li> </ul>
<p><b>Habitat diversity:</b> Water is permanent as a result of artificial maintenance and light brown in colour due to the presence of tannins leached from vegetation detritus. There is little suspended material in the water column. The river channel varies in depth from &lt; 0.1 to &lt; 1.5 m. There are infrequent instream logs limiting potential substrates for aquatic invertebrates and basking sites for turtles. The stands of weeds and overhanging streamside vegetation and litter provide a few habitats for terrestrial invertebrates and reptiles. The continuous open overstorey provides nesting and roosting sites for birds.</p>	<ul style="list-style-type: none"> <li>• Ensure weed control activities are undertaken in nodes with understorey corridors maintained to allow fauna movement.</li> <li>• Replace weeds with indigenous species (Appendix 3) within nodes, and once established continue weed control.</li> <li>• Protect instream debris to maximise habitat provision.</li> </ul>

- Ensure weed control activities do not threaten bank stability.
- Reinforce native vegetation components on banks using species recommended in Appendix 3.
