HYDROGEOLOGICAL INFORMATION FOR MANAGEMENT PLANNING IN THE ELLEN BROOK CATCHMENT

R. A. Smith and R. Shams
Water and Rivers Commission

WATER AND RIVERS COMMISSION
SALINITY AND LAND USE IMPACTS SERIES
REPORT NO. SLUI 11
SEPTEMBER 2002

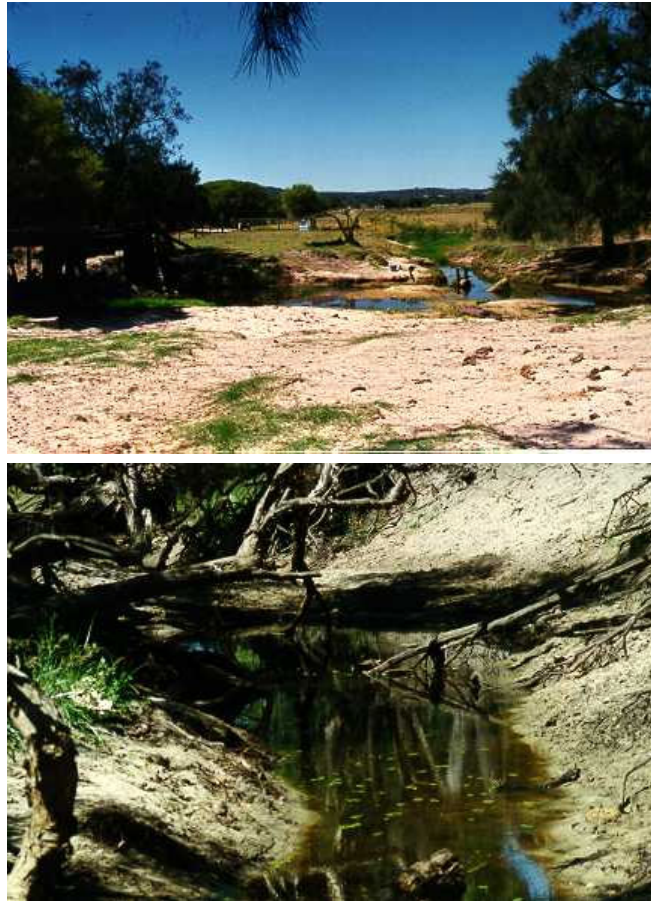
Figure 5. Pool in the Ellen Brook channel, March 2000
