Margaret River Action Plan

2003

Prepared for the Cape to Cape Catchments Group

Genevieve Hanran-Smith

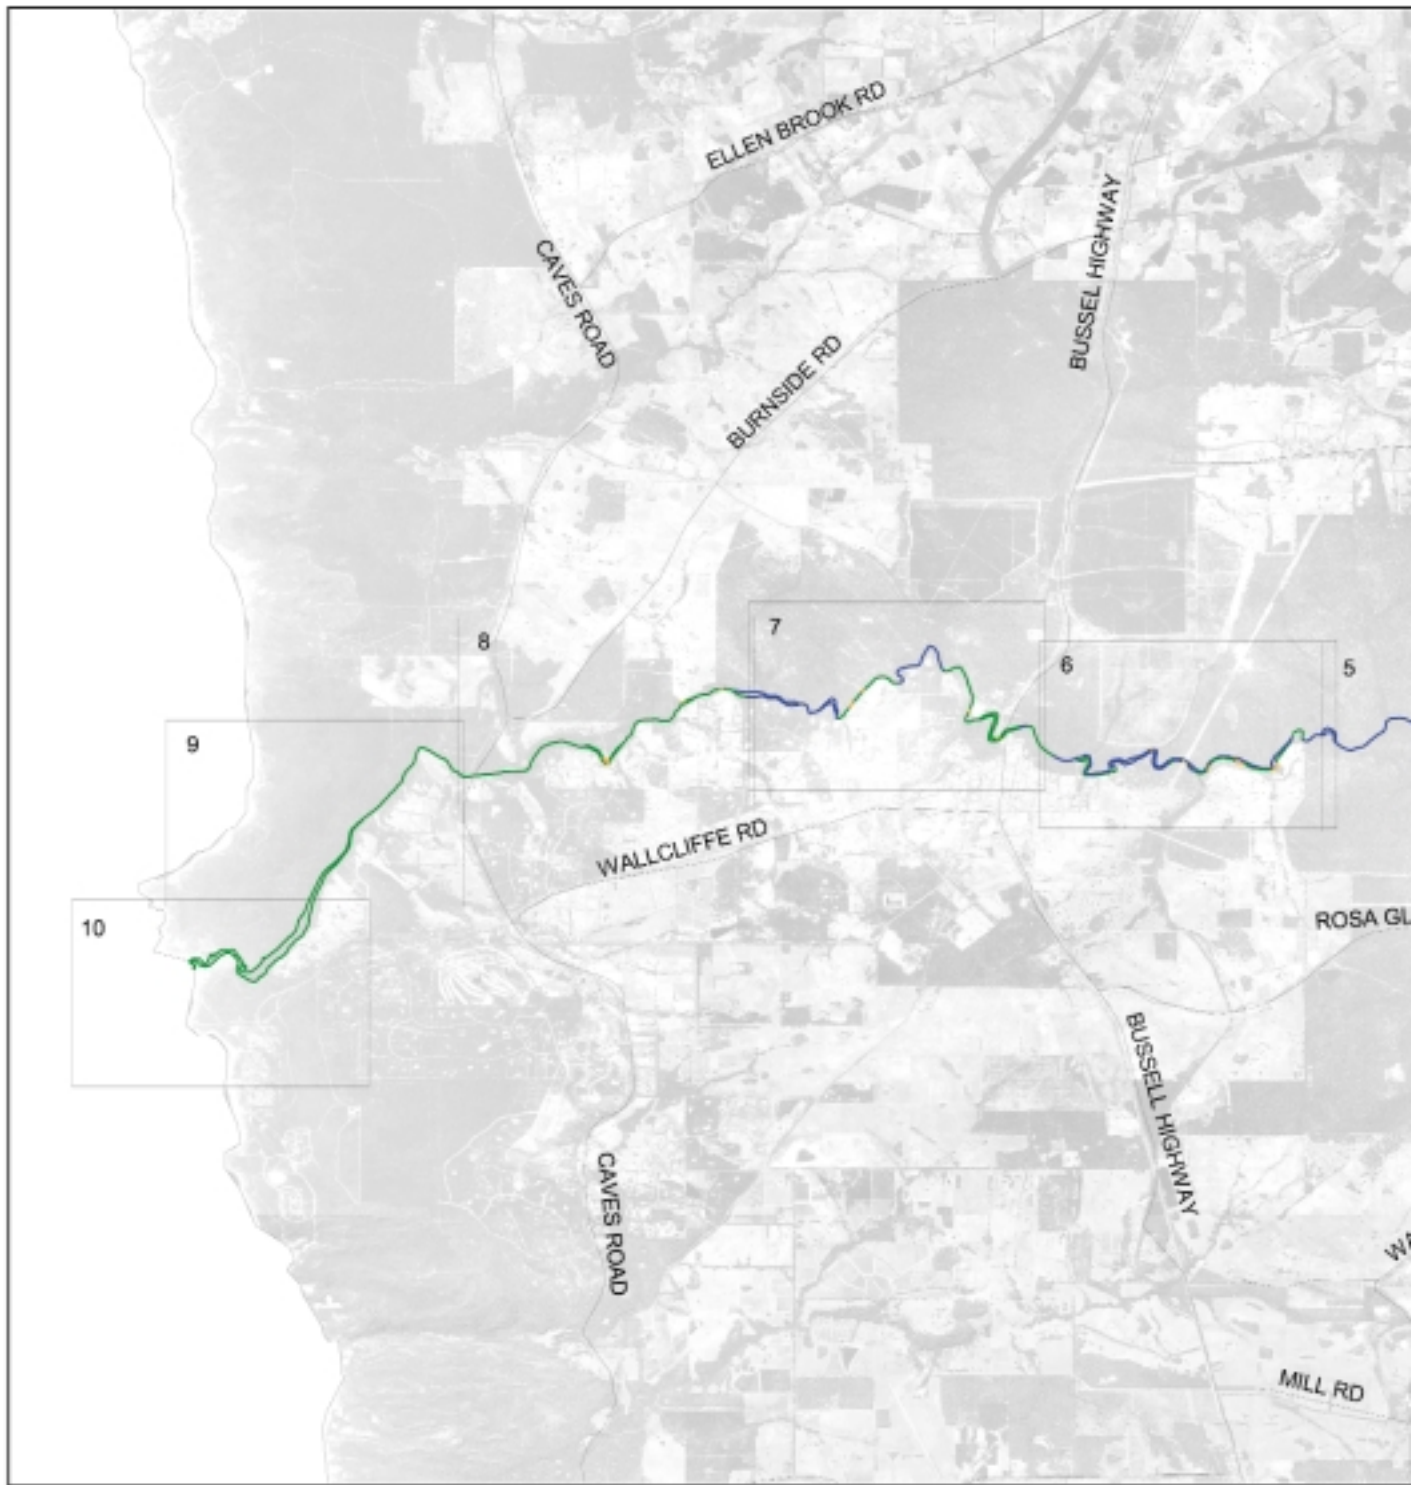
Figure 11: Index map

Figure 11 uses colour codes to show the foreshore conditions of the whole river system. It also provides an index to assist with locating specific sections of river.
