River Action Plan for the Cape Naturaliste Streams

Jingarmup Brook, Meelup Brook,
Dolugup Brook, Dandatup Brook
and Dugulup Brook

Prepared for the Geographe Catchment Council

Kirrily White, trading as Naturaliste Environmental Services

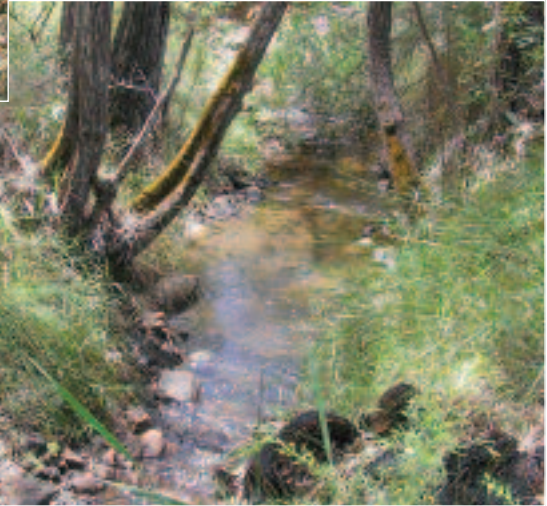
B) A2 Grade foreshore on the Meelup Brook. Fringing vegetation provides back support, shade and leaf litter while a riffle oxygenates the water (Photo by Don Hanran-Smith).

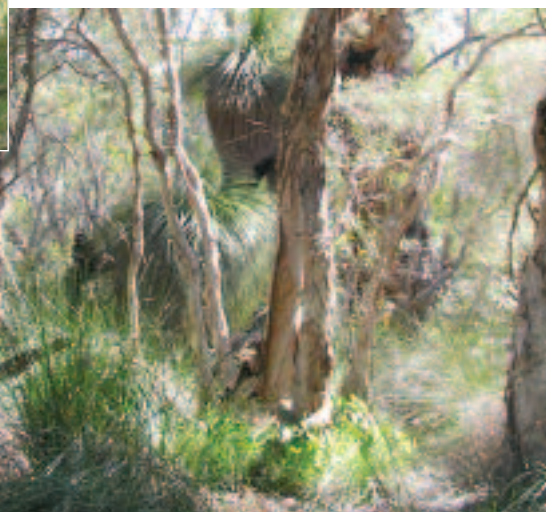
D) B1 Foreshore on the Dandatup Brook. The Melaleucas and native rushes and sedges remain dominant but arum lilies have invaded the understorey.

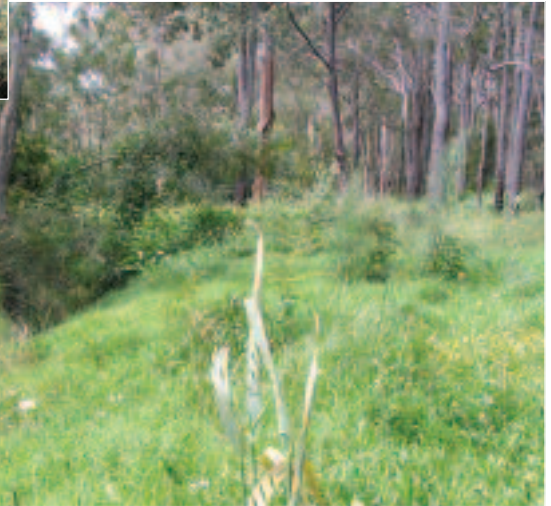
F) C1 Foreshore on the Dugulup Brook.
Grasses dominate the foreshore and while there are a few trees, there is no sign of regeneration.

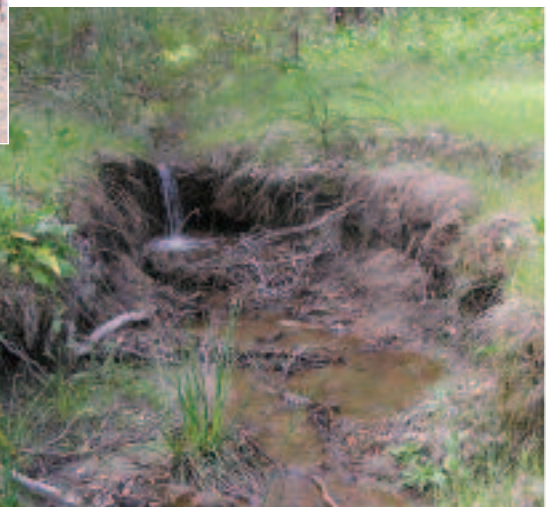
H) C3 grade foreshore on the Dandatup Brook.
Native vegetation is absent and erosion is active with a head shown here migrating upstream.
