# River Action Plan for the Sabina, Abba and Ludlow Rivers

Volume 2. Maps and Recommendations for Abba River

2002

Prepared for the Geographe Catchment Council - GeoCatch  
and the Vasse-Wonnerup Land Conservation District Committee

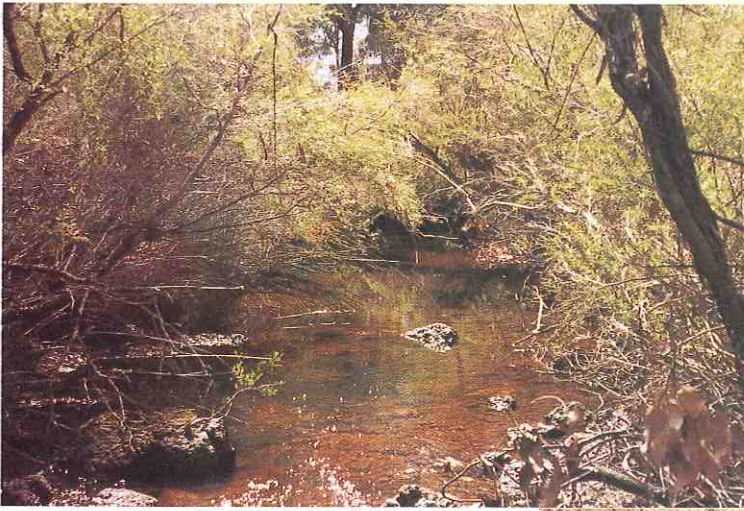
*A2 grade foreshore on the upper Sabina River. Native fringing vegetation protects the banks from erosion and traps sediment and organic material before it reaches the river*

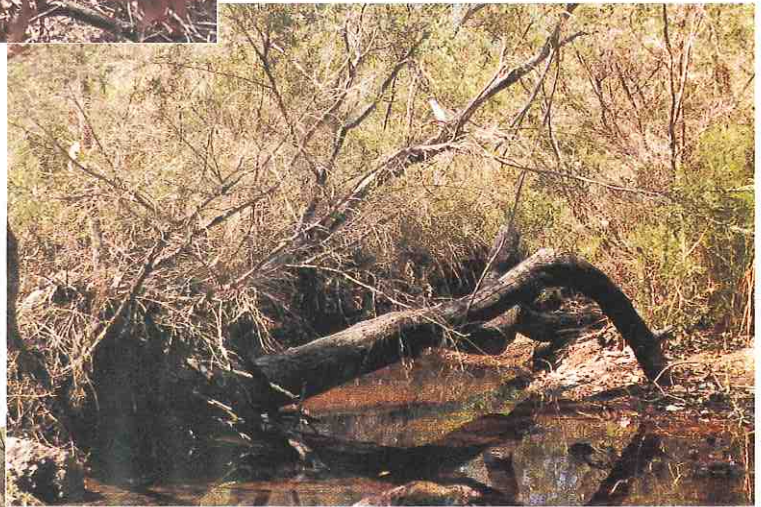
*A2 grade foreshore on the upper Sabina River. Fringing vegetation shades the water, providing a cooler environment for aquatic fauna and limiting algal growth.*

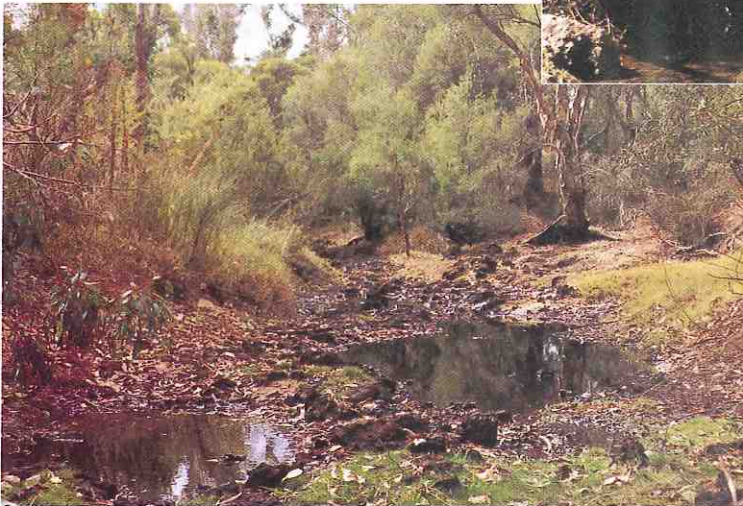
*B1 grade foreshore on the Ludlow River. Weeds, mainly grasses, have become a significant component of the understorey vegetation.*

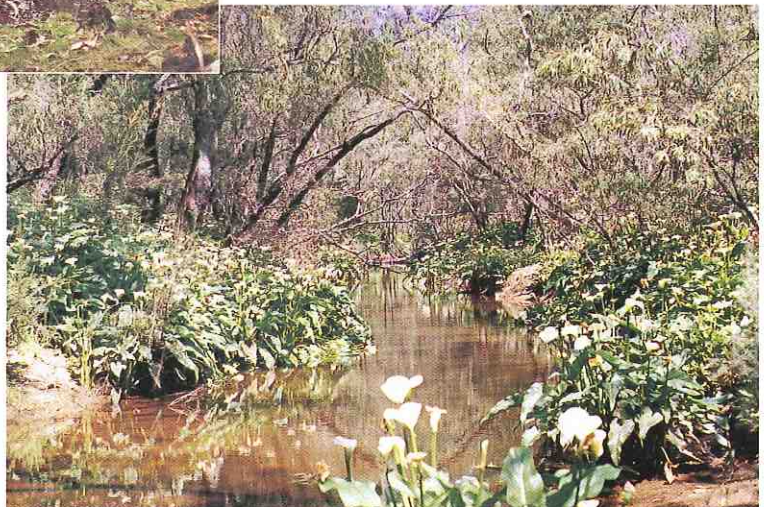
*B3 grade foreshore on the Abba River. Weeds dominate the understorey, restricting the regeneration of native species.*

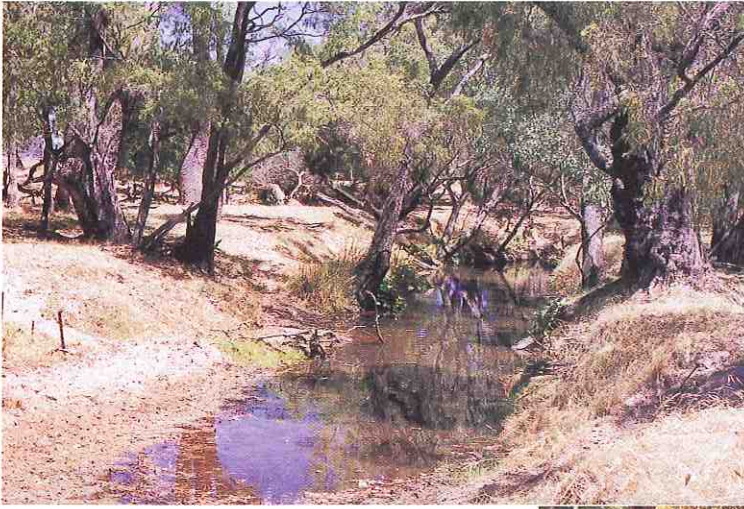
*C1-C2 grade foreshore on the Sabina River. Trees remain though there is little evidence of regeneration. The shallow-rooted weedy understorey provides no support to the soil, making the banks vulnerable to erosion.*

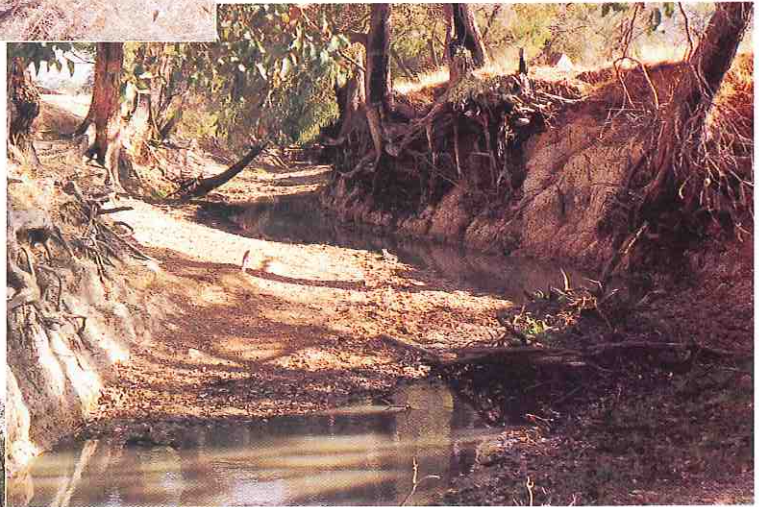
*C3 foreshore on the Sabina River. Soil is being washed away from between tree roots and the undermined trees are at risk of falling into the river. This will cause ongoing erosion problems.*

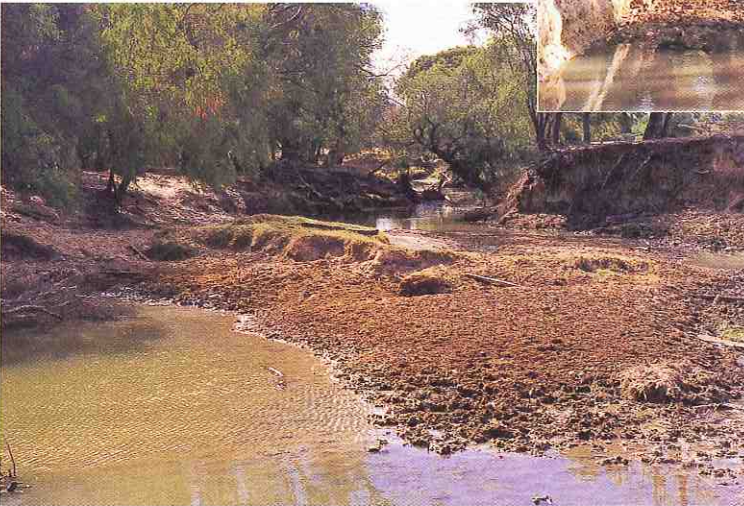
*D1-D2 grade foreshore on the Abba River. Large deposits of sediment are accumulating along the river and the channel is widening and eroding back into farmland. The remaining trees retard erosion in places but are doomed to be undermined eventually.*

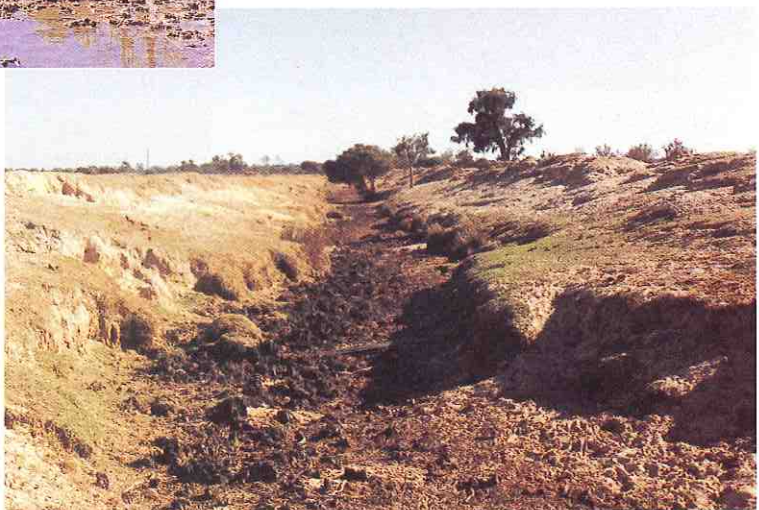
*D2 grade foreshore on the Abba River. No vegetation remains to control erosion. The sandy banks are actively eroding and contributing to the accumulation of sediment downstream.*

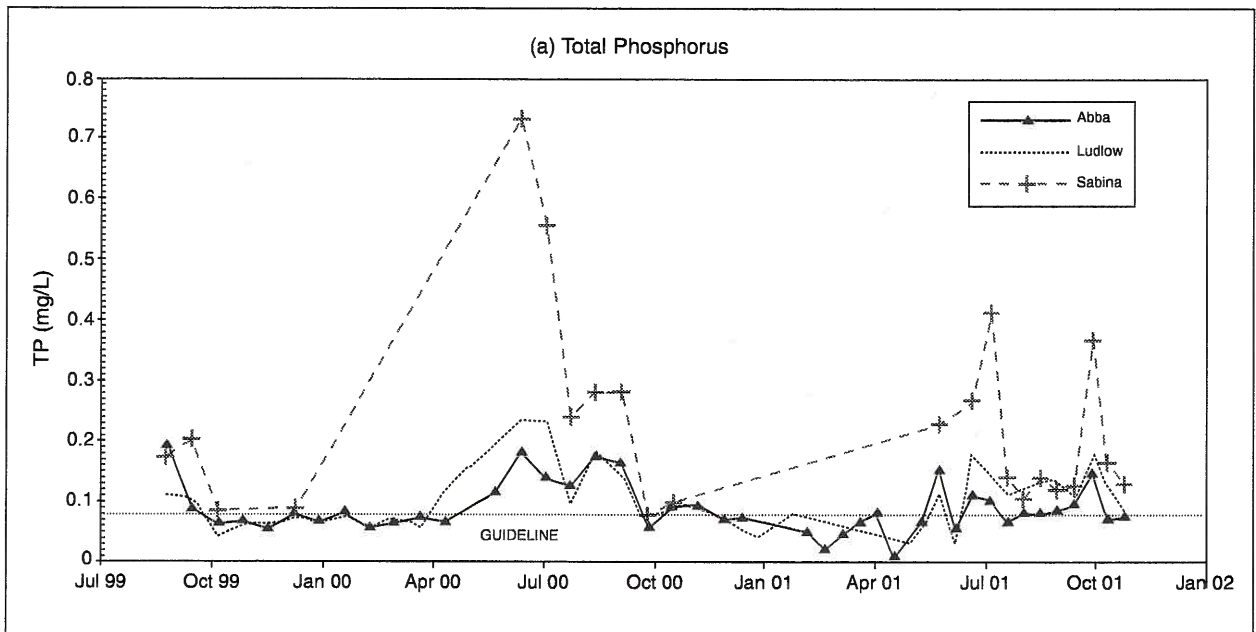
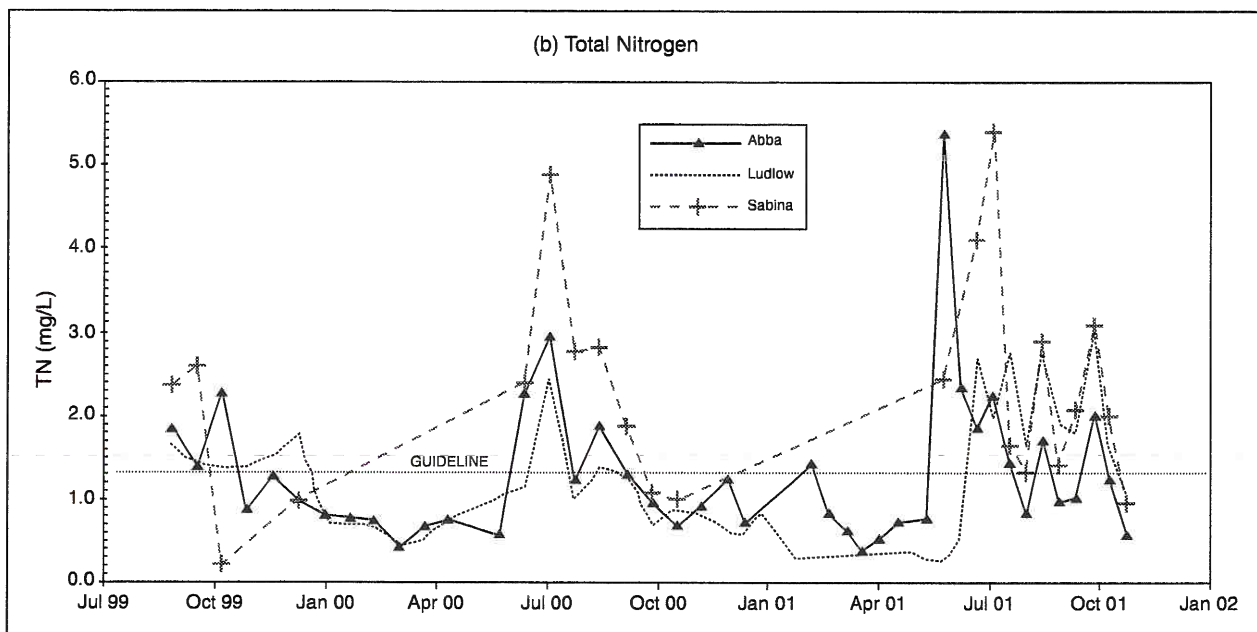
Figure 4: Total nutrient data for the Sabina, Abba and Ludlow Rivers: (a) total phosphorus; (b) total nitrogen

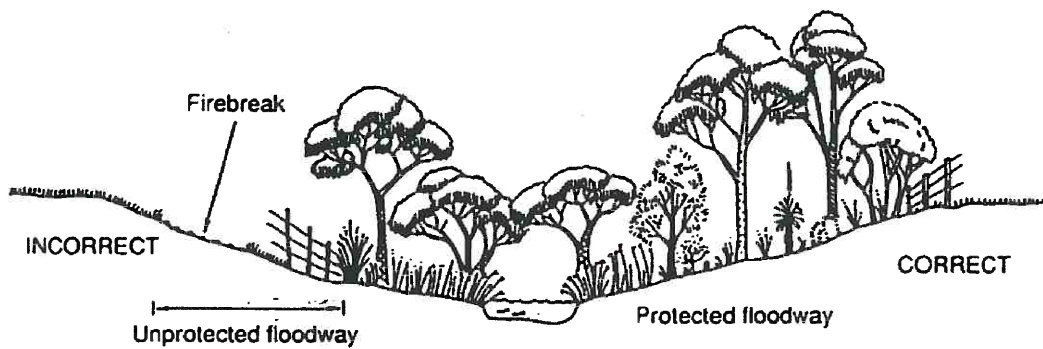
Figure 6: The correct placement of fences in relation to the river valley: (A) the deep river valley, (B) the shallow river valley and (C) the broad river valley with broad flood-plain (APACE Green Skills & Pen, 1995)

In the case of shallow river valleys, there is little chance that embankments will subside. Nevertheless, fence-lines should be located above the river valley (Figure 4 B). This is because fences and firebreaks located within the river valley will be damaged and eroded by floodwaters. When they

If the river valley is particularly broad and floodplains have been cleared for grazing, fencing them off may mean sacrificing good farmland. In this case it is necessary that only those areas that are prone to water erosion or stock damage, such as embankments and secondary river channels which only flow strongly at times of flood, need to be fenced off (Figure 4 C). Some of these fence-lines will be prone to flood damage, but this can be minimised if fences run, as much as possible, parallel to the direction of floodwaters.
