# River Action Plan for the Sabina, Abba and Ludlow Rivers

Volume 3. Maps and Recommendations for Ludlow River and Tiger Gully

Prepared for the Geographe Catchment Council - GeoCatch  
and the Vasse-Wonnerup Land Conservation District Committee

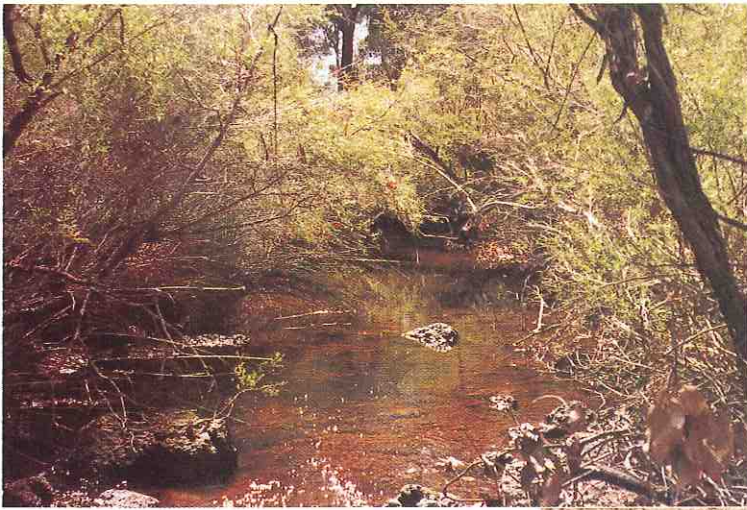
*A2 grade foreshore on the upper Sabina River. Native fringing vegetation protects the banks from erosion and traps sediment and organic material before it reaches the river*

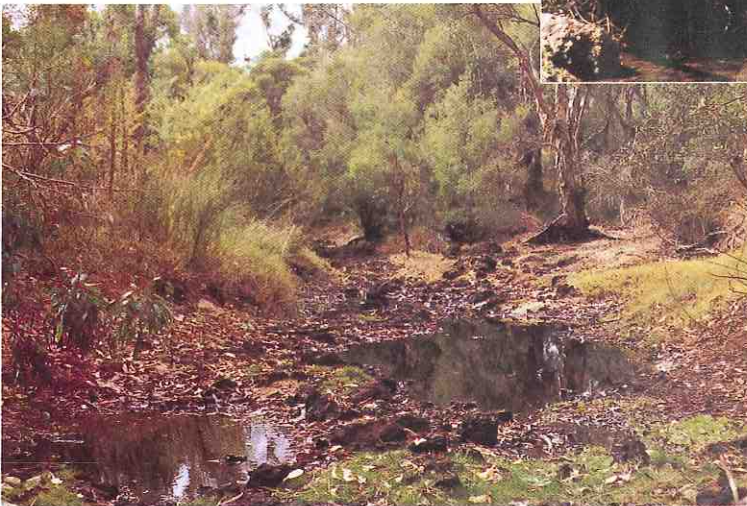
*B1 grade foreshore on the Ludlow River. Weeds, mainly grasses, have become a significant component of the understorey vegetation.*

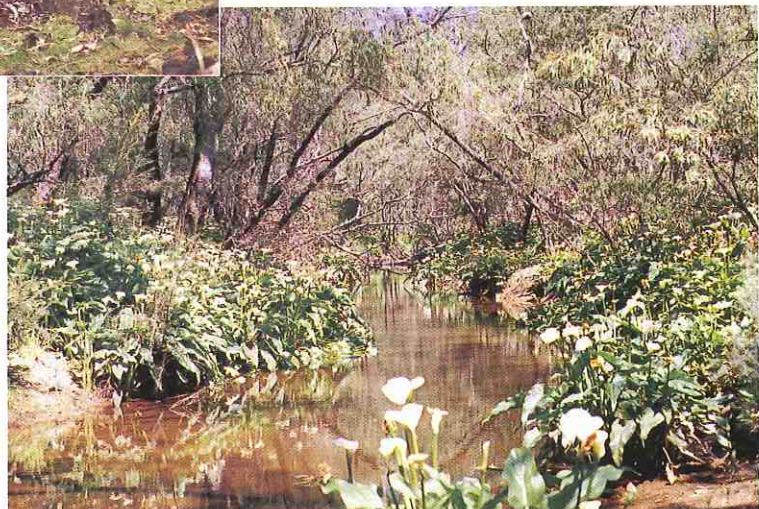
*B3 grade foreshore on the Abba River. Weeds dominate the understorey, restricting the regeneration of native species.*

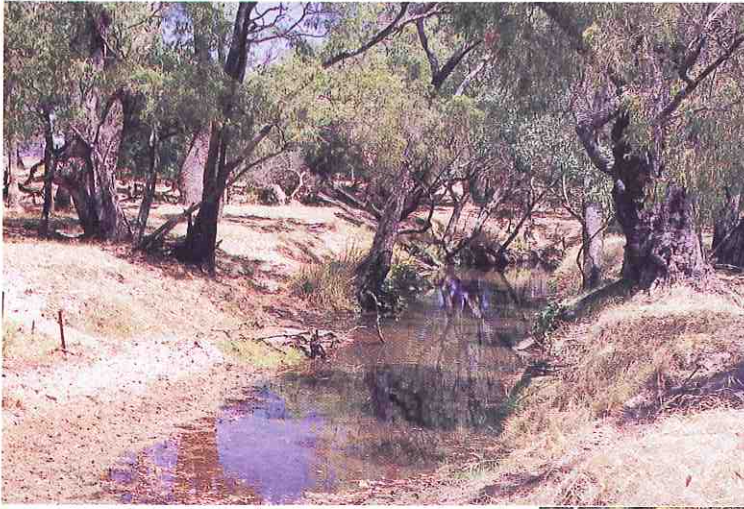
*C1-C2 grade foreshore on the Sabina River. Trees remain though there is little evidence of regeneration. The shallow-rooted weedy understorey provides no support to the soil, making the banks vulnerable to erosion.*

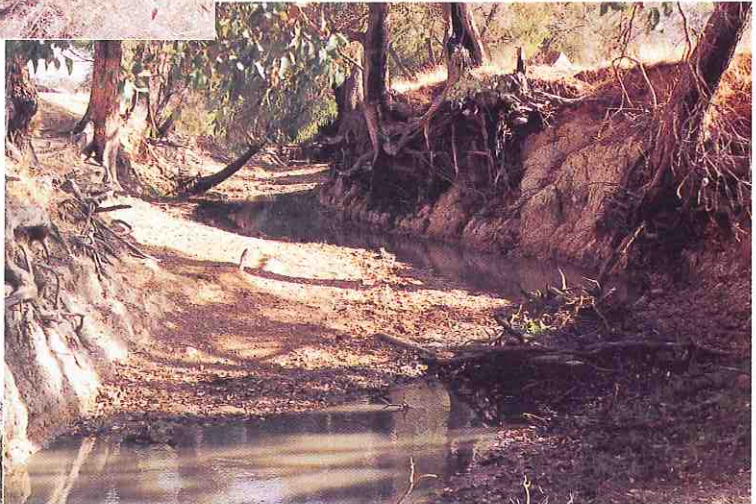
*C3 foreshore on the Sabina River. Soil is being washed away from between tree roots and the undermined trees are at risk of falling into the river. This will cause ongoing erosion problems.*

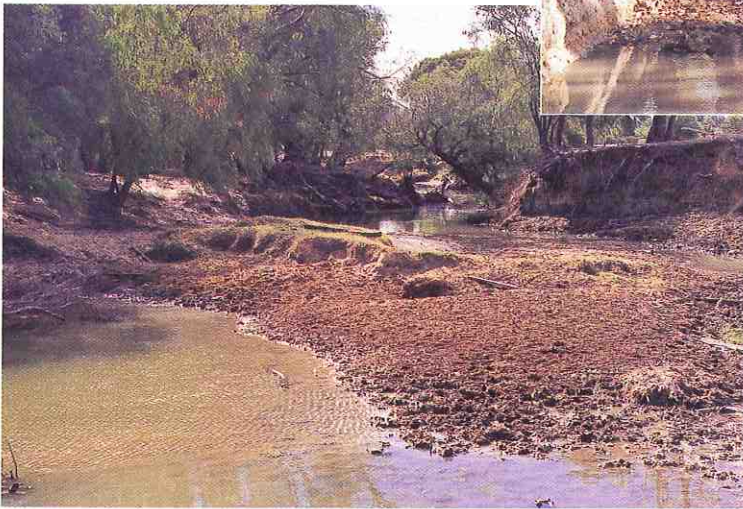
*D1-D2 grade foreshore on the Abba River. Large deposits of sediment are accumulating along the river and the channel is widening and eroding back into farmland. The remaining trees retard erosion in places but are doomed to be undermined eventually.*

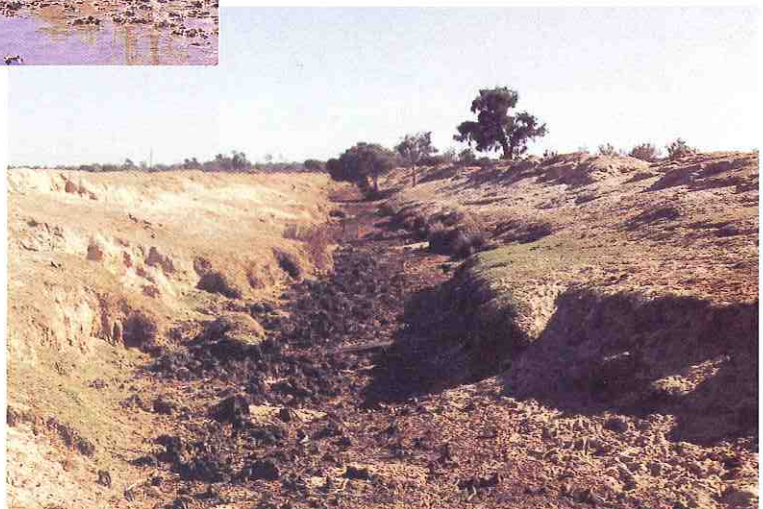
*D2 grade foreshore on the Abba River. No vegetation remains to control erosion. The sandy banks are actively eroding and contributing to the accumulation of sediment downstream.*
