AVON WATERWAYS COMMITTEE  
RIVER RECOVERY PLAN  
Sections 1 and 2 – ‘Avon Gorge’ and ‘Deepdale Valley’

prepared by  
Viv Read & Associates  
for  
Water and Rivers Commission  
and  
Avon Waterways Committee

WATER AND RIVERS COMMISSION  
RIVER RECOVERY PLAN  
REPORT No RRP 7  
AUGUST 2002

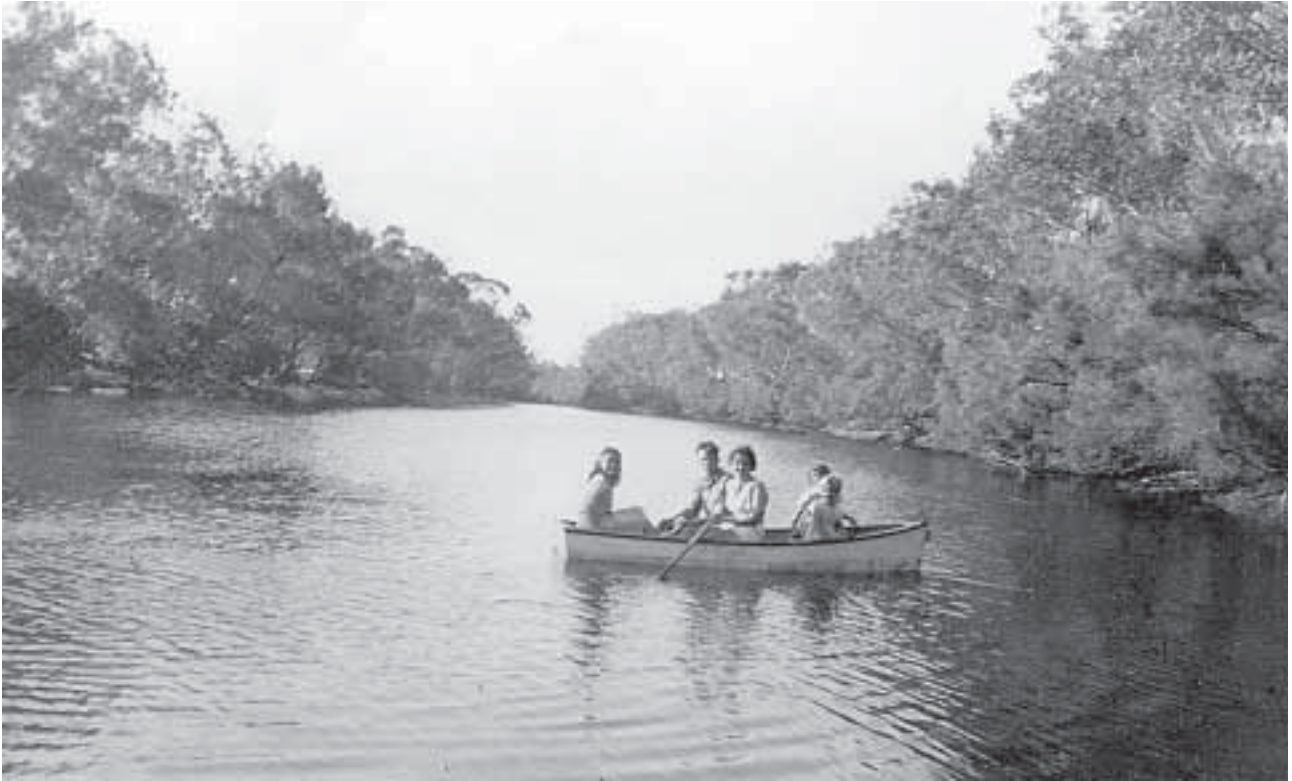
**Photo 1: Deepdale Pool, circa 1950, used for boating and swimming prior to the River Training Scheme**

**Deepdale Pool:** Prior to the River Training Scheme, Deepdale Pool was used for swimming, fishing (for cobblers and mullet) and was suitable for stock-water. The pool filled with sediments soon after the River Training Scheme was completed in this section, and surveyed as such in 1977.

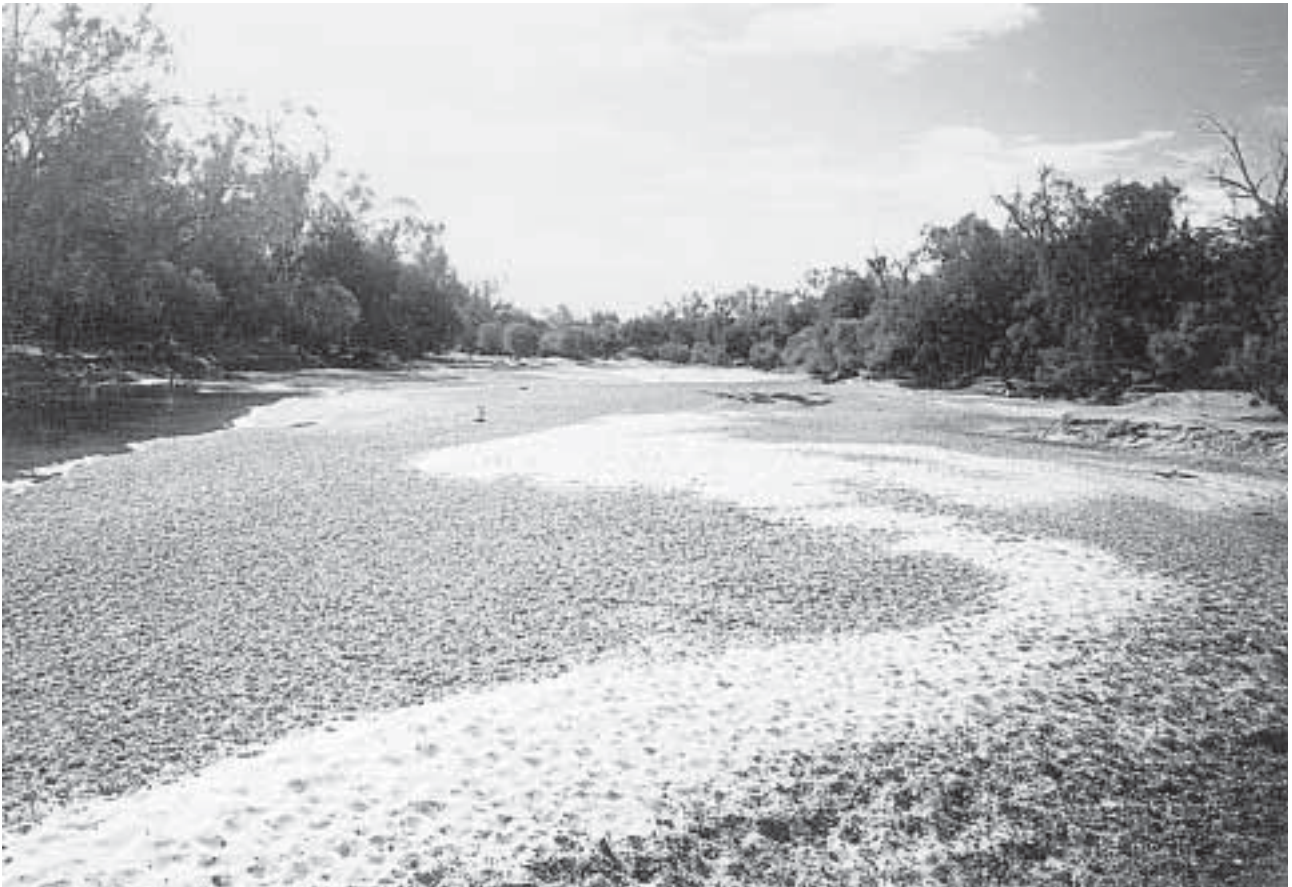
**Photo 2: Deepdale Pool filled with sediment**

The sediments in this pool are described as sand and although there has been no nutrient analysis, the sediment nutrient load can be assumed to be quite low.

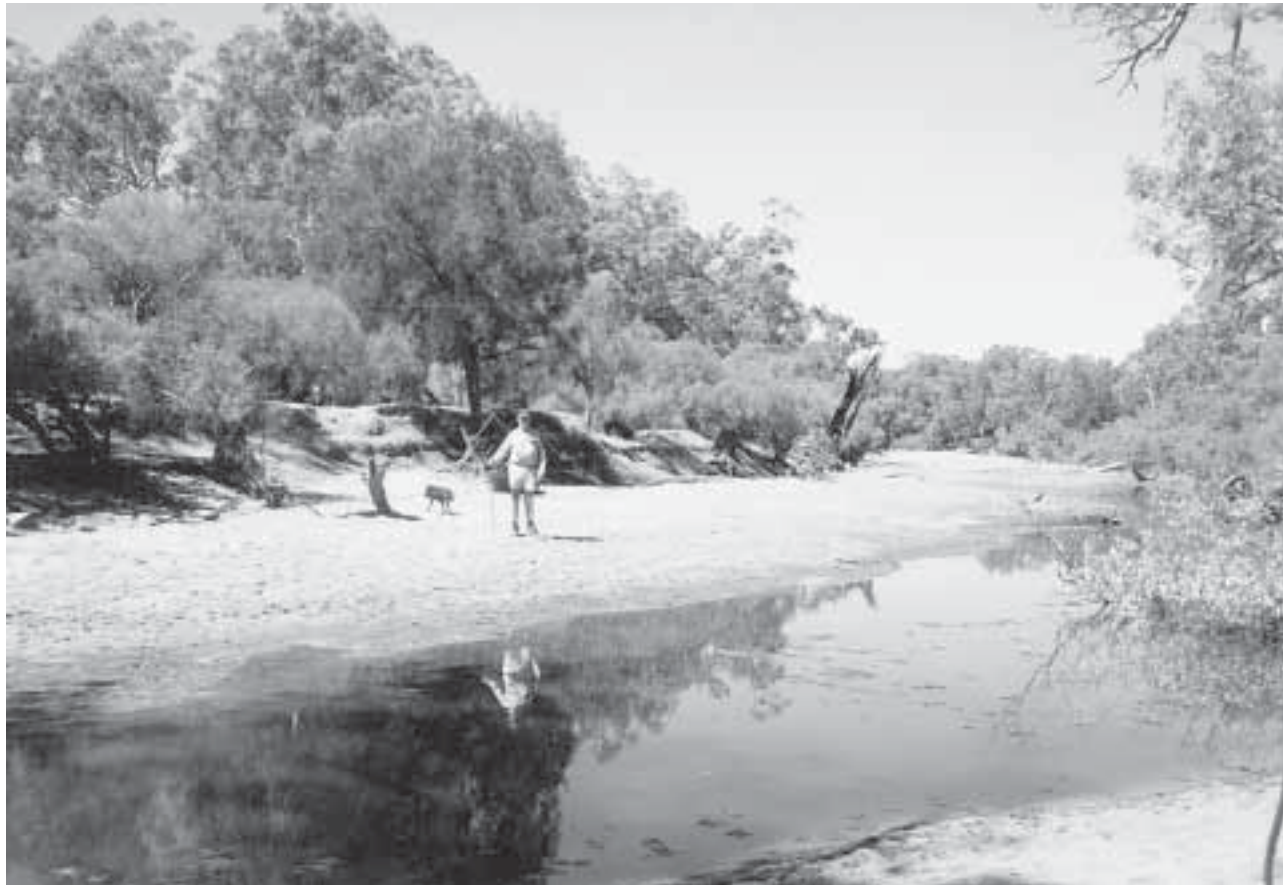
**Photo 3: Sediment in the downstream end of Jimperding Pool**

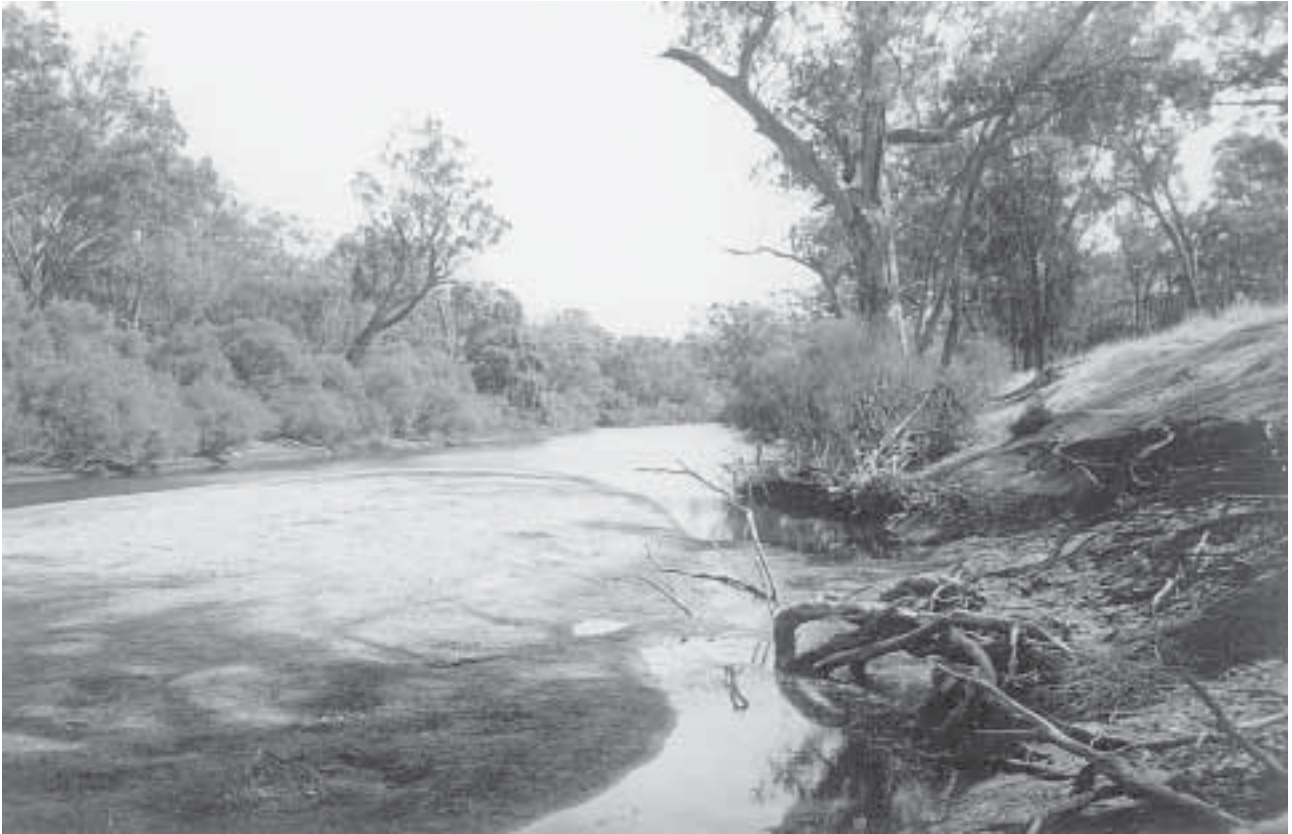
**Photo 4: Sediment infill to Long Pool**

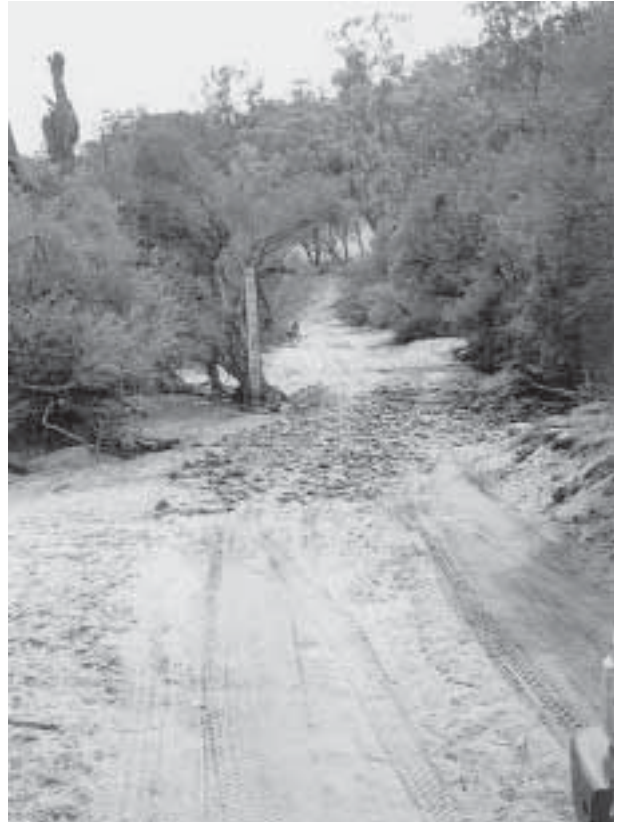
**Photo 5: River crossing for property access at the upstream end of Long Pool**

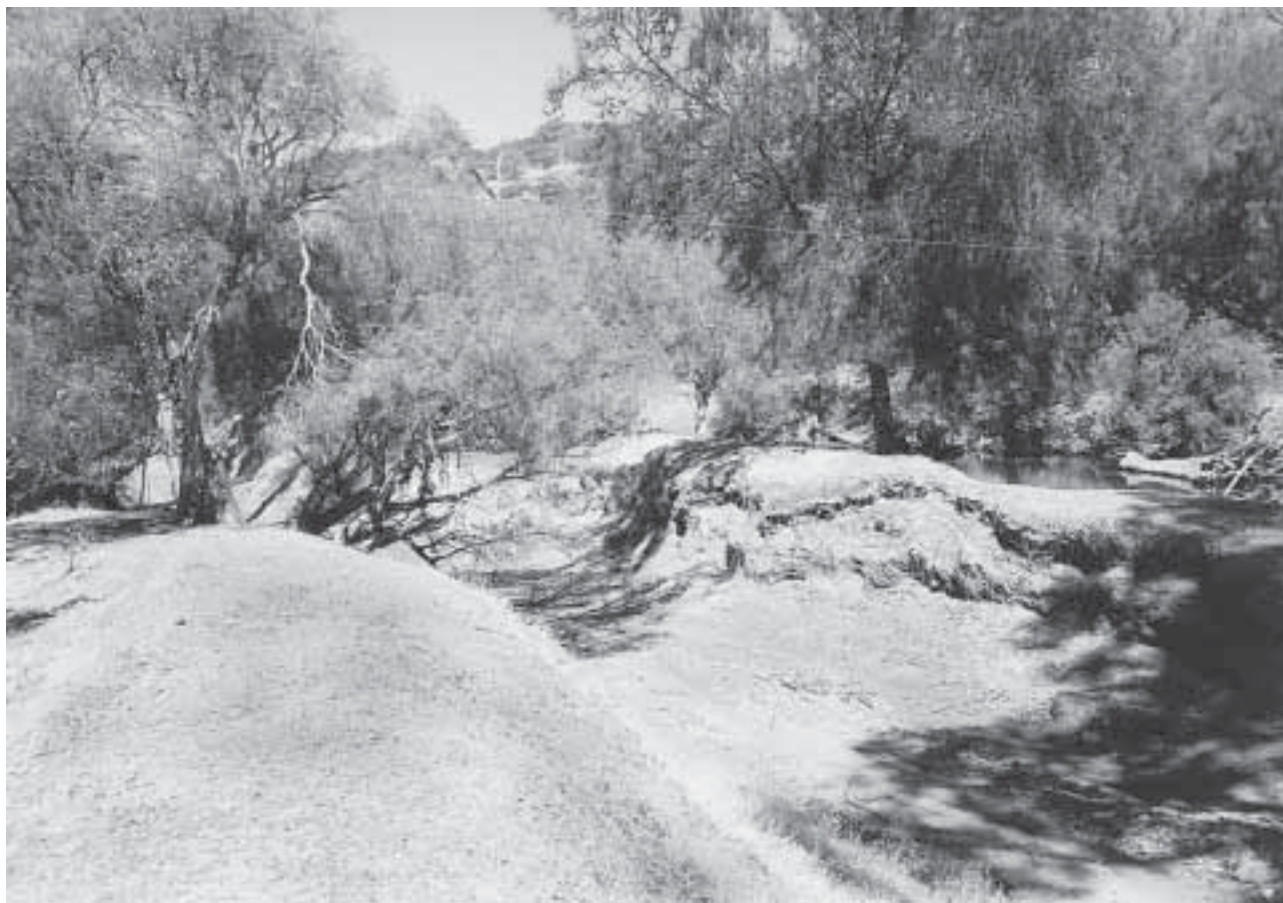
**Photo 6: Sediments trapped in the braided channel of the 'Avon Gorge' river section**
