AVON WATERWAYS COMMITTEE  
RIVER RECOVERY PLAN  
Sections 7, 8 and 9 – Mile Pool to Spencers Brook

prepared by  
Viv Read & Associates  
for  
Water and Rivers Commission  
and  
Avon Waterways Committee

WATER AND RIVERS COMMISSION  
RIVER RECOVERY PLAN  
REPORT No RRP 9  
NOVEMBER 2002

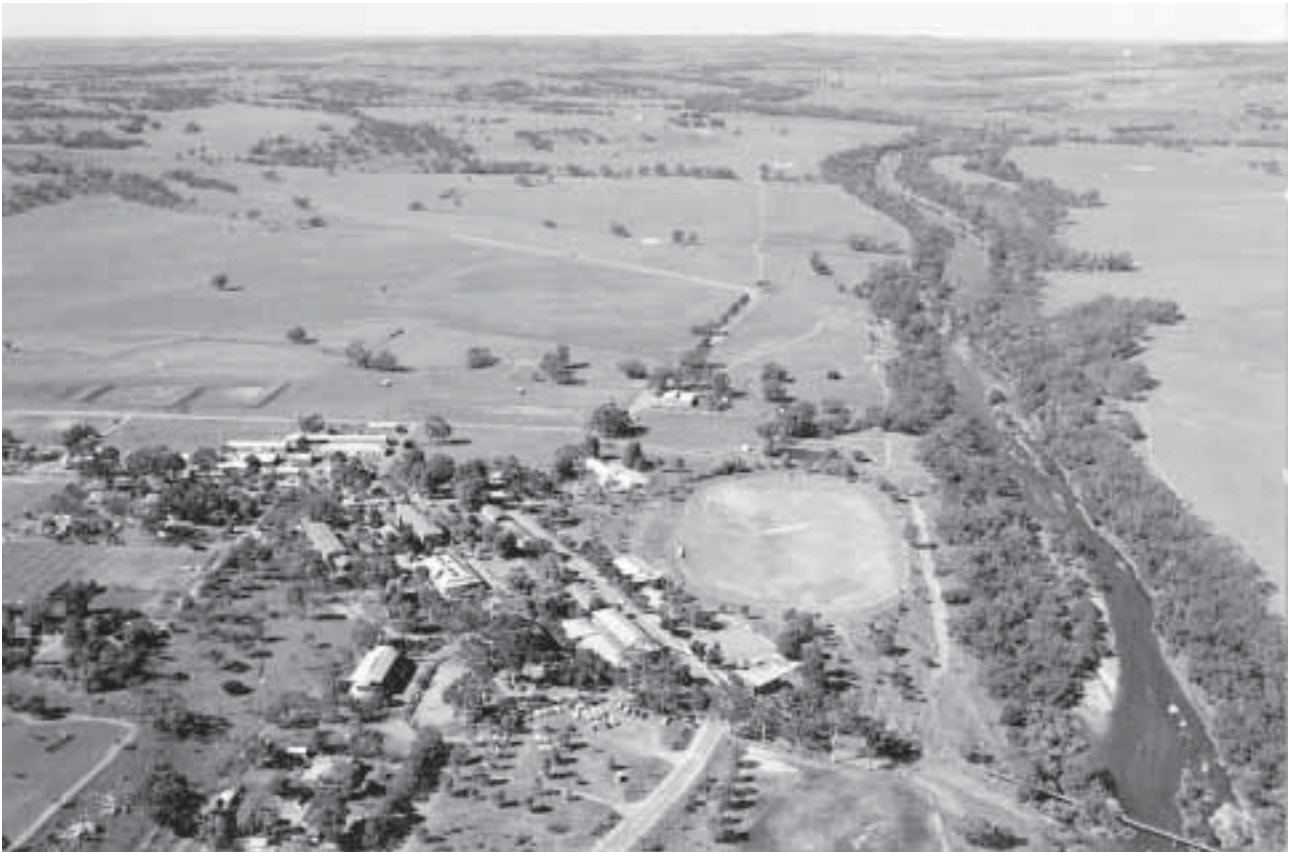
**Photo 1: Aerial view of the Avon River upstream from Muresk**

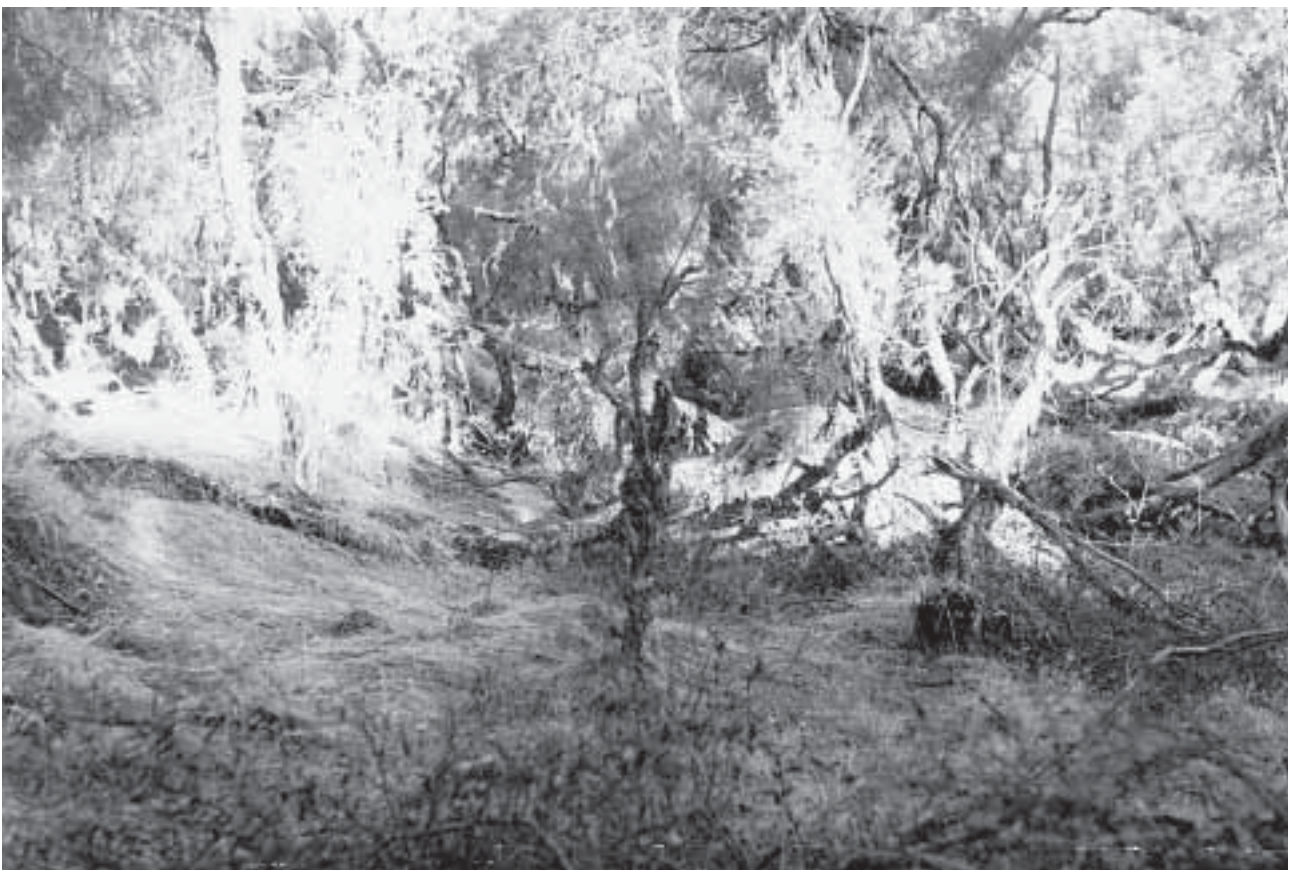
**Photo 2: Characteristics of the pre-training braided river channel**

Prior to the River Training Scheme (RTS), the river channel was braided (many intertwining channels). Training works during the 1960s converted this to a single channel approximately 60 m wide. Bulldozer action to clear the channel during the RTS has resulted in heaped spoil deposition parallel to streamflow. In places, this performs as a levee, restricting access of floodwaters to the adjacent floodplain. It also truncates some floodways and affects the discharge to the river of some tributaries.

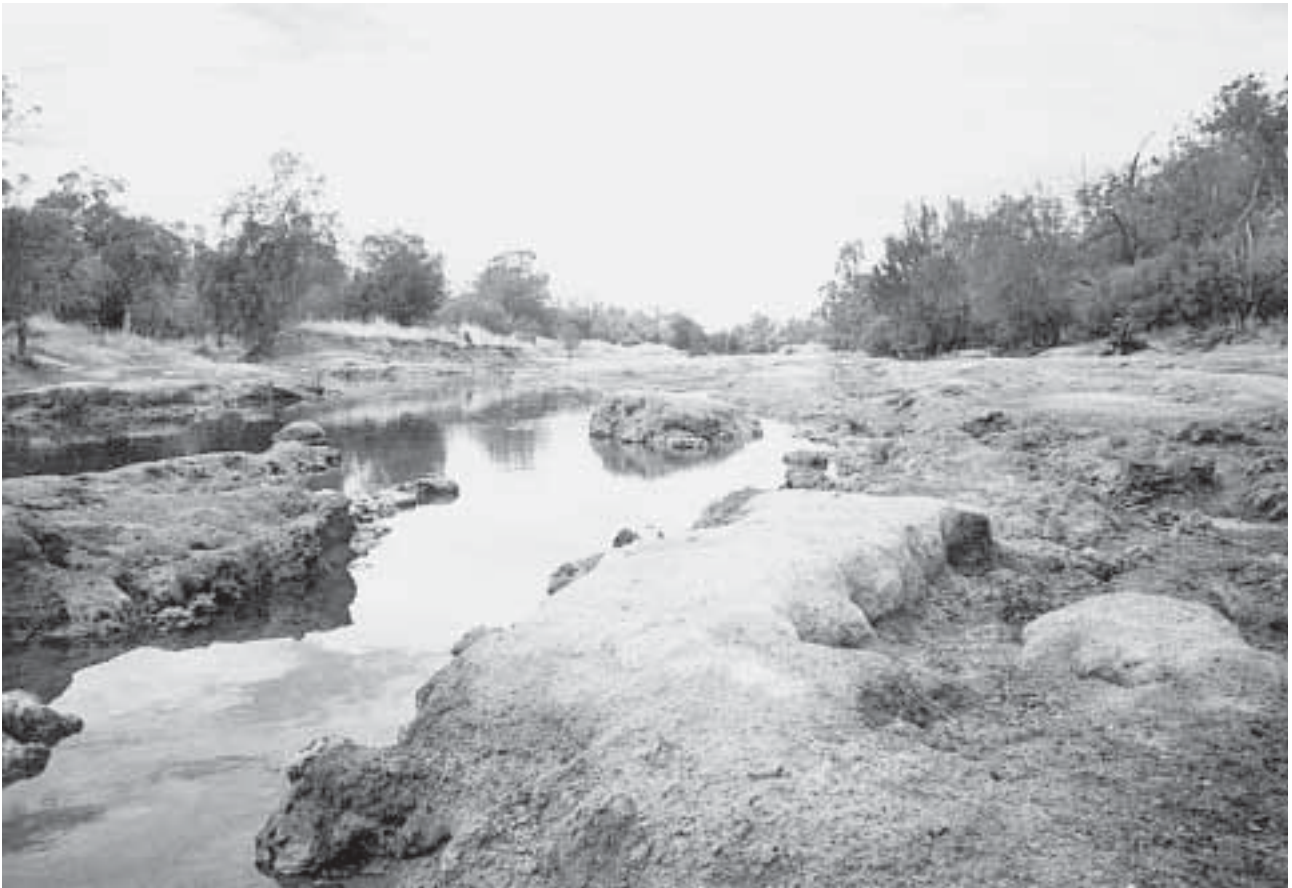
**Photo 3: The scoured river channel after the training scheme**

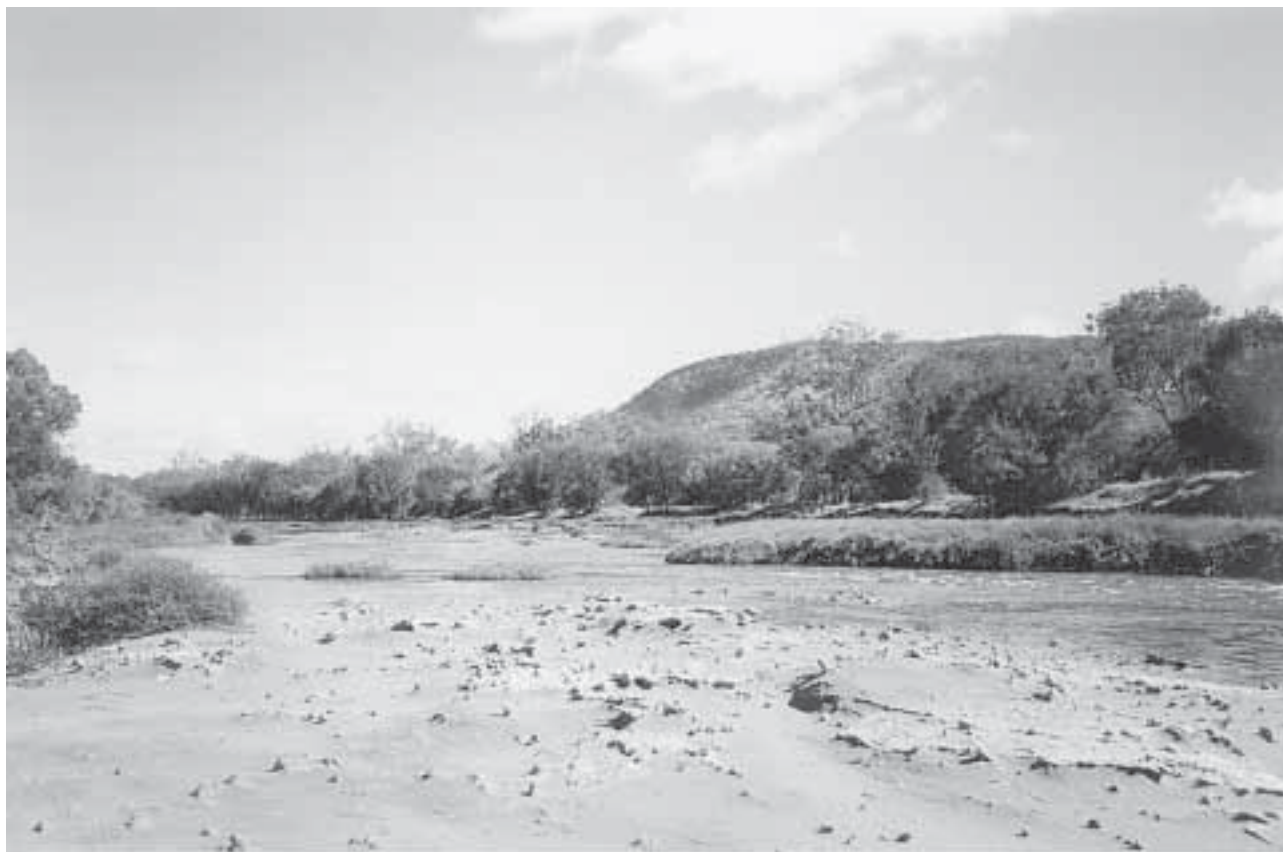
**Photo 4: Stabilised island formed from sediments adjacent to recent scouring of the river bank**

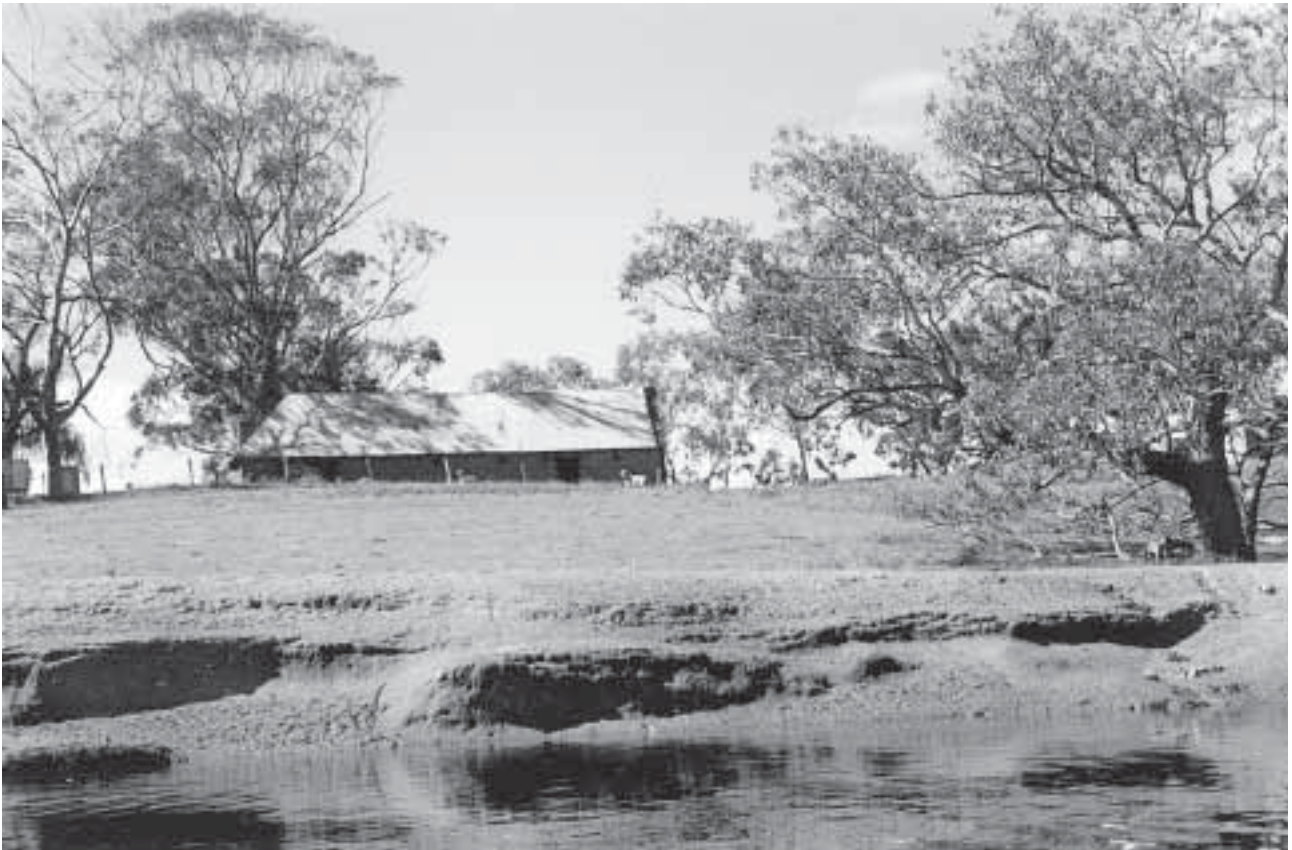
**Photo 6: The east bank of Meares Pool without fringing vegetation**

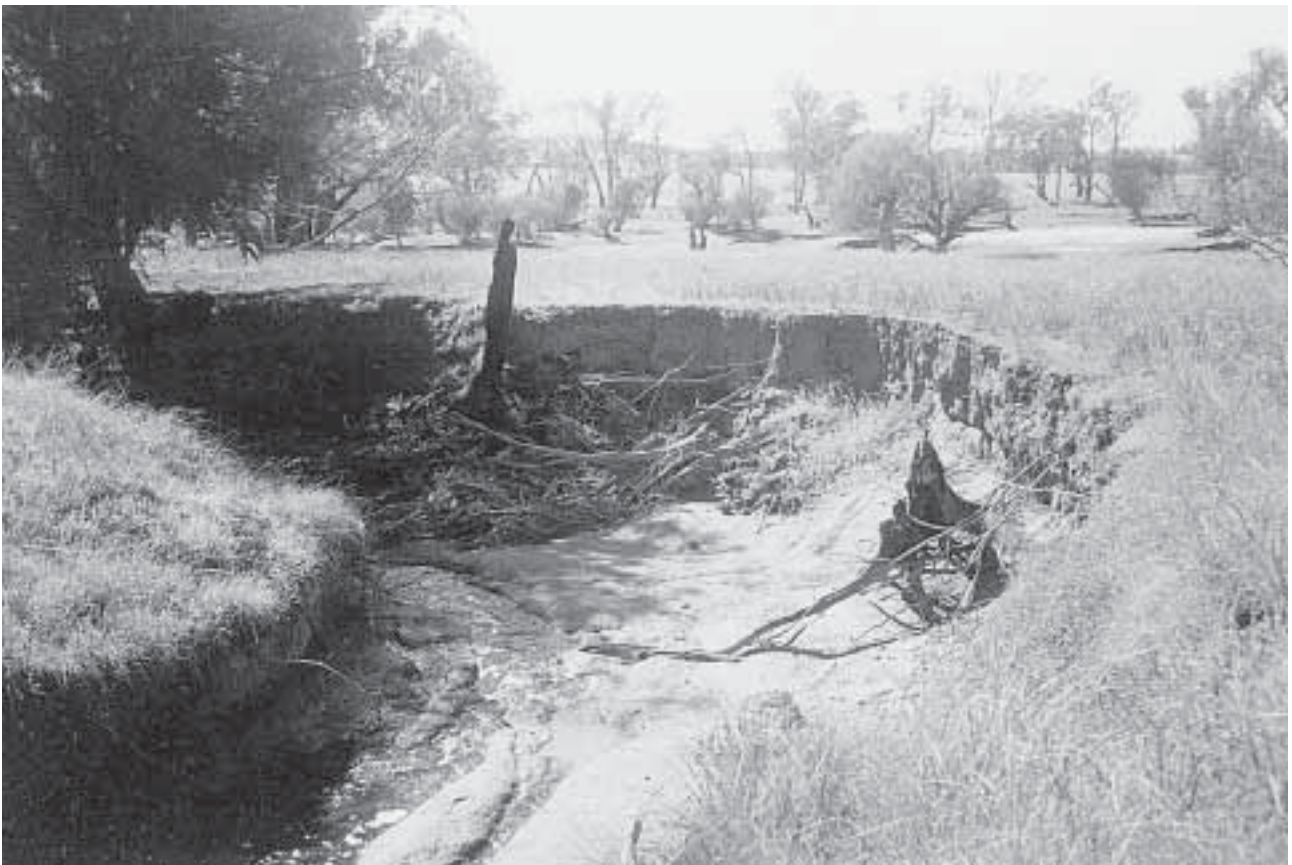
**Photo 9: Active erosion of the Breckna Brook channel on the river floodplain**

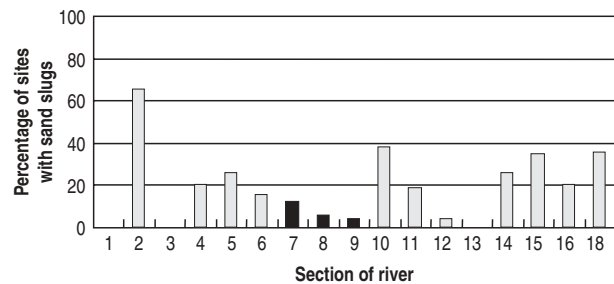
**Figure 3: Sediment 'slugs' along the Avon River**  
(from Black, 1997a)

The occurrence of bed sediments ('slugs') in the river was generally low although there were more in Section 7 (Figure 3). Each of the three sections had scour channels at approximately 20% of the sites. (Figure 4).

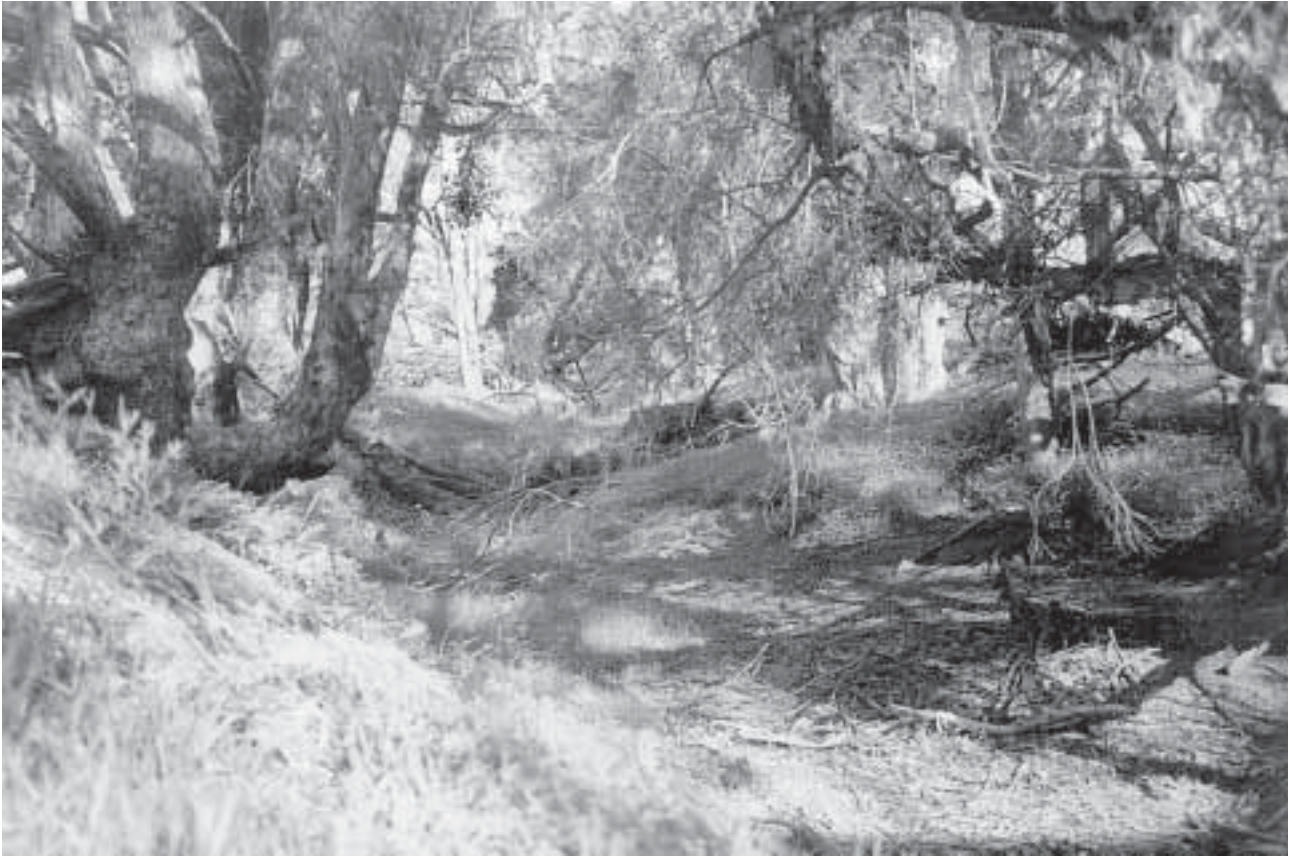
**Photo 10: A mature stand of fringing vegetation with balanced regeneration**

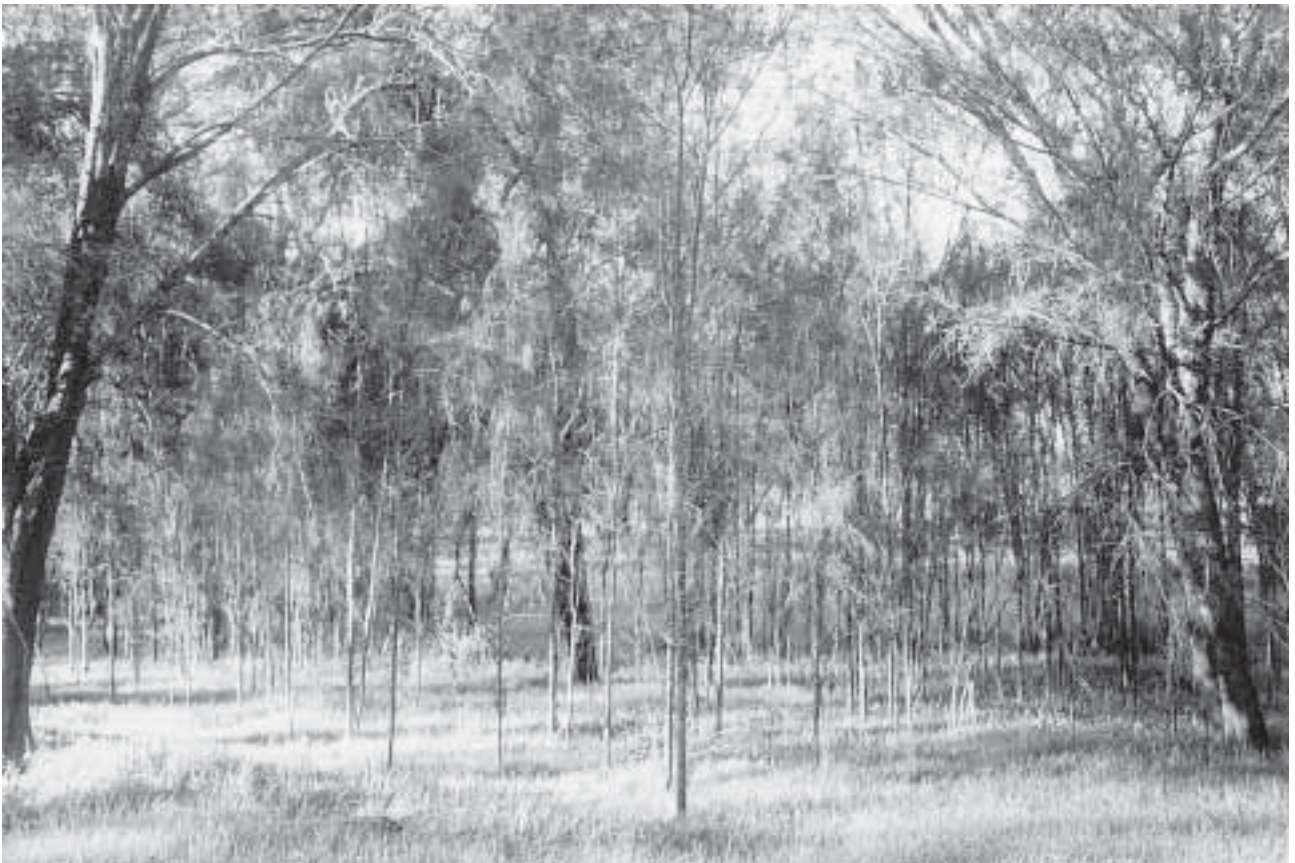
**Photo 11: Fringing vegetation dominated by Sheoak (*Casuarina obesa*)**

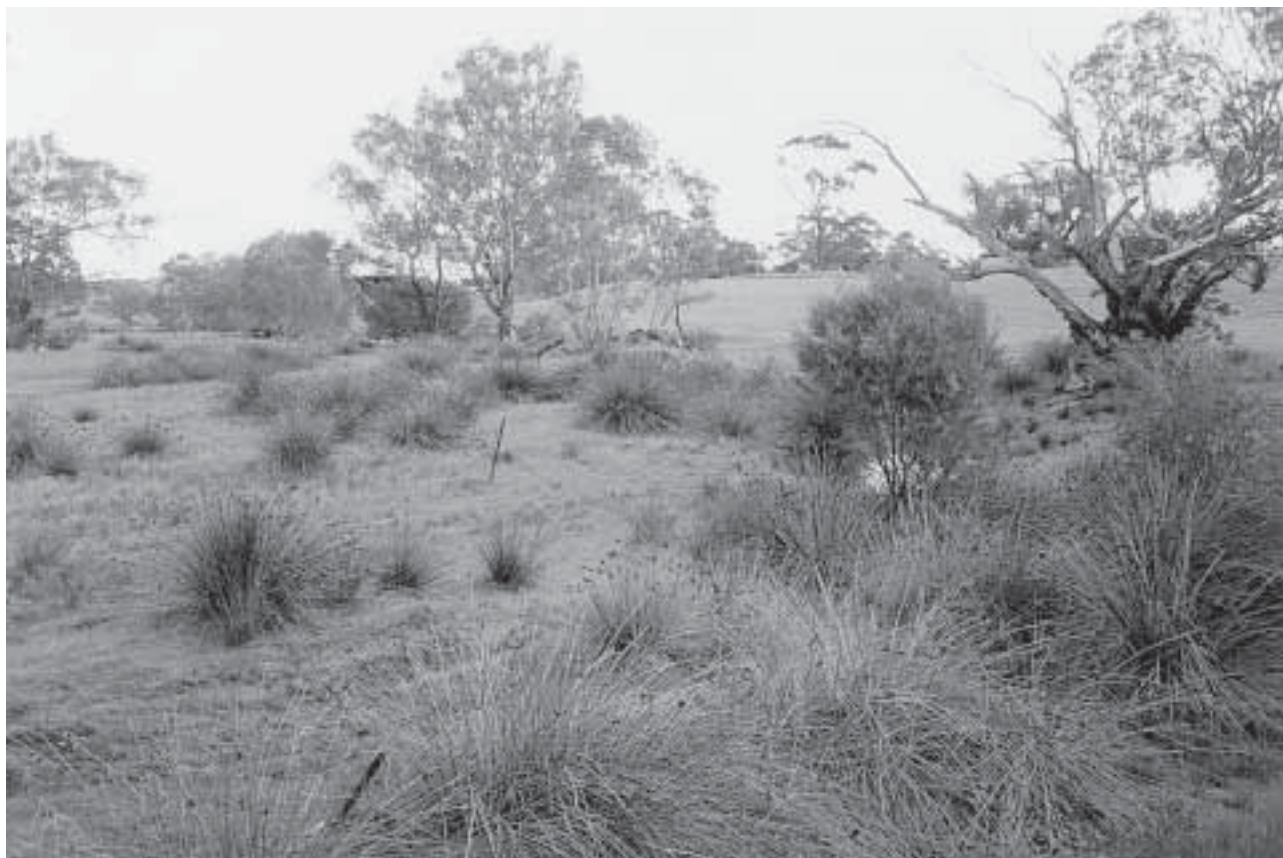
**Photo 12: Spiny Rush (*Juncus acutus*) established in Sermon Brook**

In addition to annual weeds, there is a significant threat to the river environment by the rapid spread of Spiny Rush (*Juncus acutus*). This rush currently chokes smaller tributaries and is a contaminant to wool. Control is difficult but there has been some success with glyphosphate

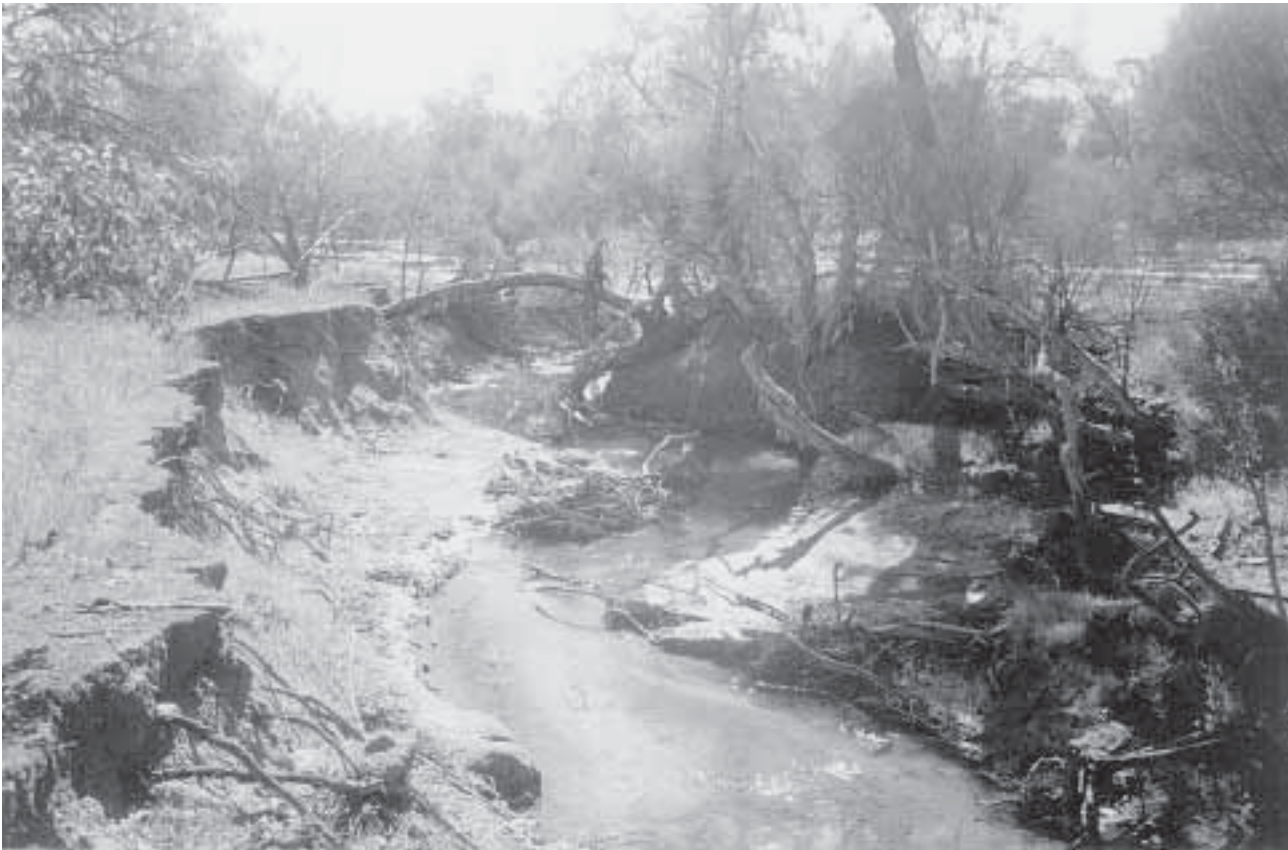
**Photo 15: Active erosion of Breckna Brook at the confluence with the river**

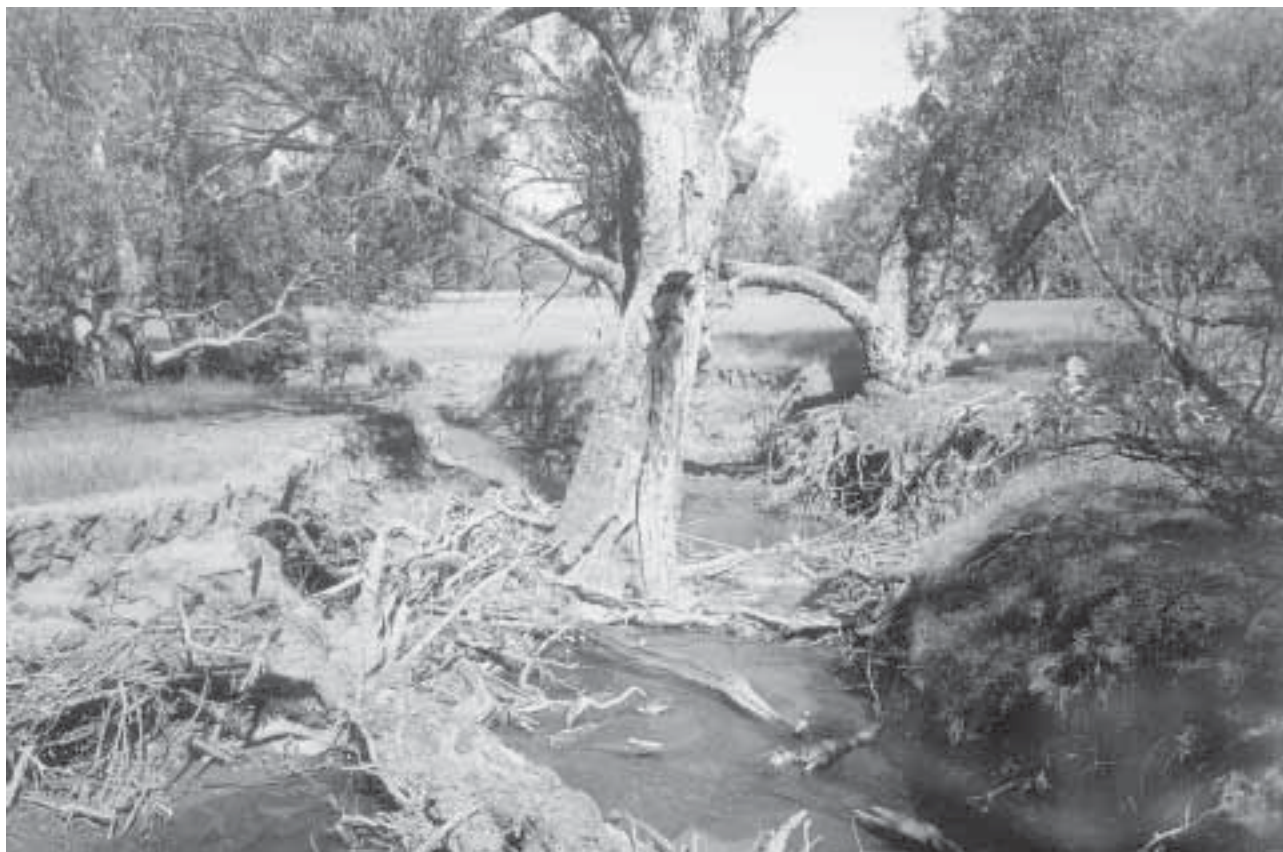
**Photo 16: Channel erosion under-cutting fringing vegetation on Breckna Brook**

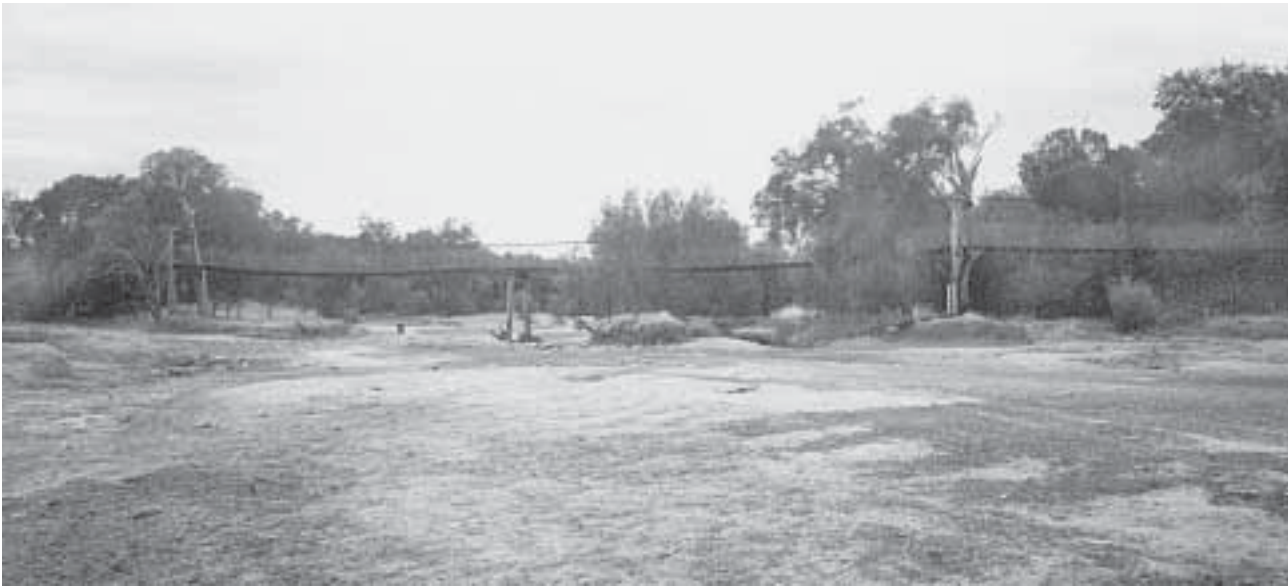
**Photo 17: The Swinging Bridge at Muresk**

The Swinging Bridge at Muresk, built in 1926 for student access to the college, is currently unsafe for use. An assessment of the feasibility to reconstruct the bridge to safe standards is proposed. Access across the bridge would provide a significant complement to river walks suggested for this area.

*Action 7.3* Assess the feasibility of repairing Muresk's Swinging Bridge suitable for public use and developing a river walk trail.

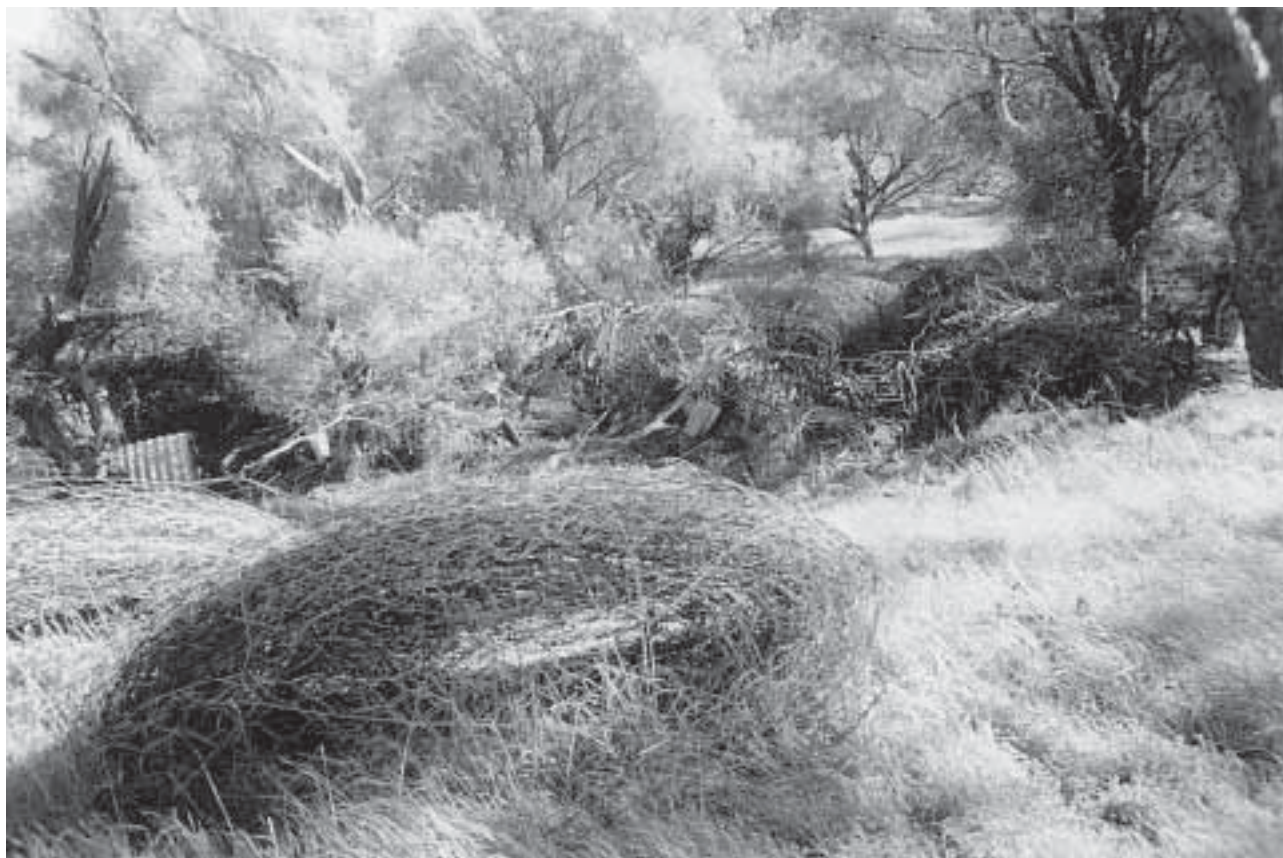
**Photo 18: Coils of wire dumped in the river**

Dumping of rubbish into creeks or the river was a previous traditional practice, which should now not occur. There are places where farm rubbish has been covered with soil on the floodplain. Other areas have considerable amounts of rolled fencing wire discarded in the river. Farm tips should be located in clay soils and at a substantial distance from the river. Chemical drums should not be stored where they can leak or be washed to the river during floods. Landholders should be encouraged to make use of the Drum Muster facility.

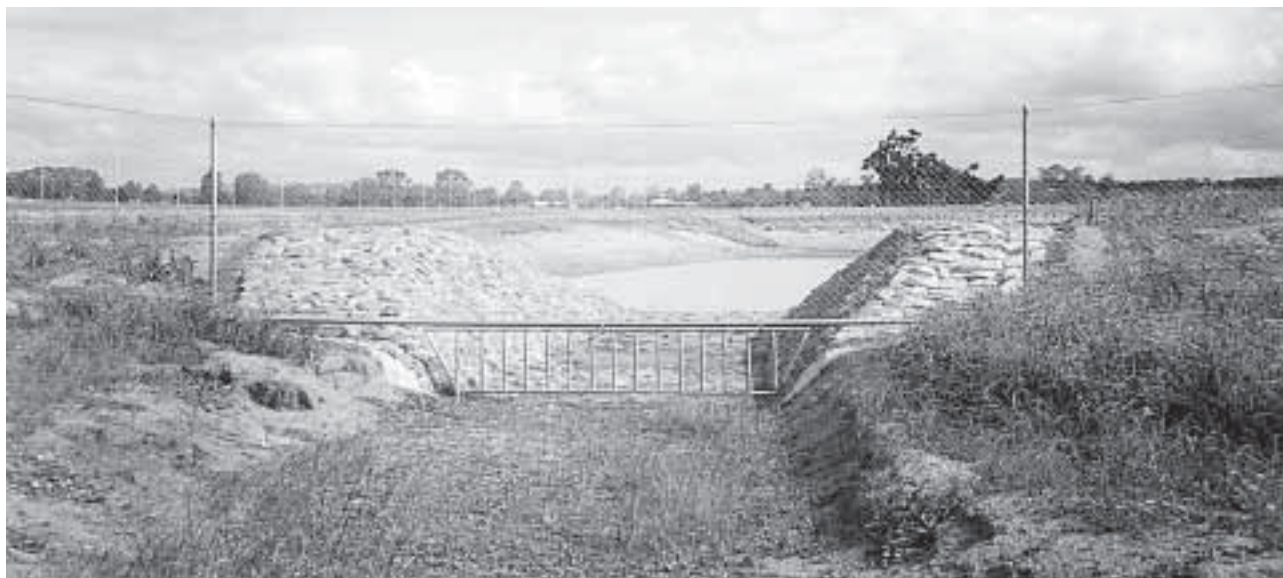
**Photo 19: Detention pondage for rural-residential development near York**
