STATE OF THE PALLINUP RIVER  
AND THE BEAUFORT INLET

Water and Rivers Commission

WATER AND RIVERS COMMISSION  
WATER RESOURCE MANAGEMENT SERIES  
REPORT NO WRM 37  
MARCH 2003

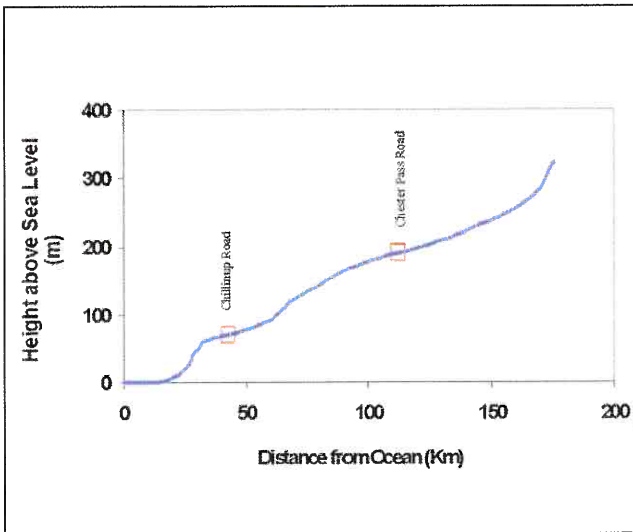
Figure 4. The longitudinal altitude profile of the bed of the Pallinup River

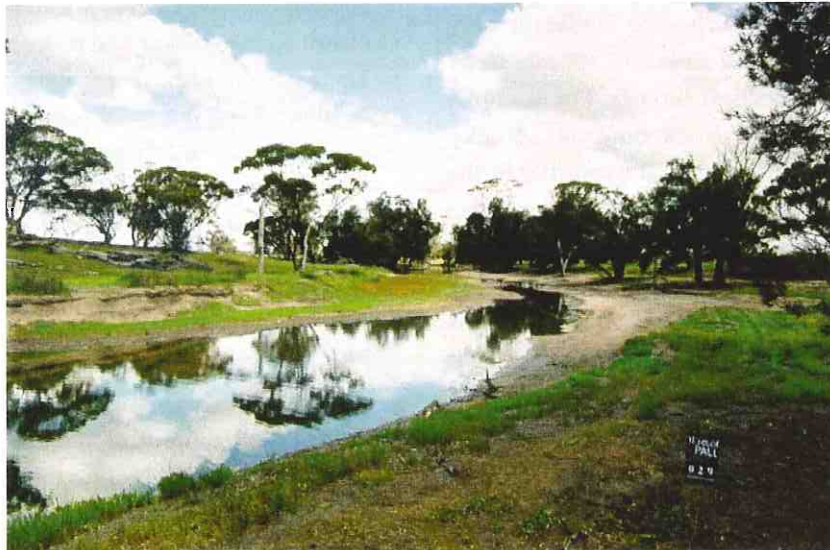
Figure 6. The typical broad floodway with low flow channel

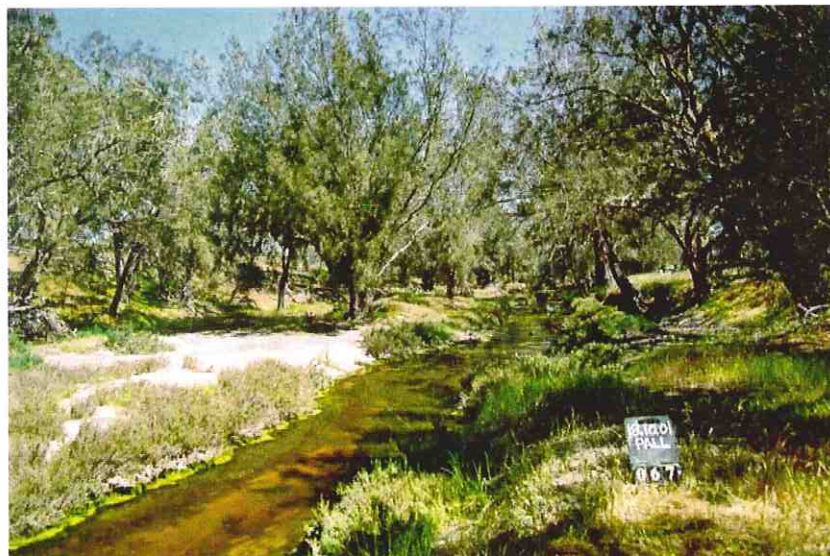
Figure 7. A more distinct low flow channel lies within the main floodway with sediment deposits and samphire regeneration

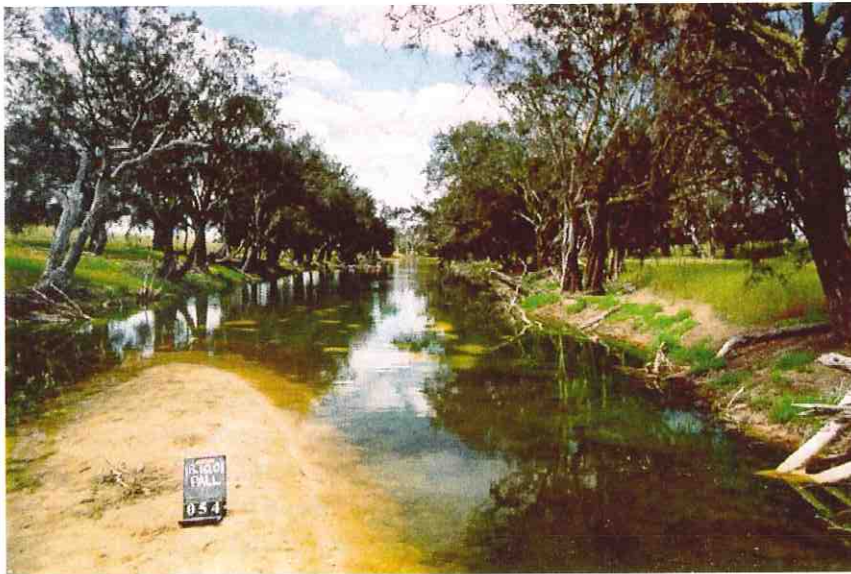
Figure 8. A medium-sized pool on the Pallinup showing an encroaching sediment plume at the upper end

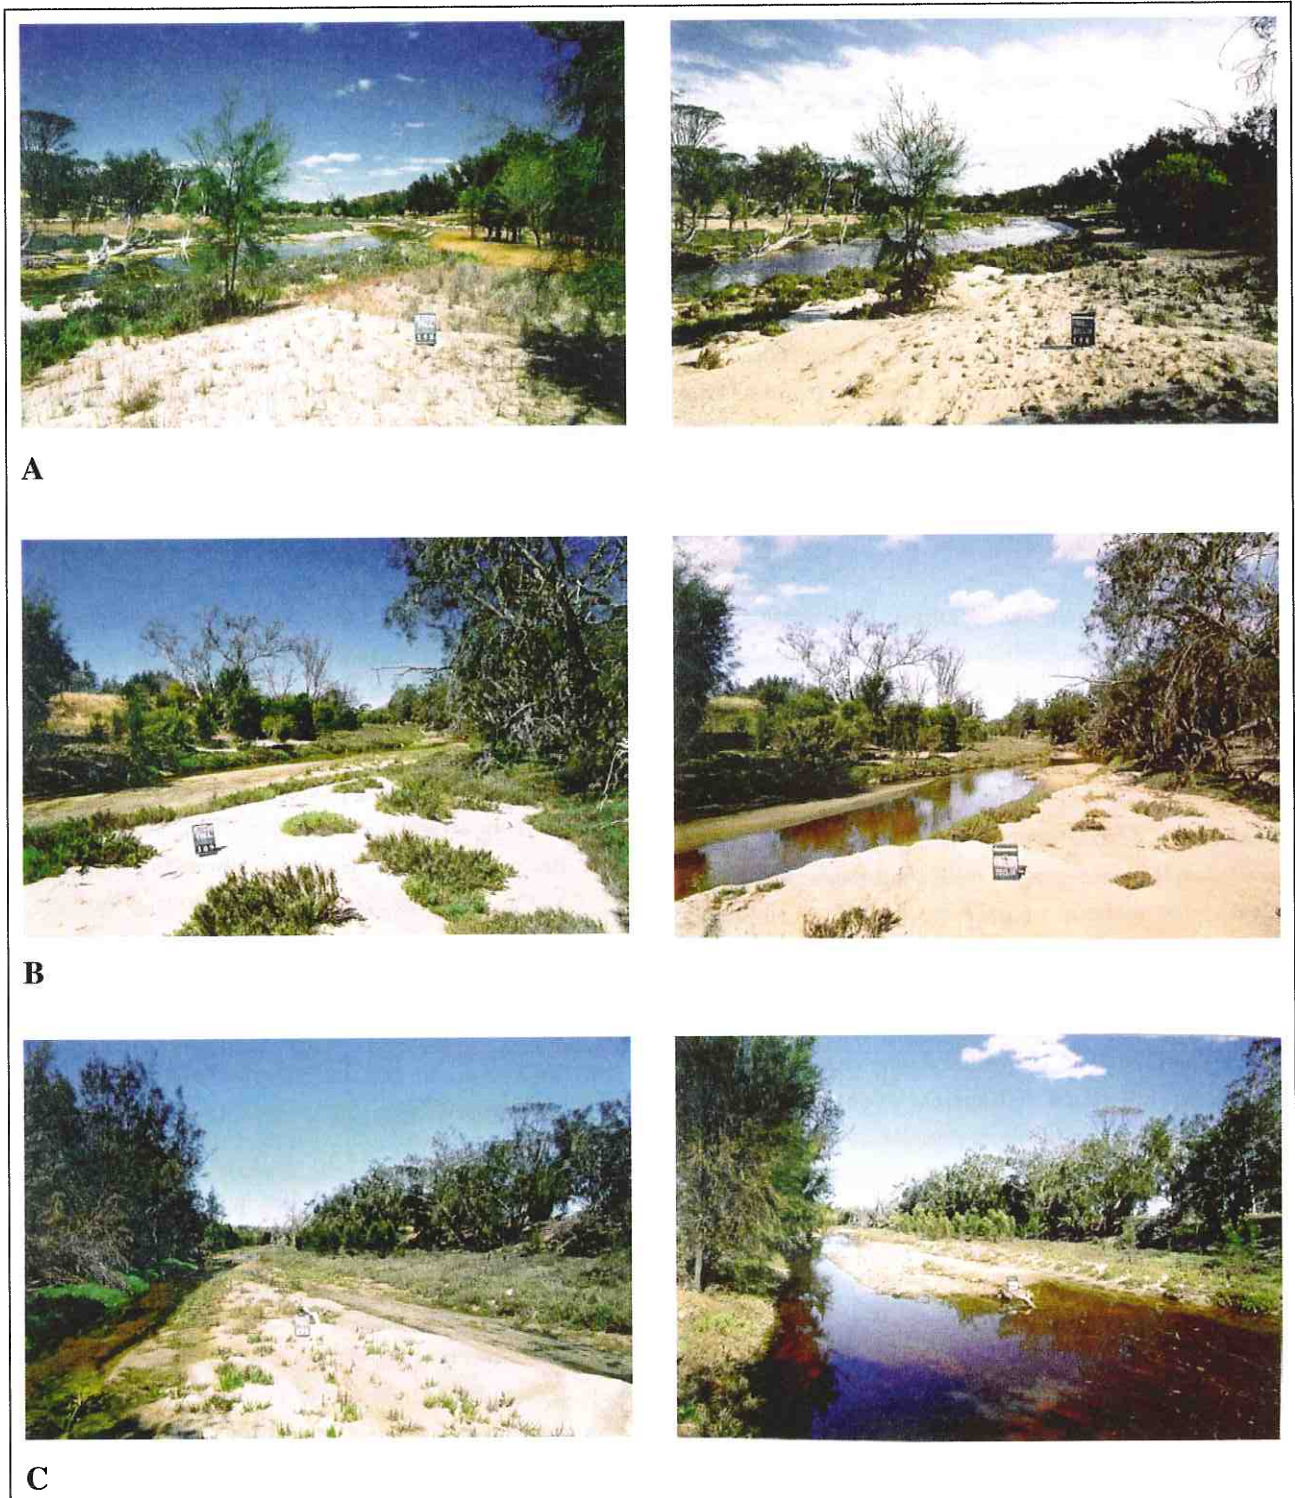
Figure 10 A-C. A comparison at the same sites showing the effect of high velocity floods on floodway vegetation and sediments between early February and late December 2001

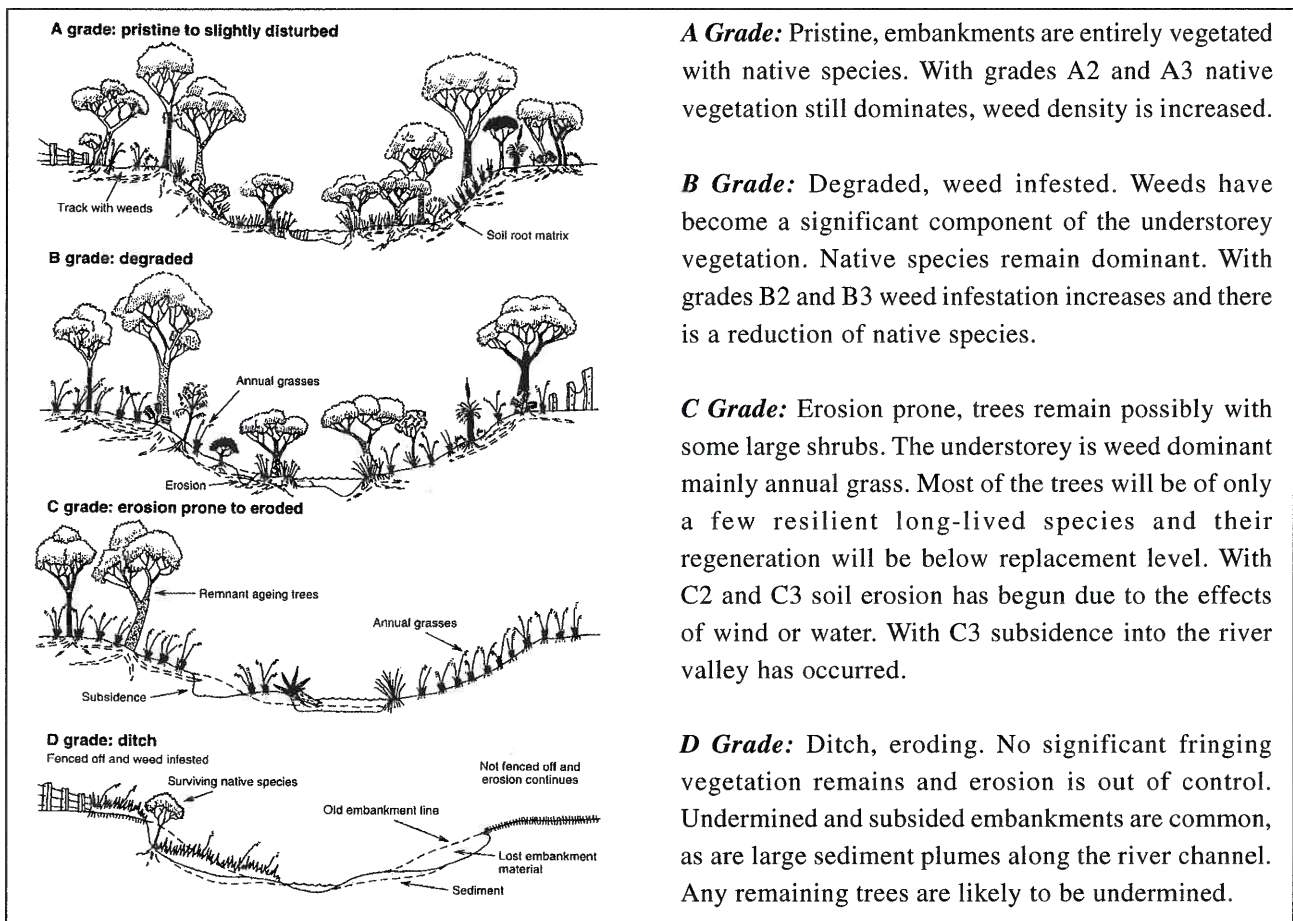
Figure 13. The stages of river degradation

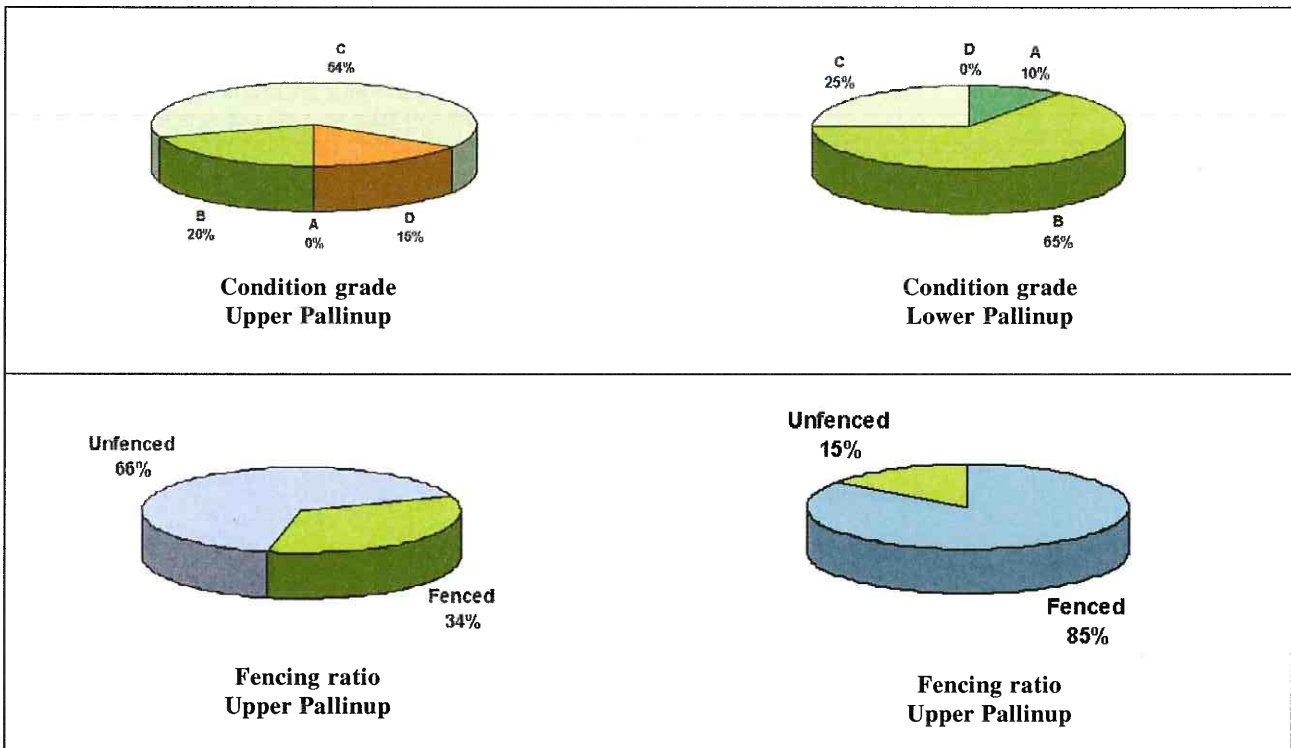
Figures 15. Graphical summary of fencing and foreshore condition for Pallinup River above Chester Pass Road

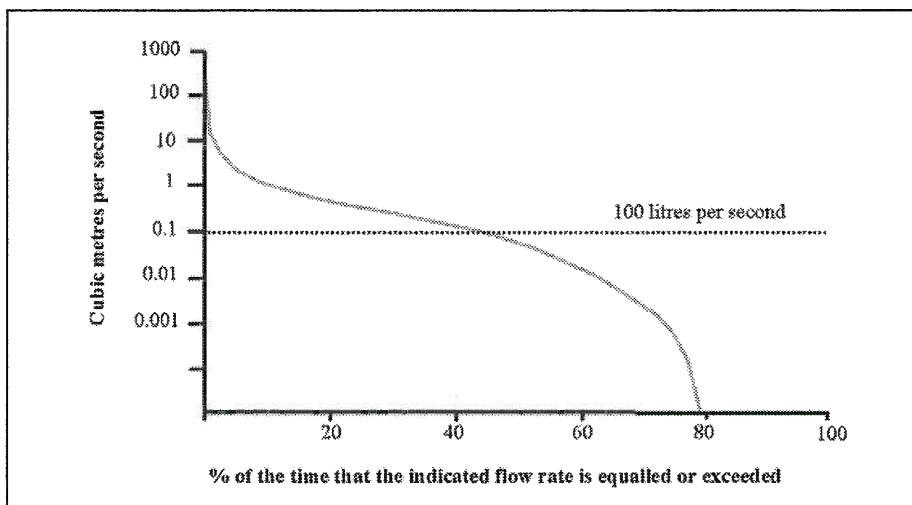
Figure 17. The durage of flows

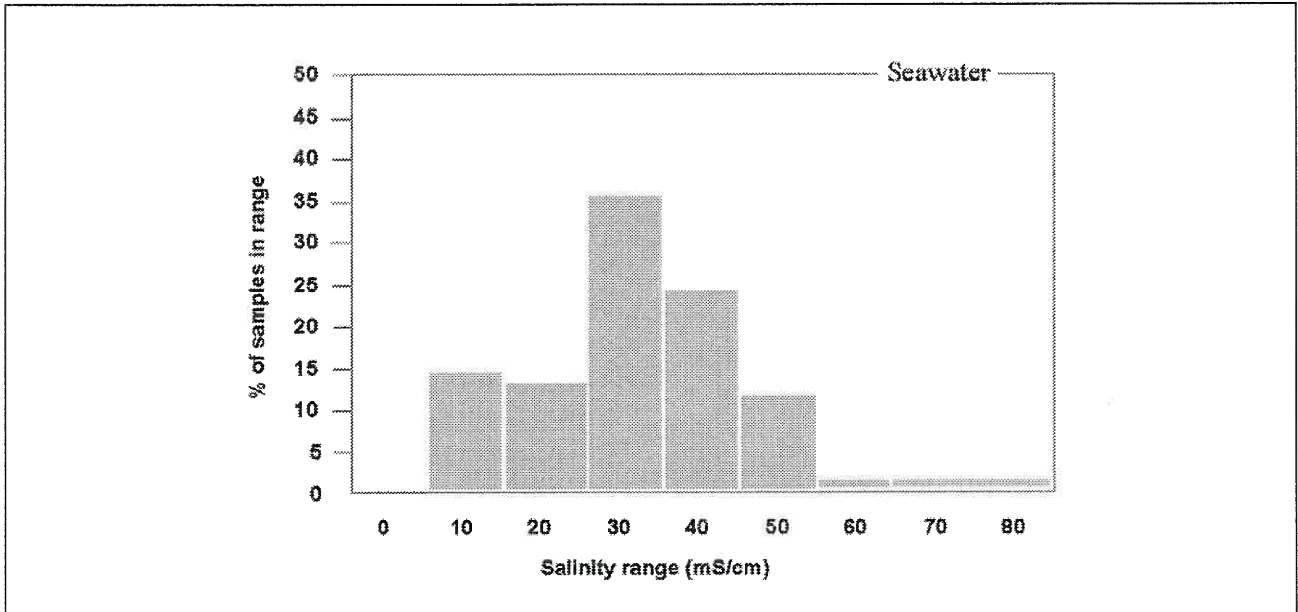
Figure 18. The distribution of salinities (EC) measured between 1998 and 2000 for all sites along the river

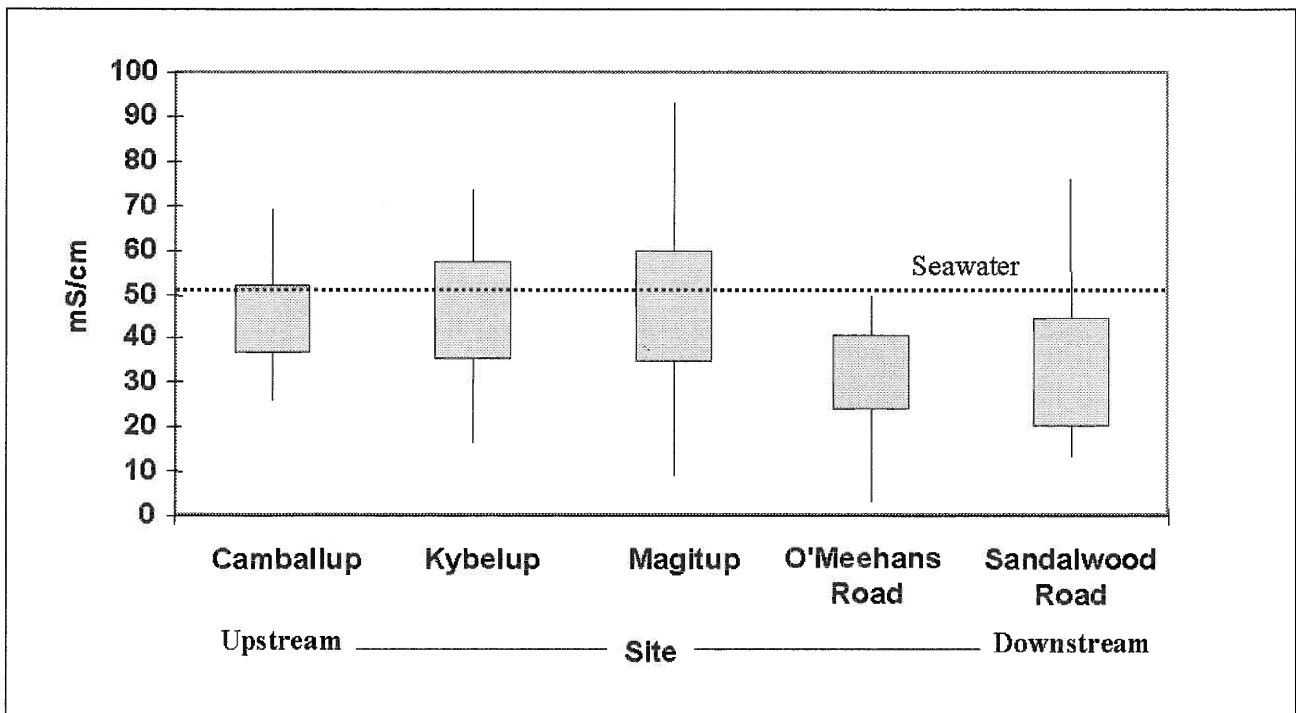
Figure 21. Salinity range for samples collected along the main channel of the Pallinup River (The 'whiskers' extend from the maximum to the minimum values and the boxes show the range of the middle 50% of the measurements)

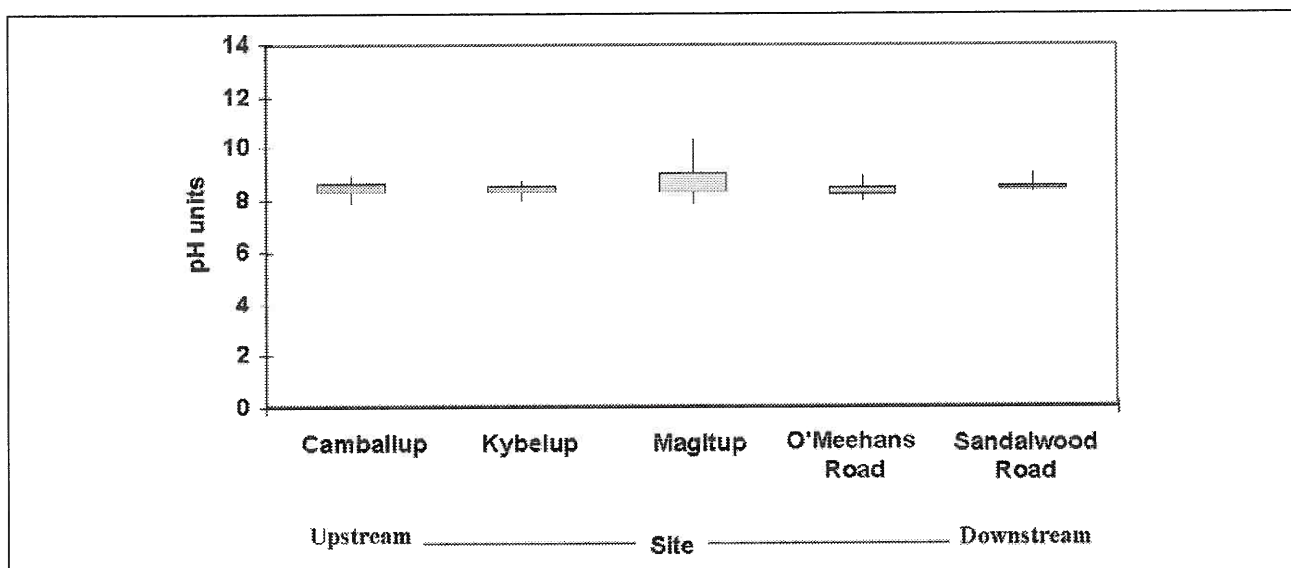
Figure 22. The variation in pH values along the Pallinup River (1998-2000)

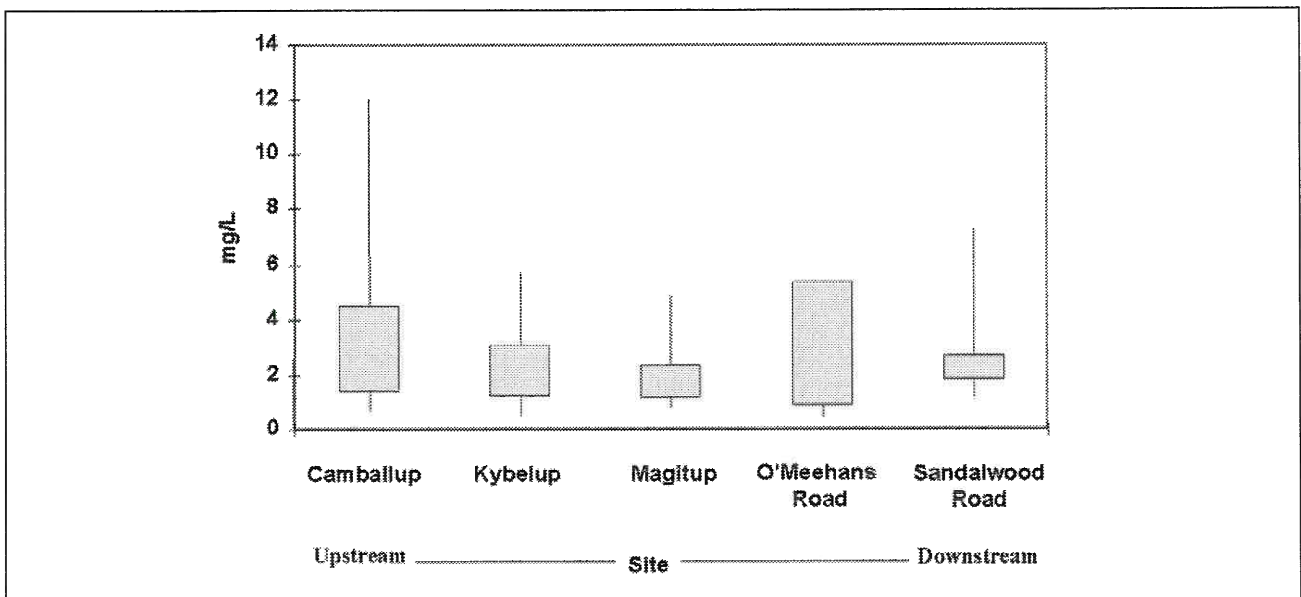
Figure 23. Total Nitrogen (TN) levels along the Pallinup River channel in 1998–2000

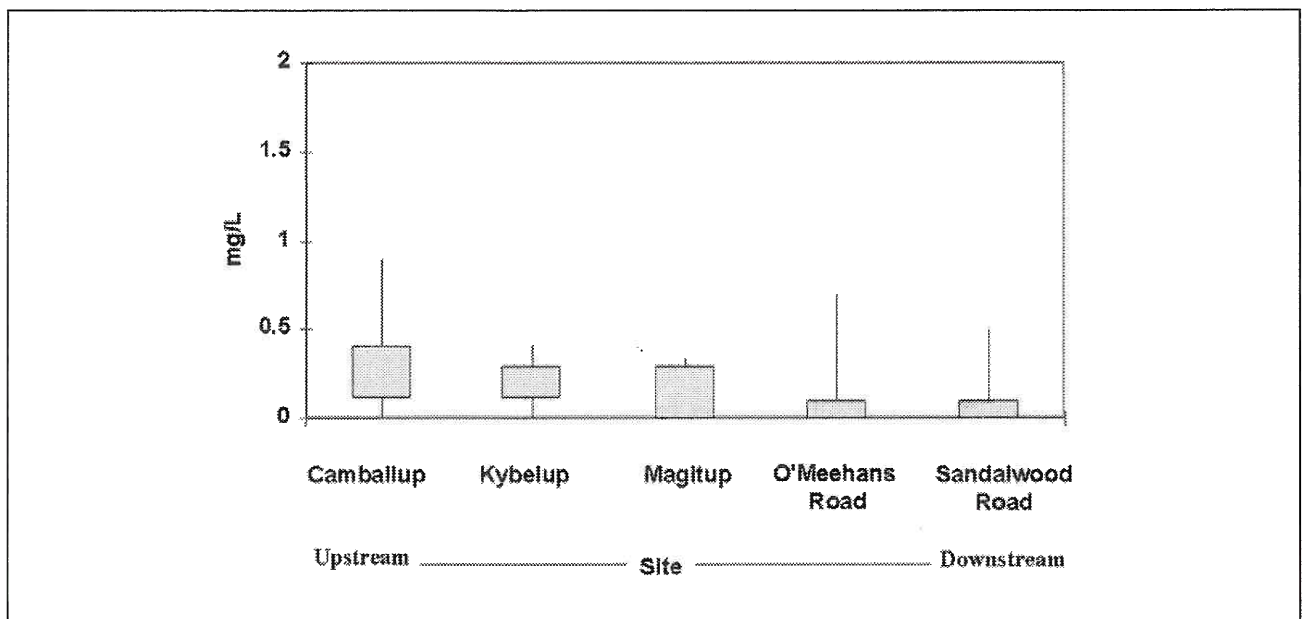
Figure 24. Total phosphorus levels along the Pallinup main channel

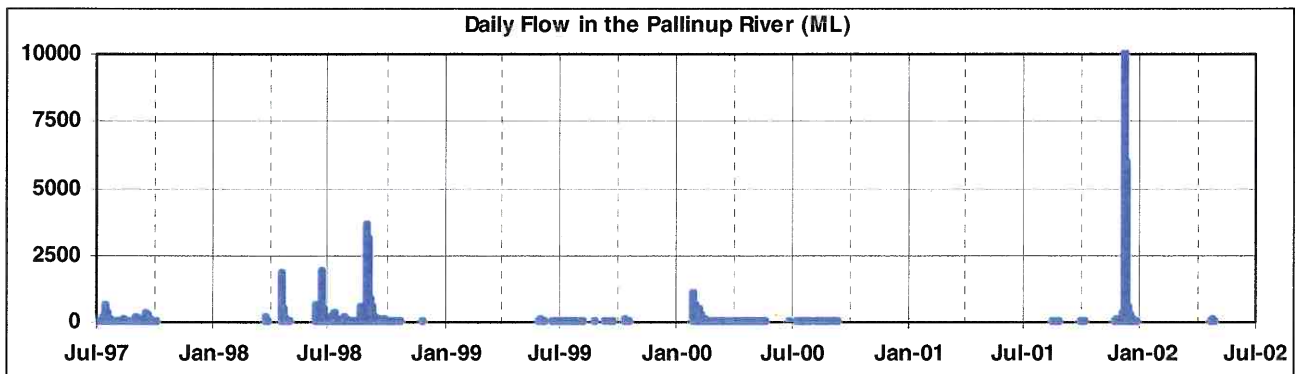
Figure 29. Daily flow in the Pallinup River (ML/day) at Bull Crossing

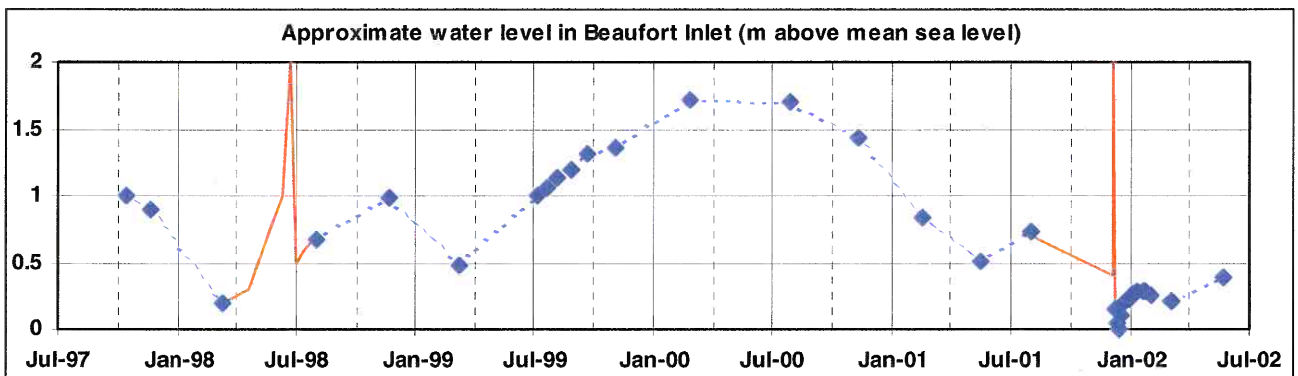
Figure 30. Approximate water level in Beaufort Inlet (estimated metres above mean sea level). Blue squares (joined by dashed line) are the measured water levels, the red line is an estimate of water levels during the bar opening events

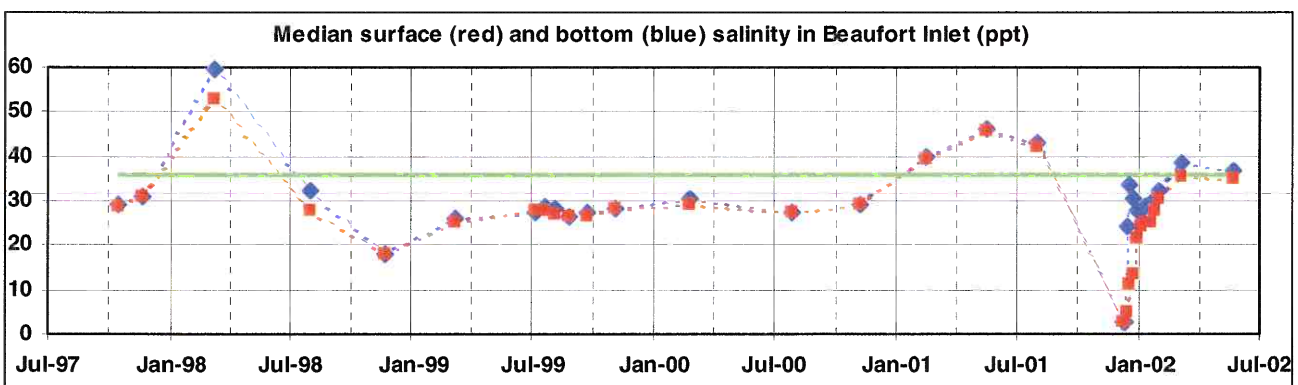
Figure 31. Salinity in Beaufort Inlet (ppt). Medians of surface (red line) and bottom (blue line) data for all sites. The green line is an approximate estimate of seawater salinity for comparison

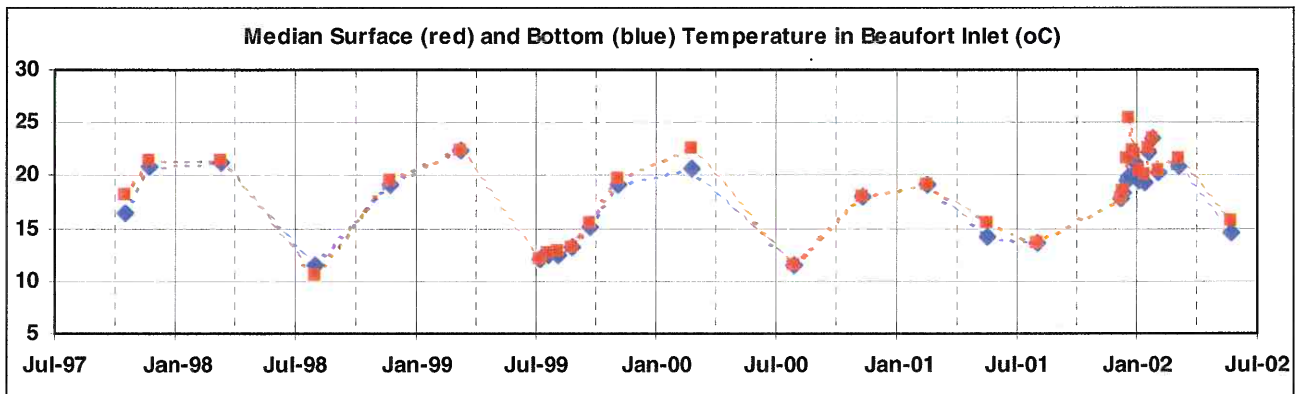
Figure 32. Water temperature in Beaufort Inlet. Strong vertical stratification is present but not obvious at this plot scale

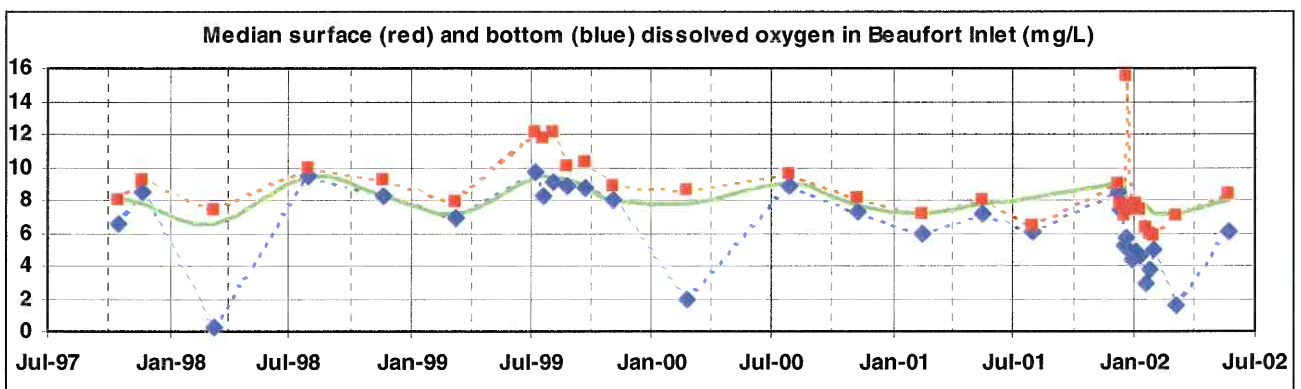
Figure 33. Dissolved oxygen in Beaufort Inlet. The green line is the approximate saturation oxygen concentration. Deviation above the green line indicates supersaturation due to primary production of oxygen and below the line indicates deoxygenation

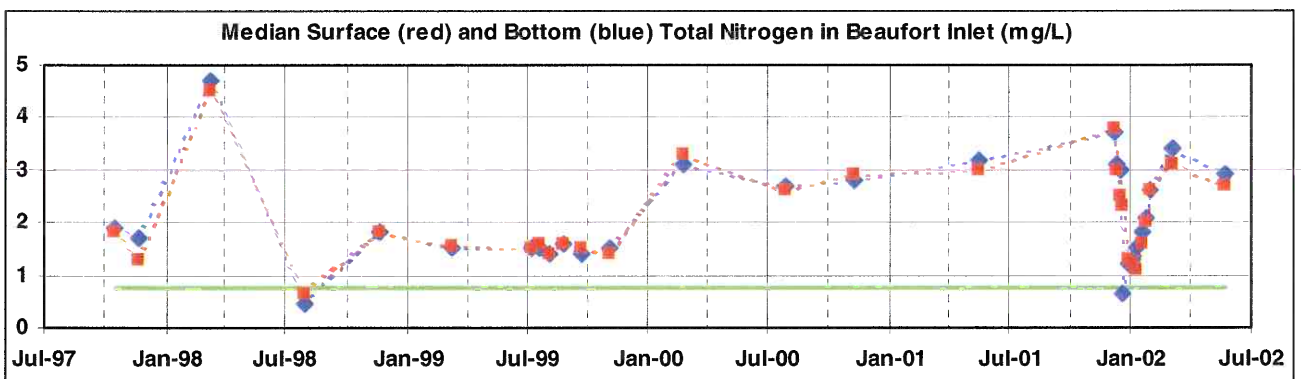
Figure 34. Total nitrogen in Beaufort Inlet. The green line is the ANZECC guideline (developed from a composite of the data from all of the estuaries in the South West of WA)

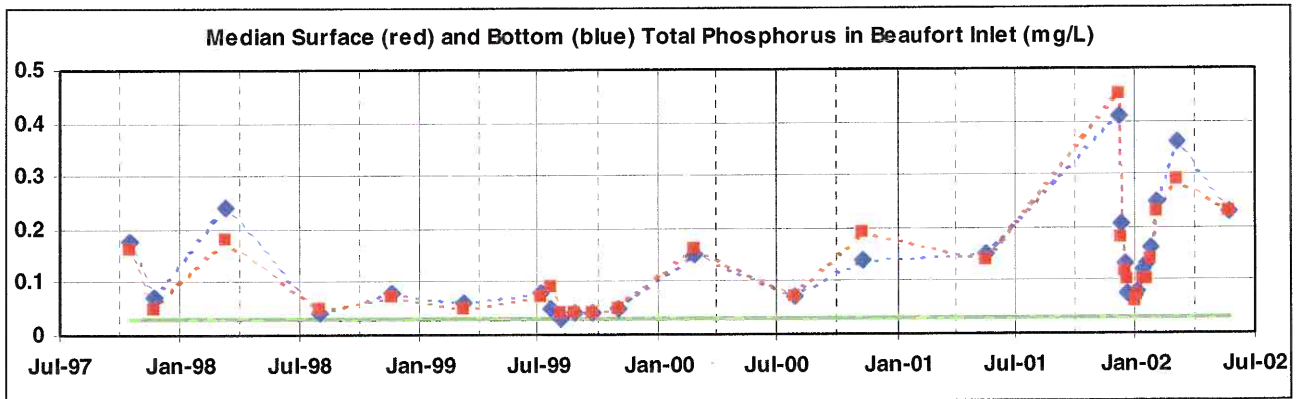
Figure 35. Total phosphorus in Beaufort Inlet. The green line is the ANZECC guideline (developed from a composite of the data from all of the estuaries in the South West of WA)

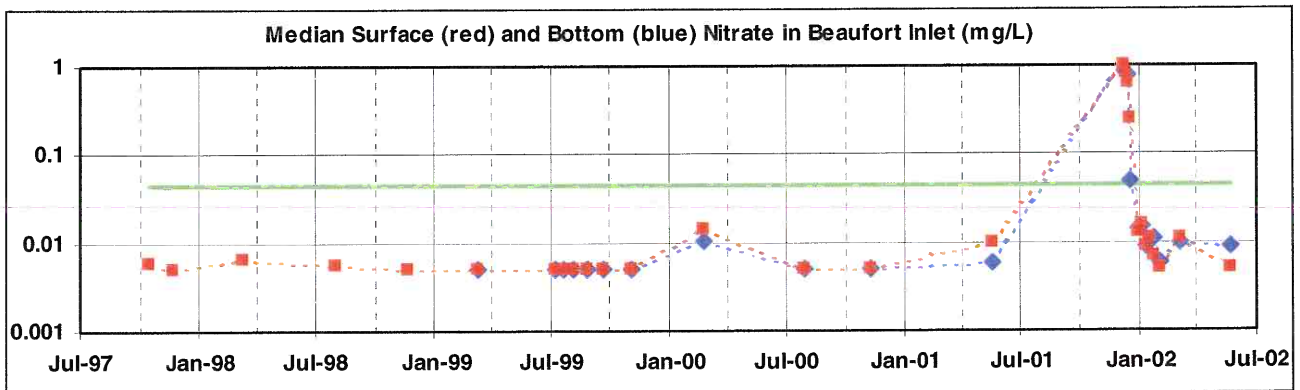
Figure 36. Nitrate in Beaufort Inlet. The green line is the ANZECC guideline (developed from a composite of the data from all of the estuaries in the South West of WA)

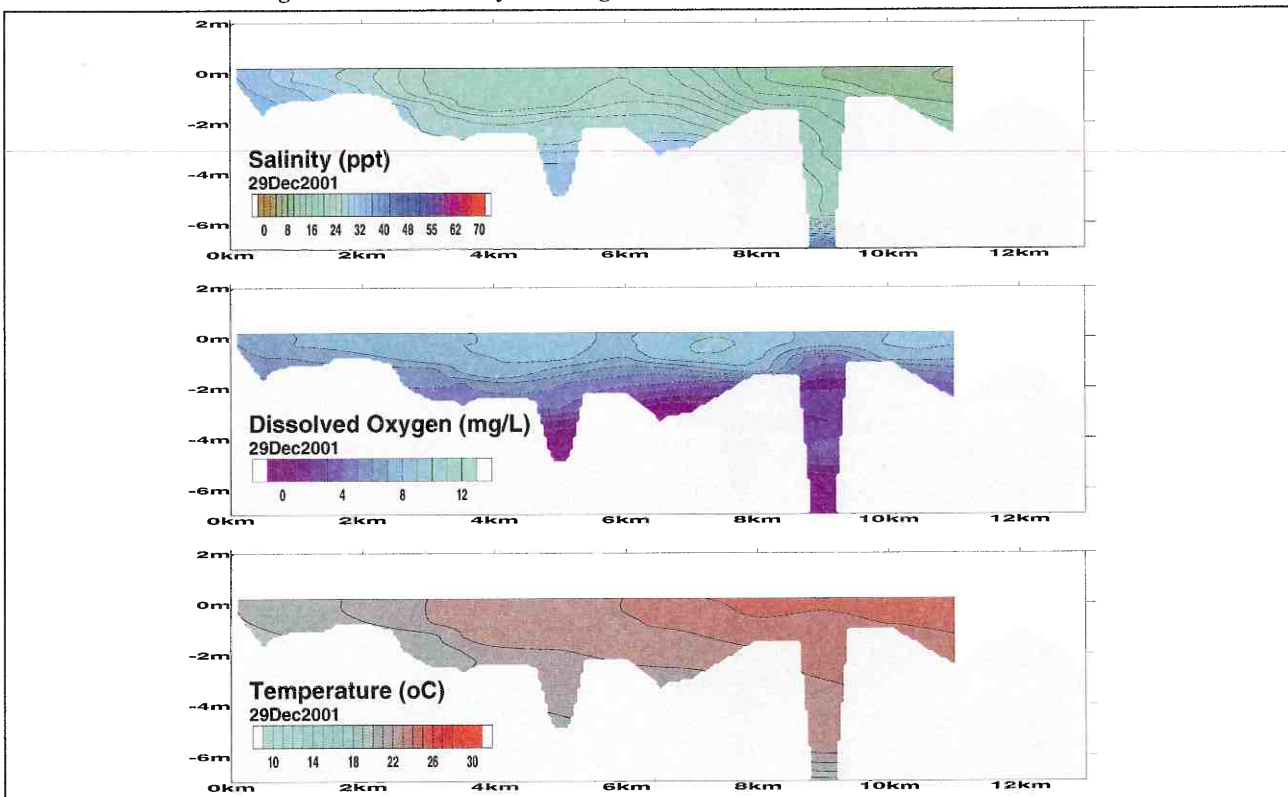
Figure 53. Sample 24. The spatial extent of stratification and deoxygenation had increased since previous sample runs. Note the dissolved oxygen inversion above the halocline (seen throughout the data) in the deep hole at 9 km from the bar. This was possibly related to photosynthetic bacteria above the halocline utilising the high nutrient concentrations trapped below

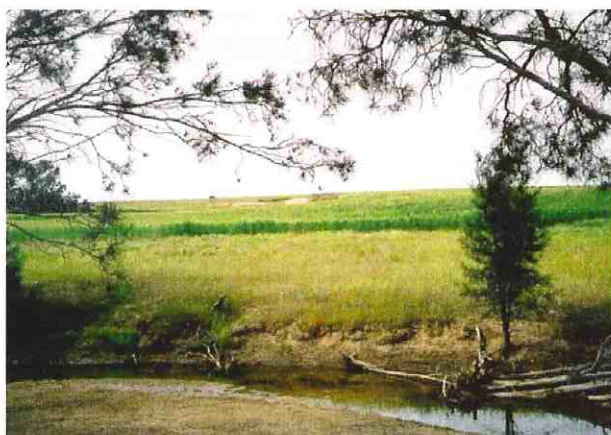
Figure 55. Cropping well into the floodway

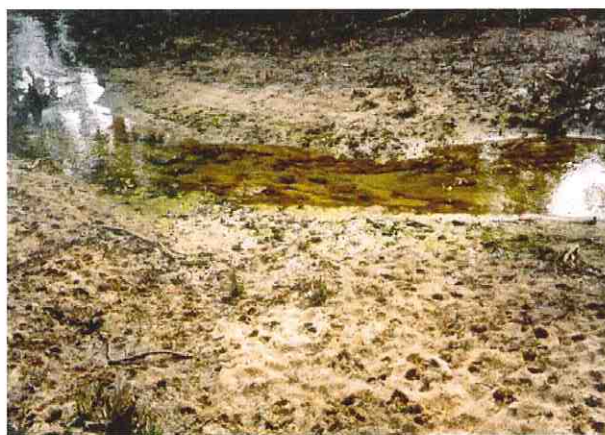
Figure 56. Stock impact in the channel

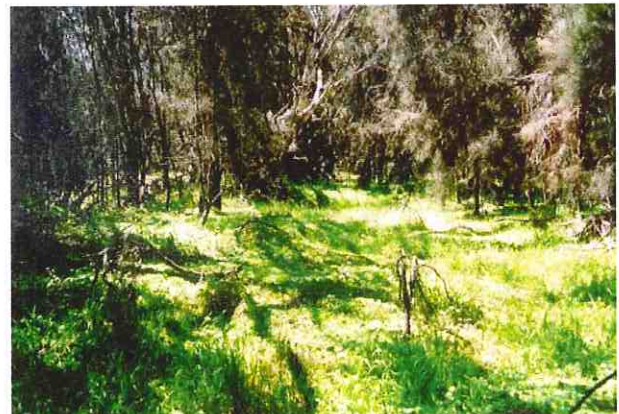
Figure 58. Sour sob has dominated much of the ground cover along the river banks

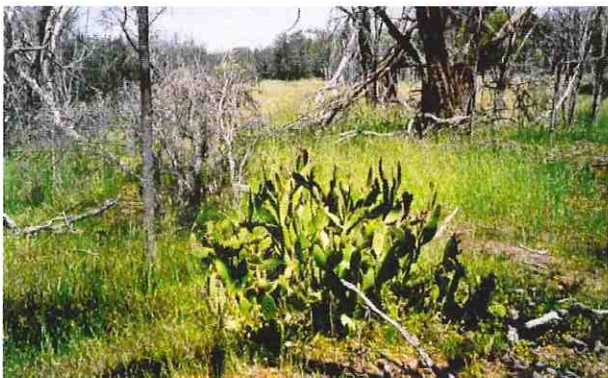
**Figure 59.** Less common plants such as this cactus were sometimes encountered along the river. They may not pose a threat, but should be dealt with now

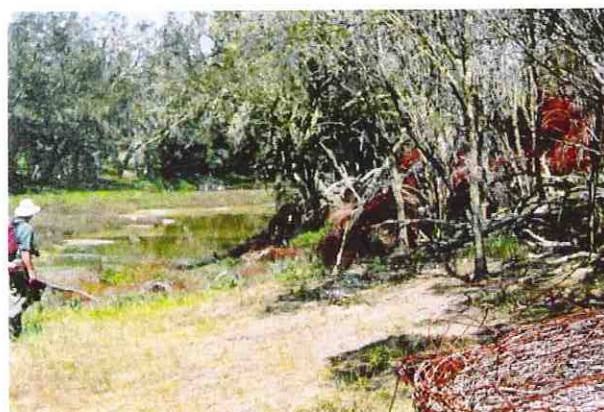
**Figure 60. Rubbish in the river – a thing of the past**

In the past, many landholders along the Pallinup have used the river as a place to dispose of refuse. During the Foreshore Condition Assessment, it was noticed that piles of soil and cleared vegetation, old fencing equipment and machinery had been dumped in the floodway or on the bank. Along parts of the lower sections of the river the peak level of a past flood could be detected from the old bottles lying stranded in the bush well up from the channel bed.

Many landholders now have a sense of responsibility toward the river and have endeavoured to clean up their sections. Rubbish was not an excessive problem along the floodway. People now realise that what enters the river will eventually reach the Beaufort Inlet and perhaps the sea. Anecdotal information suggests that in the past it was not unusual to see chemical drums floating down the river. The Beaufort Inlet is an area where many locals like to visit, camp and fish. This has encouraged a sense of ownership and responsibility among landholders to look after their stretch of river.

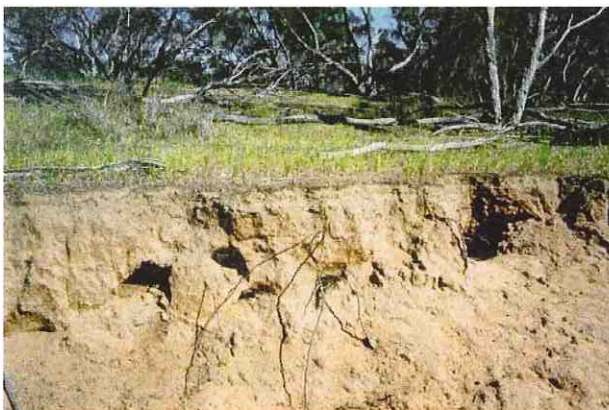
Figure 61. Rabbit warrens in deep sandy area

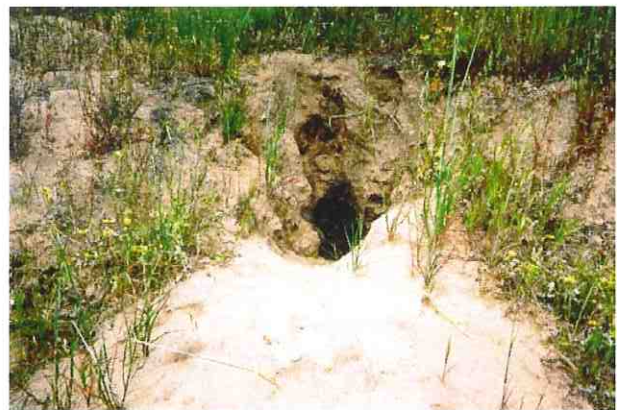
Figure 62. Fox hole

Several fox holes were seen dug into the loose sand on the riverbanks along the Upper Pallinup (figure 62). No feral cats were seen in the river reserve, but are likely to be using the area as a hunting ground. Both pests can seriously reduce numbers of small and medium-sized mammals, frogs, reptiles, birds and insects, nevertheless bobtail lizards were quite common during the Spring assessment and a number of snakes were also seen. Accurate information on the distribution and intensity of feral animals along the river is not available so landholders are responsible for individual on-ground control.

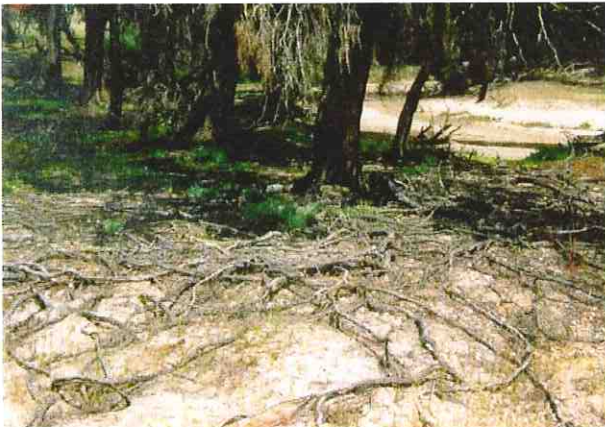
Figure 63. Soil scoured from root system by floods

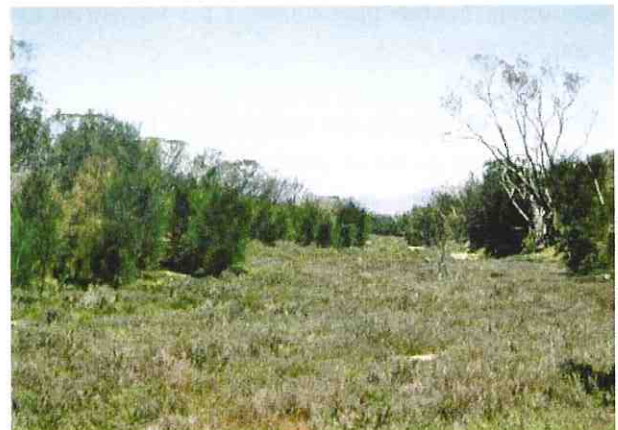
Figure 64. Sediment-filled pool colonised by samphire
