Waterway assessment of the Camm River: Lockhart River confluence to Hyden

Water resource management series
Looking after all our water needs

Report no. WRM 57
December 2009

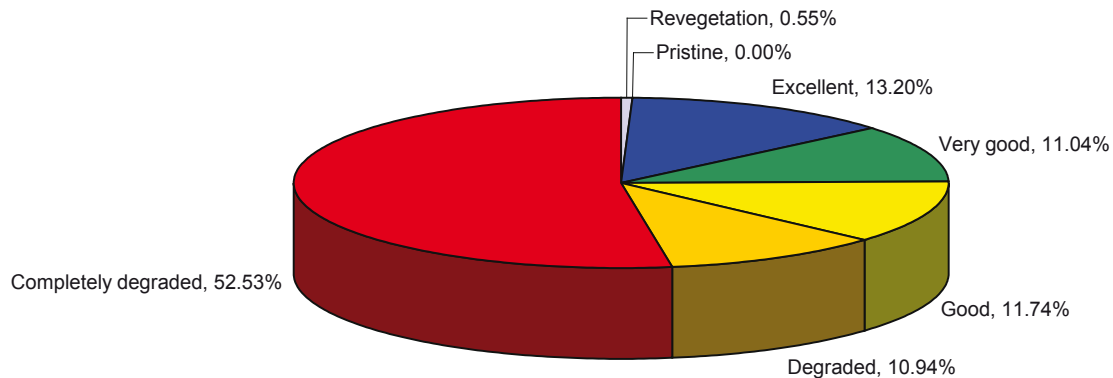
Figure 3 Estimated area of vegetation surveyed within each vegetation condition rating

An estimate of the area of vegetation in each vegetation condition category is shown in Figure 3 below. Although this figure is an estimate (based on an estimate of the percentage of each condition category in each remnant and an estimate of the proportion of vegetated area in each remnant), it shows that most of the vegetation surveyed in the study area is in *completely degraded* condition.

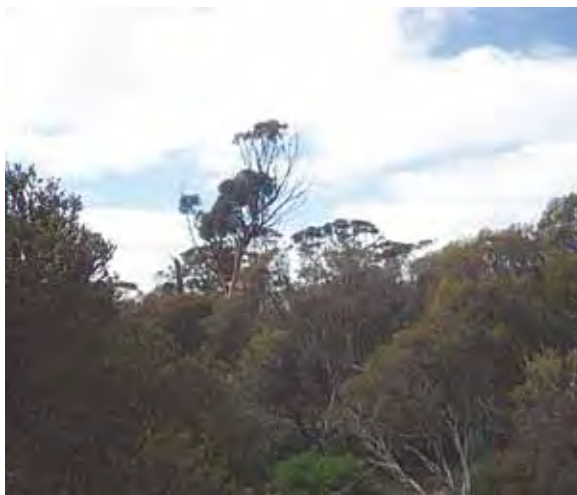
Photo A1.1: CR01

Very good condition vegetation association 1: *Eucalyptus spathulata* Open Low Woodland over *Melaleuca latifolia*, *Melaleuca pauperiflora* and *Rhagodia preissii* Scrub over mixed annual Herbs.

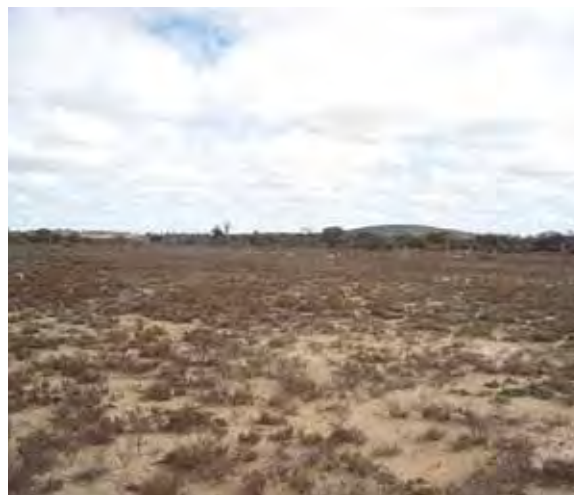
Photo A1.2: CR01

Good condition vegetation association 2: *Tecticornia* sp. Dwarf Scrub over *Senecio* sp., *Spergularia marina* and *Disphyma crassifolium* Very Open Herbs.

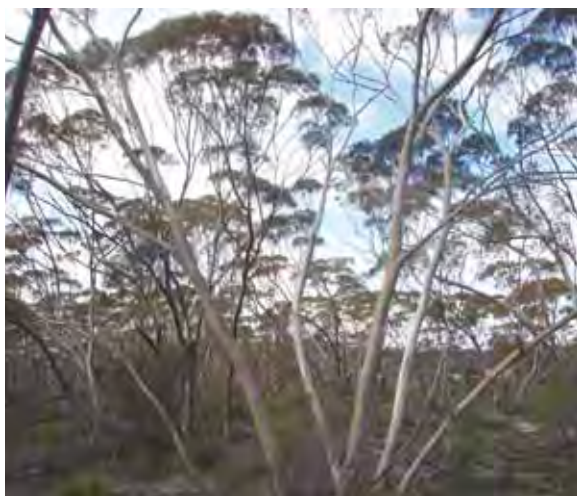
Photo A1.3: CR01

Excellent condition vegetation association 3: *Eucalyptus horistes* Very Open Tree Mallee over *Olearia dampieri*, *Acacia erinacea* Low Scrub.

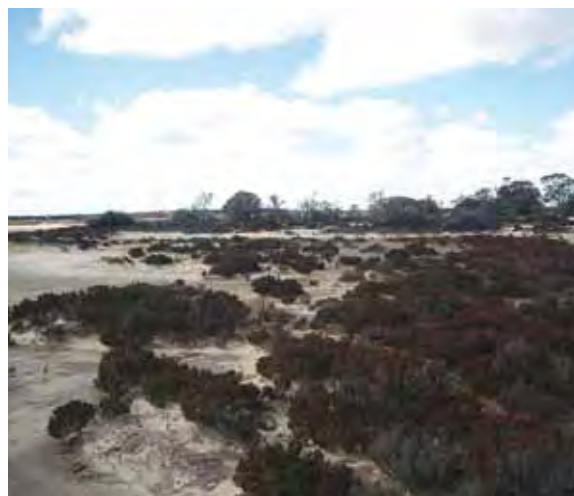
Photo A1.4: CR01

Good condition vegetation association 4: *Tecticornia* spp. Dwarf Scrub.

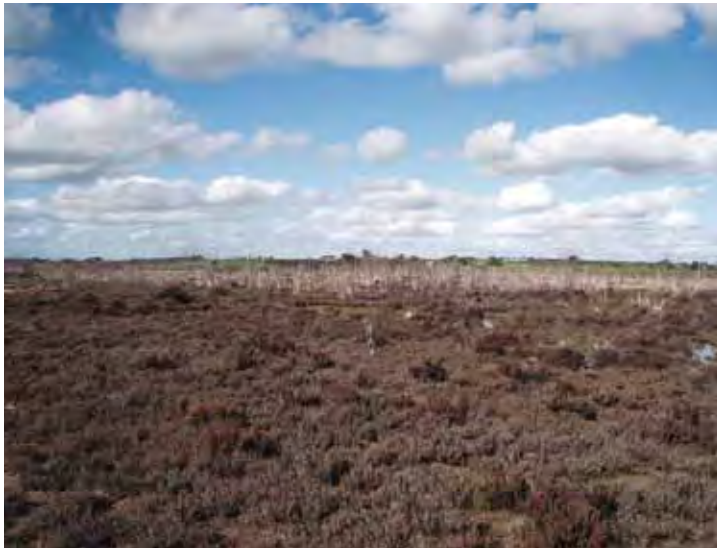
Photo A1.5: CR02
Degraded condition vegetation association 1: Tecticornia spp.
Low Heath (dead stems indicate different vegetation in the past).

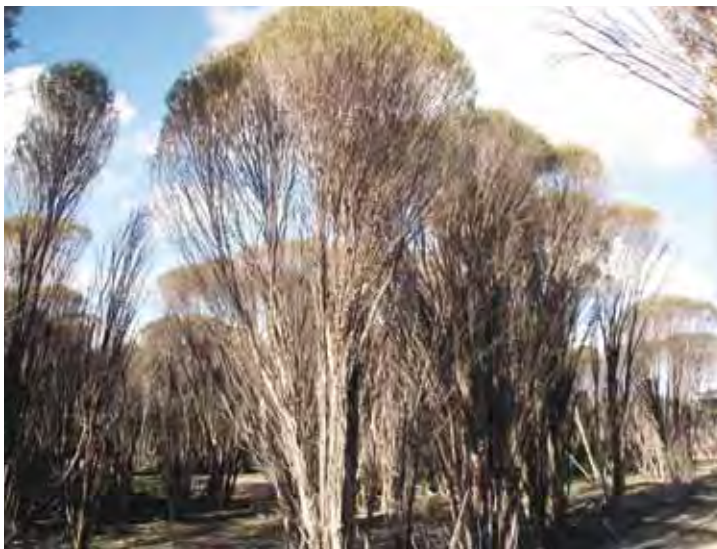
Photo A1.6: CR02
Good condition vegetation association 2: Melaleuca hamata
Low Woodland over *Rhagodia preissii* Low Open Low Scrub.

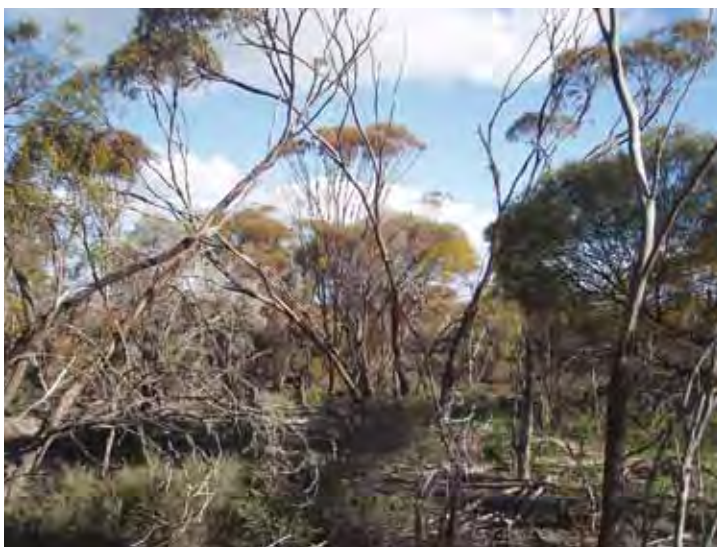
Photo A1.7: CR02
Very good condition vegetation association 3: Eucalyptus kondininensis Open Woodland over *Acacia acuminata* Open Low Woodland over *Melaleuca pauperiflora* and *Dodonaea viscosa* Open Scrub over Open Herbs.

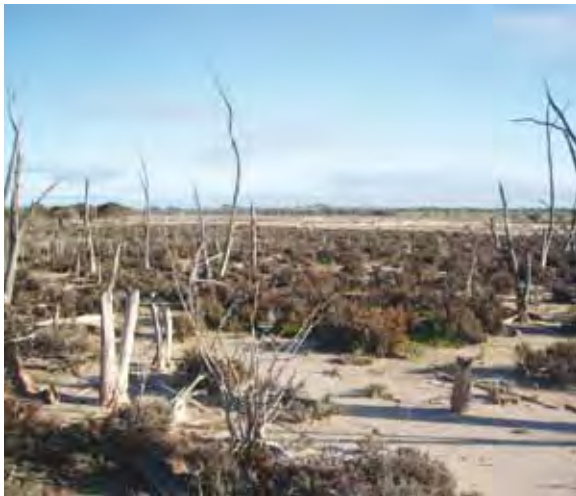
Photo A1.8: CR03
 Degraded condition vegetation association 1: *Tecticornia* spp. Dwarf Scrub over *Mesembryanthemum nodiflorum* Very Open Herbs.

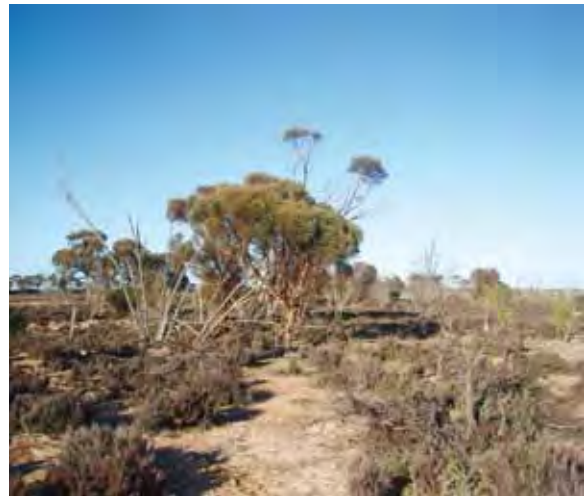
Photo A1.9: CR03
 Good condition vegetation association 2: *Melaleuca pauperiflora* Open Scrub with scattered *Eucalyptus spathulata* over *Lycium australe* Open Low Scrub over *Tecticornia* spp. Dwarf Scrub over Open Herbs.

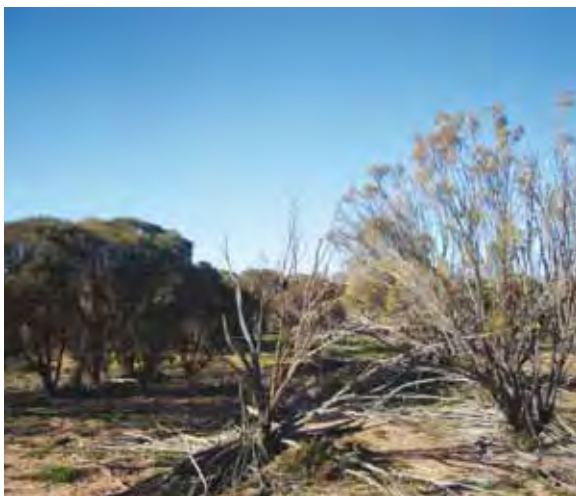
Photo A1.10: CR03
 Good condition vegetation association 3: *Melaleuca lateriflora* and *Melaleuca pauperiflora* Scrub over *Mesembryanthemum nodiflorum* Very Open Herbs.

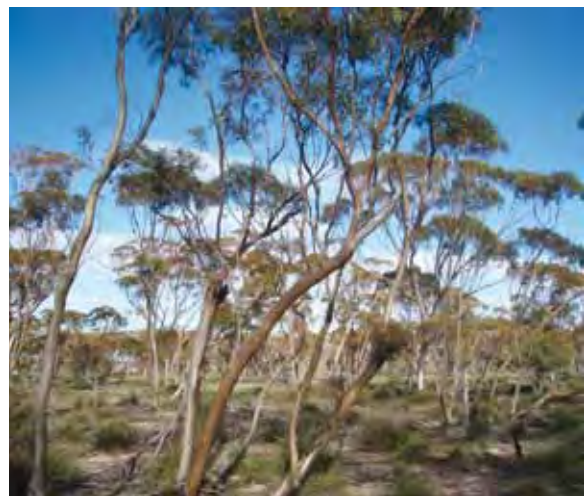
Photo A1.11: CR03
 Very good condition vegetation association 4: *Eucalyptus horistes* Very Open Tree Mallee over *Lomandra effusa* and mixed annual Very Open Herbs and *Neurachne alopecuroidea* Very Open Low Grass.

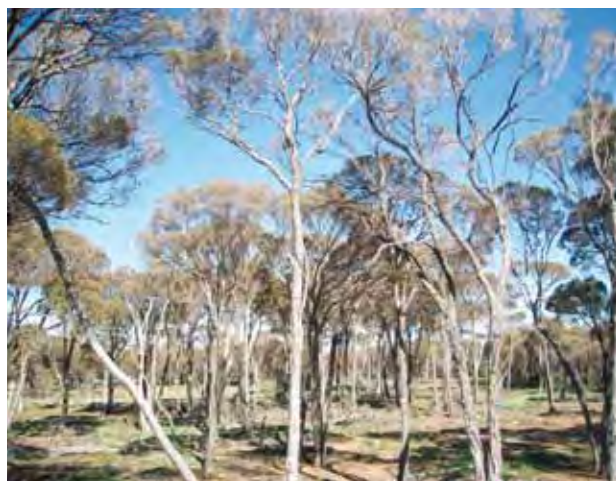
Photo A1.12: CR04
 Very good condition vegetation
 association 1: *Melaleuca pauperiflora*
 Open Scrub over Open Herbs.

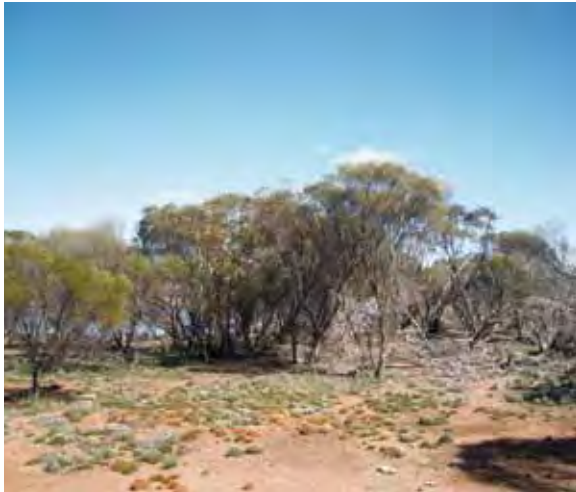
Photo A1.13: CR04
Excellent condition vegetation association 2: *Acacia acuminata* and *Allocasuarina campestris* Scrub over *Amphipogon strictus* Very Open Low Grass over *Borya constricta* Very Open Herbs.

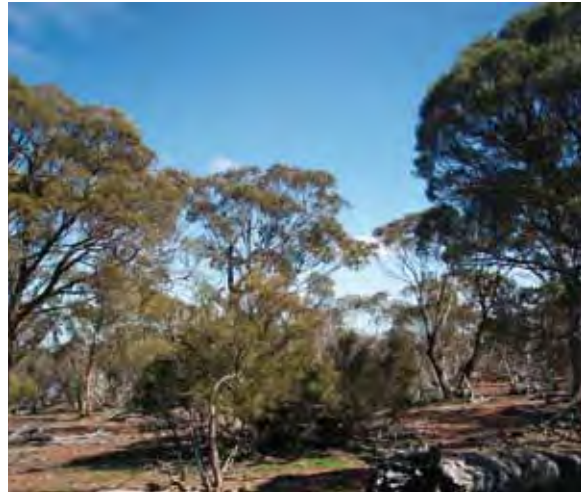
Photo A1.14: CR04
Very good condition vegetation association 3: *Eucalyptus myriadena* and *E. longicornis* Open Woodland over *Melaleuca pauperiflora* and *Exocarpos aphyllus* Open Low Woodland over Very Open Herbs (mostly introduced).

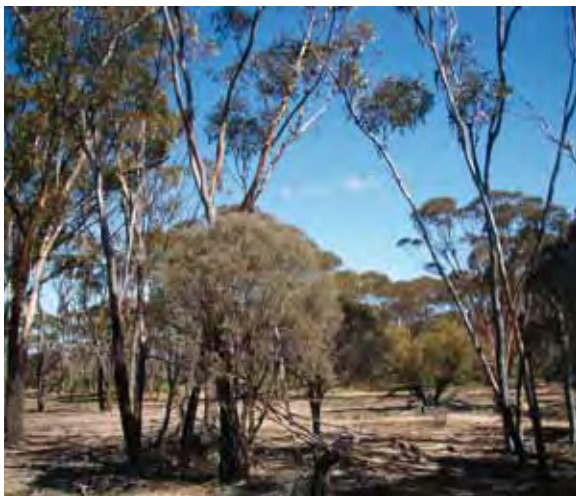
Photo A1.15: CR04
Very good to Excellent condition vegetation association 4: *Eucalyptus salmonophloia*, *E. longicornis*, *E. salubris*, *E. kondininensis*, *E. loxophleba* subsp. *gratae* and *E. myriadena* Open Woodland over *Melaleuca pauperiflora* and *Exocarpos aphyllus* Open Low Woodland over Very Open Herbs.

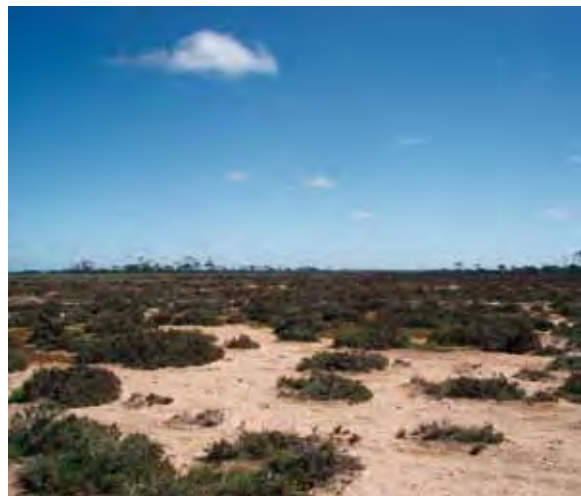
Photo A1.16: CR04
Completely degraded vegetation association 5: *Tecticornia* sp. Open Dwarf Scrub over *Mesembryanthemum nodiflorum* Very Open Herbs.

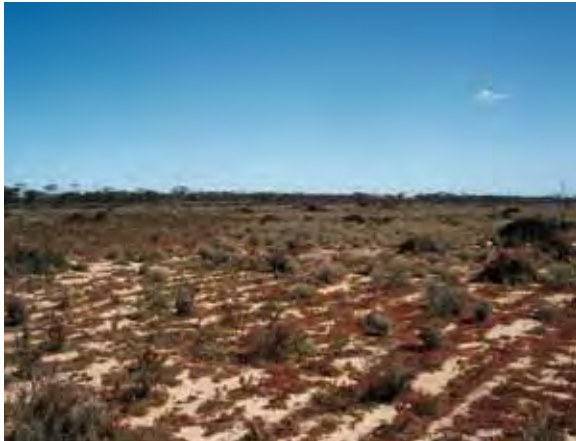
Photo A1.17: CR05
Completely degraded vegetation association 1: *Tecticornia* sp., *Maireana brevifolia*, *Atriplex paludosa* Open Dwarf Scrub over *Mesembryanthemum nodiflorum* Open Herbs on a previously cleared area.

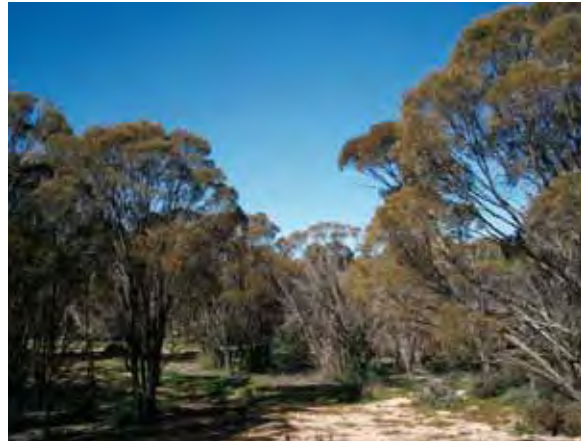
Photo A1.18: CR05
Very good condition vegetation association 2: *Melaleuca pauperiflora* and *M. lateriflora* Scrub over mixed annual Open Herbs.

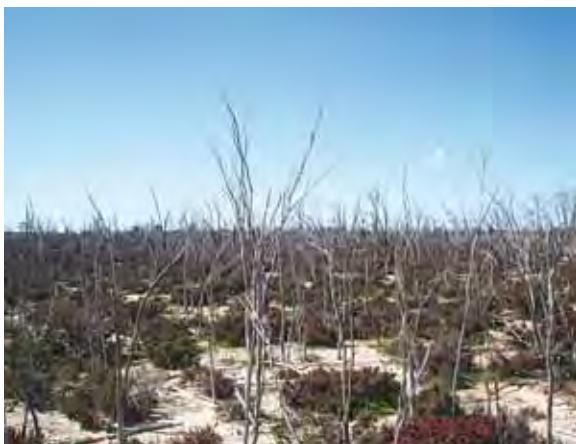
Photo A1.19: CR05
Completely degraded vegetation association 3: *Tecticornia* spp. Dwarf Scrub over *Mesembryanthemum nodiflorum* Open Herbs.

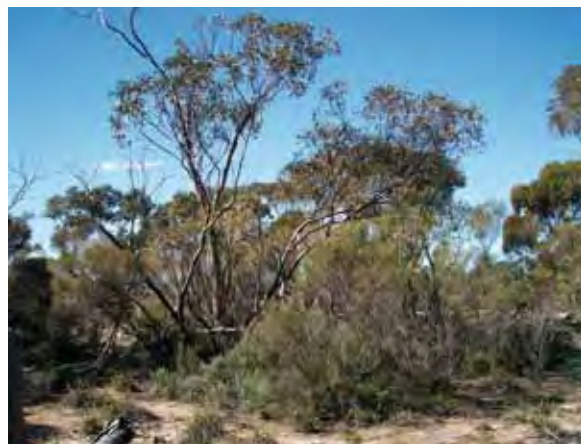
Photo A1.20: CR05
Excellent condition vegetation Association 4: *Eucalyptus loxophleba* and *E. salmonophloia* Open Woodland over *Melaleuca pauperiflora*, *M. acuminata*, *Hakea kippistiana* and *Santalum acuminatum* Open Low Woodland over *Scaevola spinescens* and *Rhagodia preissii* Open Low Scrub over *Lomandra effusa* Very Open Herbs.

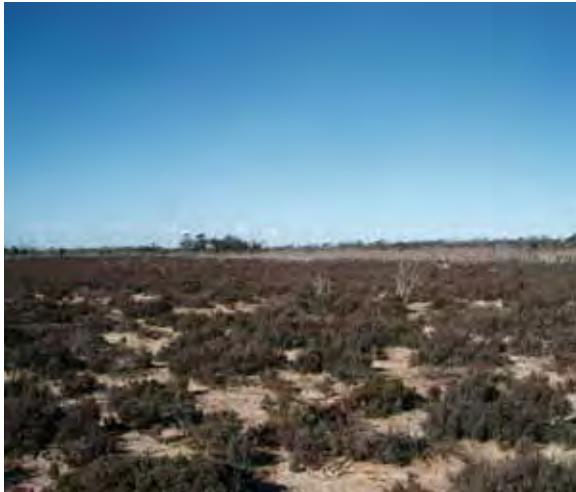
Photo A1.21: CR06
 Completely degraded vegetation association 1: *Tecticornia* spp. Dwarf Scrub over mixed introduced annual Very Open Herbs.

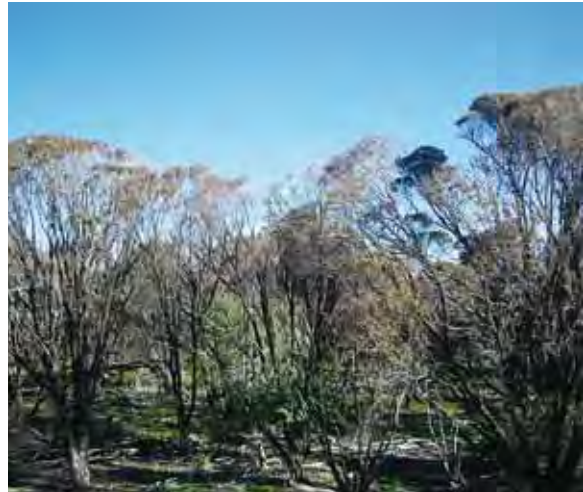
Photo A1.22: CR06
 Very good condition vegetation association 2: *Melaleuca lateriflora* and *M. pauperiflora* Scrub to 4 m with scattered *Eucalyptus spathulata* over mixed annual Herbs.

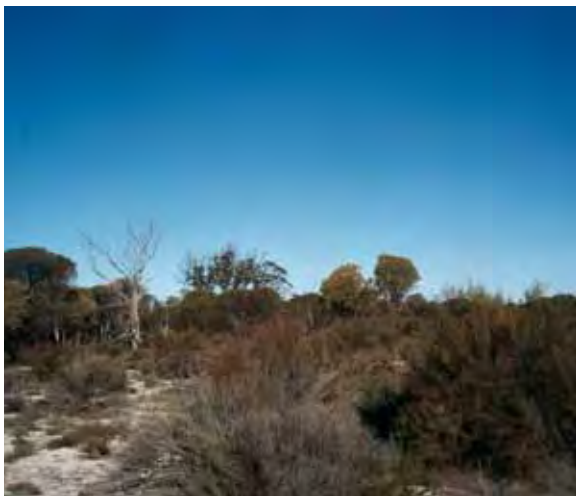
Photo A1.23: CR06
 Excellent condition vegetation association 3: *Grevillea anethifolia*, *Melaleuca uncinata*, *M. viminea* and *Darwinia halophila* Low Scrub over *Desmocladius asper* and *Lepidobolus chaetocephalus* Very Open Low Sedges.

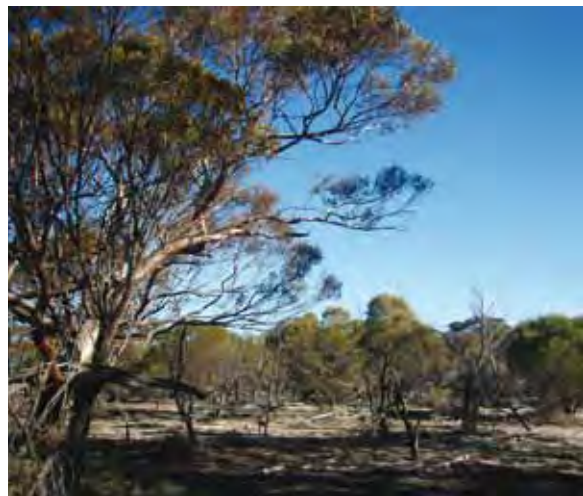
Photo A1.24:
 Very good condition vegetation association 4: *Eucalyptus spathulata* Open Woodland A over *Acacia acuminata* and *Santalum acuminatum* Open Low Woodland over *Rhagodia preissii* and *Leptospermum erubescens* Open Low Scrub.

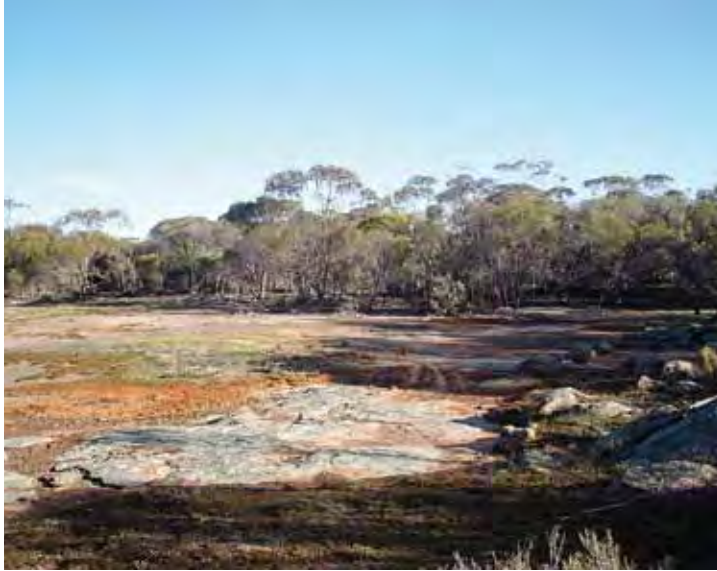
Photo A1.25: CR06

Excellent condition vegetation association 5: Mosaic of:

- *Eucalyptus loxophleba* Low Woodland over *Acacia acuminata* Scrub over mixed annual Open Herbs on deeper soils
- *Acacia acuminata* Open Low Scrub over *Verticordia chrysanthella* Open Dwarf Scrub over *Borya sphaerocephala*, *B. laciniata* and *Drosera* spp. Herbs on soil around rocks
- *Allocasuarina campestris*, *Melaleuca elliptica* and *Grevillea anethifolia* Scrub over mixed annual Open Herbs.

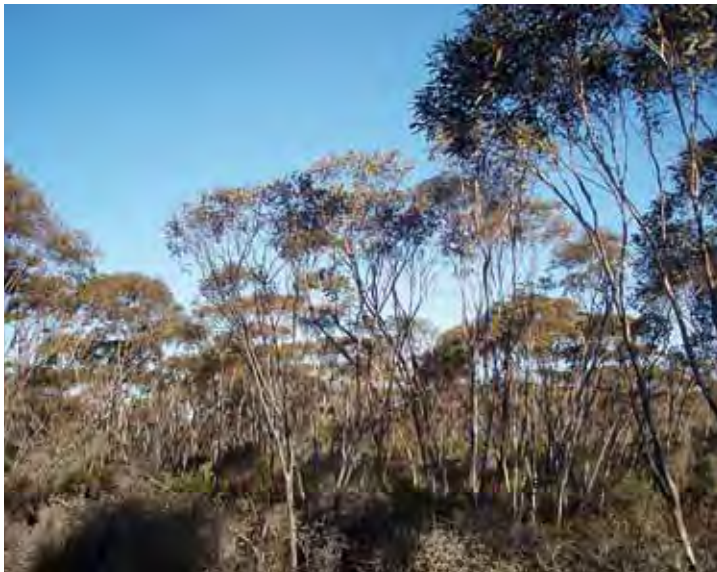
Photo A1.26: CR06

Excellent condition vegetation Association 6: *Eucalyptus*

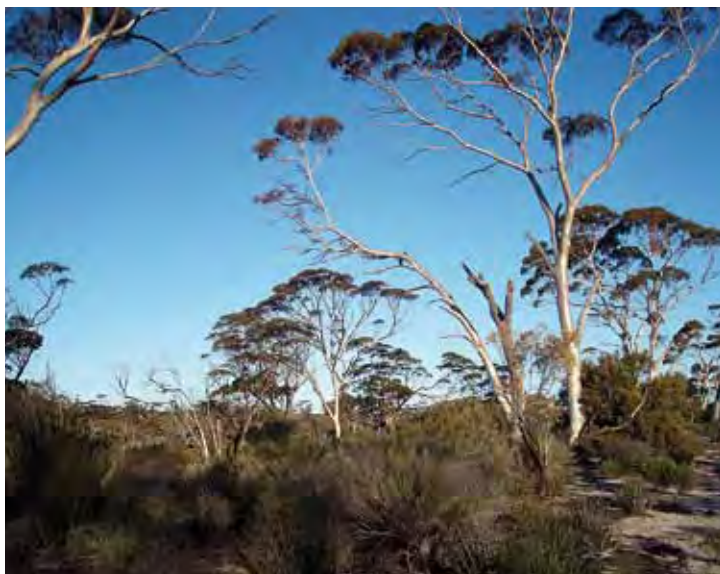
Photo A1.27: CR06
Excellent condition vegetation association 7: *Eucalyptus salicola* Open Low Woodland over *Dodonaea viscosa* subsp. *angustissima*, *Alyxia buxifolia* and *Hakea kippistiana* Scrub over *Rhagodia preissii* Open Dwarf Scrub over *Lomandra effusa* Very Open Herbs.

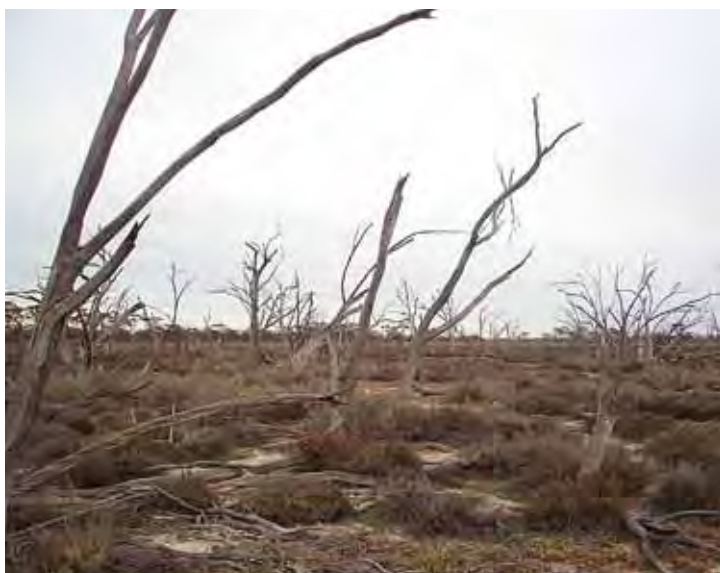
Photo A1.28: CR06
Degraded condition vegetation association 8: *Tecticornia* spp. and *Atriplex* sp Open Dwarf Scrub over *Disphyma crassifolium* Open Herbs (many dead tree stumps, possibly *E. myriadena*).

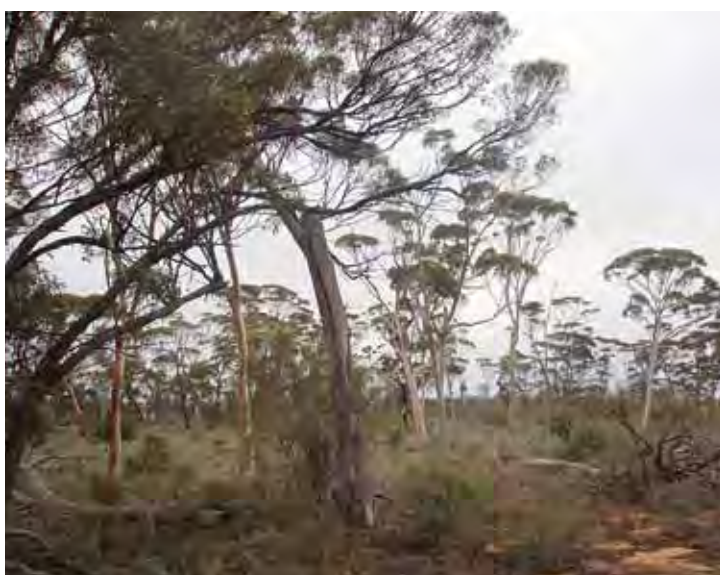
Photo A1.29: CR06
Very good condition vegetation Association 9: *Eucalyptus salmonophloia*, *E. longicornis* and *E. myriadena* Open Woodland over *Atriplex* sp., *Olearia muelleri*, *Scaevola spinescens*, *Rhagodia drummondii* and *Exocarpos aphyllus* Dwarf Scrub.

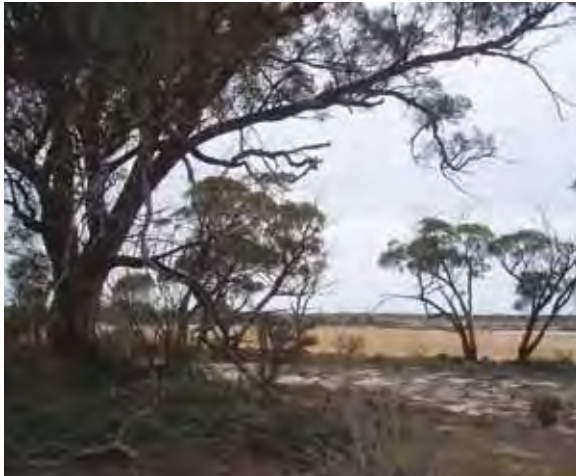
Photo A1.30: CR07

Very good condition vegetation association 1: *Eucalyptus spathulata* and *E. sargentii* Open Low Woodland over *Melaleuca uncinata* Open Scrub over *Dodonaea viscosa* subsp. *angustissima*, *Alyxia buxifolia* and *Exocarpos aphyllus* Open Scrub over *Rhagodia drummondii* Open Dwarf Scrub over *Disphyma crassifolia* Very Open Herbs.

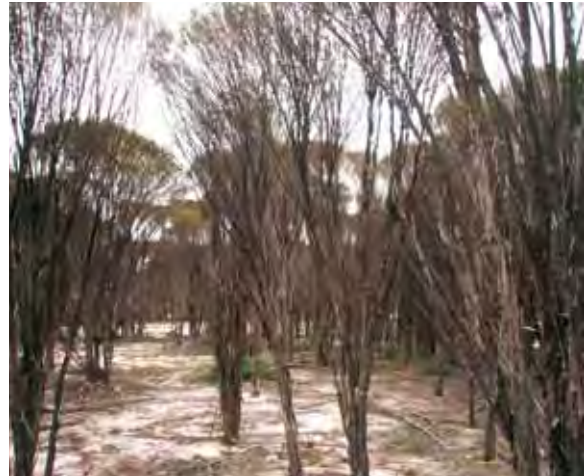
Photo A1.31: CR07

Very good condition vegetation association 2: *Melaleuca uncinata* Scrub over *Rhagodia drummondii* and *Maireana amoena* Open Dwarf Scrub over mixed Open Herbs.

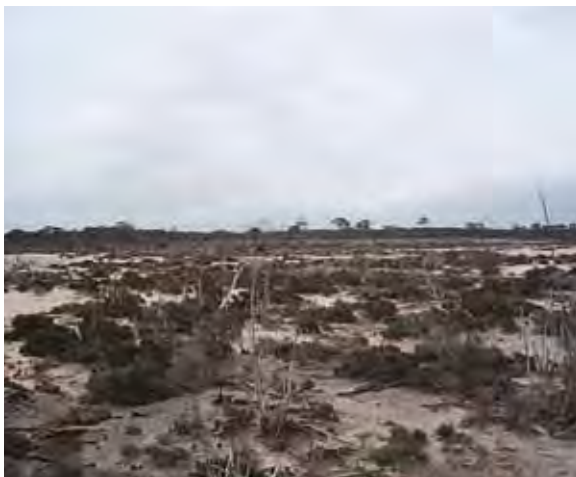
Photo A1.32: CR07

Degraded condition vegetation association 3: *Tecticornia* spp. Dwarf Scrub.

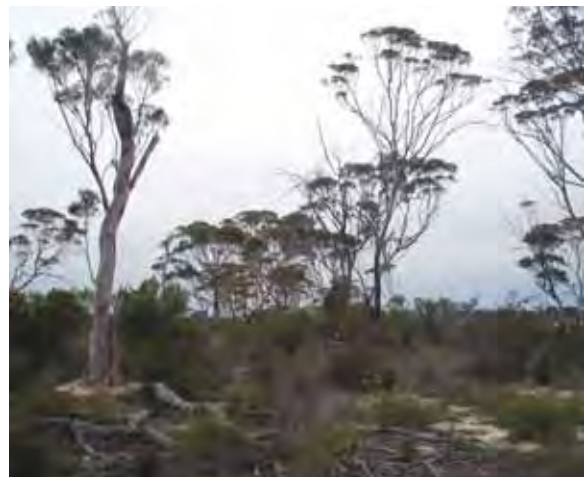
Photo A1.33: CR07

Excellent condition vegetation association 4: *Eucalyptus salicola* Open Low Woodland over *Dodonaea viscosa* subsp. *angustissima* and *Hakea preissii* Open Scrub over *Olearia dampieri*, *Westringia rigida* and *Platysace effusa* Dwarf Scrub over *Lomandra effusa* Very Open Herbs.

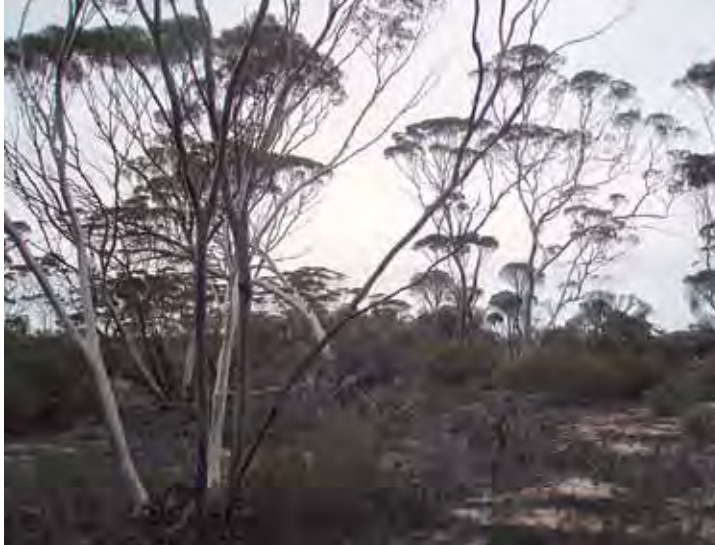
Photo A1.34: CR07
Excellent condition vegetation association 5: Eucalyptus salicicola Open Low Woodland over E. horistes Very Open Tree Mallee over Dodonaea viscosa subsp. angustissima, Trymalium daphnifolium and Baeckea sp. Open Low Scrub over Platysace effusa and Rhagodia drummondii Dwarf Scrub over Lomandra effusa Very Open Herbs.

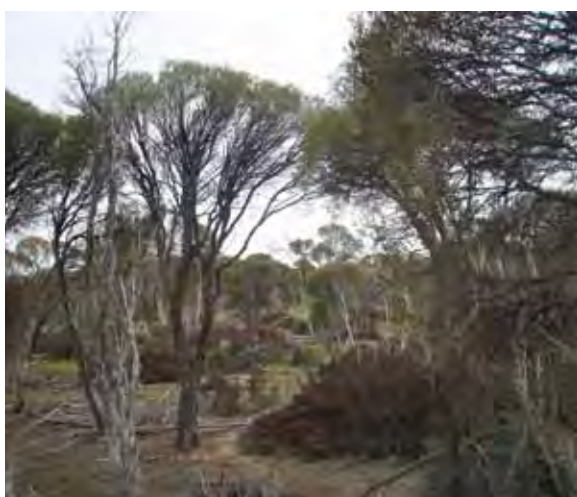
Photo A1.35: CR08
Degraded condition vegetation
Association 1: *Melaleuca lateriflora*
and *M. acuminata* Open Scrub over
Tecticornia spp. Open Dwarf Scrub over
mixed annual Open Herbs.

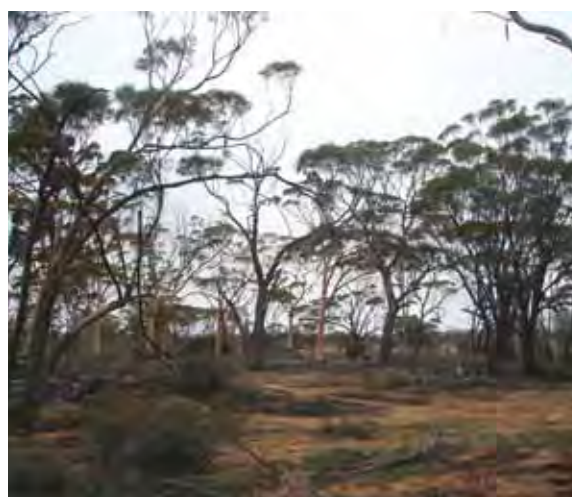
Photo A1.36: CR08
Very good vegetation association
2: *Eucalyptus myriadena*,
E. salmonophloia and *E. loxophleba*
Open Woodland over *Olearia muelleri*
Open Low Scrub over *Angianthus*
tomentosus and *Brassica tournefortii*
Very Open Herbs over *Austrostipa* sp.
Very Open Tall Grass.

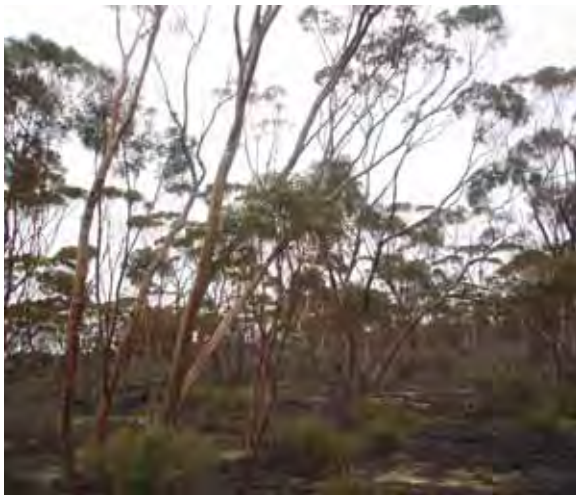
Photo A1.37: CR08
Excellent condition vegetation association 3: *Eucalyptus horistes* Very Open Tree Mallee over *Olearia dampieri* Open Low Scrub over *Lomandra effusa* Very Open Herbs.

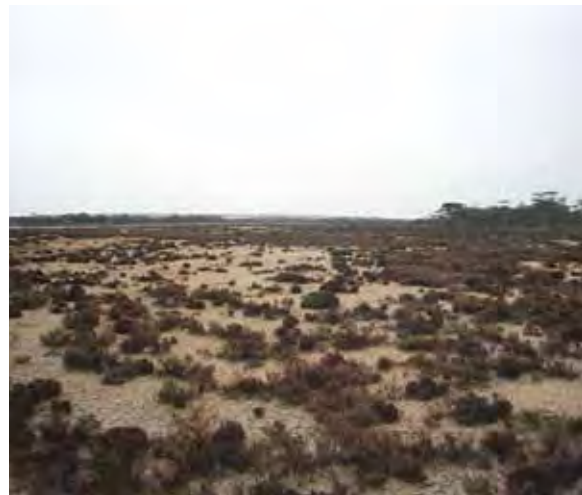
Photo A1.38: CR08
Degraded condition vegetation association 4: *Tecticornia* spp. Dwarf Scrub over *Mesembryanthemum nodiflorum*, *Cotula bipinnata* Very Open Herbs and *Parapholis incurva* Very Open Low Grass.

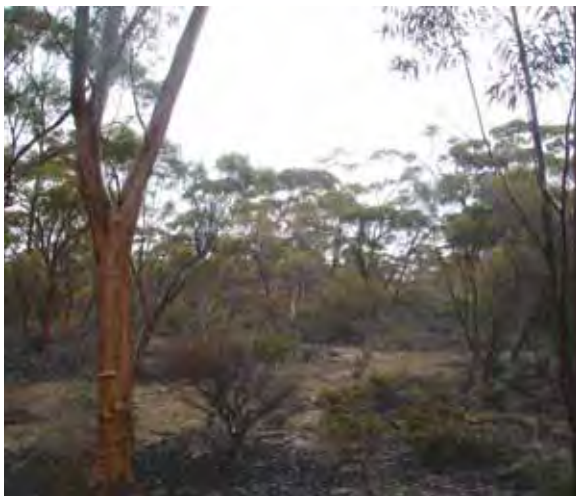
Photo A1.39: CR08
Excellent condition vegetation association 5: *Eucalyptus salubris* Open Low Woodland over *Melaleuca acuminata*, *M. adnata* and *Dodonaea viscosa* subsp. *angustissima* Open Scrub over *Acacia hemiteles*, *Grevillea acuaria* and *Olearia muelleri* Open Dwarf Scrub.

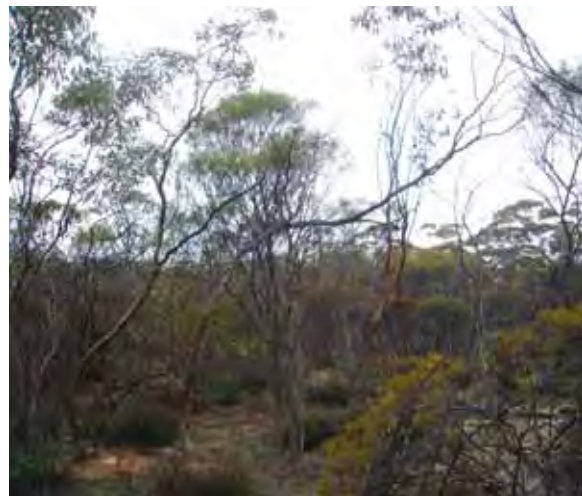
Photo A1.40: CR08
Excellent condition vegetation association 6: *Eucalyptus loxophleba* subsp. *gratiae* Very Open Tree Mallee over *Acacia acuminata* Open Low Woodland over *Melaleuca adnata* and *Leptospermum erubescens* Open Scrub over *Lepidosperma* spp. Very Open Low Sedges over *Amphipogon strictus* Very Open Low Grass over mixed annual Very Open Herbs.

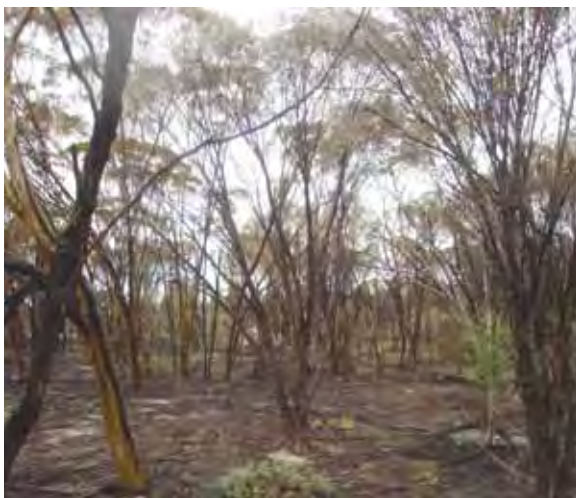
Photo A1.41: CR09

Very good condition vegetation association 1: *Eucalyptus alipes* Open Low Woodland over *Melaleuca atroviridis* Scrub over *Lycium australe* and *Rhagodia preissii* Open Low Scrub over Very Open Herbs.

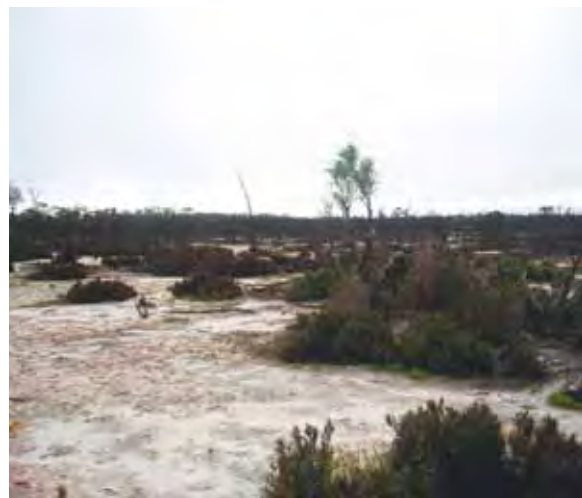
Photo A1.42: CR09

Completely degraded vegetation association 2: *Tecticornia* spp. Dwarf Scrub over *Mesembryanthemum nodiflorum*, *Senecio* sp. and *Hyalochlamys globifera* Open Herbs.

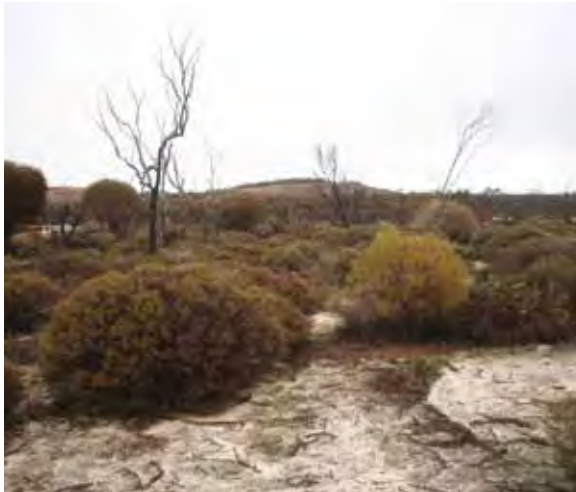
Photo A1.43: CR09

Very good condition vegetation association 3: *Eucalyptus celastroides* Open Low Woodland over *Acacia multispicata* and *Rhagodia drummondii* Open Low Scrub over *Darwinia halophila* Dwarf Scrub over *Lomandra effusa* and *Disphyma crassifolia* Very Open Herbs and *Gahnia trifida* Very Open Tall Sedges.

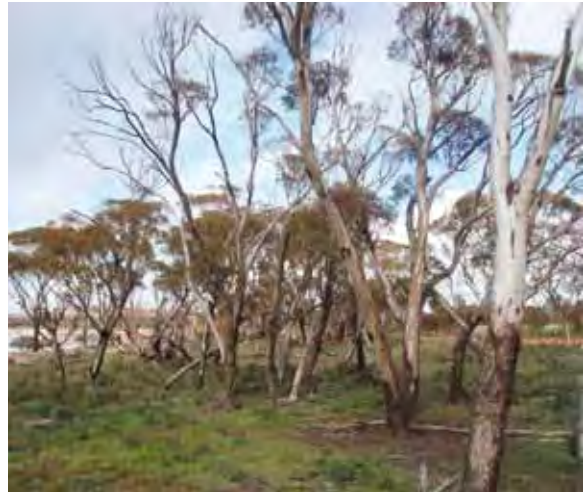
Photo A1.44: CR09

Good condition vegetation association 4: *Eucalyptus* sp. Open Low Woodland over *Maireana brevifolia* and *Enchylaena* sp. Open Dwarf Scrub over *Sclerolaena diacantha*, *Maireana carnososa* and *Mesembryanthemum nodiflorum* Open Herbs.

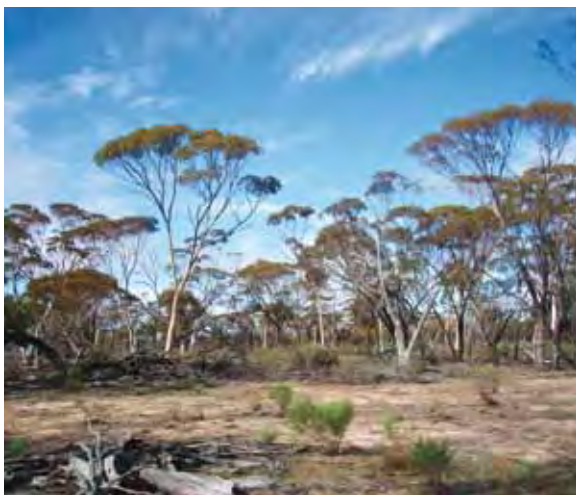
Photo A1.45: CR09

Very good condition vegetation association 5: *Eucalyptus myriadena* and *Eucalyptus salmonophloia* Open Woodland over *Olearia dampieri* and *Acacia hemiteles* Open Dwarf Scrub over Very Open Herbs.

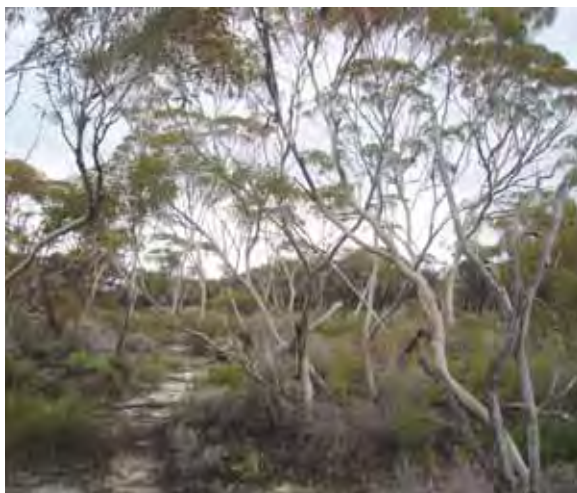
Photo A1.46: CR10
Excellent condition vegetation association 1: *Eucalyptus celastroides* Open Tree Mallee over *Platysace maxwellii*, *Pultenaea* sp. and *Rinzia crassifolia* Dwarf Scrub and *Gahnia trifida* Very Open Tall Sedges over *Lomandra effusa* Open Herbs.

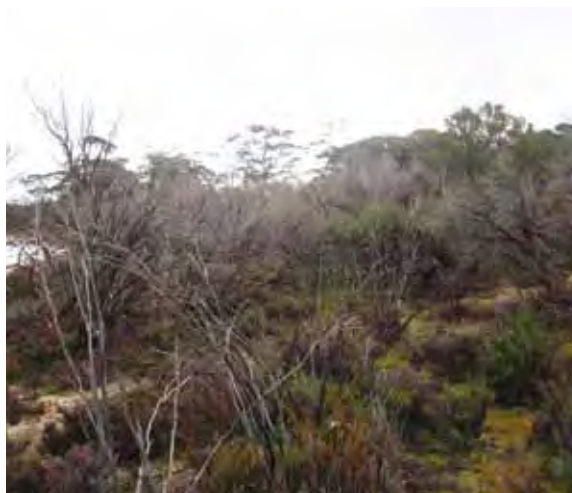
Photo A1.47: CR10
Degraded condition vegetation association 2: *Melaleuca thyoides* Open Scrub over *Tecticornia* spp. Dwarf Scrub over *Gunniopsis septifraga*, *Crassula colorata* and *Senecio* sp. Open Herbs.

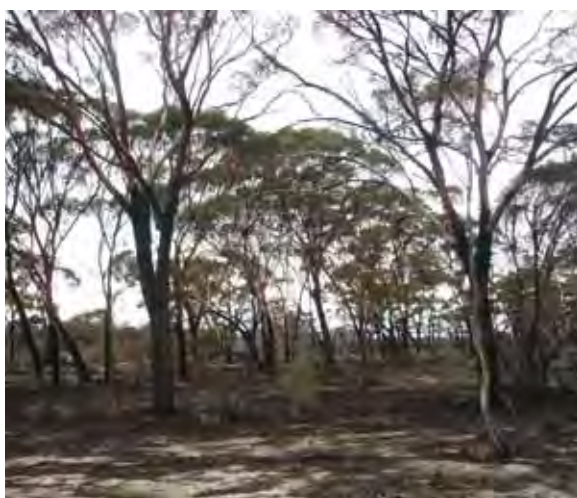
Photo A1.48: CR10
Very good condition vegetation Association 3: *Eucalyptus kondininensis* Low Woodland over *Rhagodia drummondii* Open Dwarf Scrub over Very Open Herbs.

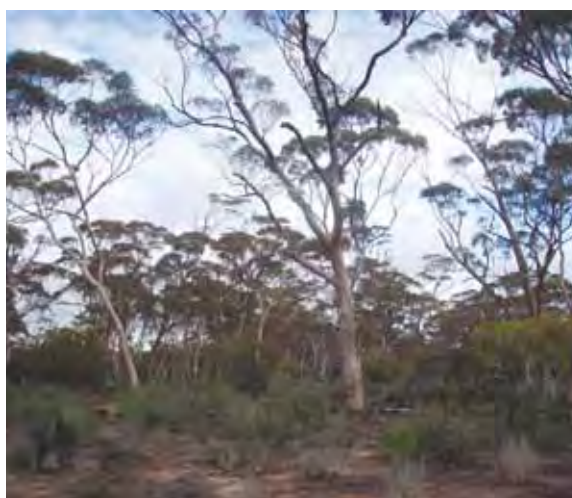
Photo A1.49: CR10
Excellent condition vegetation Association 4: *Eucalyptus salmonophloia* and *E. kondininensis* Woodland over *Exocarpos aphyllus* and *Santalum acuminatum* Low Open Woodland over *Atriplex paludosa* and *Scaevola spinescens* Dwarf Scrub.

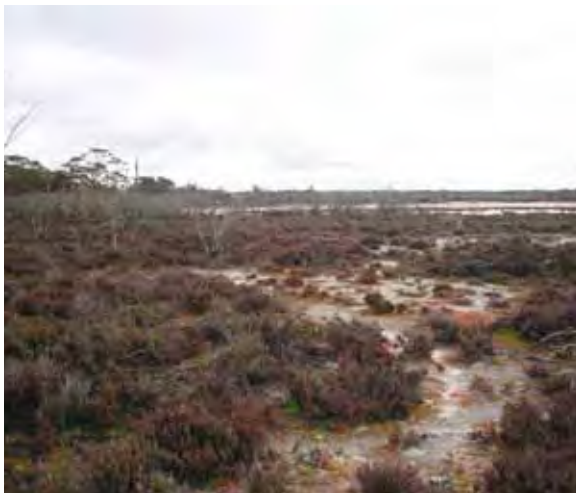
Photo A1.50: CR10
 Degraded condition vegetation association 5: *Tecticornia* spp. Dwarf Scrub over *Disphyma crassifolia* and annuals Open Herbs.

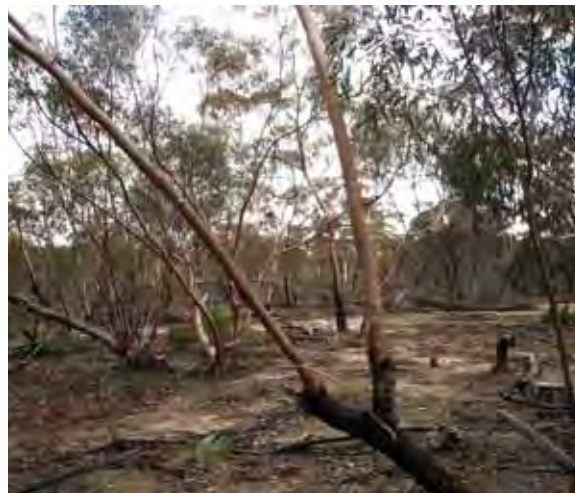
Photo A1.51: CR10
 Good condition vegetation association 6: *Eucalyptus myriadena* Open Low Woodland over *Eucalyptus loxophleba* subsp. *gratiae* Open Tree Mallee over *Lomandra effusa* Open Herbs.

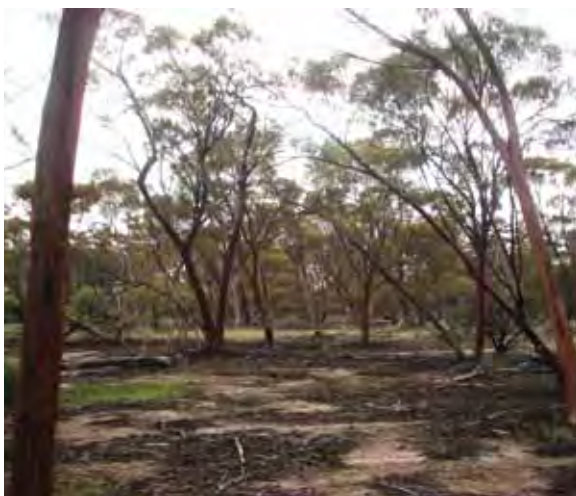
Photo A1.52: CR10
 Good condition vegetation association 7: *Eucalyptus salubris* Open Woodland over *Melaleuca pauperiflora* and *Exocarpos aphyllus* Open Low Woodland over Very Open Herbs.

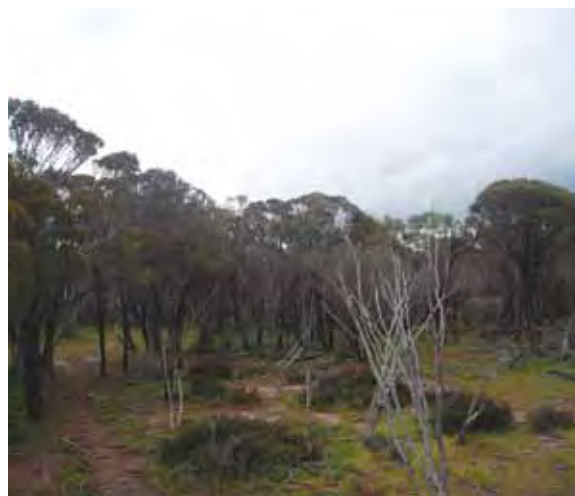
Photo A1.53: CR10
 Good condition vegetation association 8: *Melaleuca pauperiflora*, *M. lateriflora* and *M. acuminata* Thicket over *Enchylaena tomentosa*, *Tecticornia* spp. and *Maireana* sp. Open Dwarf Scrub over *Mesembryanthemum nodiflorum* Herbs.

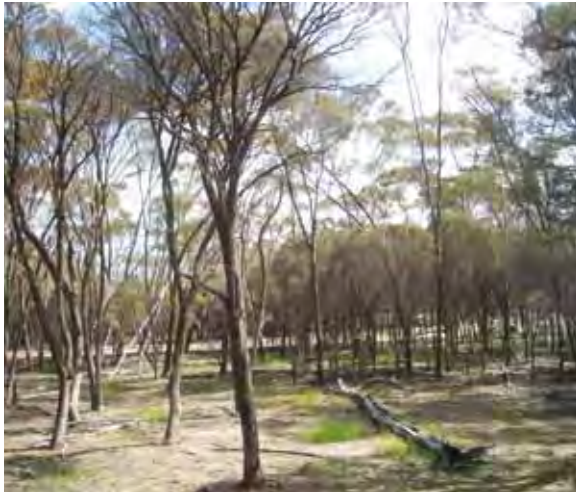
Photo A1.54: CR11
 Good condition (grazed) vegetation association 1: *Eucalyptus salubris* Open Woodland over *Melaleuca pauperiflora* Low Woodland over *Melaleuca acuminata* Open Scrub over Very Open Herbs.

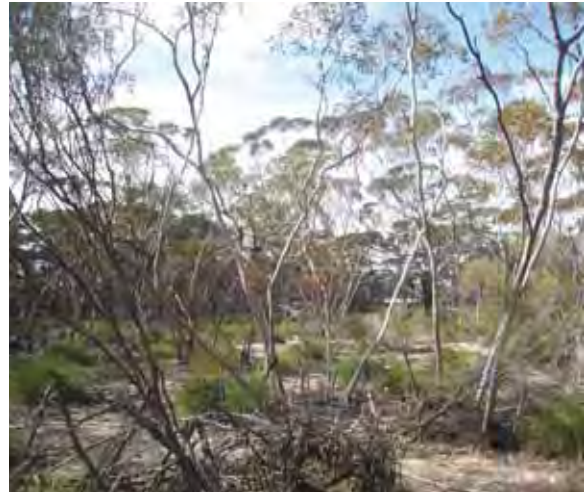
Photo A1.55: CR11
 Excellent condition vegetation association 2: *Eucalyptus sheathiana* and *E. celastroides* Open Shrub Mallee over *Lomandra effusa* and *Waitzia acuminata* Open Herbs.

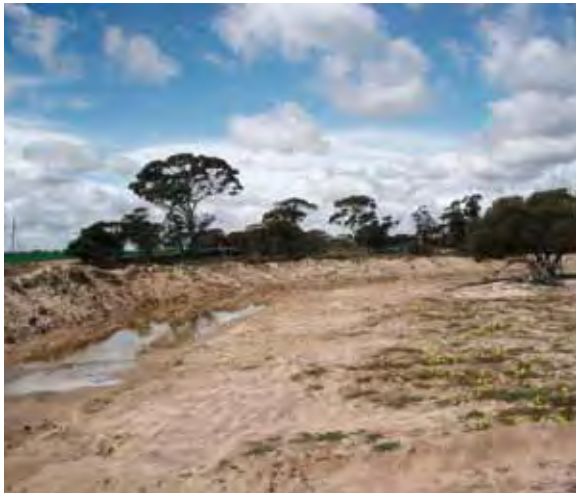
Photo A1.56: CR11
 Enhanced drainage line through site looking to the east.

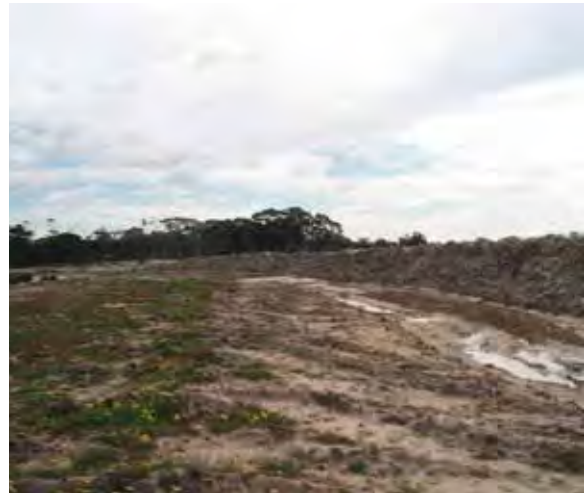
Photo A1.57: CR11
 Enhanced drainage line through site looking to the west.

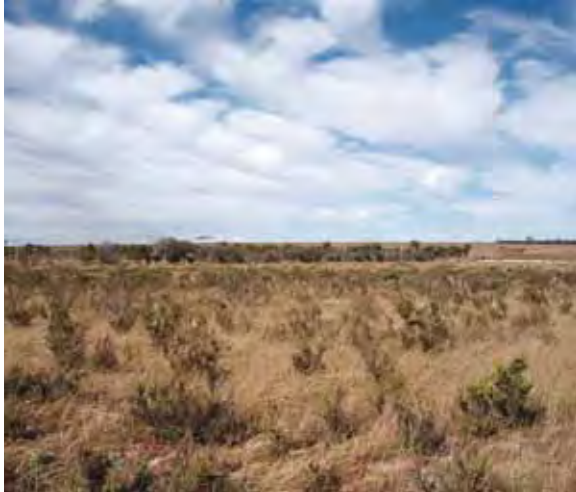
A1.58: CR12

Completely degraded condition
vegetation association 1: *Maireana
brevifolia* Dwarf Scrub over
Mesembryanthemum nodiflorum Open
Herbs and *Lolium rigidum* Low Grass.

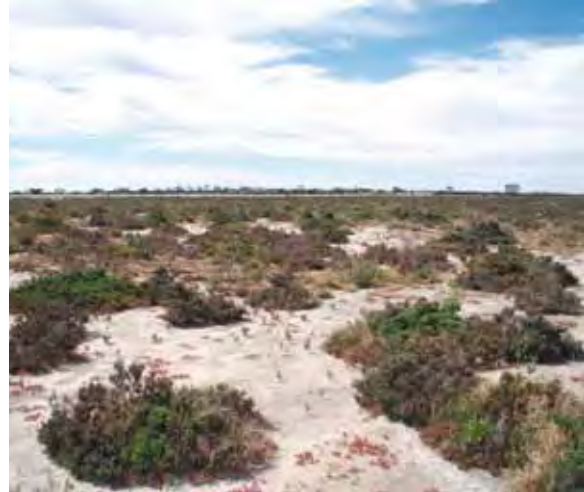
A1.59: CR12

Completely degraded vegetation
Association 2: *Tecticornia* spp. Dwarf
Scrub over *Mesembryanthemum
nodiflorum* Very Open Herbs and
Parapholis incurvata Very Open Low
Grass.

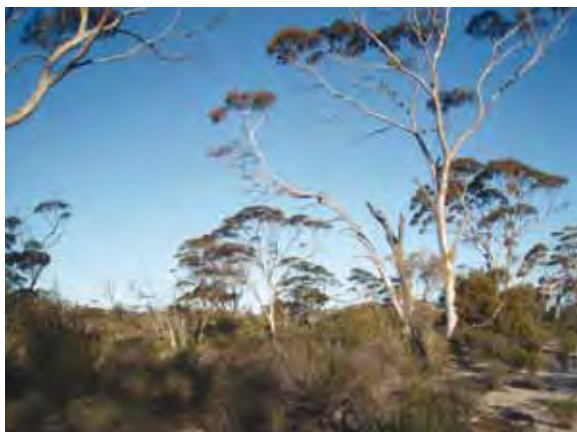
Photo A3.1: Excellent condition woodland, Karlgarin Lake (CR06 Vegetation Association 7).

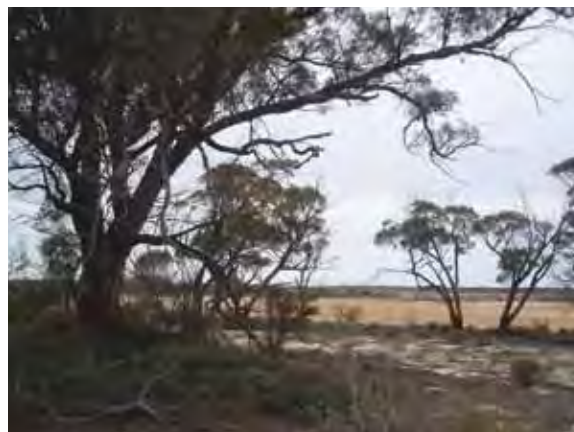
Photo A3.2: Very good condition open woodland, Lake Gounter Nature Reserve (CR07 Vegetation Association 1).

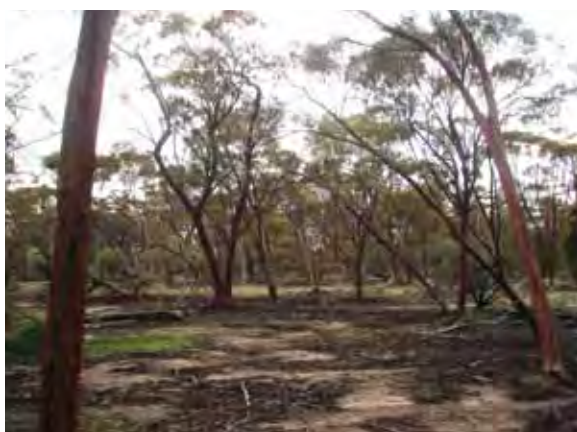
Photo A3.3: Good condition open woodland, CR10 (Vegetation Association 7).

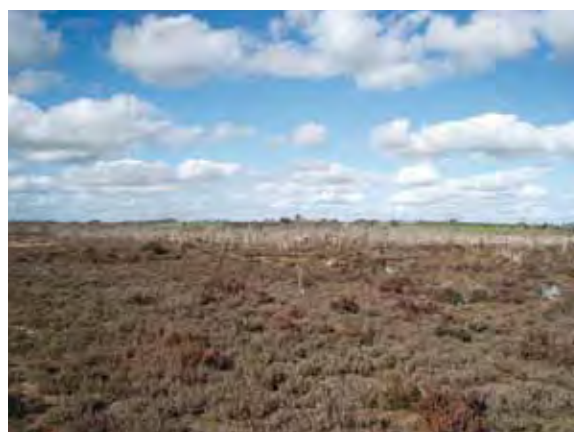
Photo A3.4: Degraded condition scrub, Henderer's (CR03 Vegetation Association 1).
