Waterway assessment of the Camm River: Lockhart River confluence to Hyden

Water resource management series
Looking after all our water needs

Report no. WRM 57
December 2009

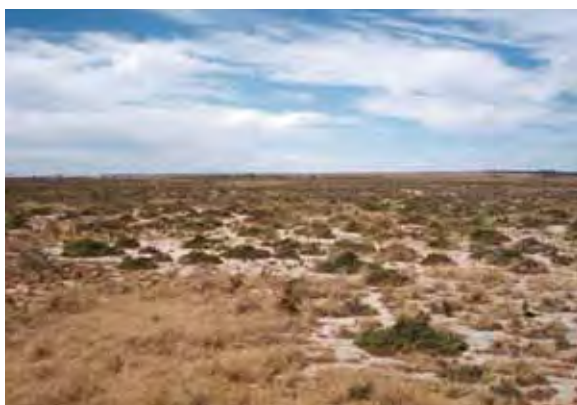
Photo A3.5: Completely degraded dwarf scrub, Di Russo's (CR12 Vegetation Association 1).

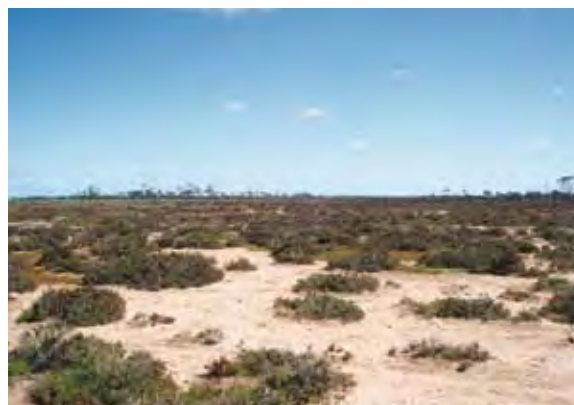
Photo A3.6: Completely degraded vegetation (formerly samphire), Weewarra (CR04 Vegetation Association 5).
