Wilyabrup Brook Action Plan

Wilyabrup Brook River Action

Prepared for the Cape to Cape Catchments Group (CCG)

November 2006

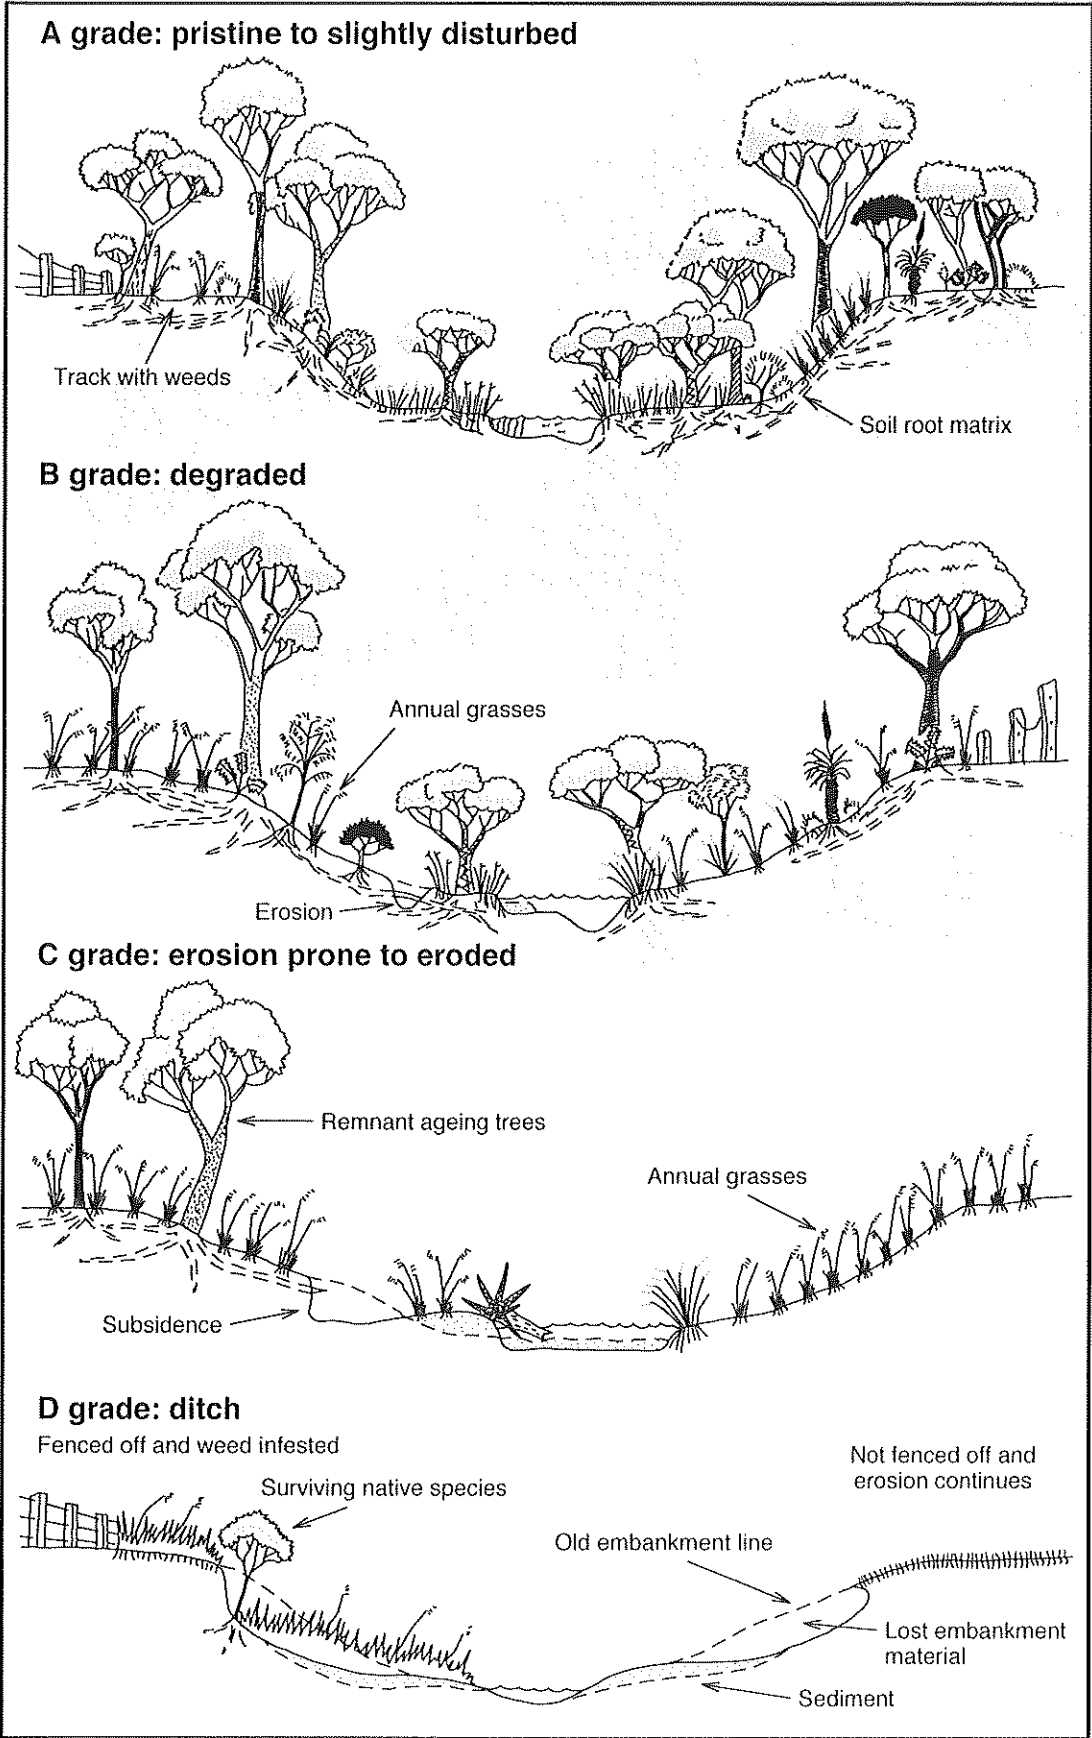
Figure 3: The four grades of river foreshore condition - (A) pristine to ditch (D).

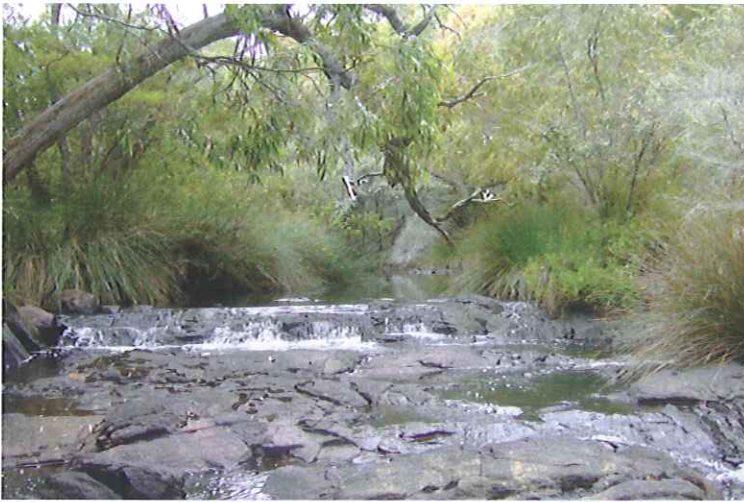
A grade foreshore: This riffle-pool sequence with intact overhanging native vegetation provides important habitat for aquatic organisms.

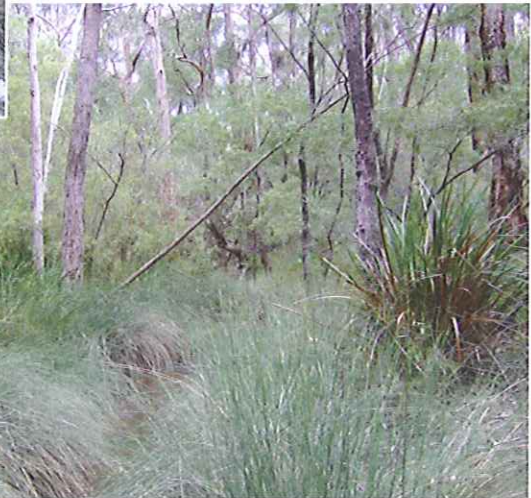
A grade foreshore: Native fringing vegetation protects the banks from erosion and traps contaminants before they reach the brook.

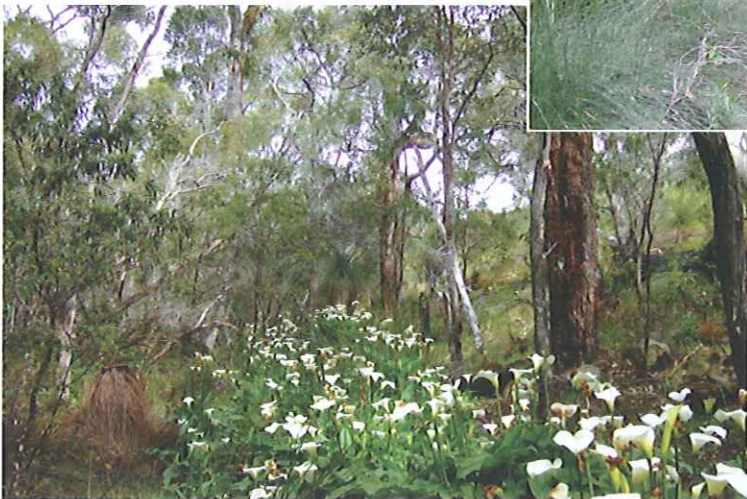
B1-B2 grade foreshore: Native vegetation is still dominant on the banks but arum lily has started to replace understorey species. Weeds will out-compete native species and provide limited habitat and food resources for native fauna.

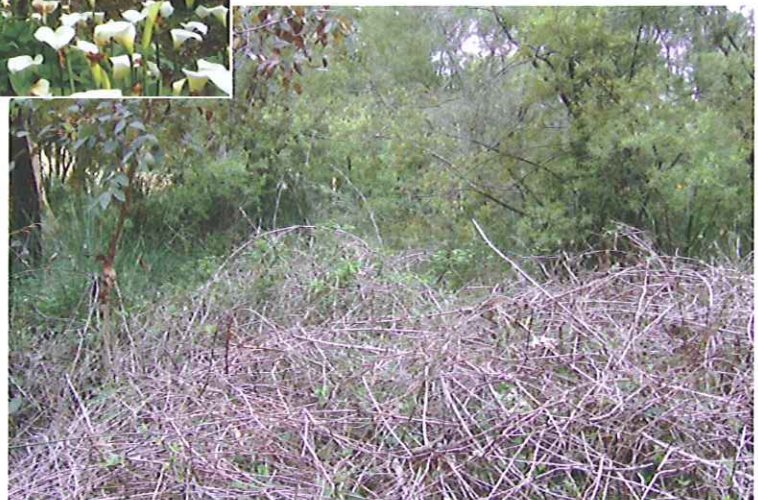
B1 grade foreshore: Once again native vegetation is dominant although blackberry is starting to smother areas restricting native plant growth. Blackberry not only threatens our bushland it also makes area inaccessible to people.

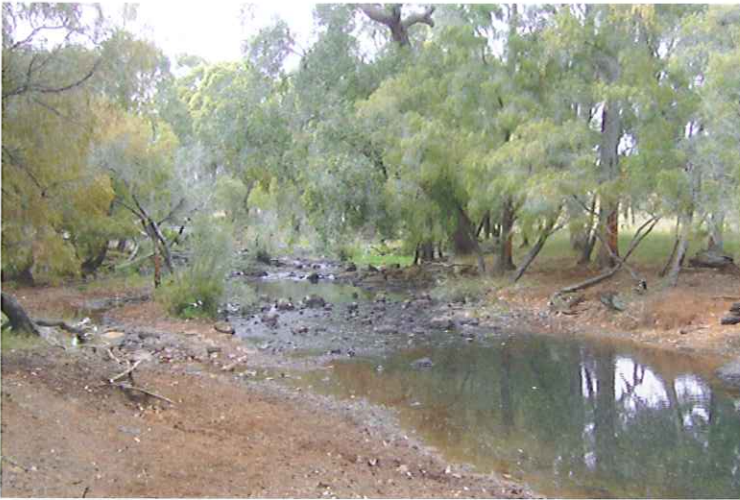
C2 grade foreshore: Stock have removed all understorey vegetation including grasses, exposing the soil to low level erosion.

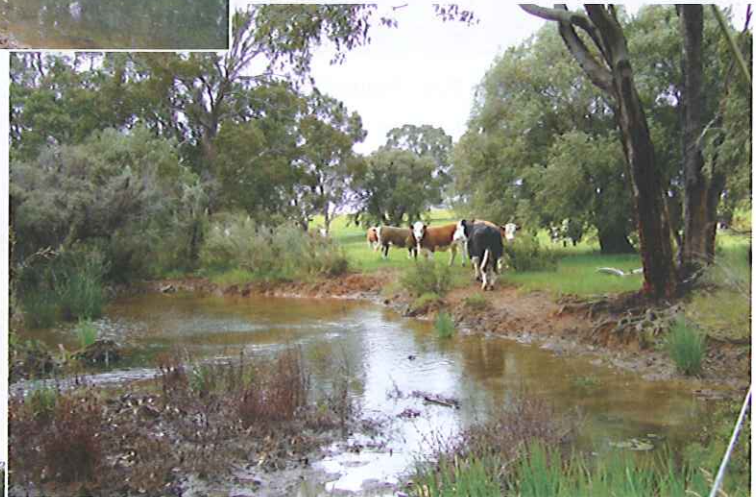
C1-C2 grade foreshore: Cattle have removed the grass and pugged the soil, allowing minor erosion.

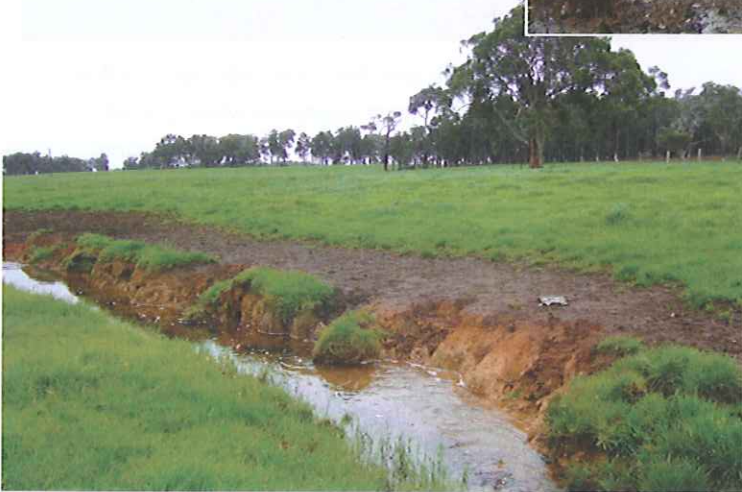
D2 grade foreshore: Stock have created a track on one side of the channel. The channel is freely eroding.

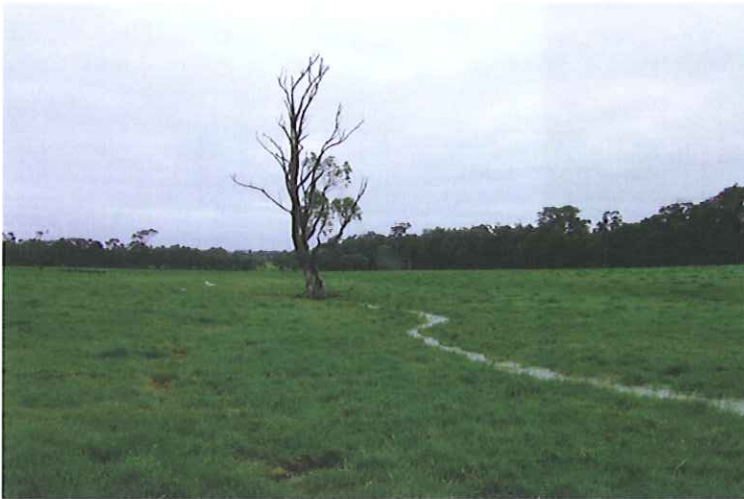
D3 grade foreshore: This low flow channel has complete perennial grass cover acting to prevent erosion.

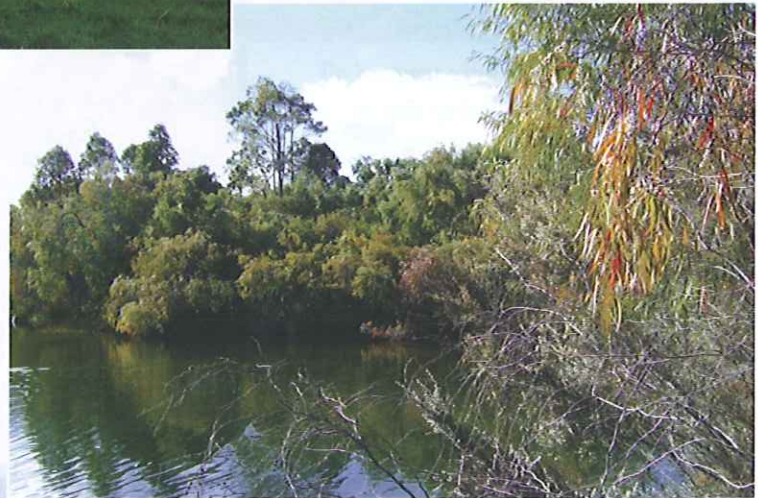
E1 grade foreshore: This dam has excellent native fringing vegetation which provides habitat for fauna and will trap pollutants before they enter the dam.

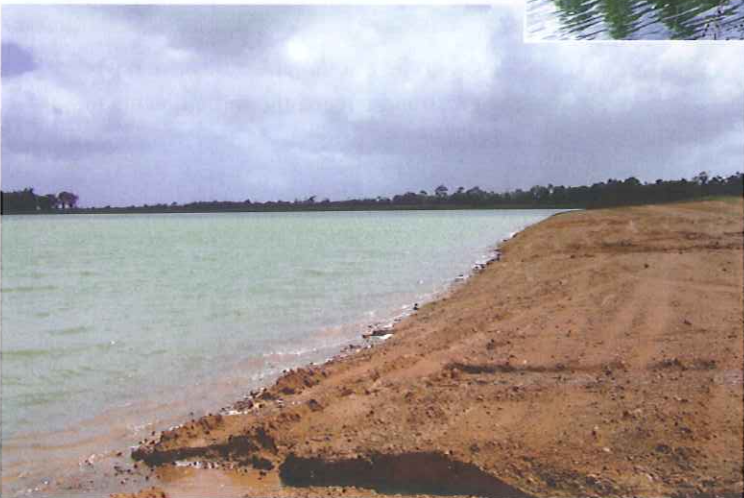
E2 grade foreshore: The banks of this dam are eroding in the absence of native fringing vegetation.

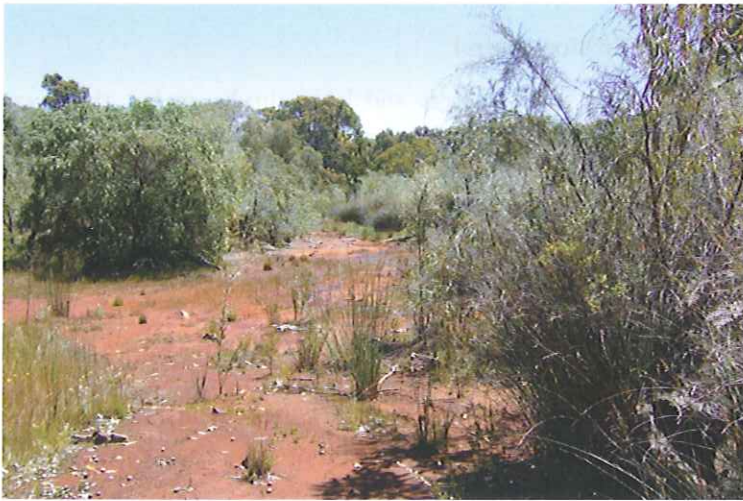
Scald near a dam in the Wilyabrup catchment, as described on p.23.

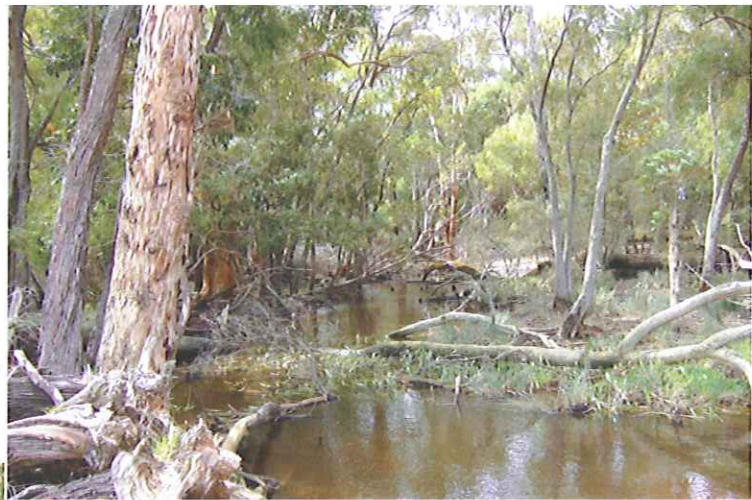
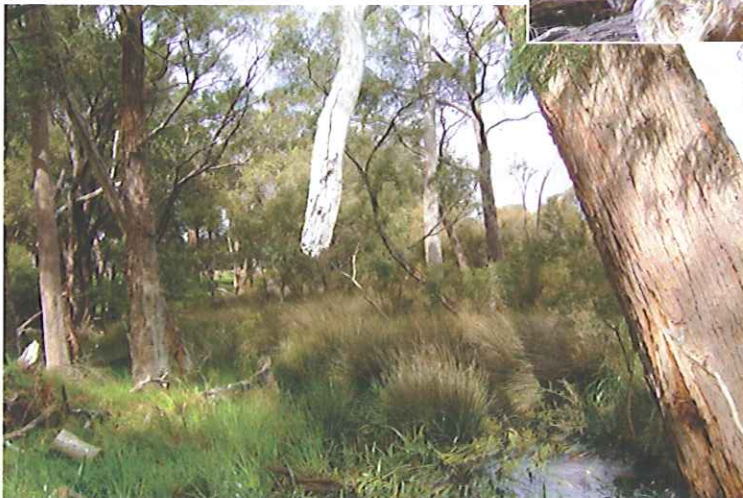
Unfenced vs Fenced: The picture above is unfenced and immediately downstream of the picture left which has been fenced for approximately 12 months. You can see the regeneration of rushes and sedges.

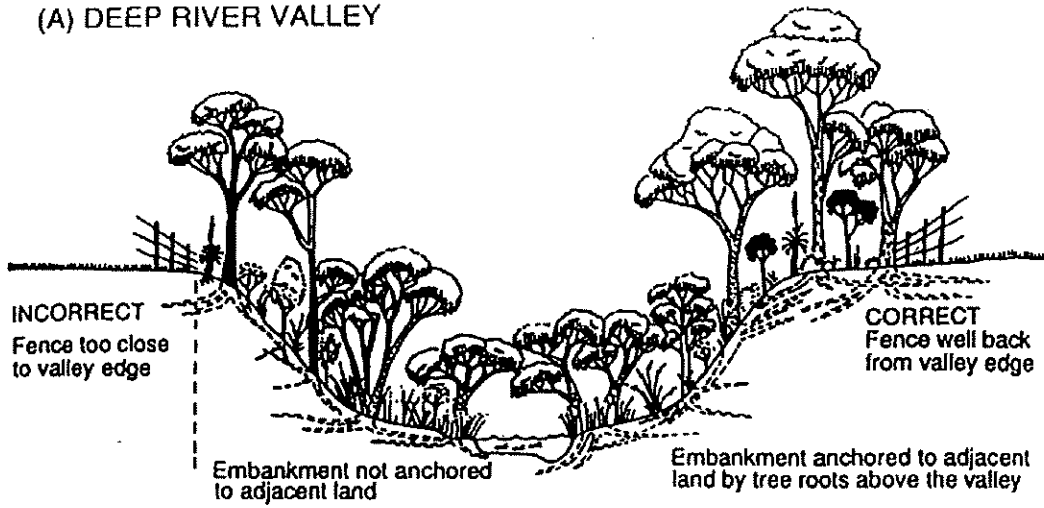
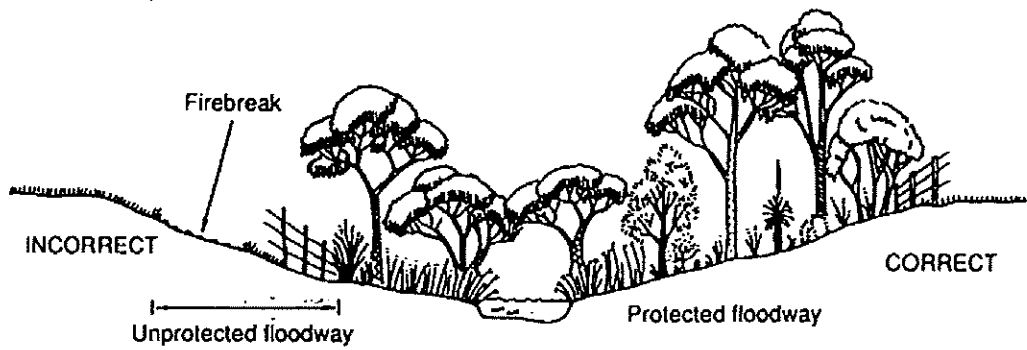
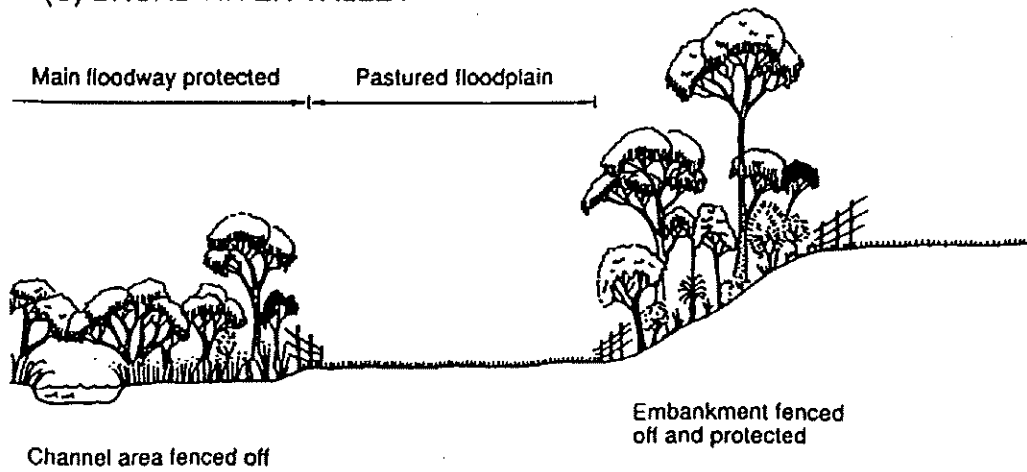
Figure 4: The correct placement of fences in relation to the river valley: (A) the deep river valley, (B) the shallow river valley and (C) the broad river valley with broad floodplain (APACE Green Skills & Pen, 1995).

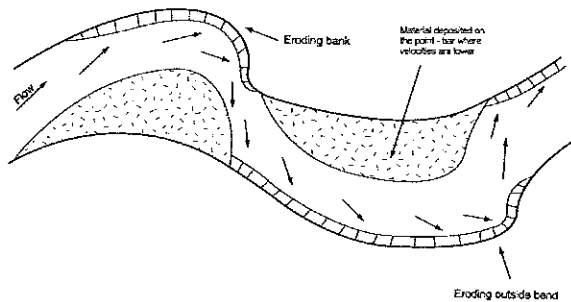
Figure 5: Outside bend bank erosion – Arrows mark the direction of flow showing that outside bends have the greatest erosion potential, so the meanders migrate downstream (Raine & Gardiner, 1995).

are located and shaped in such a way that they actually divert the stream flow onto the opposite bank further downstream, thus creating a new erosion point on the next outside bend. This cycle of erosion and deposition often continues downstream, and is a classic sign of a stream in which the hydrological balance has been disturbed (Figure 5).

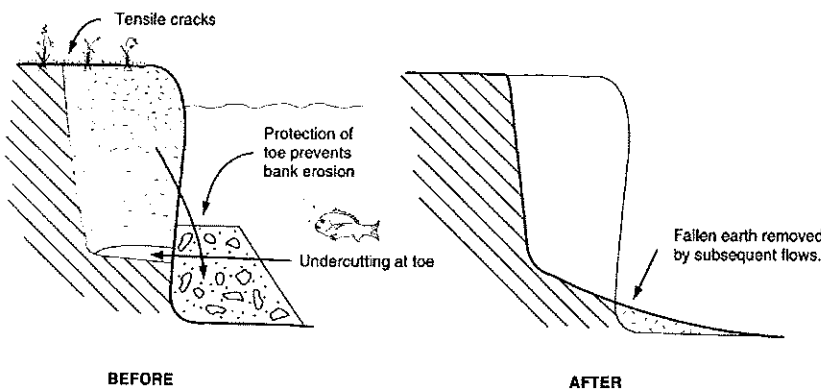
Figure 6: The use of structural works, such as a rock toe, will prevent the process of undercutting (adapted from Raine & Gardiner, 1995).

prevent undercutting. Generally undercutting will occur where there is a meander. If this is the case, only the outside bends need to be supported as the flow velocity on the inside bend is much lower. Once an outside bend is stabilised, the corresponding inside bend will usually adjust its width to cater for the change in flow.

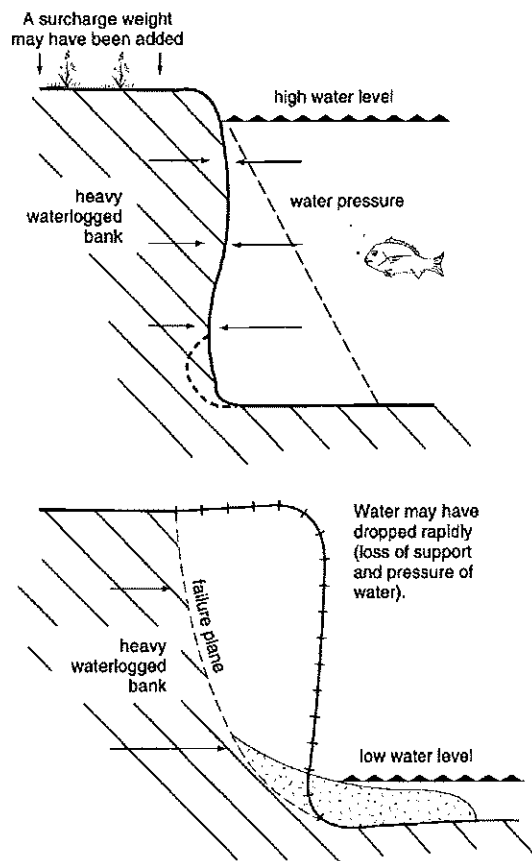
Figure 7: The process of bank slumping caused by excessive weight and lack of support (adapted from Raine & Gardiner, 1995).

Bank slumping can occur when poorly drained material within the bank becomes heavy with saturation and collapses into the stream channel (Figure 7). This can occur with or without prior undercutting. It will often occur in response to the loss of native deep-rooted riparian vegetation which is critical to bank stability. The best ways to manage this problem are to exclude stock with fencing set well back from the

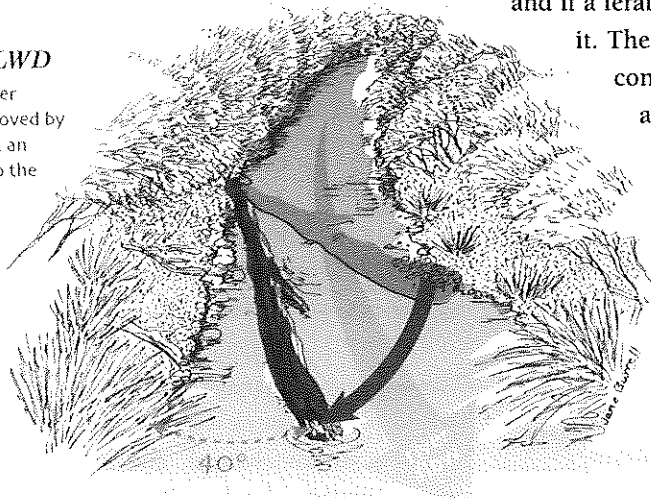
The capacity of a river channel can be improved by rotating the LWD at an angle of 20° – 40° to the streambank.

Figure 8: Repositioning large woody debris (Gippel et al., 1998).

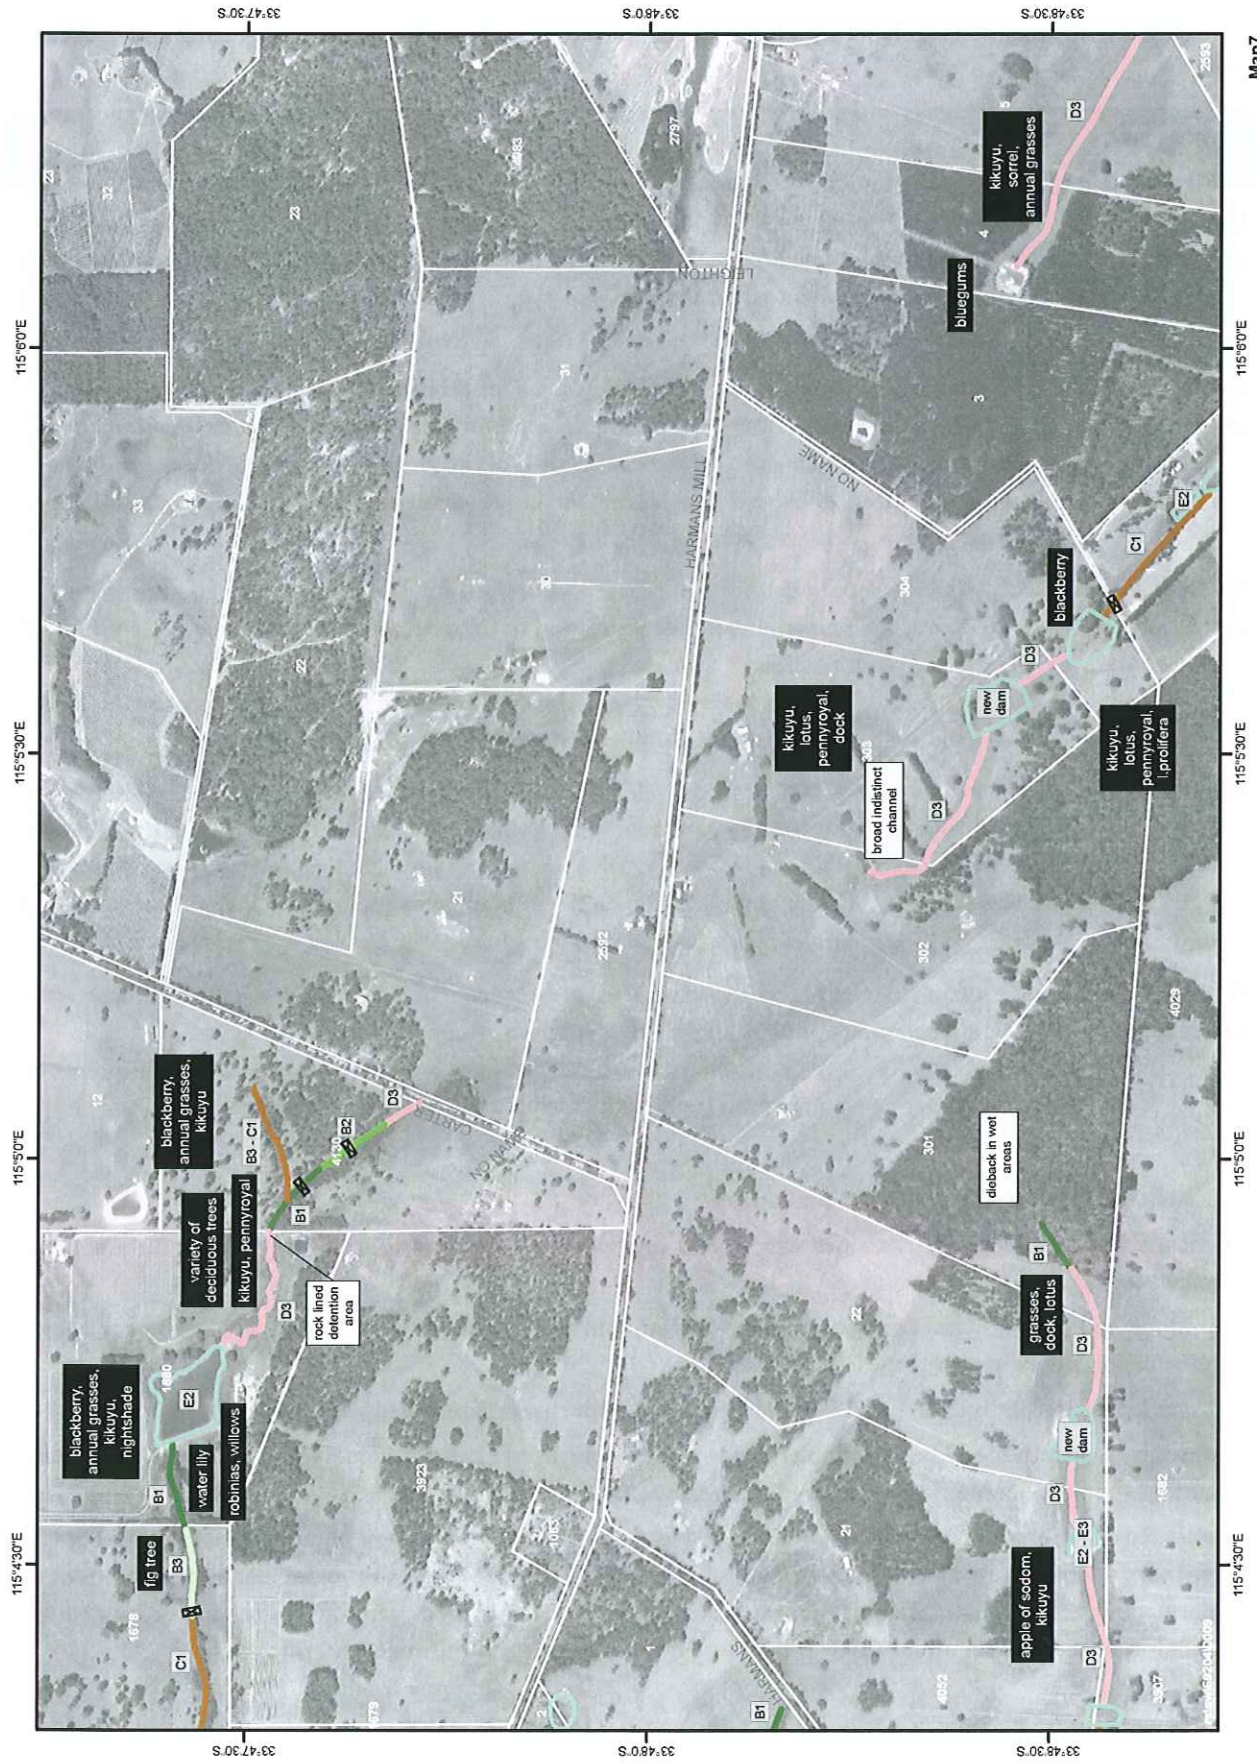
Wilyabrup Brook Map 7

- Robinias and willows are suckering on Location 1680 and need careful management to ensure they do not spread onto neighbouring properties.
- Assist regeneration of native vegetation and expand the riparian zone through planting of local native species. Appendix 1 contains a list of local species suitable for planting. See Section 6 for detailed techniques and information. In particular, establishing a buffer strip of local native trees, shrubs, rushes and sedges between agricultural land and the waterway will help to reduce sediment and nutrients entering the brook or dams.

- The SoB is encouraged to ensure new dams comply with revegetation conditions.
- The cumulative impact of gully-wall dams on tributaries needs further investigation and consideration when approving dam applications.

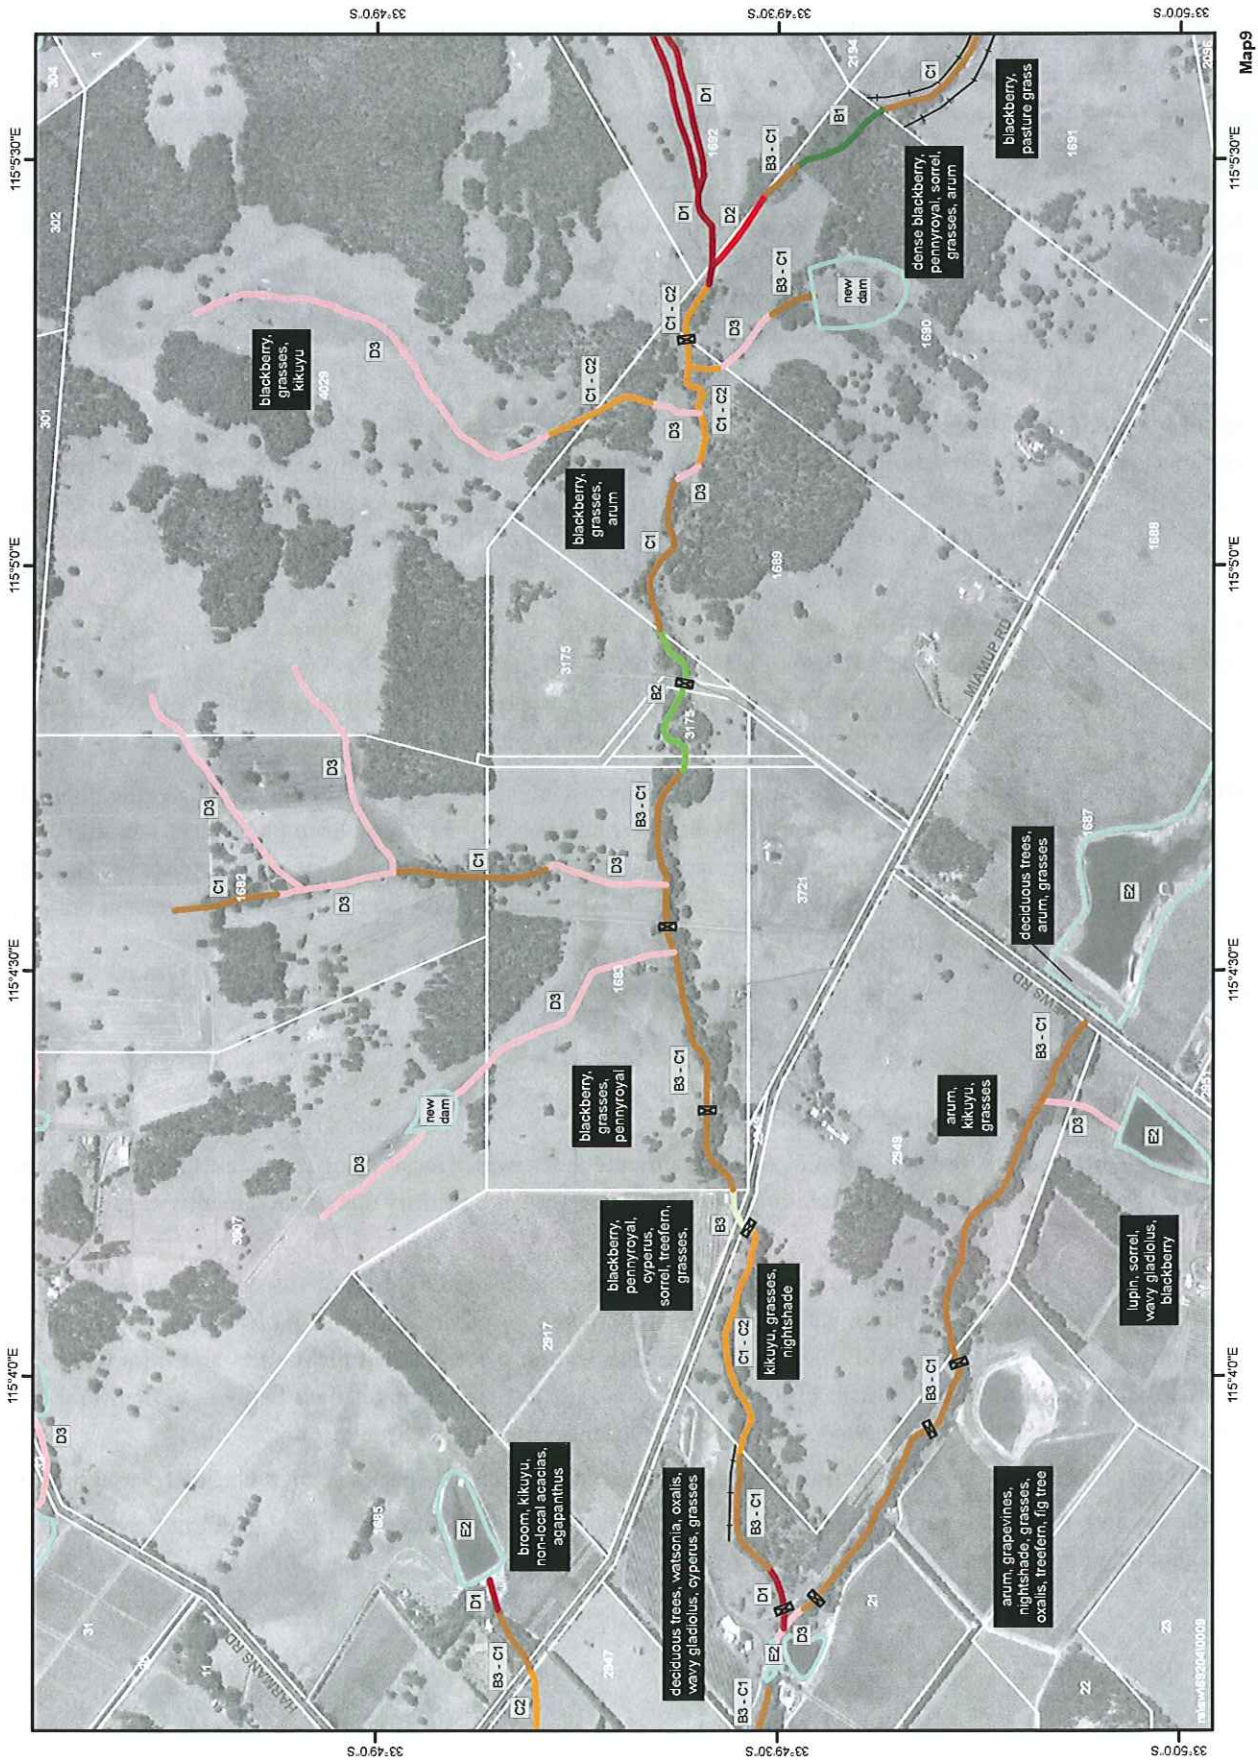
Wilyabrup Brook Map 9

- Assist regeneration of native vegetation and expand the riparian zone through planting of local native species. Appendix 1 contains a list of local species suitable for planting. See Section 6 for detailed techniques and information. In particular, establishing a buffer strip of local native trees, shrubs, rushes and sedges between agricultural land and the waterway will help to reduce any sediment and nutrients entering the brook or dams.

- The AMRSC and SoB are encouraged to ensure new dams comply with revegetation conditions.
- The cumulative impact of gully-wall dams on tributaries needs further investigation and consideration when approving dam applications.

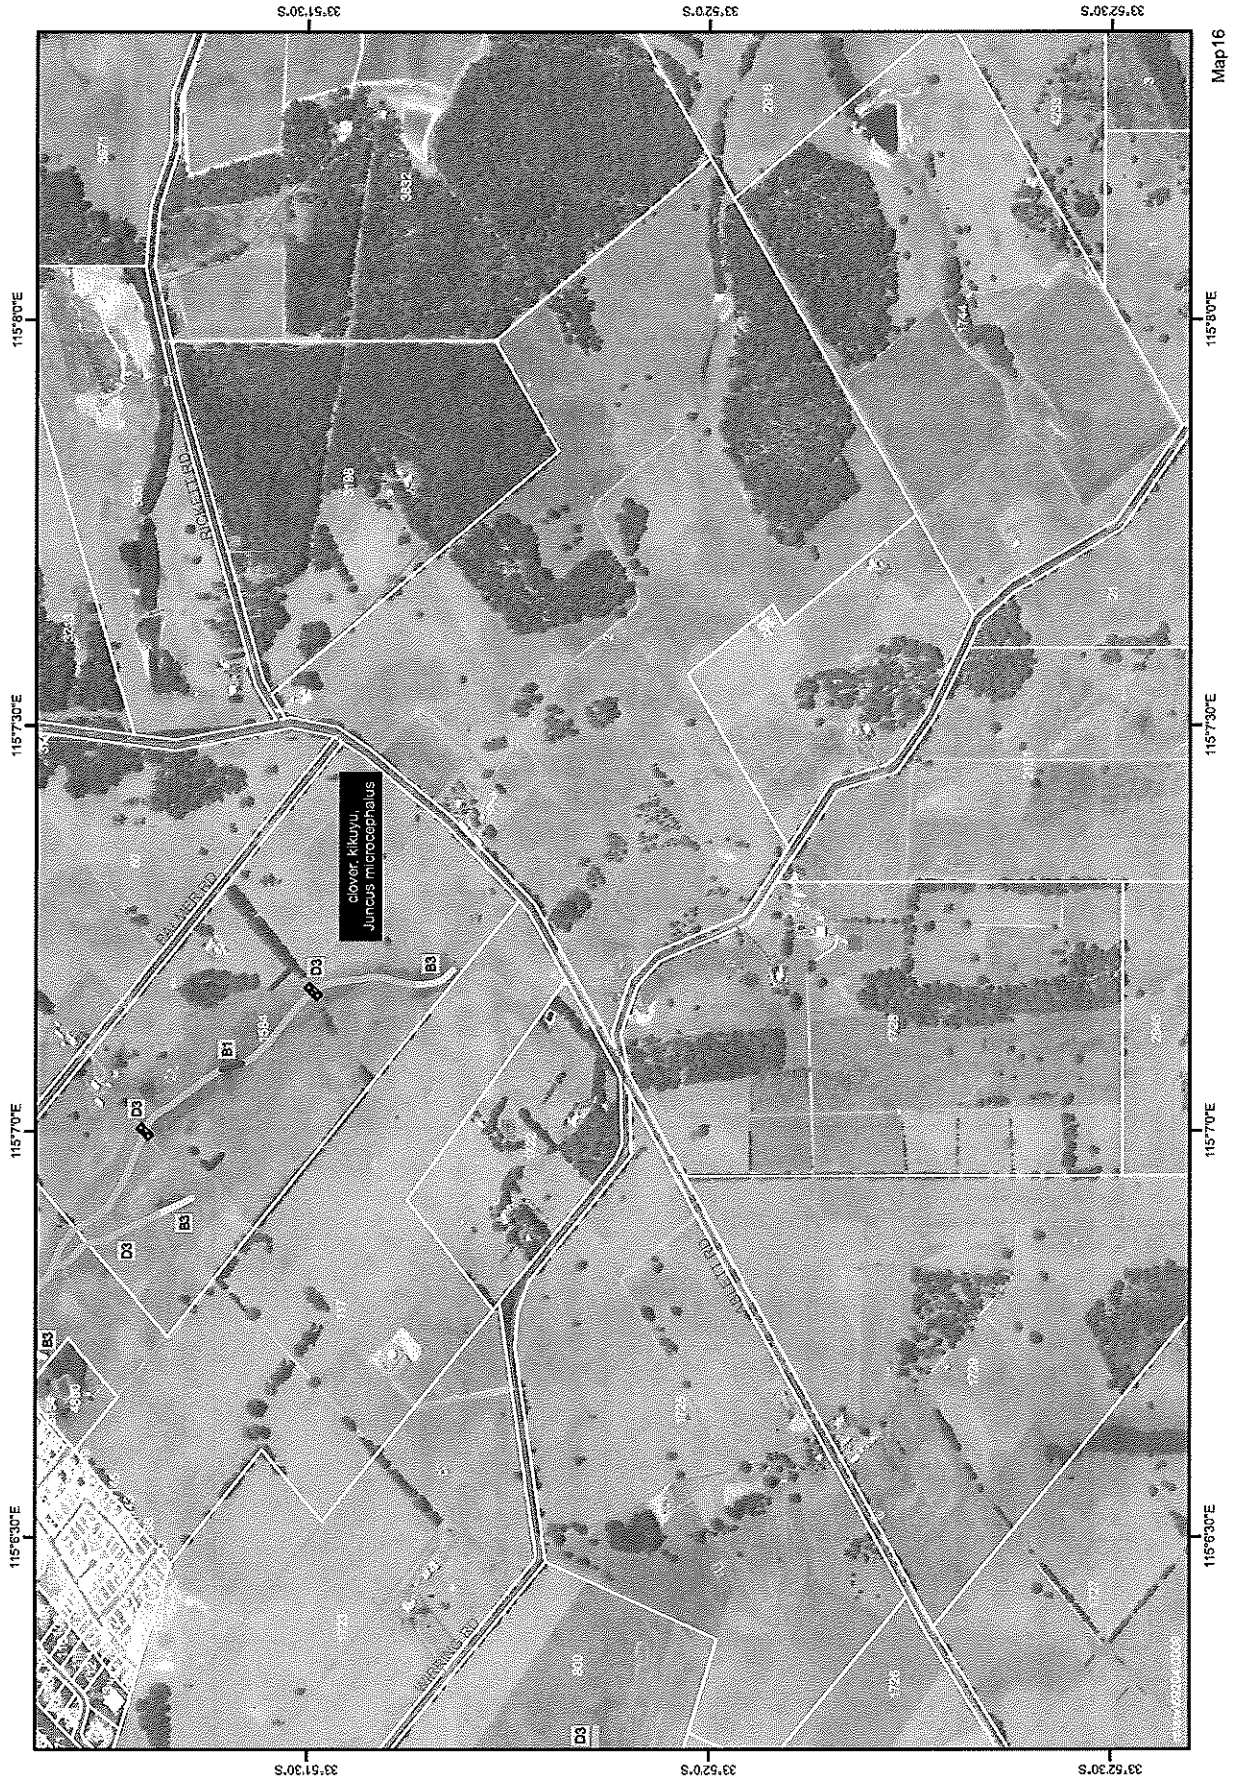
Wilyabrup Brook Map 16

This map shows the headwaters of the main channel which begins as broad wet area.

- Fence off the creek to restrict stock access, and provide stock water away from the creek to minimise bank damage and protect water quality.
- Regeneration of native vegetation will be limited once stock are excluded due to limited seed bank, weed invasion and soil compaction. Revegetation by planting of local native species after undertaking weed control is encouraged in this area. Appendix 1 contains a list of local species suitable for planting. See Section 6 for detailed techniques and information. In particular, establishing a buffer strip of local native trees, shrubs, rushes and sedges between agricultural land and the waterway will help to reduce sediment and nutrients entering the brook or dams.
