Turuwood Creek

This data report provides a summary of the nutrients at the Turnwood Creek sampling site in 2019 as well as historical data from 2005–19. This report was produced as part of Healthy Estuaries WA. Downstream of this site, the creek discharges to the Hardy Inlet.

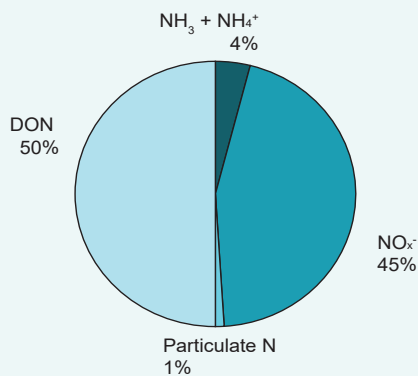
2019 average nitrogen fractions at site 6091758.

Total N is made up of different types of N. In 2019, Turnwood Creek had one of the largest average percentage of N present as nitrate (NO_x^-) of the nine sites sampled in the Blackwood River catchment. Nitrate is readily bioavailable to plants and algae to use to fuel rapid growth. The main source of nitrate was likely fertilisers. Most of the rest of the N was present as dissolved organic N (DON). This type of N consists mainly of degrading plant and animal matter, though it may also include other types. Most types of DON are not very bioavailable, though some are readily used by plants and algae to fuel growth. The large proportion of N present as nitrate is typical of an agricultural catchment where most of the N is coming from non-natural sources.

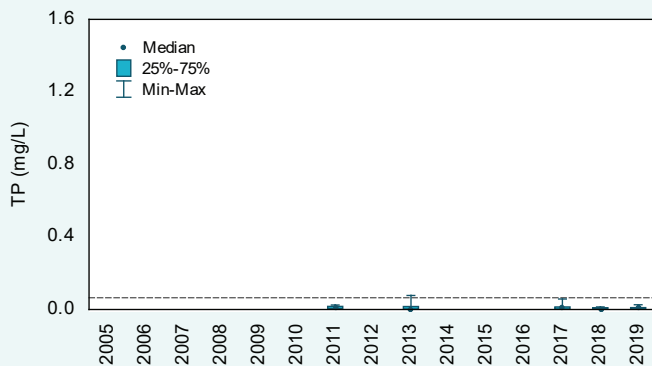
Total phosphorus concentrations, 2005–19 at site 6091758. The dashed line is the ANZECC trigger value.

Total phosphorus (TP) concentrations were low in Turnwood Creek with only one sample, collected in 2013, over the Australian and New Zealand Environment and Conservation Council (ANZECC) trigger value. Using the SWRWQA methodology, all years with sufficient data to graph were classified as having low TP concentrations. The high P-binding capacity of the soils present in the catchment contributed to the low P concentrations recorded.

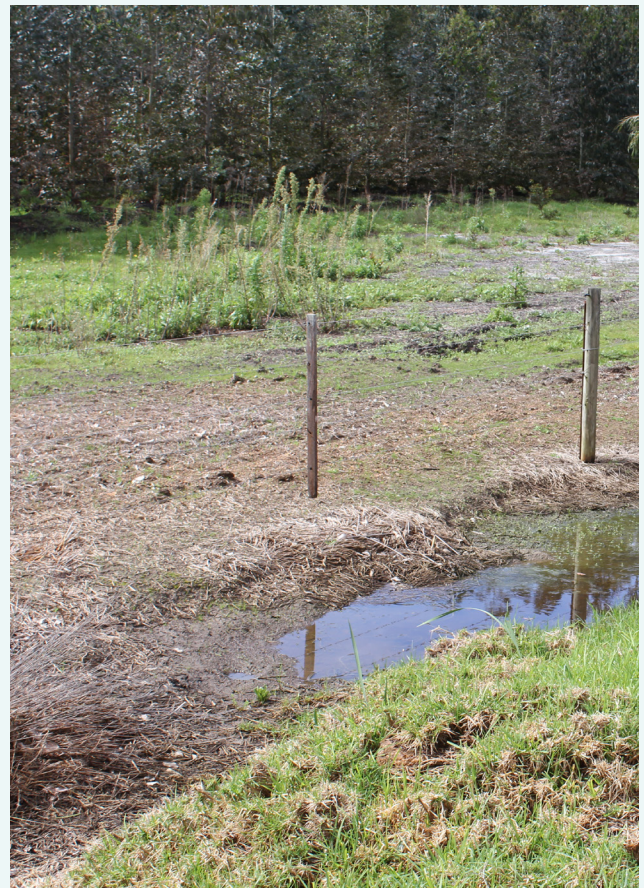
A shallow drain which runs between Fisher Road and the bluegum plantation and contributes flow to Turnwood Creek, September 2018.

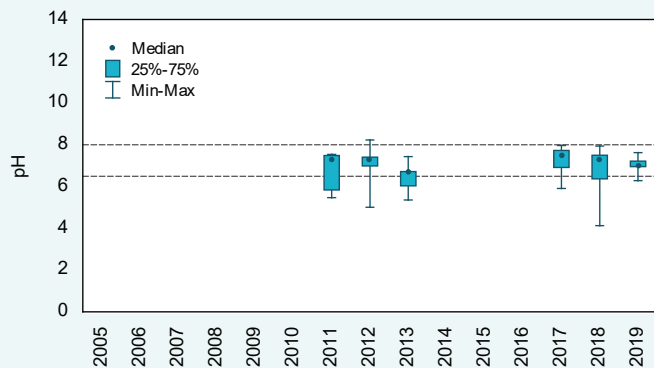
pH levels, 2005–19 at site 6091758. The dashed lines are the upper and lower ANZECC trigger values.

The median pH was within the upper and lower ANZECC trigger values in each of the years for which there were sufficient data to graph. Each year had a proportion of samples below the lower ANZECC trigger value, though in 2019 this was only one sample.

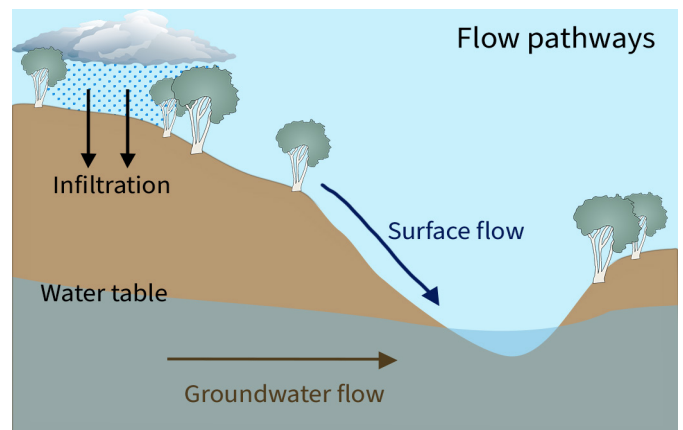
The schematic below shows the main flow pathways which may contribute nutrients, particulates and salts to the waterways. Connection between surface water and groundwater depends on the location in the catchment, geology and the time of year.
