Denmark River

This data report provides a summary of the nutrients at the two Denmark River sampling sites in 2019 as well as historical data from 2005–19. This report was produced as part of Healthy Estuaries WA. Downstream of the southern-most sampling site, the river discharges to Wilson Inlet.

Estimated loads and flow at Denmark Ag

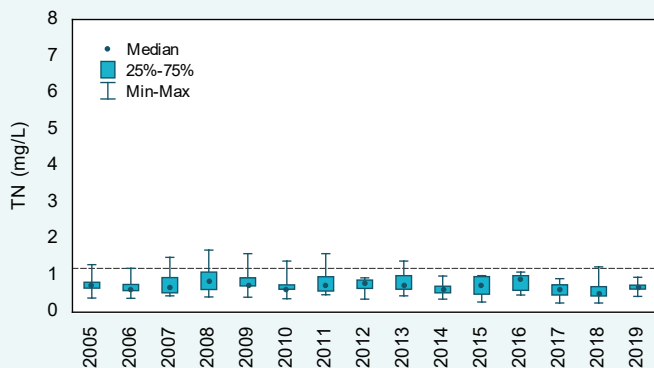
Denmark Ag

Total nitrogen concentrations, 2005–19 at site 603021. The dashed line is the ANZECC trigger value.

The two Denmark River sites had similar total nitrogen (TN) concentrations and all annual medians were below the Australian and New Zealand Environment and Conservation Council (ANZECC) trigger value. Using the State Wide River Water Quality Assessment (SWRWQA) methodology, all annual TN concentrations at both sites were classified as low.

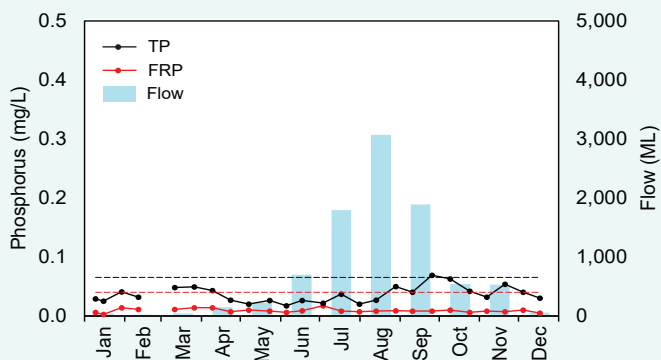
2019 phosphorus concentrations and monthly flow at 603021. The dashed lines are the ANZECC trigger values for the different P species.

P concentrations were very low in the Denmark River (below the relevant ANZECC trigger values) on all sampling occasions bar one in September at the Denmark Ag site which was just above. TP and phosphate concentrations fluctuated slightly throughout the year. During the drier months, the majority of the P was entering the river via groundwater and in-stream sources, with surface flows contributing less. During the wetter months, surface flows contributed proportionally more P.

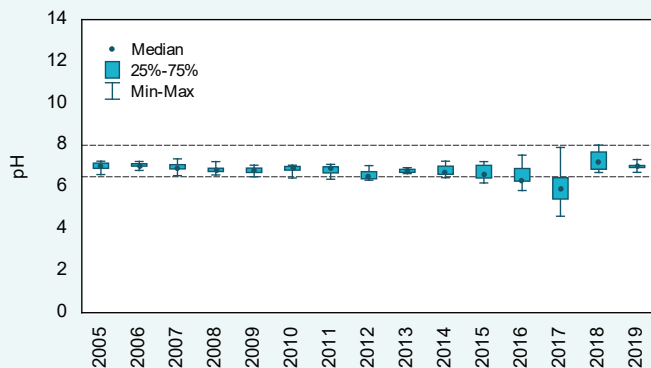
Denmark Ag

pH levels, 2005–19 at site 603021. The dashed lines are the upper and lower ANZECC trigger values.

pH fluctuated over the reporting period at both sites in the Denmark River. In 2019, all samples bar one at Denmark ML fell within the upper and lower ANZECC trigger values suggesting that pH at these sites is within the bounds required for a healthy ecosystem.

There is some concern the probe used to collect the pH data from the catchments of Wilson Inlet (including the Denmark River sites) was not functioning correctly from about October 2016 to October 2017. This may have caused the low pH shown in the graphs below. After October 2017, a new probe was used and the pH values increased and stabilised. Although there is no way of verifying the 2016–17 data, they have still been presented here.

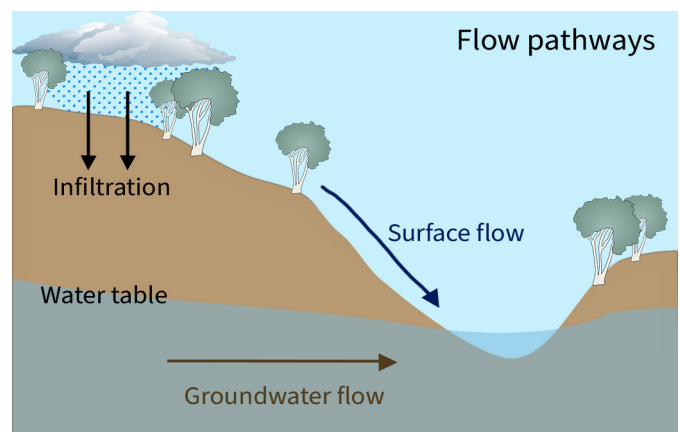
The schematic below shows the main flow pathways which may contribute nutrients, particulates and salts to the waterways. Connection between surface water and groundwater depends on the location in the catchment, geology and the time of year.
