RAPIDS LANDING LIFESTYLE COMMUNITY STRUCTURE PLAN

**Lot 9014 John Archibald Drive, Margaret
River**

Project Contact: Glenn Ahola
Project Job Code: 00100
Identification No: AUGU/2021/____ - 1
Date: 30 January 2024

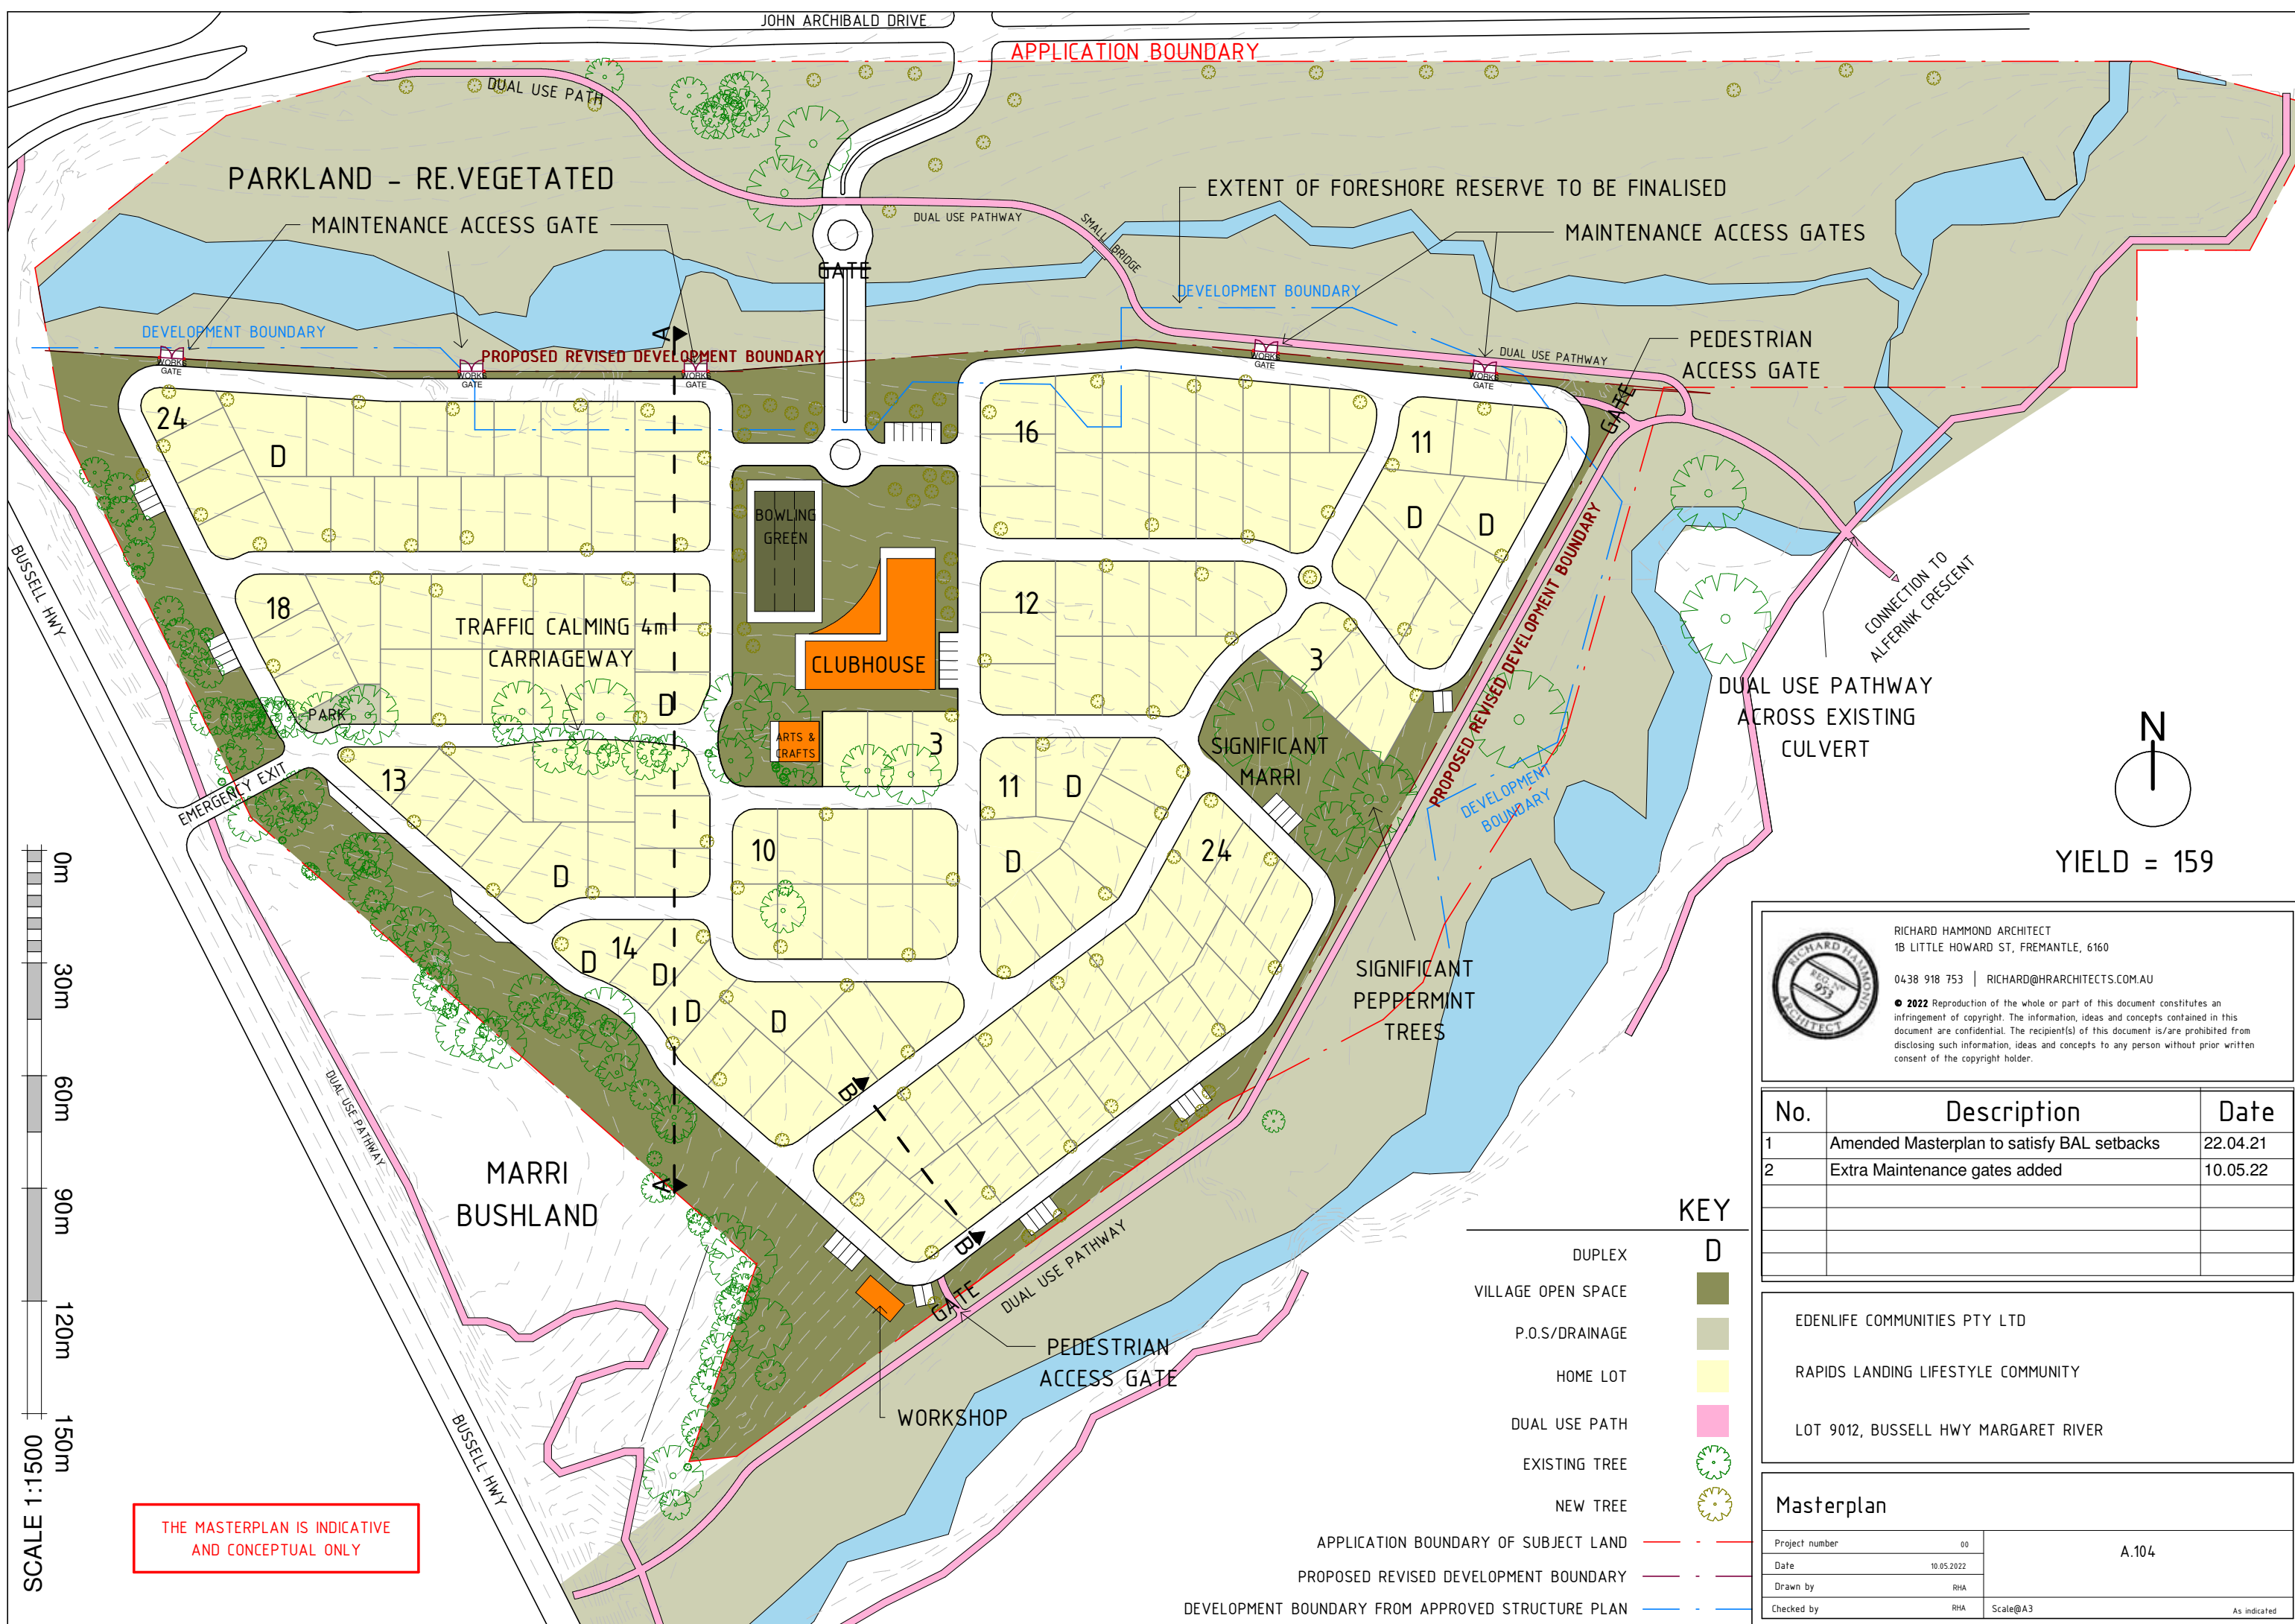
**Rapids Landing Community Village Master Plan
(Richard Hammond Architects)**

SCALE 1:1500
 0m
 30m
 60m
 90m
 120m
 150m

THE MASTERPLAN IS INDICATIVE AND CONCEPTUAL ONLY

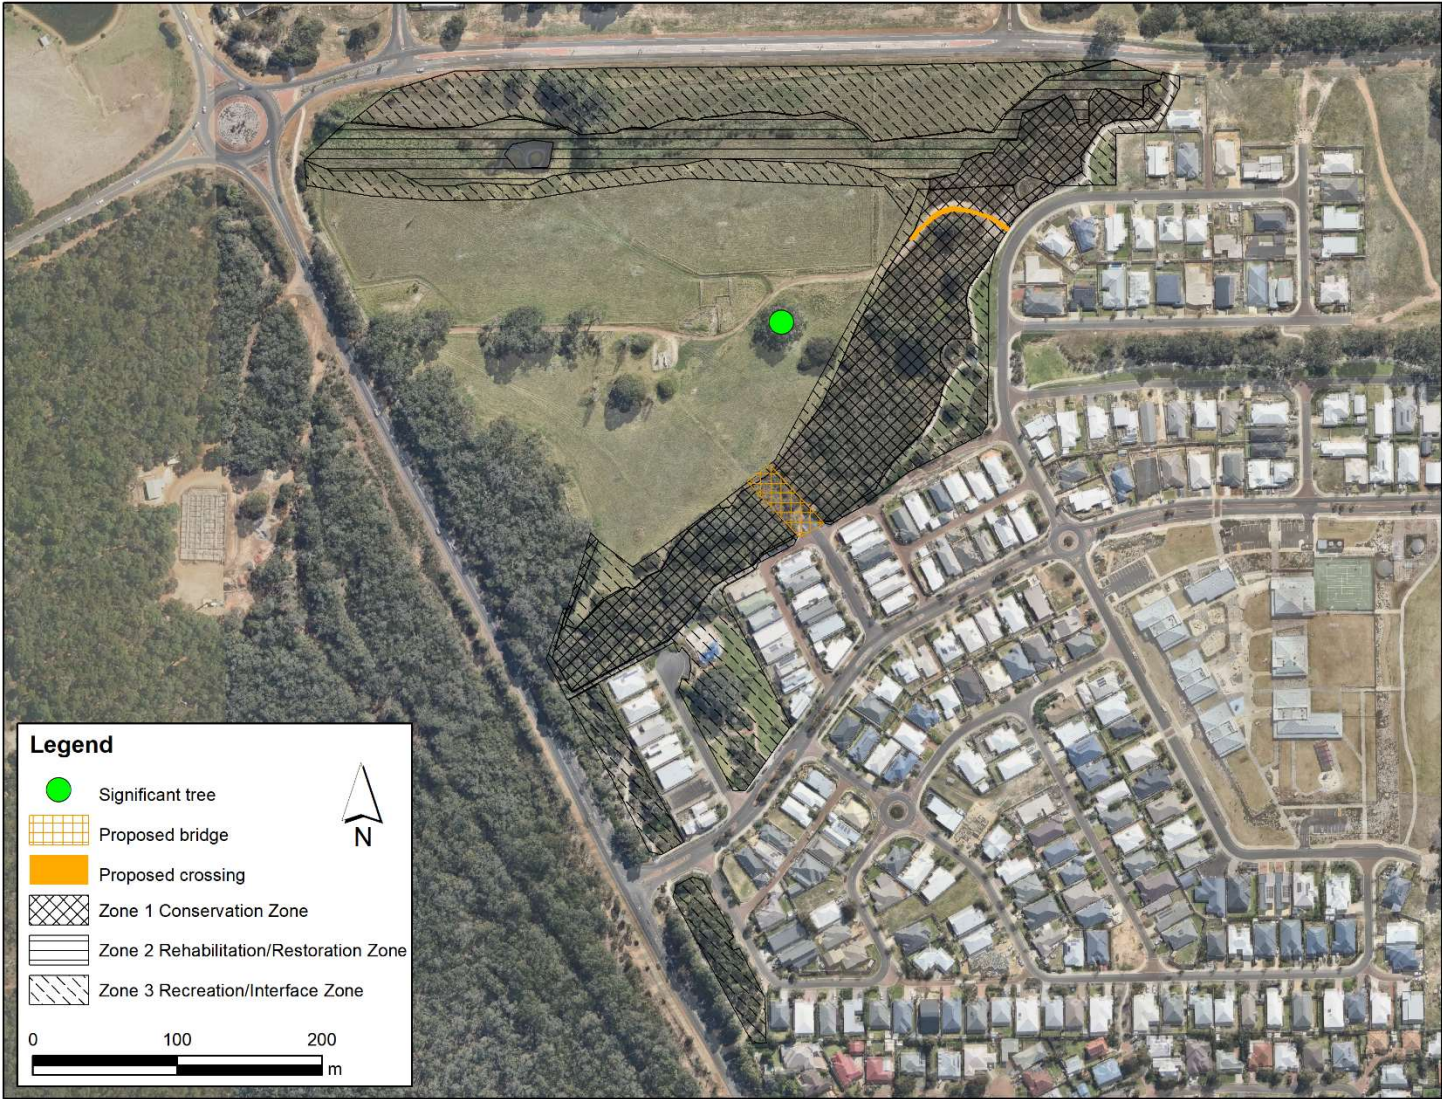
Map 5: Management zones

Semi-aquatic and weed species located in waterlogged zones include *Juncus microcephalus*, *Isolepis prolifera* and *Juncus bufonius*. These provide habitat functions and control is problematic due to the duration of inundation. The SAMR invasive species prioritization process does not require control of these species unless in small populations and there is sufficient native vegetation to meet bank stability and habitat requirements.

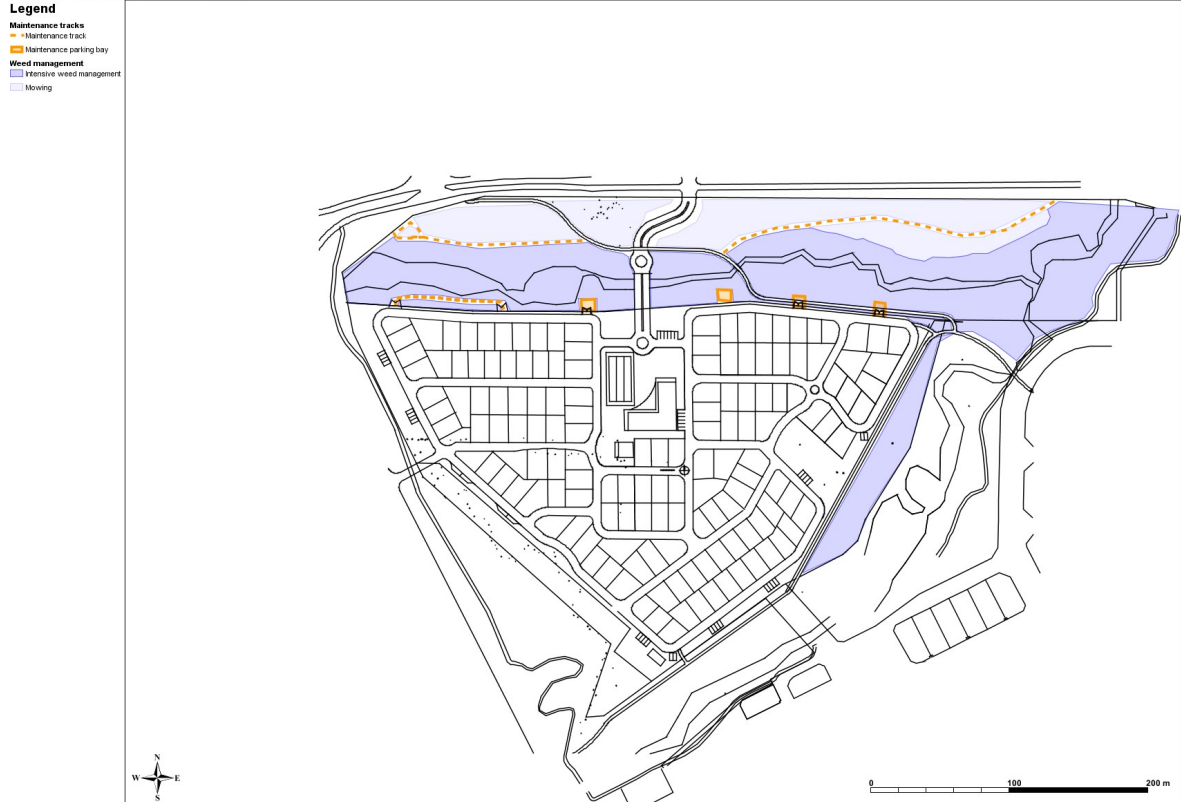
Figure 2:

Proposed weed management

Monthly monitoring of weed growth should be sufficient in the riparian zones and appropriate control methods implemented as necessary. More frequent maintenance will be necessary in the landscape and peripheral interfaces between the native vegetation and recreational areas.

Regular mowing between the trees is suggested for the higher areas.

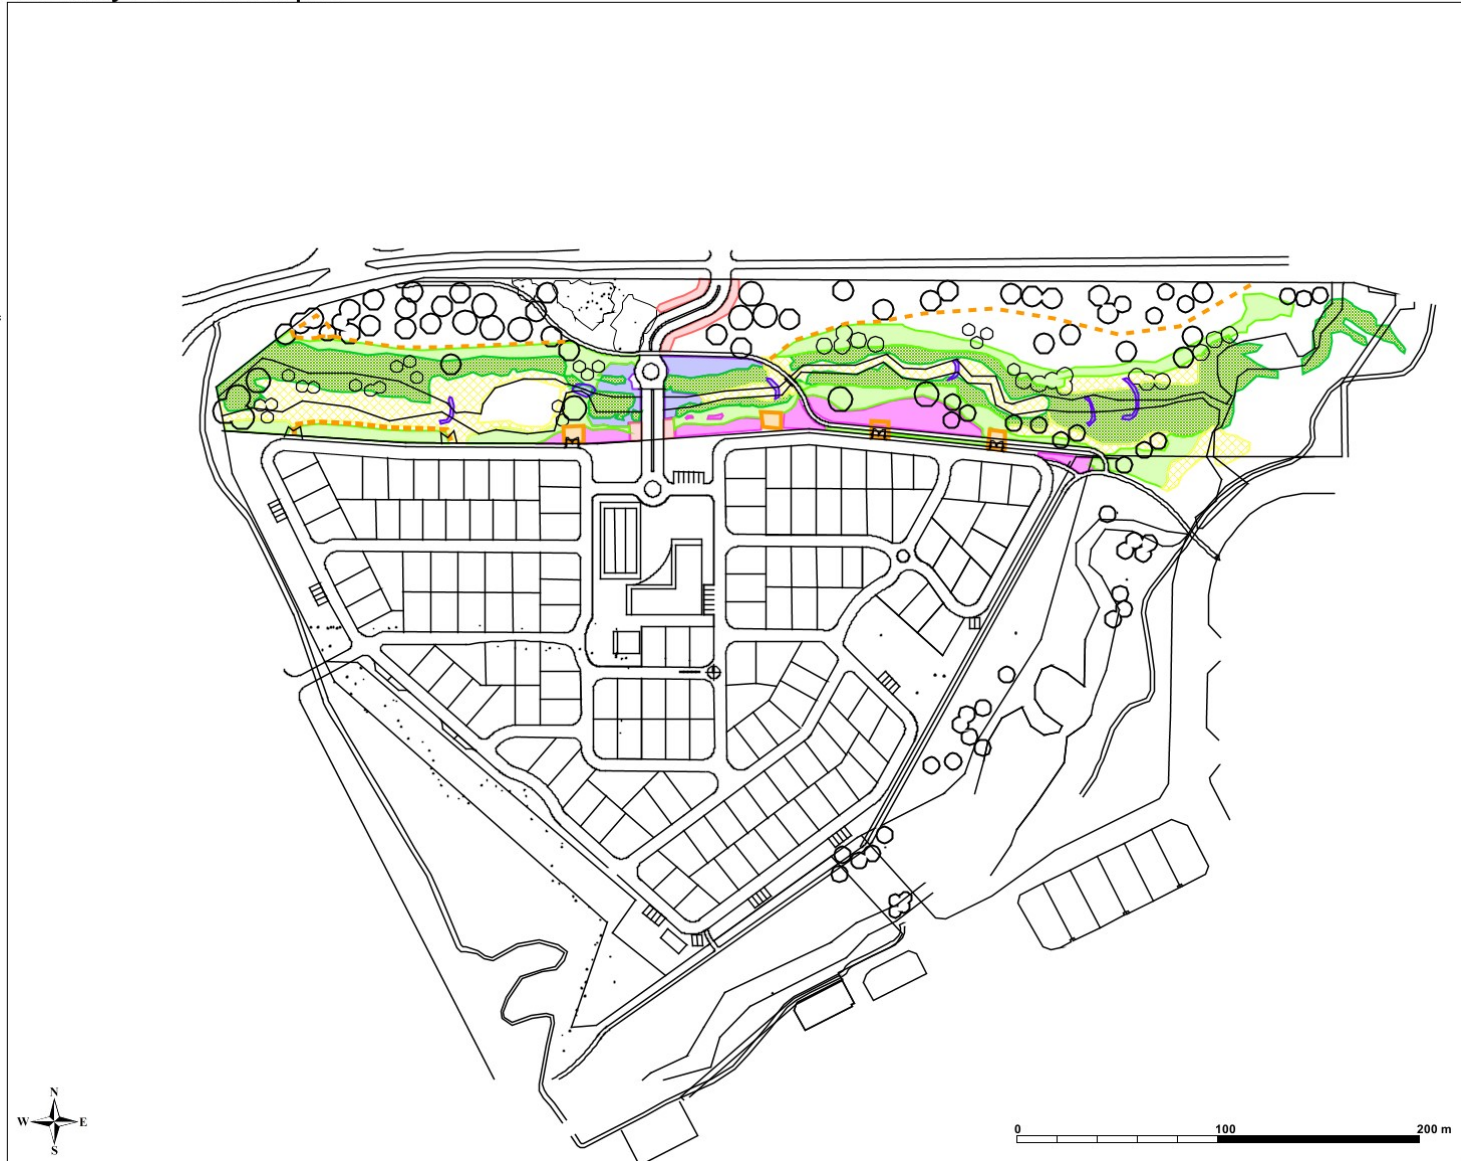
- Maintenance tracks**
- Maintenance track
- Maintenance parking bay
- Proposed riffle**
- Rock boulder placement
- Proposed trees**
- Large tree
- Medium tree
- Small tree
- Proposed landscape planting**
- Cultivar kangaroo paw
- Low dense shrubland
- Low dryland sedges and rushes
- Shallow emergent sedges/rushes
- Tall shrubland over dense sedges/rushes
- Wetland kangaroo paw mixed with cultivars

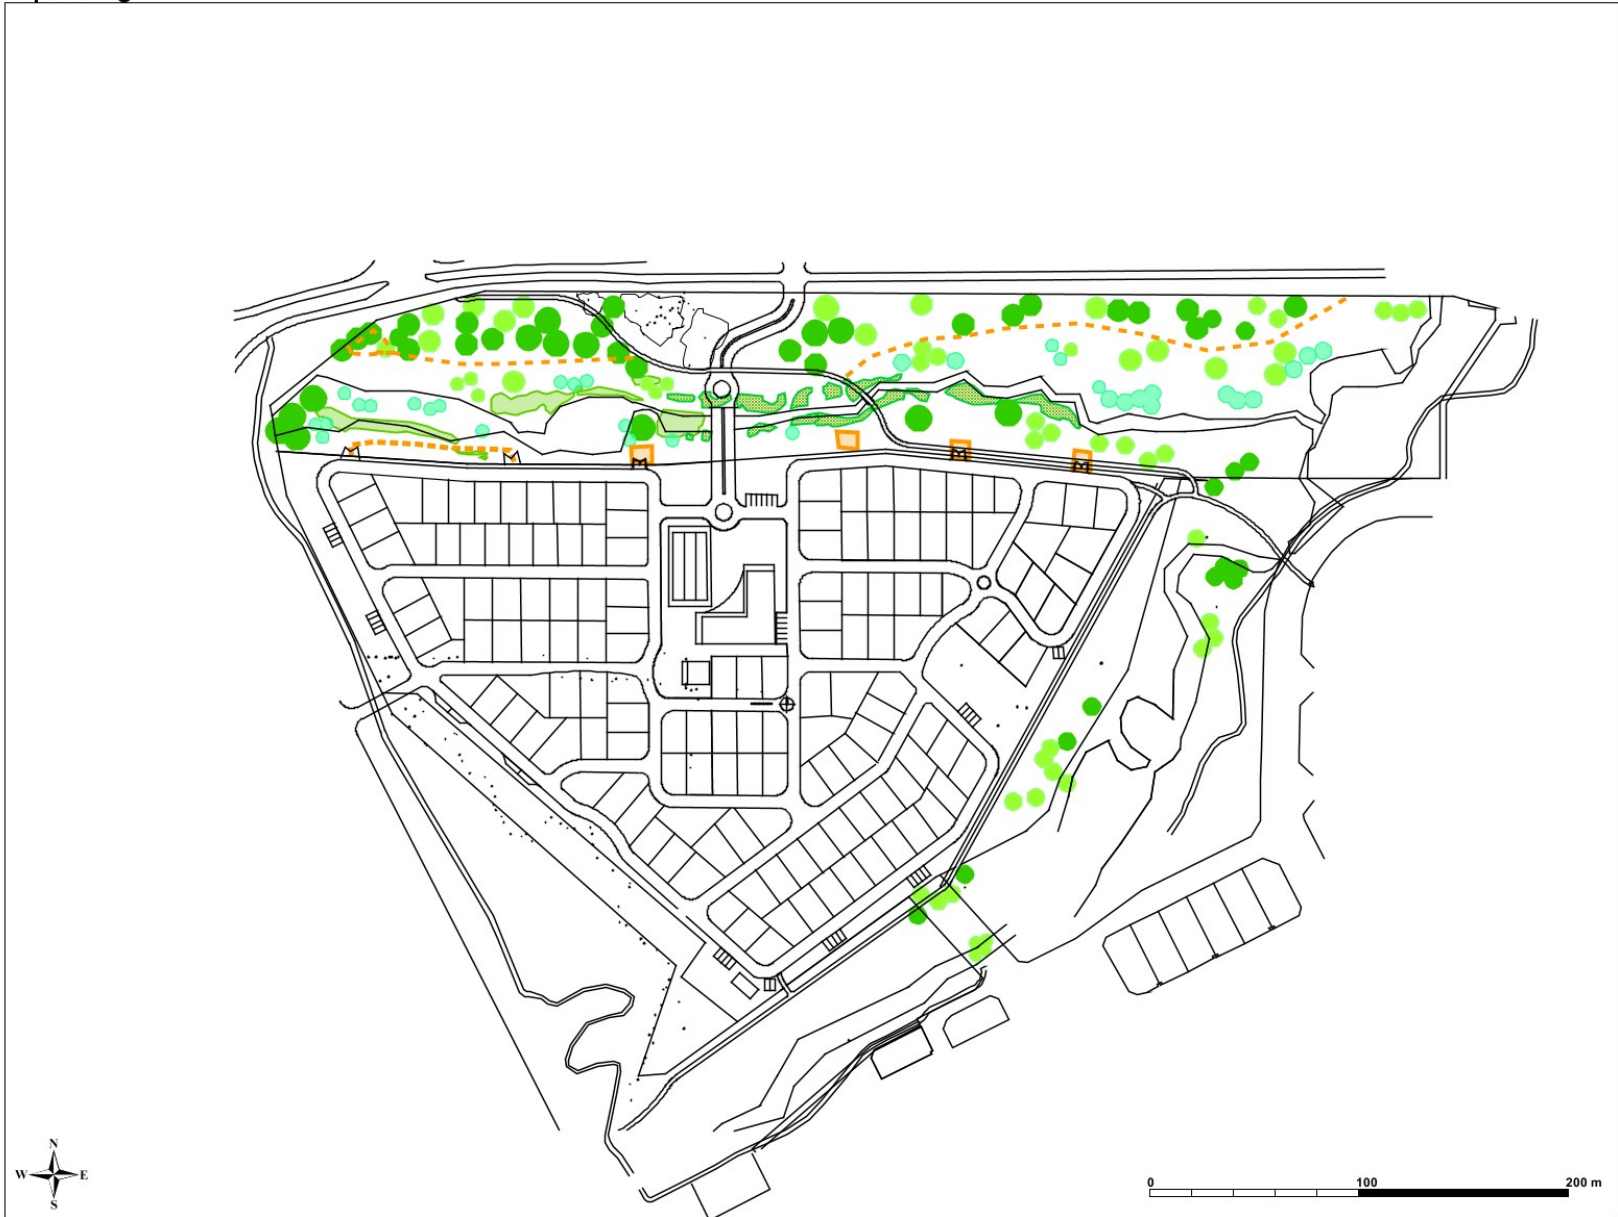
Figure 4: Proposed tree planting

- Maintenance tracks
 - Maintenance track
 - Maintenance parking bay
- Proposed trees
 - Large tree
 - Medium tree
 - Small tree
- Existing vegetation
 - Existing sedgeland
 - Tall shrubland

It is proposed that a mixture of tree strata be used to screen the development from John Archibald Drive (Figure 4) and that these include the following taxa:

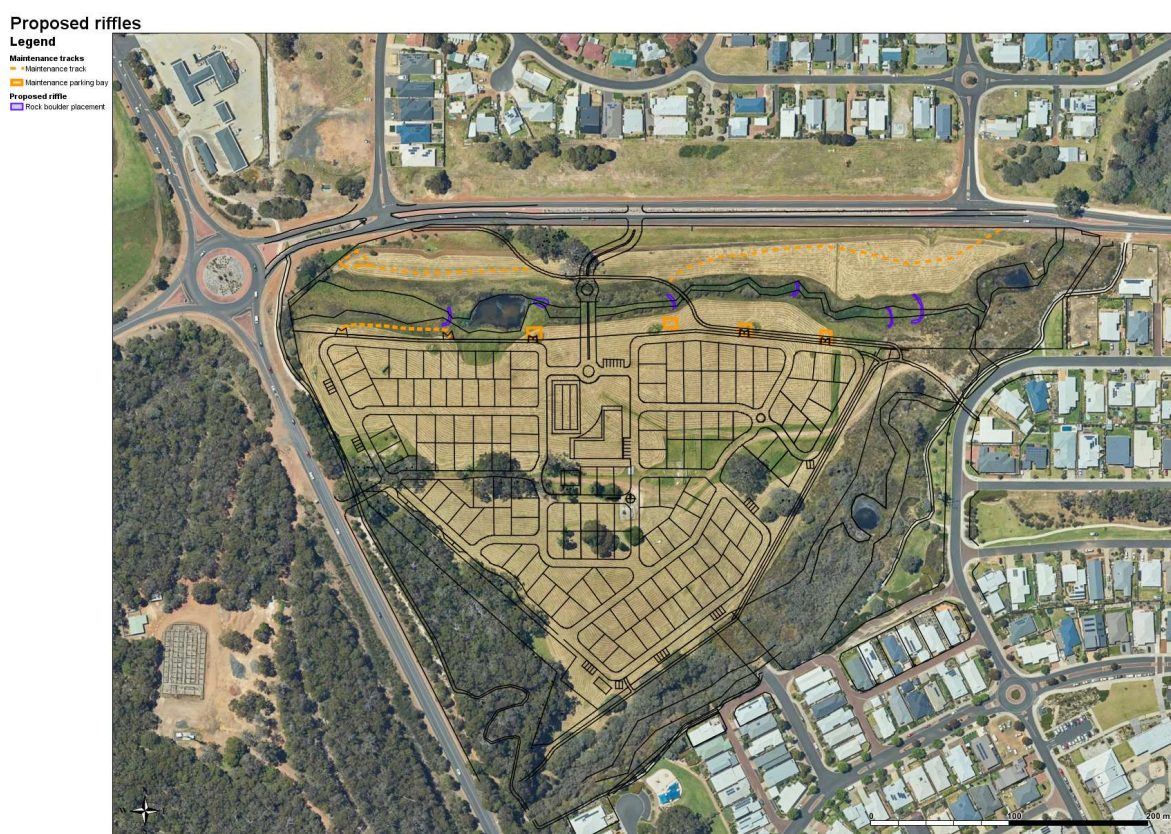
Figure 5: Proposed riffles

The existing dam on the northern tributary will require minor earthworks to batter the banks to a suitable slope. The preferred slope is 1:8 (vertical:horizontal aspect), preferably with benches to enable at least 3 m wide plantings of wetland species with the same preferred inundation tolerance. Any sediment removed in this process can be used to top dress future planting and/or landscaping areas.

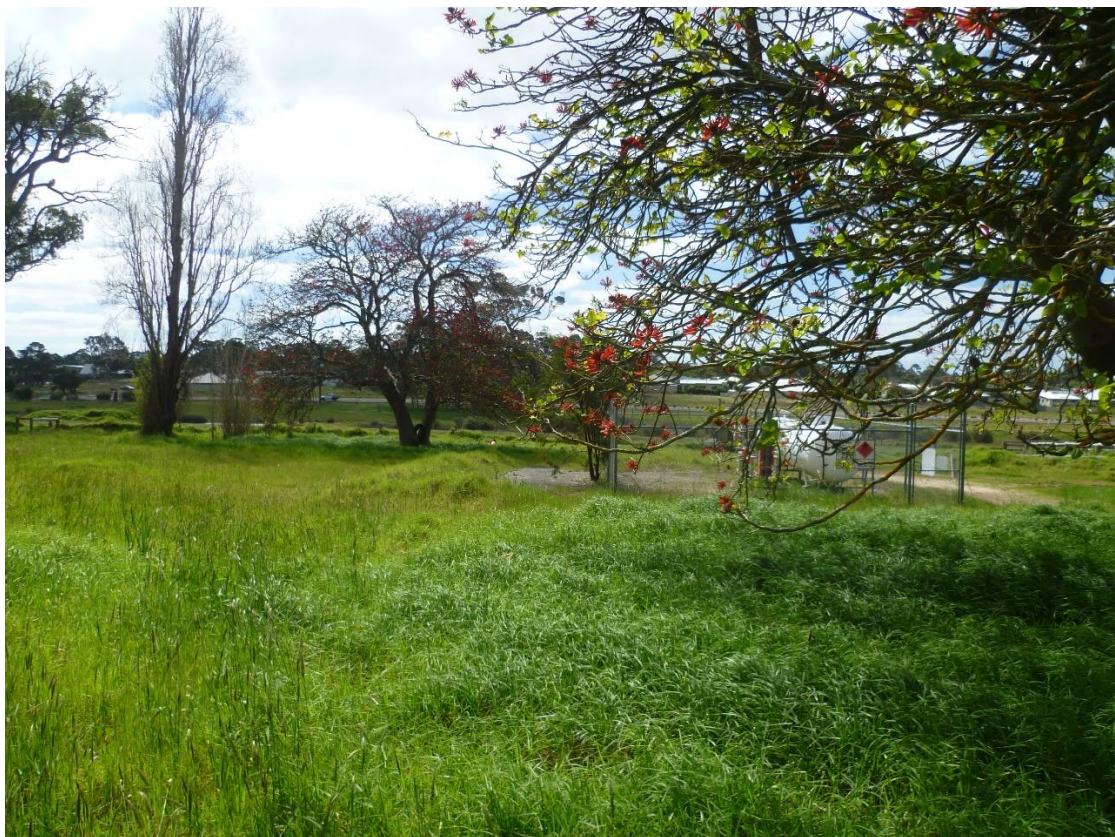
FIGURE 5: GAS TANK AND OLD FARMHOUSE SITE

The existing infrastructure consists of an old stockyard, a domestic LPG distribution tank, an underground gas distribution pipeline, and obsolete fencing.

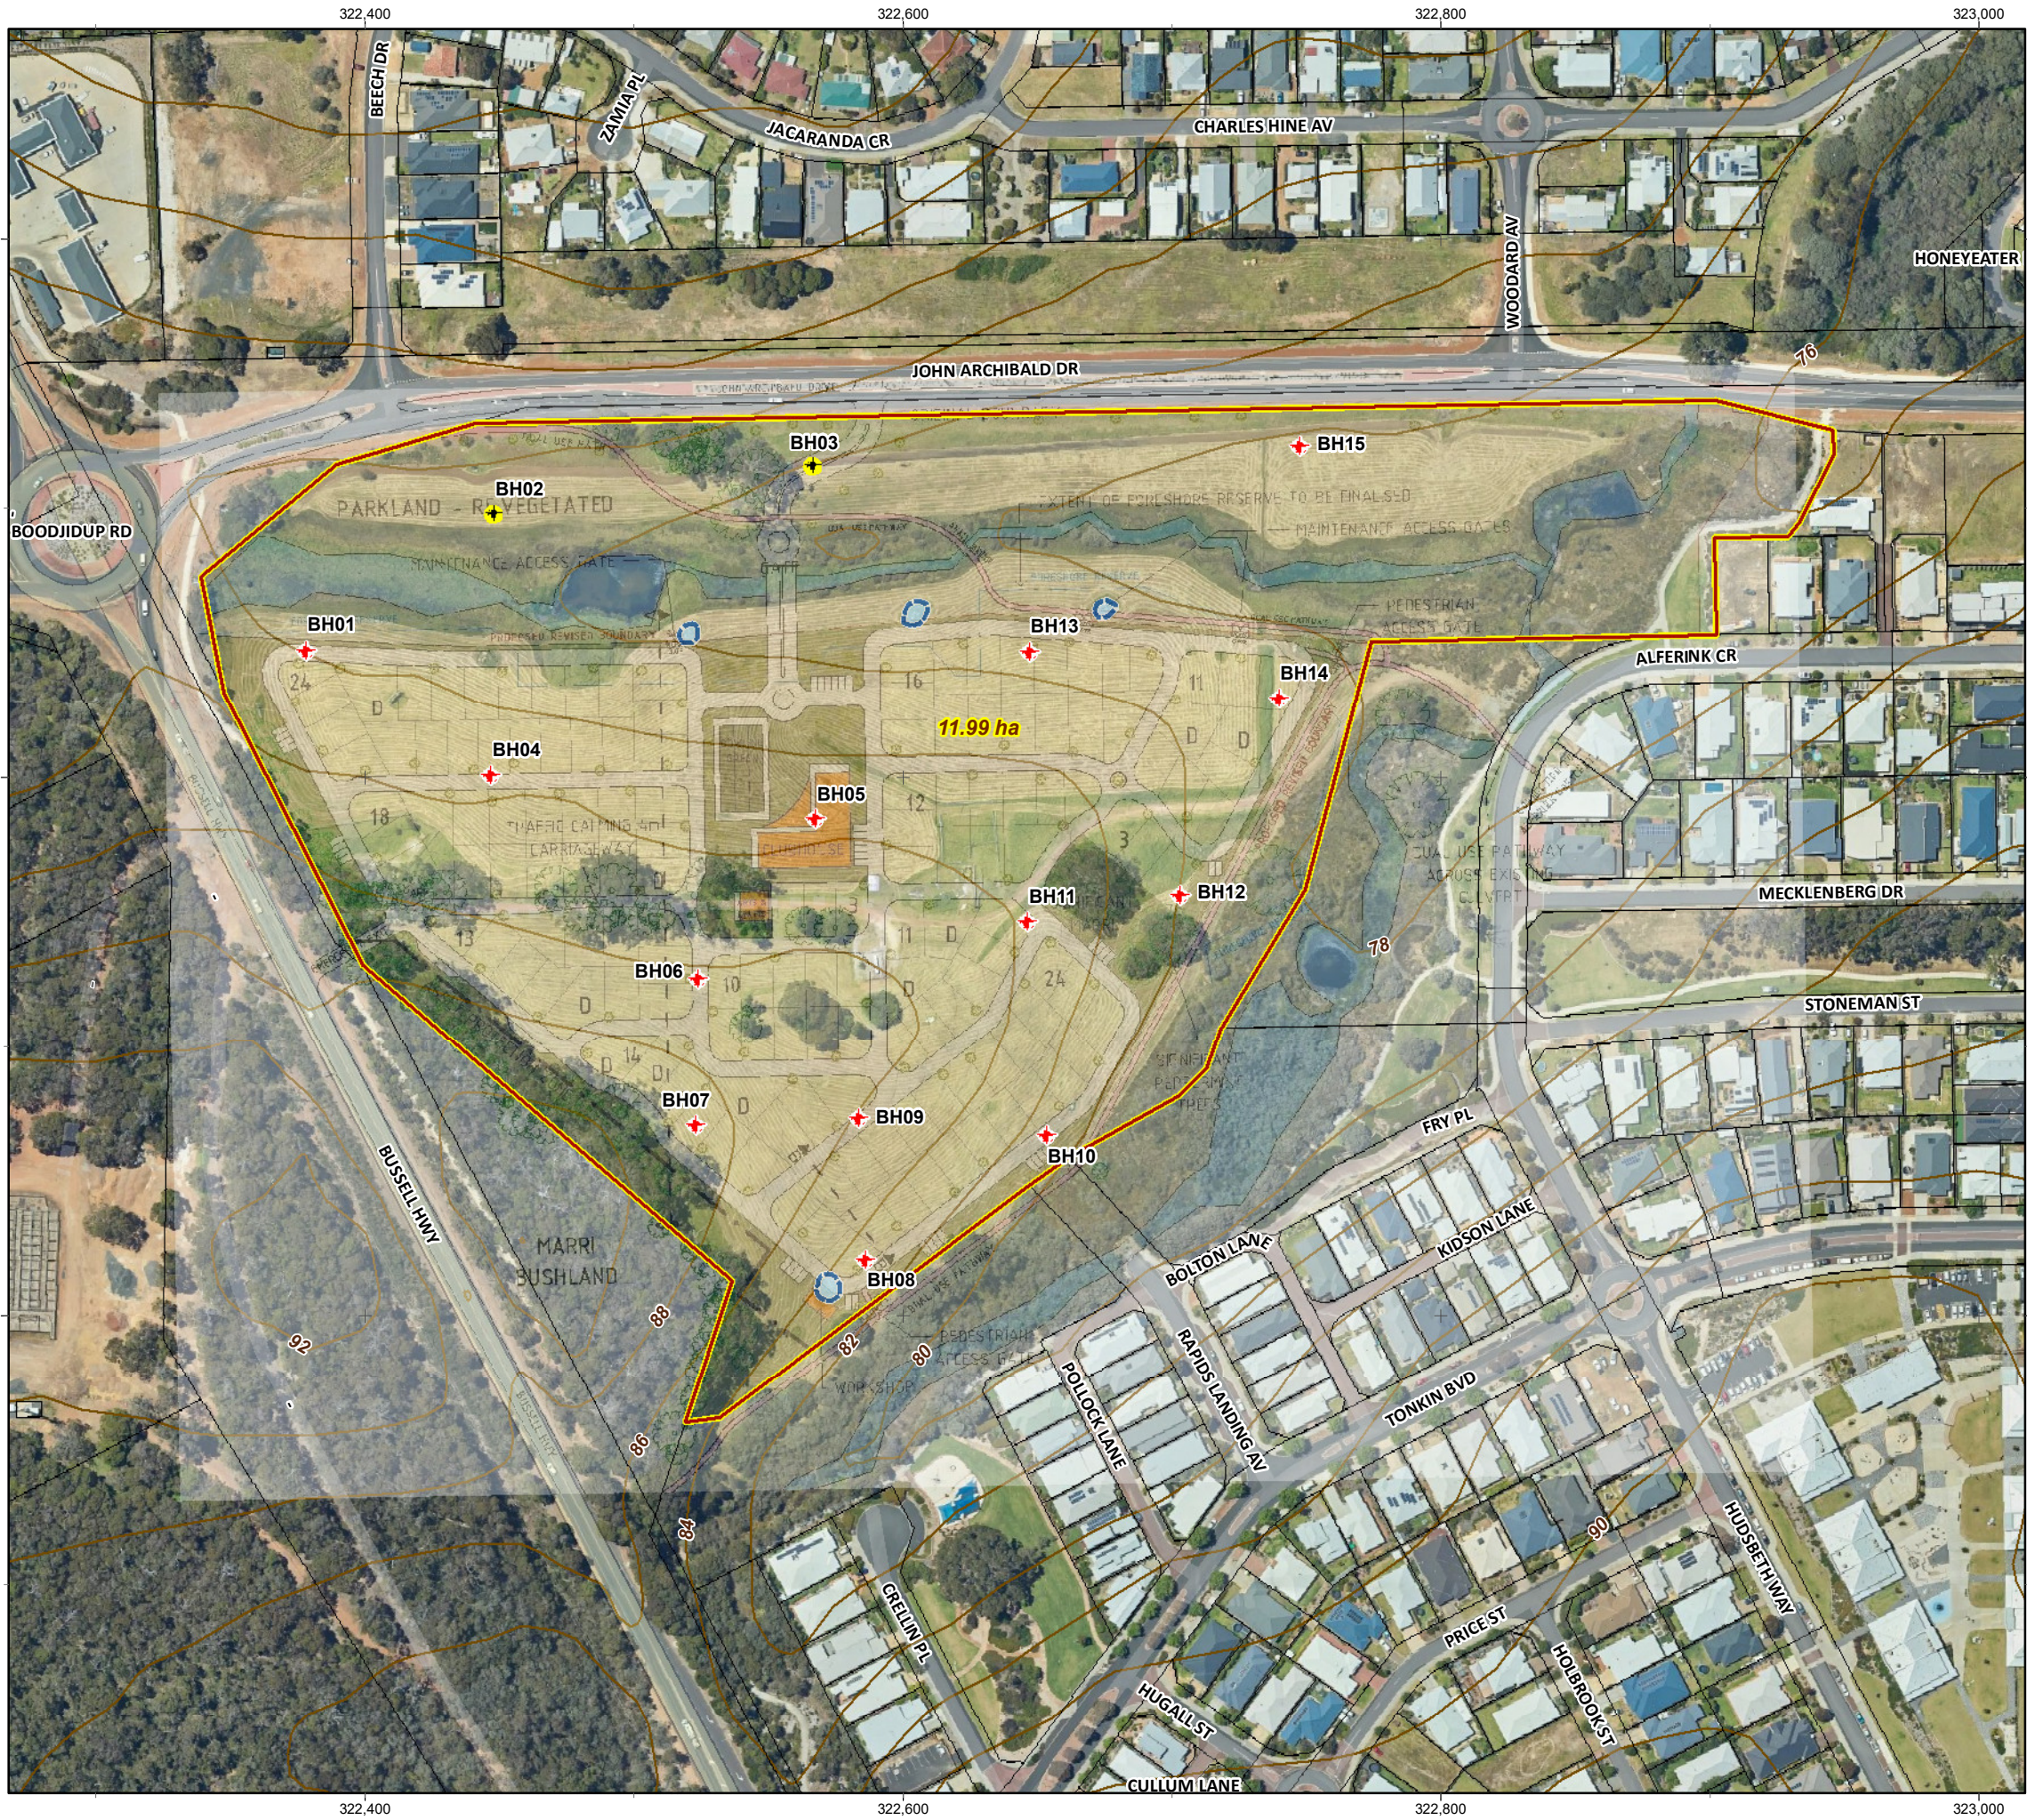
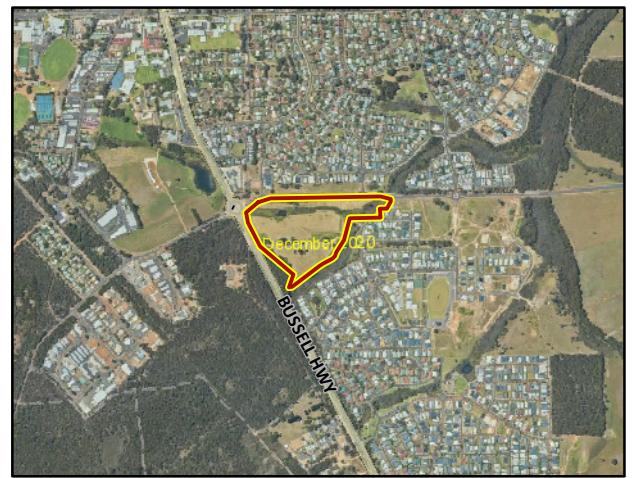
Figures

- Legend**
- Site Boundary
 - Stockpiles of loose rock boulders
 - + Borehole
 - + Borehole not conducted due to access constraints

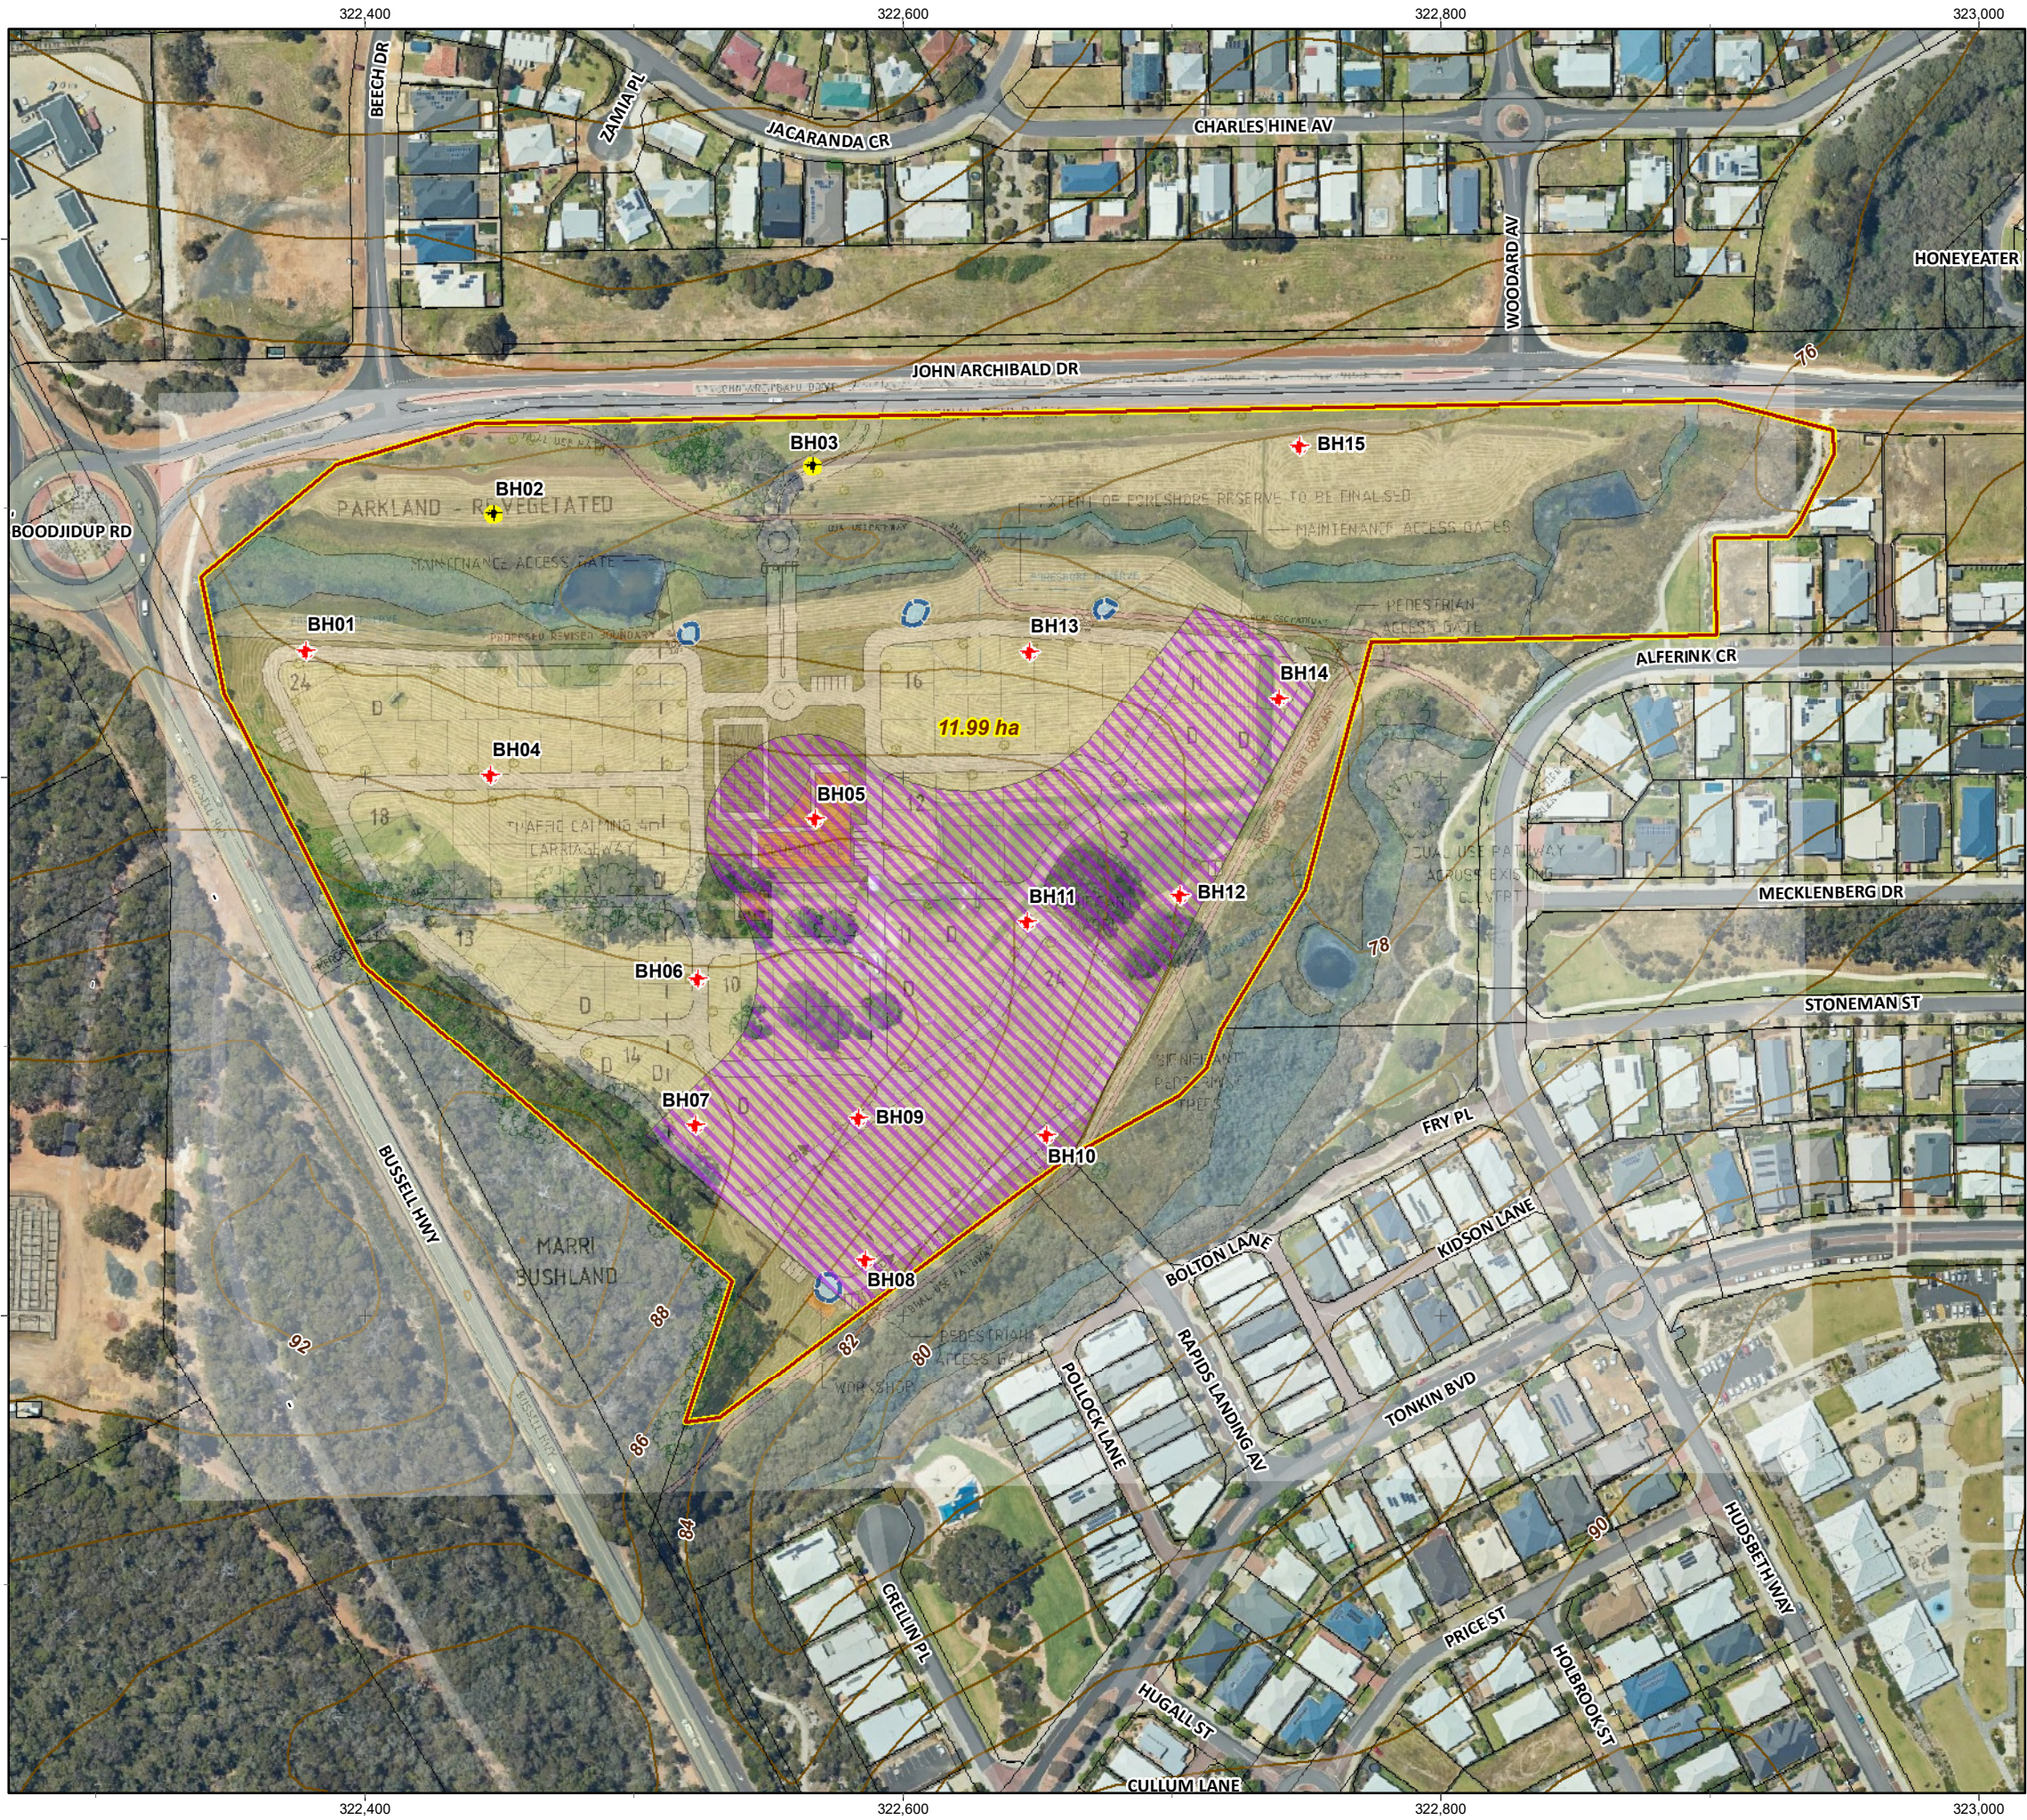
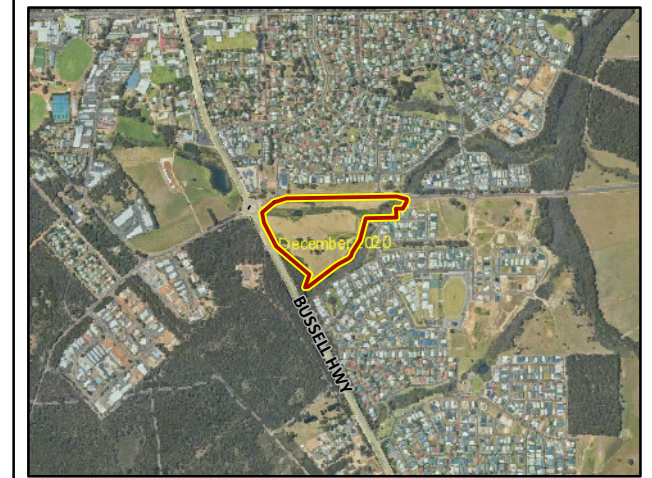
Job No	J2001180	Fig No	FIGURE 1	Rev	A
--------	----------	--------	----------	-----	----------

- Legend**
- Site Boundary
 - Stockpiles of loose rock boulders
 - 0.4 - 0.7m SAND/GRAVEL overlying clayey strata
 - + Borehole
 - + Borehole not conducted due to access constraints
